Open File Report 91-1

**Identification and Remediation  
of a Mine Flooding Problem in Rico,  
Dolores County, Colorado  
with a Discussion on the Use of Tracer Dyes**

By Mark W. Davis

Colorado Geological Survey  
Division of Minerals and Geology  
Department of Natural Resources  
Denver, Colorado  
1994

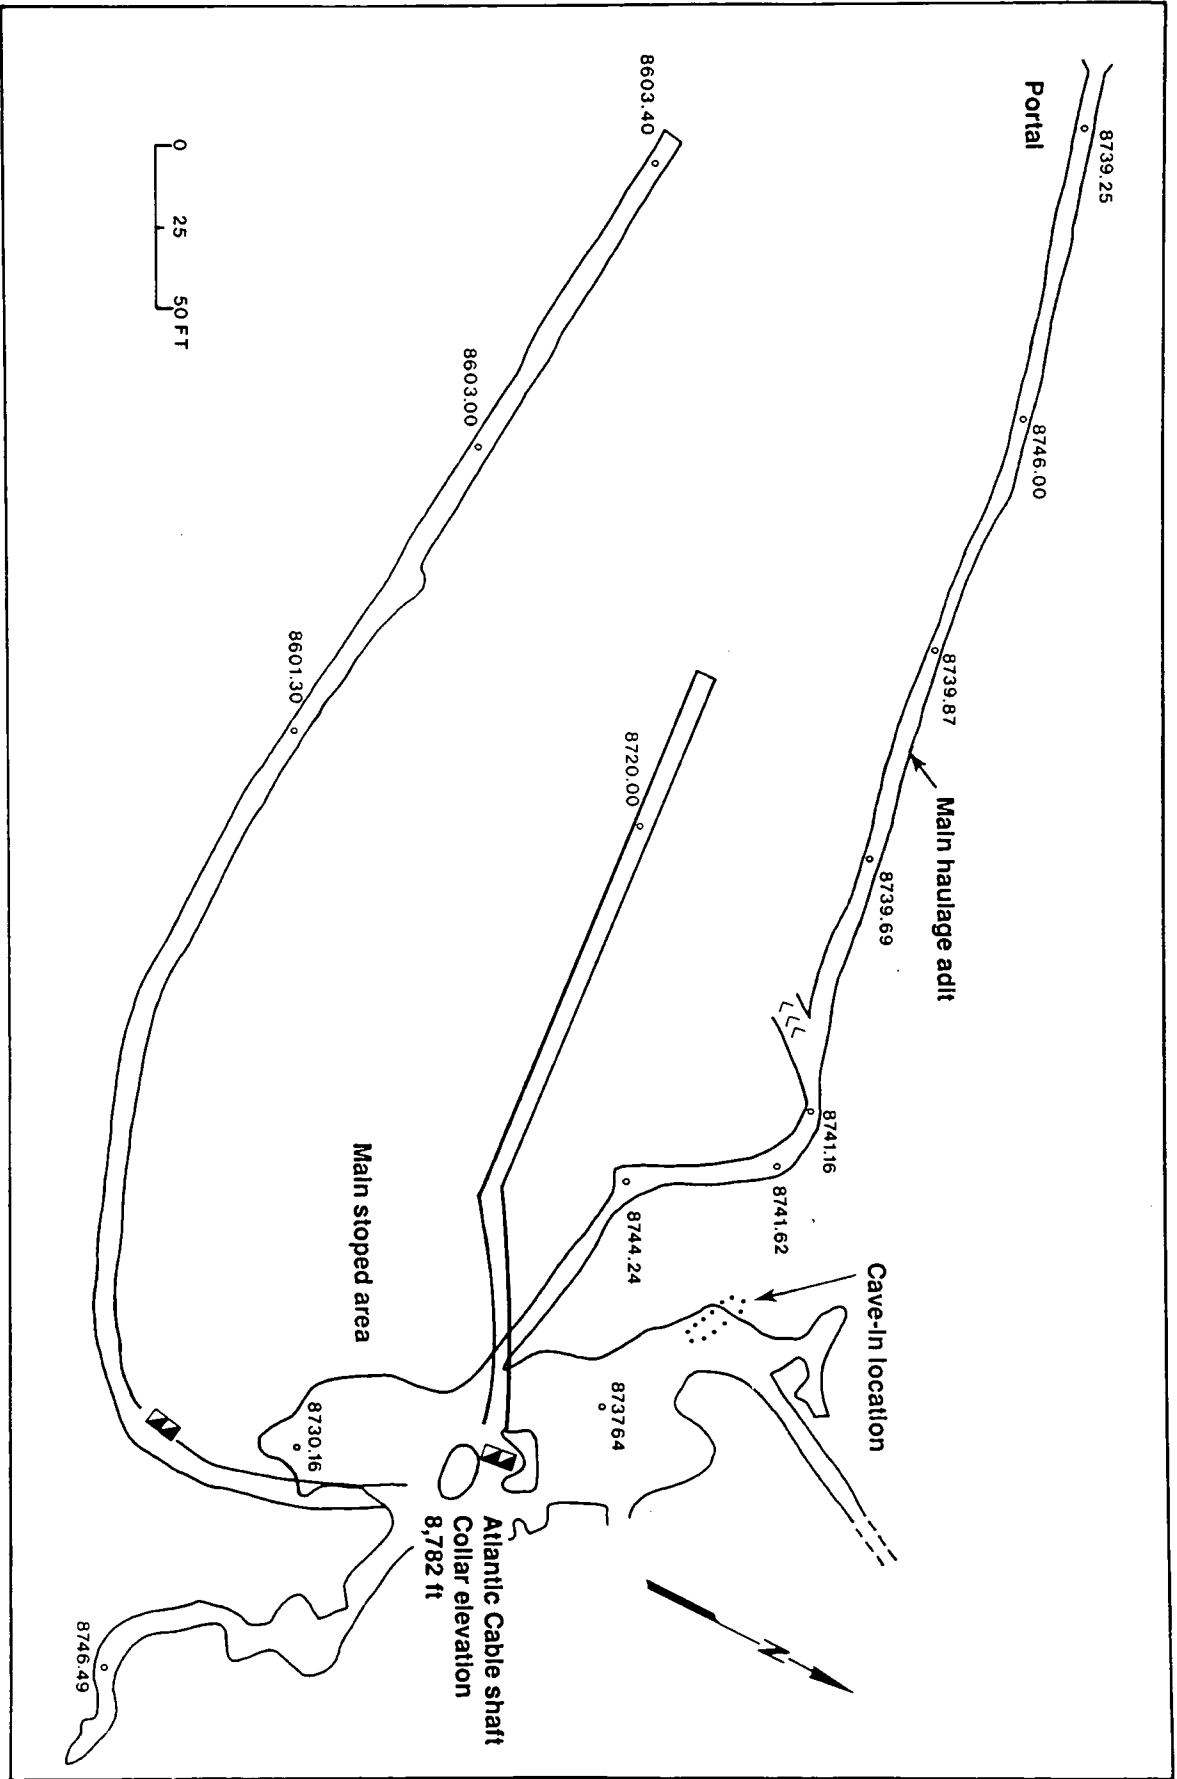
Figure 3. Atlantic Cable Mine, main haulage adit and exploration drifts.

Another map in the Dolores County Courthouse files, titled "The Van Winkle and Atlantic Cable Mines, Rico Argentine Mining Company Map 7-104" includes the west adit and shows no mining near this west adit but does show additional development headings driven from the 8600-ft level to the west and from an intermediate level assumed to be at the 8720-ft elevation. The longer of these two exploration drifts is shown on company maps to extend approximately 400 ft west of the Atlantic Cable shaft (Figure 3).

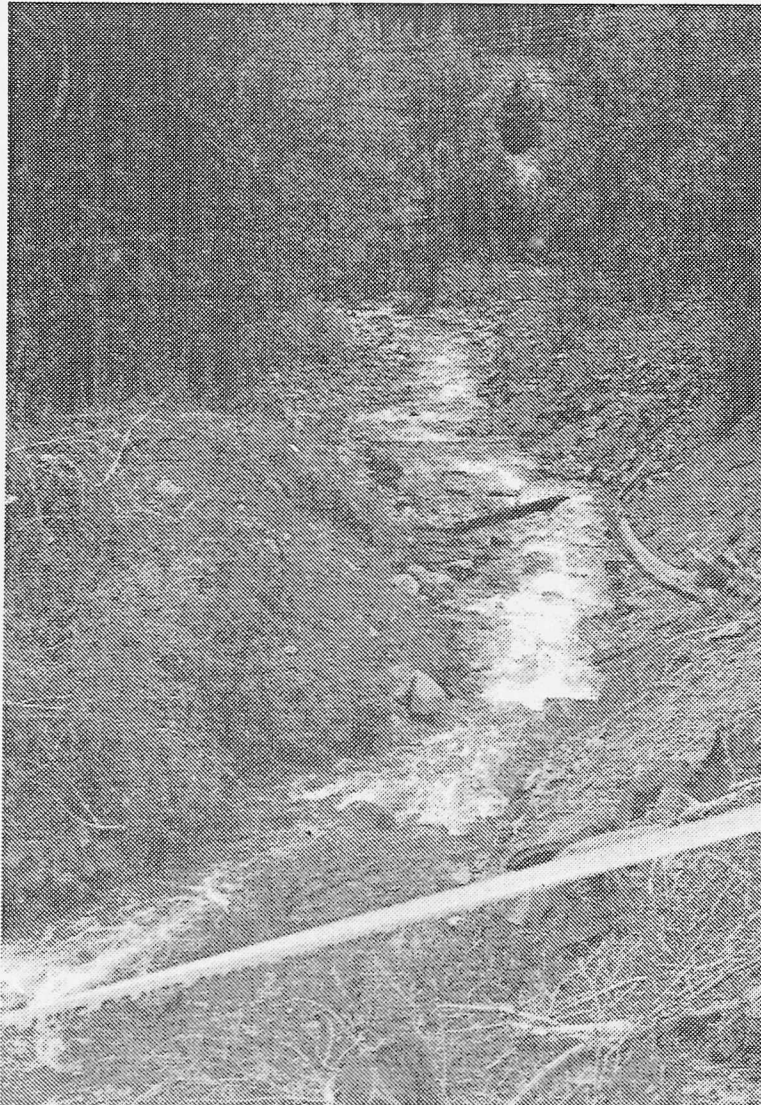
Late in May, residents noticed flooding around certain residences and also noticed a whirlpool west of the Atlantic Cable shaft in Silver Creek (Figure 4). This whirlpool was located approximately N. 60 W., 60 to 75 ft from the shaft and on the south bank. The observers could detect no reduction in stream volume. One observer mentioned that an open hole could be seen in the bedrock and that mine timbers were

encountered while he was operating a backhoe in the stream. Rico maintenance people reported that four truck loads (16 yds) of rock and soil were dumped into the whirlpool and much of this material sank into a hole. This whirlpool area overlies the first level stope suggesting that a cave-in could have occurred from the back (roof) of the stope up to the stream bed.

Figure 4. Location of whirlpool and cribbing encountered during re-alignment of Silver Creek channel. The loose fill material on the left side of the Creek in the center of the picture was dumped into the whirlpool.

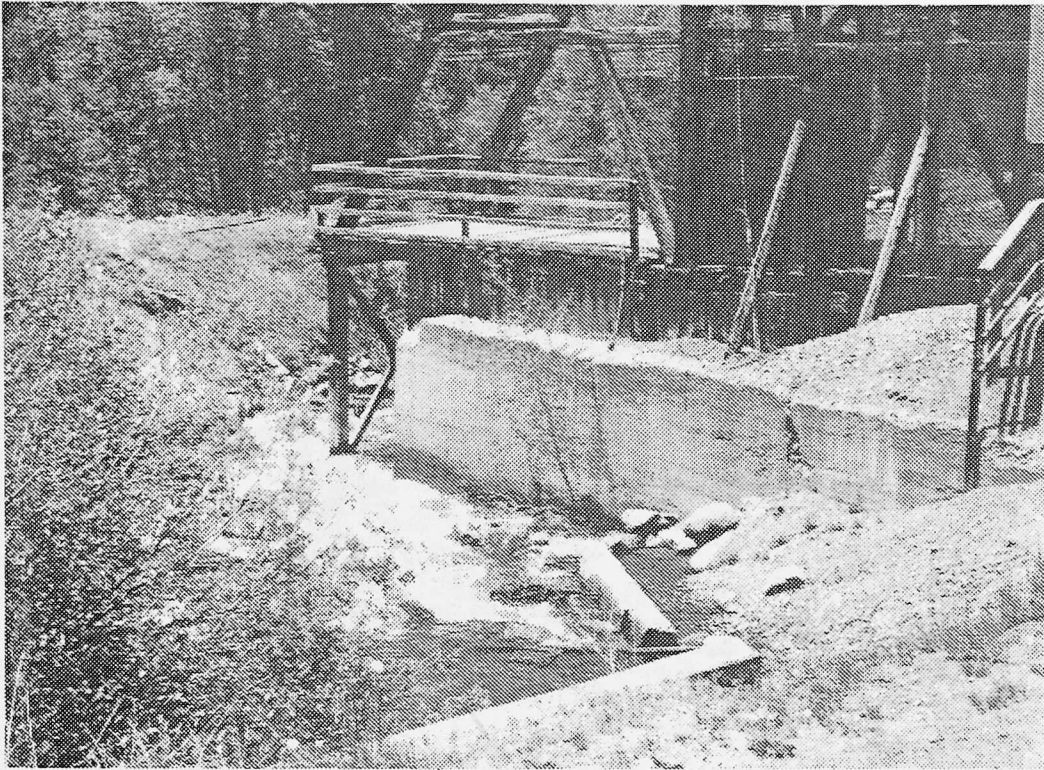
Figure 5. Looking westward at the Atlantic Cable shaft with concrete flood protection wall.

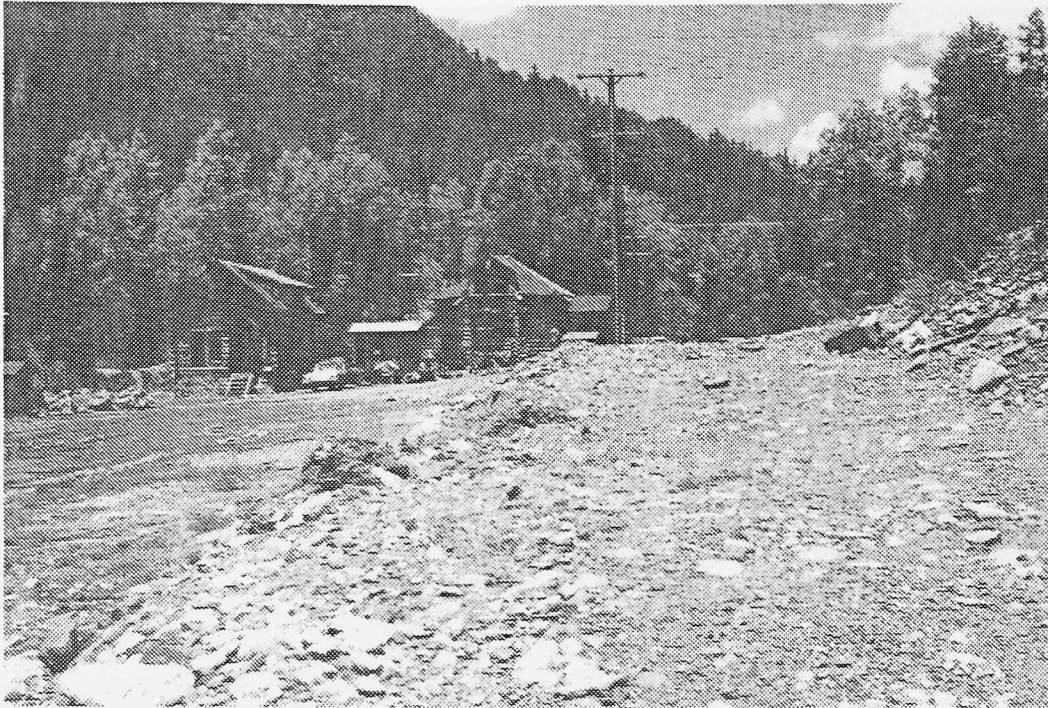
Seeping and minor piping has occurred immediately west of the west adit and could still be seen in the road, the adjacent front yard and along the bench that extends further to the south (Figures 6 and 7).

**Figure 6.** Looking north toward the most seriously affected properties. The main haulage adit is in the trees on the right of the picture.

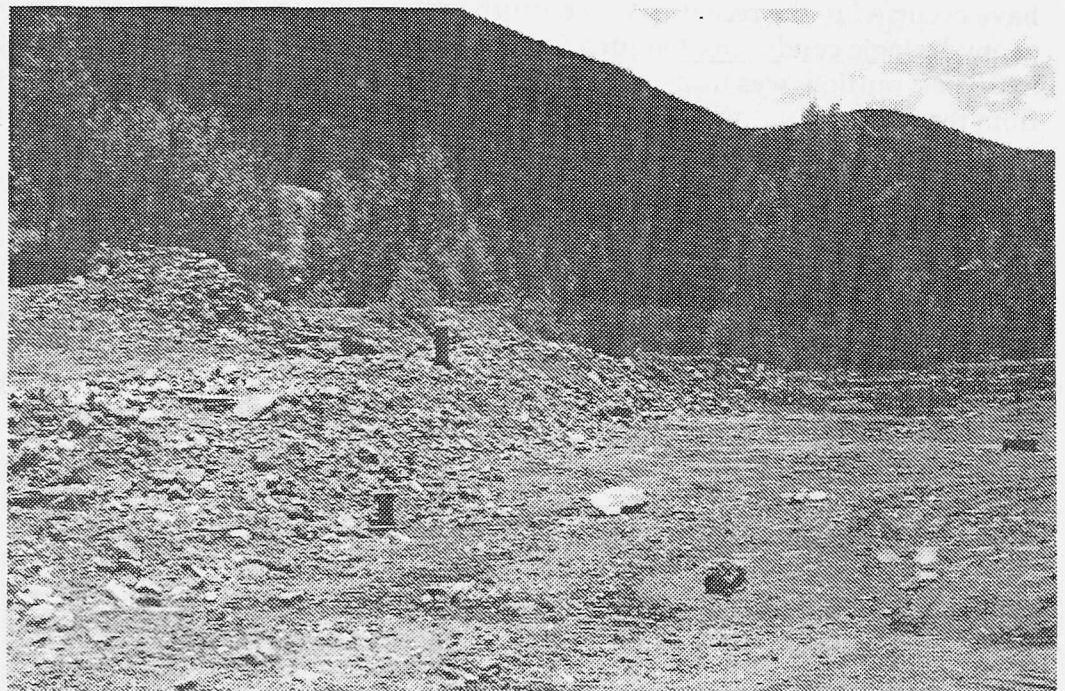
**Figure 7.** Water line on flooded bench. The riser pipe in the lower foreground and the hydrant are connected to the water line.

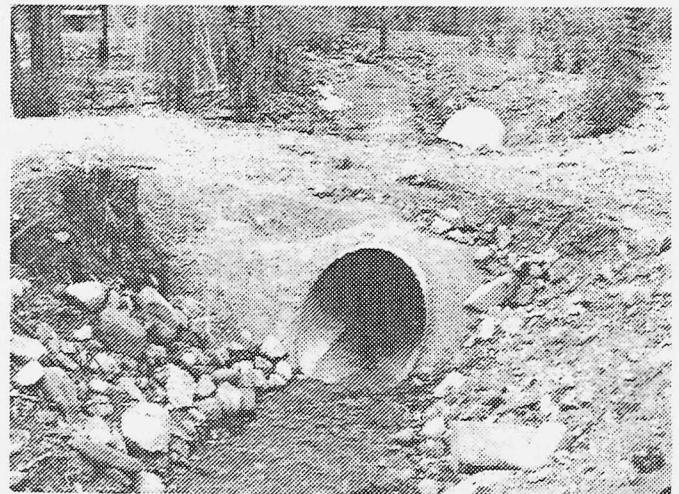
Figure 9. Silver Creek culvert over caved-in area of Atlantic Cable Mine.

Following the chemical and dye testing, Silver Creek flow had dropped off to not much more than a trickle, measured by WCD to be between 1 and 2 cfs. During this low water period, the bed of the stream was investigated and the cave-in area surveyed to the Atlantic Cable shaft. The center of the cave-in lay 63-ft west of the concrete retaining wall on the west side of the shaft. Although cobbles and boulders made identification difficult, the hole in the stream bed was approximately 3-ft wide measured perpendicular to the stream direction by 7-ft long. Timbers were observed running on either side of the hole with eight inch lagging supported on the timbers. At the time of these observations the entire above-bed flow of Silver Creek was flowing into the caved mine workings. It was decided that the most cost effective short-term solution to the flooding problem was the installation of a culvert over the cave-in beneath the creek (Figure 9).

Rico maintenance personnel and members of his own staff. The creek was contoured to accept a 6-ft-diameter by 60-ft-long culvert.

Concrete was used to pave the hole and to form a cover over the backfill and bedding material to minimize erosion at the upstream end of the culvert.
