REPORT NO. CDOH-P&R-R-77-7

PERFORMANCE OF CULVERT MATERIALS IN
VARIOUS COLORADO ENVIRONMENTS

H. N. Swanson
D. E. Donnelly
Colorado Division of Highways
4201 East Arkansas Avenue
Denver, Colorado 80222

Final Report
September 1977

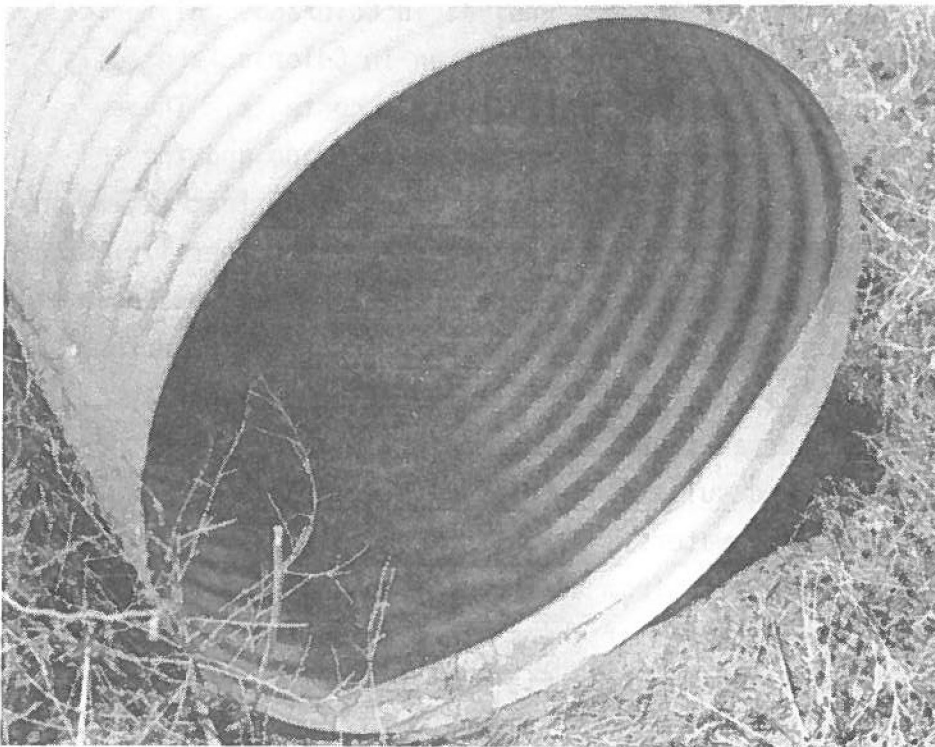
Photograph No. 1

This aluminum pipe at Punkin Center is as good today as it was when it was installed in 1962.

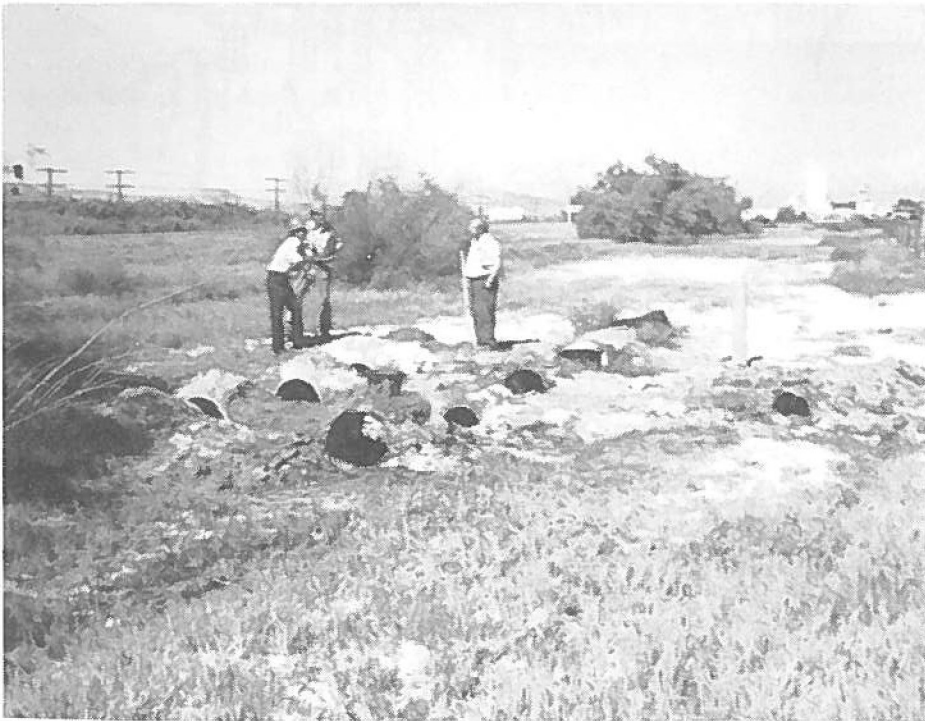
Photograph No. 3
General view of the Fruita
site with pipe samples.
Note alkali on the surface.

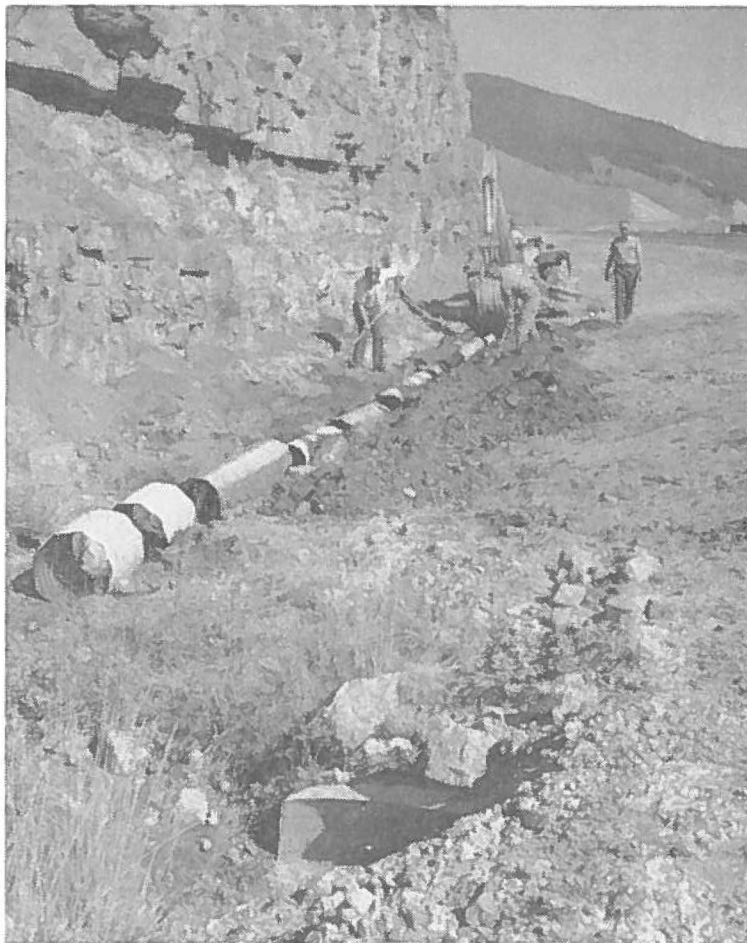
Photograph No. 4

General view of pipe samples at Straight Creek.

The concrete end section to the cross culvert under the highway is at the lower center

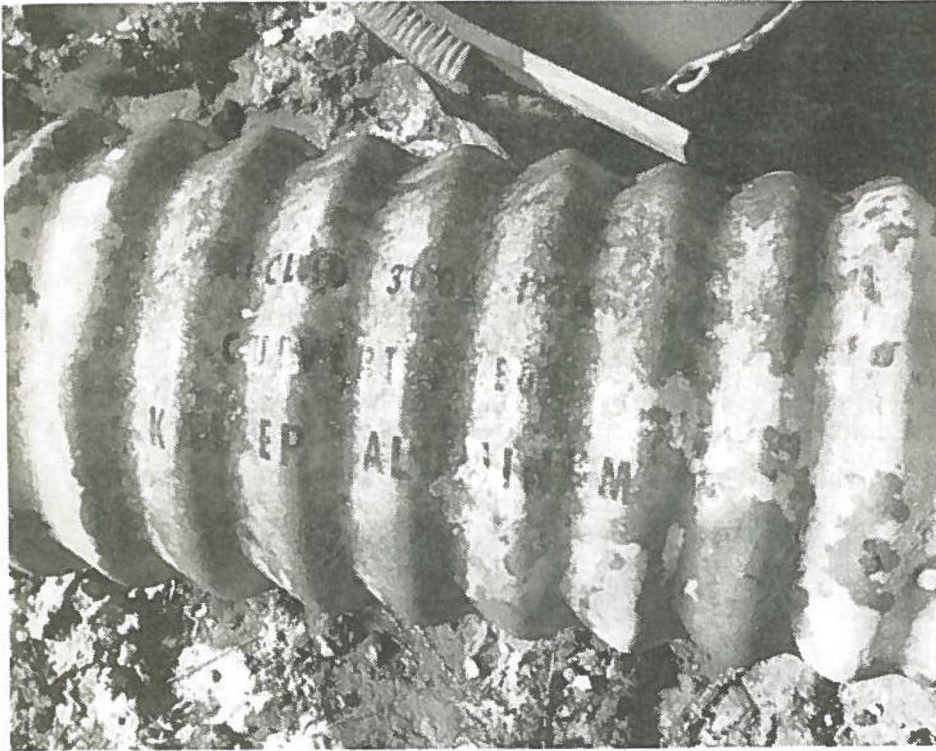
Photograph No. 5

This is an aluminum sample at Fruita.

It has been in place since 1962. There has been attack and enrustation of the cladding but the base aluminum is still sound

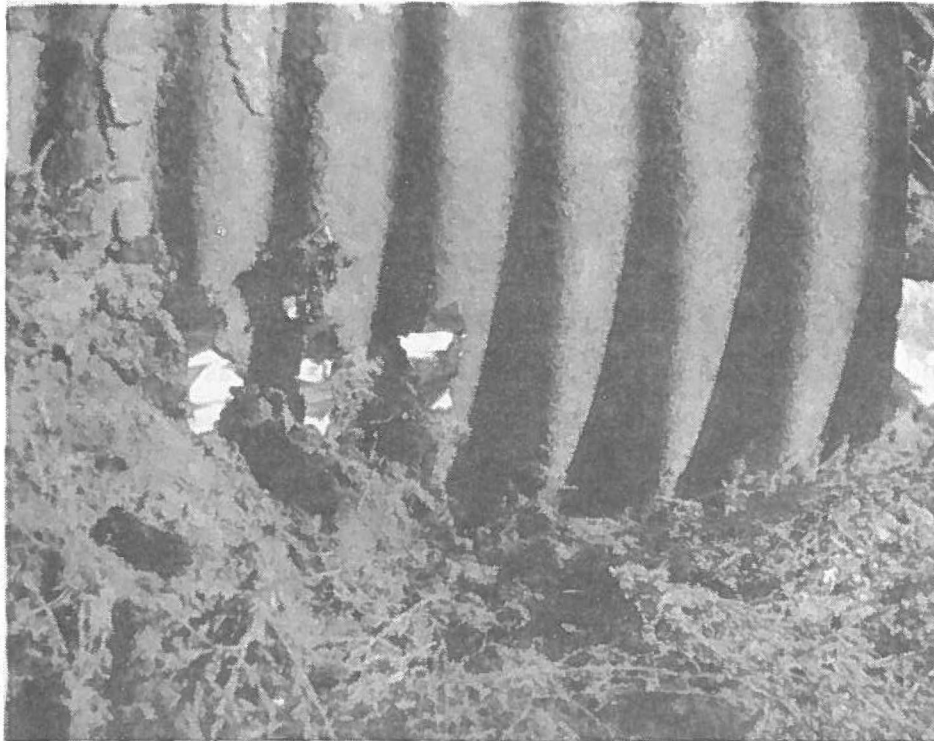
This was a galvanized steel pipe sample at Fruita.

This sample has been in this environment for 14 years. A white clot inside the pipe shows the holes eroded away. The rest of the pipe is very thin and fragil

Samples of galvanized metal pipes have been placed at test Sites 5, 6, and 8. The samples in the alkaline environment are badly corroded with many holes rusted clear through. (See Photograph No. 6 above.) The galvanizing has been heavily attacked in large patches about 2 inches (5 cm) in diameter on the Straight Creek sample. Where the galvanizing is gone, the base metal is heavily pitted. No rust color is apparent, however, and attack areas seem to be limited to a few local areas that were underwater.

Galvanized metal should not be used in these extreme environments.

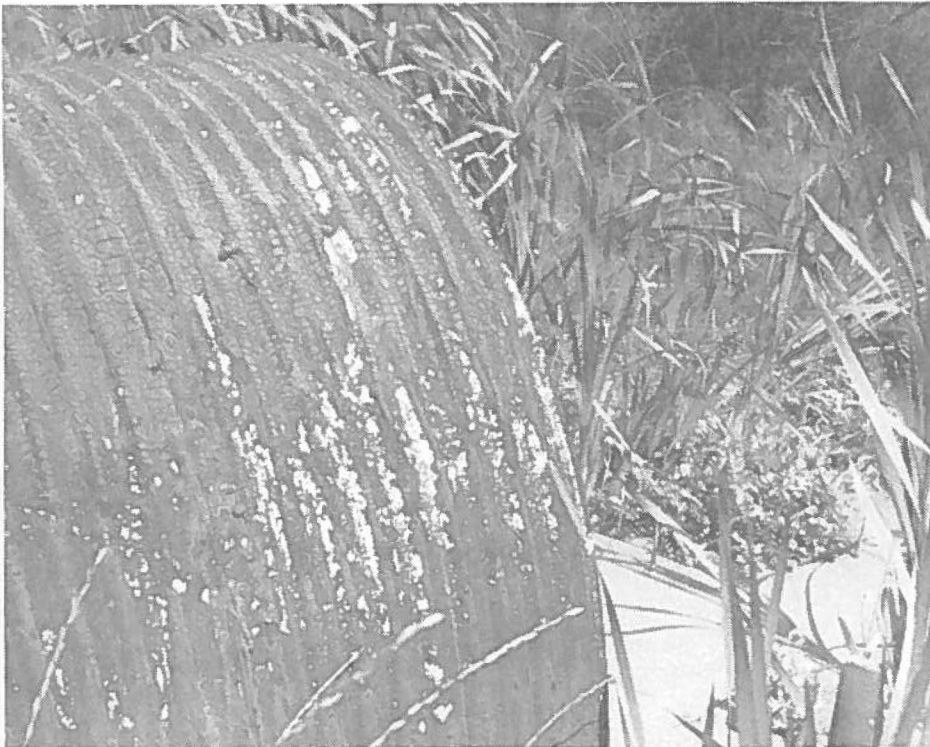
Photograph No. 7

A sample of asbestos bonded pipe at Straight Creek has spots where the asphalt has become brittle and broken off exposing the asbestos bonding. A sample of asphalt dipped pipe also at the Straight Creek site shows cracking and checking of the asphalt where it is exposed to the sun and water. (See Photographs No. 7 and 8.)

This asbestos bonded asphalt dipped cross culvert at Fossil Creek has been in place since 1963.

The exterior is cracked and being eroded away.

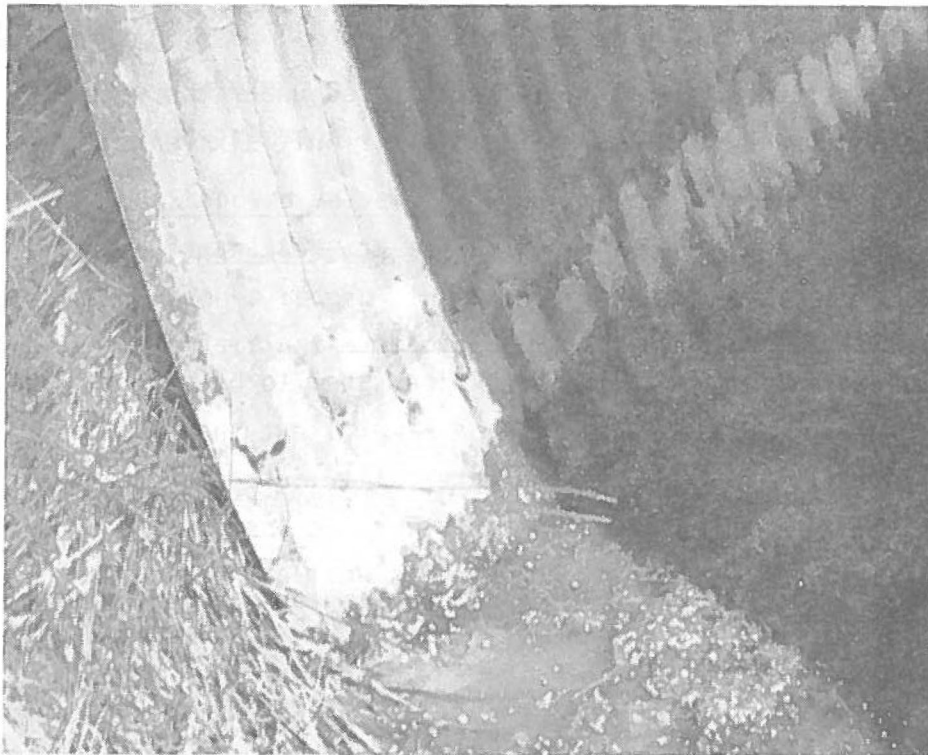
Photograph No. 8

This is the inside of the same asbestos bonded asphalt dipped pipe as shown in Photograph No.

Note: The asphalt and asbestos are gone below the high water line.

The metal bottom is corroded through in many places.

An asbestos bonded asphalt dipped metal pipe installed in 1963 during construction at Fossil Creek is corroded through and eaten away. All of the coating above the water line is checked and cracked exposing the metal which is rusting. The asphalt coating and asbestos has been removed near and below the water line. During an inspection in the spring of 1976 one man tried to walk through the pipe and fell through twice.

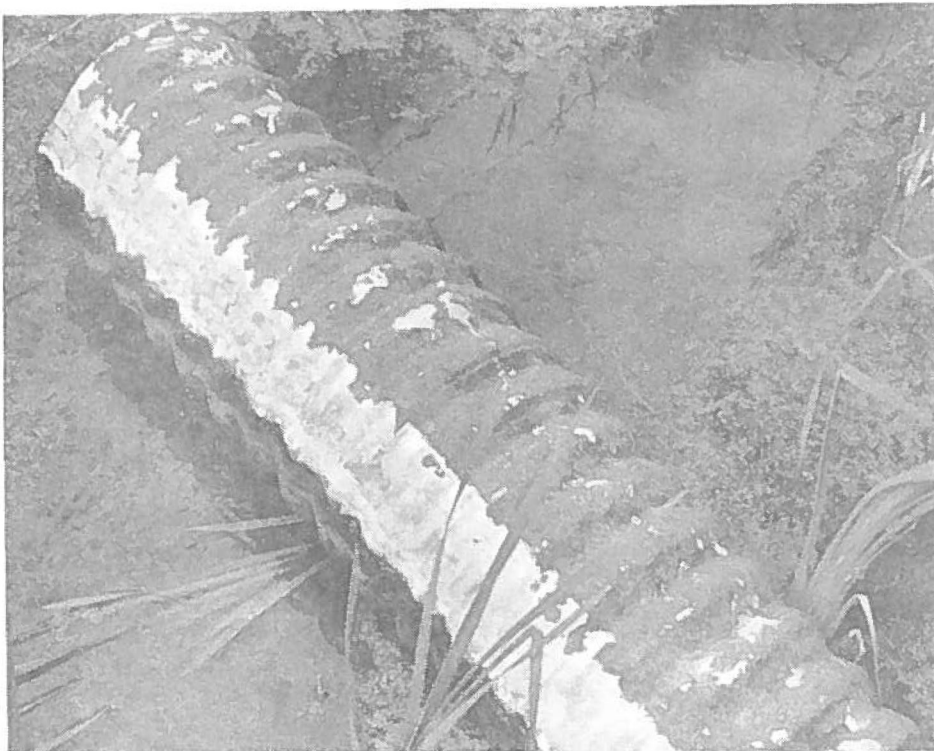
Photograph No. 9

This asphalt dipped sample at Fossil Creek was rolled up for the photograph to show that the asphalt below the water line is gone. The asphalt above the water line is cracked and being eroded off.

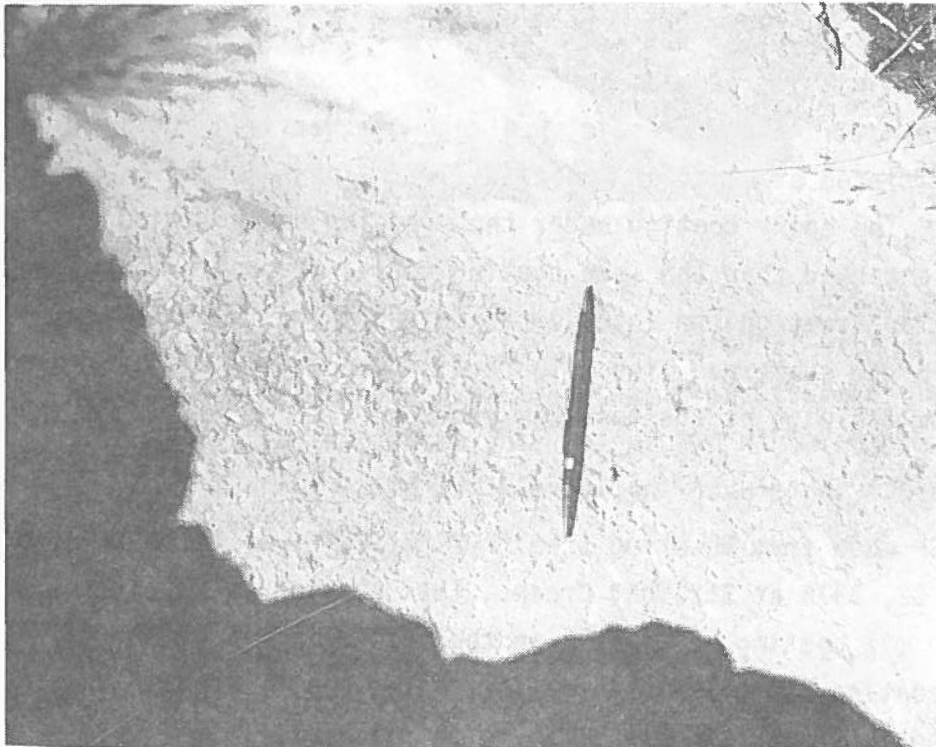
Photograph No. 10

The areas exposed to the water show definite attack by the acid water. Attack has only removed the cement surface, exposing the aggregate. (See Photograph No. 10.)

This is the bottom of the inlet end section of the concrete cross culvert at Straight Creek. This pipe was placed in 1970.

The top .2" (5 mm) of concrete mortar has been etched leaving silicate aggregate exposed.

The attack is not very serious and the pipe under the highway is expected to remain in service for at least another twenty years. The limestone aggregate in the sample listed above has also been attacked.

When and if it becomes necessary to replace this concrete culvert or any other culvert in an acidic environment, it is recommended that a small vitrified clay or plastic pipe be placed at a lower elevation than, or upstream of the inlet of the new culvert. The small pipe would carry the corrosive seep water and the larger standard pipe will carry diluted storm runoff water.

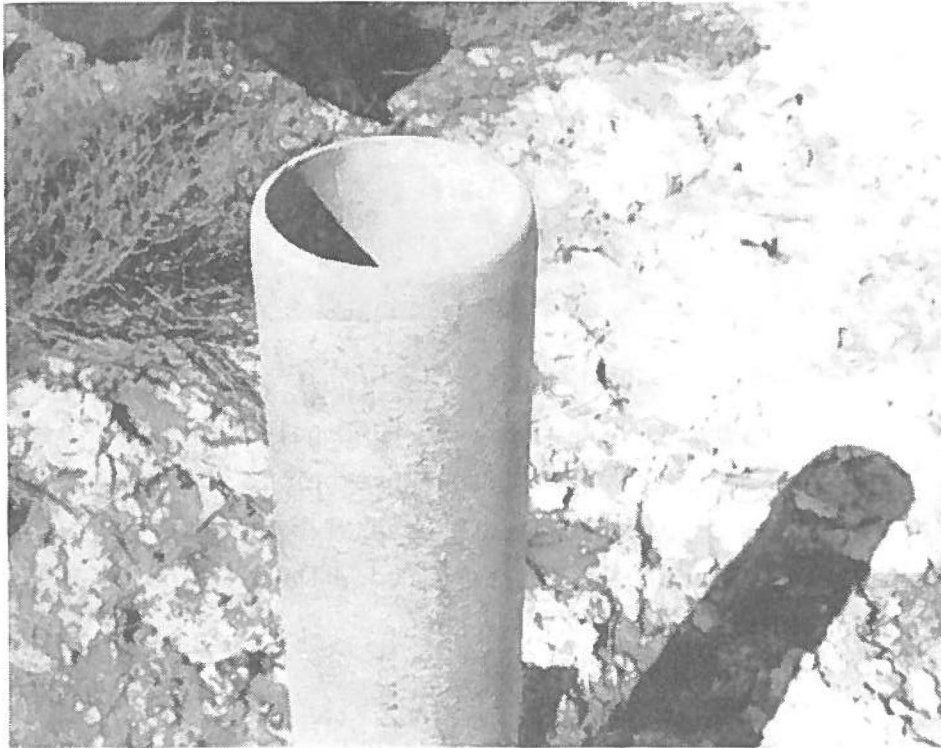
Photograph No. 11

Samples of transite pipe were placed at Fruita and Straight Creek in 1972. They are both in very good condition and show no evidence of corrosion. (See Photograph No. 11.)

This transite pipe at Fruita since 1972 is unharmed by the harsh environment

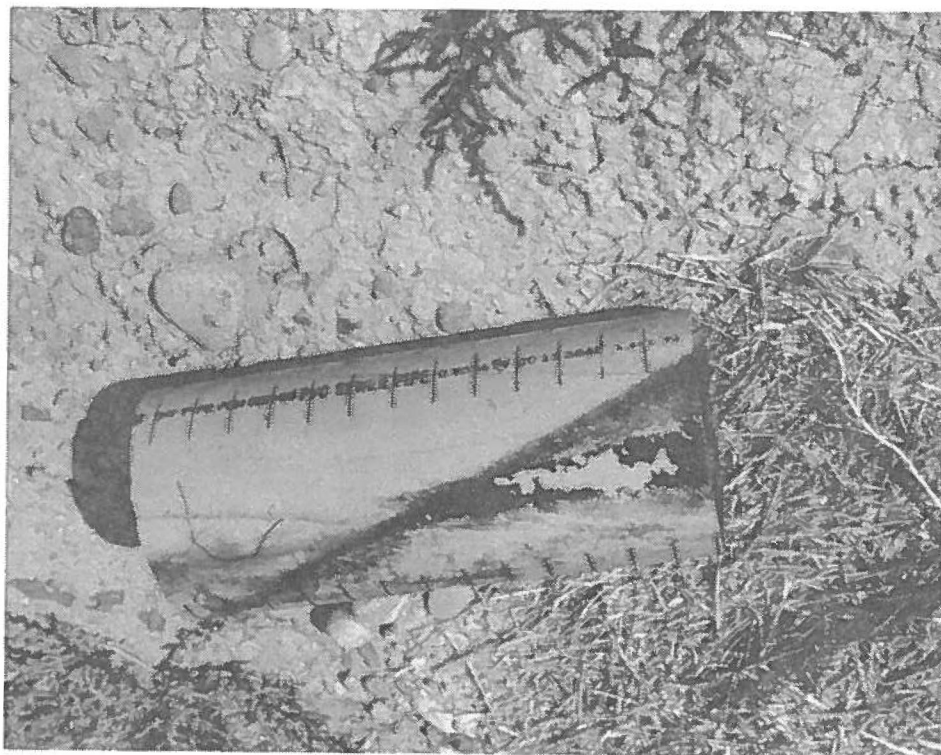
Photograph No. 12

Plastic drain pipes appear unaffected by harsh environments.

The stains are only on the surface.

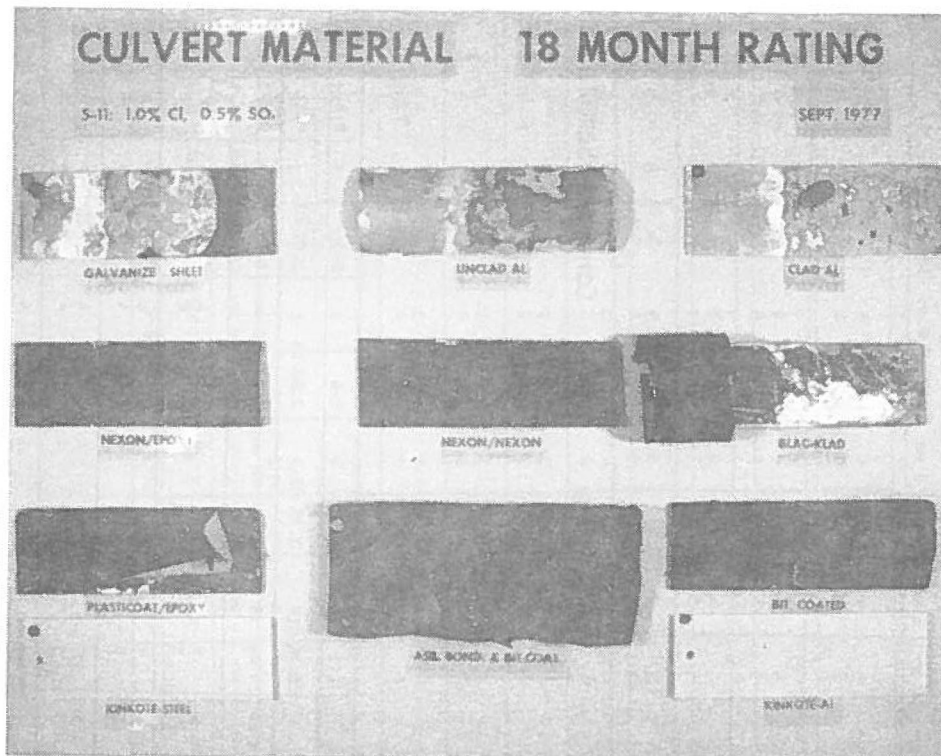
Photograph No. 14

Metal samples after 18 months in a harsh soil environment

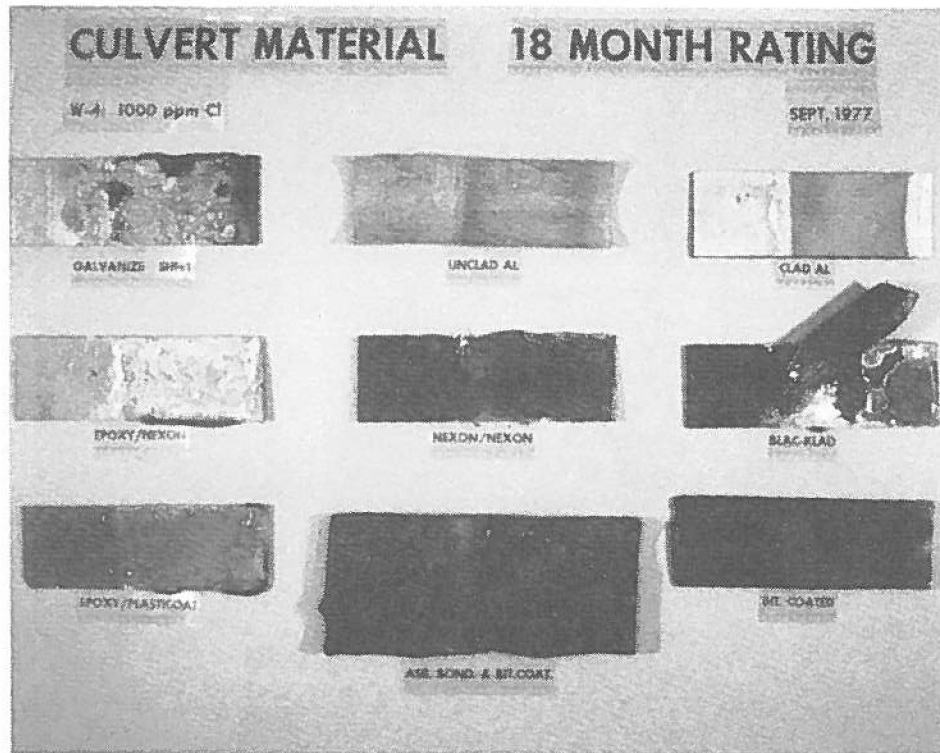
Photograph No. 15
 Metal samples after 18 months in a
 harsh water environment

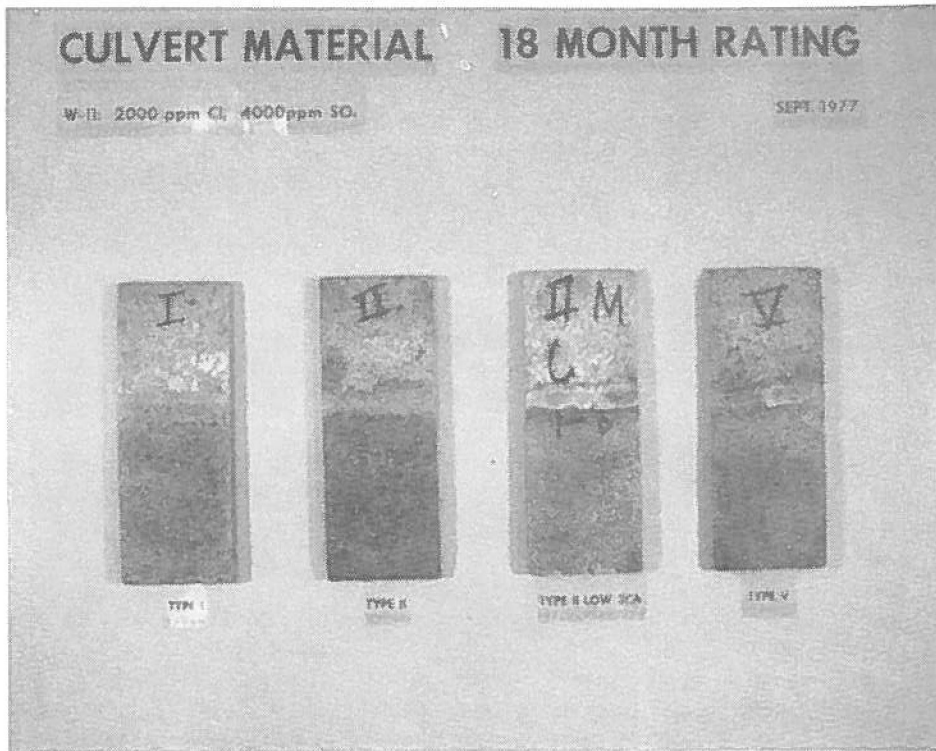
Photograph No. 17
 Concrete samples after 18 months in a
 harsh water environment

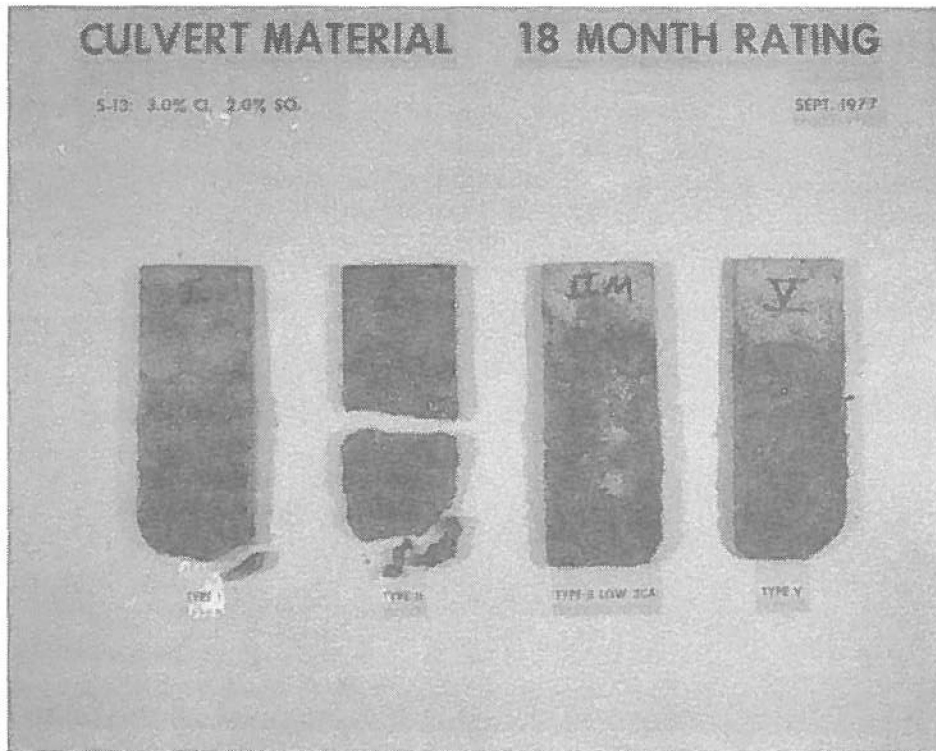
Photograph No. 18
 Concrete samples after 18 months in a
 harsh soil environment
