# **LONG-TERM MONITORING OF MECHANICAL PROPERTIES OF FRP REPAIR MATERIALS**

**July 2013**

**COLORADO DEPARTMENT OF TRANSPORTATION**  
**DTD APPLIED RESEARCH AND INNOVATION BRANCH**

1. Report No. CDOT-2013-13	2. Government Accession No.	3. Recipient's Catalog No.	
4. Title and Subtitle LONG-TERM MONITORING OF MECHANICAL PROPERTIES OF FRP REPAIR MATERIALS		5. Report Date July 2013

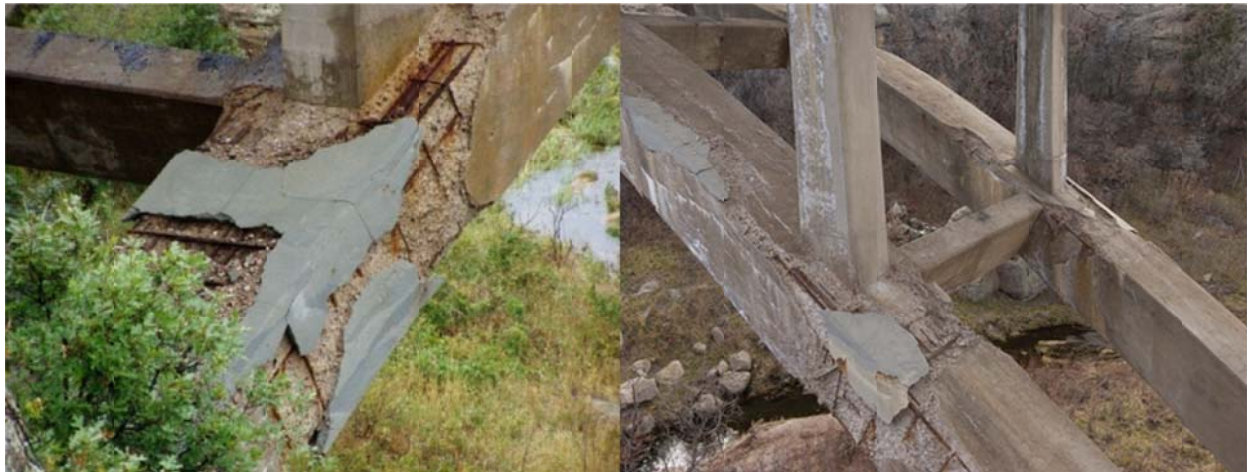
Prior to repair the concrete arches had severe spalling due to the corrosion of the internal steel reinforcement as seen in the photographs in Figure 2.8.

**Figure 2.8.** Concrete spalling on arch section prior to repair (Mohseni, CDOT)

the cross-section was restored with shotcrete which included a corrosion inhibitor, Sika FerroGard 903, to prevent further corrosion of the steel reinforcement.

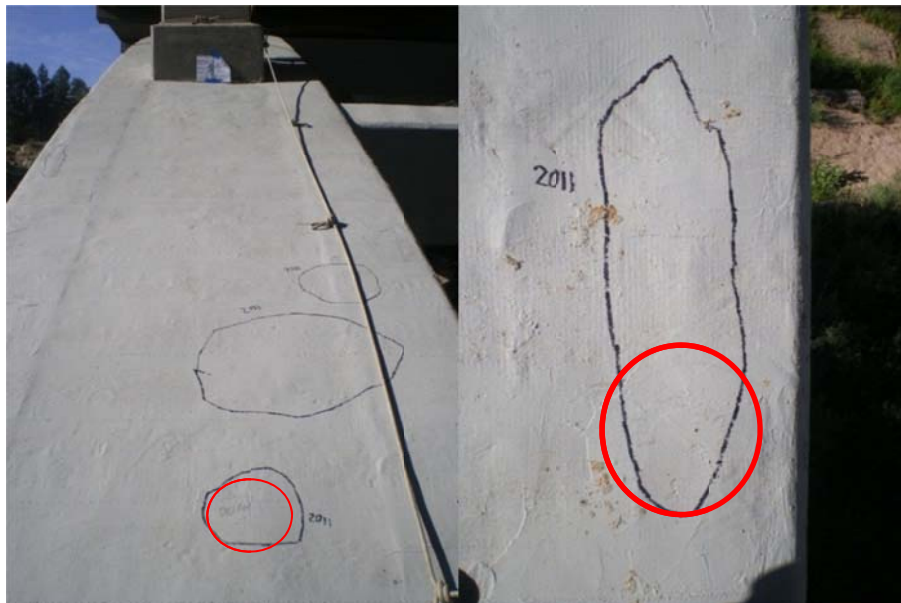
**Figure 2.14.** Outlined in permanent marker are identified areas of debonding between the FRP and the substrate developed in the structure between inspections in 2007 and 2011. Faintly denoted in the bottom of the photographs (enclosed in red circles) are previously found voids identified with “DELAM 07” and lines distinguishing the boundaries of the voids.

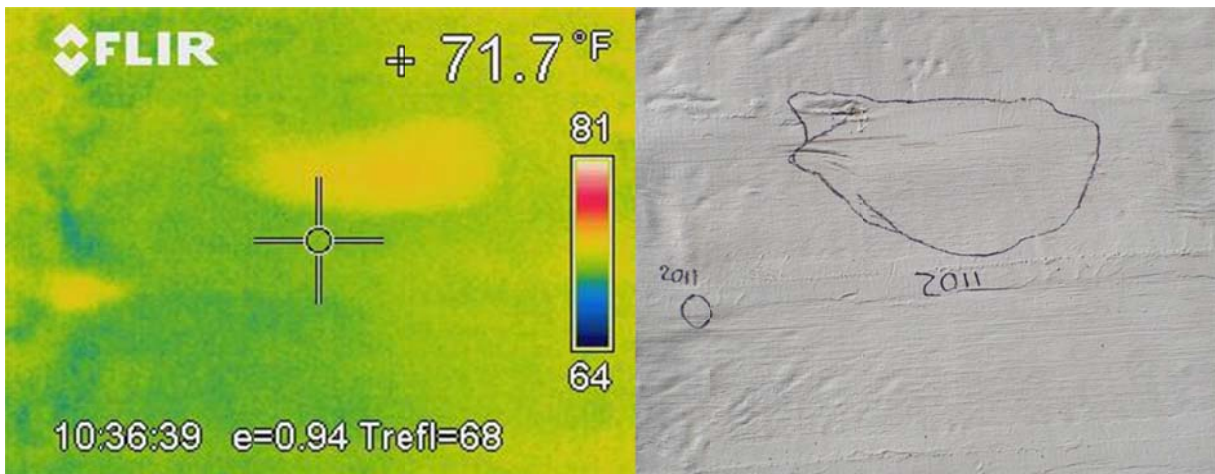
**Figure 3.1.** Photograph and thermal image from an infrared camera of two voids, (appearing yellow), found in 2011 on the 1<sup>st</sup> bay on the north side of the east arch

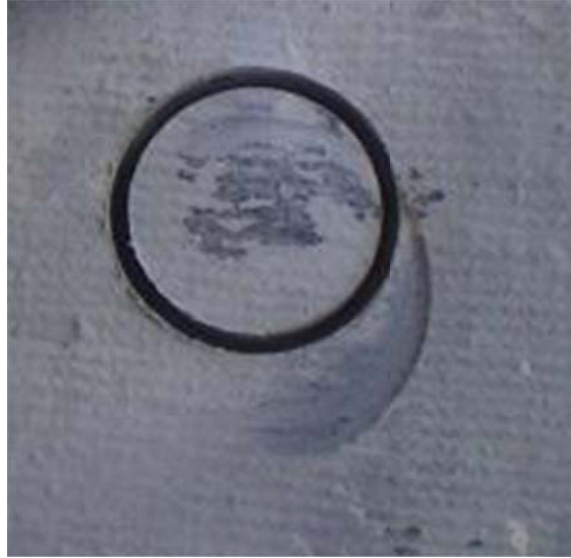
**Figure 3.4.** Damage caused by core bit without the use of the jig

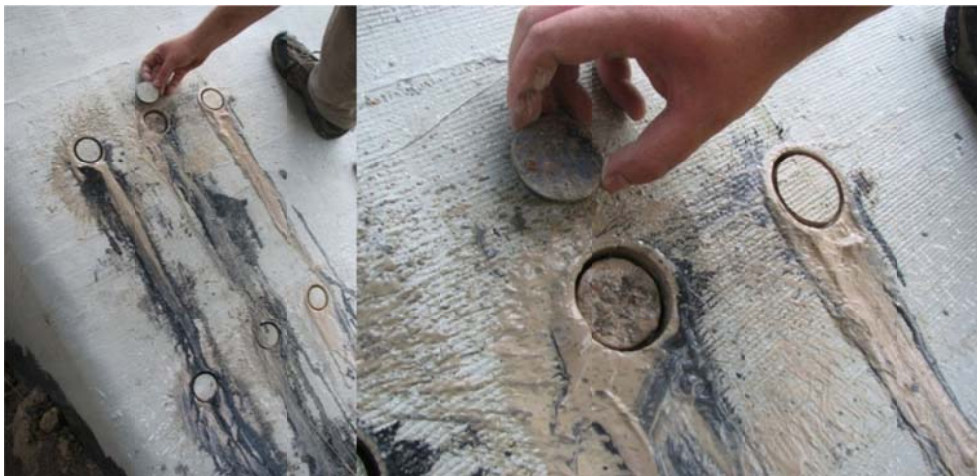
**Figure 3.6.** The core drilling location that failed due to torsional stresses during the core drilling process, bay 1NW

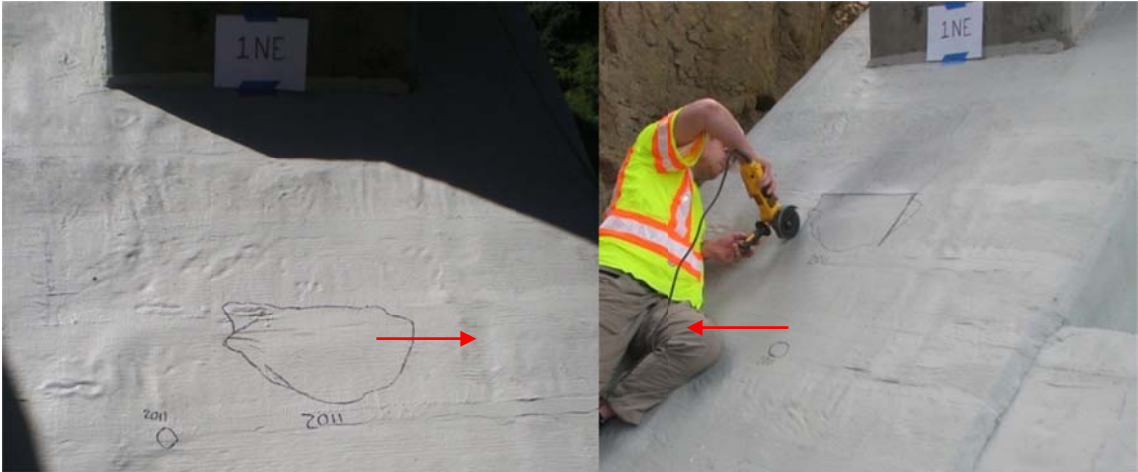
Upon cutting the lower edge of the CFRP rectangle, water exited the cut at the bottom of the void revealing standing water at the interface between the CFRP and substrate. Photographs of the void and the removal of the CFRP layer are shown in Figures 3.20, 3.21 and 3.22 below.

**Figure 3.20.** Void in CFRP with transverse crack identified with red arrows and cutting the perimeter of the void in the CFRP

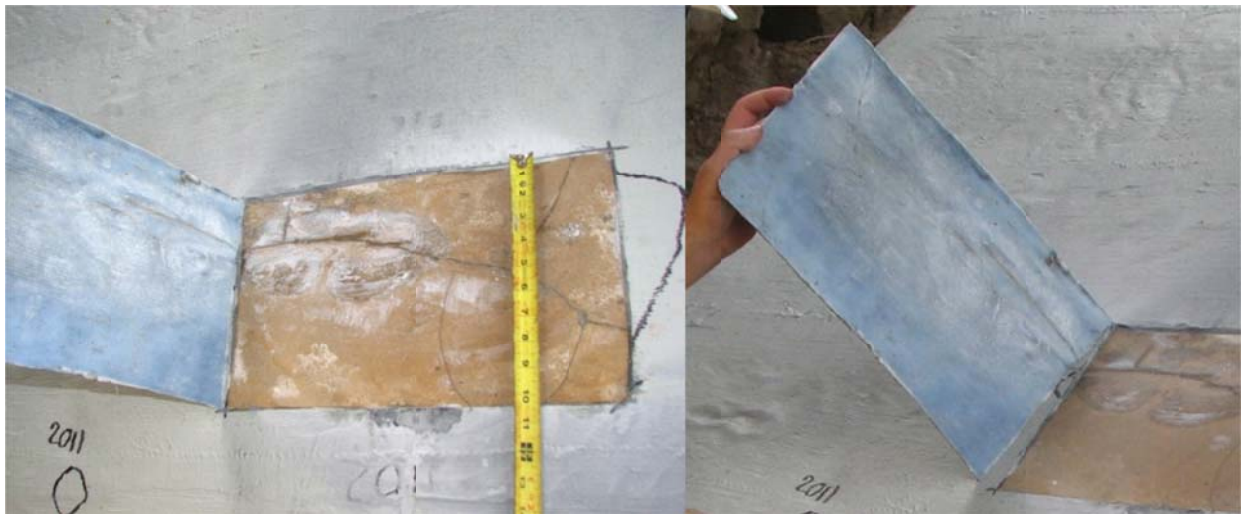
**Figure 3.22.** Cracks in the substrate were transmitted through the CFRP and notice the smooth texture and blue and white color of the underside of the CFRP

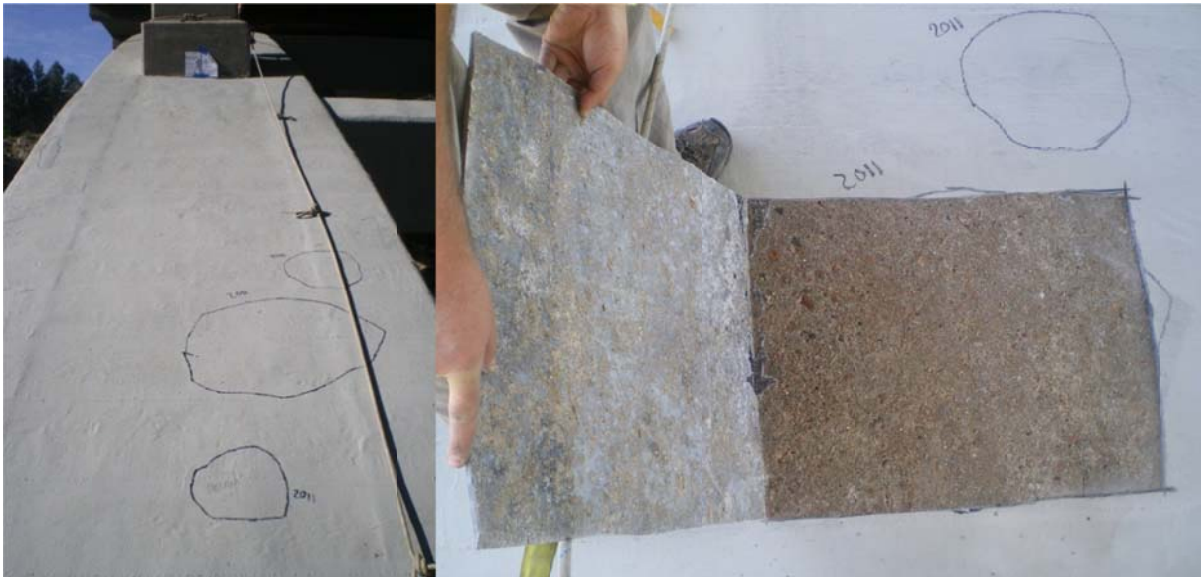
**Figure 3.23.** Voids found in the 3<sup>rd</sup> bay on the north end of the east arch and removal of the CFRP of the largest void

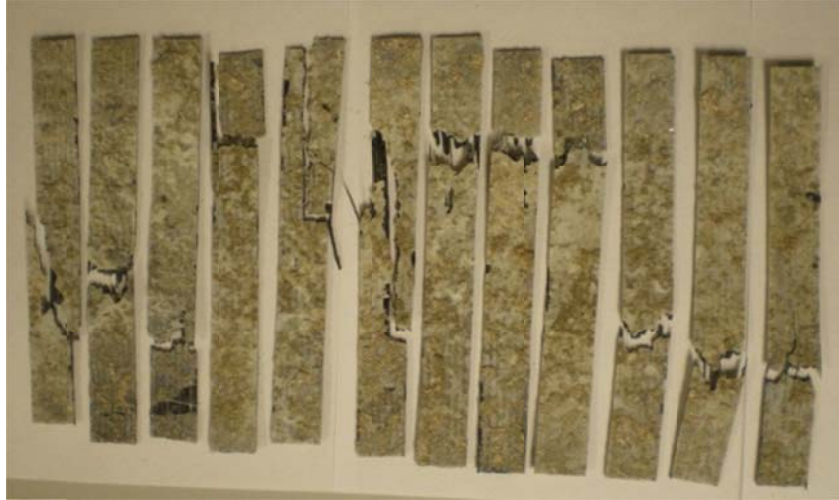
**Figure 4.2.** Failed tensile test specimens from the large void removed from bay 3NE, note the oatmeal appearance

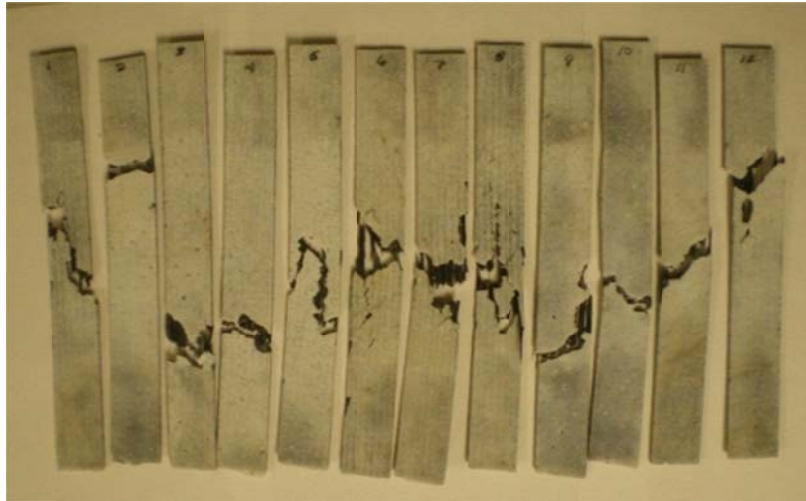
**Figure 4.3.** Failed tensile test specimens from the small void removed from bay 1NE, note the milky appearance

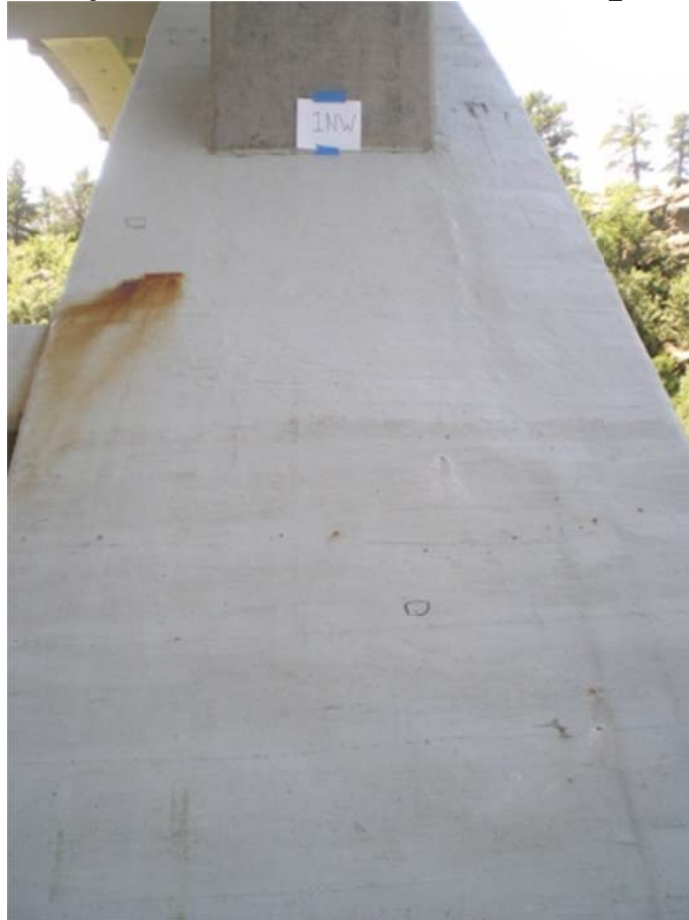
Figure A1. Bay 1NW, 2 of the 3 small voids and rust spot

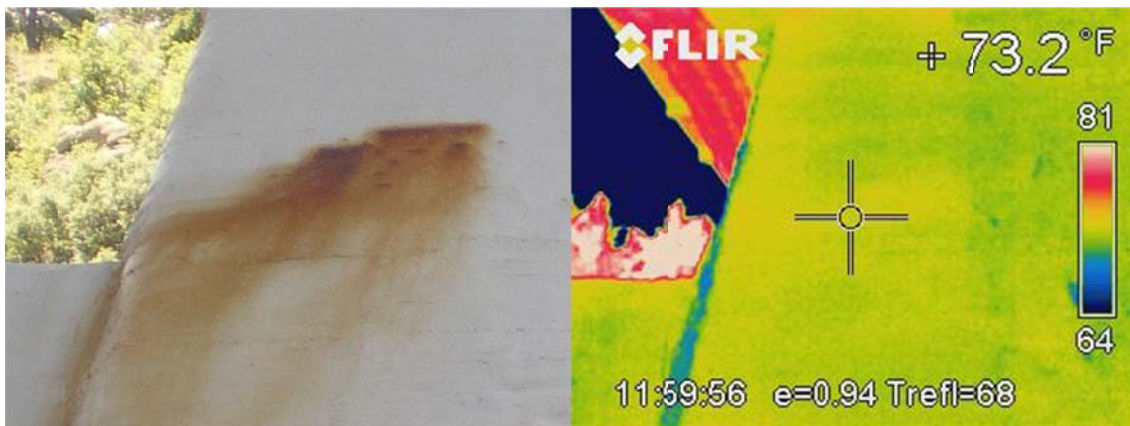
Figure A2. Photograph and thermal image of rust spot

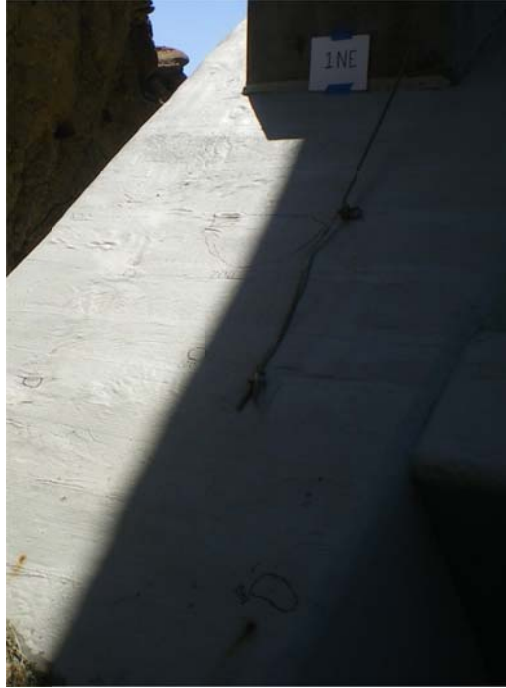
**Figure A3.** Bay 1NE, 5 voids

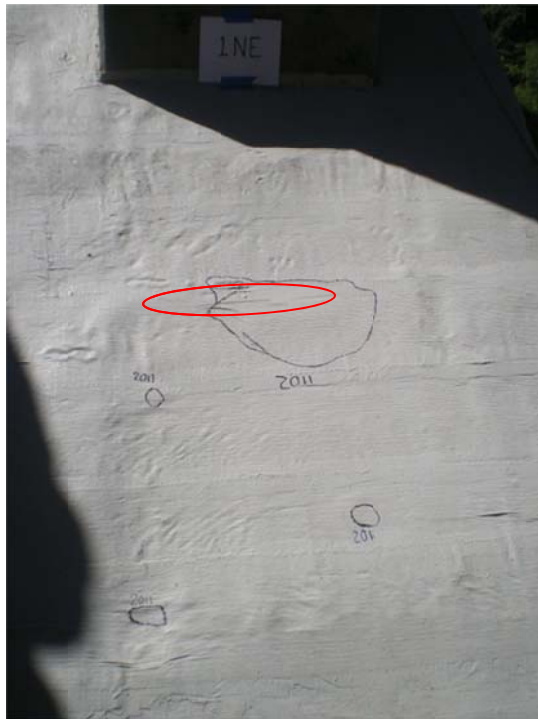
**Figure A4.** Bay 1NE, 4 of the 5 voids; crack exists, enclosed in red oval, in the top of the largest void

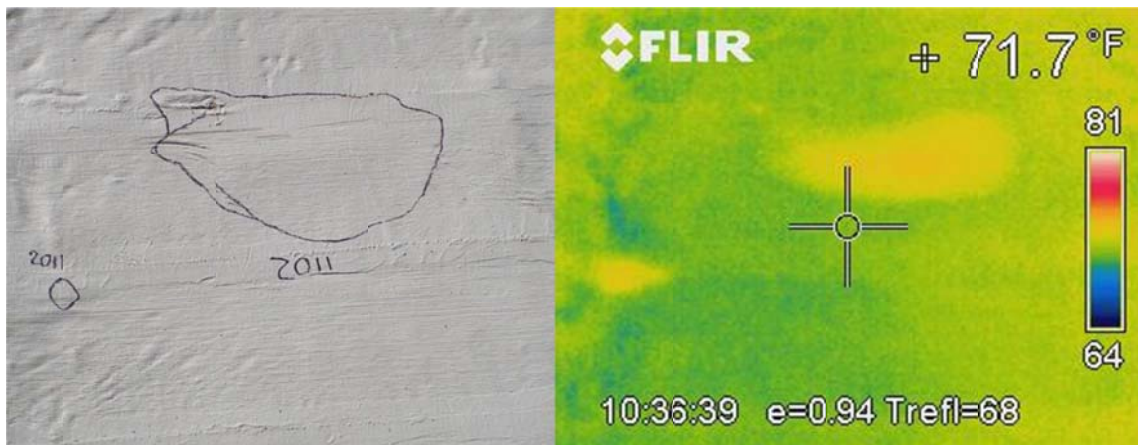
**Figure A5.** Photograph and thermal image of two voids in Bay 1NE

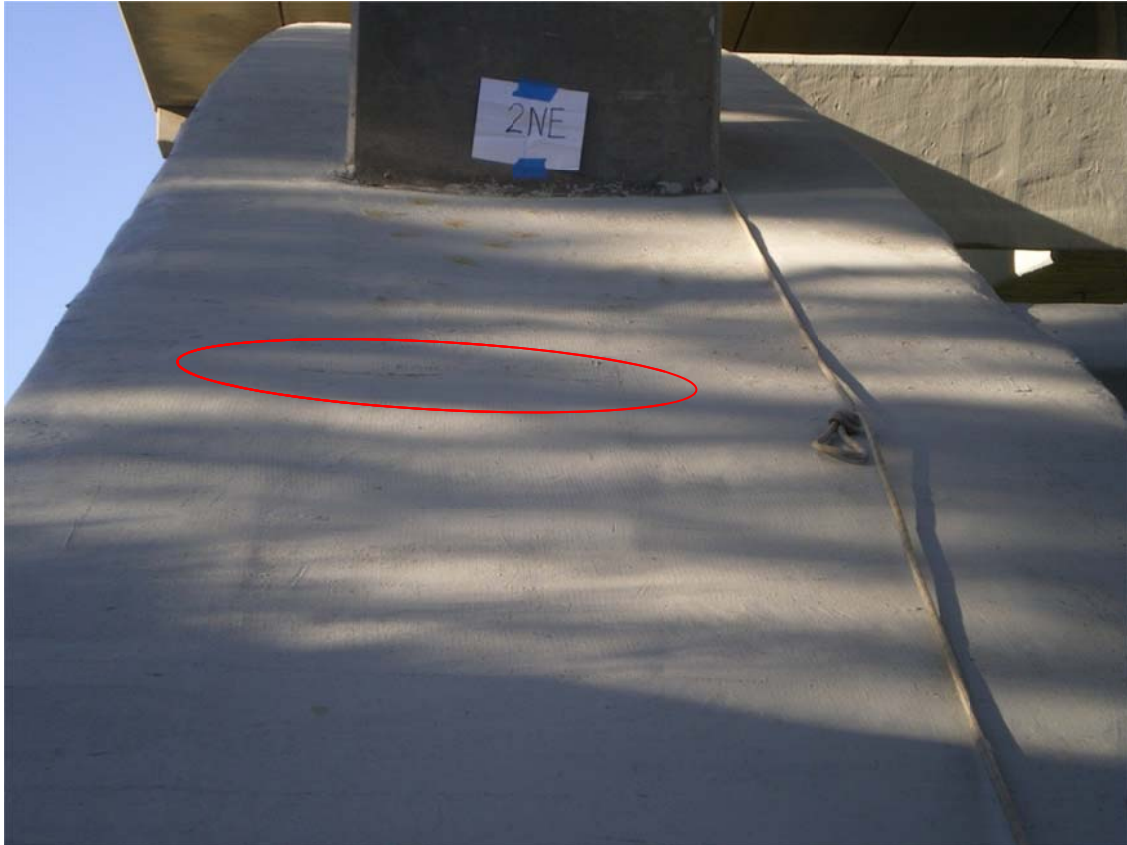
**Figure A7.** Bay 2NE, Crack enclosed in red oval was identified in 2007

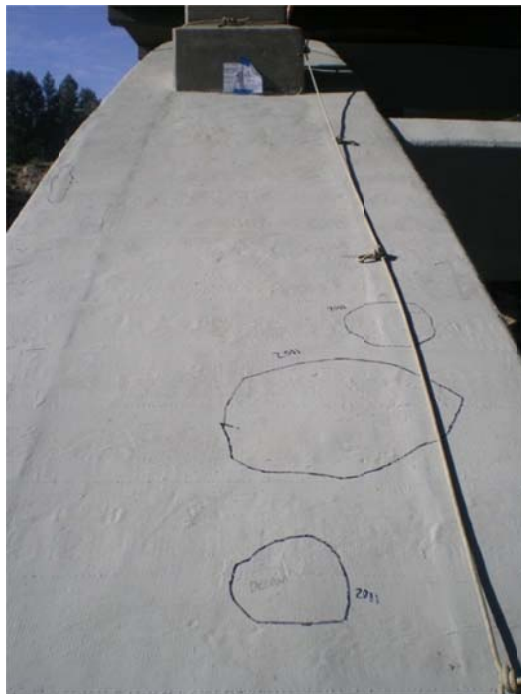
**Figure A10.** 4 of the 5 voids found in 2011

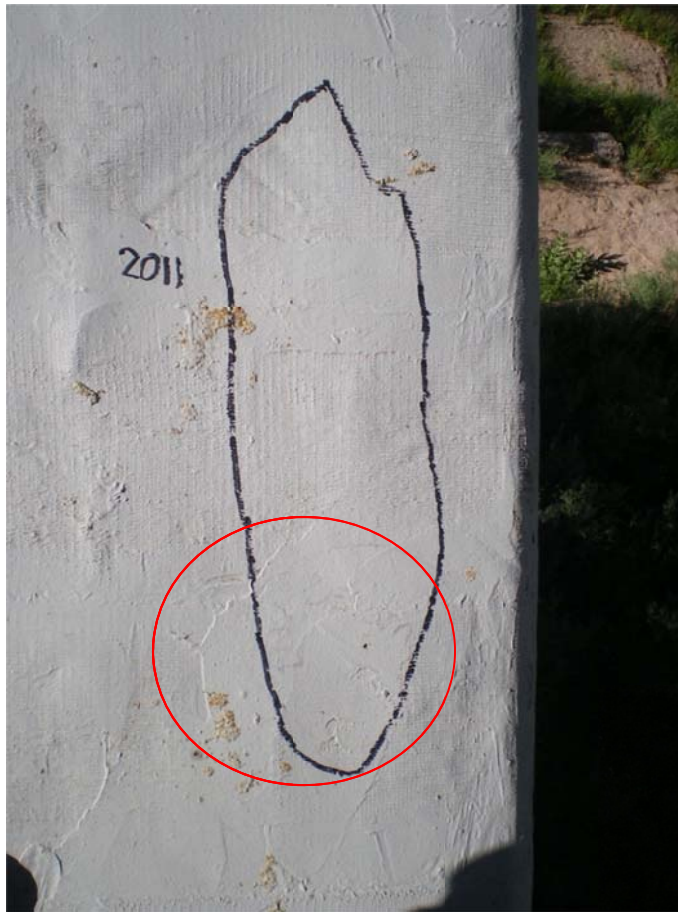
**Figure A11.** Enclosed in the red circle is 1 of the 2 voids found in 2007

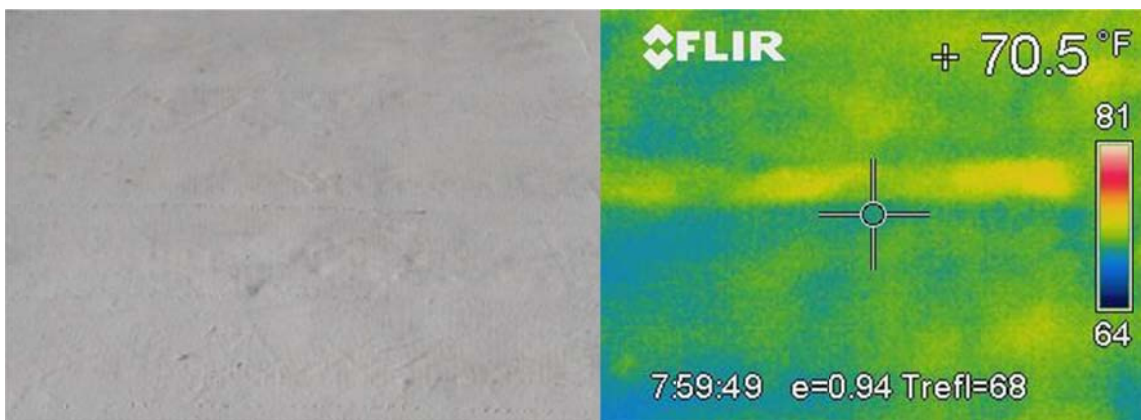
**Figure A12.** Photograph and thermal image of a seam in the CFRP sheets, no void present

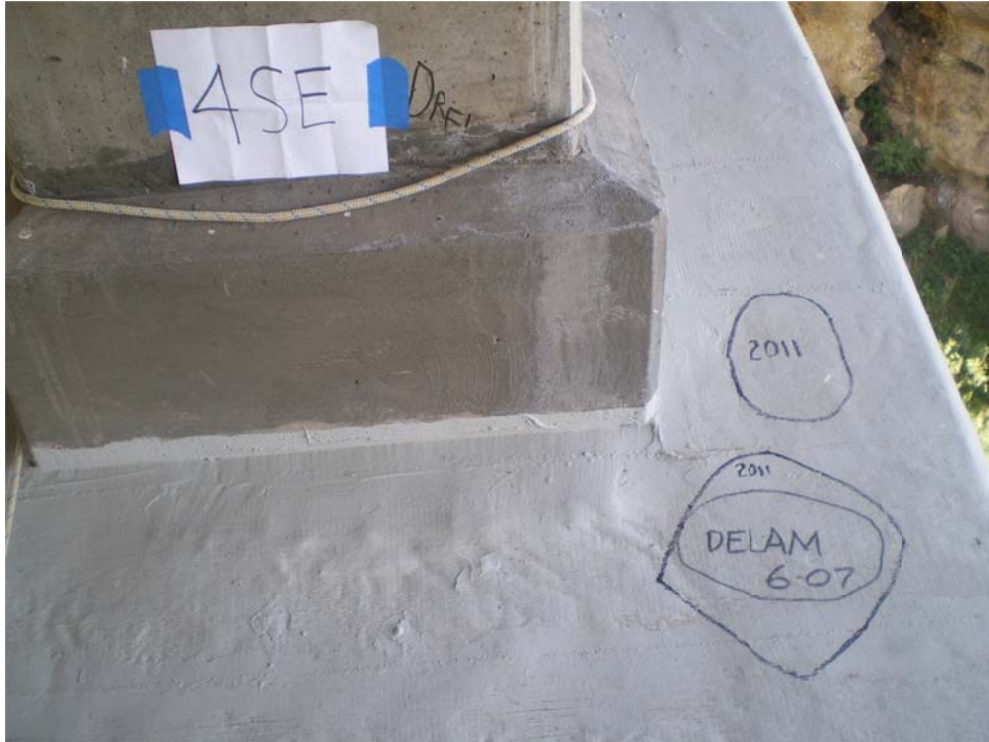
**Figure A17.** Void from 2007 has grown and a new void developed

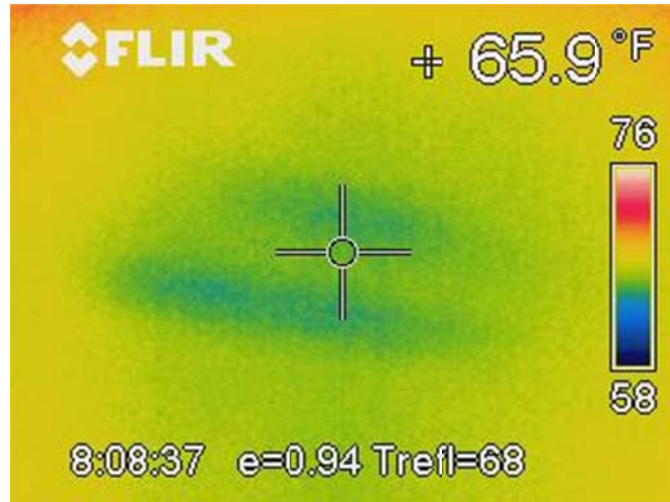
**Figure A19.** Thermal image of cracks previously identified in 2007

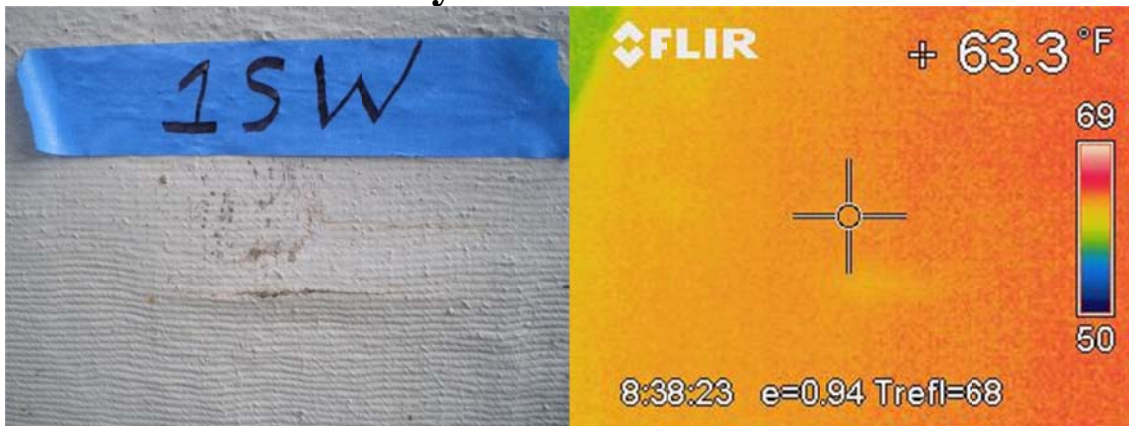
Figure A24. Photograph and thermal image of a defect found in Bay 1SW

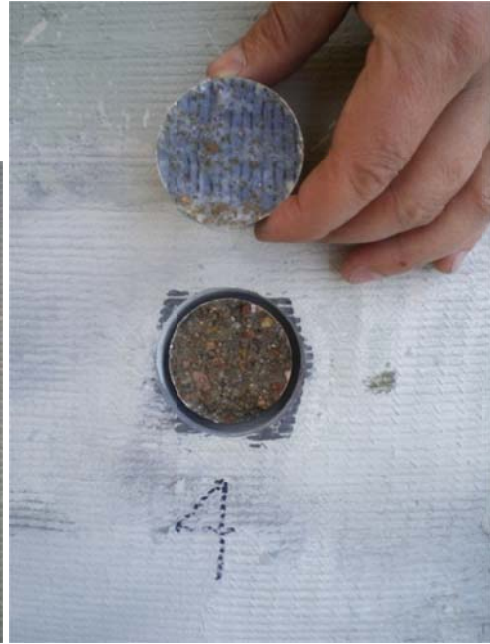
**Figures B10 and B11.** Test No.12, weak bond strength, and test No.13, weak bond strength
