Appendix D-1

Innovative Revegetation Study Task 4 Field Visit Observations

Date of Field Visit: 11/19/2013

Location: Southern Urban Foothills (Region 2)

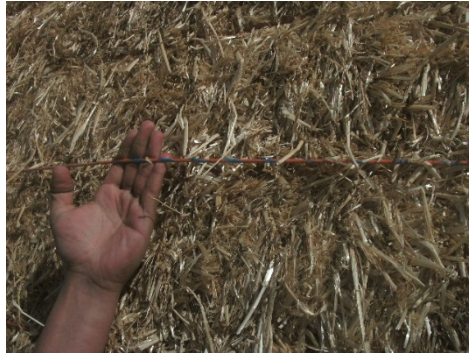
- 2) All straw mulch bales visually inspected on-site were identified as being weed free through the use of multi-colored twine (Picture 1).

Picture 1. Straw mulch twine indicating weed free straw.

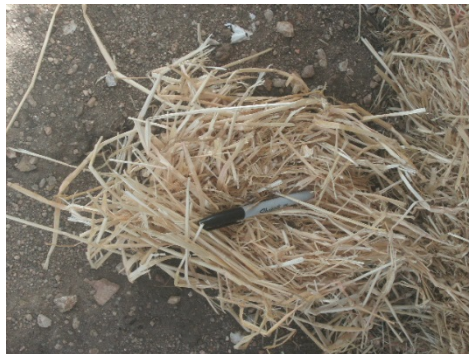
- 3) Straw bales inspected on site appeared to have adequate straw length to facilitate proper crimping (Picture 2).

Picture 2. Straw length of bales inspected.

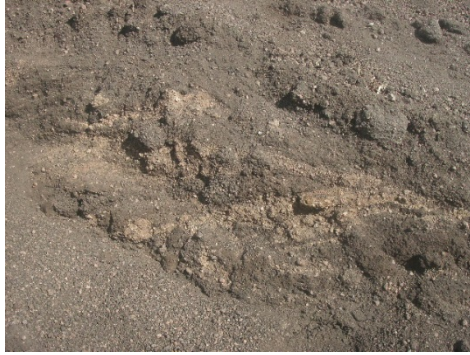
- 11) Topsoil salvage piles were reviewed. The following items were identified:
 - a. Some mixing of topsoil with subsoil was occurring (Picture 4)
 - b. Topsoil was not protected from wind or water erosion (Picture 5)

Picture 4. Topsoil mixed with subsoil.

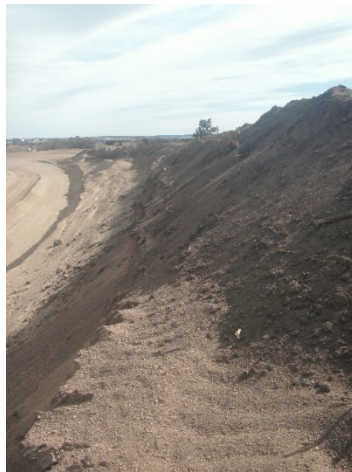
Picture 5. No wind or water erosion on topsoil piles.

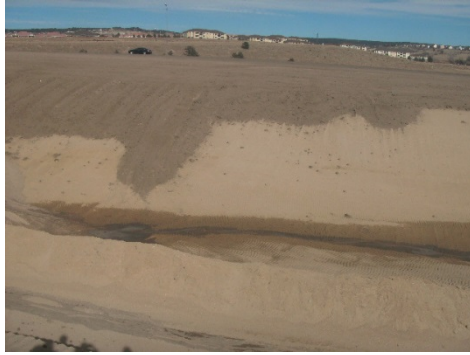
- 13) Topsoil spreading was being completed on portions of the ROW (Picture 6). It was noticed that prior to spreading the subsoil was not prepared for topsoil placement. . A clear and definite discontinuity was being established which could decrease reclamation success. This potential discontinuity between soil layers could result in poor water movement between soil layers. This lack of soil water movement between soil layers could increase erosion, decrease plant growth, and/or create a boundary that could lead to mass movement of the soil. It is not known at this time whether actions will be taken to remove this discontinuity once topsoil placement is finished.

Picture 6. Topsoil spreading in progress.
