Appendix D-2

Innovative Revegetation Study Task 4 Field Visit Observations

Date of Field Visit: 2/21/2014

Location: I-76 Brush

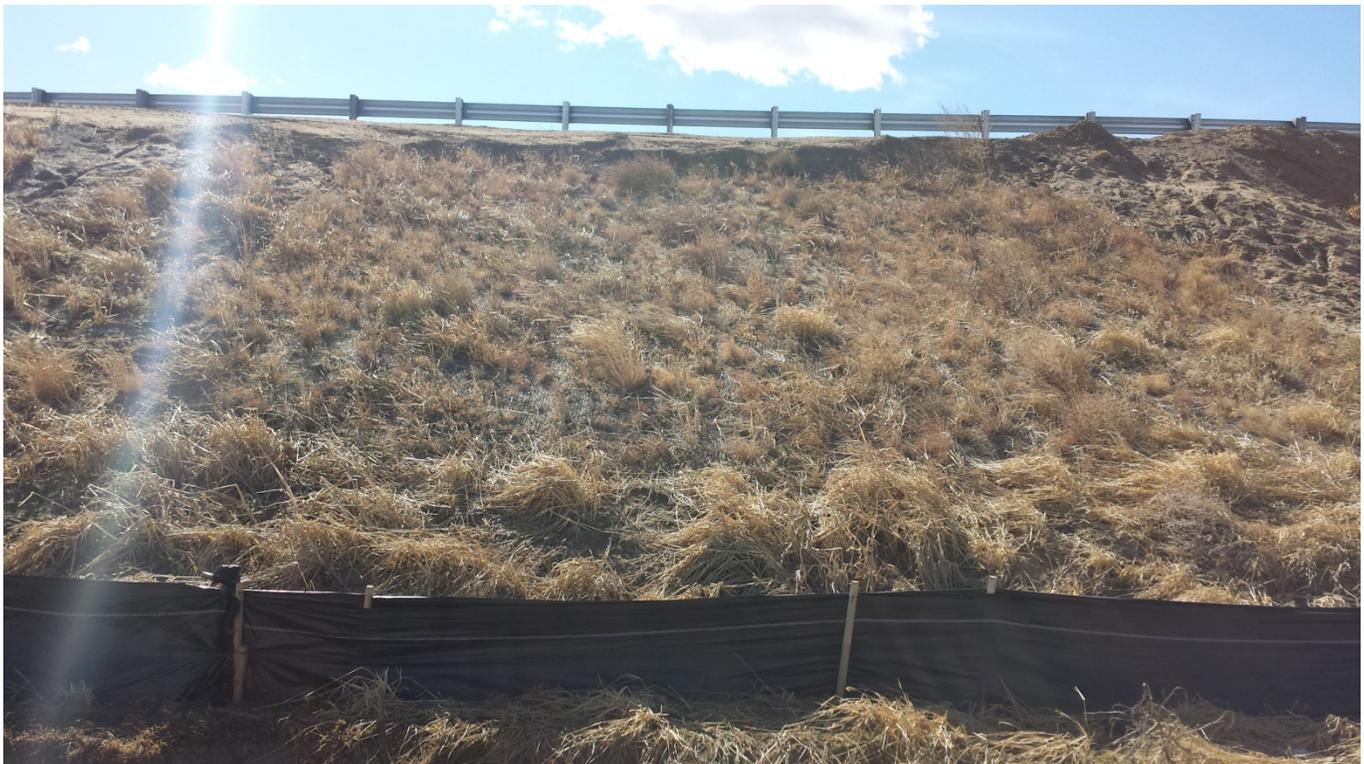
- 5) One steep area was hydroseeded, hydromulched, and then blanketed in 2013 (June?). This was the only way the area could be accessed, so CDOT approved the hydro-work. Vegetative growth was great here, partially due to large amounts of precipitation in the summer of 2013. (Note: Inspector made contractor hydro mulch as the erosion control blanket crew could not arrive until 2 days after seeding).

Figure 1. Area hydro seeded, hydro mulched, and blanketed. This is one year's growth (2013) on steep, sandy slopes.

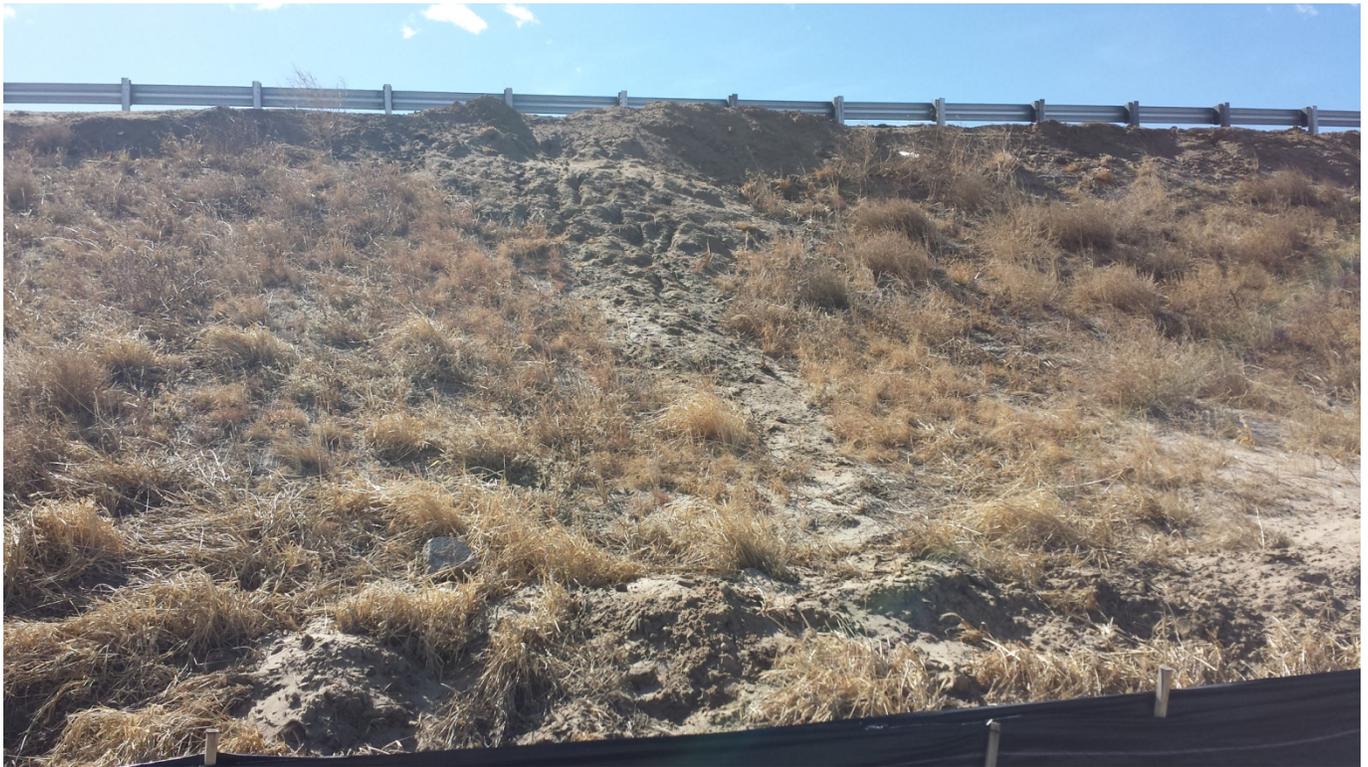
Figure 2. Hydro seeded area. Heavy rains in 2013 breached berm at the side of the highway, causing some erosion in localized areas.

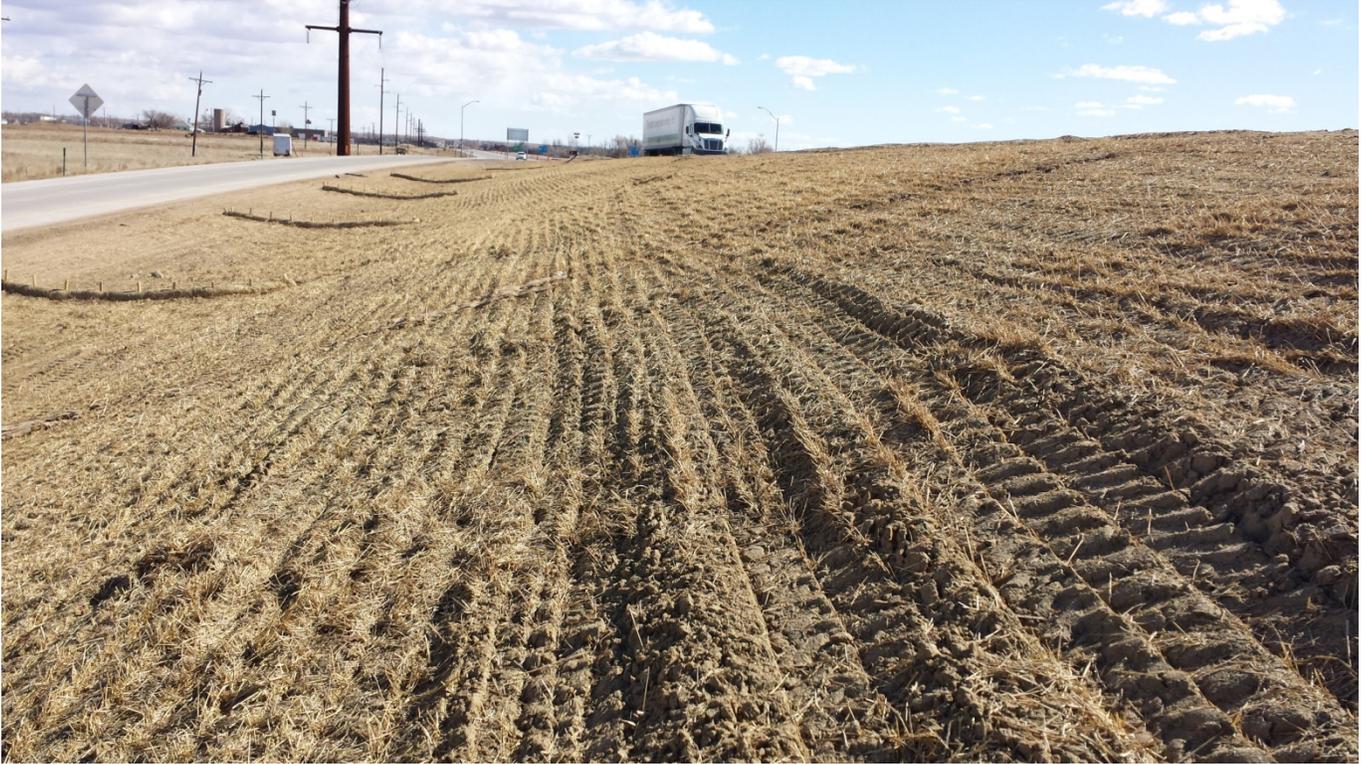
looked fresh. Inspector mentioned that the contractor had trouble crimping, straw coming out of the blower had been chopped up into short lengths (approx 4") and would not crimp well. We visited a site that had been straw mulched and crimped; this area had a great crimp. The day we visited was very windy, but straw remained in place.

Figure 3. Straw mulched area. A good crimp led to zero loss on this windy day.

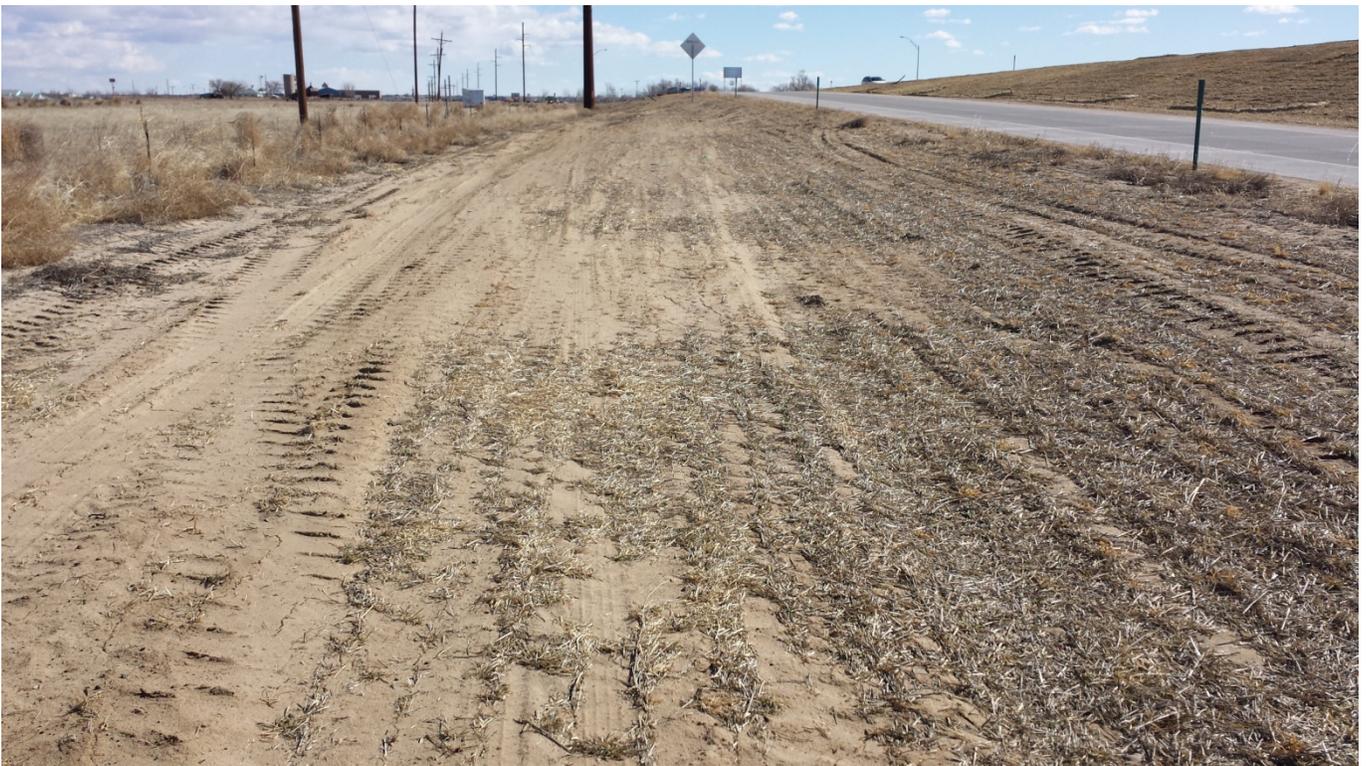
Figure 4. Straw mulched area. This side of the frontage road had been driven over by unknown vehicles. There was no evidence the area had been straw mulched.

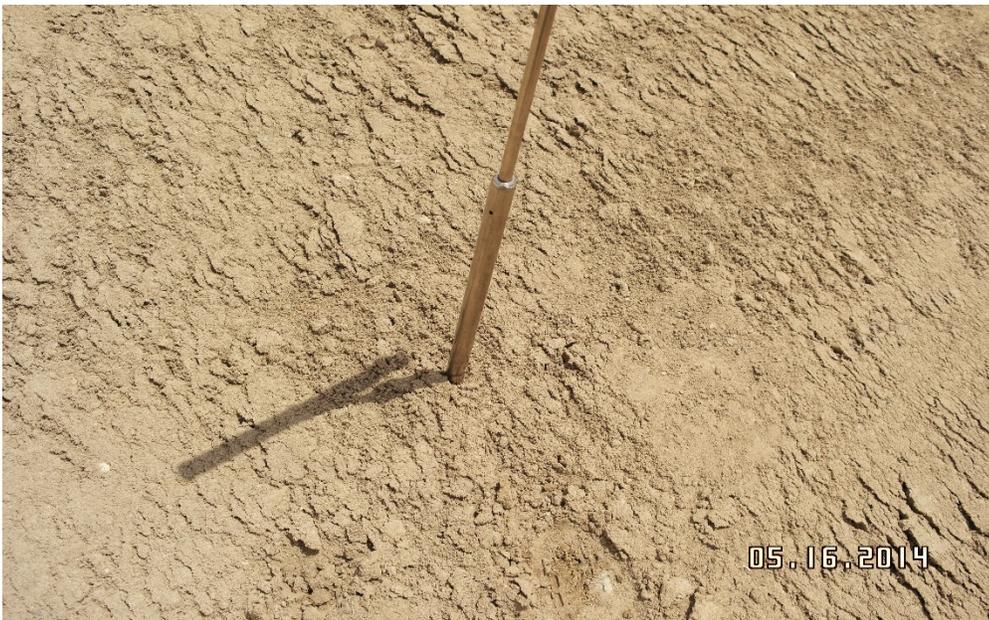
- Project is importing soil from adjacent area near staging area (picture); soil is essential "sterile" and needs amendments.
- CDOT needs better weed control along the ROW near revegetation areas to promote better revegetation success in regards to noxious weed competition for water and establishment.

New imported soil that will be used for temporary seeding

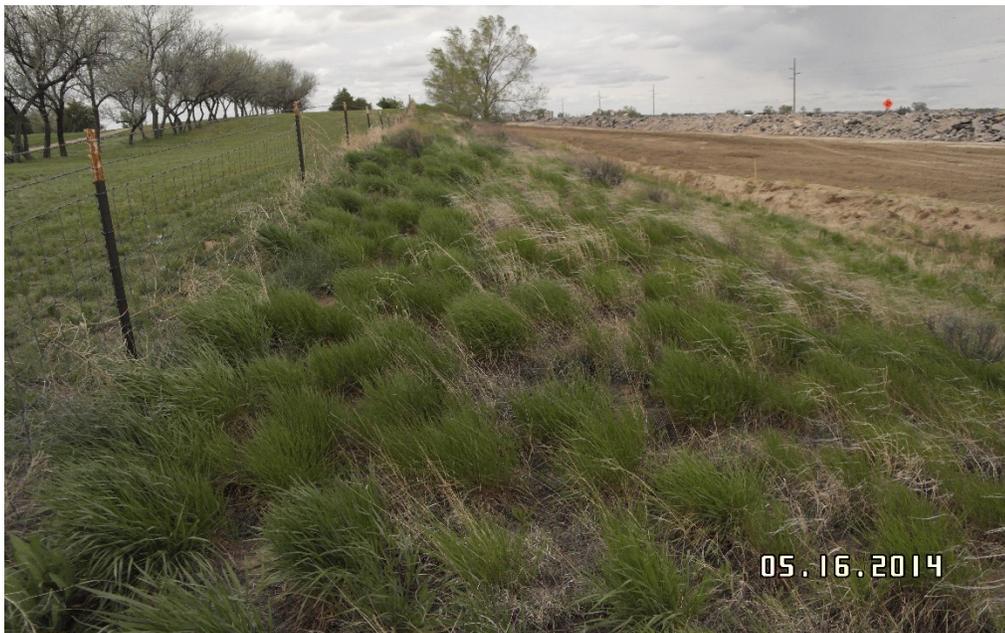
- Vegetation is starting to establish from seeding done last year; see last visit report.
- No stockpiling of topsoil was performed at the site. Topsoil that was wind rowed is essentially topsoil that was scraped off a temporary equipment road along the interstate. Observation showed not real organic matter/top soil horizon. A sample of the wind rowed topsoil was taken and pictures taken in the field (see attached pictures).

Wind rowed top soil area to the right; undisturbed reference site near fence line

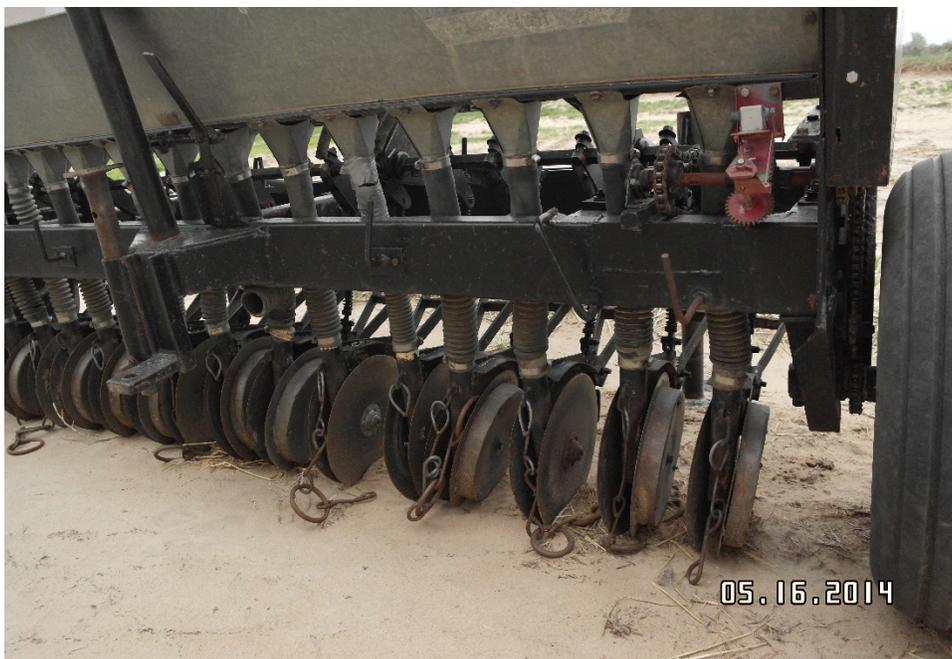
Drill Seeder

- Drill seeder is calibrated just before the project starts; I was told that it is documented but paper documentation is not given to CDOT since this is not a requirement.

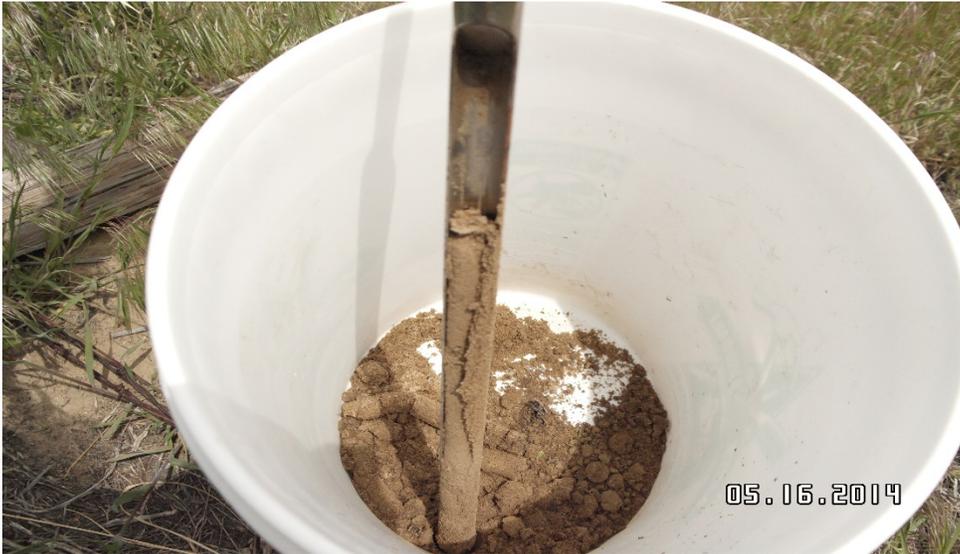
Representative soil profile for all soil samples collected
