Innovative Revegetation Study Task 4 Field Visit Observations

Date of Field Visit: 5/28/14

Location: Mountain Area

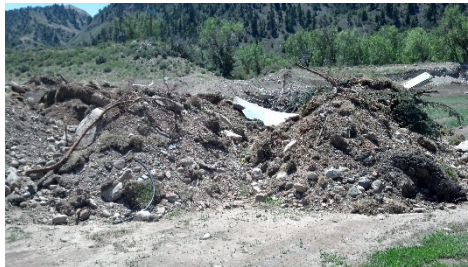
- 1) According to the ECS topsoil was salvaged and moved offsite due to limited room within the construction area within the ROW. Topsoil stockpiles were reviewed and it was determined that the stockpiles were comprised based on visual evidence of large rocks, electrical wiring, sheet metal, and large woody debris (Picture 1). The grading for topsoil development was visual and not measured.

Picture 1. Topsoil Stockpile for the I-70 Eagle project.

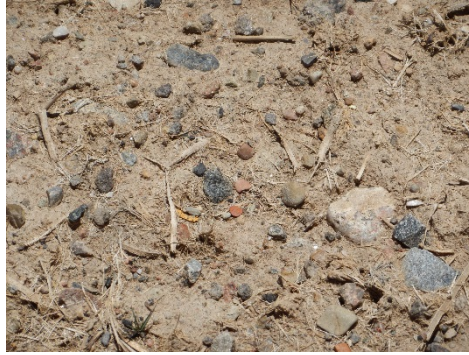
- 2) Seeding methodology was changed from drill seeding to broadcast seeding, racking and hydromulch. The change was requested due to a large proportion of steep (>2:1) slopes on the project site. Change in seeding specifications was authorized by the Project Engineer. Seeding rates were increased 1.5X for the broadcast seeding. It should be noted that during the site inspection *multiple areas that could have been drilled seeded were observed*.
- 3) Site was seeded and hydromulched around November 15, 2013 (within seeding window), little if any hydromulch was observed on the site (Picture 2).

Picture 2. Soil surface with limited hydromulch remaining.

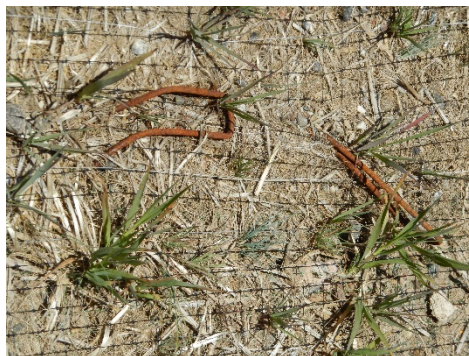
- 4) Revegetation germination appeared to be increased by the use of dozer tracking on the steeper slopes. However a high level of soil compaction was observed in the top 3 to 4 inches of the soil surface. Picture 3 shows evidence of the compaction with most of the staples for the blanket not placed all the way to depth. This increase in soil compaction may impact establishment of the reclamation grasses due to limited rooting depths.

Picture 3. Blanket staples were not able to be installed completely likely due to soil compaction.
