# **City and County of Pueblo Flood Hazard Mitigation Plan**

## **The June 3, 1994 Flash Flood**

**August 1994**

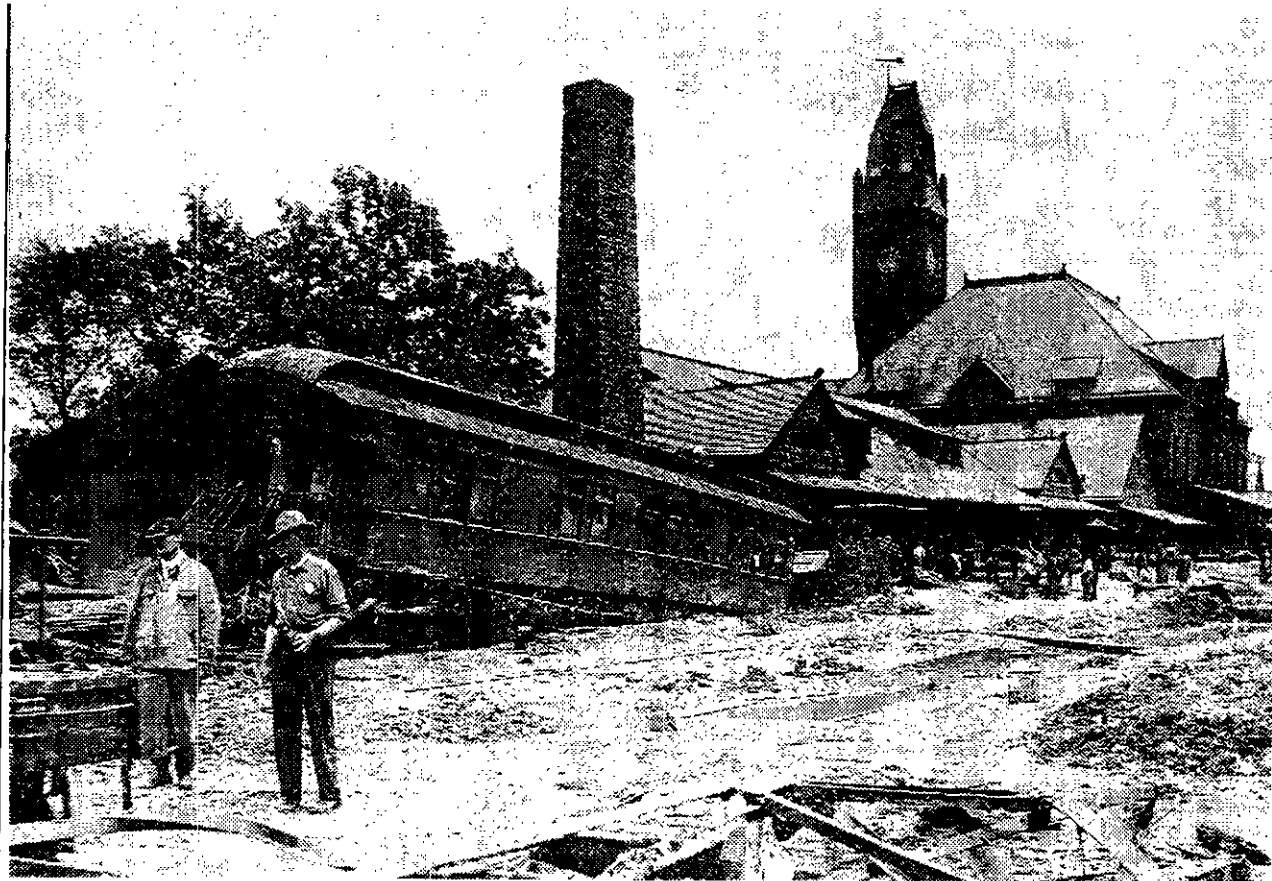
A scene in downtown Pueblo after the June 3, 1921 flood.

The levees built after the 1893 and 1894 floods could not hold the mighty flow of water that came crashing down the Arkansas River on the night of June 3, 1921. The flood demolished the business district. Over the years the community had rechanneled the river, but the floodwaters returned the river to its original course. The community was warned of the flood by curfew sirens, but instead of deterring people, the people came out to watch the flood blast down the Arkansas. By the time the people of Pueblo realized the magnitude of the flood, it was too late. The downtown Union Depot high water mark reached 11 feet.

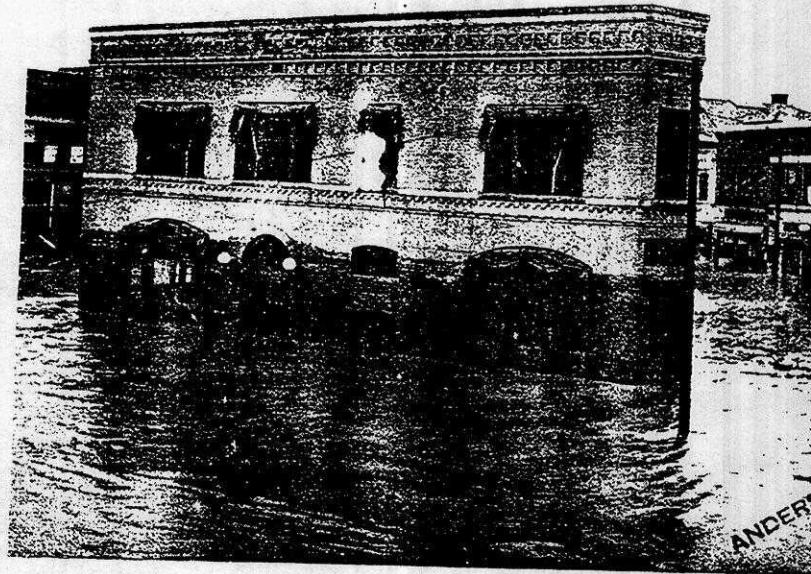
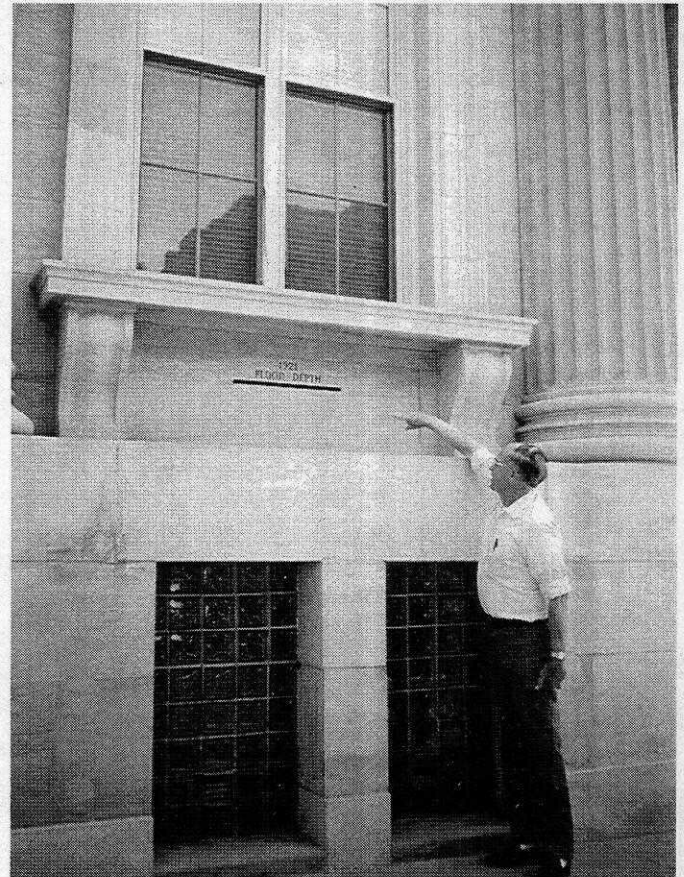
Top picture: Saturday, June 4, 1921 the high water mark shows the water has receded eight feet. Above: Volunteer for Pueblo County Historical Society Tom Cummins points to the 1921 flood high water mark on City Hall.

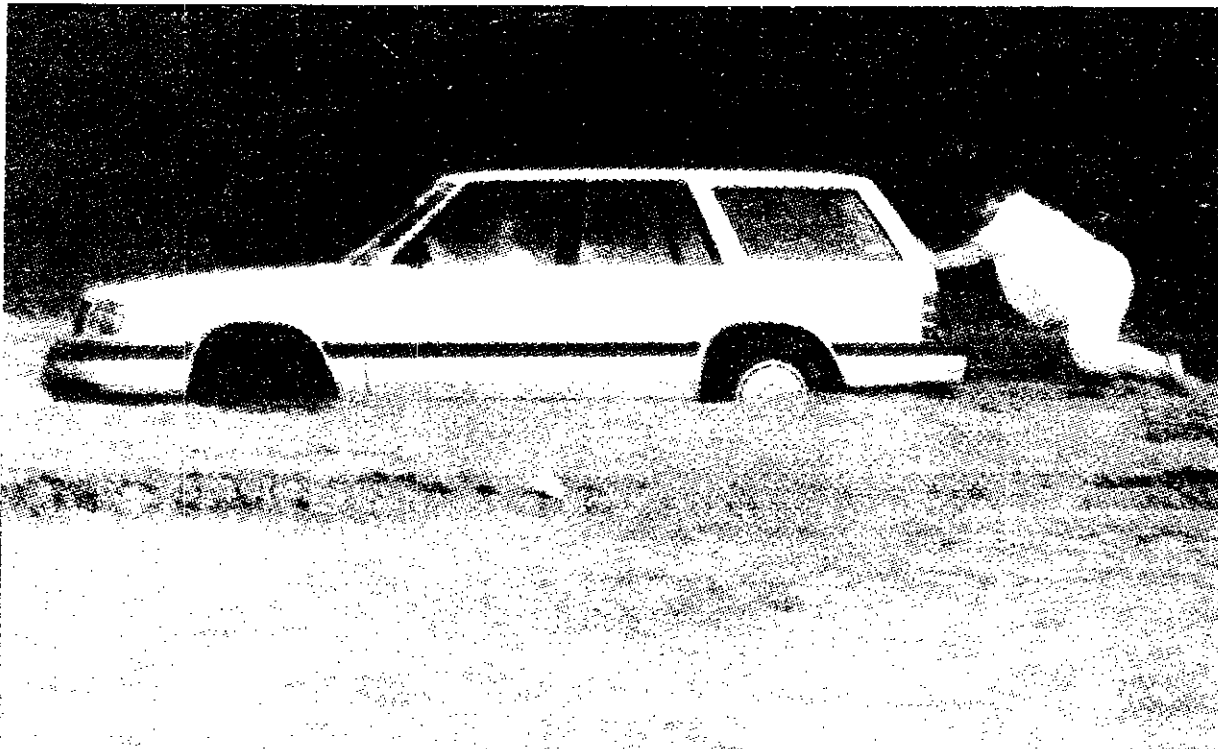
A stalled car in a flooded intersection during the June 2, 1994 storm, just before the more intense storm on June 3, 1994. The Pueblo Chieftain, June 3, 1994.

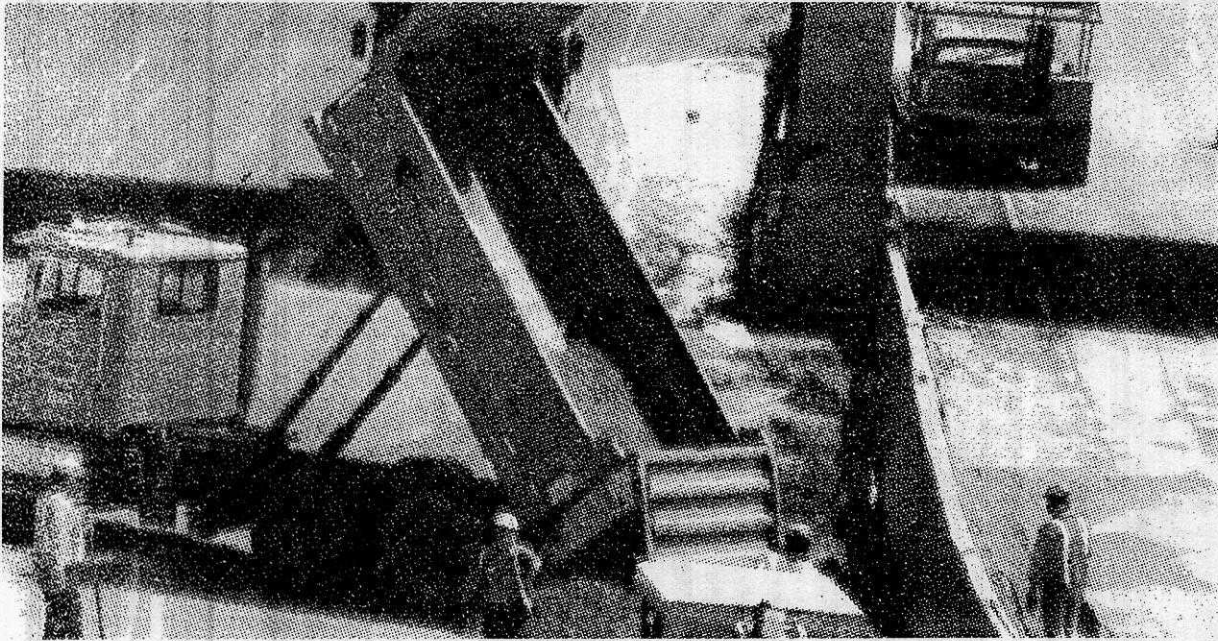
Road crews clean mud from I-25. The Pueblo Chieftain, June 4, 1994.

for most of the morning. Snowplows were used to clear the mud and sand from the roads. I-25 at Abriendo sustained major damage: a slope washed off into the interstate, chunks of asphalt and debris blocked the road, two feet of mud and water lay on the road in some places, and parts of the interstate were completely undermined. Although they cleared most of the damage very fast, they will still be working on repairing damage from this flood for quite a while, as will the City and County. Some of the damage has turned into long-term repair projects.

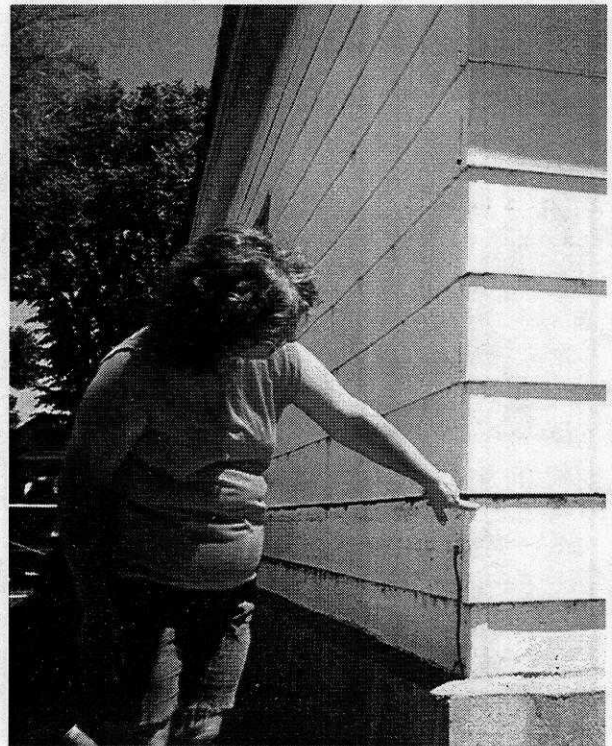
Possibly the ditch played a role in some flooding in the south side area because, in this area, the homes are about 4 to 8 feet lower than the ditch. When the rain fell hard and the storm drains could not remove it fast enough, the runoff pooled and the ditch acted as a kind of a dam. Runoff hit the "dam" and either pooled or bounced back into yards and homes. The woman in the picture (next page) lived right next to the ditch and just behind Northern Avenue (which carried quite a flow of water). The only thing between her home and the ditch is a paved parking lot.

Ms. Mascarenas points to the high water mark on her home.

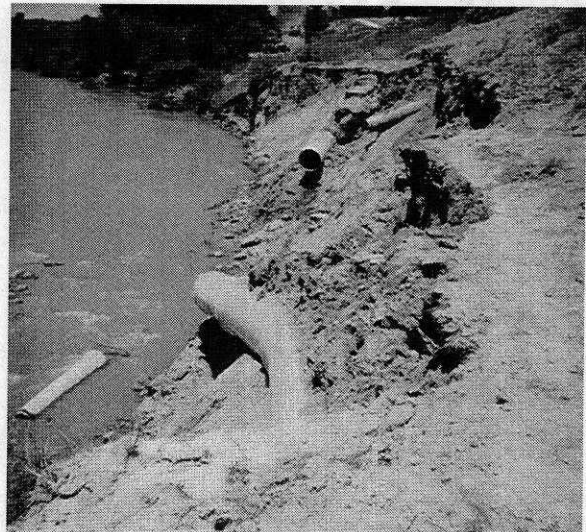
The Fountain Creek floodwaters washed out large sections of the embankment and a sanitary sewer trunk line. Photo courtesy of John Dagenais, City Public Works.
