Open-File Report 89-1

# Field Studies and Modeling Analysis of the Roan Creek Landslide, Garfield County, Colorado

By  
David Umstot\*

Colorado Geological Survey  
Department of Natural Resources  
Denver, Colorado  
1989

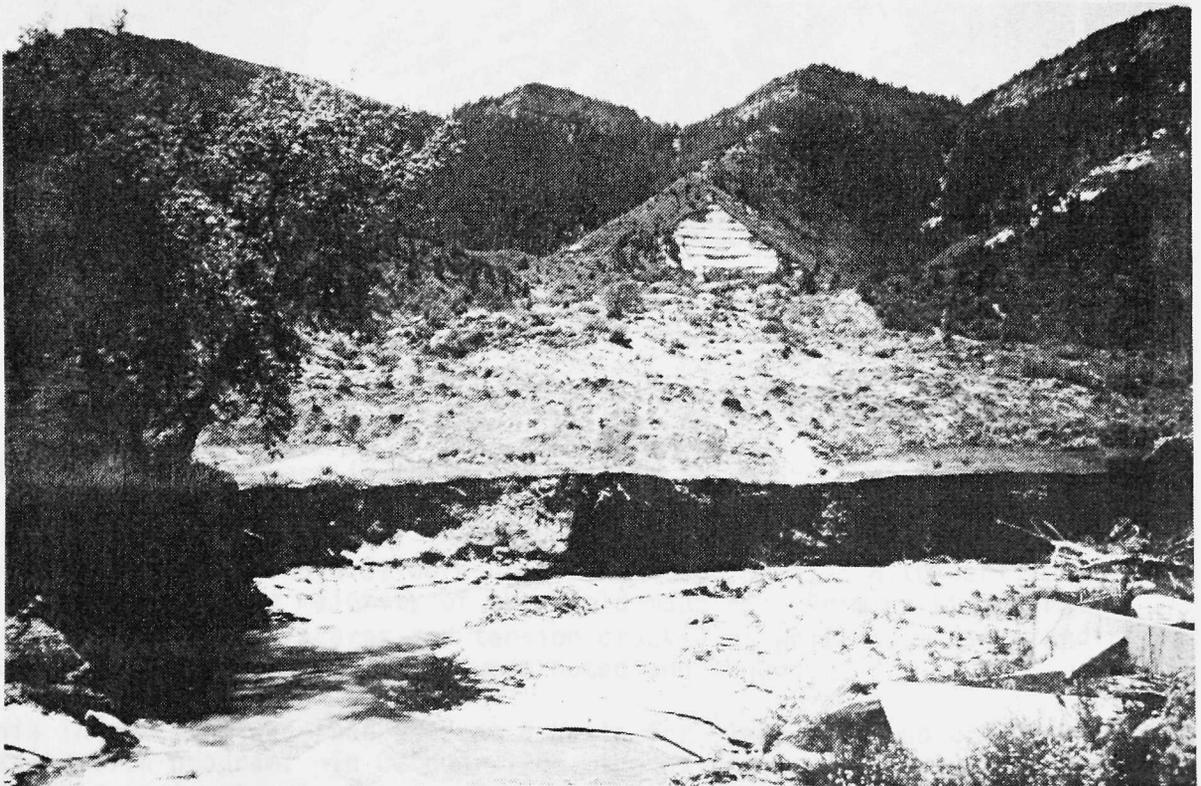
Figure 3. The Roan Creek landslide halted 50 feet from Roan Creek. The height of the cliff bank in foreground is approximately 15 feet.

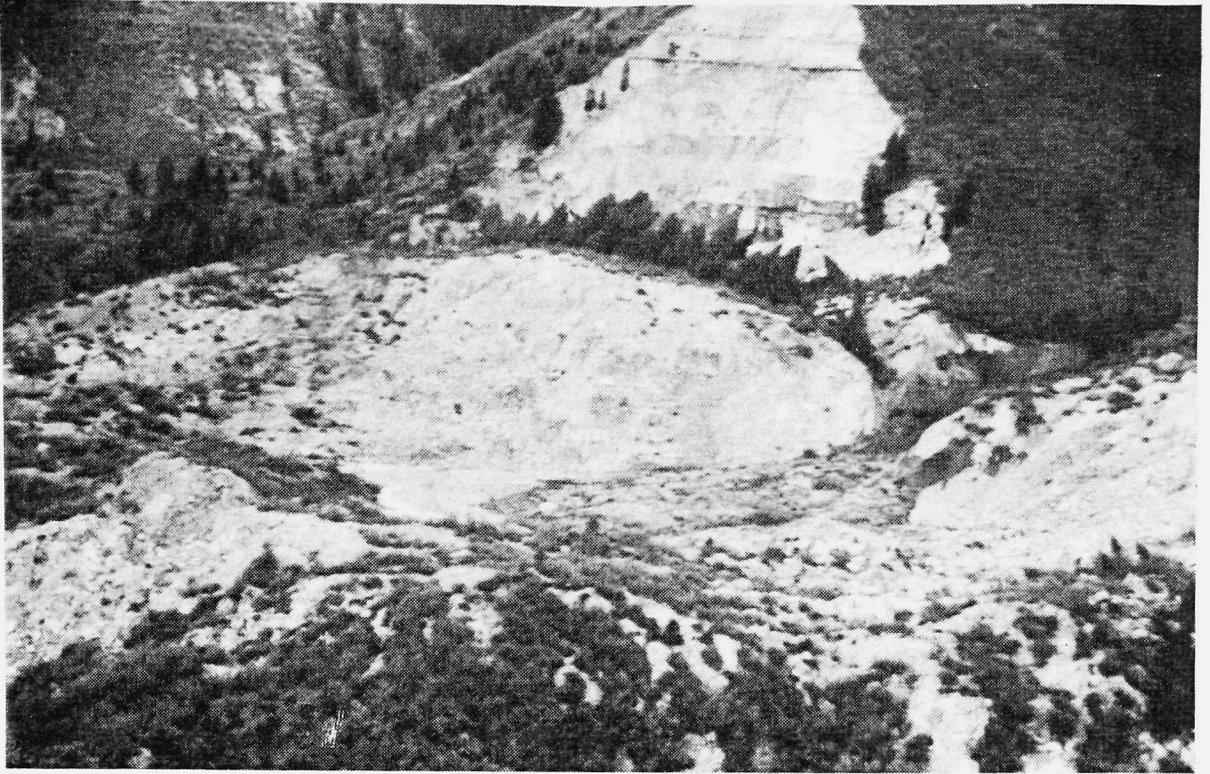
5.1.2.1 Head scarps The head scarps are present continuously around the perimeter of the slide mass in the upper third of the slide. To the west and east of the drainage are large cliff scarps (Figures 14 and 15) which are not visible on USGS topographic maps printed in 1968. Seepage in the center of the scarp face should be noted in Figure 15. Groundwater flow appears to be along horizontal bedding planes near the contact of the Garden Gulch and Douglas Creek Members of the Green River Formation as evidenced by seeps in the western cliff scarp. Olson (1974) mapped both cliff scarps in his field work, but at a lesser magnitude with less extensive associated landslide deposits. This would indicate initial failure of the slopes occurred sometime between the aerial missions flown to collect data for the topographic maps and 1974, or that the scarps were small enough to be masked when preparing a small-scale topographic base map without adequate field checking.

Figure 14. A view of the eastern head scarp which is approximately 150 feet high. Refer to Figure 16 for location.

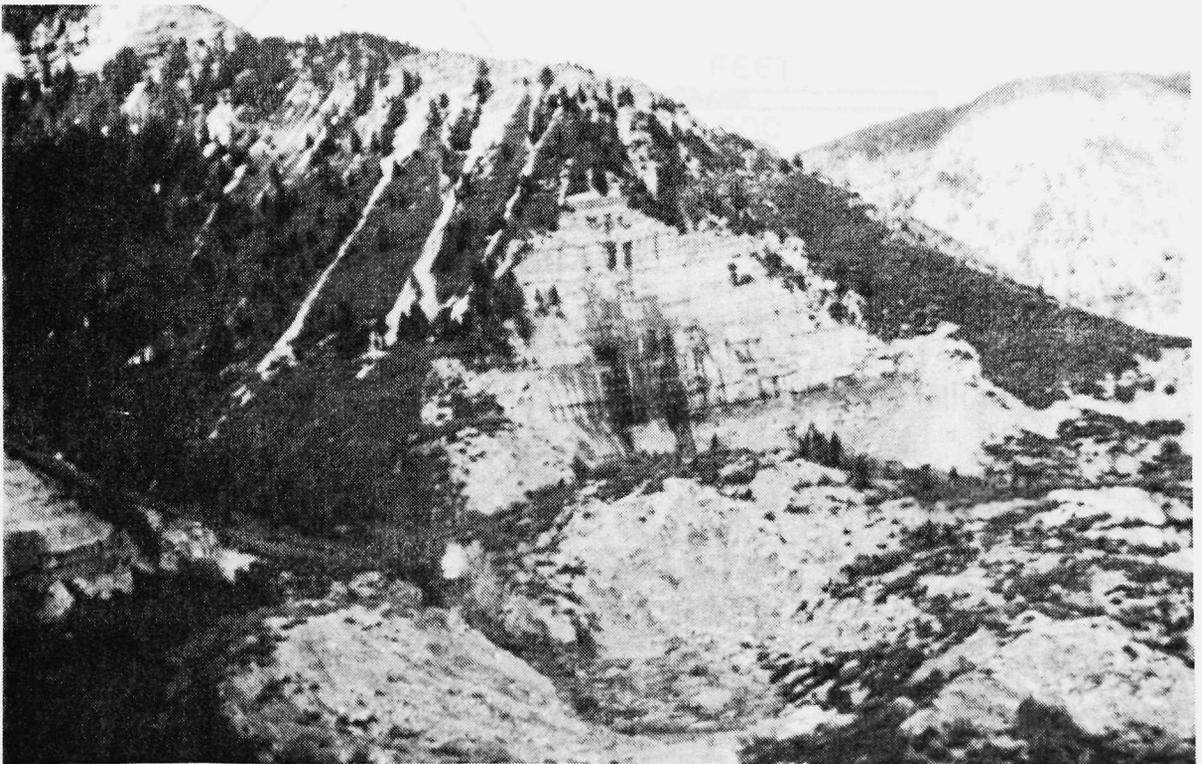
Figure 15. The western head scarp is approximately 200 feet high. Refer to Figure 16 for location.

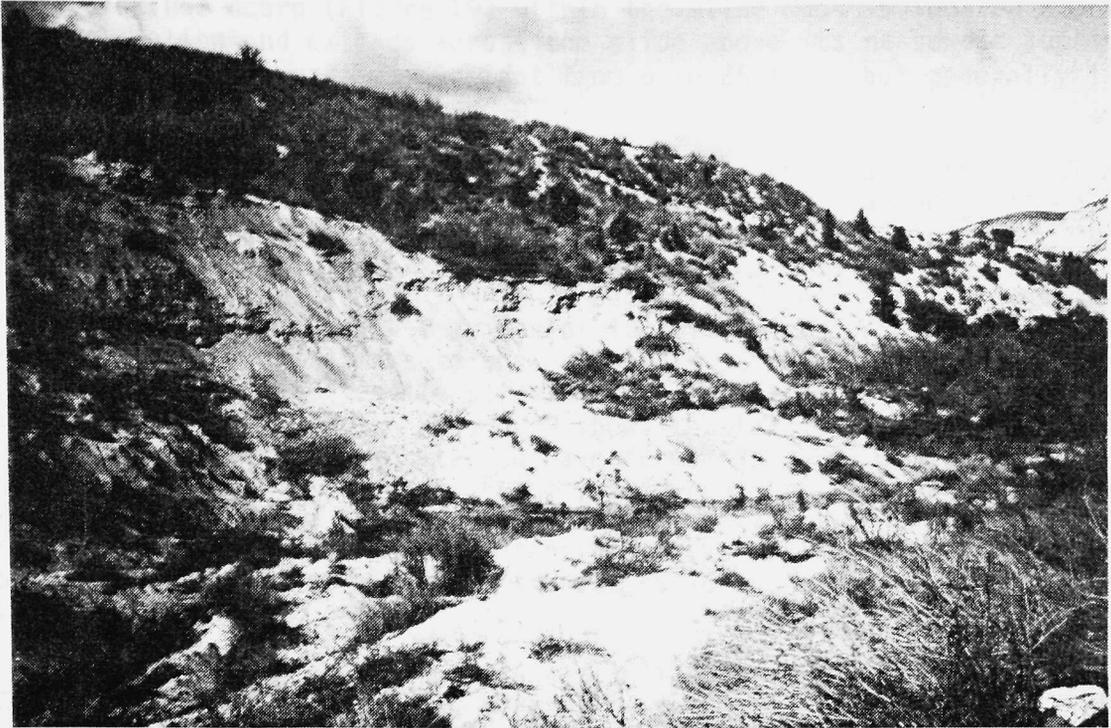
Figure 17. Scarp along western margin of Roan Creek landslide. Refer to Figure 18 for location.

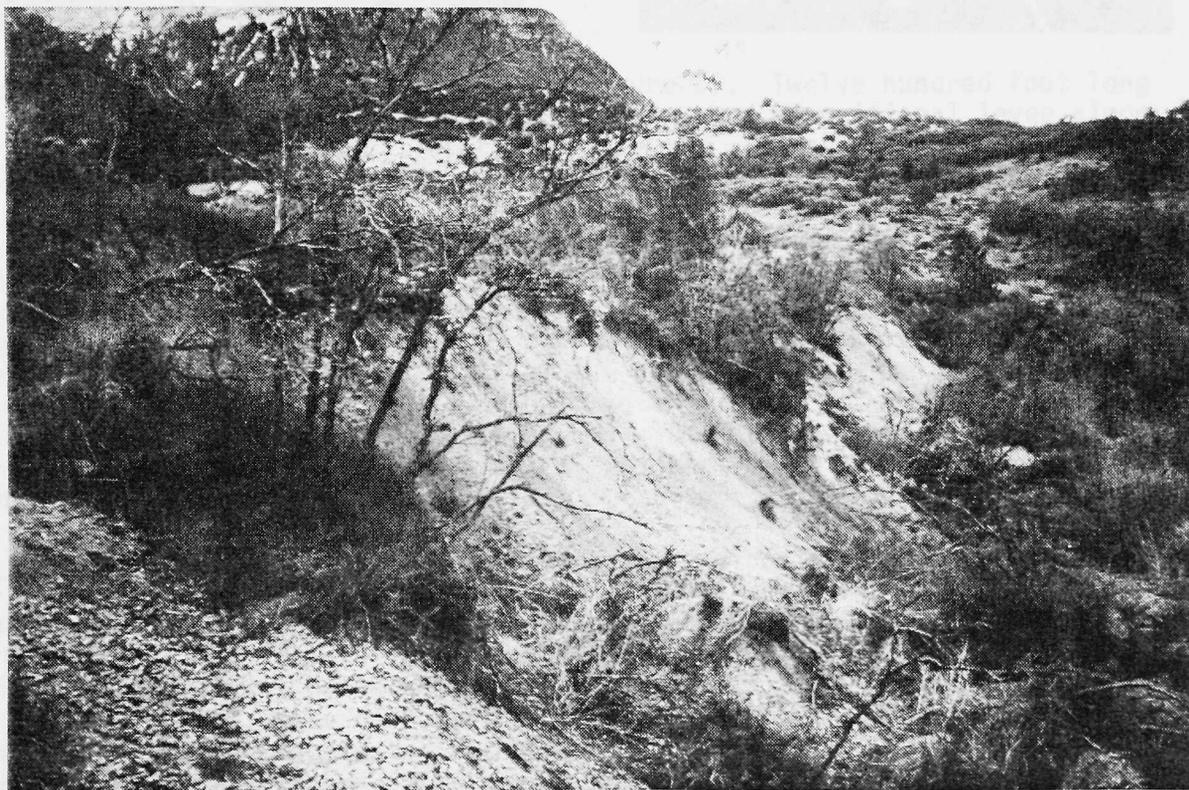
Another distinct scarp (Figure 19) within the slide mass is located at 6175 feet in elevation and extends across the slide above its narrowest juncture (see Figure 18). It varies in height from 6 to 25 feet, but generally is 20 feet high.

Figure 19. Scarp exhibiting about 20 feet of vertical displacement crosscuts the slide mass approximately one third of the distance up the slide from the toe. Refer to Figure 18 for location.

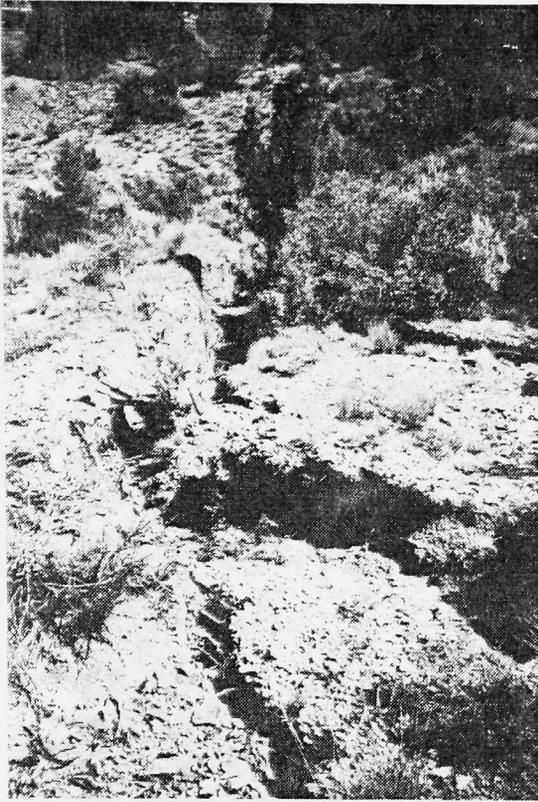
Figure 20. Tension cracks east of the slide mass. Refer to Figure 18 for location.

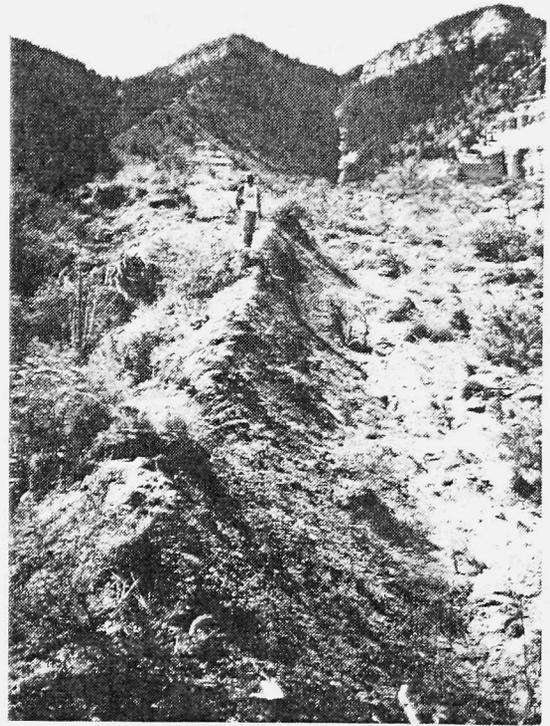
5.1.2.4 Lateral levee A lateral deposition levee is present on the eastern flank of the slide with a length of 1200 feet (Figure 21). The height of the levee varies from 4 feet in its lower reaches to 15 feet in its upper reaches. Width also is variable decreasing from 15 feet to 6 feet towards the

Figure 21. Twelve hundred foot long depositional levee along the eastern margin of the landslide. Refer to Figure 18 for location.

toe of the slide. Depositional levees are common landforms in earthflow deposits as the velocity of the flow is slower at its edges than in its center due to increased shearing stresses along the margins. Therefore, as the flow material on the sides stops, it is at the same height as the remainder of the flow material. However, flow continues in the center and the center areal mass is depleted as the soil flows onward. The difference in elevation between the center and lateral areas of the flow deposit results in what appears to be a levee.

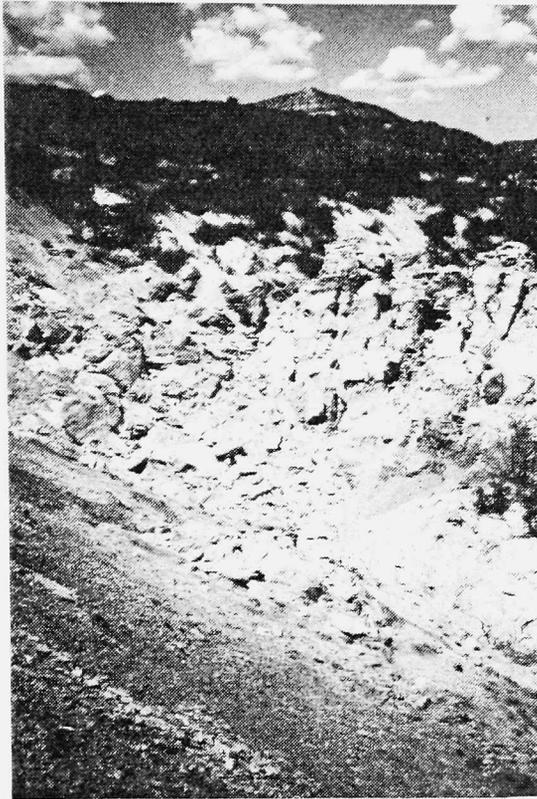
5.1.2.5 Depressions Several topographic depressions were mapped on the slide deposits, some of which form ponds. In the upper reaches of the slide are large depressions dominated by blocks of bedrock. The largest of these has dimensions of 200 feet in length, 100 feet in width and 40 feet in depth (Figure 22). It was noted that after a torrential rain, no standing water was present in any of these depressions. Numerous open cracks and holes allow infiltration of surface water into the slide mass. These depressions are interpreted to have formed when a large slab of rock present in the rock flows emanating from the western cliff scarp region broke apart due to tensile stresses.

Figure 22. Forty foot deep depression in upper reaches of slide. Person for scale in right center of photo. See Figure 23 for location.

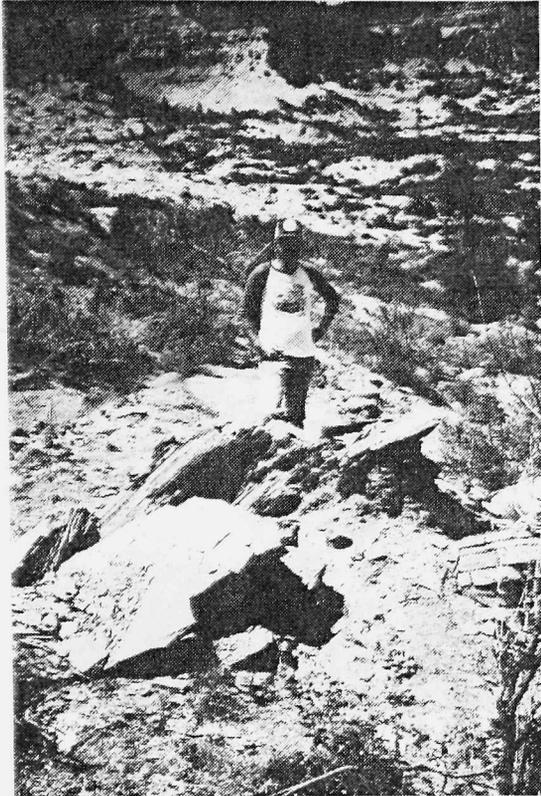
Figure 24. Highly fissile blocks of rock comprise the upper reaches of the landslide. Refer to Figure 23 for location.

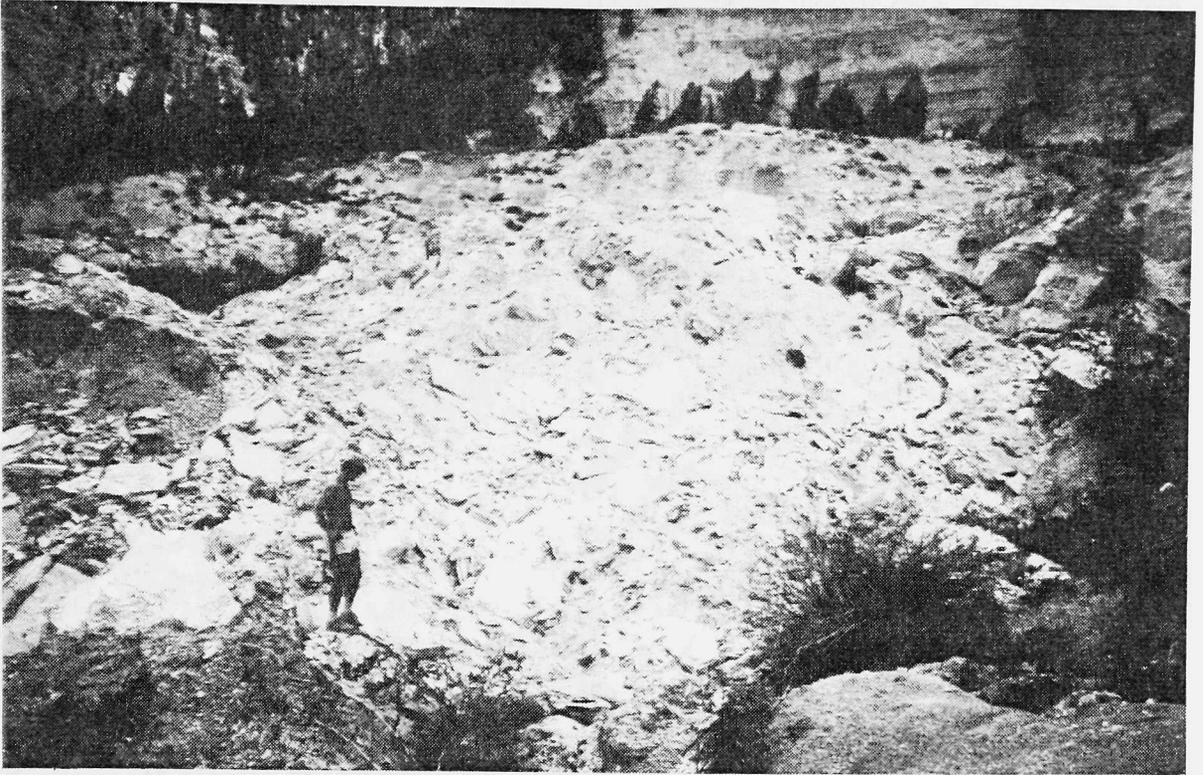
Figure 25. Texture of the upper reaches of the landslide where rock rubble dominates lithology. Refer to Figure 23 for location.

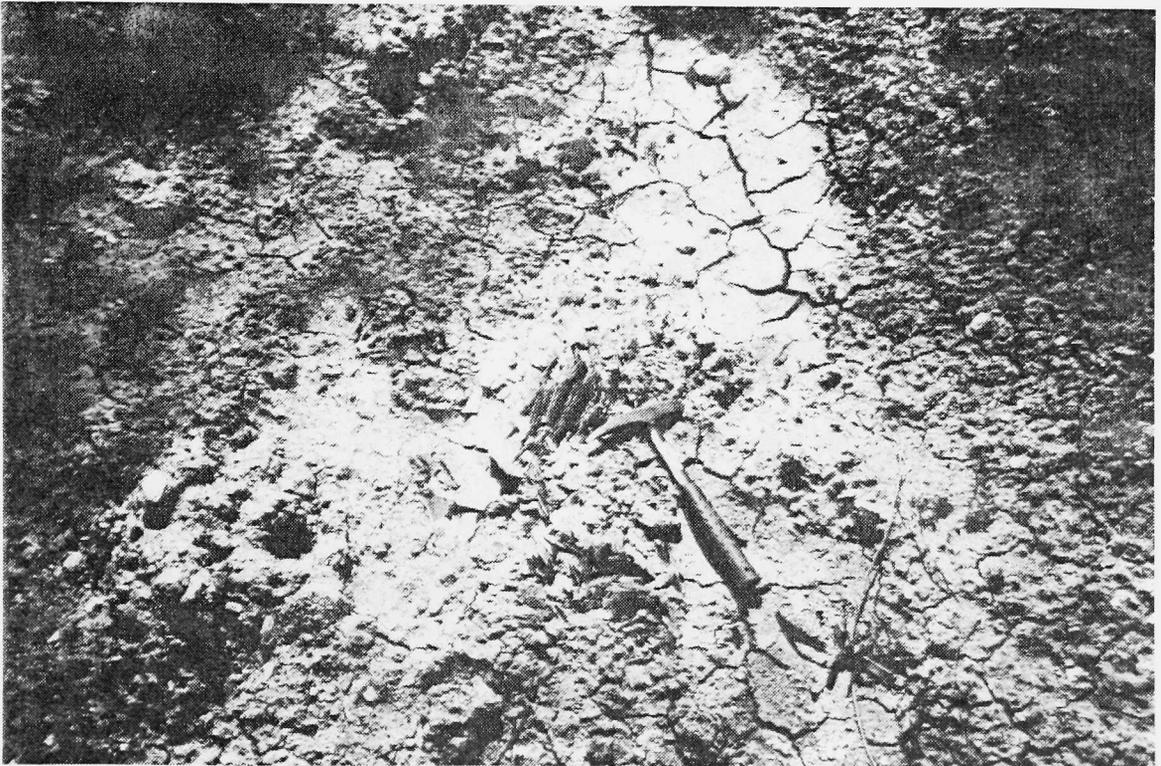
The lower two thirds of the slide is predominantly fine-grained with an abundance of smaller rock fragments suspended within the clay-size matrix (Figure 26). In this zone, abundant blocks of vegetation and "A" soil horizon appear to have rafted on top of the slide mass as it moved downhill (Figure 27). The root structures of the vegetation have kept the blocks intact. On the flanks of the toe of the slide, another zone of predominantly fine-grained material is present, denoted as fine-grained zone 2 on Figure 23. It has a different texture and color from the primary fine-grained zone 1 and correlates to the hillslopes adjacent to the slide. The material was most probably incorporated into the slide mass as the slide moved into the drainage bottleneck before spreading onto an alluvial fan. A small debris flow deposit (see Figure 23) is present at the head of the slide below the juncture where the head scarp intersects the drainage from the upper elevations of Kimball Mountain.

Figure 26. Fine-grained materials dominate the lower reaches of the landslide.

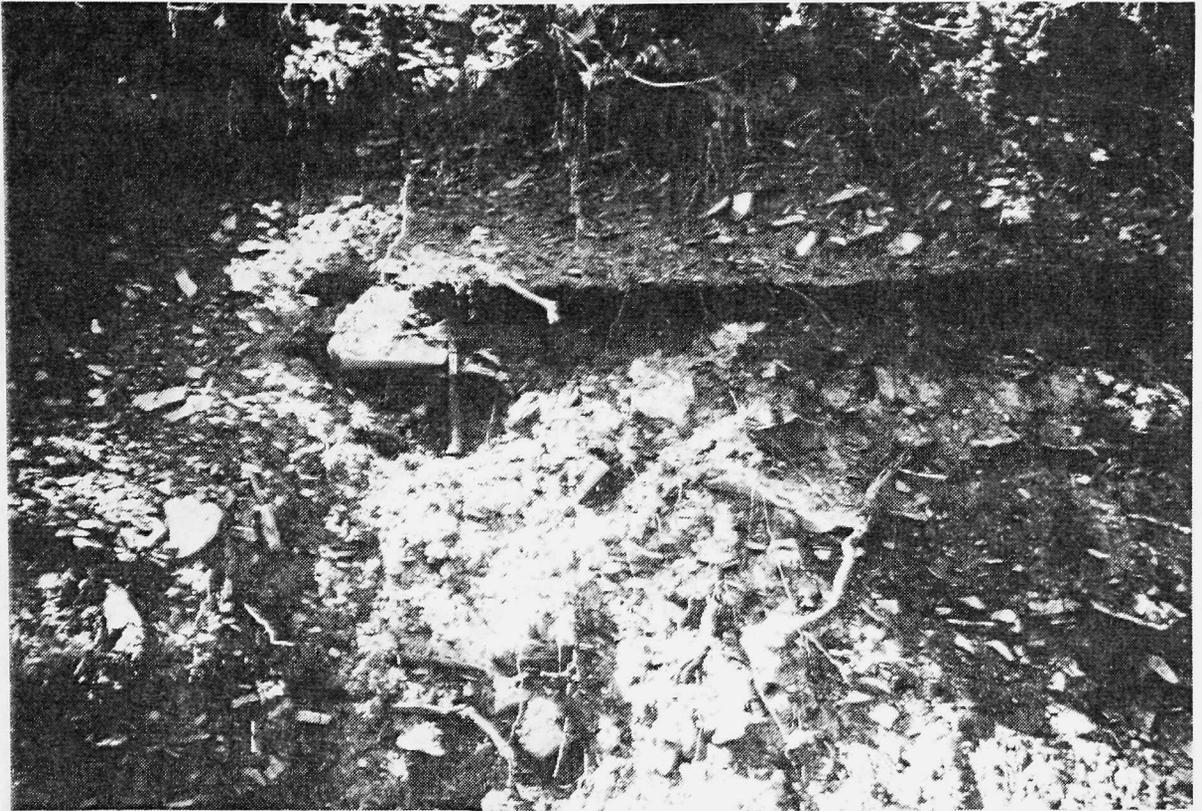
Figure 27. Vegetation and A-horizon "rafts" found in the central portion of the landslide. Refer to Figure 23 for location.

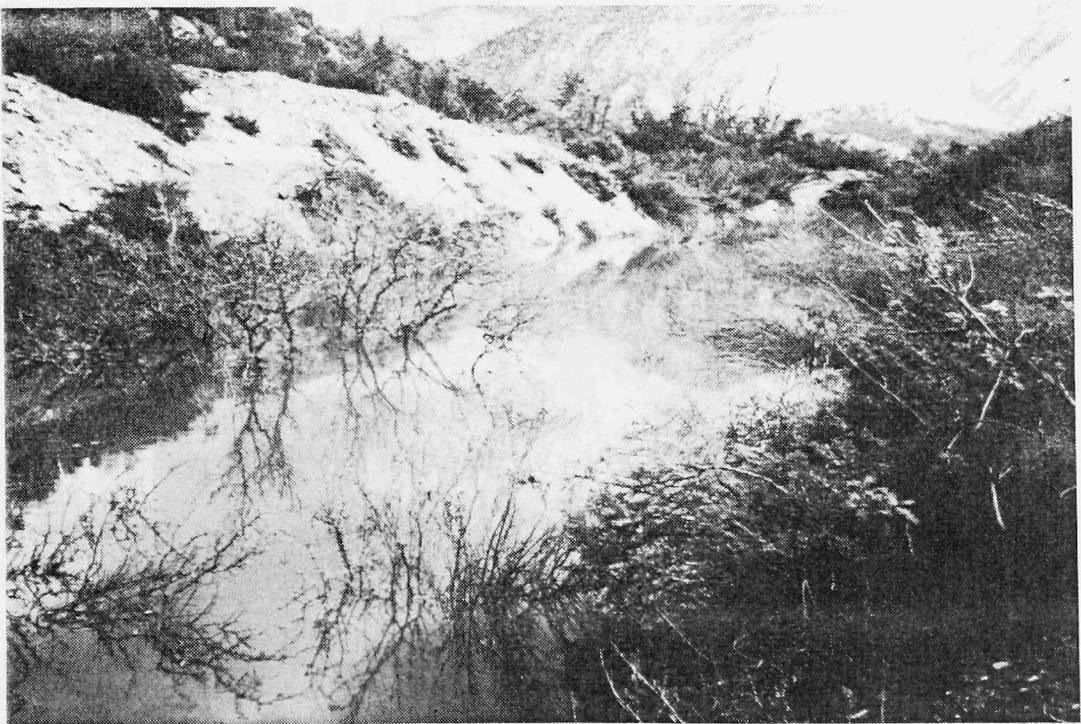
Figure 28. Standing water in the west central part of the landslide. Refer to Figure 23 for location.

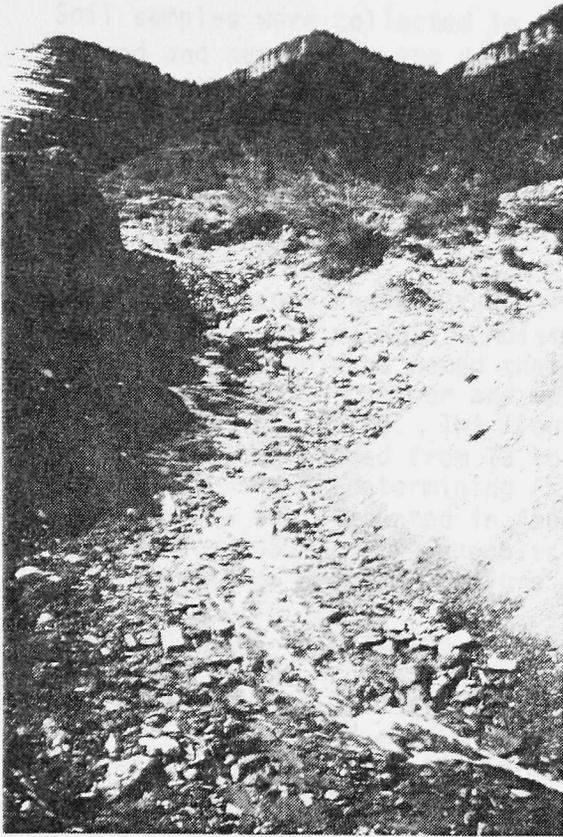
Figure 29. Stream flowing on toe of slide (Figure 23 for location).

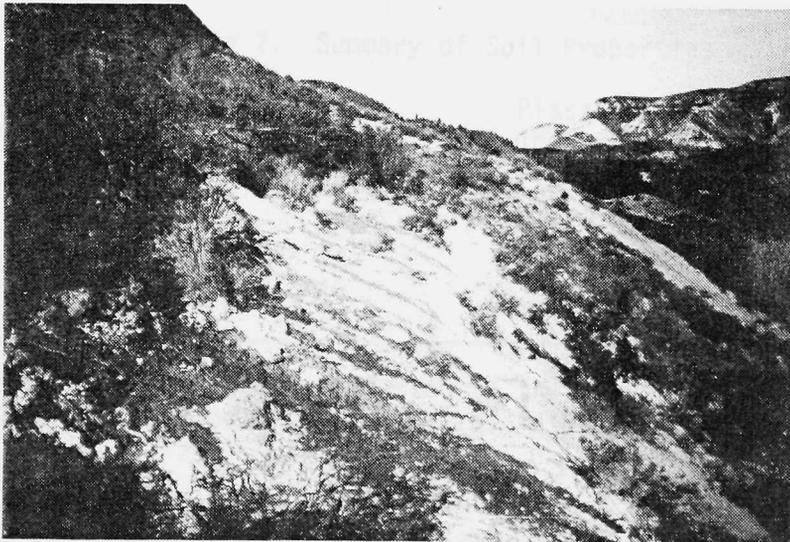
Groundwater recharge to the slide material most probably is the source of the water flowing off the slide. Several seeps were noted and mapped (Plate 1). Seeps are highly concentrated along the western flank in the lower one half of the slide (Figure 30), but also occur in other locations on the slide. The whiter areas on the photo are areas of calcite and gypsum mineralization. Study of the 1978 and 1985 aerial photographs indicates a well-defined drainage was overridden and infilled by the Roan Creek landslide along the western margin in the lower one half of the slide in 1985. This infilled, pre-existing drainage may act as a conduit for groundwater flow due to a differential permeability with the surrounding subsurface material and explain the high concentration of seeps along the western flank of the landslide. Abundant crystals of calcite, aragonite and gypsum are present on the surface throughout the lower one half of the slide suggesting groundwater was present at or very near the surface at some time, quite possibly at the time of failure and immediately after subsequent movement of the slide. The surface water and groundwater observations are important as water played an important role in the failure of the Roan Creek landslide.

Figure 30. Seeps and associated calcite and gypsum mineralization along the central western margin of the landslide (Figure 23 for location).
