Special Publication 42

Heaving-Bedrock Hazards Associated with Expansive, Steeply Dipping Bedrock in Douglas County, Colorado

By David C. Noe and
Marilyn D. Dodson

Colorado Geological Survey
Department of Natural Resources
Denver, Colorado/1999

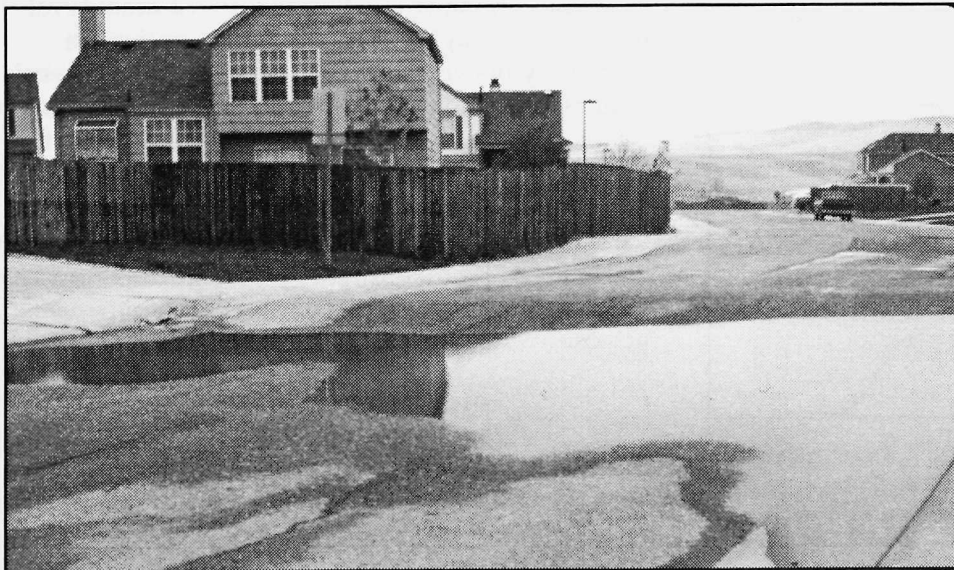
Figure 1. Linear heave feature associated with heaving bedrock in Douglas County. This heave feature has literally formed a dam that blocks storm drainage, resulting in surface-water ponding. Heaving bedrock has caused extensive damage in this neighborhood.

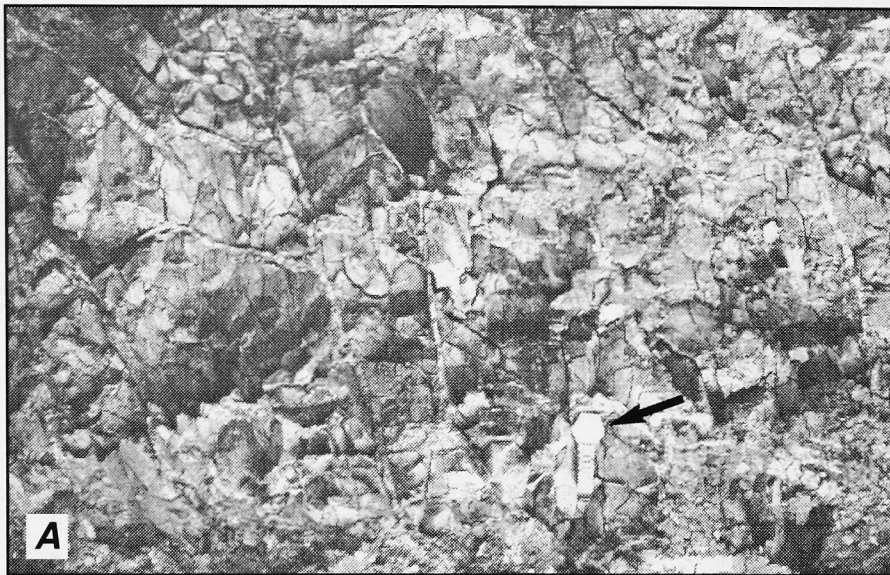
Gypsum is a chemical by-product of the leaching and weathering of claystone. Its presence as a fracture fill (see Fig. 6A) suggests that water has penetrated and chemically altered the claystone in the past, and could do so again. Fibrous calcite, another weathering product, is almost exclusively associated with beds of bentonite. Published investigations from South Dakota (summarized in Grimm and Guven, 1978) show that the bentonites having the highest potential for expansion will almost always contain some secondary calcite, a relationship that appears to be substantiated by CGS observations in Colorado (e.g., Fig. 7A).

(6A) Highly fractured bedrock in an area where heaving bedrock damage has occurred. Most of these fractures are filled with veins of gypsum crystals. Note wristwatch for scale (arrow).

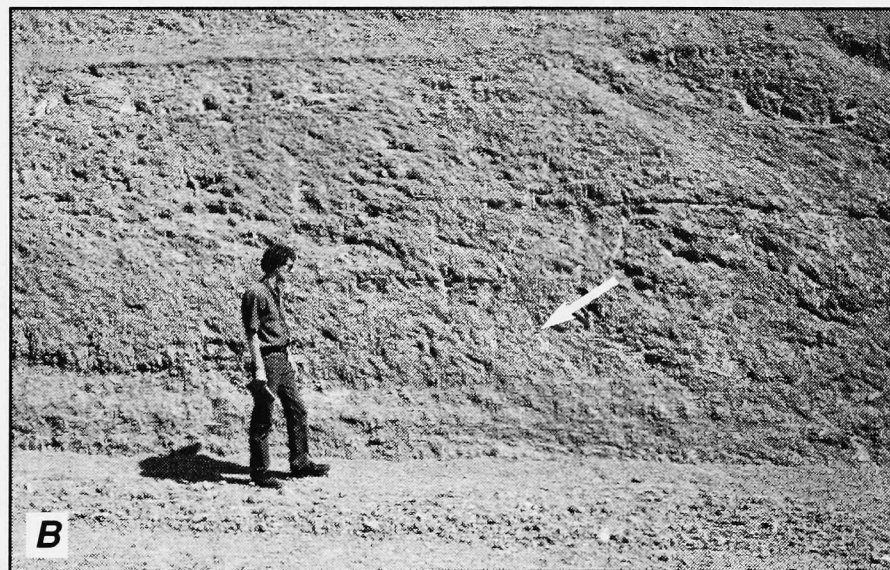
(6B) Fractured and sheared Pierre Shale exposed in a deep trench. The arrow points to a place where a steeply dipping bentonite bed has been offset nearly 4 inches by movement along a low-angle shear plane. The shear plane runs from behind the geologist's shoulders on the left side of the photo to the bottom right corner.

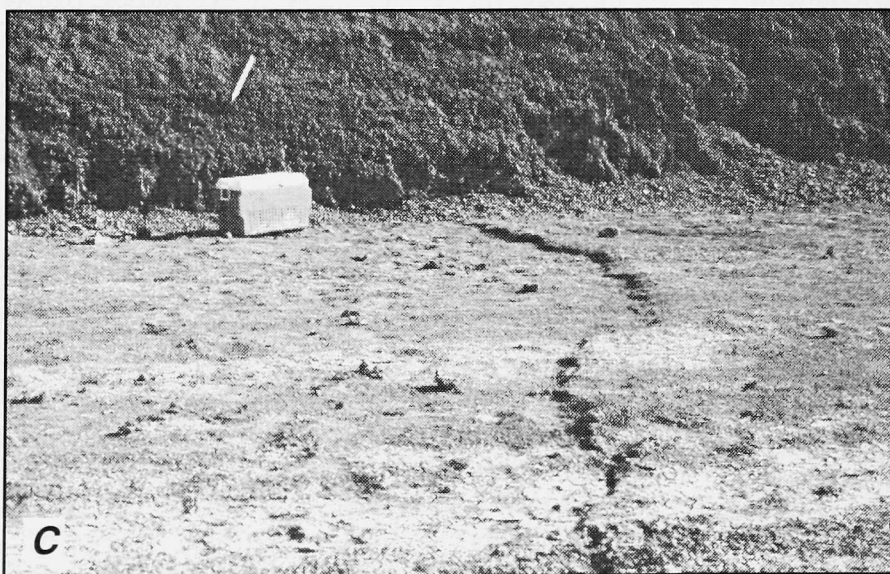
(6C) Asymmetrical heave feature in a graded cut area, caused by the heaving of the bedrock block on the right. Note the curving heave-front path. This feature formed along a pre-existing fracture plane. Over 12 inches of displacement had already occurred along the fracture plane before grading, and the re-initiation of movement resulted in another 3 inches of displacement within 24 hours after a rain storm.

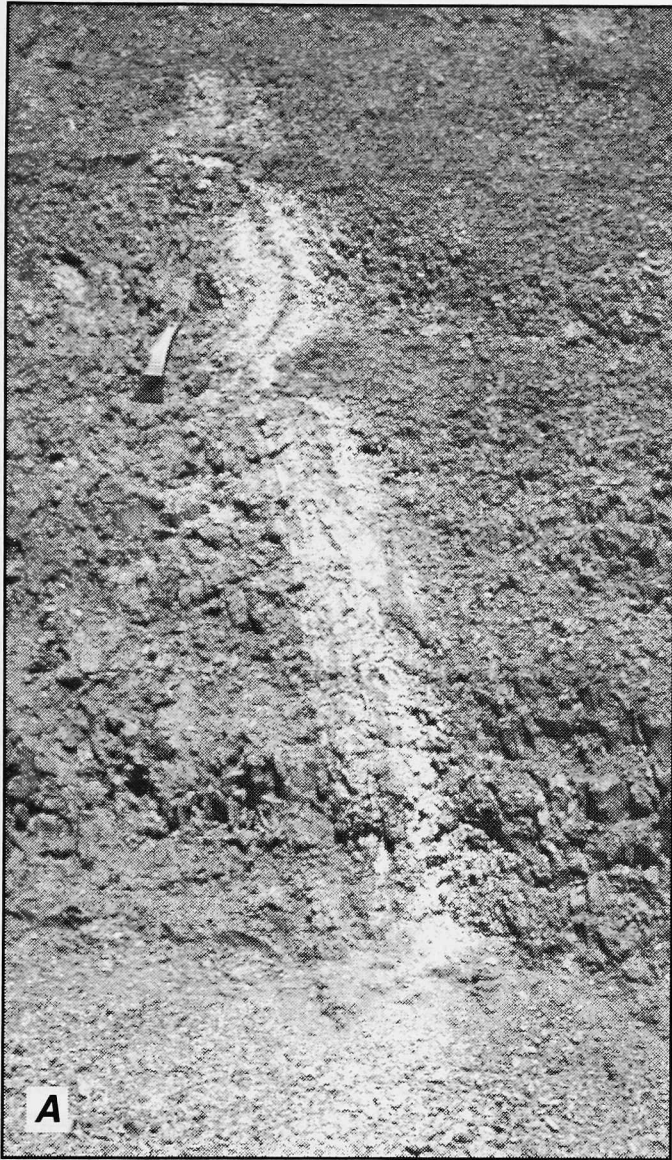
(7A) Cross-sectional view of a near-vertical bentonite layer containing lenticular veins of fibrous calcite fracture-fill, flanked on either side by less-expansive claystone (note window scraper for scale). This one-foot thick bentonite layer forms the core of the large, linear heave feature shown in Figure 1.

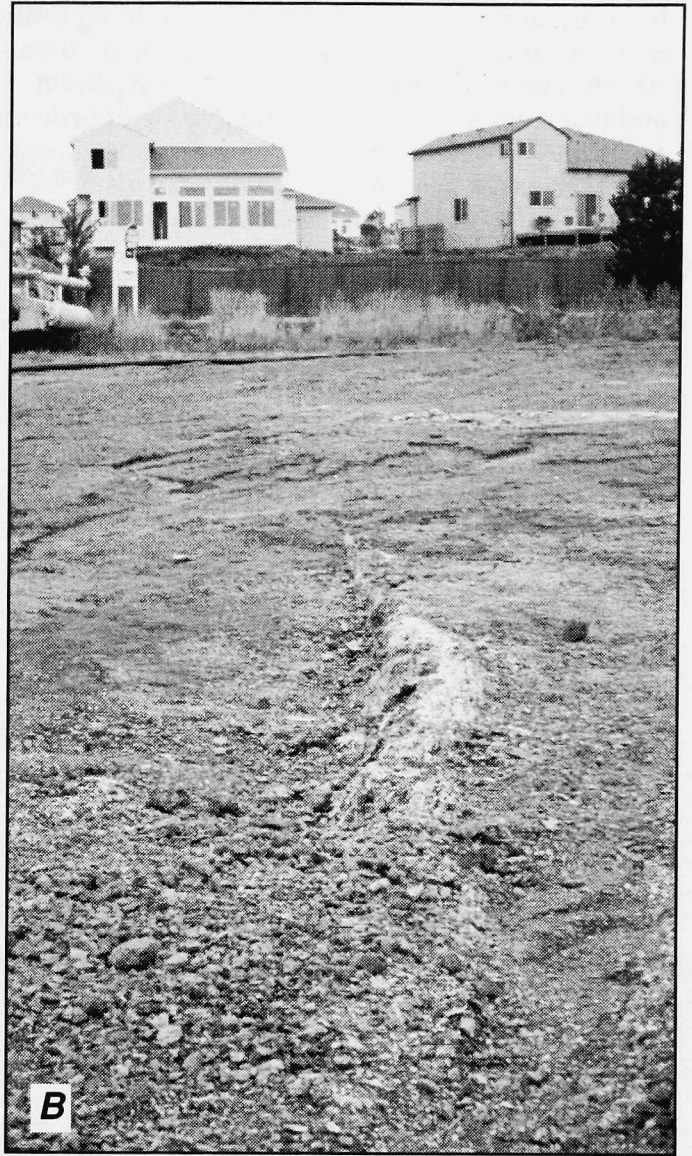
(7B) Surface view of a near-vertical bentonite layer that heaved 3 inches vertically after a rainstorm at a construction area. Heaving bedrock damage has occurred in the neighborhood in the background, along the trend of this and other bentonite layers.

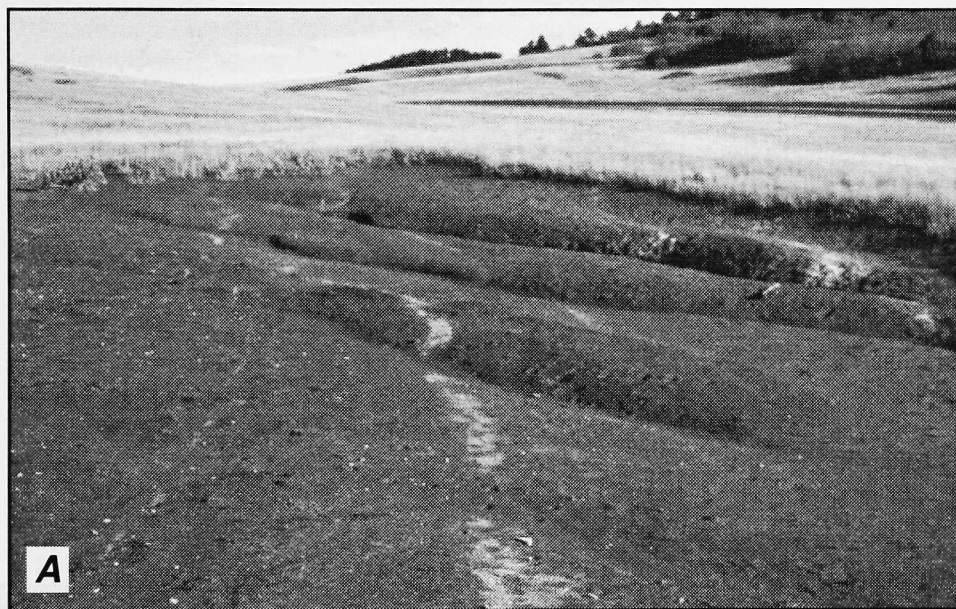
(12A) Outcrop during dry weather. The dark areas are composed of silty claystone, and the white stripes are bentonite beds.

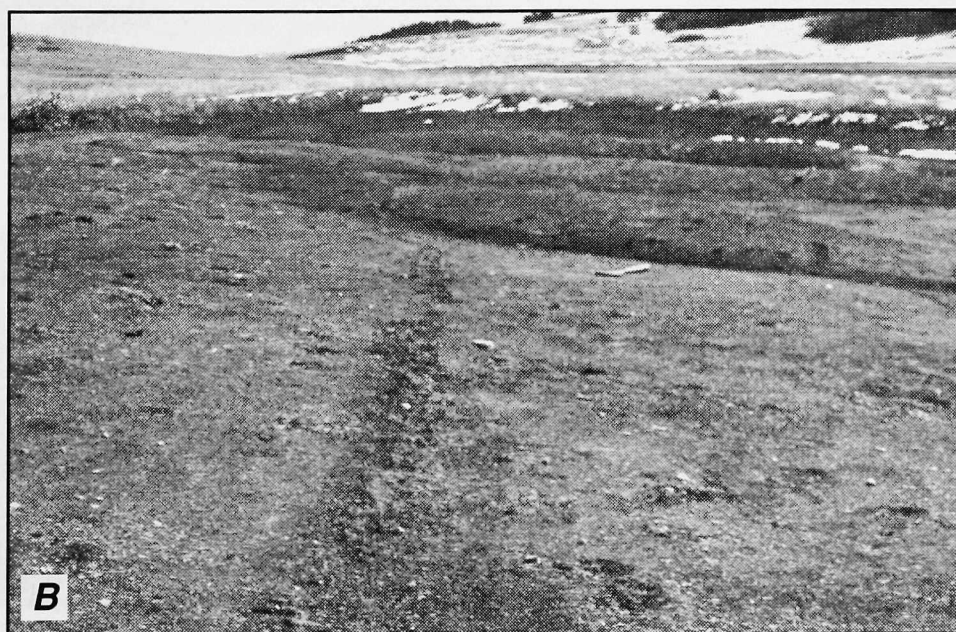
(12B) The same outcrop after a spring snowstorm. The bentonite beds have absorbed the moisture from the melted snow, turned darker in color, heaved out of the ground, and are beginning to desiccate in the sun. The desiccated chips will later blow away, and the scene will quickly revert into one resembling that shown in (A).

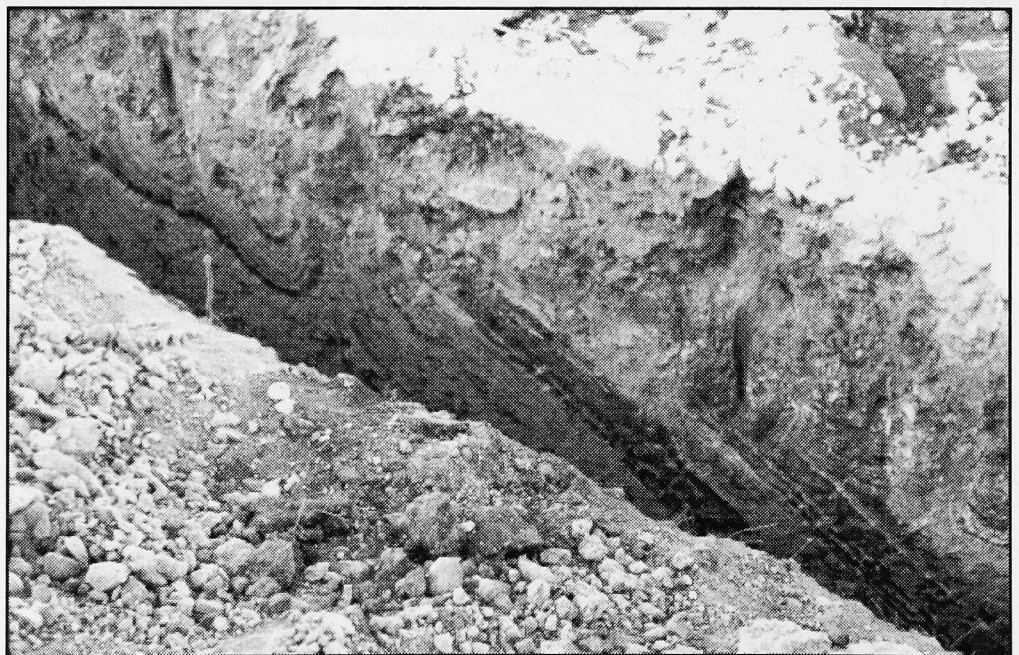
Figure 13. Smoky Hill Shale exposed in a trench in Jefferson County. Bentonite beds are seen in the trench as dark bands that are contorted on the left and steeply dipping on the right.

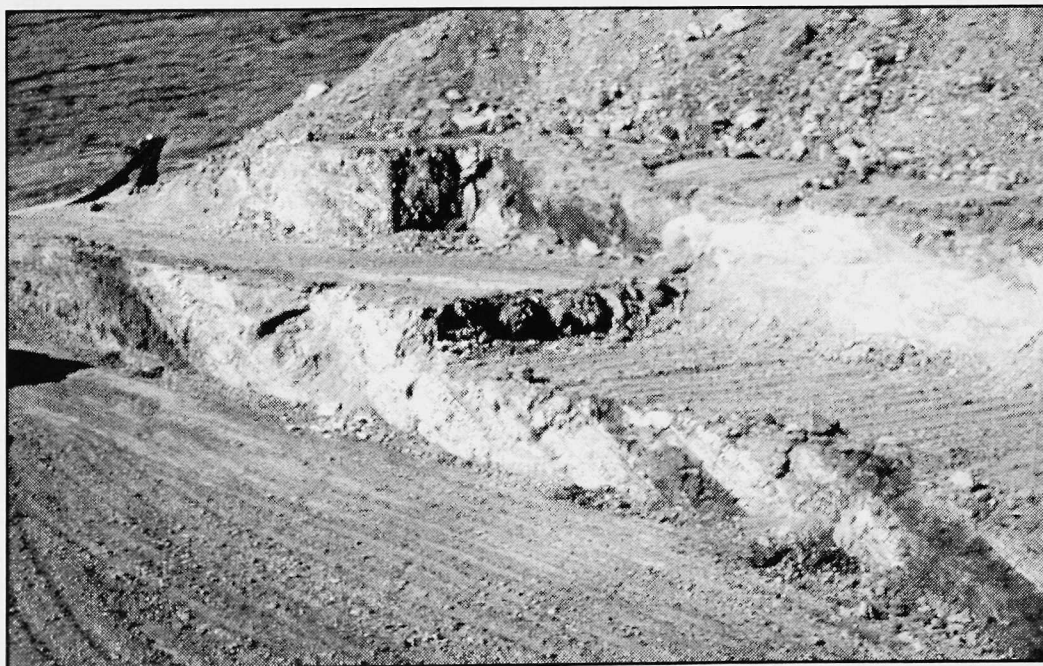
Figure 14. Middle part of Morrison Formation exposed in a basement excavation in northwestern Douglas County. The bedrock consists of steeply dipping layers of dark-red claystone, light-gray claystone, and medium-brown sandstone. The claystone beds tend to be moderate- to high-swelling, while the sandstone beds are typically non-swelling.

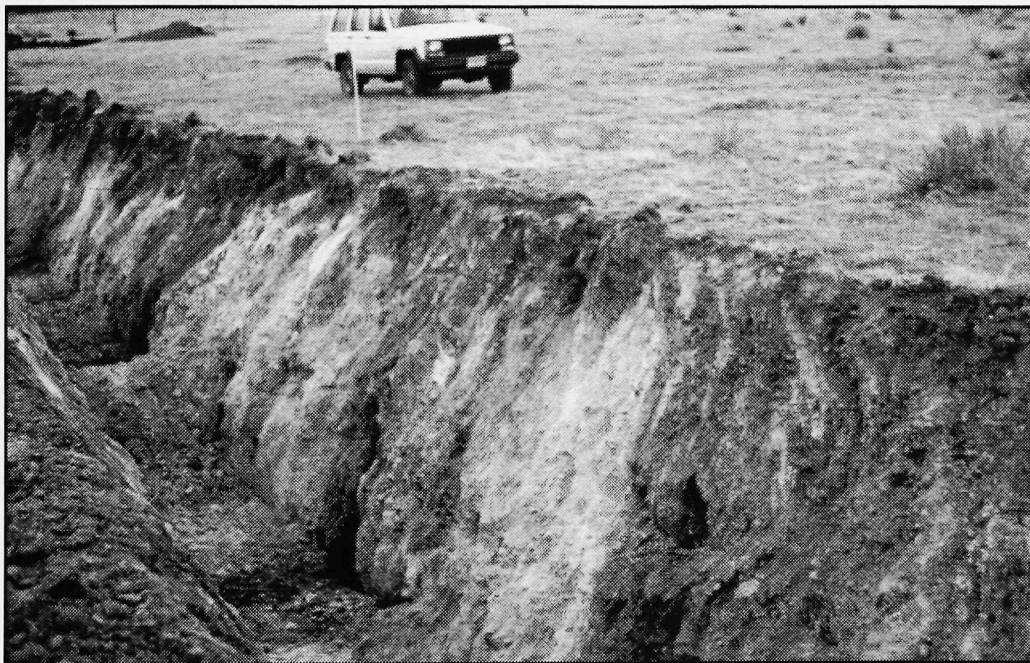
Figure 15. Upper unit of Laramie Formation exposed in a trench in Jefferson County. The bedrock consists of steeply dipping layers of black coal, medium-gray shale, and white sandstone. The claystone beds tend to be moderate- to high-swelling, while the sandstone beds are typically non-swelling.

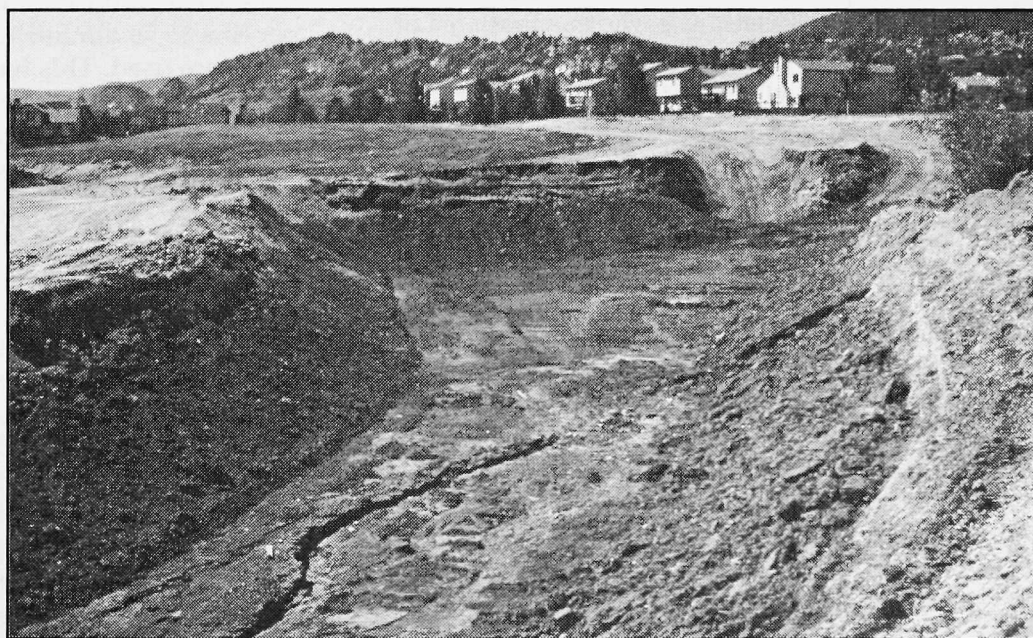
Figure 17. Overexcavation operation in progress at a subdivision in northwestern Douglas County. The overexcavation area consists of a 16–20 foot deep cut that has been partially refilled with claystone as a sealant. The upper part of the cut was later filled with non-expansive material, and houses were built on the fill. beds are typically non-swelling.
