CULVERT PERFORMANCE  
AT  
TEST SITES IN COLORADO  
AUGUST 1968

RESEARCH REPORT 68-8

STATE DEPARTMENT OF HIGHWAYS  
DIVISION OF HIGHWAYS--STATE OF COLORADO

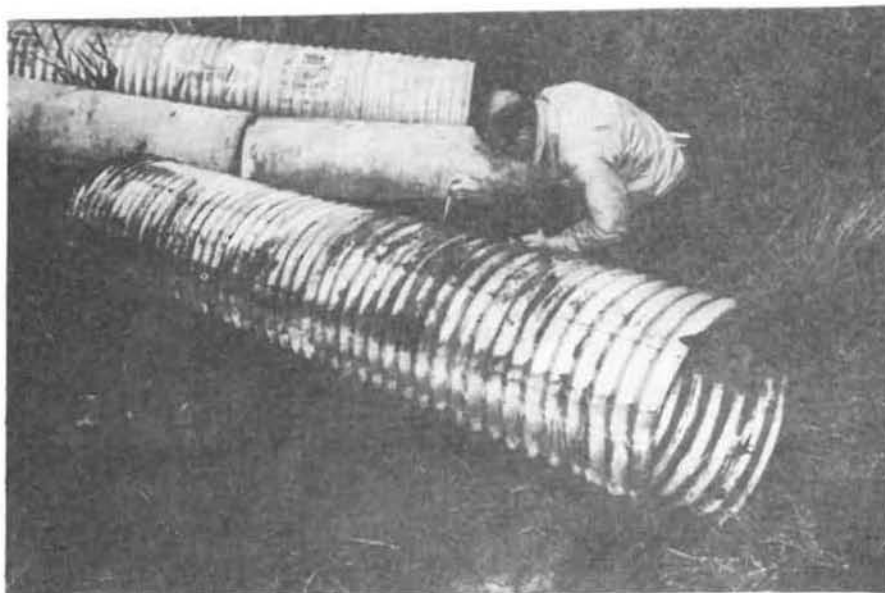
In April 1967, a routine inspection of the pipe at Fossil Creek revealed several  $\frac{1}{4}$  inch to 2 inch diameter areas of corrosion on the bottom of the pipe. Some of these spots were corroded completely through with the resulting holes measuring up to  $\frac{1}{16}$  inch in diameter. The bottom of the pipe was completely covered with a very plastic black mud. At other places on the pipe, exposed only to water, a yellow stain had formed, which when removed exposed pits approximately  $\frac{1}{32}$  inch in diameter and depth, but no severe corrosion as had been detected on the bottom of the pipe. (See Figure 2.) Between April 1967 and August 1968, three of the holes mentioned above enlarged to  $\frac{1}{4}$ " diameter, but no new areas of corrosion were formed. Since the corrosion is confined to small distinct areas on the culvert, and the remainder of the surface is in good condition, there is a feeling among

Fossil Creek. The yellow stain on the stainless steel pipe in the foreground is said to indicate the presence of iron chloride - a factor in the corrosion of stainless steel. Note the concrete and steel pipes in the background and the asbestos bonded pipe in the upper right corner.

"Chlorides, which exist as salts in the soil, will form iron chlorides (the yellow stain indicates the formation of these chlorides) and will then convert under acidic conditions to hydrochloric acid. (The water at both locations is mildly acidic.) This acid breaks down the passivity to corrosion that stainless steel possesses. A lack of oxygen as might exist under a layer of mud in a swampy condition prevents this passivity from reforming and corrosion of the stainless steel follows."

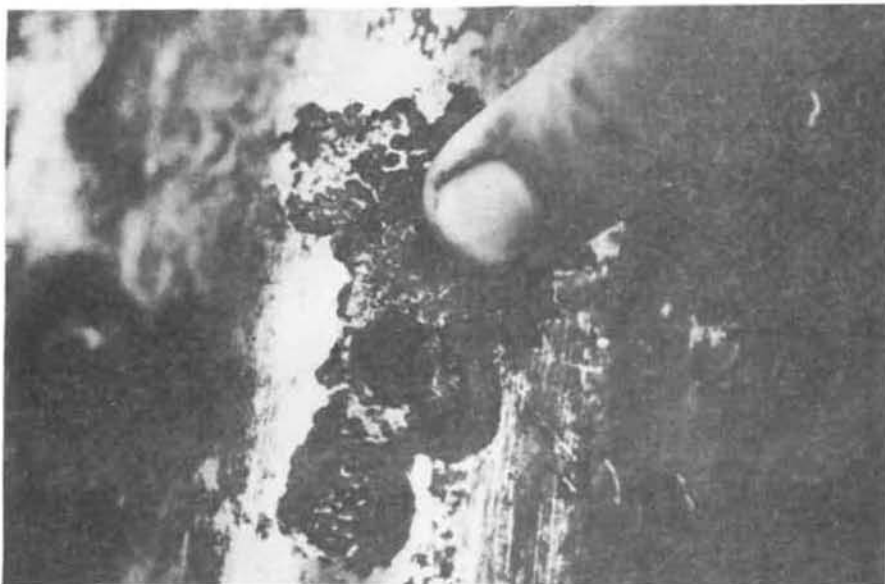
Figure 2

Fossil Creek. This picture shows the typical corrosion and perforation of the stainless steel pipe.

the inspectors that the metal comprising these stainless steel culverts is not completely homogeneous. For some reason, certain areas of the culvert appear to be more susceptible to corrosion than other areas. At any rate, the corrosion has been observed to take place in a very blotchy manner.

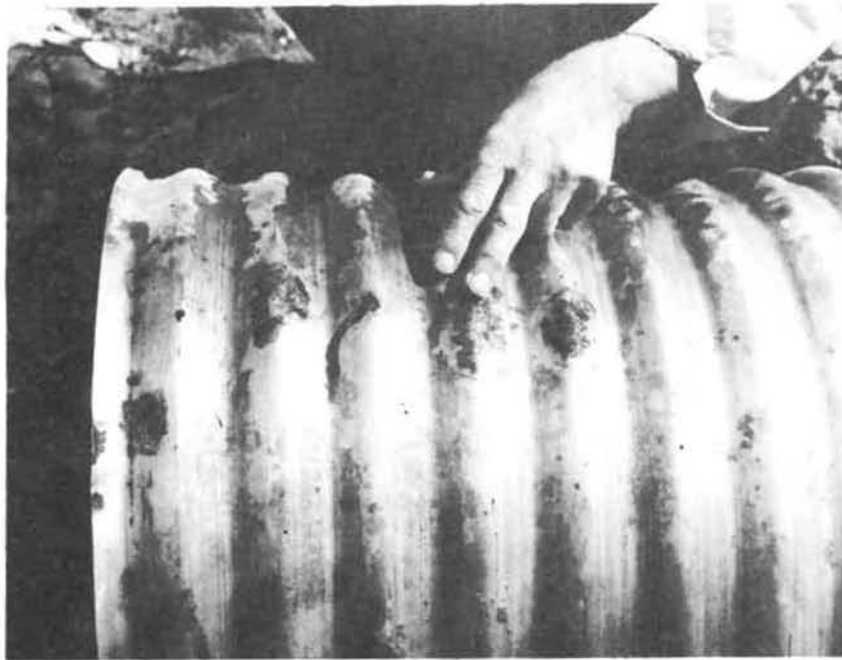
Figure 3

The pipe at Fruita is in about the same condition as the one at Fossil Creek except that no holes have been detected. The yellow stain exists on the pipe at Fruita also with the same small pits underneath. (See Figure 3) A representative of a steel firm visited both test sites in June 1968 and offered the following explanation for the yellow stains and serious corrosion:

Fruita. Corrosion on the stainless steel pipe which was uncovered for evaluation. Note the alkali on the ground surface in the upper left corner.
