I 70 ACROSS VAIL PASS
FINAL GEOTECHNICAL INVESTIGATIONS

Robert K. Barrett

COLORADO DEPARTMENT OF HIGHWAYS
Colorado Division of Highways
DISTRICT III
Grand Junction
August, 1978

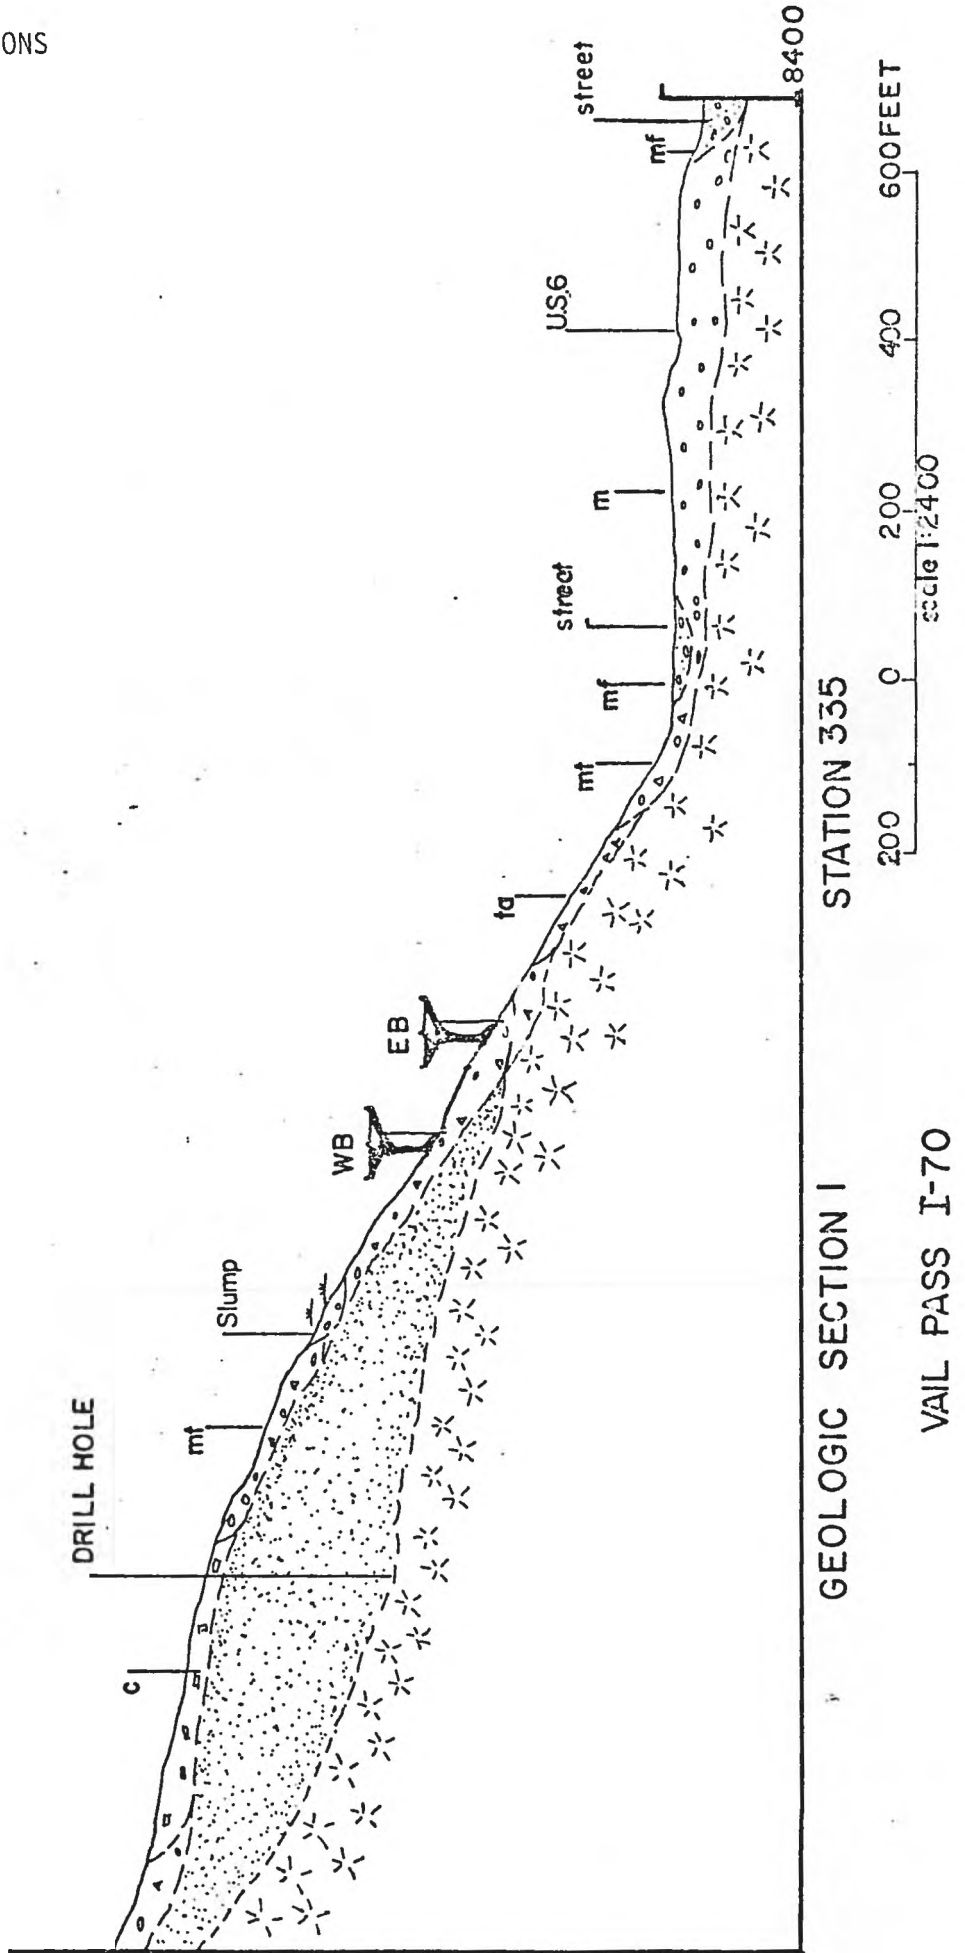
GEOLOGIC SECTION I

The consultant's preliminary studies concluded that the hillside in the vicinity of Station 310 to 340 probably contained deep deposits of unconsolidated materials. There was concern expressed about the extensive side hill cuts proposed for that area (Refer to Geologic Section 1, page 17).

The drilling program verified that deep, unconsolidated glacial deposits were perched on the mountainside above the proposed extensive cuts. These deposits consisted primarily of sand overlaid by gravel and boulders, and contained organic horizons at various depths. The deepest deposit exceeded 43 metres (140 feet) and the water table was near the surface. Had cuts been attempted in this area, extensive failures---probably involving over a million yards---would have resulted.

Based on the drilling information, it was recommended to the designers that no cuts be made in this area. Two alternates remained. One, a standard fill slope; the second, a side-hill viaduct. Partly due to extensive condominium development and high land values, it was determined that a viaduct was the better choice.

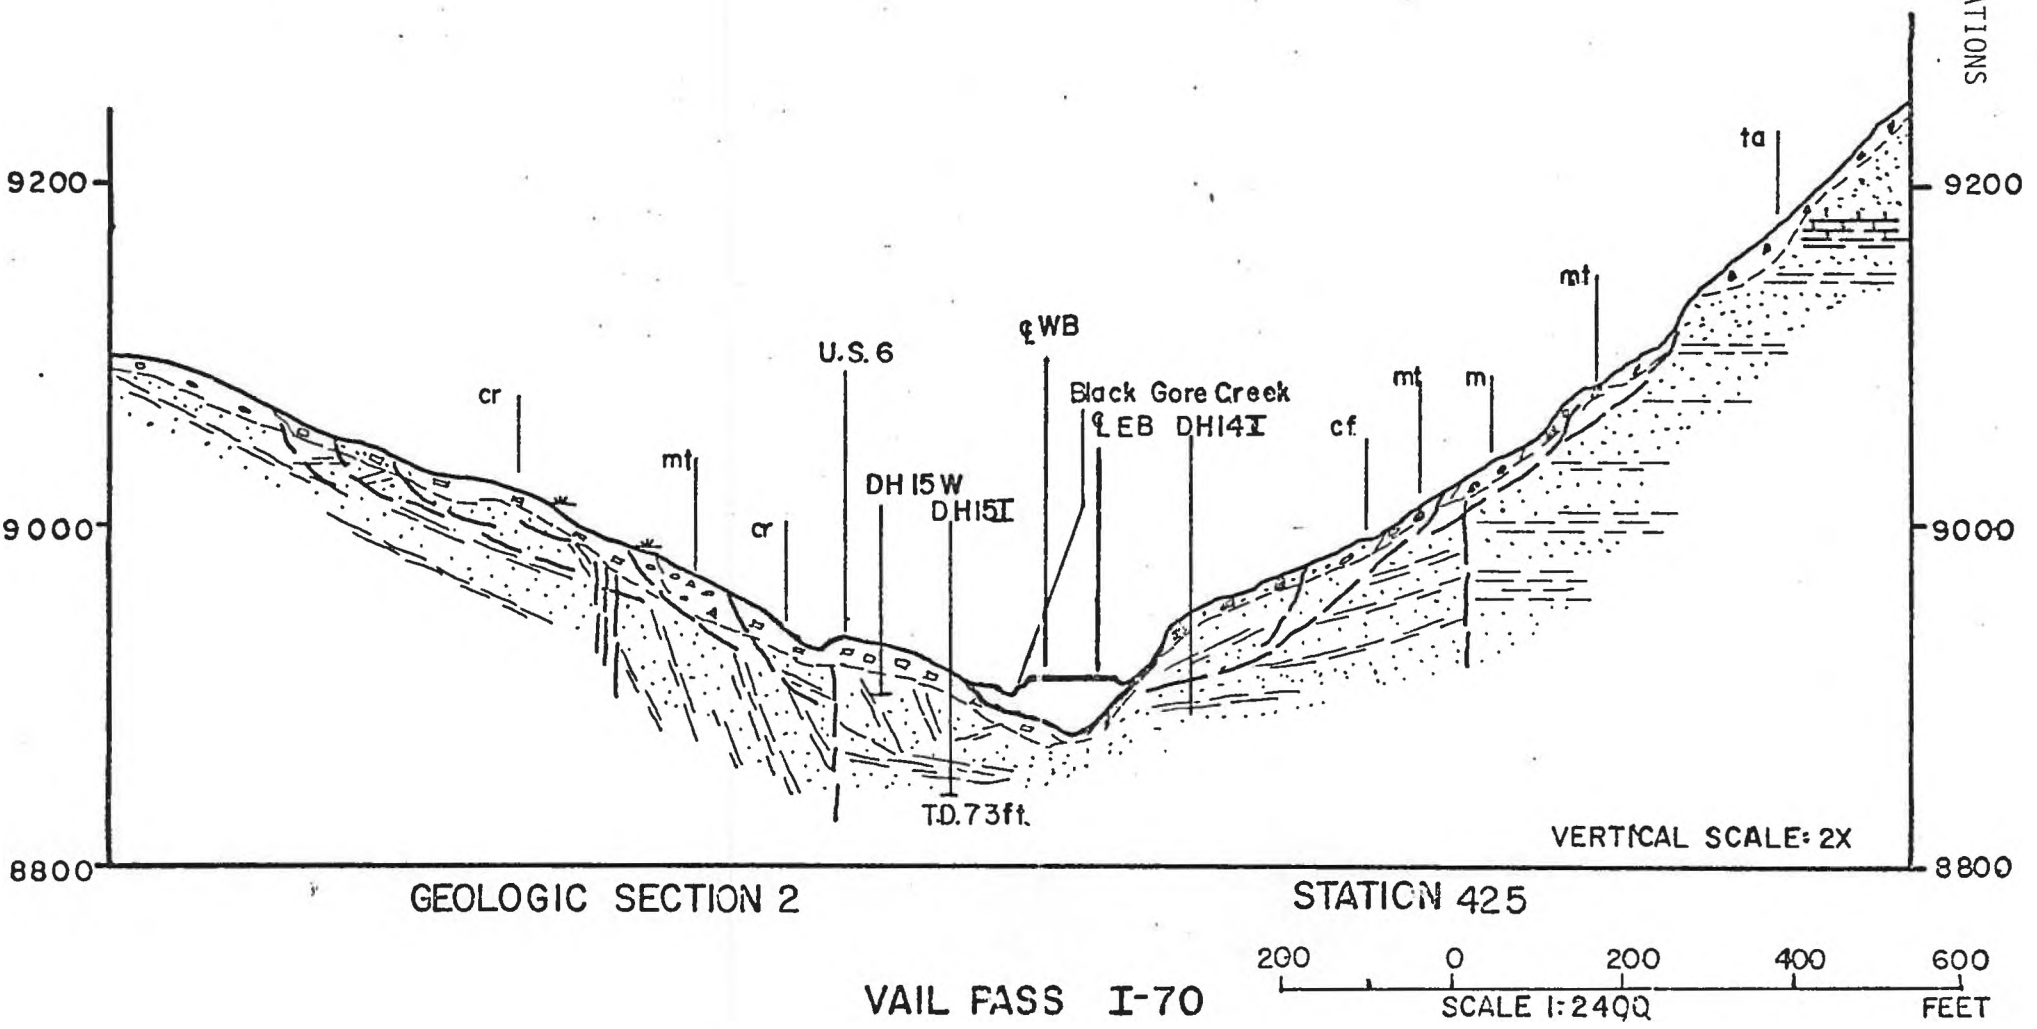
Geologic mapping and subsequent instrumentation by a geological consulting firm defined an area where two active landslides were moving from opposite sides of the valley and constricting Black Gore Creek. After intensive studies and analyses, it was decided that an extensive earth buttress would successfully stop movement in the slides. This buttress would fill the channel and floodplain of Black Gore Creek and cause the slides to push against each other. This is illustrated in Geologic Section II, page 18.

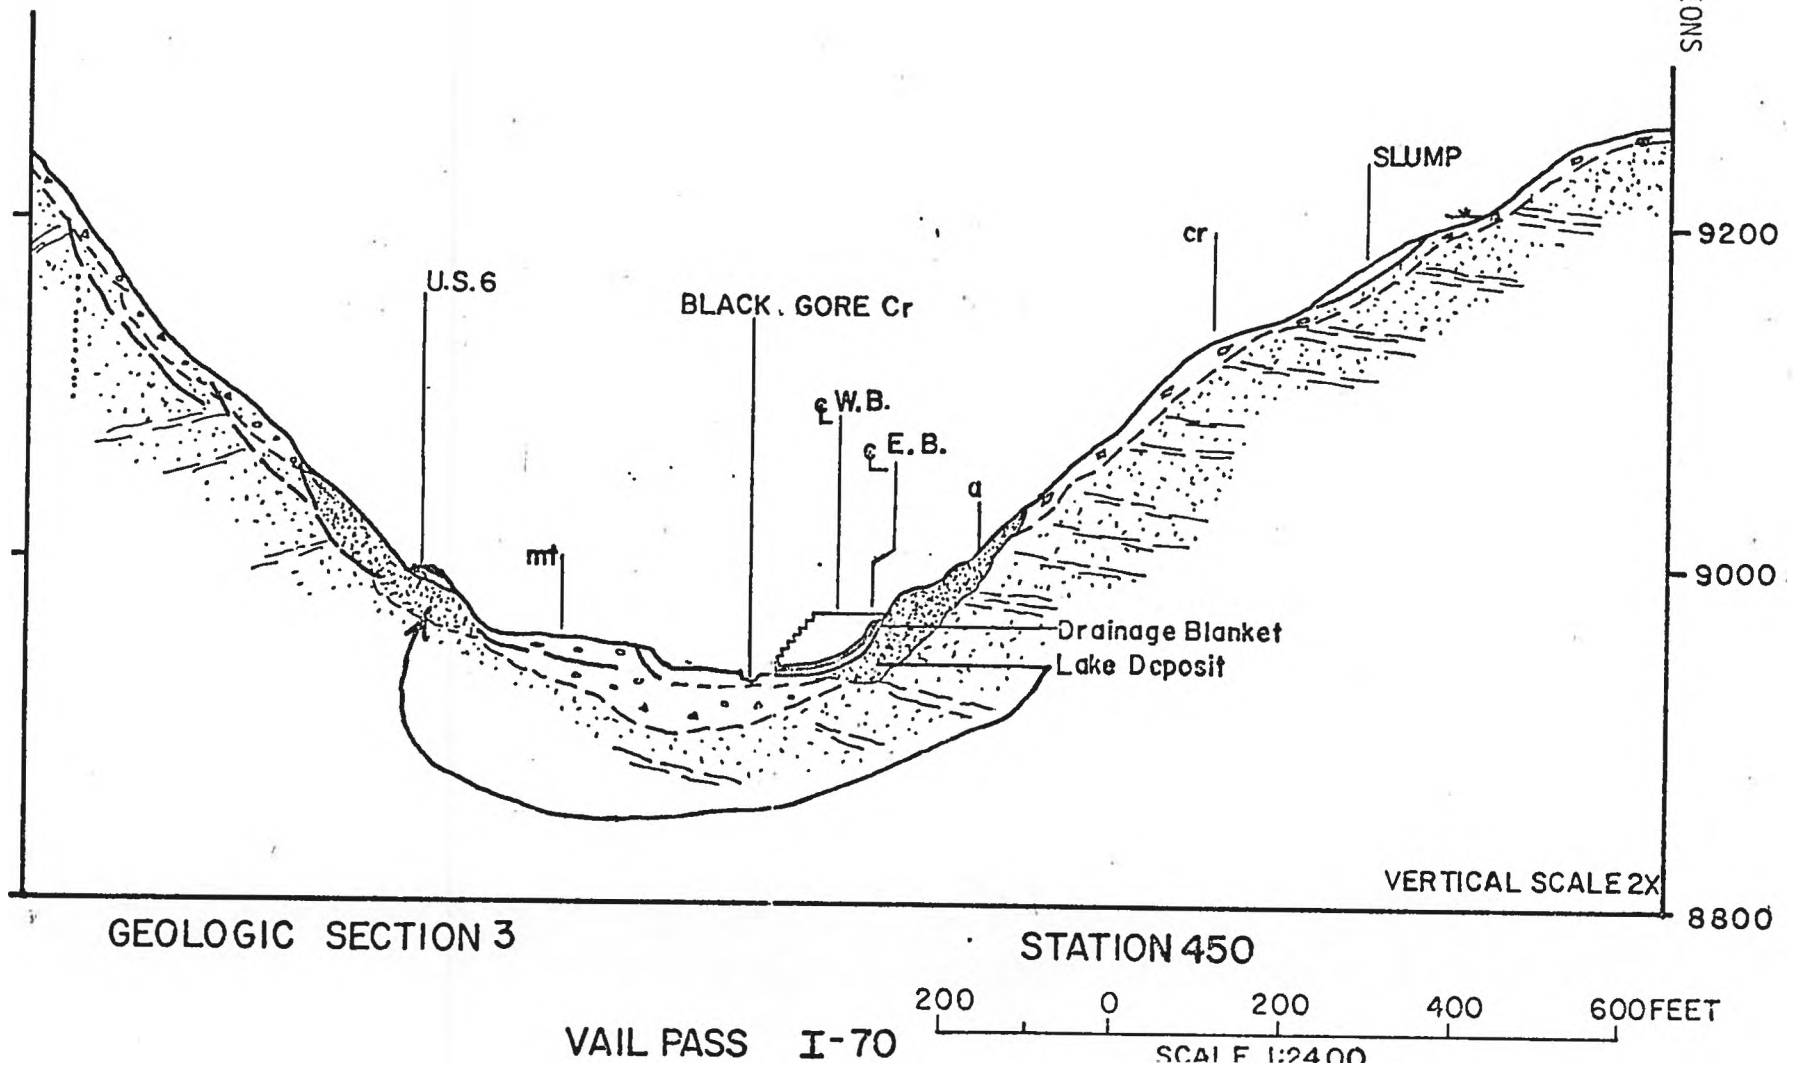
GEOLOGIC SECTION 3

Subsurface investigations revealed the presence of a lake deposit consisting of silt and fine sand perched on the hillside where a balanced cut-fill alignment was planned. The lake sands were saturated and cuts into these deposits would certainly be unstable. Pre-drainage was not a practical alternative. Neither was a standard all-fill template, since moving the alignment out to an all-fill section would have necessitated extensive rechannelization of Black Gore Creek. A channel change was not recommended due to the

The remaining choices were high wall or sidehill viaduct. Due to foundation conditions and cost factors, a Reinforced-Earth wall was selected. Prior to construction of the wall, organic soils in the floodplain of Black Gore Creek were excavated and a drainage blanket was placed over most of the wall foundation area and on the slope behind the wall. Extensive underdrain systems were installed to further assure continued adequate drainage (See Geologic Section III, page 19).

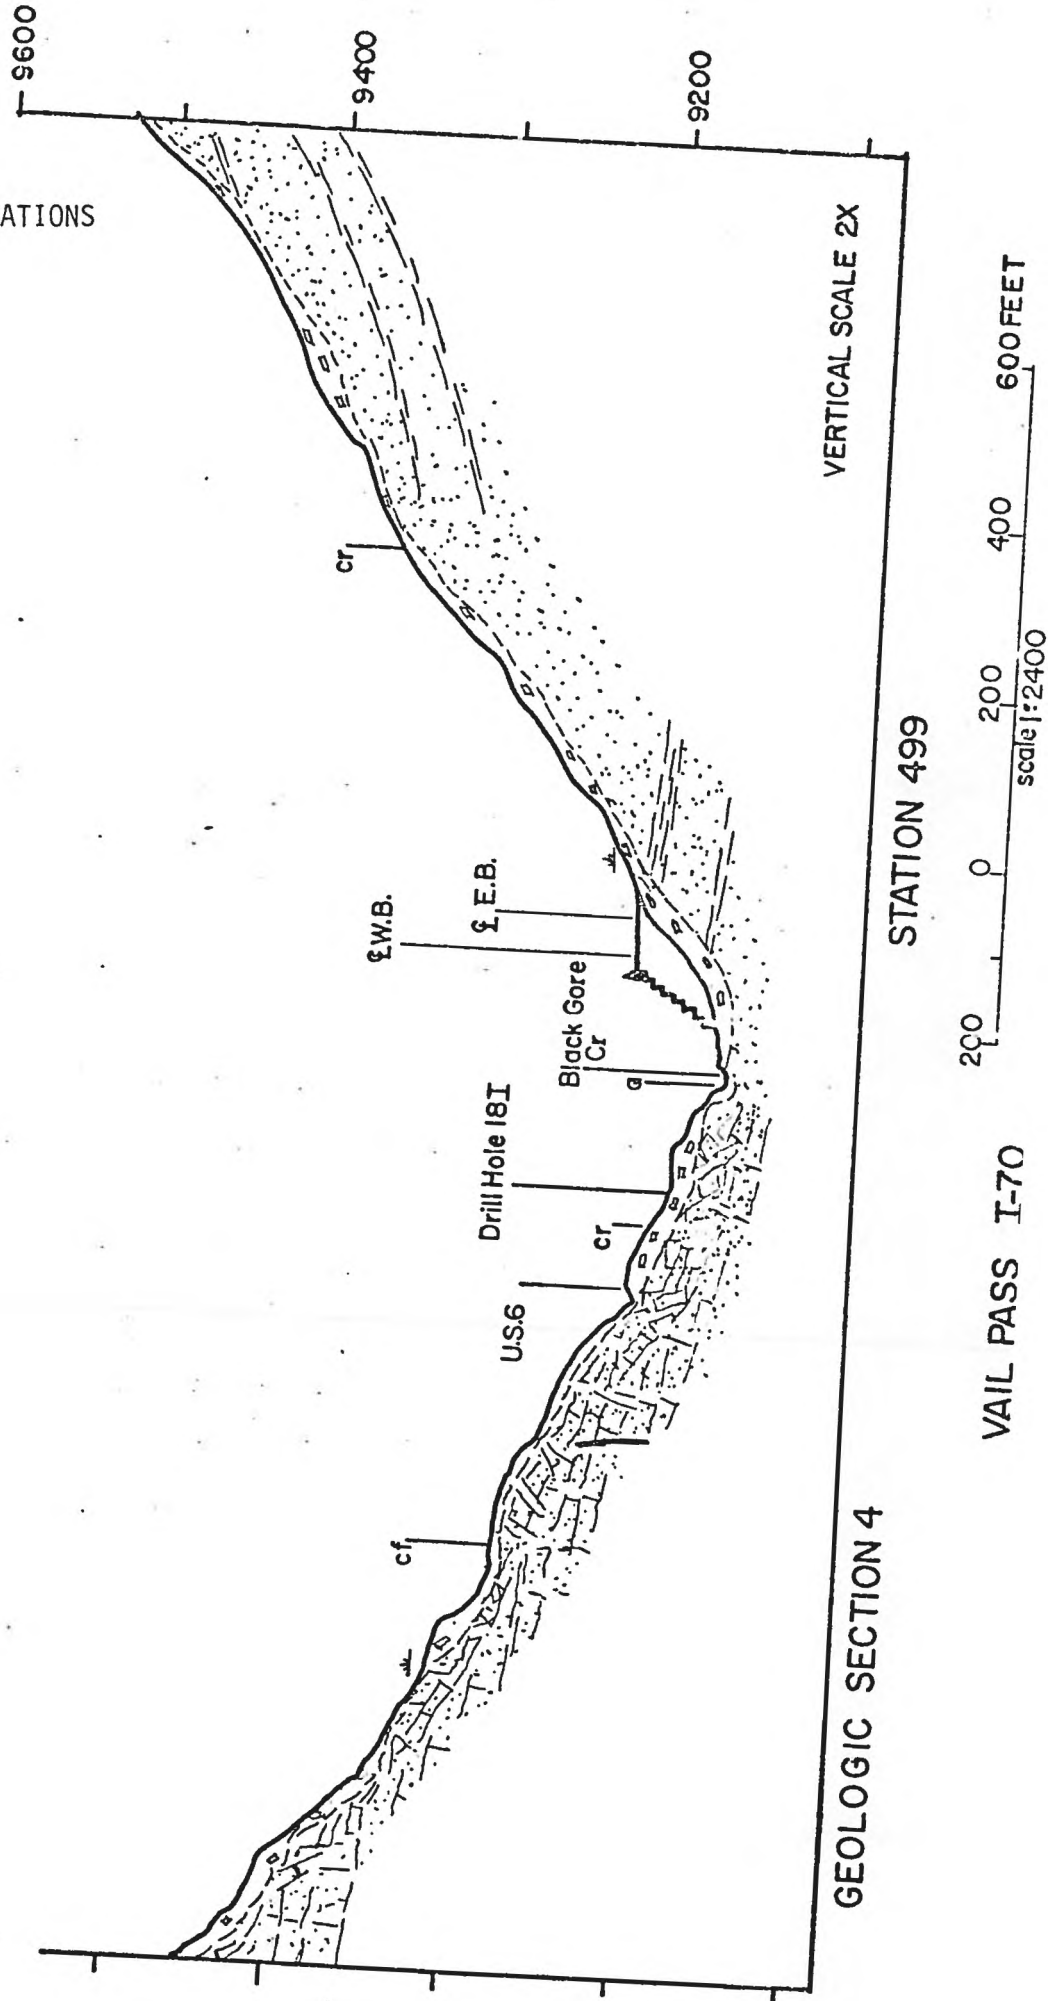
Instrumentation installed during the Intermediate Study identified an active landslide on the north side of Black Gore Creek. This discovery resulted in the final alignment being placed totally south of the creek and required one high retaining wall. This retaining wall was the first pre-cast tieback wall to be constructed on a highway project. There was a substantial amount of instrumentation on this wall, including load cells, inclinometers, and strain gauges. The wall system proved effective and efficient. Geologic Section IV, page 21, illustrates the final cross section.

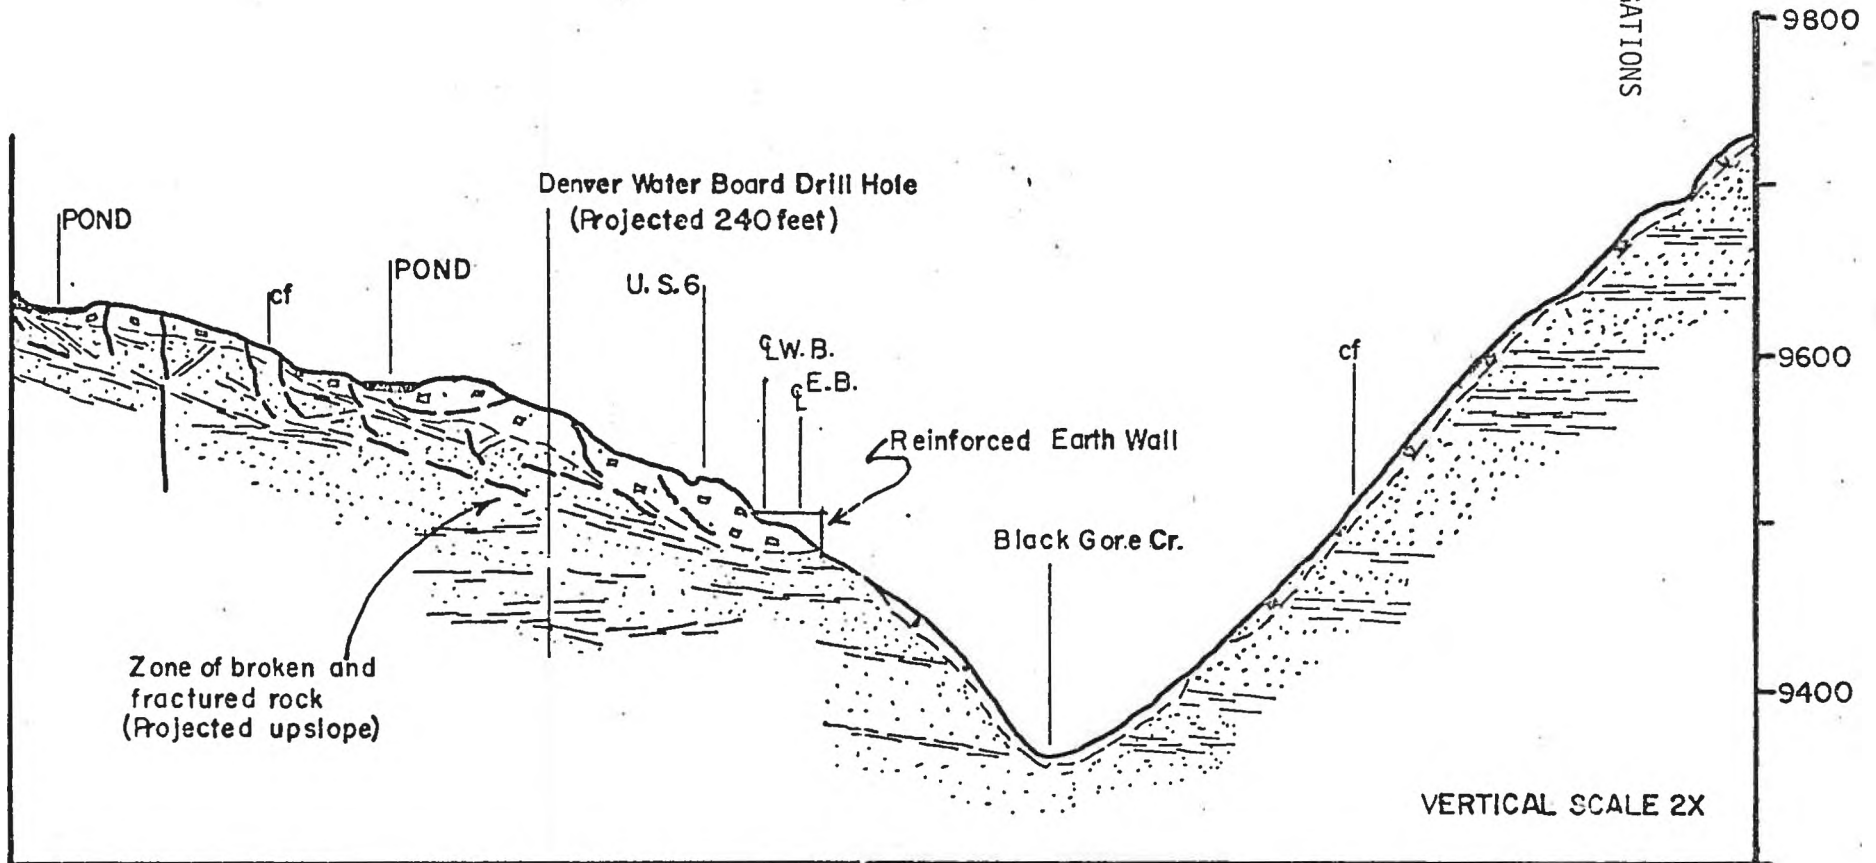
GEOLOGIC SECTION 5

The most difficult and challenging problem for geotechnicians on Vail Pass was in the area known as the Miller Creek Slide. This slide is over one kilometre long, nearly one kilometre wide, and about 46 metres (150 feet) deep. The slide consists of up to 21 metres (70 feet) of surficial silty soils overlying some 24 metres (80 feet) of failed bedrock. Water levels were erratic and varied from surface ponds in some areas to dry in other areas.

The topography in the Miller Creek Slide, shown on Geologic Section V, page 21, area included a deep canyon at the slide toe into which the slide spills during active periods. Severe grade restrictions, both up and down station from the slide area, dictated that the alignment must cross the slide toe. In other critical areas, it was usually possible to vary vertical and/or horizontal alignment to optimize alignment and geological conditions.

The remaining alternate was a high, vertical, Reinforced Earth wall whose toe would be placed on the edge of the steep canyon wall and whose base would necessarily have to be placed on intact bedrock. In place, this design raised existing safety factors by an insignificantly small number; however, excavation of the toe of the slide to permit construction showed a mathematically significant reduction in the safety factor on the critical circle.

A detailed geotechnical investigation followed a tentative decision to try the wall concept. It was decided that if the water table could be lowered some 11 metres (35 feet) to 17 metres (55 feet) below the ground line for 91 metres (300 feet) horizontally behind the excavation that it would be possible to construct the wall. Based on readings from several water level monitoring sites, it was also decided the wall would have to be constructed during the winter months, the period of lowest ground water levels and least ground water recharge.

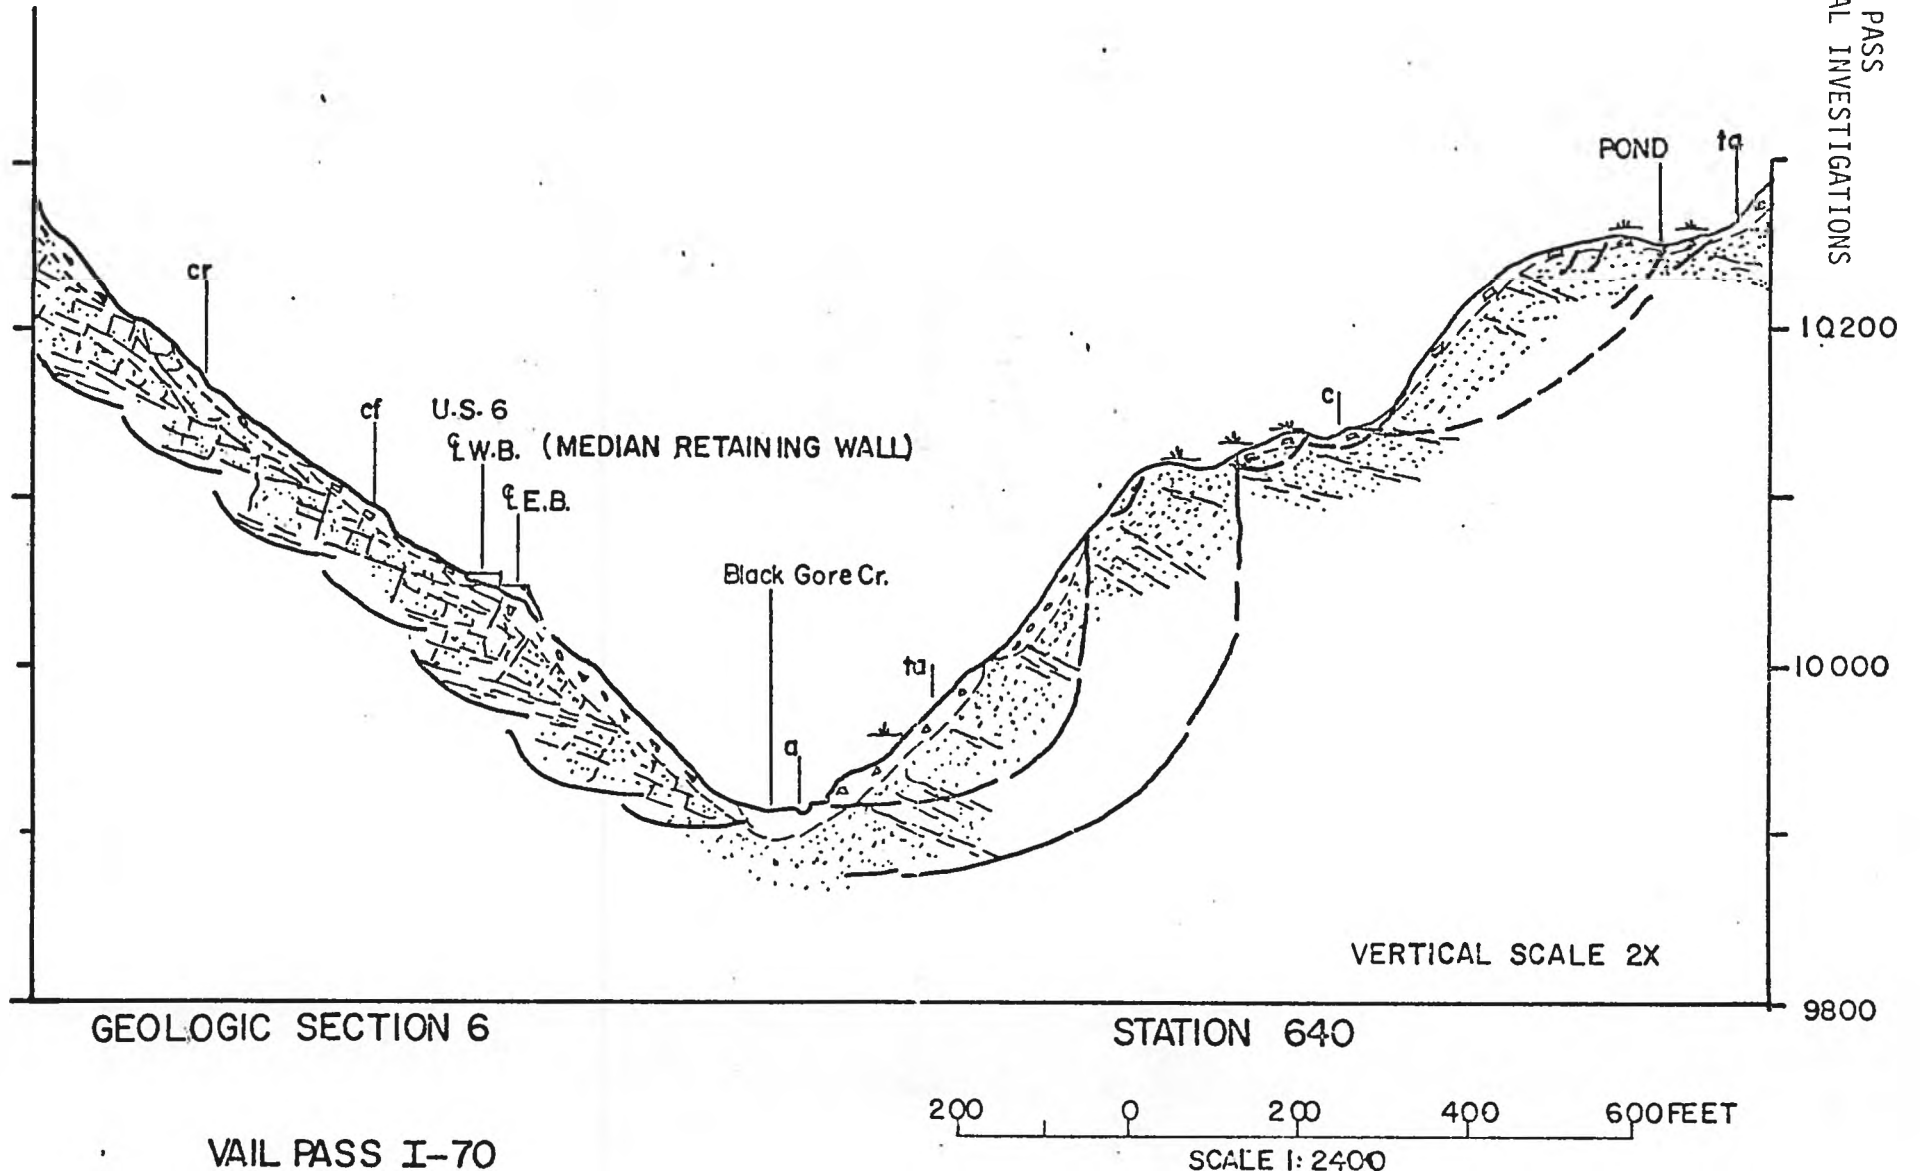
GEOLOGIC SECTION 6

Bedrock failures were observed throughout the upper reaches of Black Gore Creek. One failure series was continuous from station 615 to station 750+. Alignment location was first split, with east bound on the south valley wall while west bound utilized the existing U.S. 6 platform. This concept was abandoned when it was discovered that a bridge from the west valley wall would have to be located on marginally stable failed bedrock.

The remaining choice was to place both directions of travel on or near the existing U.S. 6 alignment. The roadway template was minimized by using a median wall, which allowed a better fit on the steep hillside. Several attempts were made at defining critical failure circles and strength parameters through this area. None were felt to be entirely reliable, and the final design was accepted by geotechnical personnel on the basis that it caused the least disturbance, that is, the least reduction in safety factor on mathematical models. It was the consensus of opinion that the final alignment had a reasonable and acceptable probability of success (see Geologic Section VI, page 22).
