REPORT NO. CDOH-DTP-R-84-3

HOT MIX RECYCLING DURANGO-HESPERUS

Final Report
September 1984

PROJECT C 20-0160-12

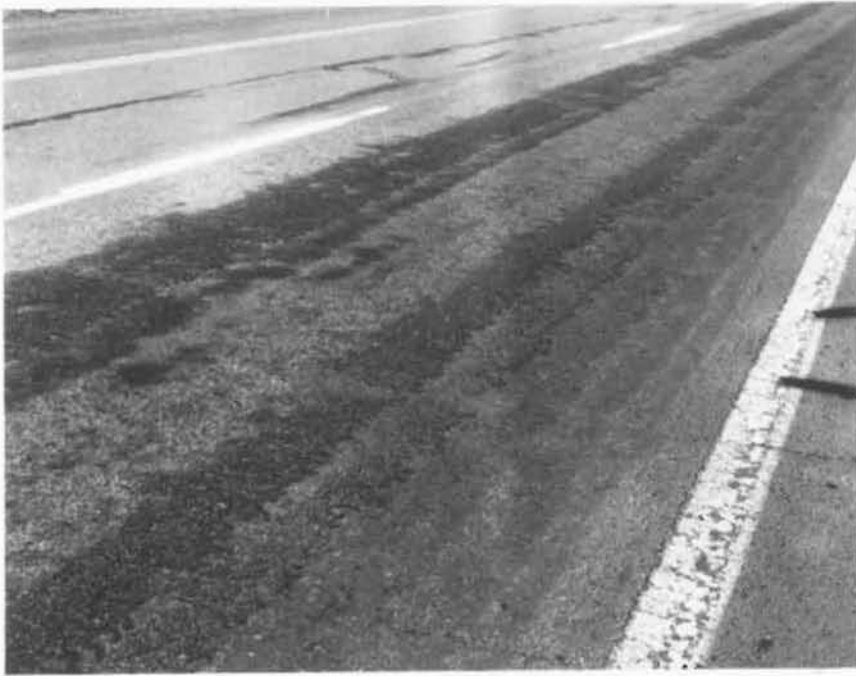
PHOTOGRAPH NO. 1

PRECONSTRUCTION ROADWAY
CONDITION. NOTE: RICH
WHEELPATHS IN THE DRIVING
LANE AND NUMEROUS TRANS-
VERSE AND LONGITUDINAL
CRACKS.

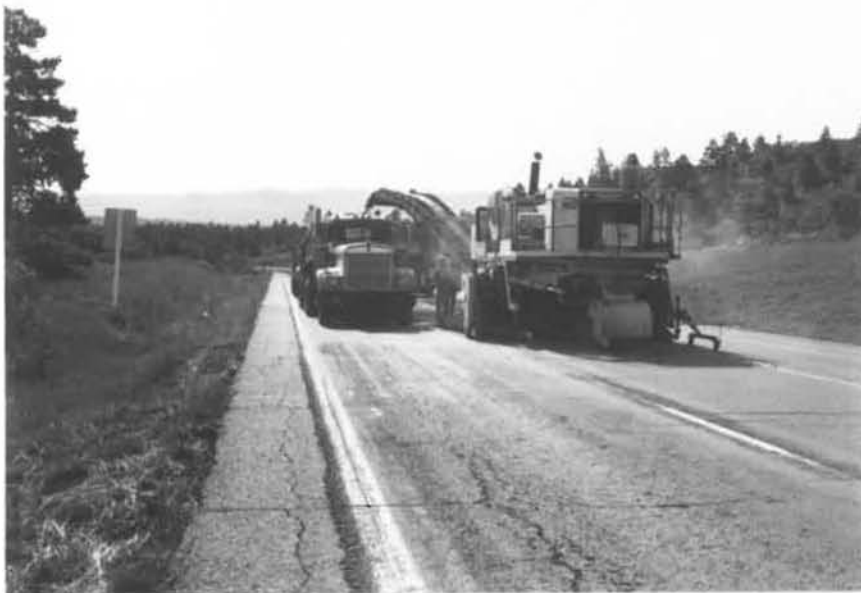
PHOTOGRAPH NO. 2

ROTOMIL PLAINING ON
CENTER LANE.
NOTE: CRACKING AND
ROADWAY CONDITION IN
FOREGROUND.

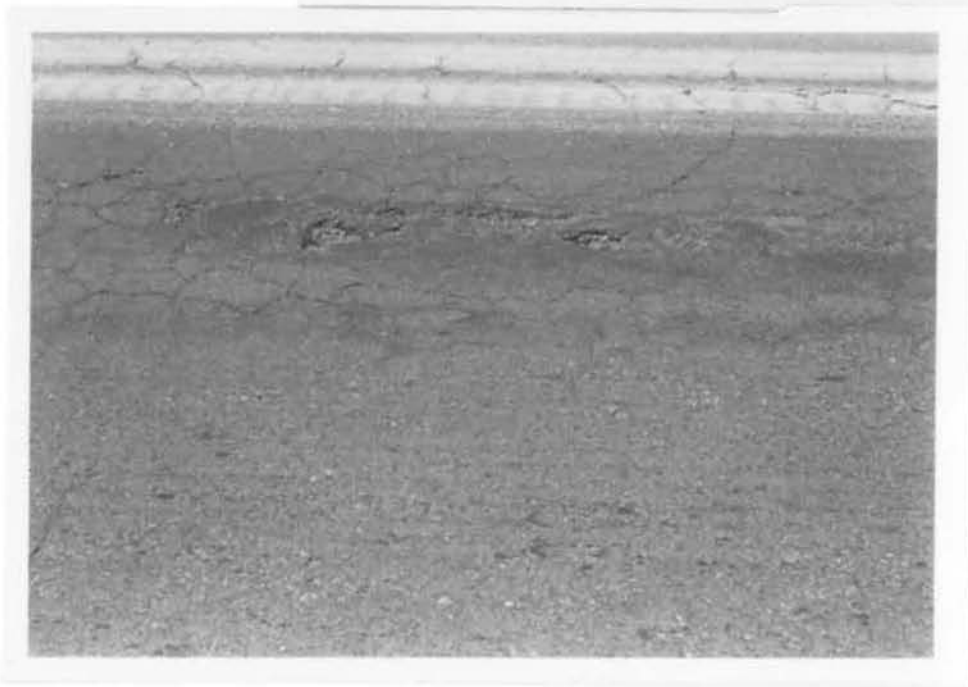
PHOTOGRAPH NO. 8

SECTION 1 SHOWING SURFACE
DISTRESS IN MAINTENANCE
OVERLAY. BASE FAILURE IS
BELIEVED TO BE THE PRIMARY
CAUSE OF DISTRESS HERE.

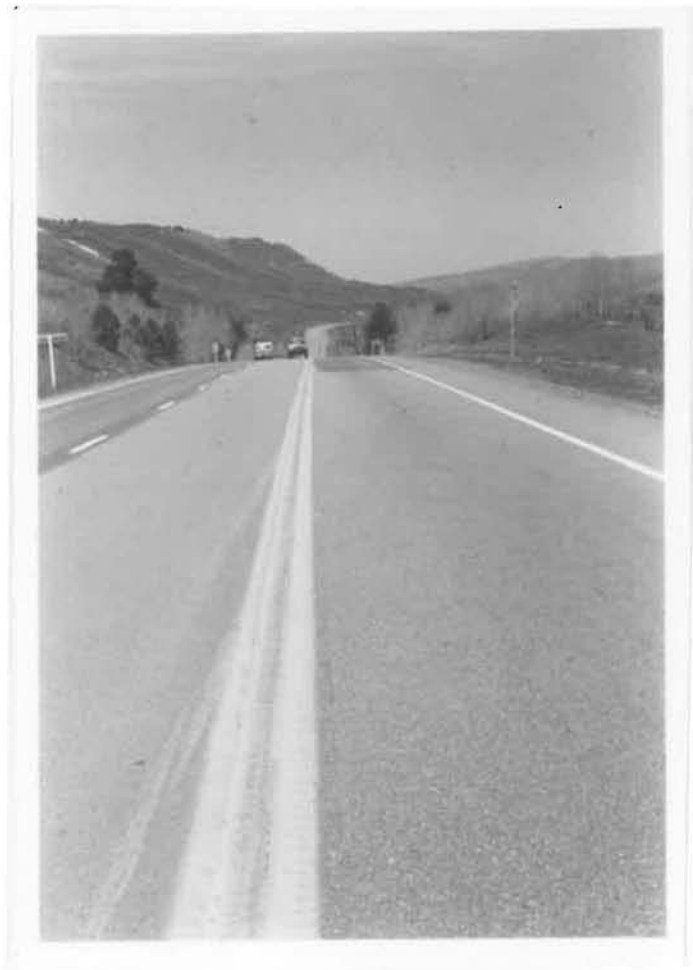
PHOTOGRAPH NO. 9

SECTION 1 (65/35 BLEND)
OVERALL VIEW SHOWING GOOD
PERFORMANCE IN THICKER
SECTIONS.

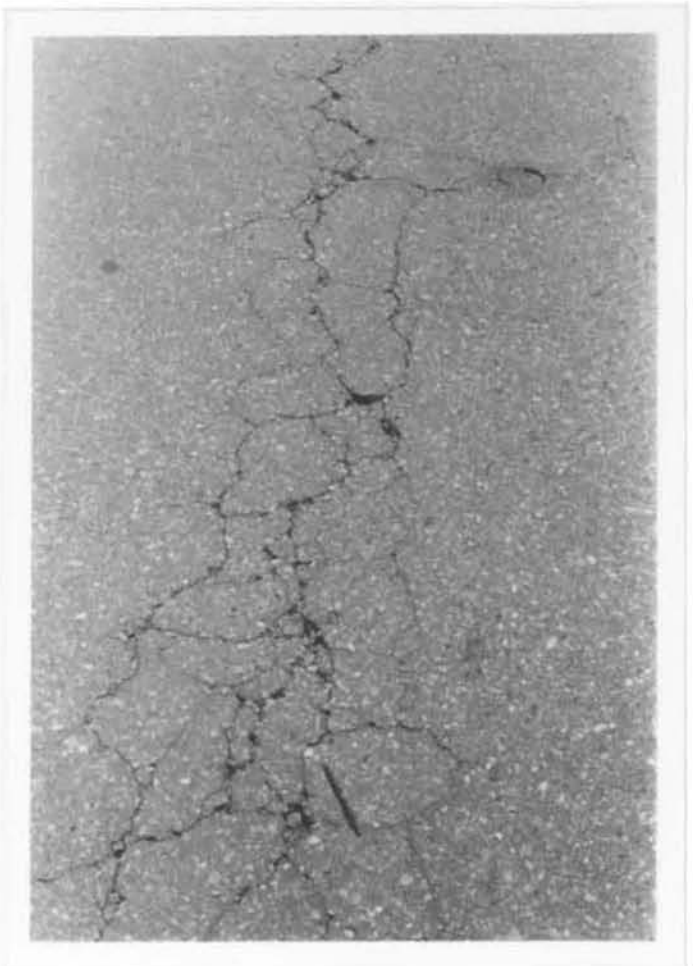
PHOTOGRAPH NO. 10

SECTION 1 SHOWING CLOSE-UP
OF WHEEL-PATCH CRACKING IN
WORST AREA OF DISTRESS.

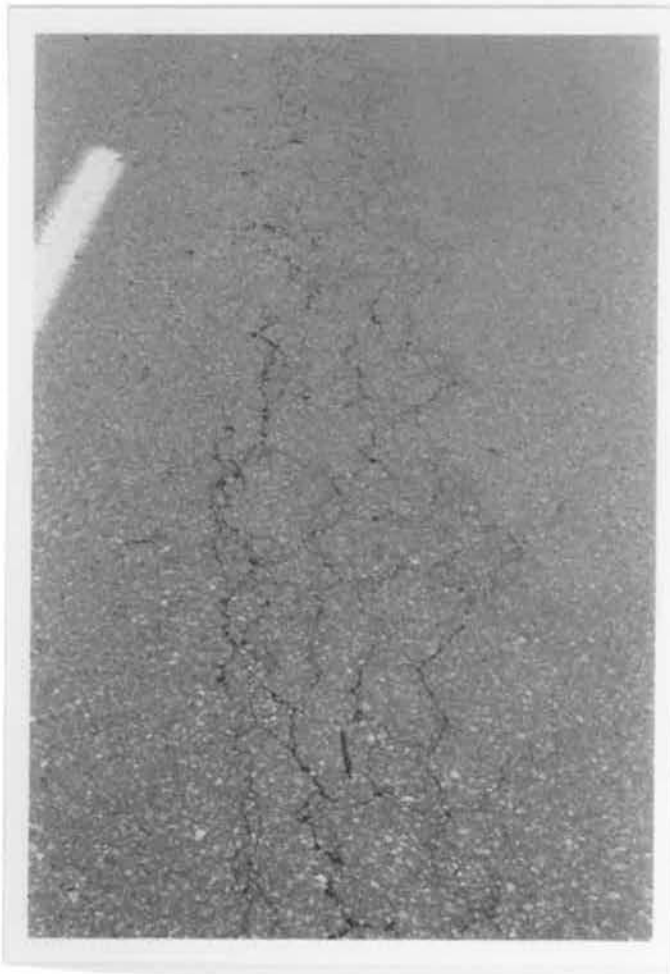
PHOTOGRAPH NO. 12

CLOSE-UP OF WORST CASE
CRACKING IN WHEELPATH.

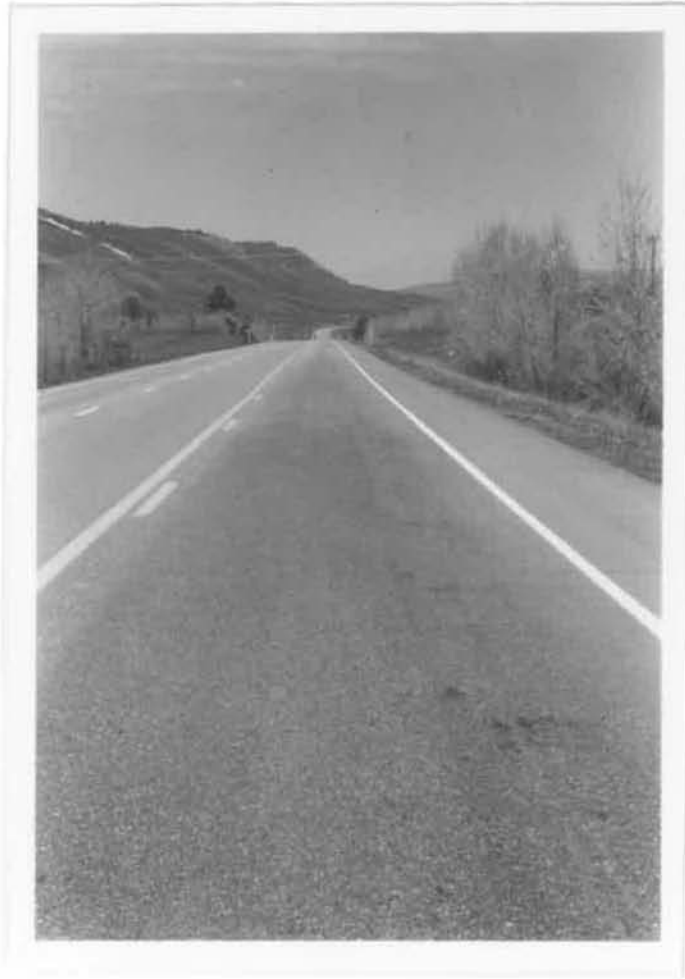
PHOTOGRAPH NO. 13

SECTION 3 (VIRGIN MIX)
OVERALL VIEW SHOWS A
RICHER LOOKING SURFACE

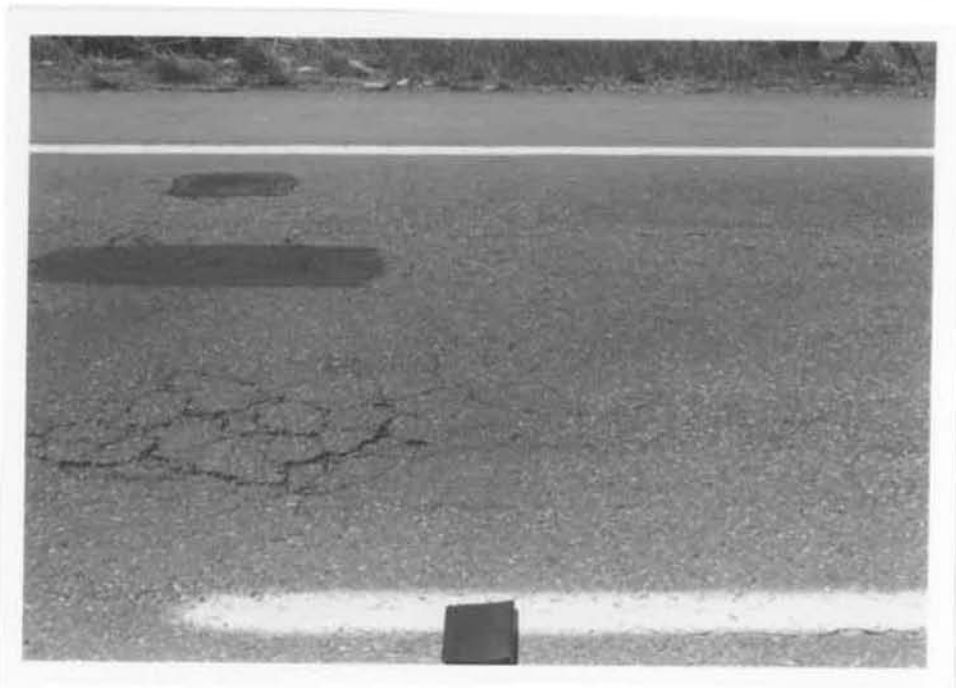
PHOTOGRAPH NO. 15

INTERFACE BETWEEN SECTIONS SHOWING RICHER
VIRGIN MIX ON RIGHT AND LEANER MIX ON LEFT

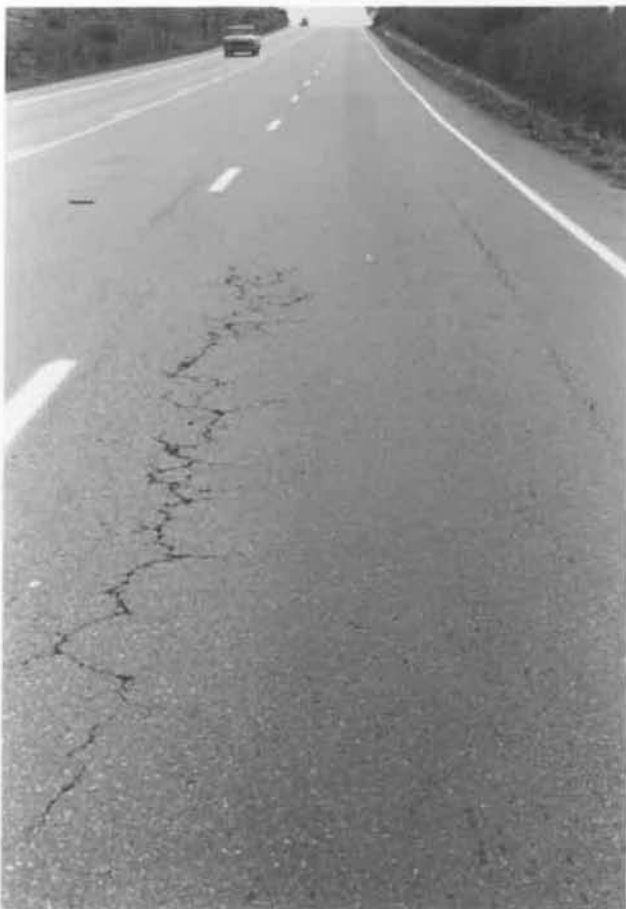
PHOTOGRAPH NO. 17

SECTION 4 SHOWING CLOSE UP
OF WHEELPATH CRACKING.
ALLIGATOR CRACKING ON LEFT
IS ATTRIBUTED TO BASE FAILURE,
LINEAR CRACKING ON RIGHT IS
ATTRIBUTED TO EDGE OF UNDER-
LYING PAVEMENT.

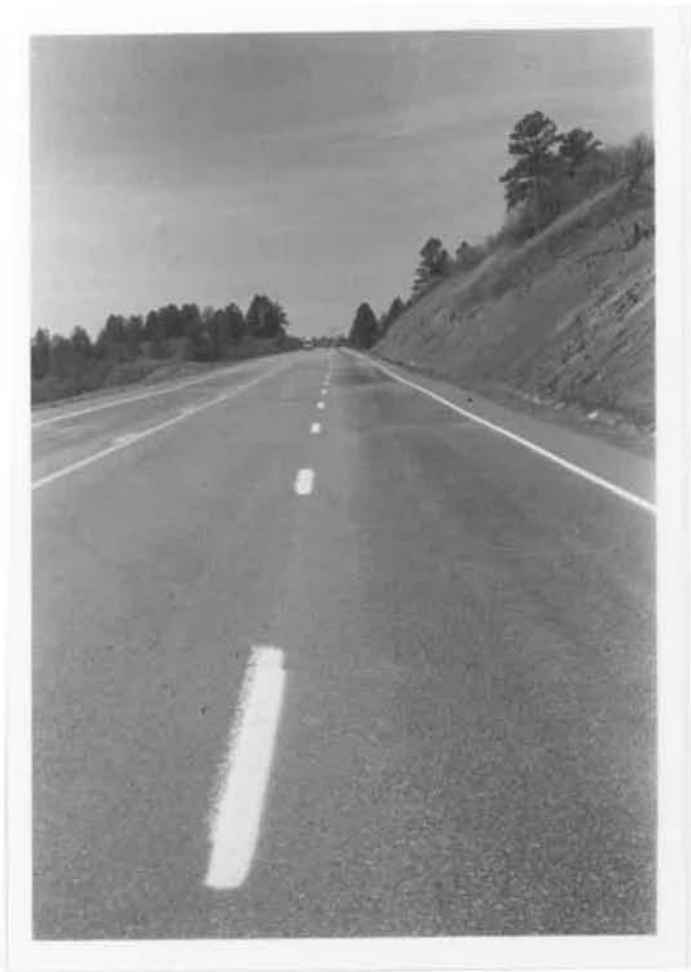
PHOTOGRAPH NO. 18

SECTION 5 (VIRGIN MIX)
OVERALL VIEW VIRGIN MIX
SECTION APPEAR RICHER THAN
RECYCLED SECTIONS WITH
BLEEDING OCCURING

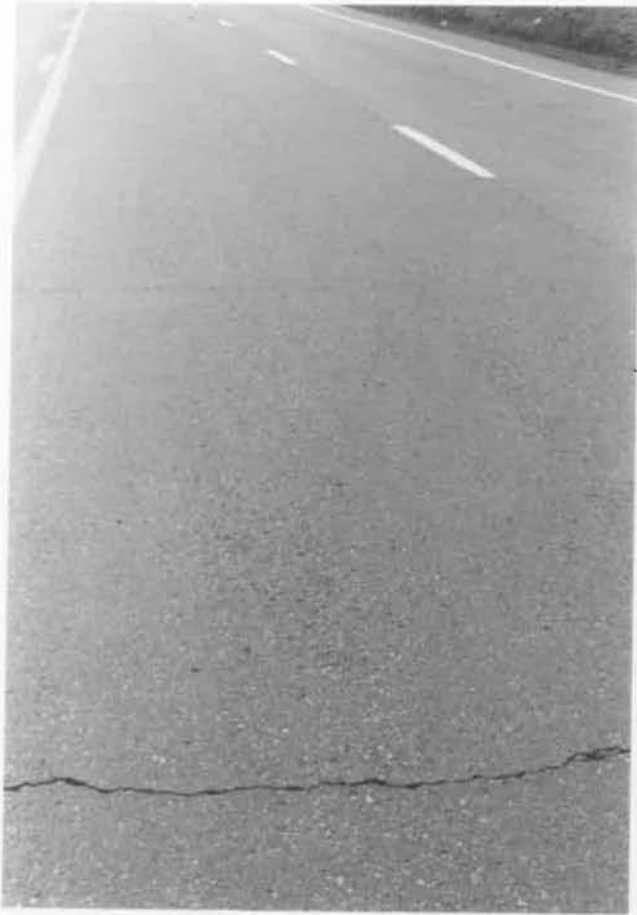
PHOTOGRAPH NO. 19

SECTION 5 CLOSE-UP OF
TRANSVERSE CRACKING IN
LEANER AREA OF THE SECTION

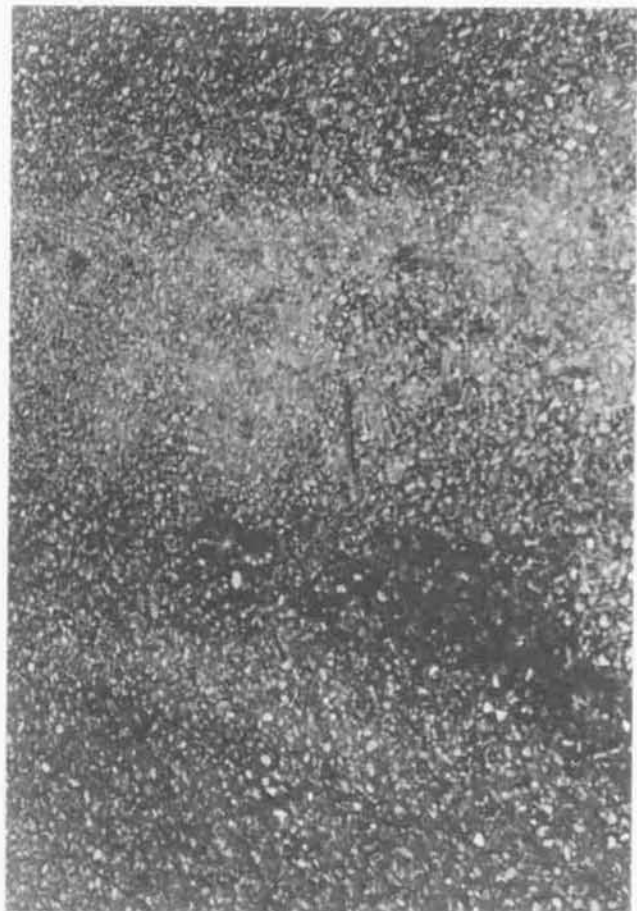
PHOTOGRAPH NO. 20

SECTION 5 CLOSE-UP OF
BLEEDING TYPICALLY
OBSERVED IN VIRGIN MIX
SECTIONS

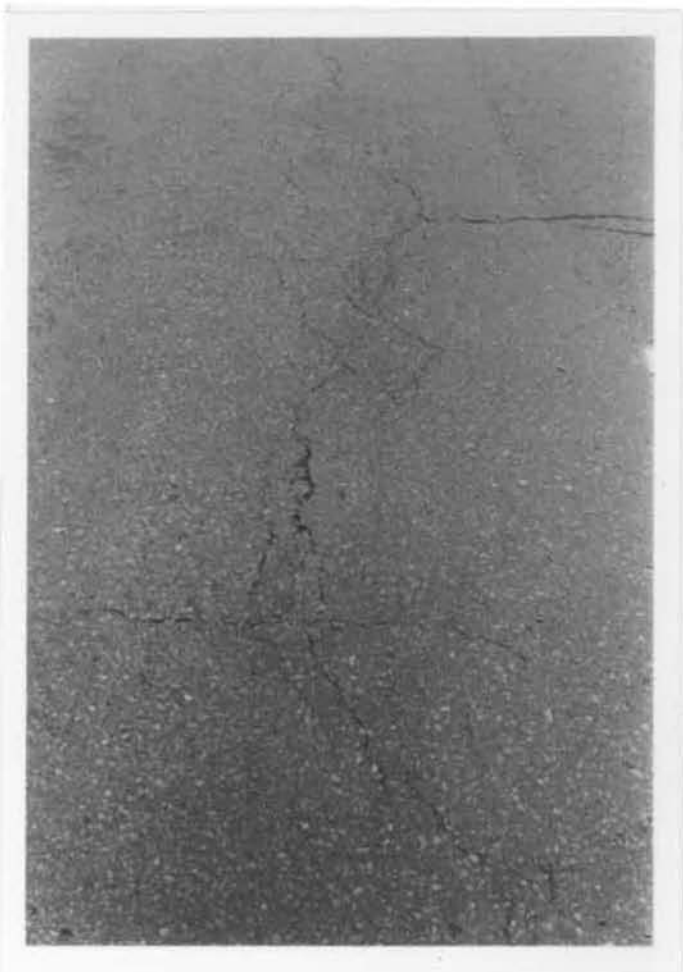
PHOTOGRAPH NO. 22

SECTION 6 CLOSE-UP
OF WORST CASE CRACKS
IN WHEELPATHS OF DRIVING
LANE.

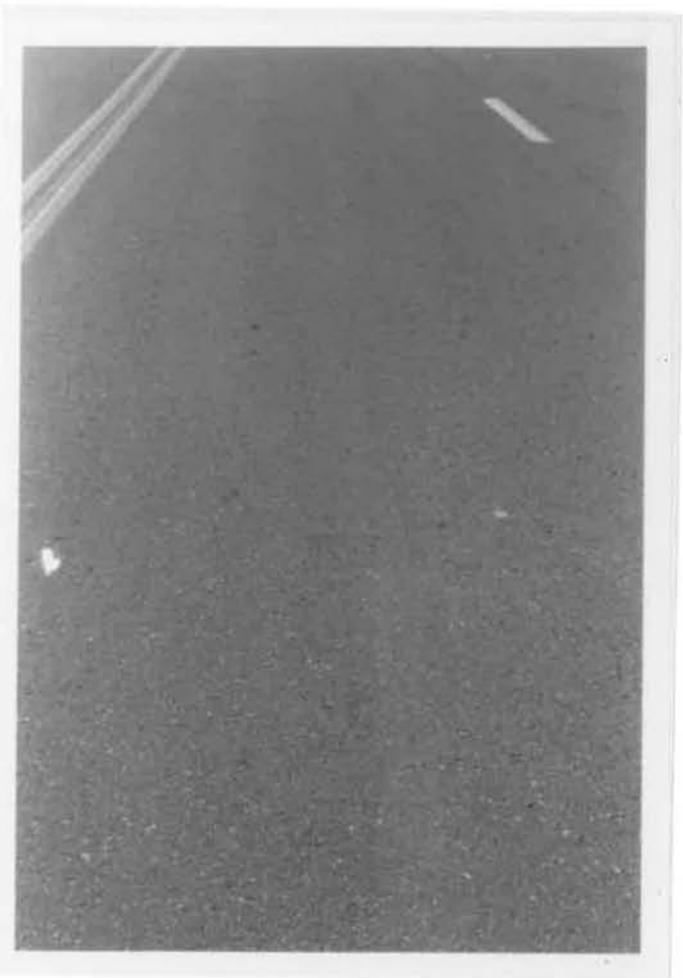
PHOTOGRAPH NO. 23

SECTION 6 CLOSE-UP
OF CENTER PASSING LANE
SHOWING PERFECT CONDITION.
