Report No. CDOH-DTP-R-84-5

# EVALUATION OF CONCRETE PAVEMENT RESTORATION PROCEDURES AND TECHNIQUES

**K.L.WOOD**

INITIAL REPORT  
MARCH 1984

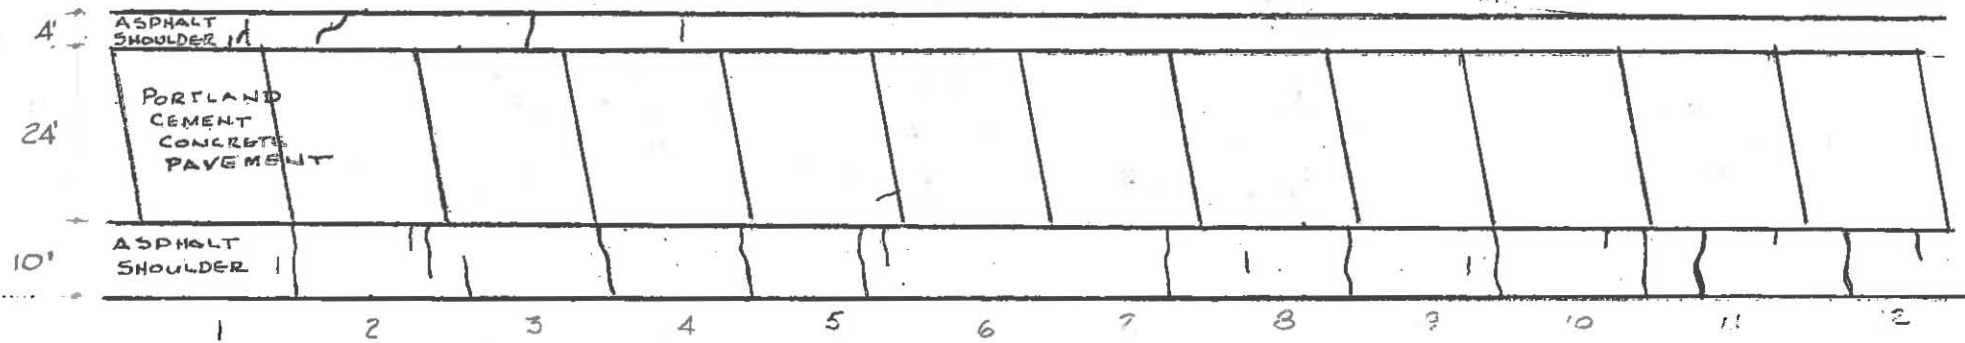
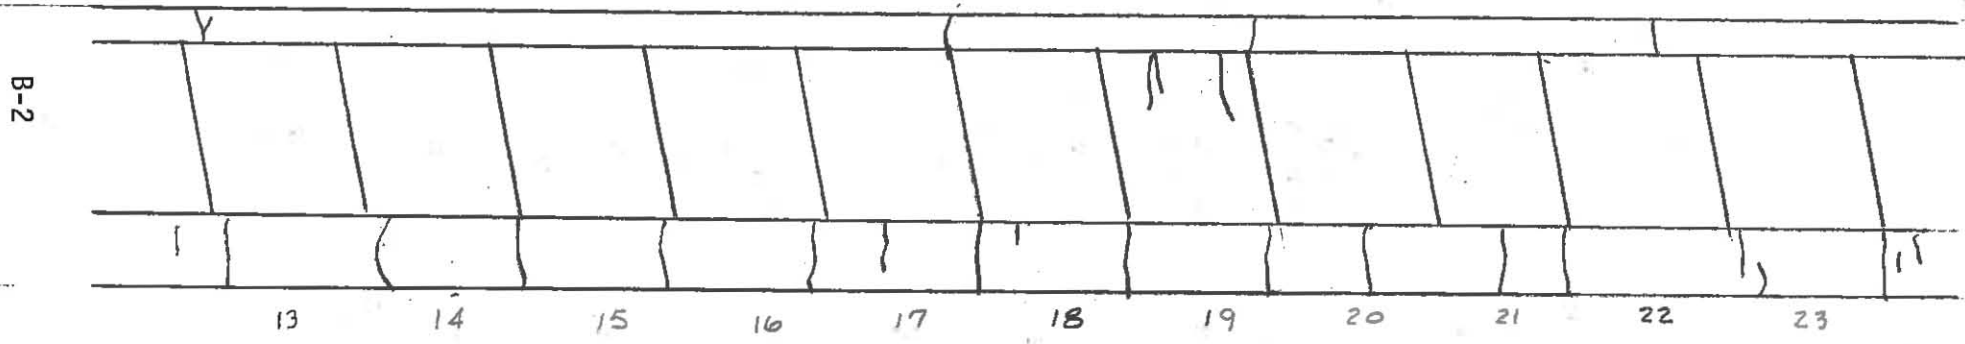
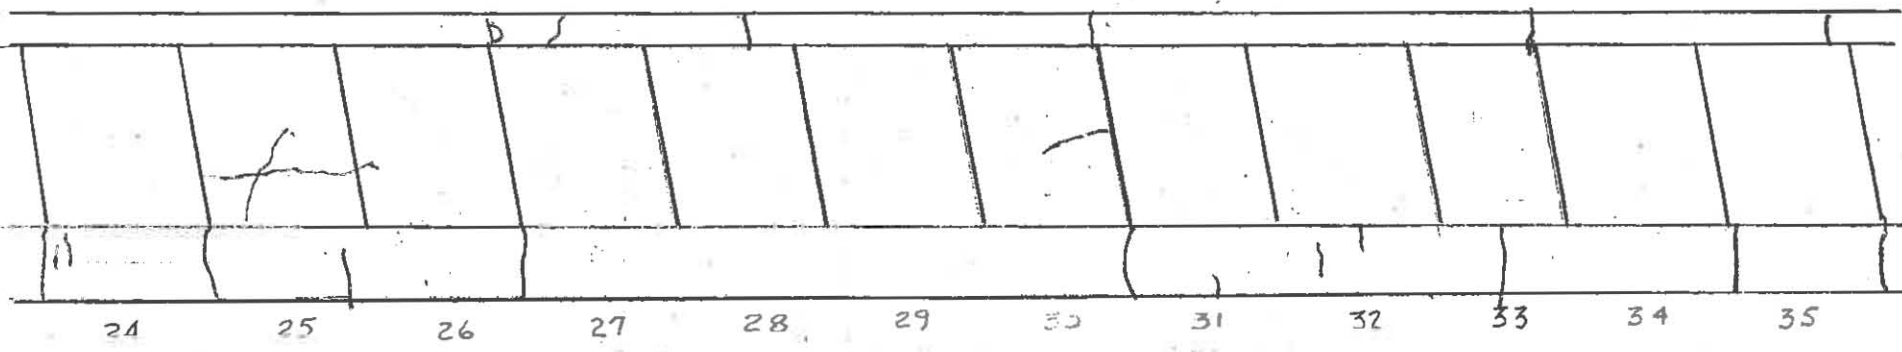
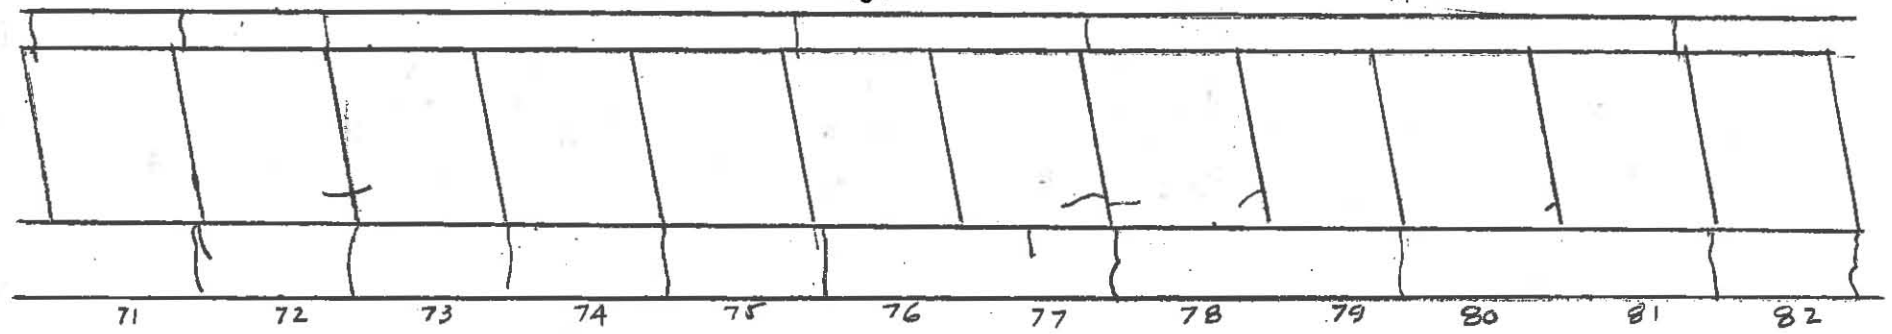
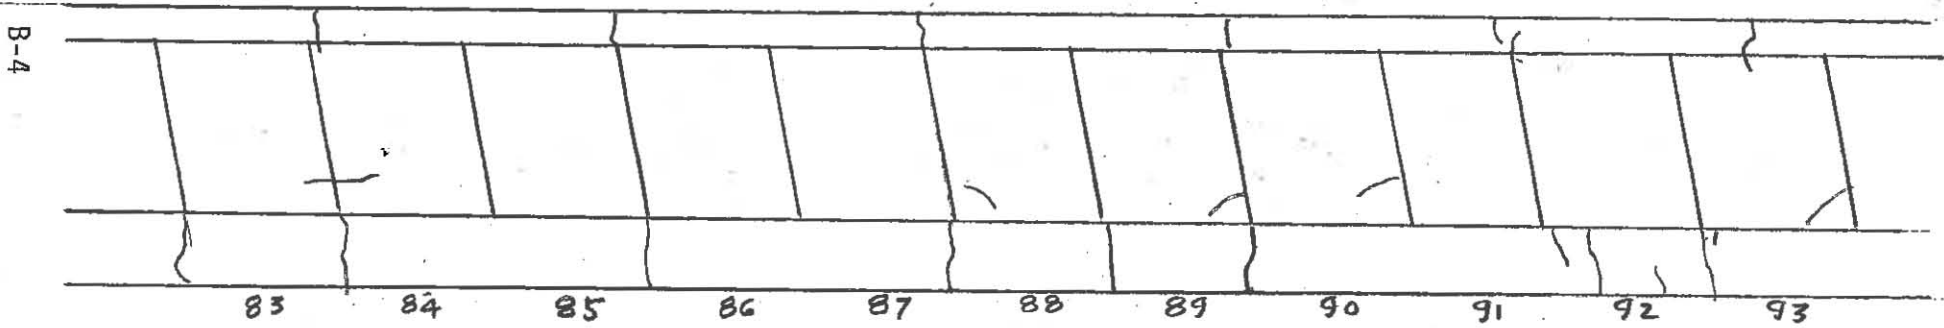
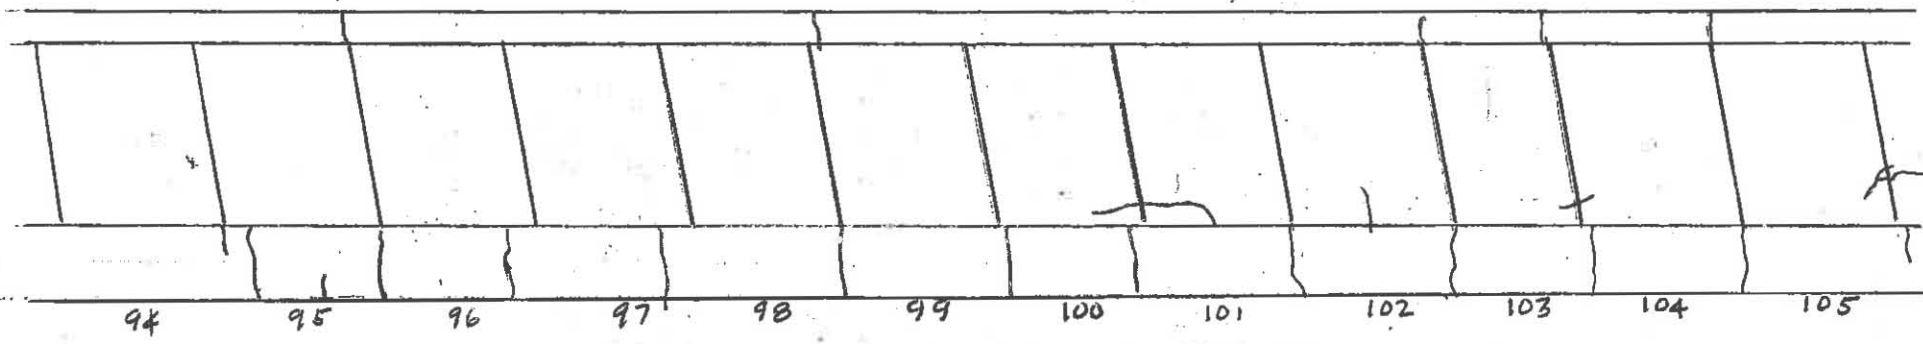
CONDITION SURVEY (Cracking Maps)  
I-70, EBL (Chambers to Tower Rd.)  
August '83

The last part of the Pavement Condition survey consisted of mapping the existing cracks and measuring the faulting. The results of the condition survey are shown in Appendix B.

The Condition Survey is the guide for determining the rehabilitation alternatives. For example, a review of the crack maps indicate very few of the PCCP slabs are broken and that there is no joint spalling. This plus the roughness measurements made by the profilograph indicate the slabs are stable and the ride quality is good. Also, the deflections measured indicate the PCCP slabs are relatively stable. Using only the above information, alternatives such as reconstruction and thick overlays of asphalt or PCCP would not be recommended at this point in time. What is needed are restoration procedures and techniques to prolong the life of a PCCP that is in relatively good condition as shown by the very important Condition Survey.

Based on the Condition Survey, the Department decided to remove the few cracked and broken slabs full depth and replace them with new PCCP. (The few joints that were spalled would be repaired by partial depth removal and

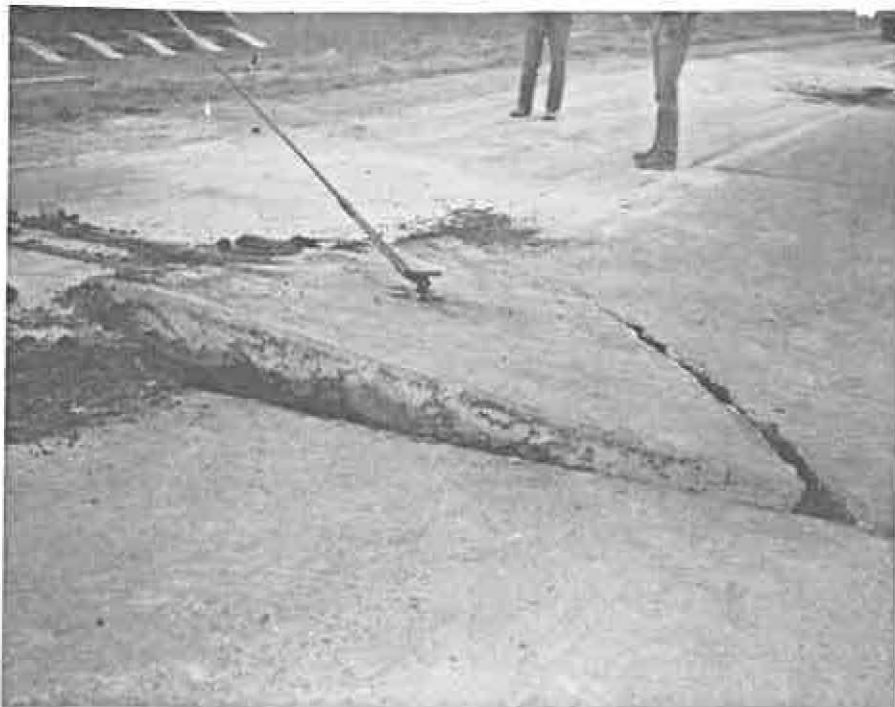
Removal and placing of old, broken concrete slabs is the first CPR procedure. Pictured is an 8 inch slab being lifted out of place. Prior to removal the slab was outlined with a full depth sawcut. Eight inch concrete will replace the old removed slab.

Approximately 185 sq. yd. of full depth concrete pavement was removed and replaced. The method of removal was first to outline the removal area with a full depth sawcut. One of the transverse sawcuts would be on a slight angle so that the side at the center line was shorter than the longitudinal side at the asphalt shoulder forming a wedge. (All removals were 12 ft. wide, 9 full lane width, and in the driving lane). Next, the contractor drilled holes into the slab and inserted pins. With a cable attached to the pin and a rubber tire front end loader he slid and lifted the slabs out. The wedge shape of the slab allowed it to slide back before lifting without causing any damage to the adjacent concrete pavement. It is very easy to spall and damage the adjacent concrete. Caution must be exercised. Enough slabs were removed so that the concrete replacement pours would be completed by noon. This allowed traffic, which was detoured to the passing lane, to be back on the driving lane by 5:00 p.m., assuming the concrete would have enough strength. To assure this strength, the following design mix was used.

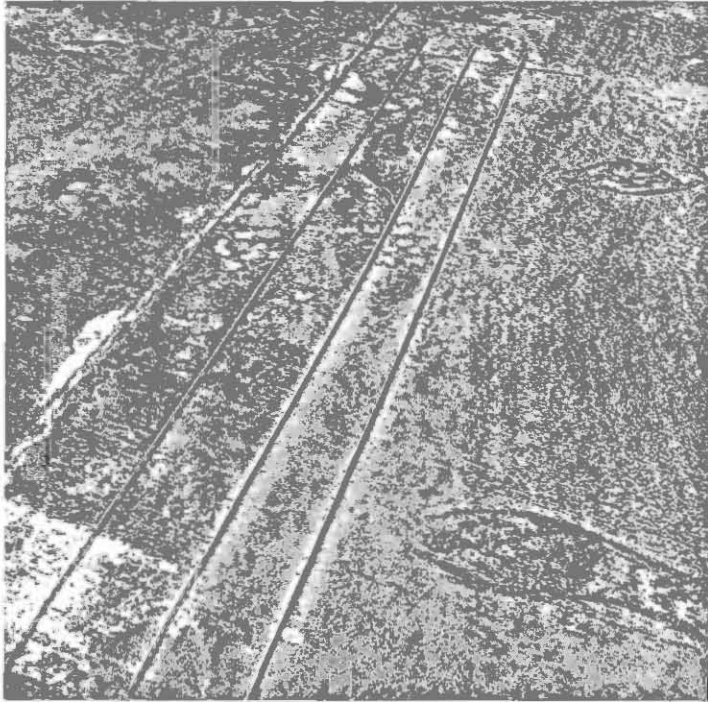
Spalled joints and cracks are also repaired during the period of time full depth removal and replacement is being performed. Since there was no spalling on the project, several slabs were selected to demonstrate partial depth repair. Here 3 sawcuts, 2 inches deep are made next to a joint for removal of a spalled area.

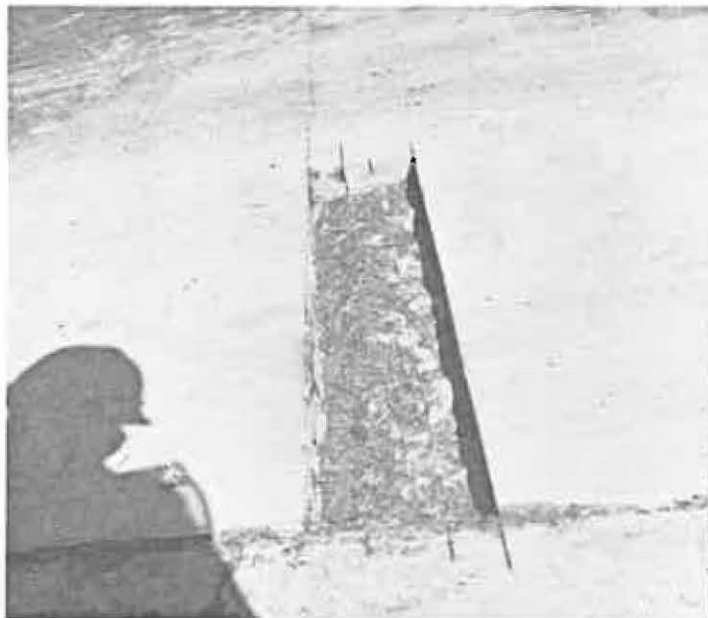
The material is removed with air hammers to the bottom of the spall. Attention was given to cleaning the spall before the modified Portland cement patching materials were placed.

The 30 day post inspection showed the partial depth patches performing as expected with one exception. The aggregate used with the prepackaged Polymer Concrete system (Methyl Methacrylate) resulted in a harsh surface. To correct this a skim coat of polymer concrete was placed over the surface. This has resulted in some spalling over the patch.

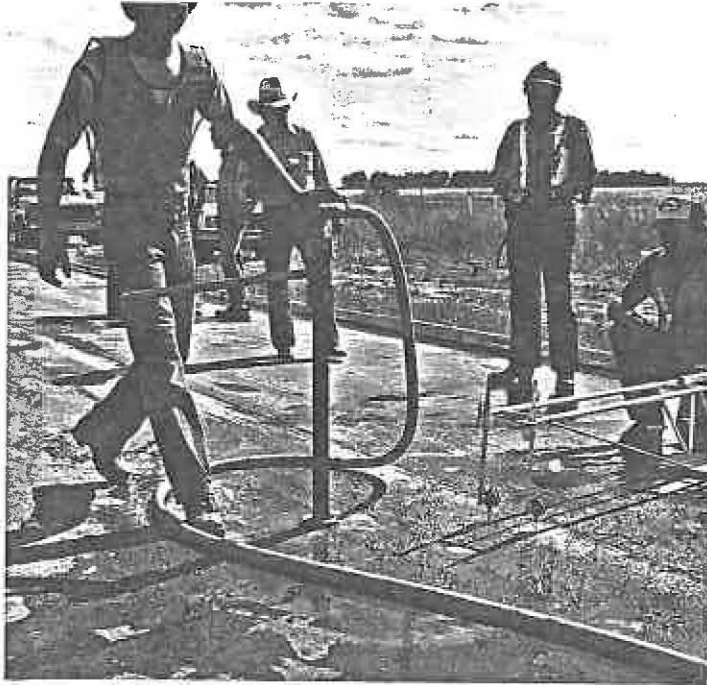
Another CPR technique that was demonstrated was the slab undersealing. In a complete CPR system it would follow the full and partial depth slab repair. Pictured is the injection of the cement/fly ash mixture into the voids under the slab. A modified Benkleman Beam is being used to monitor the uplift of the slab.

Another item monitored is the uplift of the slab. Since the objective of the undersealing is to fill voids under the concrete slabs and not displace the concrete slabs, a modified Benkleman Beam is used to signal cut-off of the pump. The allowable up lift of the slabs was established at .125 inches (1/8").

The undersealing significantly reduced slab deflections. Measurements recorded during this 30 day evaluation in the same locations averaged .016 inches, on the approach side and .009 inches on the leave side. The average difference was .008 inches.

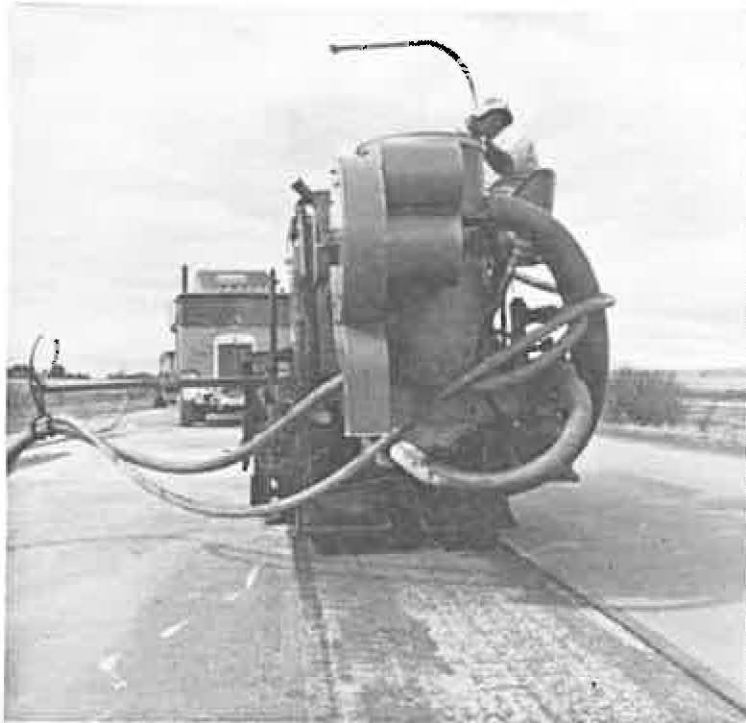
After undersealing is completed, the concrete slab can be resurfaced by diamond grinding. Grinding was done on this project not only to provide a new surface but to remove the rutting and faulting.

After the slab replacement, spall repair, and undersealing were completed, the contractor removed 1/4" to 3/8" of the surface in the driving lane (a full lane width), by diamond grinding, thereby eliminating the faulting and rutting. The grinding machine (shown in photographs 9 and 10 in Appendix D), was an old Concut G-38, that had been rebuilt (using only the original frame and transmission). The contractor had removed the original 200 H.P. gasoline engine, among other things, and replaced it with a 375 H.P. diesel. This resulted in more than 250 H.P. at the cutting head.

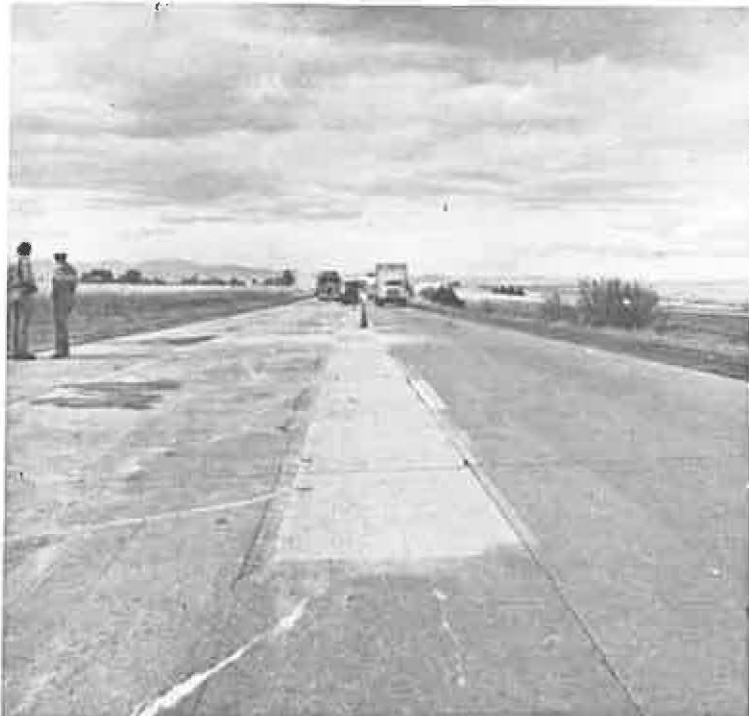
Grinding was performed in the heavily traveled lane in the heavily traveled lane only (truck lane), while traffic was carried on the adjacent passing lane. The grinder cuts 38 inches wide, which requires four passes per lane.

The 38" wide cutter made four passes in the driving lane with 2" of overlap per pass (after the first). The grinding was performed against the traffic. The contractor cited two reasons for this. First is safety. The operator can keep his eyes on the on coming traffic. Also, the large water tanker is placed between the grinder and traffic which serves as protection. Second, this allows the grinder to go up against the faulted joints as opposed to dropping off the joint. The result is a smoother surface after grinding. The first field evaluation 30 days after construction showed an increase in the skid number from 40 to 53. The roughness measured by the Rainhart Profilograph went from 6.7 inches to 3.1 inches in the test section.

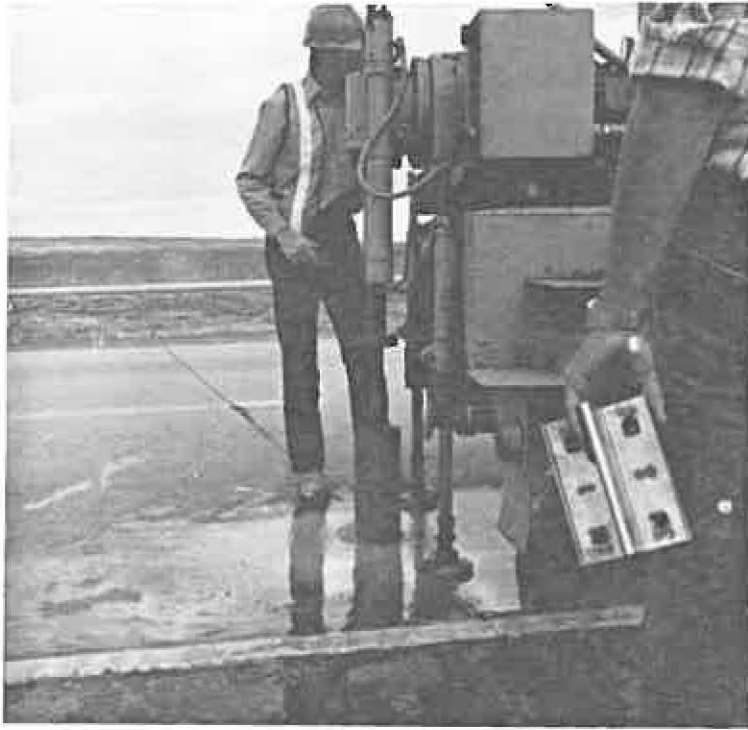
The fourth CPR technique demonstrated was the restoration of the load transfer at the transverse joints. Pictured is the diamond load transfer device used on the project and the drilling operation.

The device selected for use on the Demonstration Project was the diamond device (as shown in photograph 11 in Appendix D). Thirty devices were installed in ten consecutive joints in the heavily traveled truck lane. Two were placed in the right wheel path and one in the left wheel path. The first one in the right wheel path is spaced 18 inches from the edge of pavement. The second is 18 inches inside the first. In the left wheel path the device is 18 inches from the longitudinal centerline joint.

Six inch core holes were drilled and centered over the transverse joints for the load transfer devices to be placed. The diamond shaped devices were fabricated from stainless steel, which protects them from corrosion. Inside the diamond or bellows is a factory installed flexible polyurethane foam for compression caused by normal horizontal slab movement. Also, foam rubber applied in the field is wrapped around the outside of the diamond to create a void for the necessary contraction. This is the same as the Double V or Barenburg device.

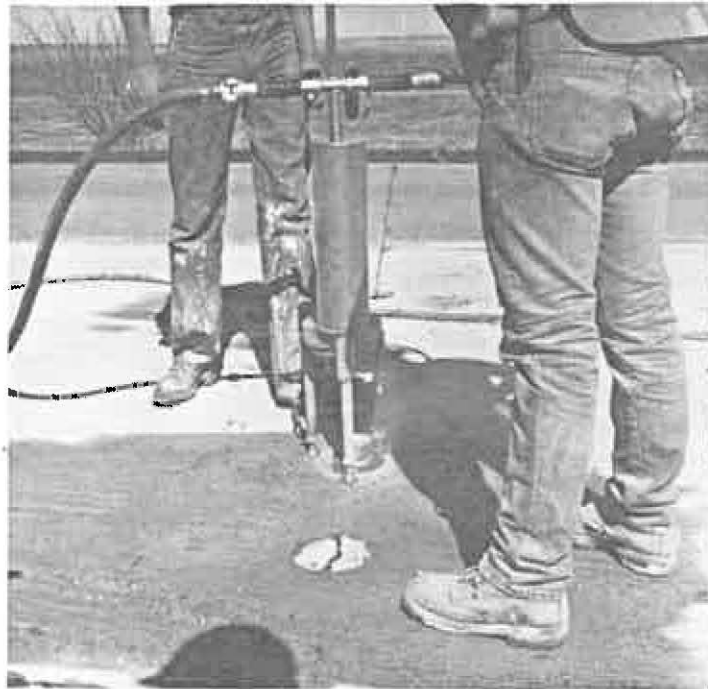
A special air driven tool was used to groove the inside of the core hole. This provides more area for bonding the grout to the concrete slabs and mechanical shear at the face of the grout/slab joint.

The core holes were grooved with an air powered tool (photograph 12 in Appendix D) that put three grooves in the holes. This provides more area to bond to and additional shear interlock (grout to slab). The grout used to secure the load transfer devices was a two component polymer concrete (Methyl Methacrylate System). A Methyl Methacrylate based primer was brushed on ahead of the placement of the load transfer device. This is a low viscosity primer

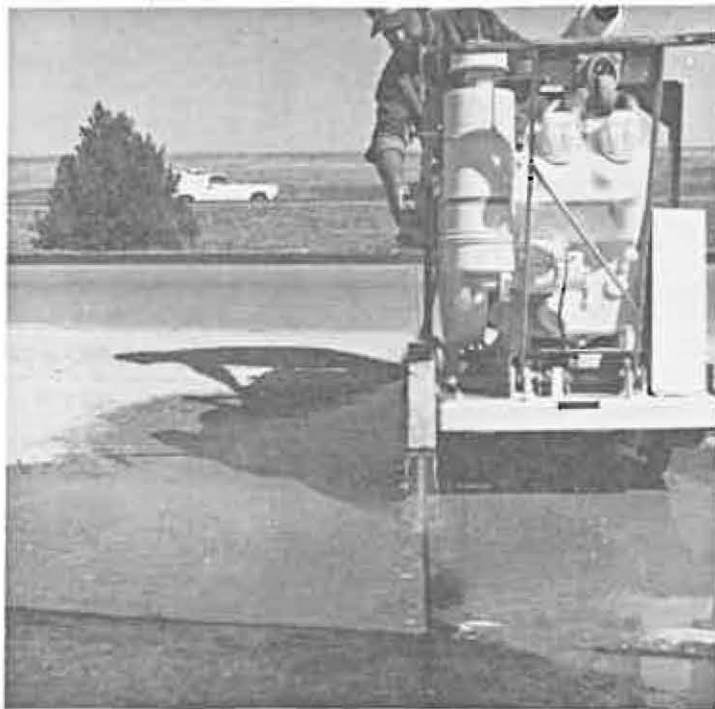
**The last CPR procedure that the contractors demonstrated was the resealing of joints and cracks. Here, a diamond saw is refacing a concrete transverse joint.**

Prior to installation of the sealants, the joints had to be prepared. The old sealant was removed and the sides of the old joints were refaced using a diamond blade saw. The joints in the concrete were cut 3/8 to 1/2 inches wide and 1 3/4 inches deep with one exception; the joints where the preformed compression seal was placed were all cut 1/2 inch wide. The asphalt shoulder joint was routed 3/4 inch wide and approximately 1/2 inch deep. After resawing the concrete, the joints were sandblasted to remove any residual sealer oil or other foreign material which may prevent bonding of the new sealer. The last step was blowing out the joint with an air compressor to remove sand, dust, or any water remaining. The concrete/asphalt joint received only the air blast after routing.

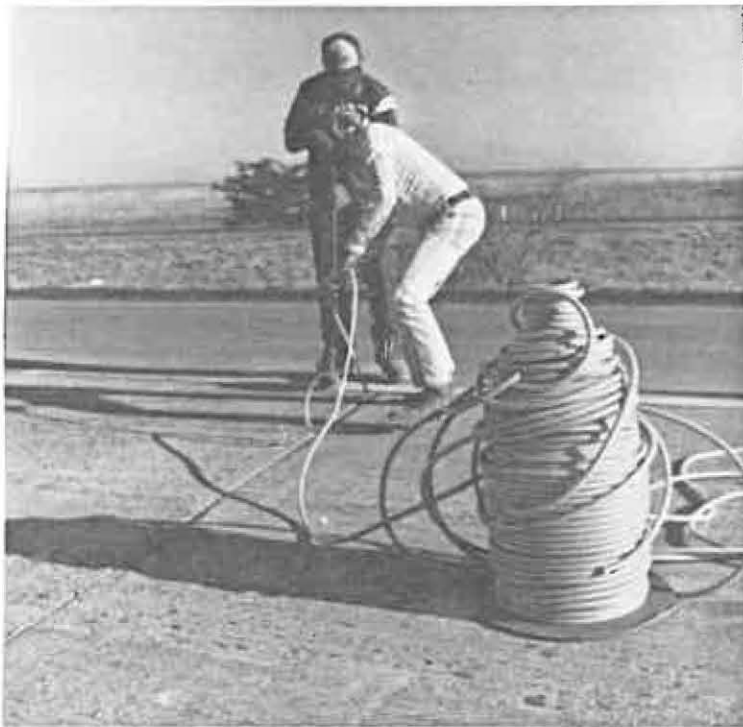
Next, after a thorough cleaning of the refaced joint, a backer rod was installed. The joints receiving the compression seal do not require a backer rod.

On all of the concrete joints, except where the preformed compression seal was placed, a closed cell, compressible, polyethylene foam backer rod was placed in the joint. The backer rod prevents three sided adhesion and excessive use of sealants. It also helps provide the proper shape factor, since the parabolic curve formed by the backer rod at the bottom of the sealant results in less strain on the joint sealer. In the case of the silicone seals, it also provides support for the finishing tool. (See photograph 15 in Appendix D).

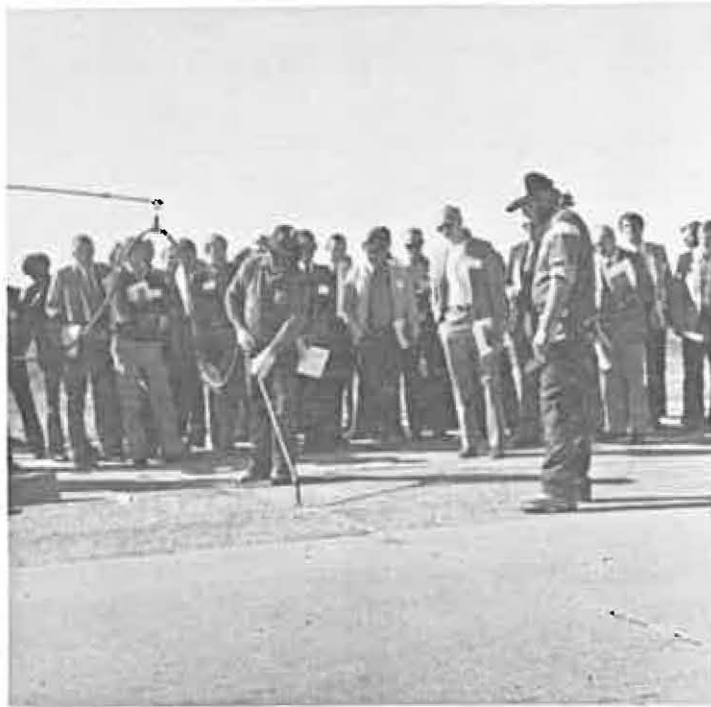
Procedures for applying silicone sealant are demonstrated.

Two different Silicones were installed in joints 41 through 80 (photograph 17 in Appendix D). The gray colored silicone (Dow-Corning) was placed in joints 41 through 60, and the black silicone (G.E.) was installed in joints 61 through 80. It should be noted that the black silicone required a primer. Both silicones were installed using air driven pumps. The silicone is placed

into the joint and tooled so that the result is a concave curvature recessed 1/4 inch below the surface of the pavement. The curve at the bottom of the sealant provided by the backer rod and the concave curve on the finished top provided by the tooled surface result in the most desirable sealant shape for minimum strain. During the 30 day evaluation, some adhesion failures were noticed at joints 63, and 69 through 72. They are typically 3 inches long and 1/4 inch wide. It was the black colored silicone that debonded.

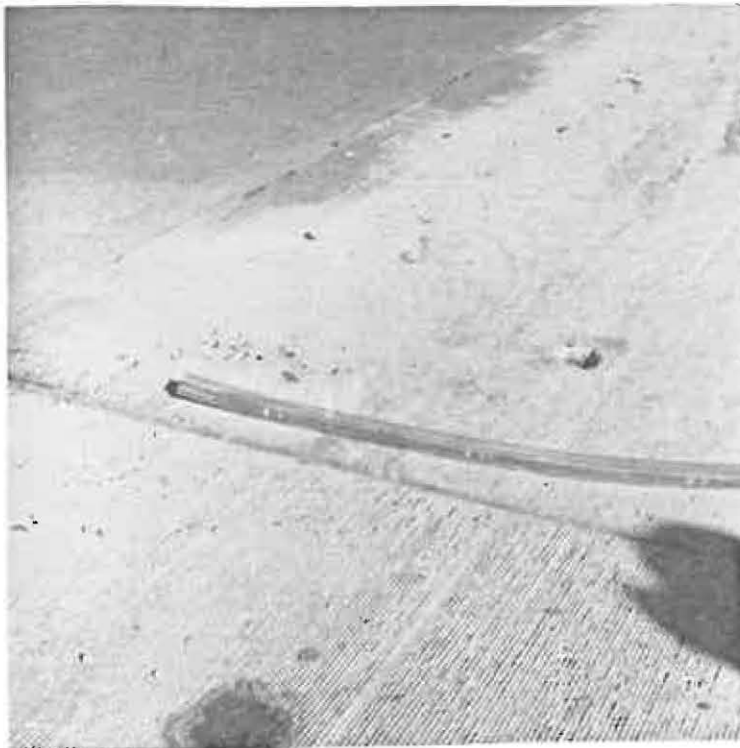
A 1 inch by 1 inch piece of preformed neoprene compression seal is prepared for installation into the joint.

This material was placed in joints 21 through 40. The contractor installed a 1 inch x 1 inch low stress seal with a complex web profile that may be a very effective seal if it remains in place. However, it may be too large a section for the short 20 feet spaced joints. A more desirable section would have been a 7/16 inch by 7/16 inch seal. It is also the most expensive of the joint seal materials. (See attached estimate cost).

Prior to installation, a lubricant was applied to the open joint to help slide the seal in place. After this lubricant dries it provides very little adhesion between the seal and concrete. Therefore, this seal relies solely on compression. The installation of the neoprene seal required two people. One would stretch the material approximately 5% while the other pushed a 4 wheel installation tool over the joint forcing the material in place. (See photograph 18 in Appendix D).

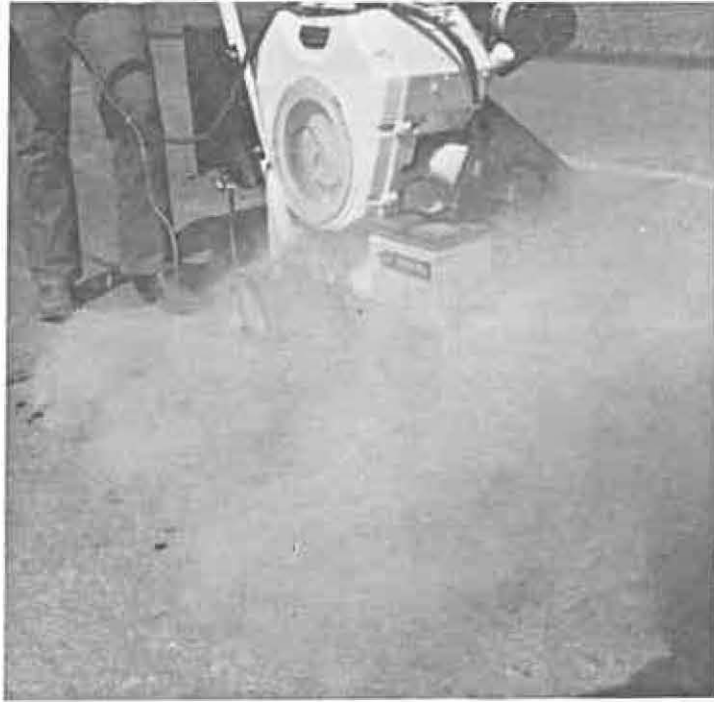
**This machine is a short pivotal saw used to rout cracks.**

A small gas powered pivotal saw (as shown in photograph 19 in Appendix D) was used to route the cracks sealed on the project. The contractor demonstrated both carbide and diamond cutting saw blades. The diamond provided a superior cut because it did not spall (the carbide blades work best in the asphalt shoulder). The concrete cracks were routed about 3/8 inch wide and 1/4 inch deep. A modified hot poured rubber sealant was placed in the cracks. No backer rod was used in the bottom of the routed crack.
