Report No. CDH-DTP-R-83-13

SQUEEGEE SEAL AND CRUMB RUBBER CHIP SEAL  
SAPINERO - EAST

Final Report  
NOVEMBER, 1983

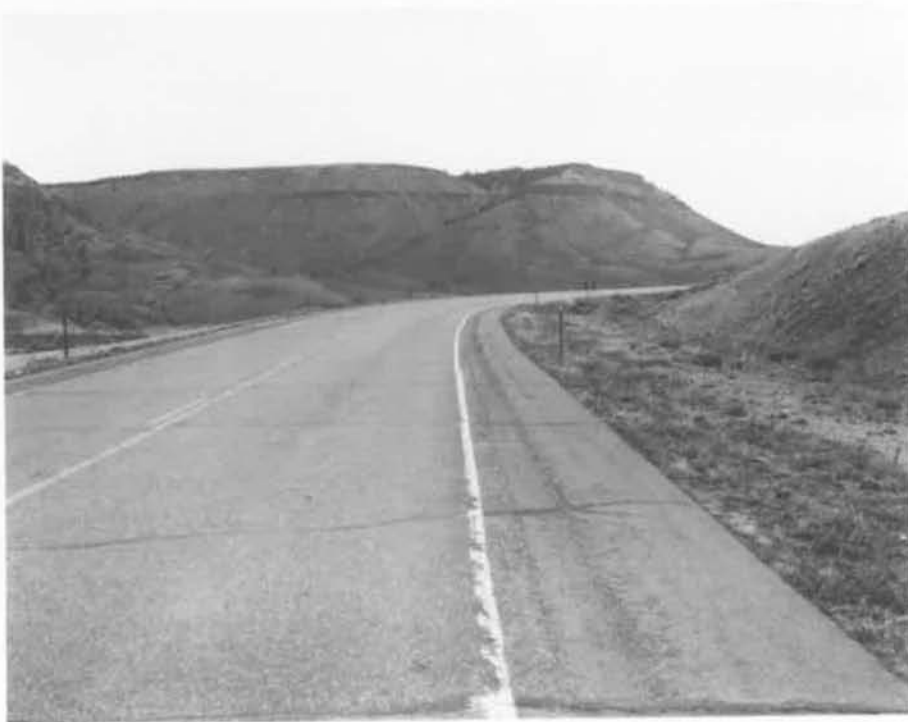
Photograph No. 1

Table A contains a summary of the deflections, PSI's, and cracking and rut depth data. As can be seen from a review of Table A, the existing roadway was in poor condition. Photograph Number 1 shows the typical roadway condition prior to construction.

The large amount of cracking is attributed primarily to aging of the pavement and the extreme thermal conditions in the project area. Transverse cracks had approximately a 12-foot spacing with numerous connecting longitudinal cracks located primarily at the center line or between wheel paths.

Typical roadway condition  
prior to construction.

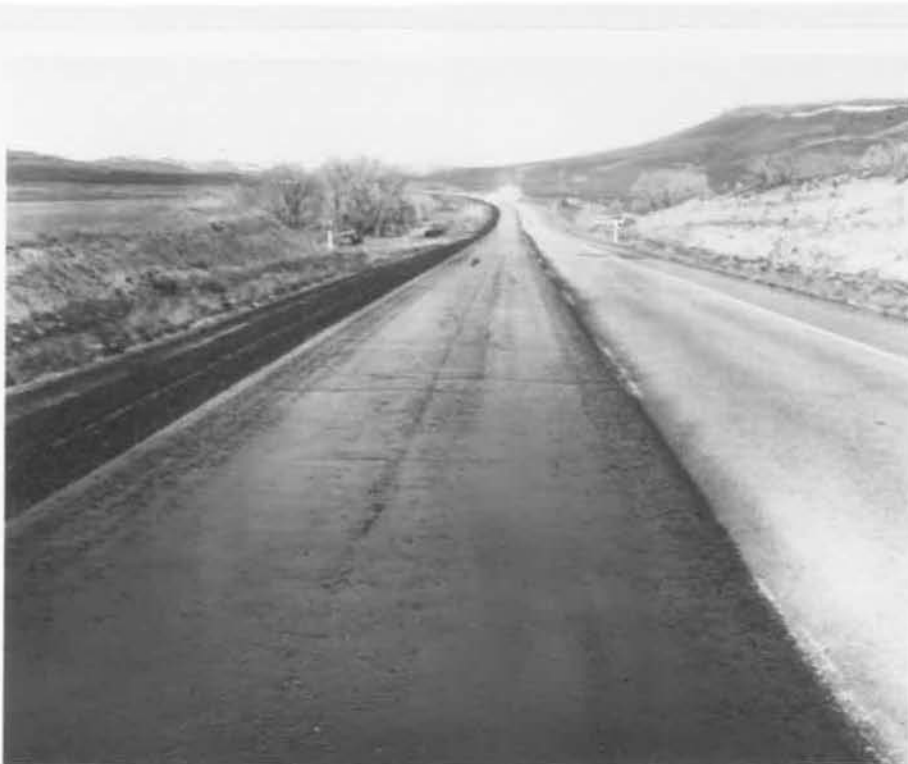
Photograph No. 2

Squeegee Seal  
Driving lane shot with  
MC-70 at 0.16 gal./yd<sup>2</sup>.  
The shoulder was shot at  
0.13 gal./yd<sup>2</sup>, but received  
the excess MC-70 from the  
driving lane.

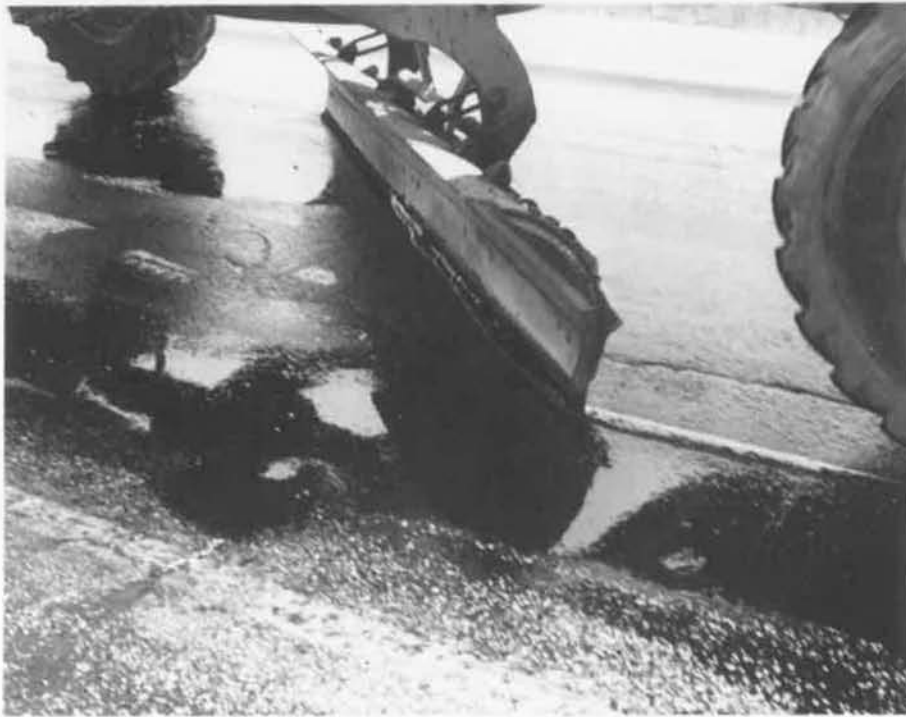
Photograph No. 3  
Squeegee Seal

Two motor graders with rubber tipped blades squeegee the MC-70 back and forth to fill the cracks.

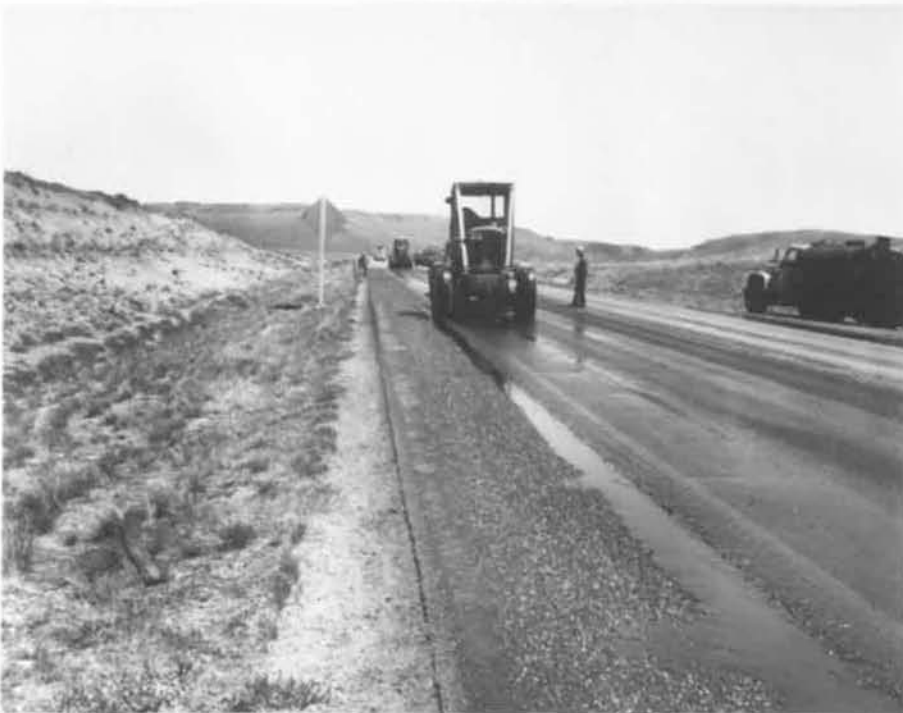
Photograph No. 4  
Squeegee Seal

Following several passes with the two motor graders, excess MC-70 is squeegeed on to the shoulder.

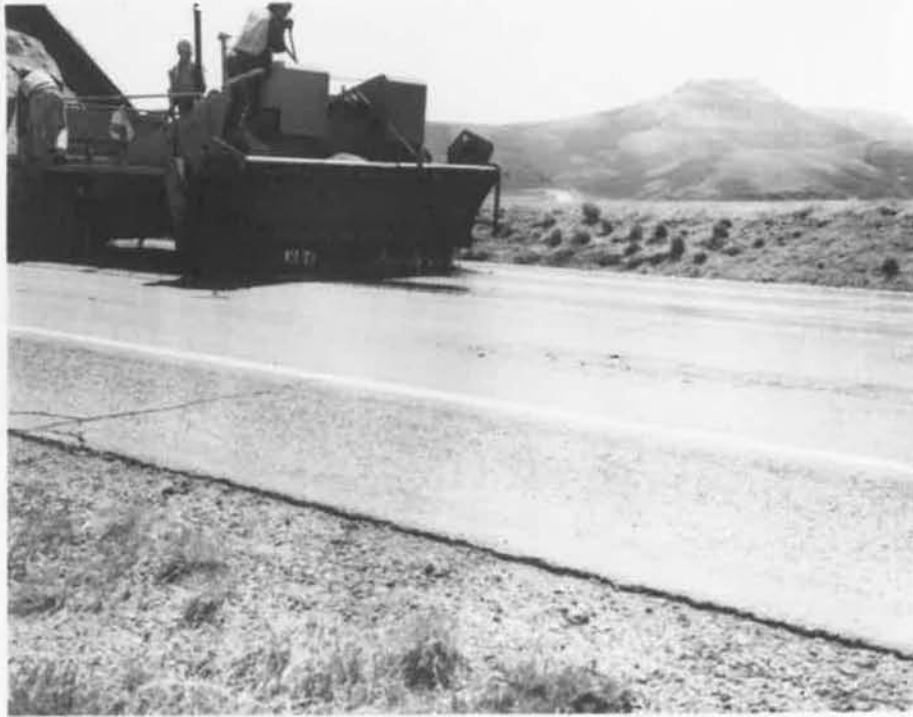
Photograph No. 5  
Squeegee Seal

After completion of the squeegee process, a sand blotter was applied at a rate of 9.6 lbs/yd<sup>2</sup>.

The roadway was then opened to traffic for four to five weeks so the MC-70 would fully cure, and traffic would work sand into the cracks.

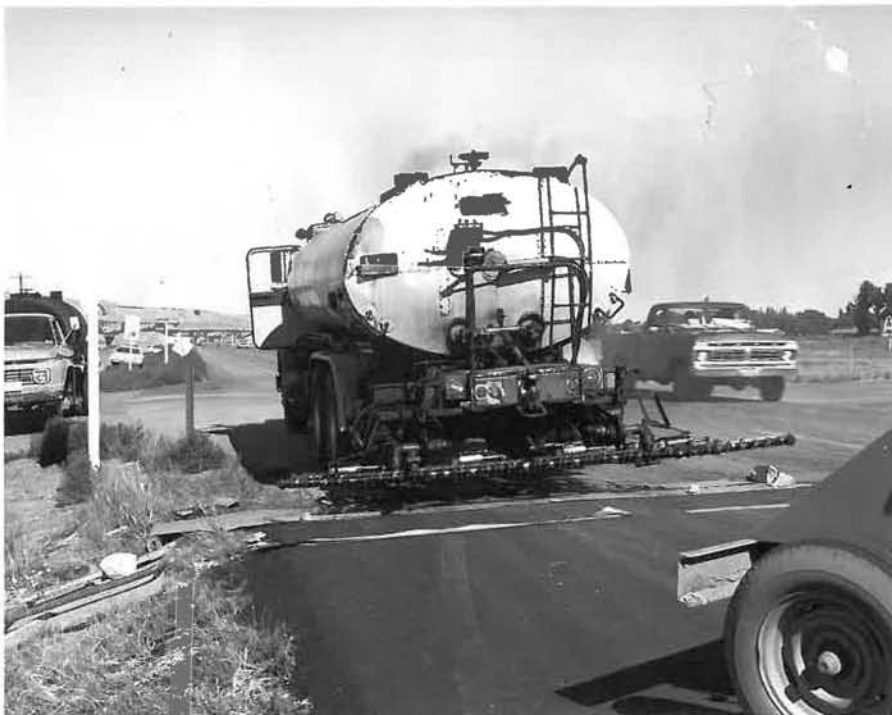
Photograph No. 6

Crumb Rubber distributor truck. These trucks contain agitators to mix the asphalt cement with the scrap rubber and keep the rubber suspended during application.

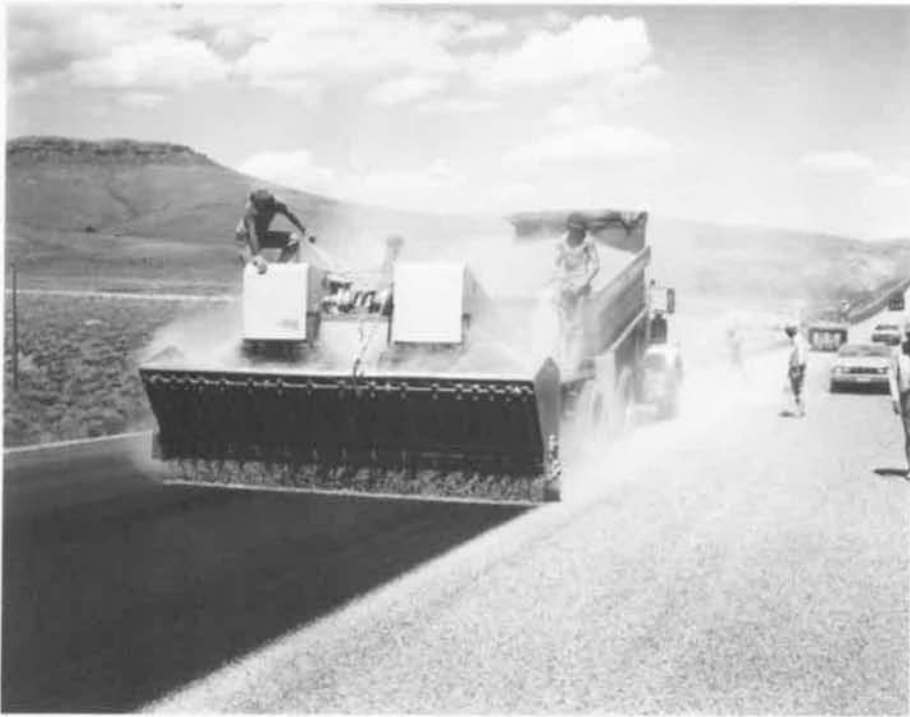
Photograph No. 7

A Flaherty chip spreader was used to apply the hot chips. Traffic was kept off the new seal using a pilot car.

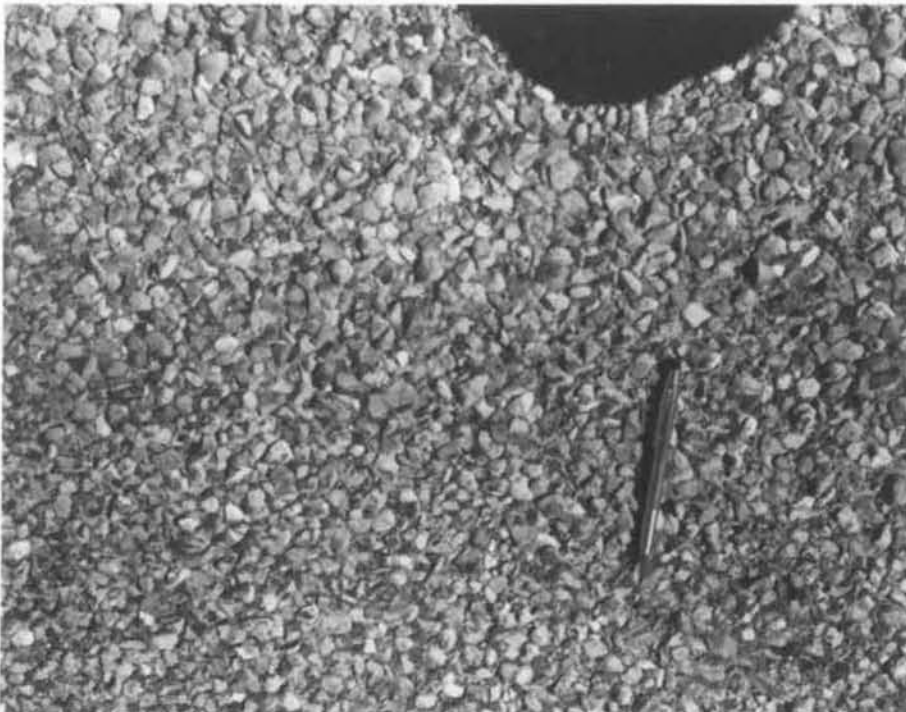
Photograph No. 8

Closeup of fractured chips shortly after placement. Note: Coarse surface texture.

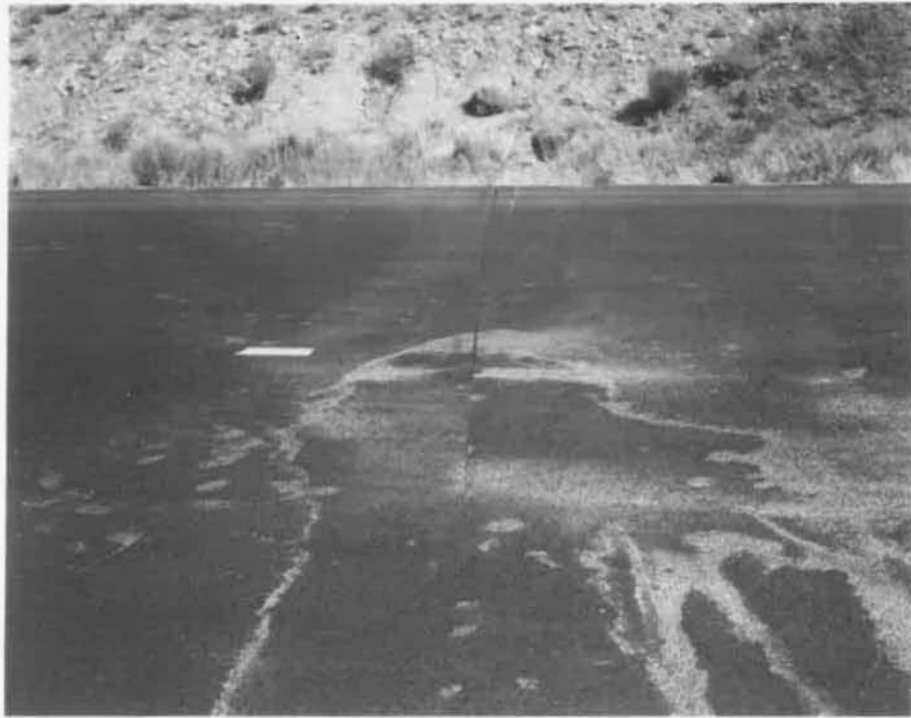
Photograph No. 9

In Section J, 10 joints were sawed through the leveling coarse prior to the application of the chip seal.

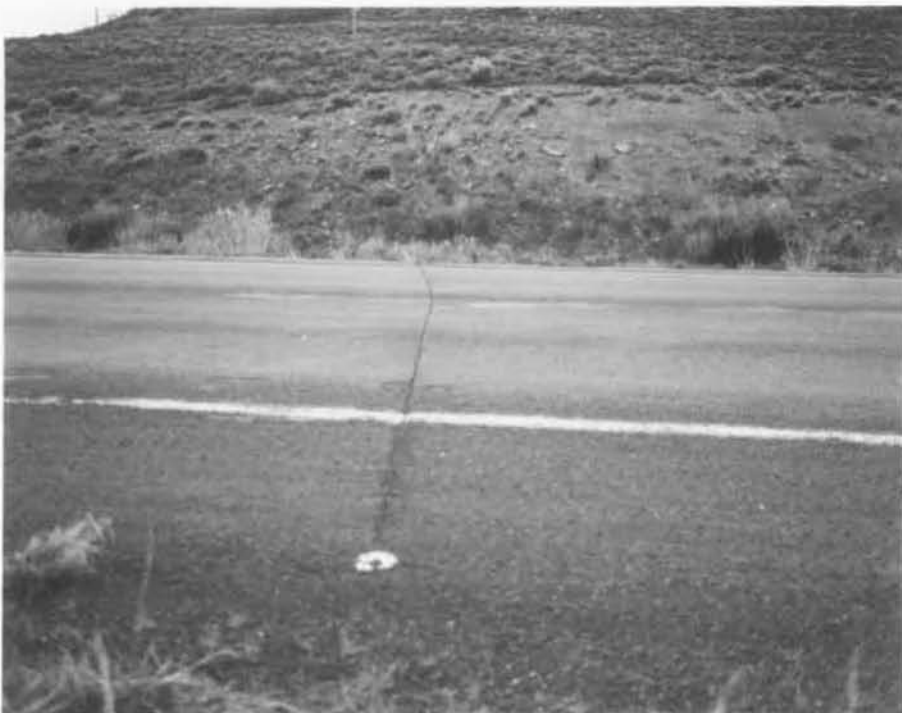
Photograph No. 10

The sawed joints replaced random transverse cracks in test section J; however, the total length of the joints plus the random cracks was almost equal to the amount of cracking in the standard sections.

By May 1982, 4 years after construction, the joints are clearly visible, and essentially replaced any transverse cracking in Section J.

The sawed joints in Section J did replace the random transverse cracks which occurred in other sections, however, as noted earlier, the total length of joints plus other random cracks was almost equal to the amount of cracking in the other sections. Because the amount of crack filling material required would be the same in either the sawed or random cracked areas, it is doubtful that enough time would be saved in crack filling to off-set the initial cost of sawing the joints in a new pavement. Therefore, unless it can be shown that sawing joints would result in considerably less total cracking, their use is not recommended.

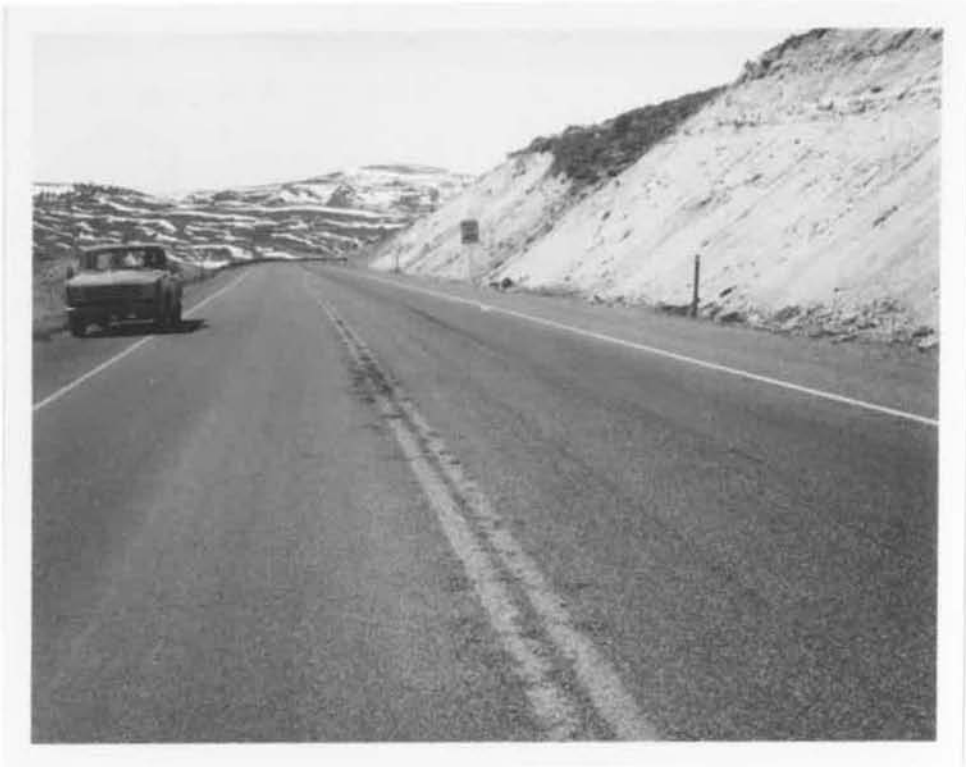
Photograph No. 11

One area of project performance not related to any particular test section is the snow plow damage to the chip seal. The chip seal suffered extensive damage from snow plows during the first winter following construction. Damage was especially bad in the test section areas. Sections 2 and 6 which received

Test Section No. 7 in April 1979. This photograph shows typical snowplow damage for the majority of the project with only slight damage at the centerline.

From the findings of this research project and the performance of other crumb rubber chip seals in mountainous areas, the use of crumb rubber chip seals is not recommended for areas where packed ice has to be removed by snowplows. This project and two other projects in mountain terrain suffered severe snow plow damage during the removal of packed ice especially in areas with even minor rutting where high spots existed in the pavement. This project performed the best of the three because of the leveling course evening the pavement prior to chip seal application. Squeegee seals have performed well in other areas of the state including mountain areas, when the major problem was alligator cracking. As demonstrated here, the squeegee seal is not very effective in preventing reflection cracking of thermal transverse

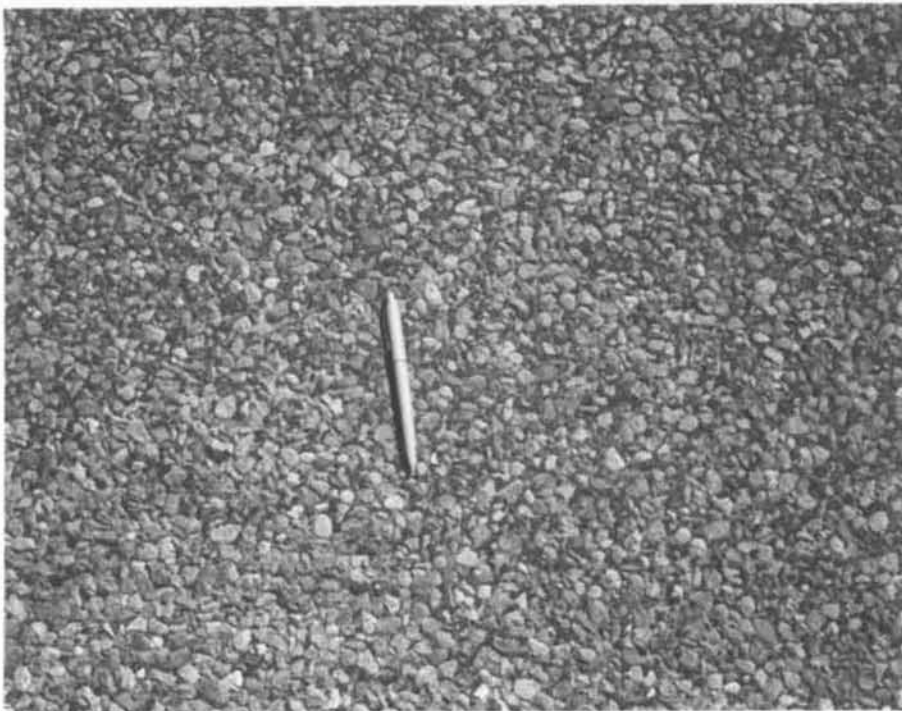
Photograph No. 12

Section No. 1  
April 1979.

Typical wheel path texture one winter after construction.

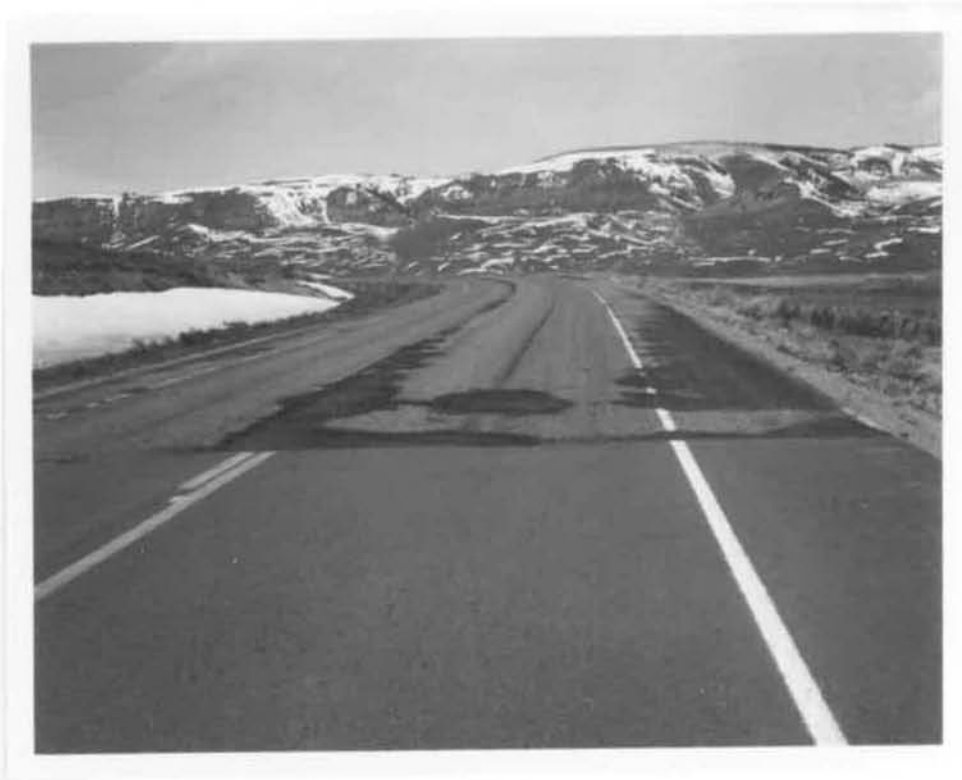
Photograph No. 13

no leveling course had the seal removed on all of the high spots in the pavement. Another area of extensive damage was on either side of test sections 4 and 8. The transition from pavement without a seal to a chip sealed area allowed the snowplow blades to more easily dig into the crumb rubber chip seal. The bulk of the project received less damage than the test sections. From conversations with local maintenance forces most of the damage occurred during times of extremely cold weather when packed ice had to be removed from the roadway. The chips seemed to pop off the surface during plowing. As seen by the photographs, more than just chips were removed by the snowplows; in many areas the entire asphalt-rubber seal was removed.

Section 3  
April 1979

Typical snowplow damage at  
a transition from smooth  
pavement to a chip sealed  
area.

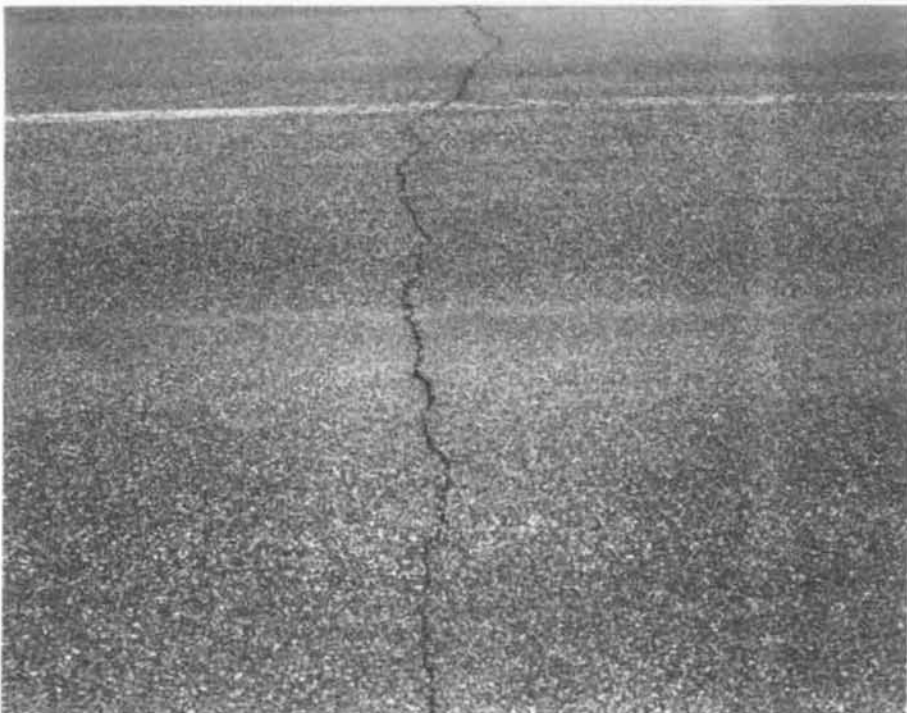
Photograph No. 14

Section 5  
May 1980

Typical transverse crack  
through the leveling  
course and chip seal.

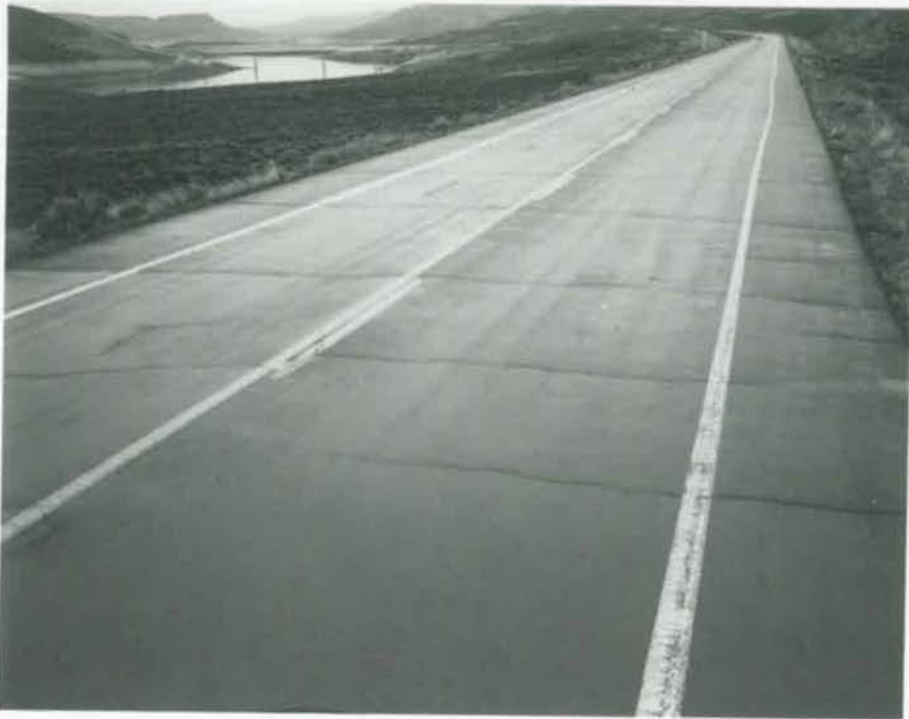
Photograph No. 15

Section 4  
May 1982

Typical transverse cracking on the project. Cracks are quite visible on this section which did not receive a chip seal. Cracking is similar to the preconstruction condition (see photo. No. 1).

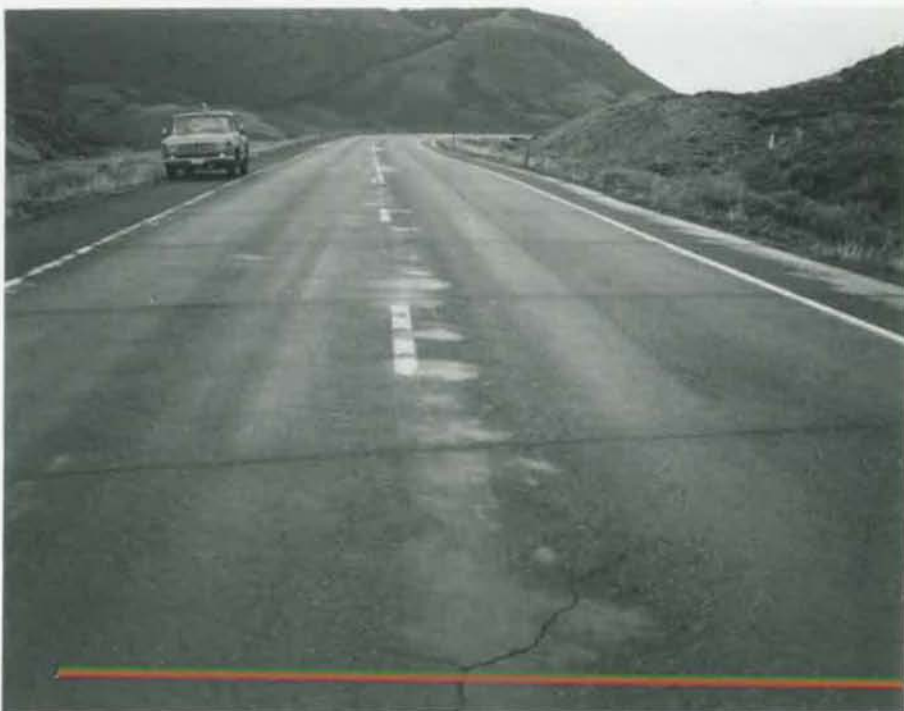
Photograph No. 16

Section J  
May 1982

The sawed joints replaced any transverse cracking in this section. Snowplow damage at the centerline and outside shoulders is typical for the project.

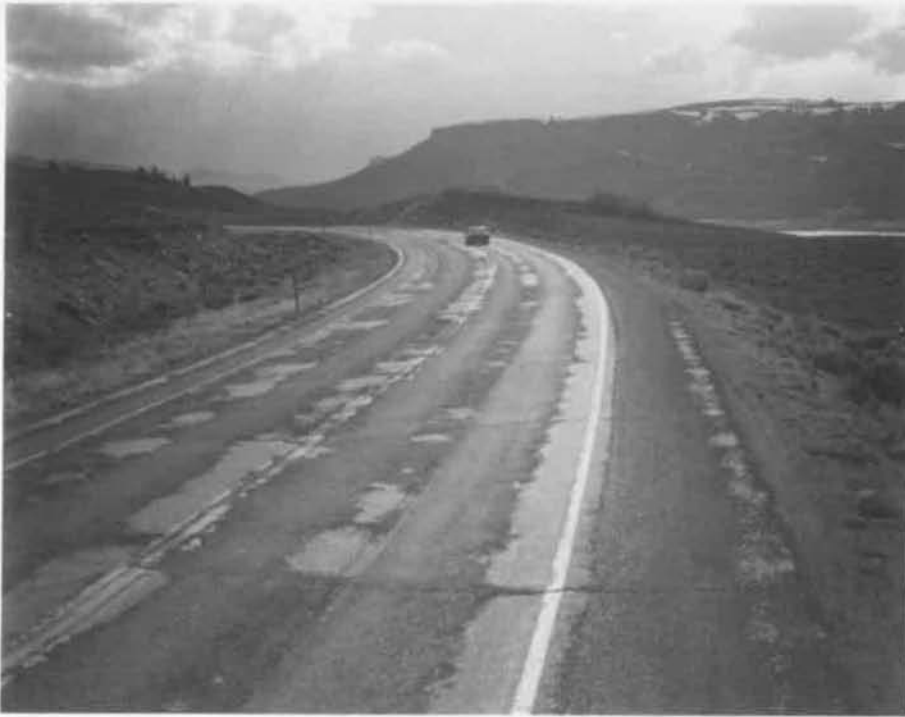
Photograph No. 17

Section 2  
May 1982

This section did not receive a leveling course and snowplows have removed the chip seal from all of the high spots in the pavement. This is some of the worst snowplow damage on the project.

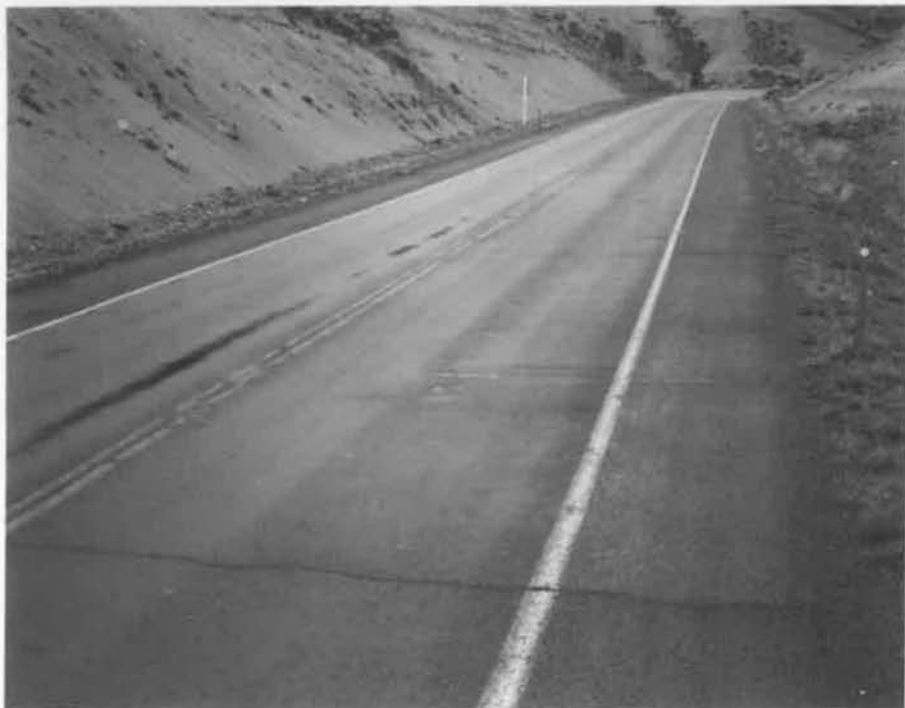
Photograph No. 18

Section No. 5  
May 1982

This section is the standard for the project and shows the typical conditions with snowplow damage at the center line, and outside shoulders and prevalent transverse cracking.
