Report No. CDH-DTP-R-82-11

DRIP SUBSURFACE  
IRRIGATION SYSTEM  
FOR ROW LANDSCAPING  
PROJECT IXFU 040-4 (7)

Final Report  
December, 1982

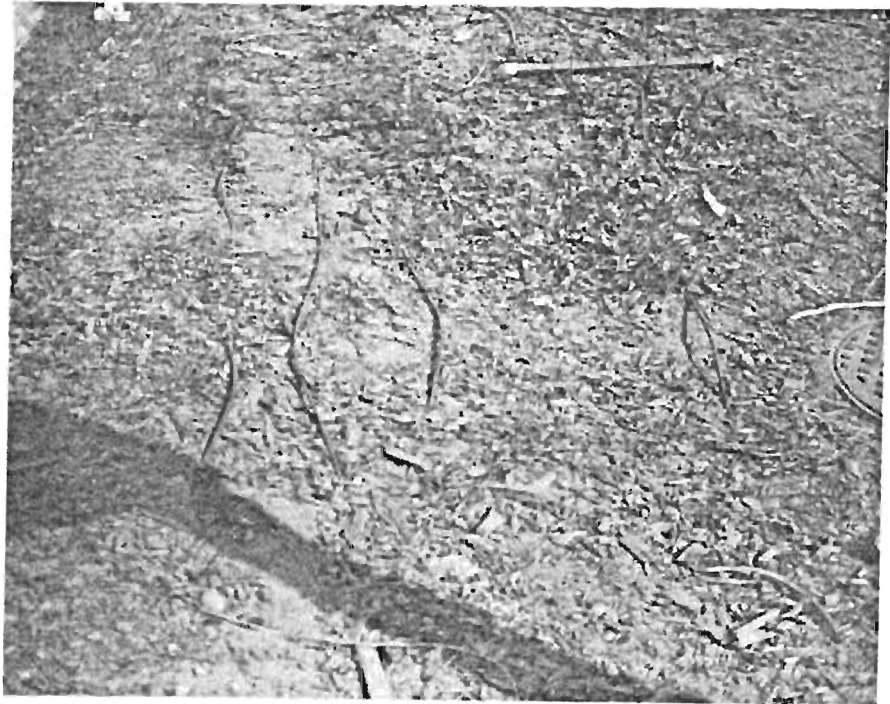
Photo 9

A major problem in the median barrier planter section was the loss of mulch. During the wintertime the mulch is removed by wind action and pedestrian disturbance. The seep tubes and piping is uncovered and exposed to the elements. Some root probes were pulled out and connections were broken. This requires increased maintenance attention prior to using the system the next spring. Photographs on pages 11 through 13 show the loss of cover and exposure of the tubing.

This section of barrier median is subject to pedestrian damage. The mulch has been displaced and much tubing is exposed.

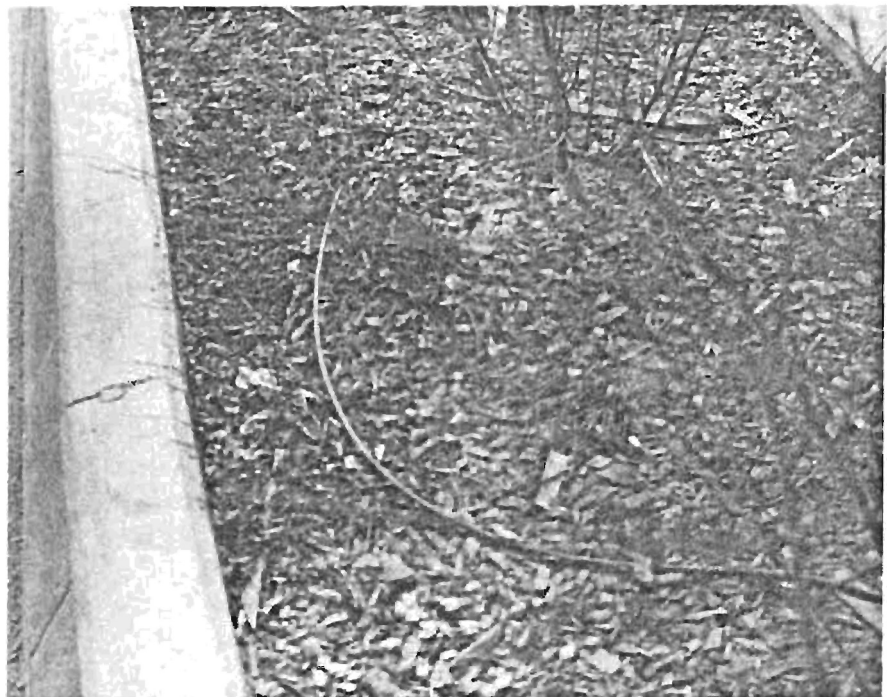
Photo 10

This root probe has been pulled from the ground and the mulch displaced.

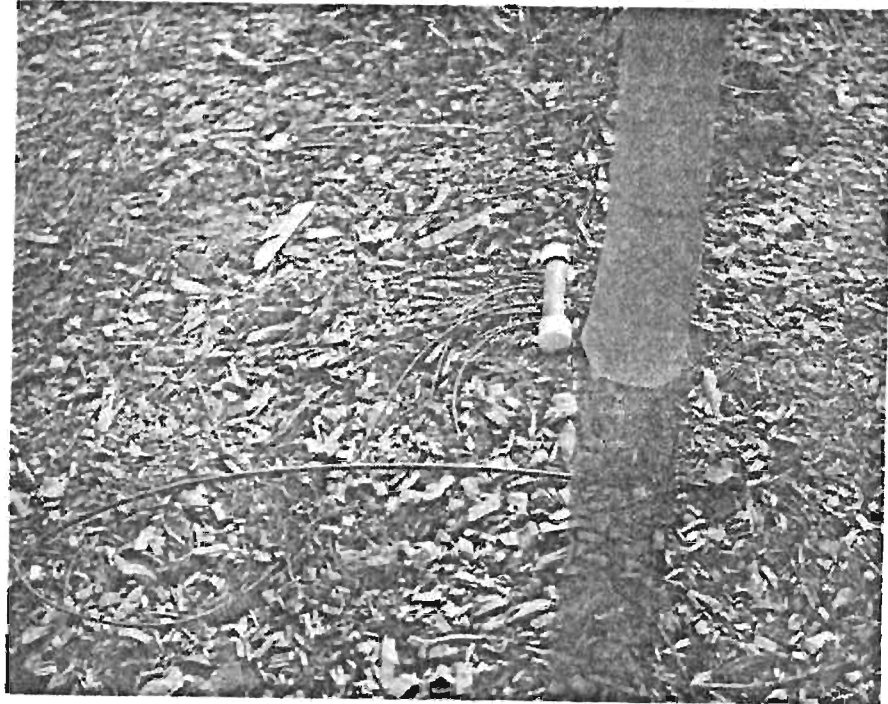
Photo 11

Supply manifold and root probes exposed.

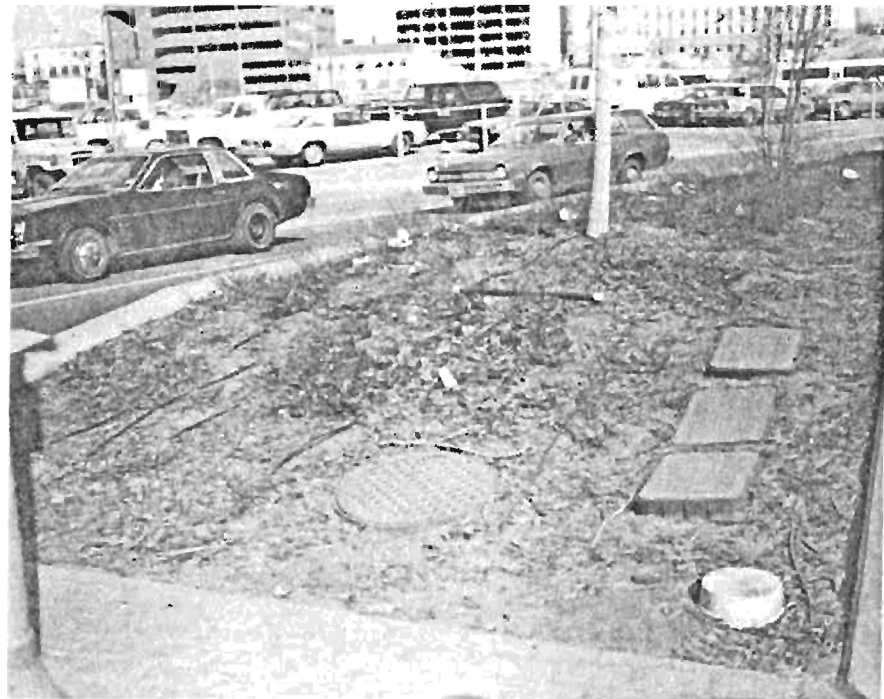
Photo 12

Tubing and manifold piping exposed. This area is adjacent to pedestrian walkway. The mulch has been stripped away.

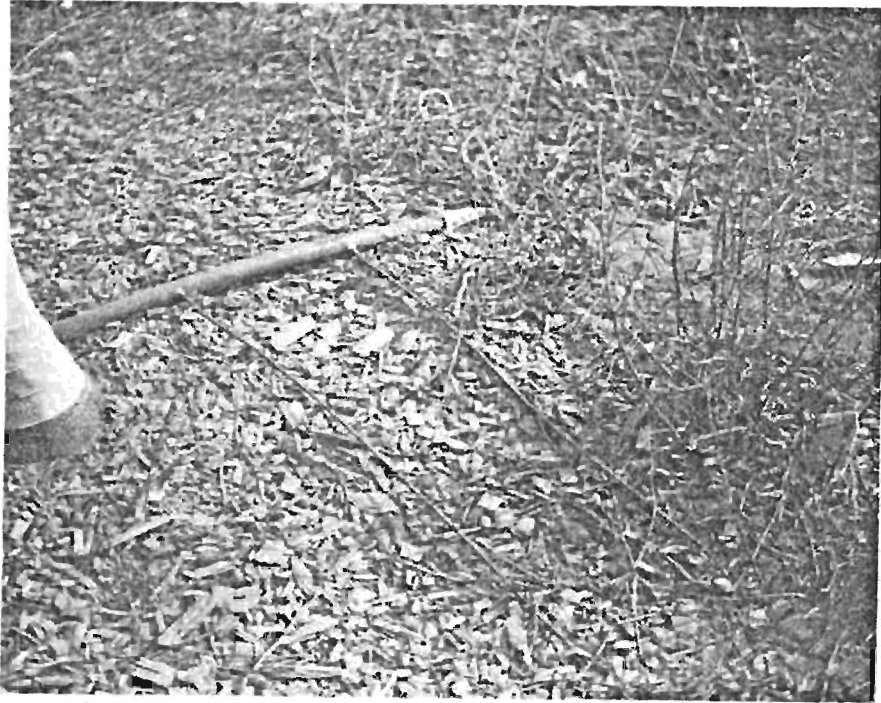
Photo 13

Manifold and seep tubes lie exposed on surface.

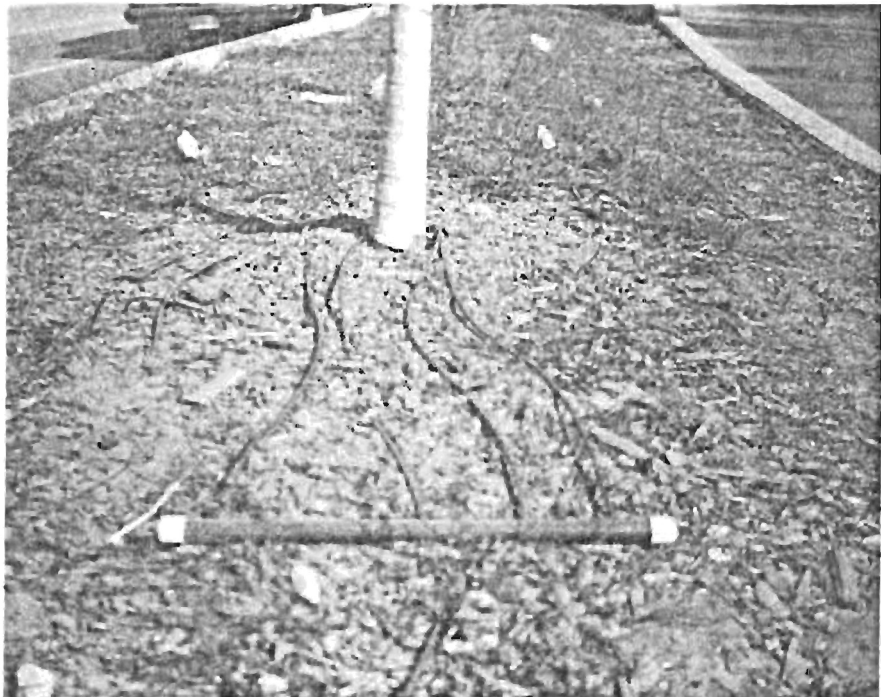
Photo 14

Root probes and supply manifold exposed. Mulch must be replaced and tubing covered.

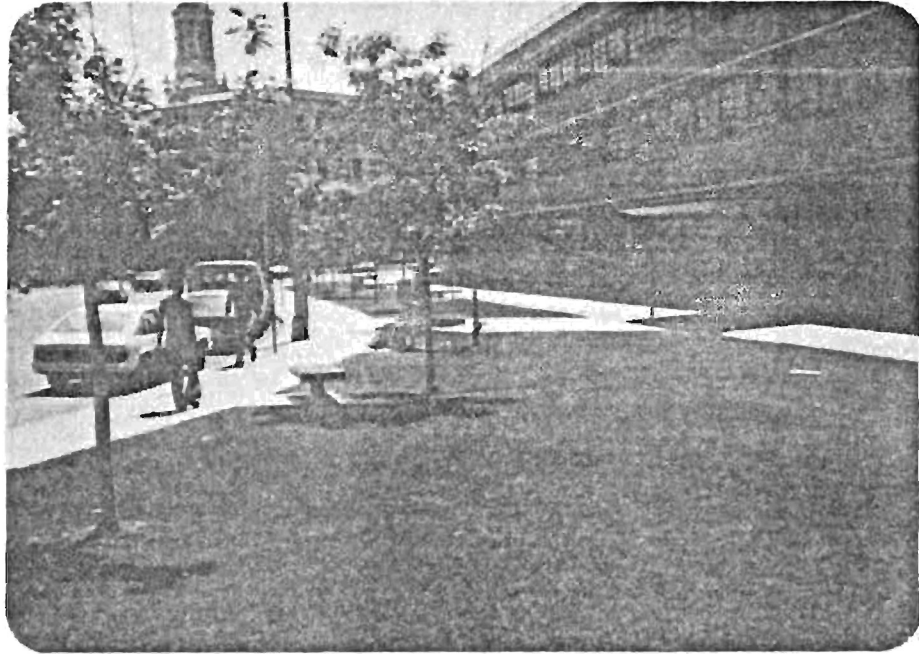
Photo 15

Grass sodded section after two growing seasons.

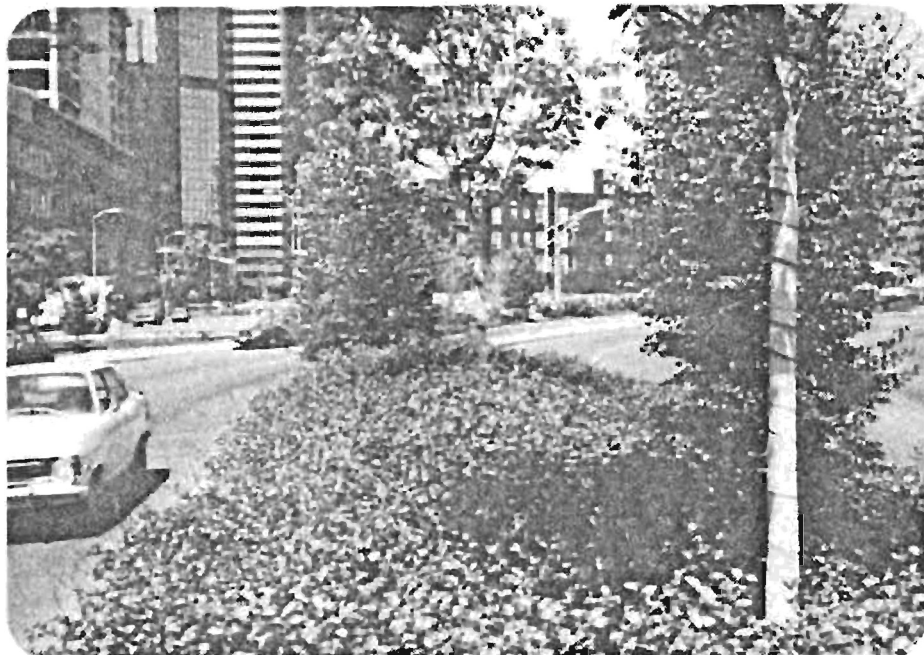
Photo 16

Median Barrier section after two growing seasons.
