Report No. CDH-DTP-R-82-9

PREFORMED PAVEMENT MARKING MATERIAL
FOR CONSTRUCTION ZONE
PROJECT I 76-1 (58)

Final Report
December, 1982

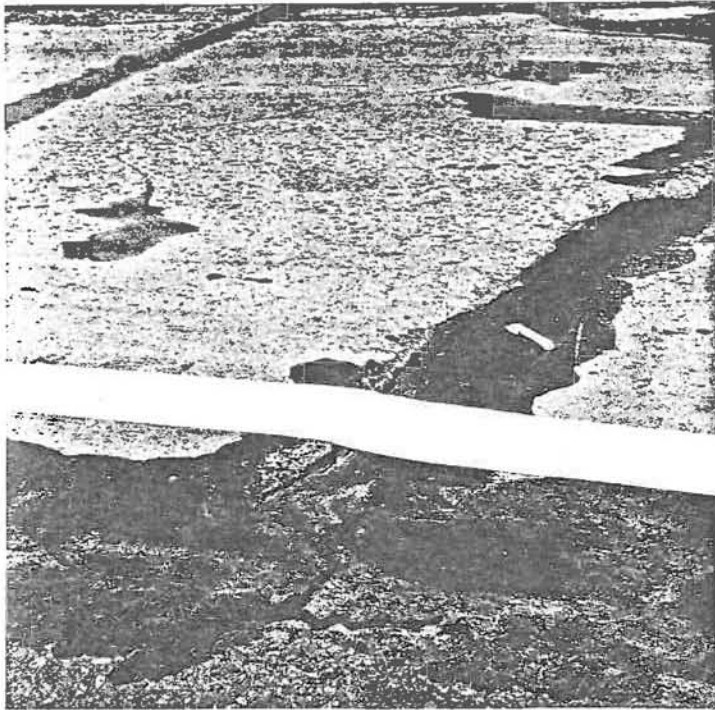
Marking applied over a high spot. This area will probably suffer damage from plowing operations.

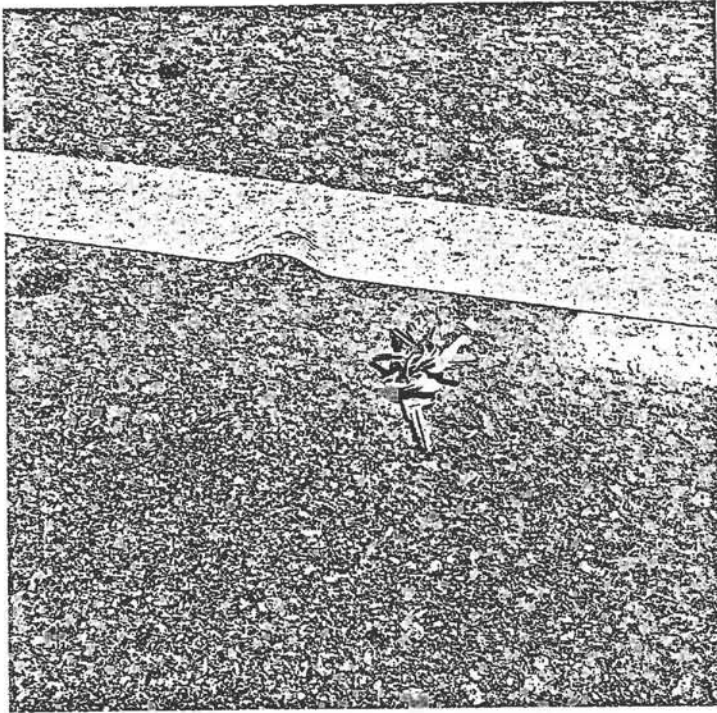
Yellow edge line which had recieved damage and discoloration shortly after being applied.

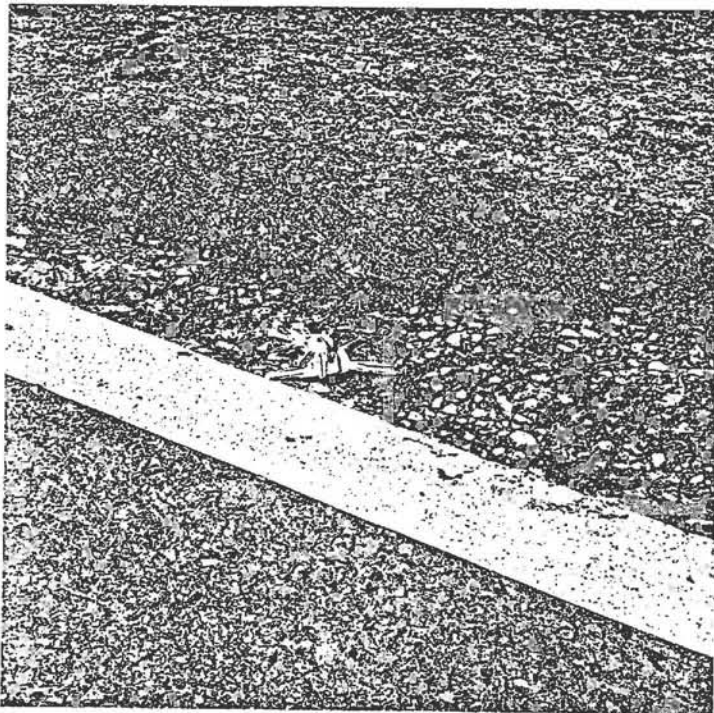
Yellow edge line which was applied over a rough section of pavement. Damage occurred shortly after application.

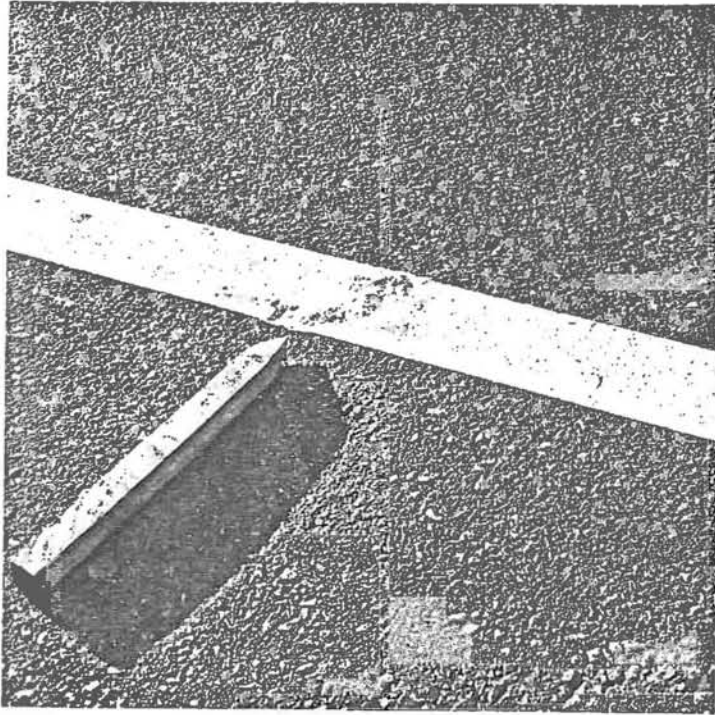
Area where plastic has bubbled probably due to water under the plastic which had frozen.

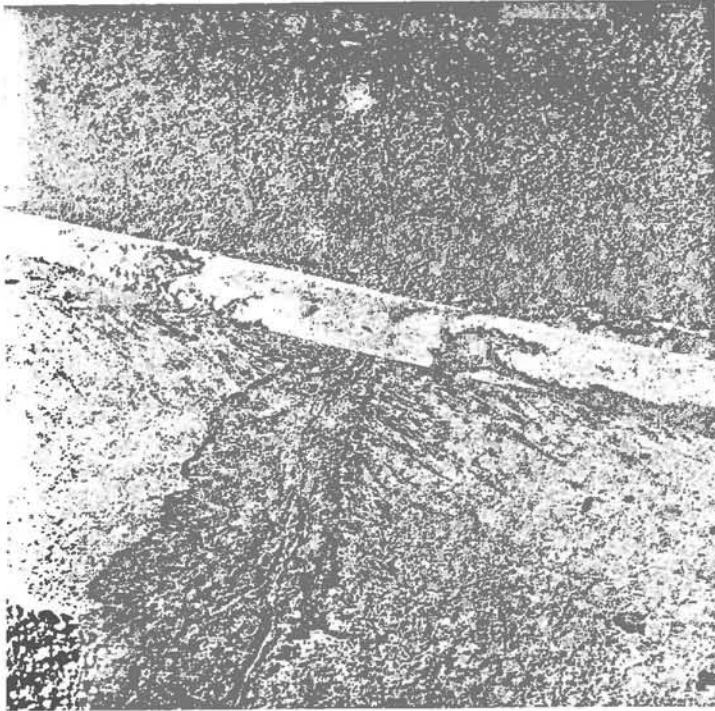
The striping material had excellent adherence qualities. There were small patches where the material was bladed off by snowplowing operations. These small matches were in areas of rough pavement and the high spots on the pavement were subject to wear by the snowplow blade. These areas were not significant and did not reduce the effectiveness of the striping. The striping was very resistant to abrasive wearing due to sand application for ice and snow removal.

Marking worn off at a high spot.

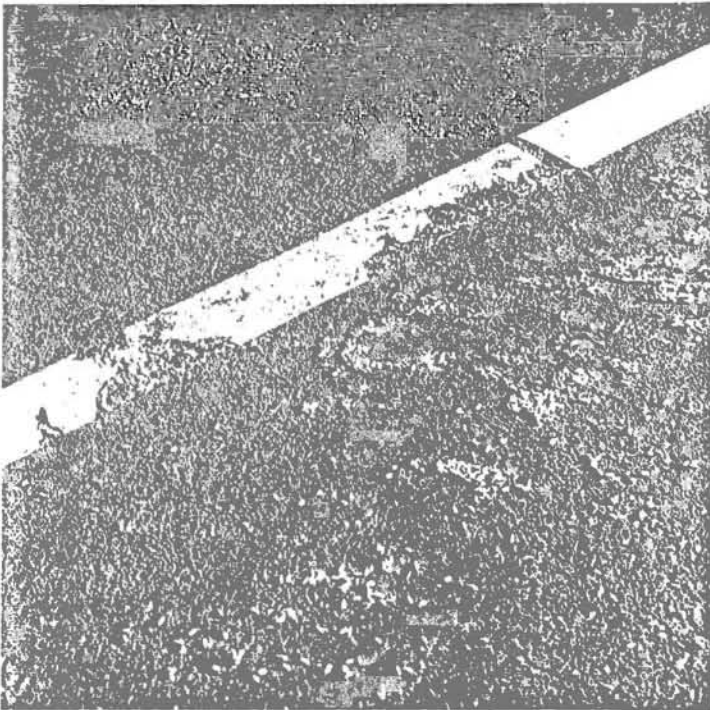
Marking bladed off of rough spot in pavement. Some pavement pulled off with marking material.

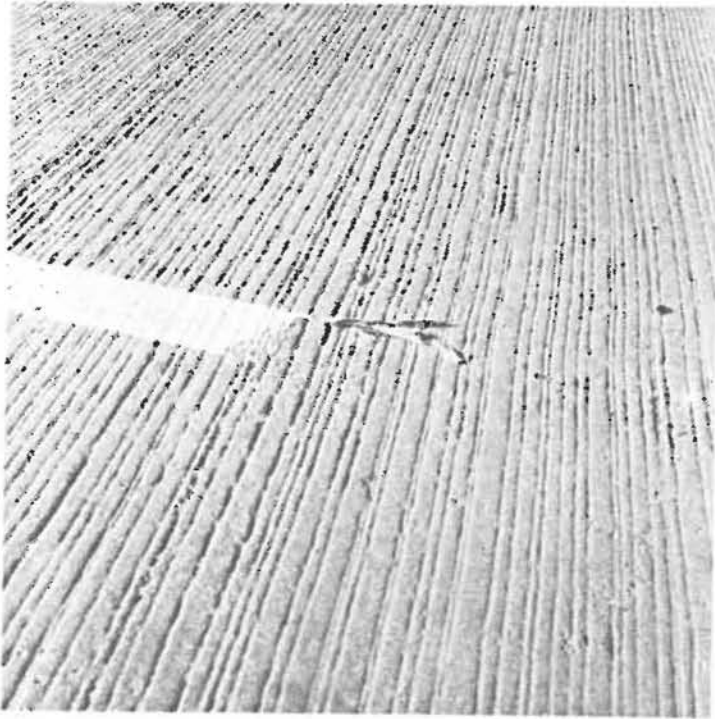
Area where the snowplow blade
has peeled back the striping.

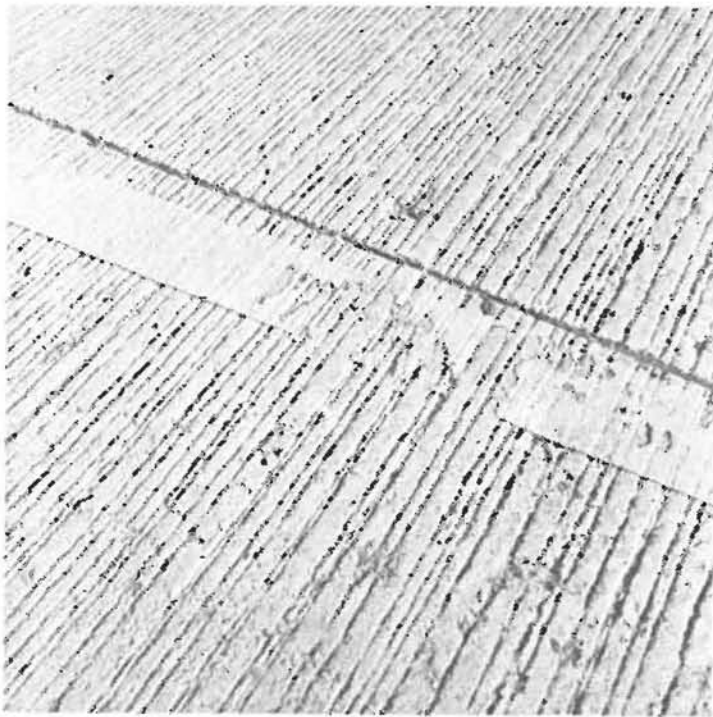
High spots in the concrete pave-
ment allow the snowplow blade
to wear off the striping material.

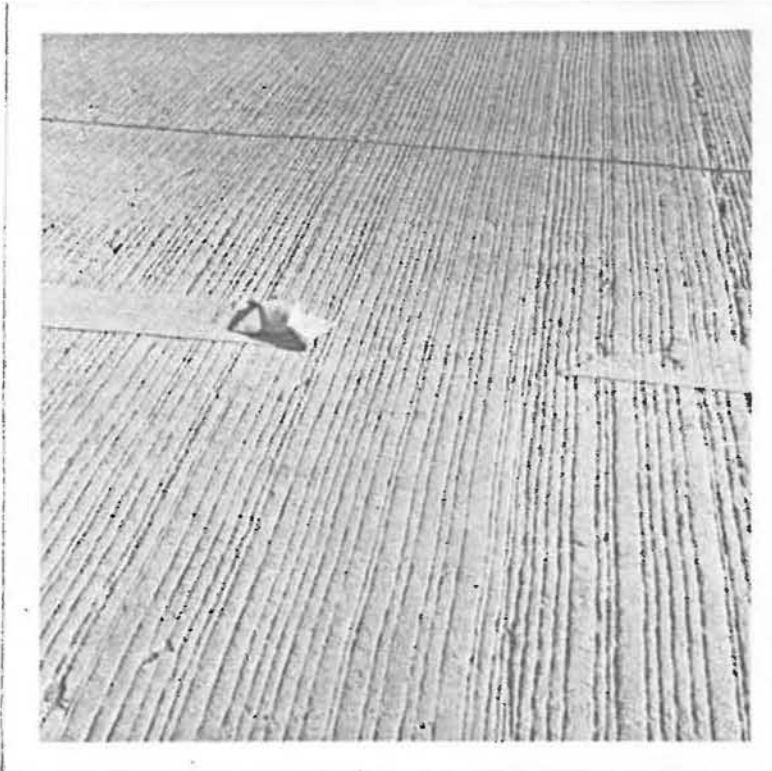
Centerline striping where the snowplow blade picked the edge of the striping and peeled it off.

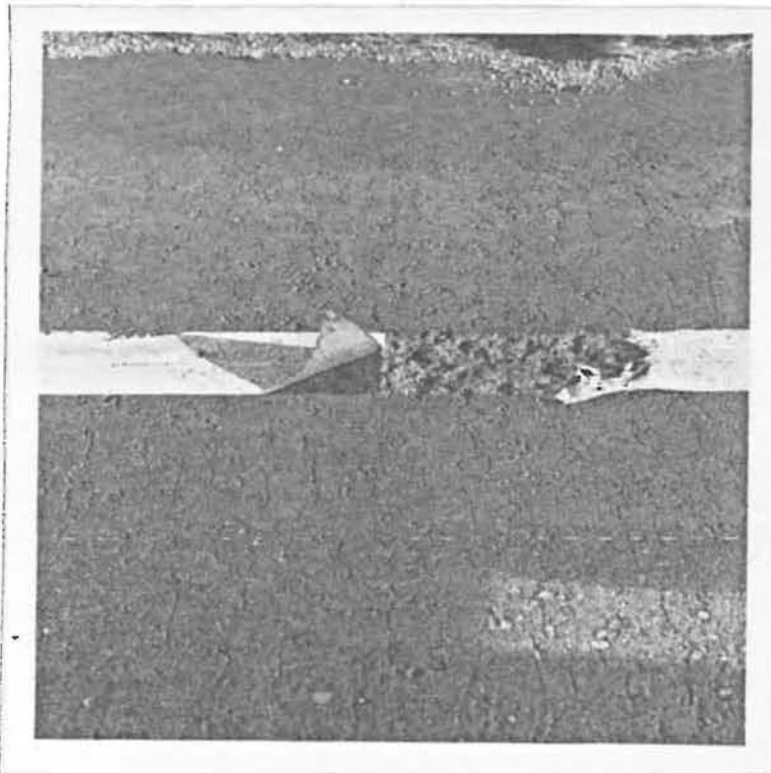
This shows a place where two strips of material were joined. The piece on the right was picked up by the snow plow blade and removed some pavement which adhered to the striping. The piece on the left was intentionally pulled up from the pavement to test its adherence.

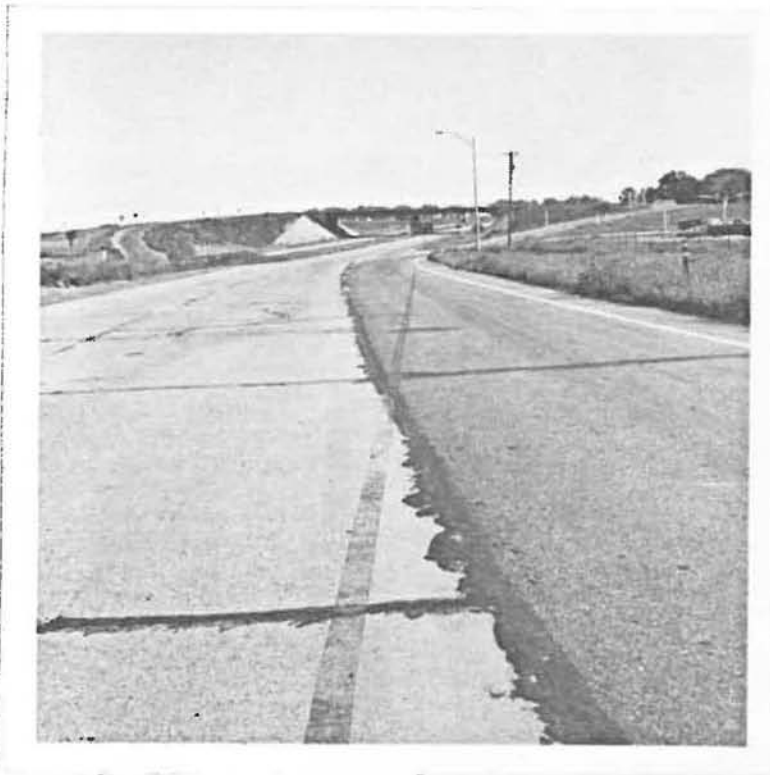
In some areas, removal of the tape left visible residue which resembled tire scuff marks. This visible residue was soon obliterated by normal traffic and did not interfere with normal lane striping.

Area where some residue
remains after removal
of marking material.

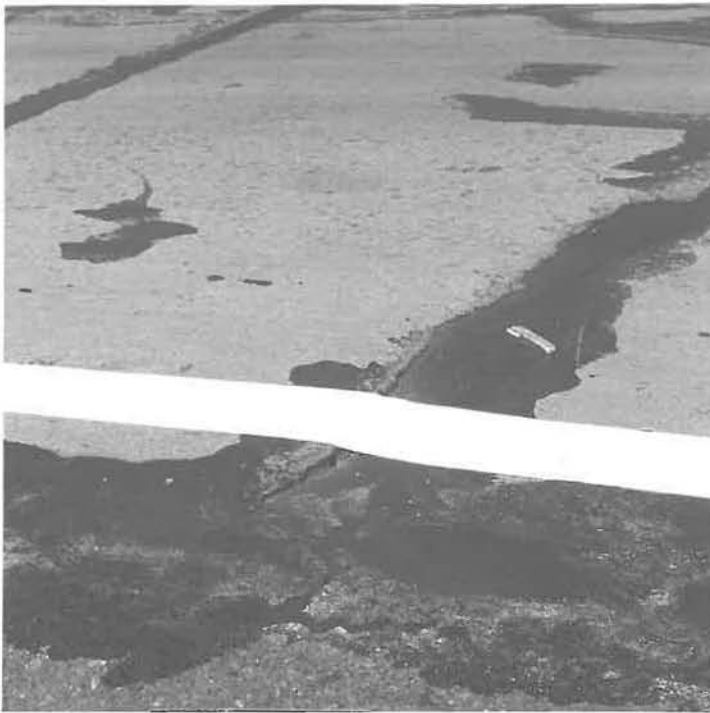
Marking applied over a high spot. This area will probably suffer damage from plowing operations.

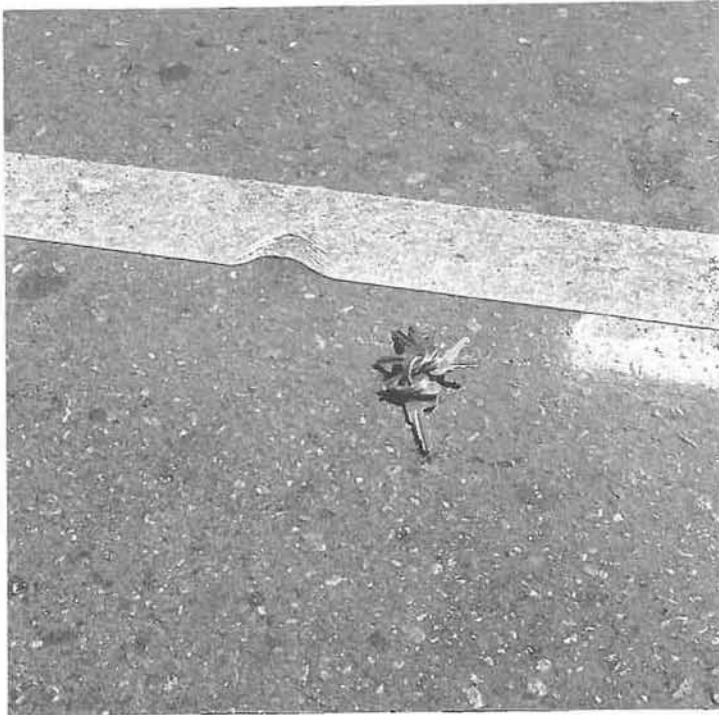
Yellow edge line which had received damage and discoloration shortly after being applied.

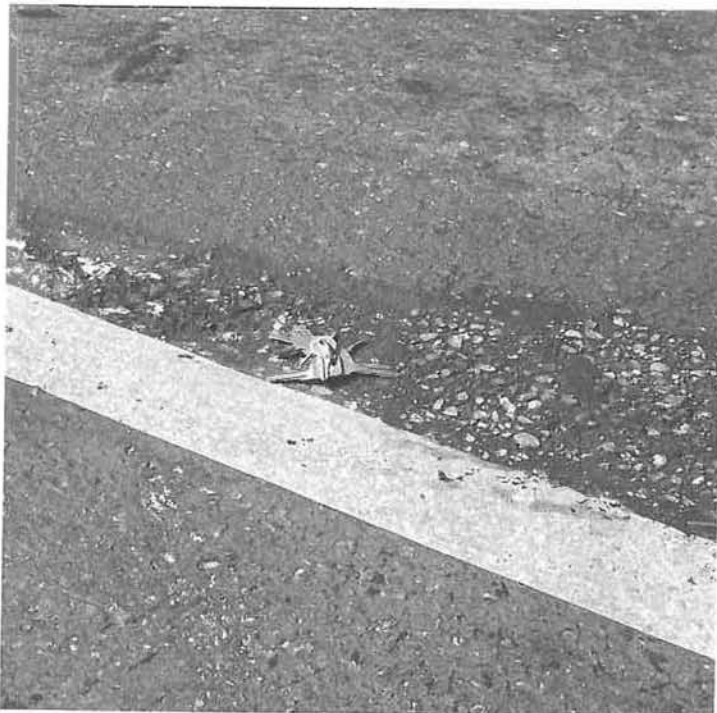
Yellow edge line which was applied over a rough section of pavement. Damage occurred shortly after application.

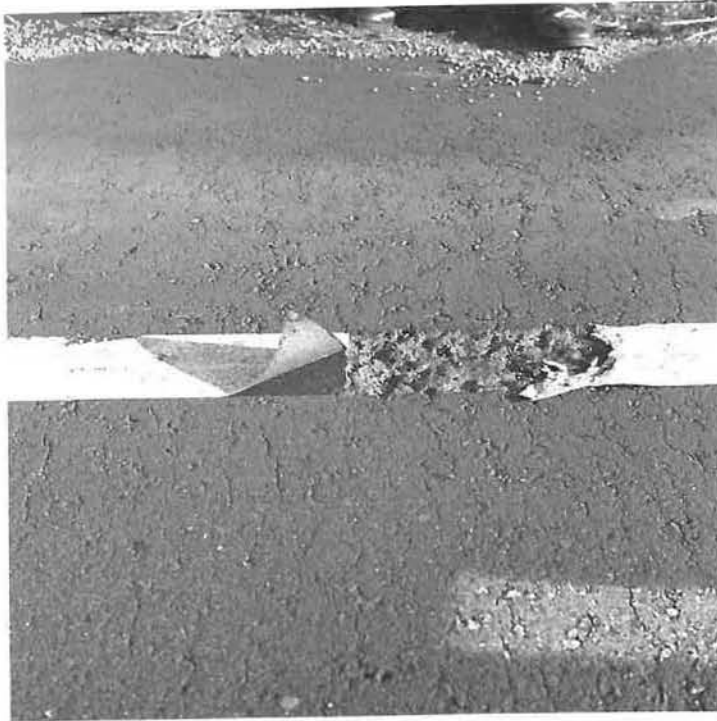
The piece of marking tape on the left was intentionally pulled up from pavement to test its adherence. The piece on the right was scraped off by plowing operations. Some pavement was also displaced where the tape adhered to the pavement.

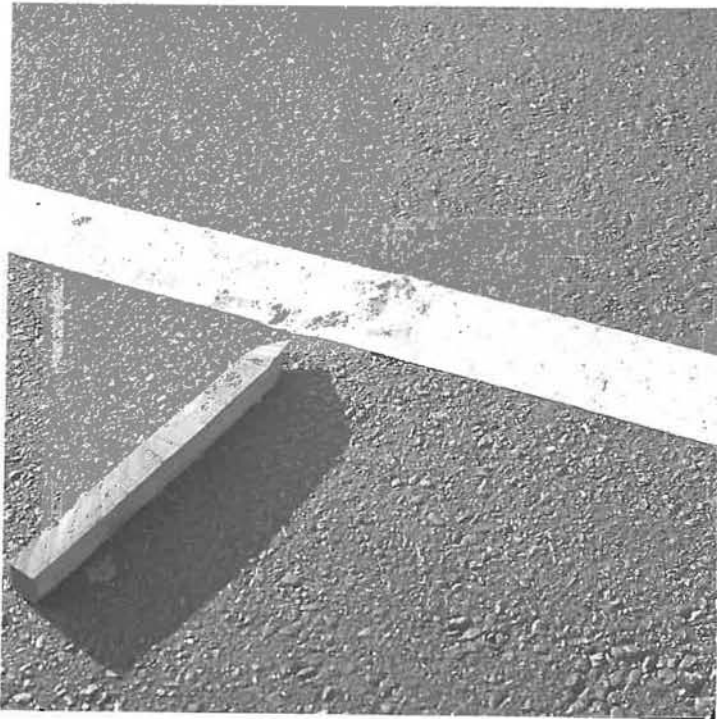
Area where plastic has bubbled probably due to water under the plastic which had frozen.

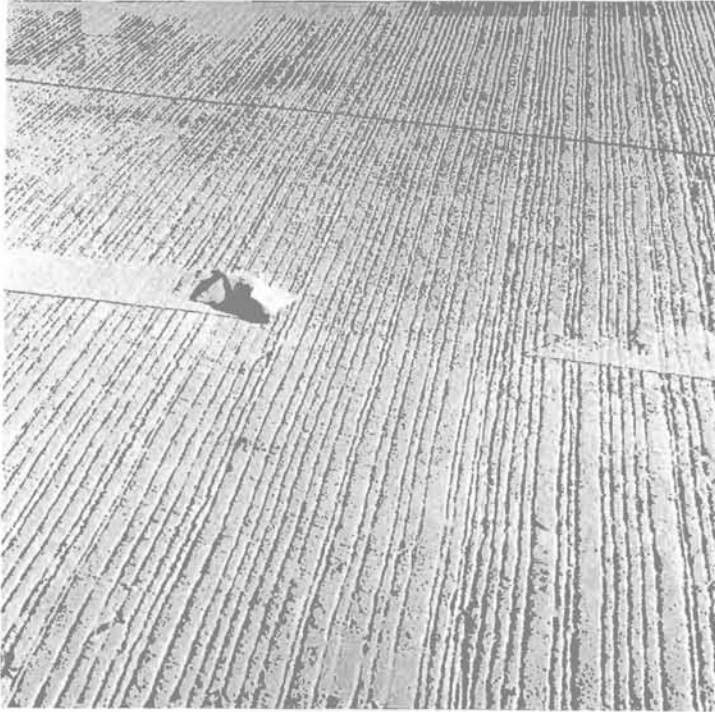
Area where snow plow blade has peeled back the plastic pavement marking.

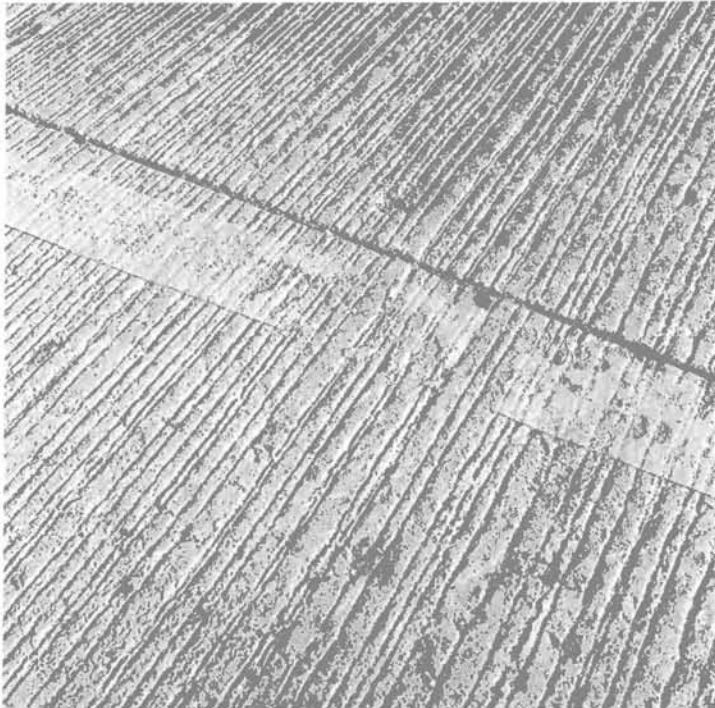
High spots in the concrete pavement allow the snow plow blade to wear off the pavement markings.

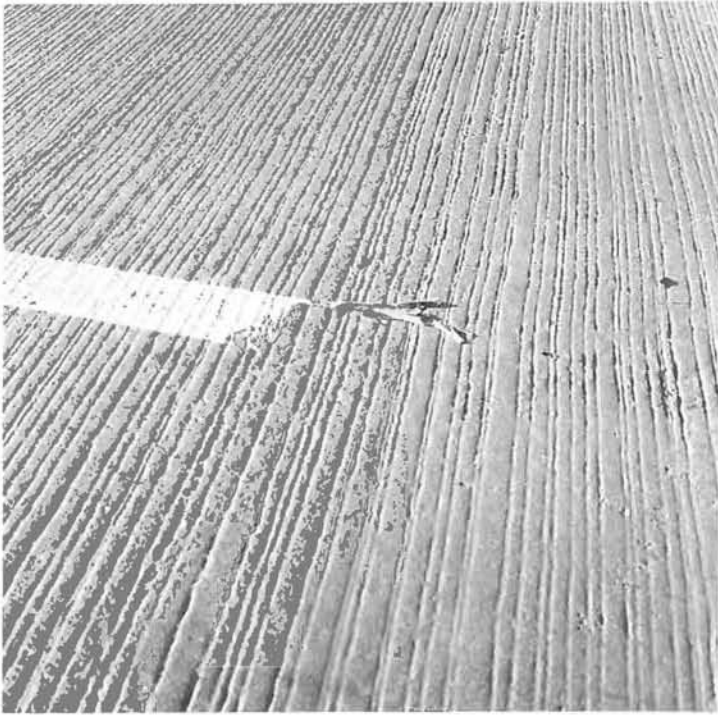
Area of scoured concrete pavement where the snow plow blade has scuffed off the plastic pavement marking strips.

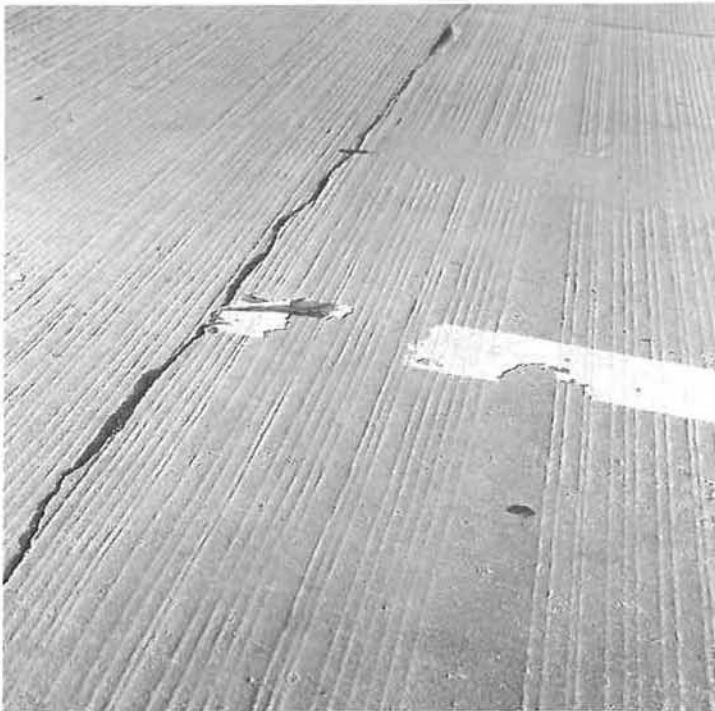
Same conditions as above.

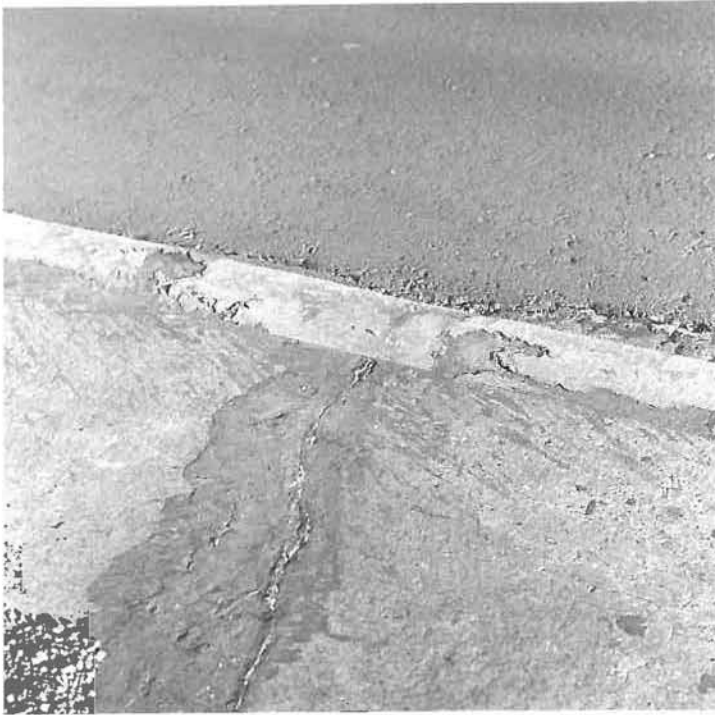
Marking worn off at a high spot.

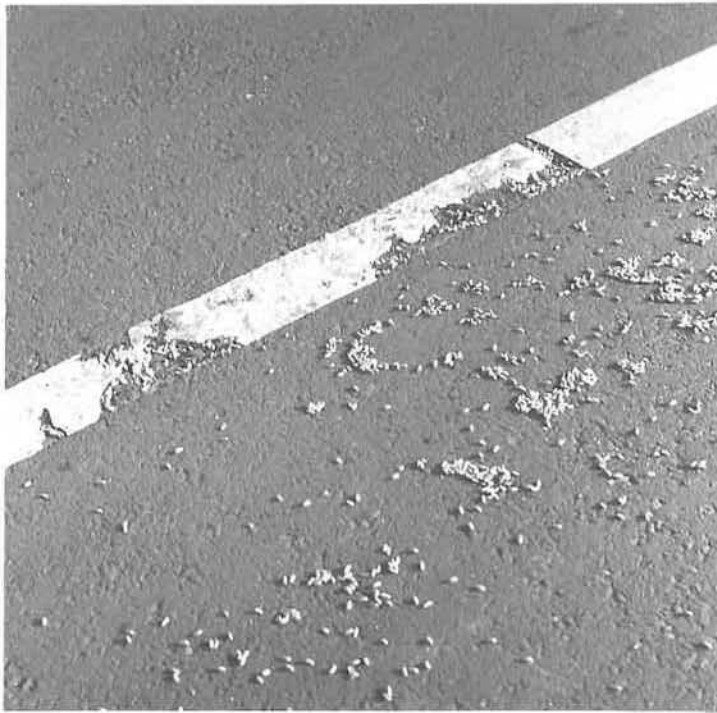
Marking bladed off of rough spot in pavement. Some pavement pulled off with marking material.

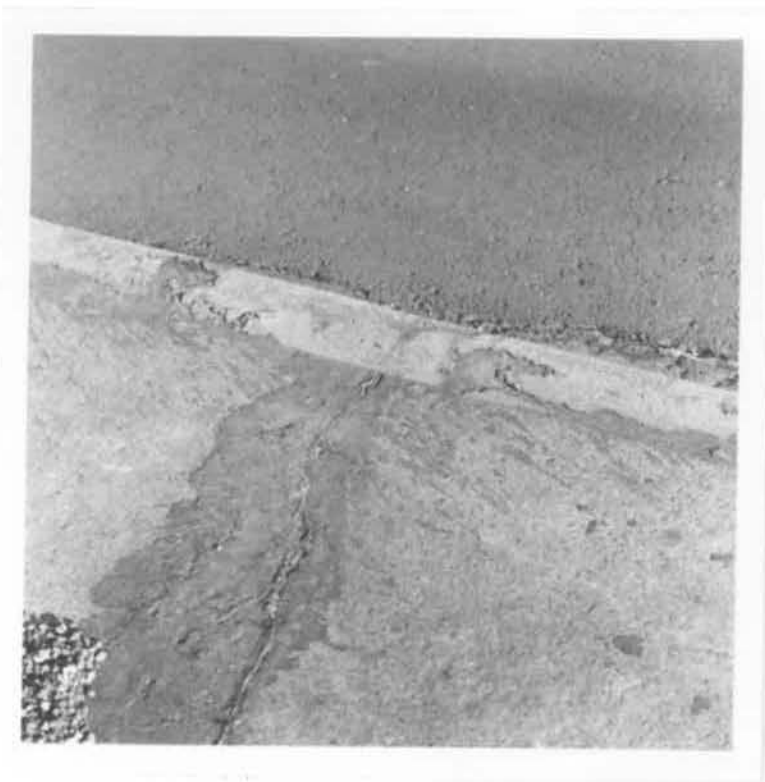
Striping worn off by snowplow blade at high spot on pavement.

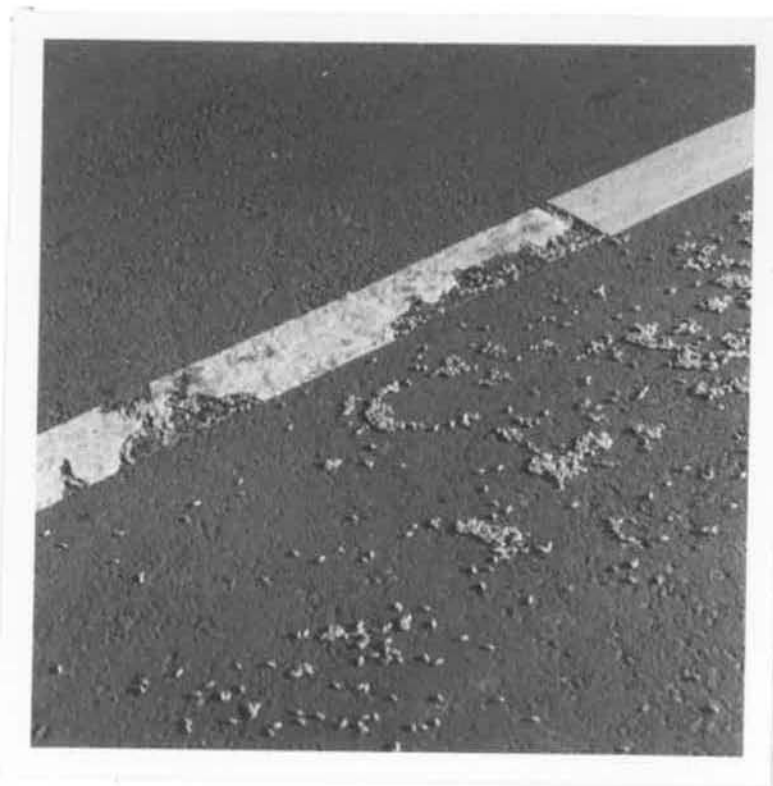
Striping bladed off at rough spot on pavement. Some asphalt pavement was pulled off with the striping material.

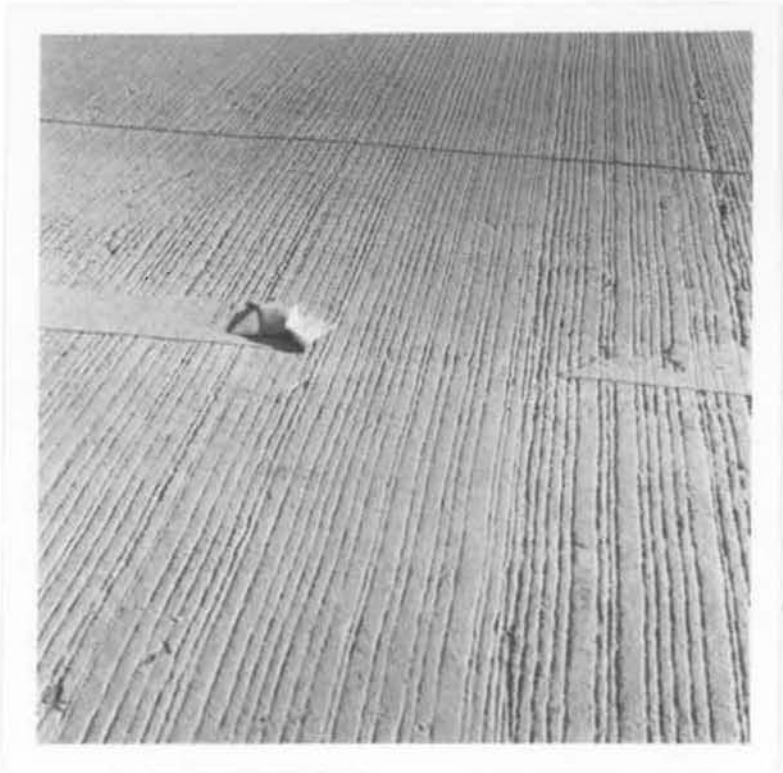
Centerline striping where the snowplow blade picked the edge of the striping and peeled it off.

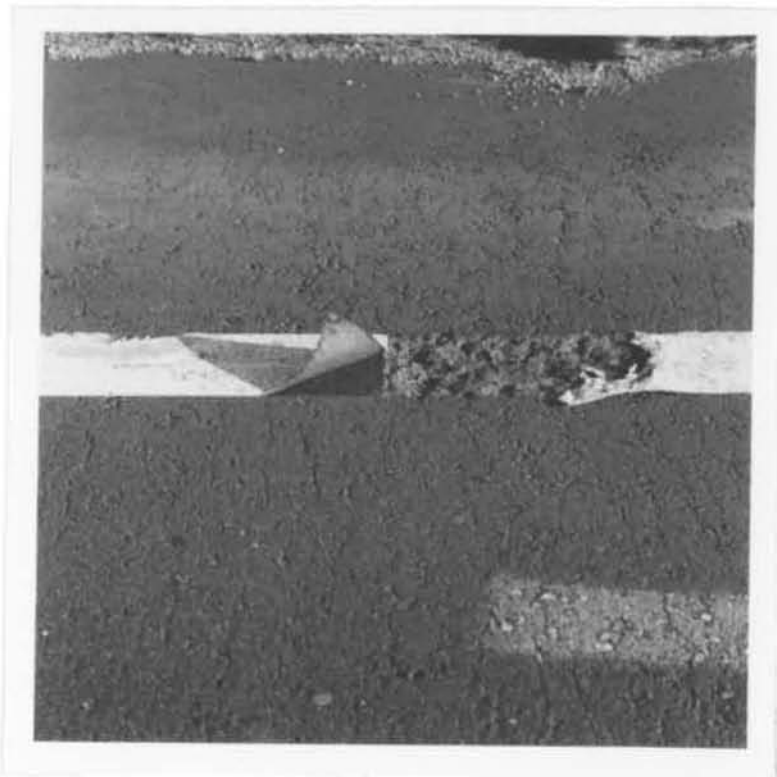
This shows a place where two strips of material were joined. The piece on the right was picked up by the snow plow blade and removed some pavement which adhered to the striping. The piece on the left was intentionally pulled up from the pavement to test its adherence.

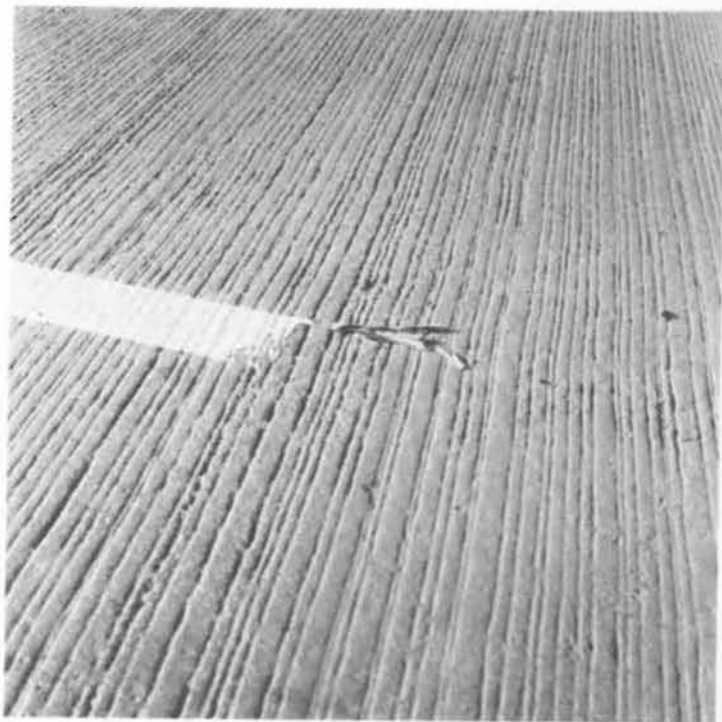
Area where the snowplow blade
has peeled back the striping.

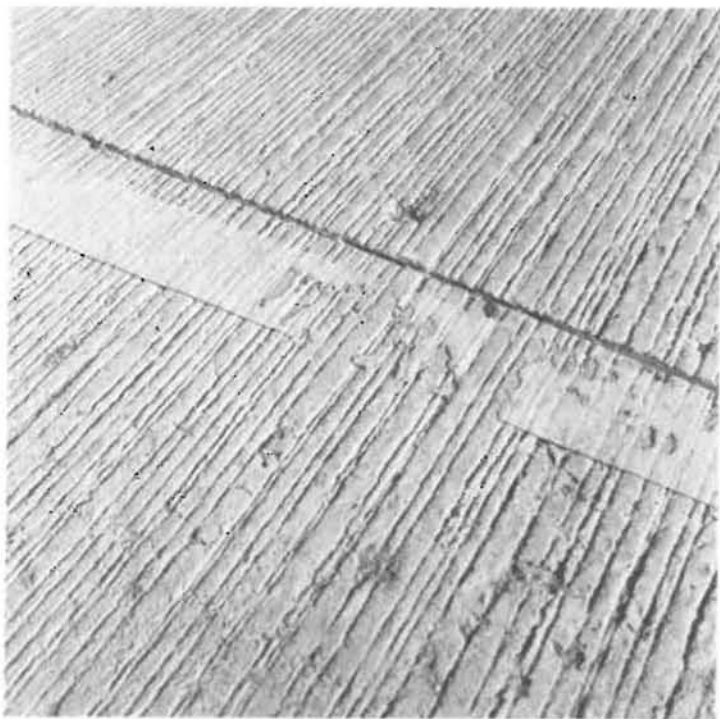
High spots in the concrete pave-
ment allow the snowplow blade
to wear off the striping material.
