Mt. Vernon Canyon Runaway Truck Escape Ramp

Report No. CDOH-DTP-R-83-03

Final Report December, 1982

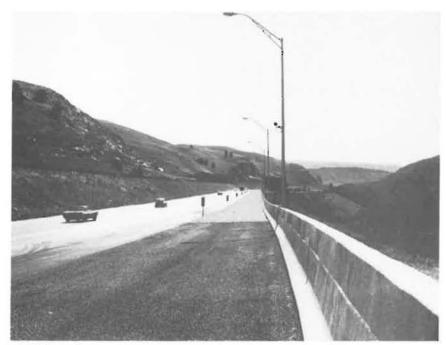
Looking down the escape ramp from the paved approach toward the gravel arrester bed. NOTE POLE MOUNTED VIDEO CAMERA.

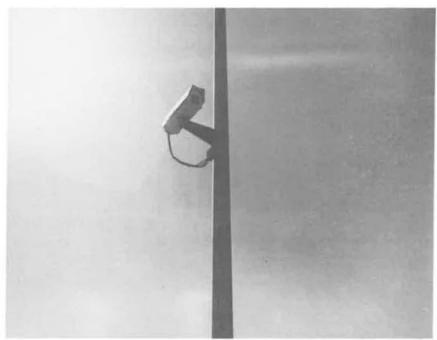
One of four video cameras that were used to record trucks using the escape ramp.

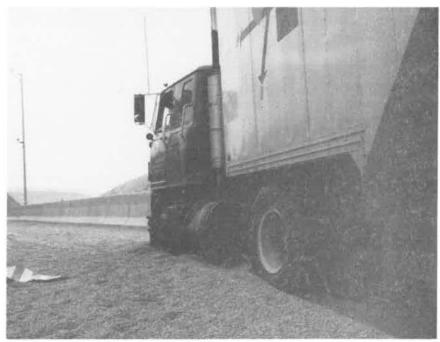
July 30, 1979 - This was the first use of the escape ramp, and it occurred only two weeks after the gravel had been placed in the arrester bed. Entry speed was 60 to 65 mph by the driver's estimate. The truck travelled 510 feet through gravel, jackknifed out onto the shoulder, went 320 feet on the shoulder, then reentered the gravel and safely stopped in 94 feet. An investigation conducted by the Colorado State Patrol revealed the tractor had good brakes, but the brakes on the trailer were worn out. Since the driver applied his brakes in the ramp, this may have caused the trailer to push the tractor out of the gravel.

The first use of the escape ramp was on July 30, 1979-two weeks after it was completed.

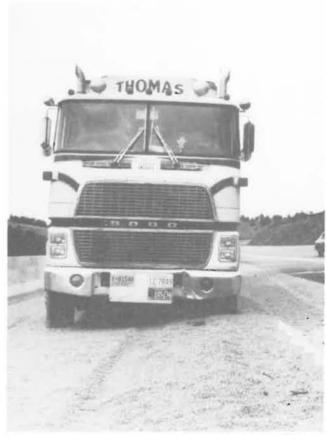
August 24, 1979 - The truck brakes would not hold, and as it picked up speed, the driver kept upshifting to avoid blowing the engine. The truck was on the shoulder to avoid colliding with other vehicles. It entered the ramp at a driver estimated speed of 70 to 80 mph and stopped in 738 feet.

The second use was on August 24, 1979.

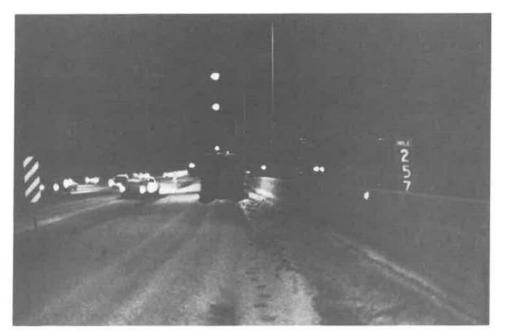
January 13, 1980 - The truck entered the escape ramp at a driver estimated speed of 50 mph and stopped in 475 feet. The entry was at 4:30 pm on a Sunday in the midst of heavy traffic returning from the ski areas. It is unlikely that the truck could have gone much further without having a collision with another vehicle.

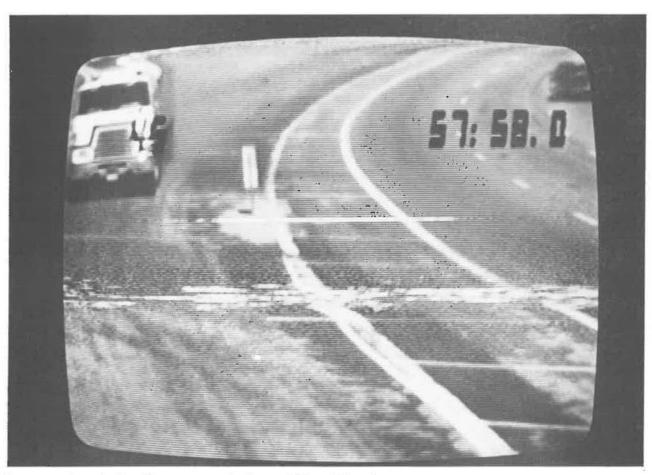
Runaway truck in the approach travelling 54 mph.

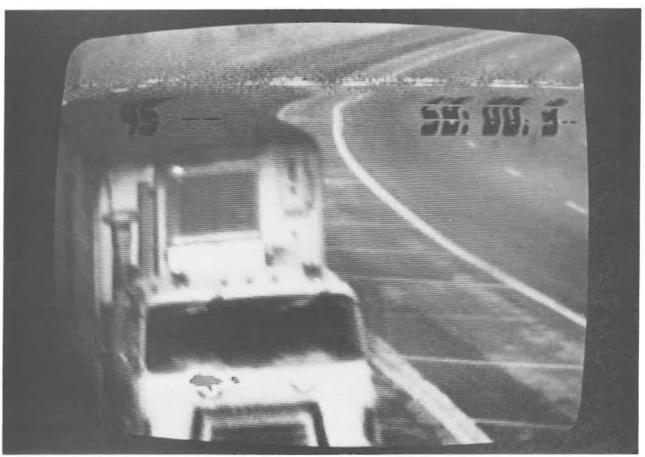
Truck in the approach just before entering the gravel arrester bed.

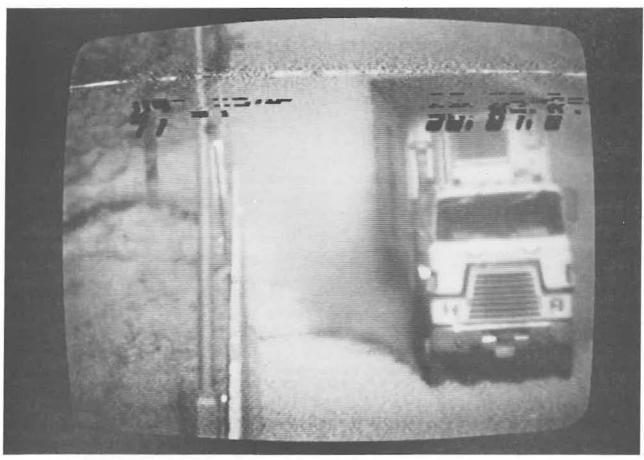
Truck after entering the gravel arrester bed.

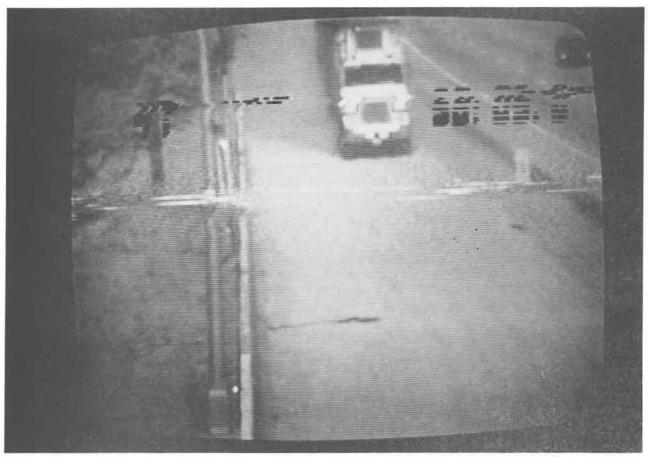
Note the gravel spray being thrown from the wheels and the cloud of dust.

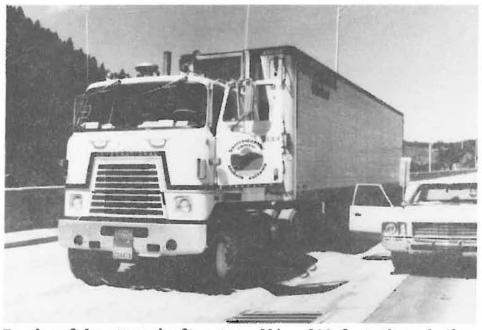
June 12, 1980 - The driver overheated his brakes and entered the gravel at 55 mph (speed from video tape analysis). The truck bounced severly at the ramp entrance when it hit ruts left by unauthorized vehicles, fishtailed for a few hundred feet, and stopped after travelling 800 feet into the arrester bed.

Truck safely stopped after travelling $800\ \text{feet}$ through the gravel.

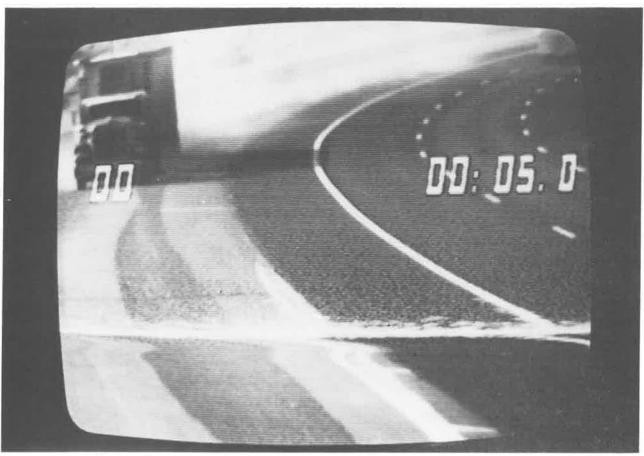
Runaway truck in the approach travelling 65 mph.

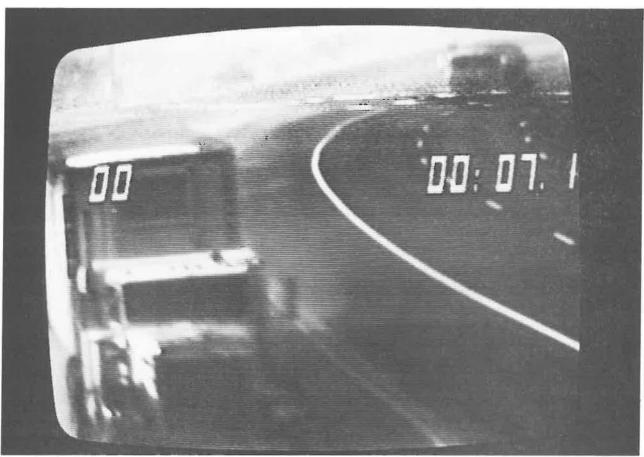
Truck just before entering the gravel.

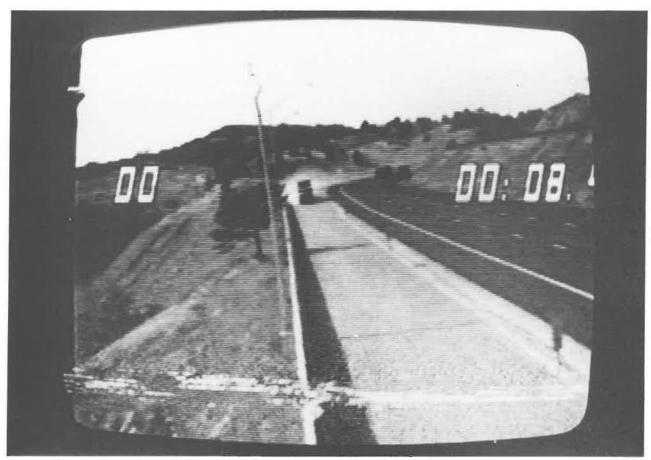
Just after entering the gravel.

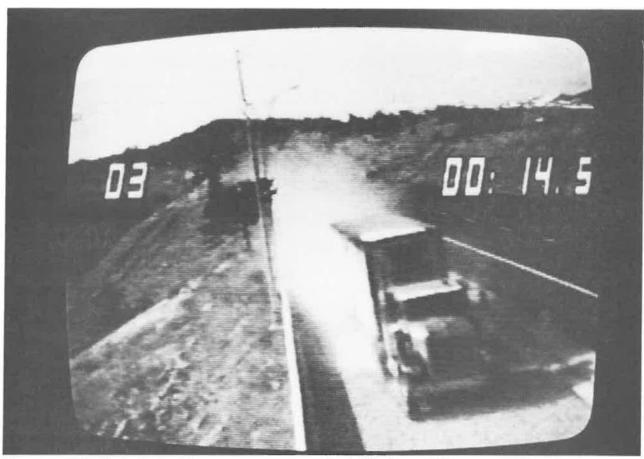
Runaway 500 feet into the escape ramp and still travelling over 50 mph. D-10

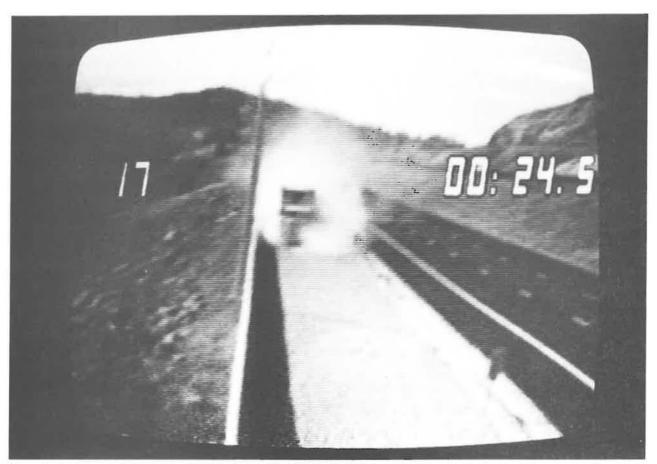
- October 17, 1980 The truck entered the ramp at 65 mph (from video tape analysis) and stopped in 1000 feet. The video tape showed the truck maintaining an almost perfectly straight path through the arrester bed.

Truck just as it came to a stop after travelling 1000 feet into the gravel.

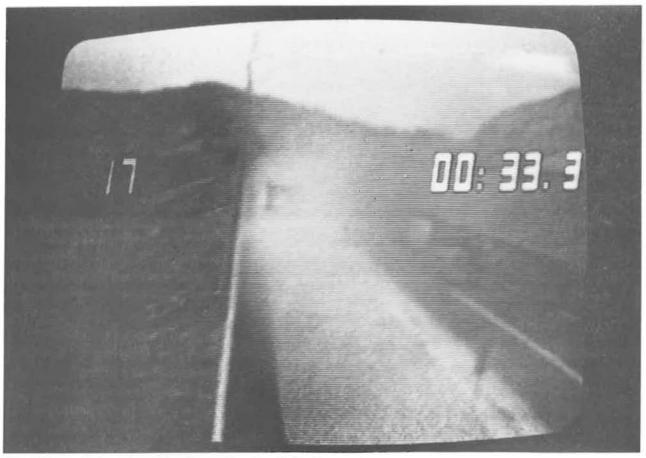
Truck overtaken by its own cloud of dust.

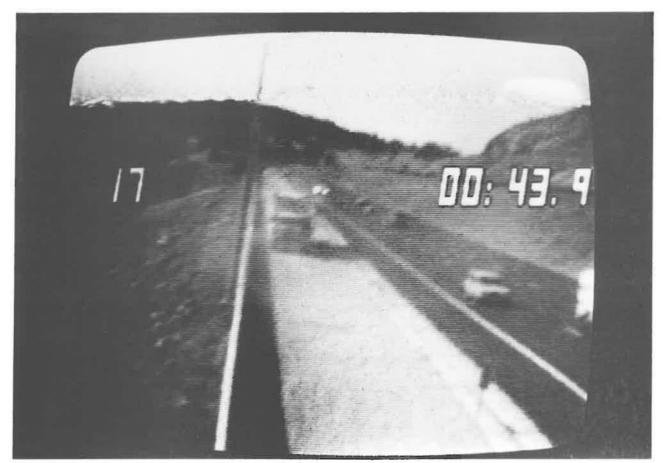
Truck stopped after dust has cleared.

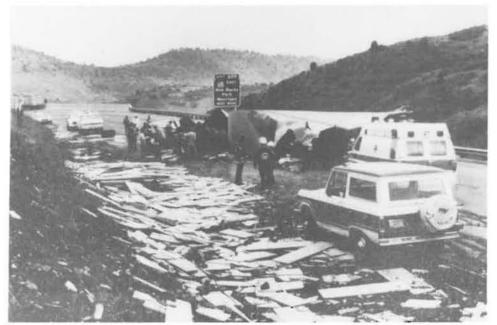
Runaway truck that didn't use the escape ramp. The truck was completely destroyed and both drivers were killed.

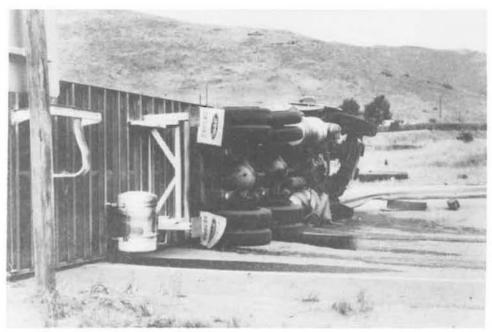
Another runaway that didn't use the escape ramp. The driver was seriously injured.
