Bridge Deck Repair Investigation and Quantity Estimation

COLORADO
Department of Transportation

1. Report No. CDOT-2020-19		2. Government Accession No.		3. Recipient's Catalog No.	
4. Title and Subtitle Bridge Deck Repair Investigation and Quantity Estimation				5. Report Date Dec. 2020

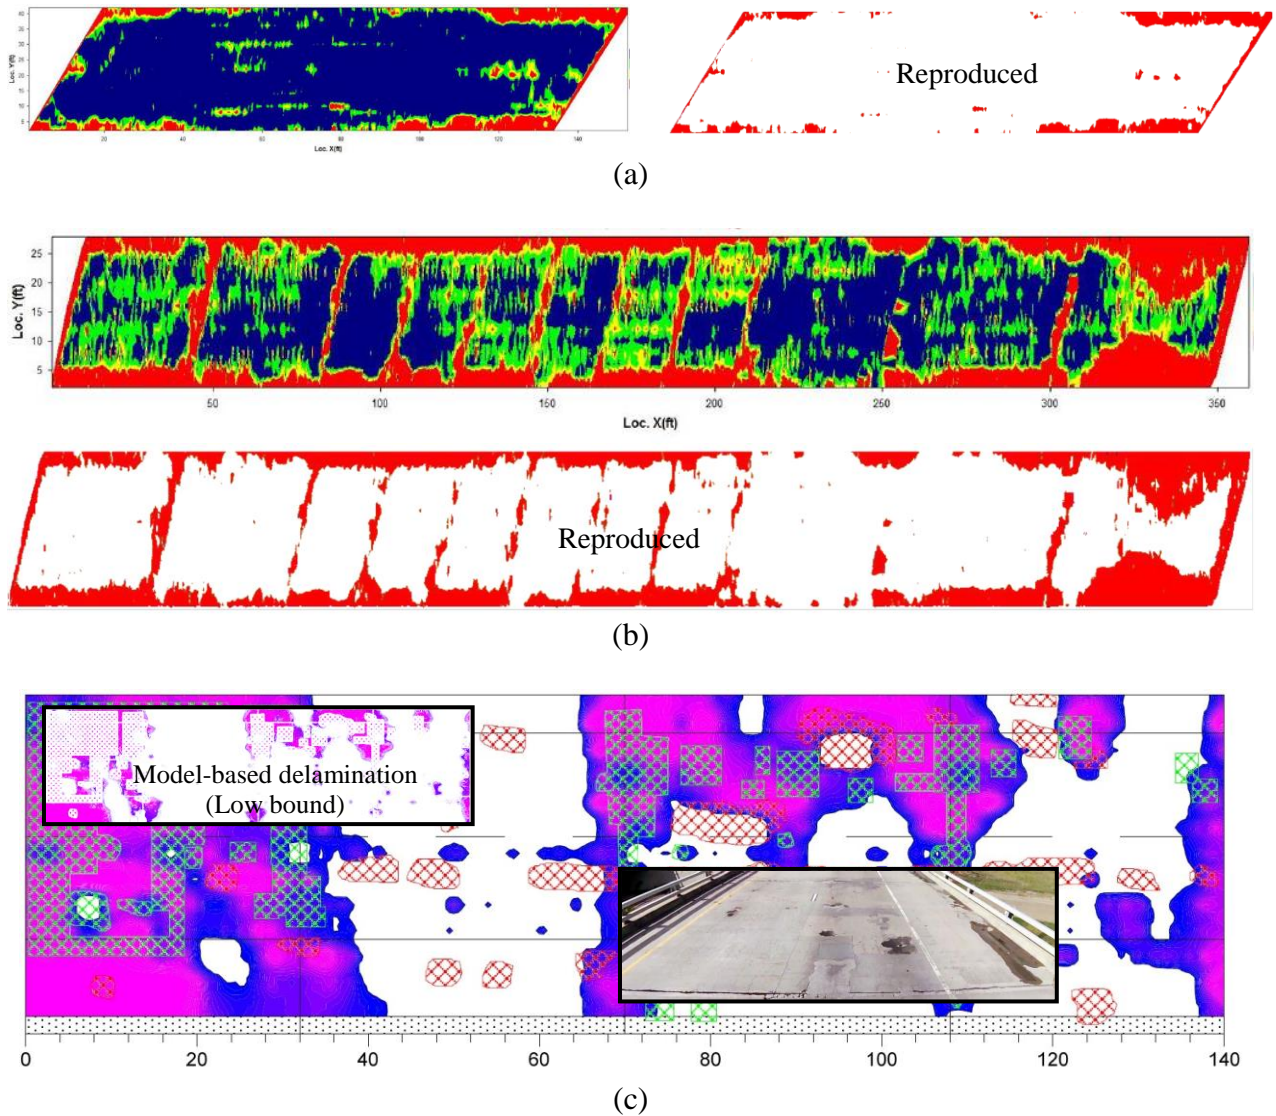
The reproducibility of the proposed method is shown in Figs. 14(a) and (b). These bridges (N-10-V and I-12-T) are located in Colorado, and GPR-scanning was conducted to graphically examine the condition of the decks. The agent-based model effectively replicated the most deteriorated regions, indicated in red. The delamination ratio of $\lambda = 40\%$ was, then, applied to the GPR map of another bridge (F-20-BQ) on the interstate highway I-70 (Fig. 14(c)). The bridge was constructed in 1966 with a roadway width of 39.5 ft (12 m) and a length of 140 ft (43 m), including the total deck area of 5,530 ft² (514 m²). An NBI deck rating of 4 was assigned at the time of GPR-testing in 2014 and the patch-repaired area was 1,067 ft² (99 m²). The area of deterioration (delamination) was quantified to be 2,898 ft² (269 m²) and 498 ft² (46 m²) by GPR and infrared spectroscopy, respectively. In compliance with the proposed modeling approach, a delaminated area of 1,022 ft² (95 m²) was acquired at $\lambda = 40\%$ (Fig. 14(c), inset), which revealed an improved result against the repaired area.

Fig. 14. Independent appraisal of proposed approach: (a) reproducibility of GPR maps (Bridge N-10-V); (b) reproducibility of GPR maps (Bridge I-12-T); (c) Bridge F-20-BQ for (green grids = patched area; red grids = damage detected by infrared spectroscopy)

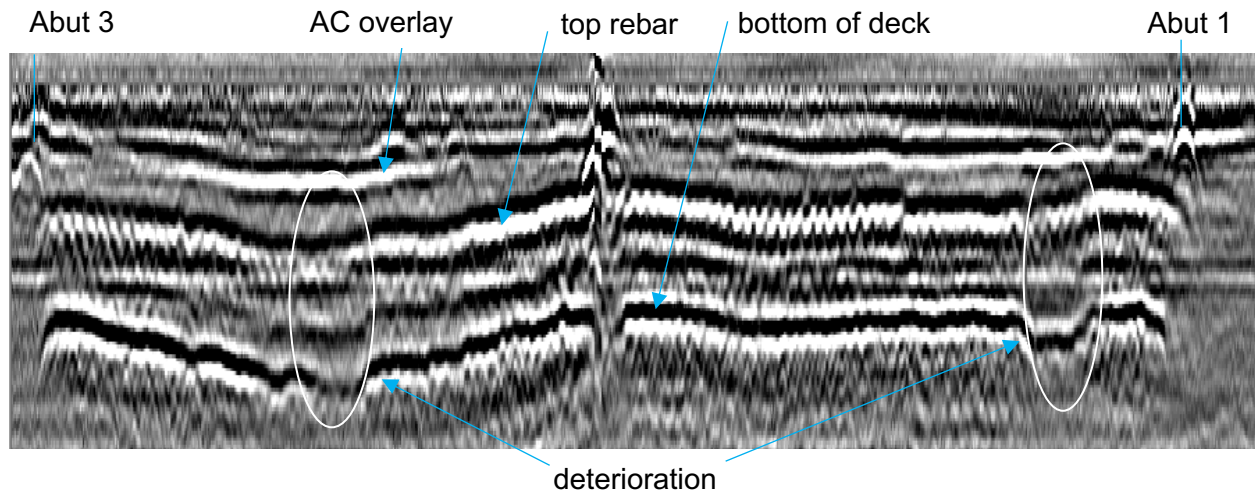
Figure 3 - Sample GPR Data Presenting Evidence of Deterioration on Structure B-06-A
