Report No. CDOH-P&R-R&SS-73-7

Seibert Experimental Project

December 1973
FINAL REPORT

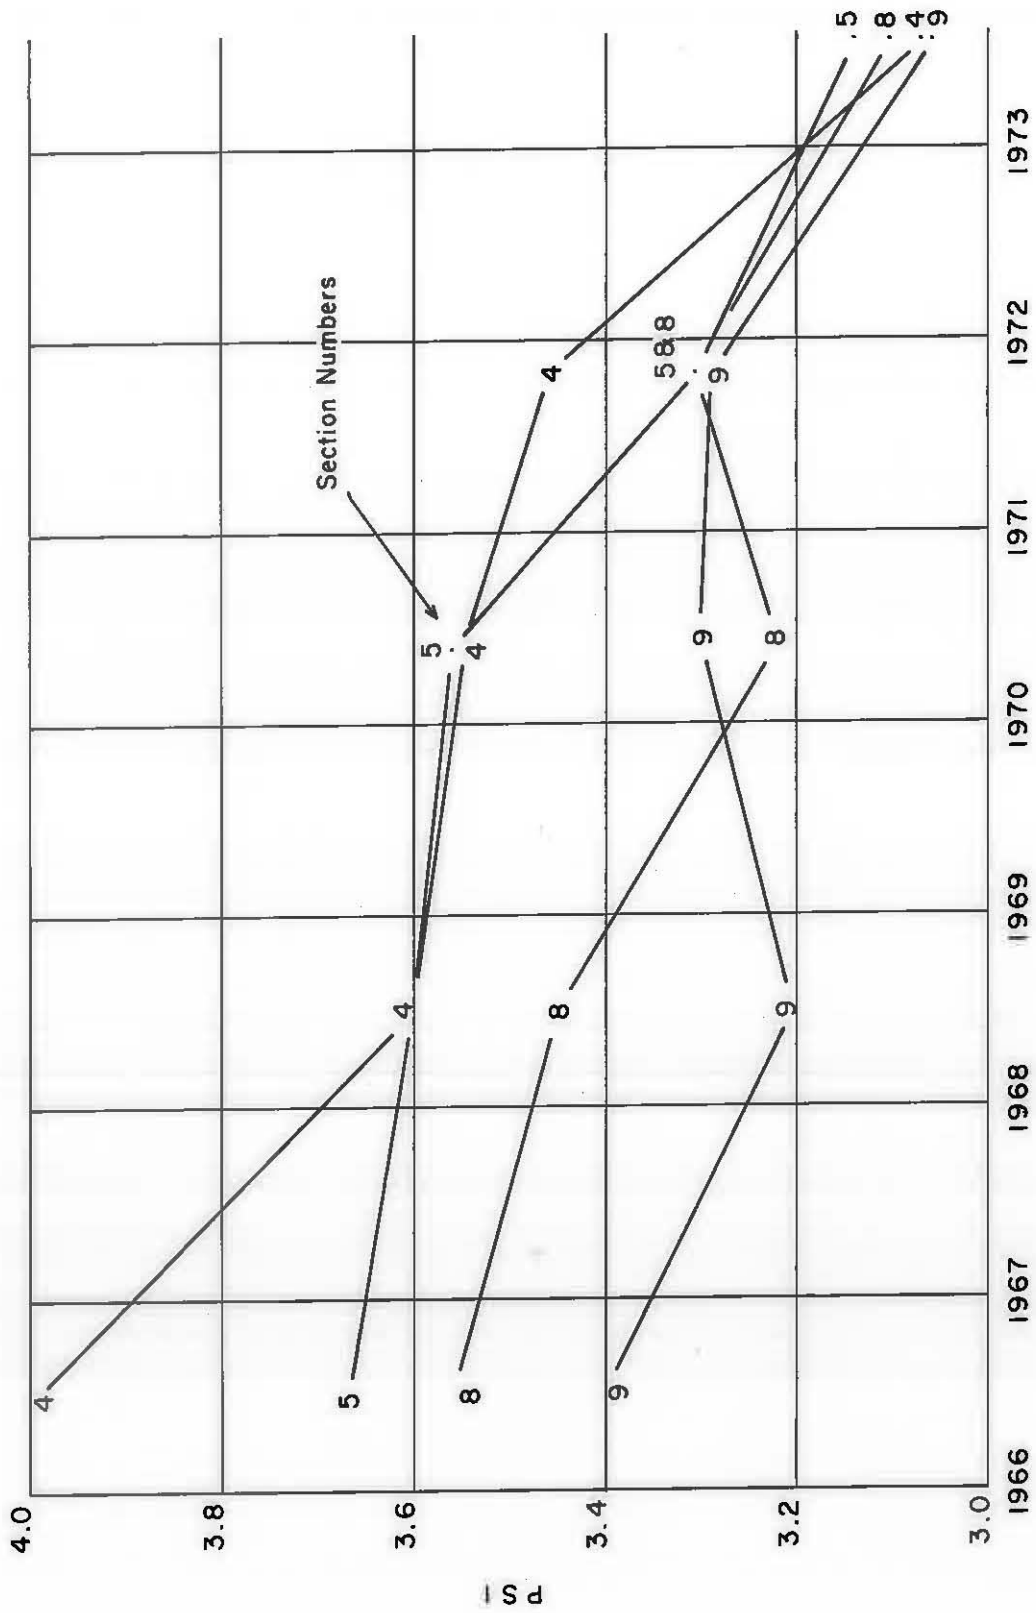
FIGURE I

These values for all sections are plotted in Figure 1. The downward slopes of the PSI lines would indicate that major maintenance work might be necessary in ten years or so, but it is anticipated that the sections will perform better than that. There is only minor joint faulting at present (0 to 1/4 inch), very little distortion and no random cracking.

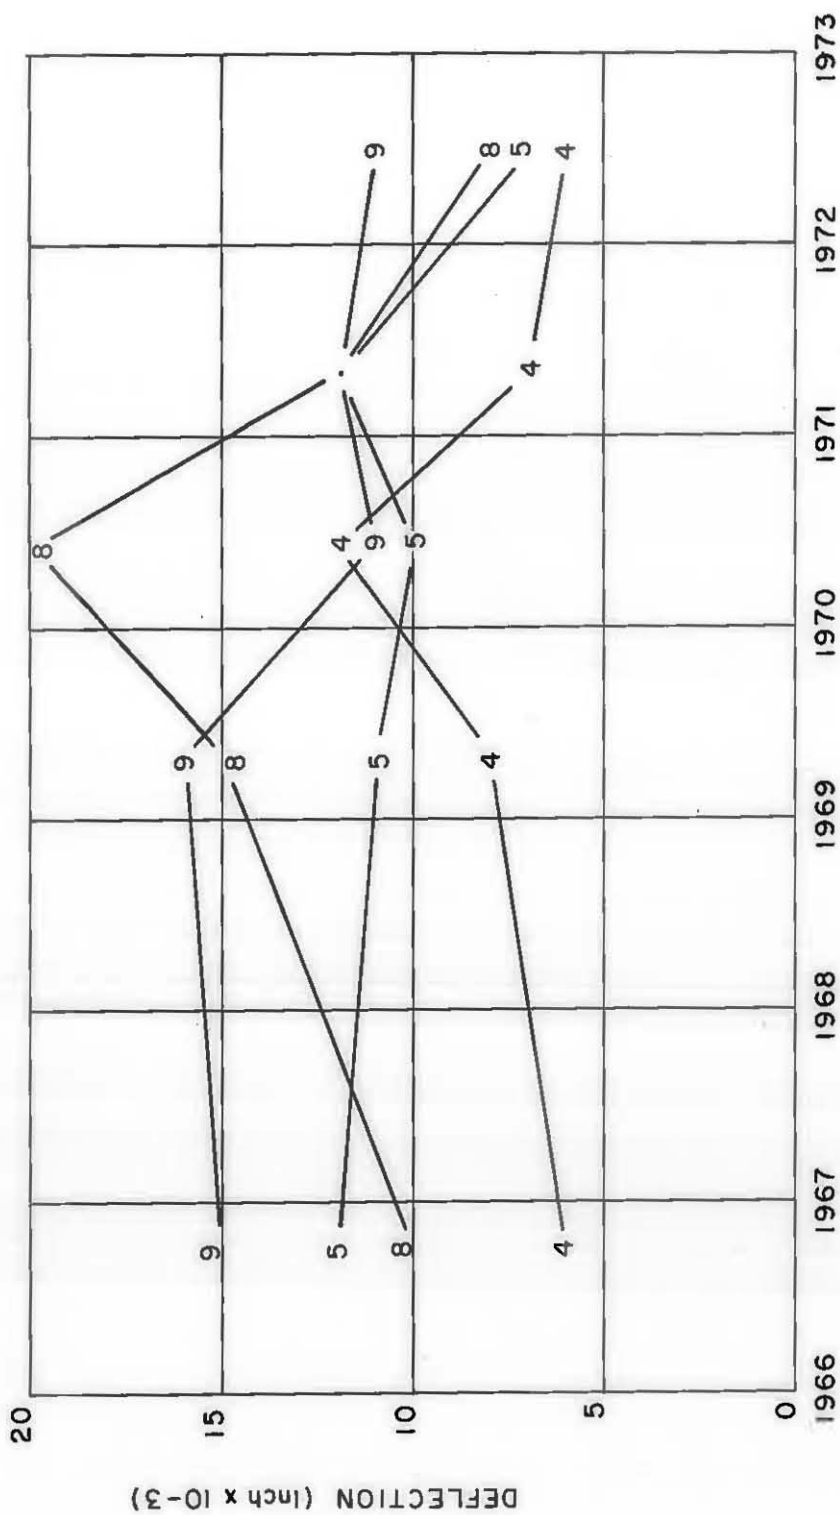
FIGURE 2

The pavement deflections under an 18,000 pound axle load were measured by a Benkelman Beam. These values which are graphed in Figure 2 indicate no significant trend and are quite typical of Portland cement concrete pavements on Colorado highways. The radius of curvature values shown in Figure 3 were measured by a Texas Basin Beam at the same times that deflections were measured. No failures are indicated by these measurements.

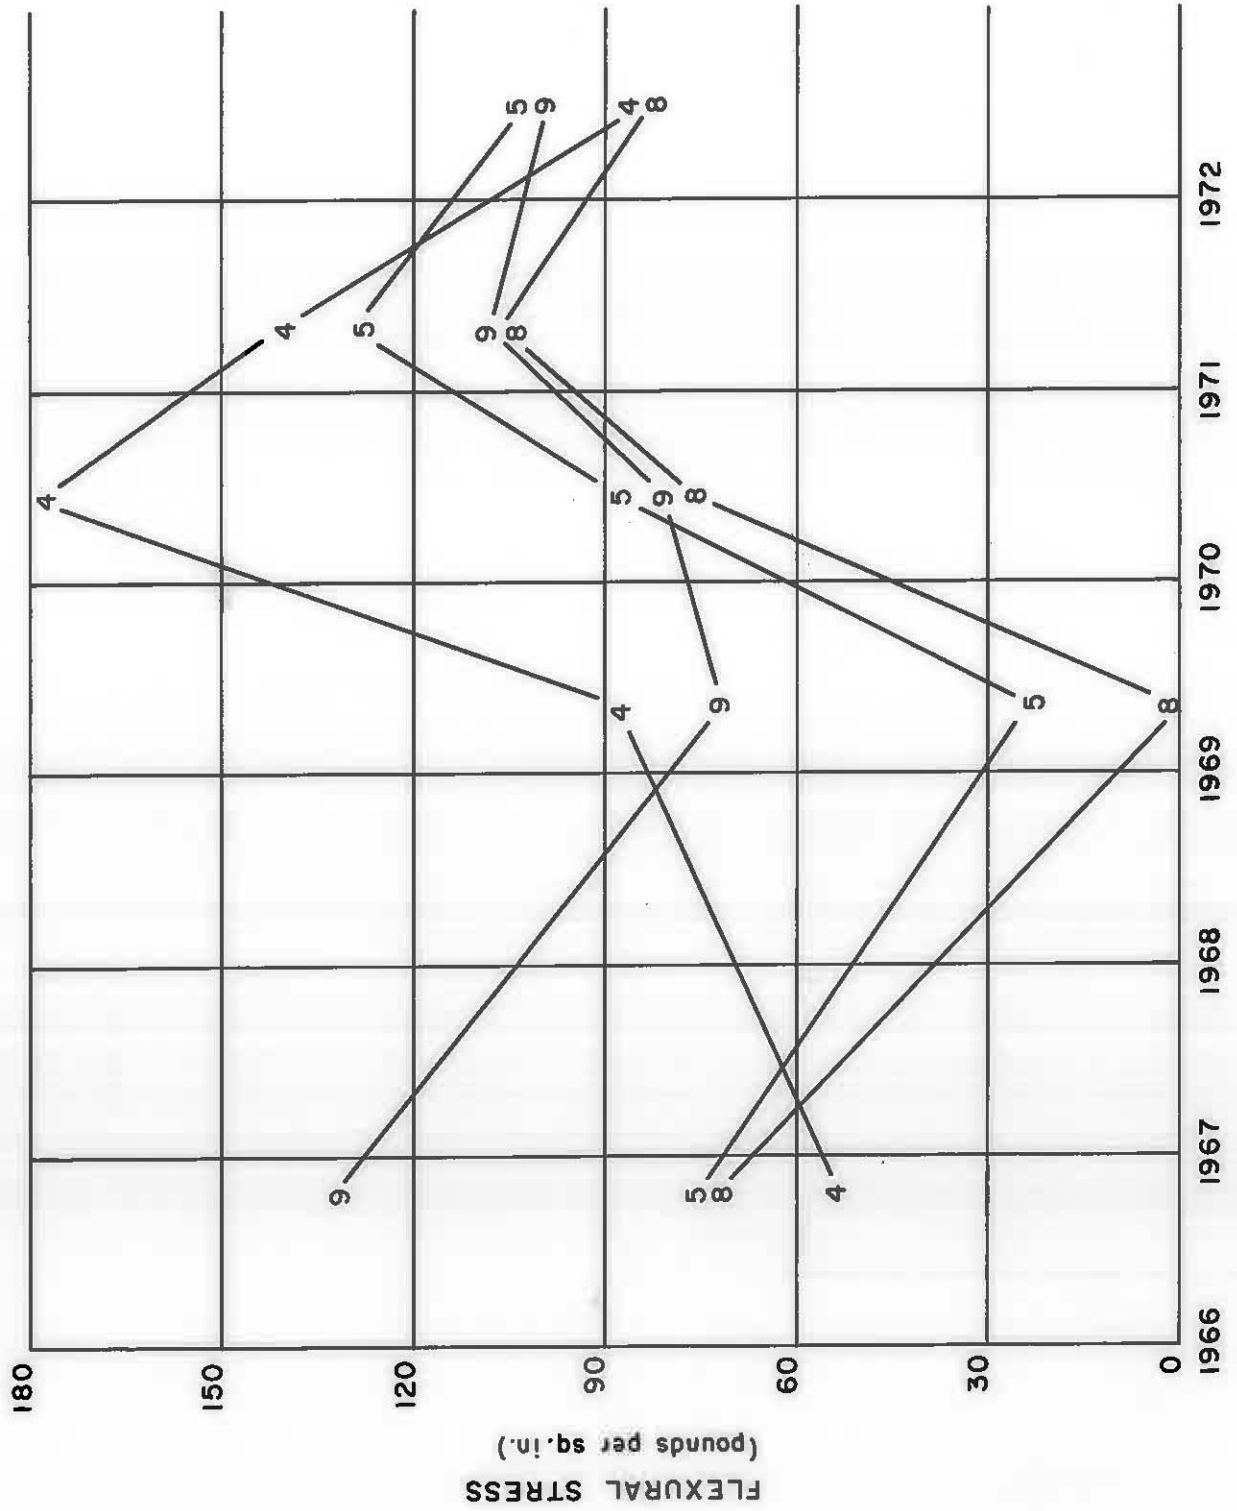
FIGURE 4

The results from the Basin Beam measurements were used to calculate the flexural stresses which are plotted in Figure 4. These are somewhat erratic but do not indicate any serious level or trends.

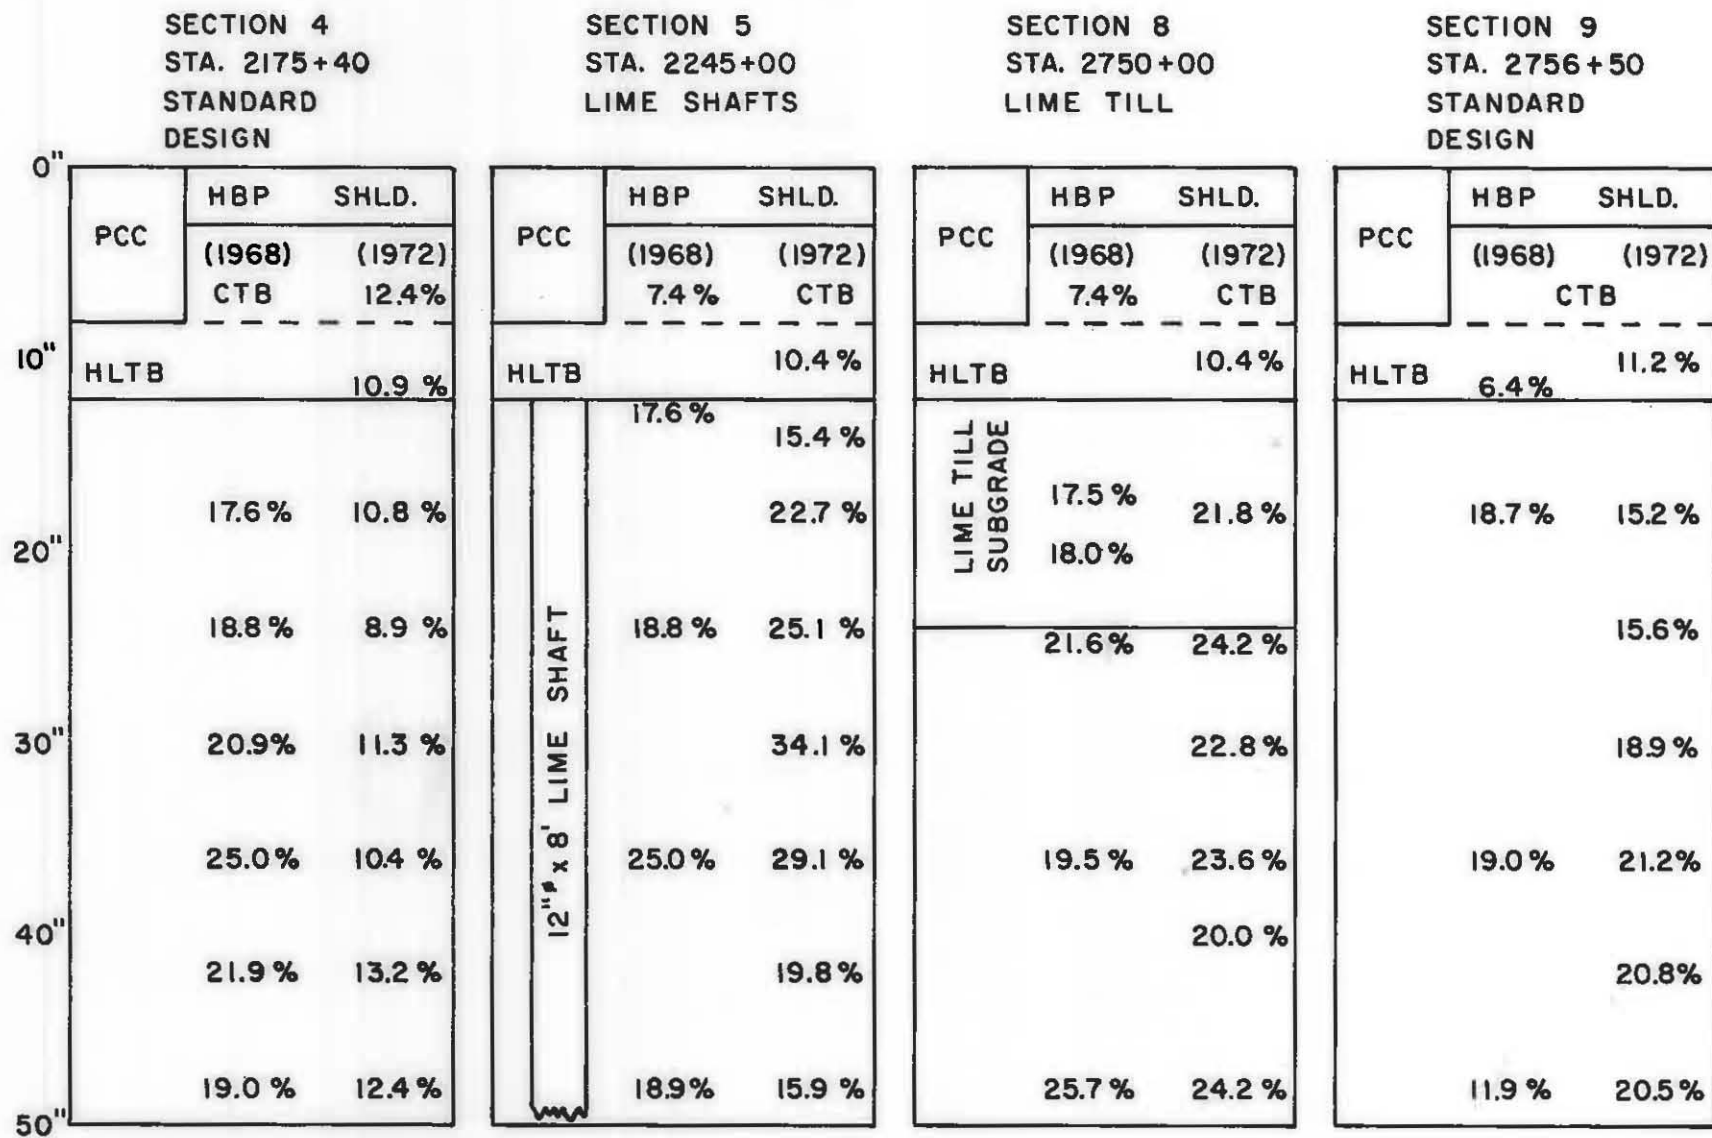
FIGURE 5

Moisture content of the base and subgrade was determined periodically in an attempt to correlate with performances. Figure 5 shows the first and last complete moisture profiles recorded for the test sections. The water content in the subgrade of Section 5 is quite high because the lime that was added in the shafts attracts and holds the moisture. The 1968 moisture profile was probably sampled at a location slightly further from the lime shaft than the 1972 profile. The subgrades of the standard sections have dried since 1969 except for the 36 inch and lower depths in Section 9 which have gained in moisture content. The moisture samples were removed from an area just outside of the concrete pavement.

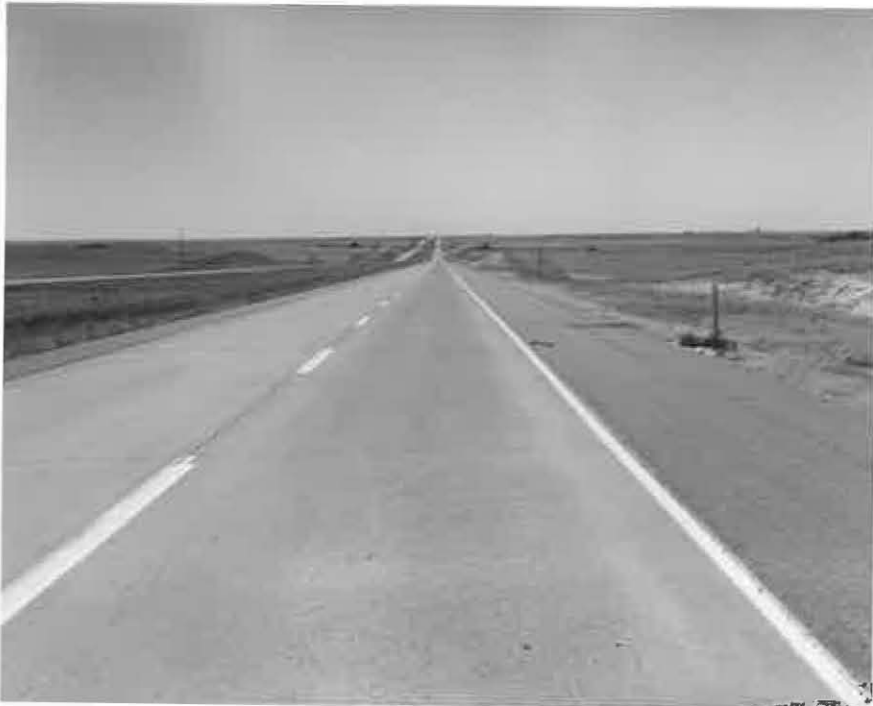
Photograph No. 1 is from the middle of the Section looking west, and Photograph No. 2 is of the east half of the Section. The change of spacing in the lime shafts is at the hammer on the shoulder. No difference was noted in the conditions of the halves of the section. Note the separation of the asphaltic shoulder from the concrete and that there is no cracking and very little faulting in the concrete pavement. The terrain is similar to that of the other test sections.
