CLIFTON - HIGHLINE CANAL EXPERIMENTAL PROJECT I 70-1114133

B. B. Gerhardt
M. C. Safford
Colorado Division of Highways
Planning and Research Division
4201 E. Arkansas Avenue
Denver, Colorado 80222

December 1973

Final Report

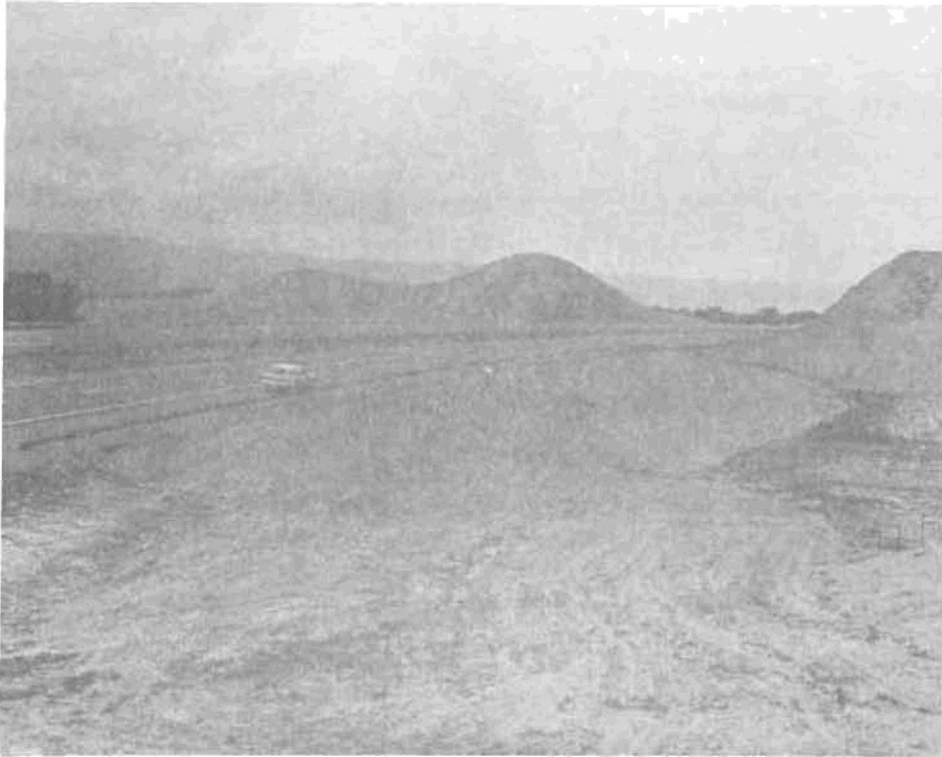
Photograph 1

This is the final report of that experimental highway project constructed in the Mancos Shale Formation on Interstate 70 in Western Colorado. The grading was completed under one project in 1964. During the grading operation an informal study was being conducted in an attempt to determine the cause of swelling noted in other highways through the same formation. The District Engineer, Planning and Research Division, and the Bureau of Public Roads (now Federal Highway Administration) agreed to design 19 different test sections in the roadway cut sections. These sections were included in the stabilization and paving project which began in the fall of 1964 and was completed in the spring of 1965. Photographs No. 1 and 2 indicate the type of valley floor in which the test sections are located.

Mancos Shale formations are generally located in the plateau area of Colorado, Utah, and Wyoming at elevations of 4,000 to 6,500 feet above sea level. This is semi-desert country with annual precipitation of five to twelve inches. Very little vegetation grows in this arid climate as shown in Photographs No. 1 and 2. These massive beds are usually highly foliated with an irregular vertical joint system.

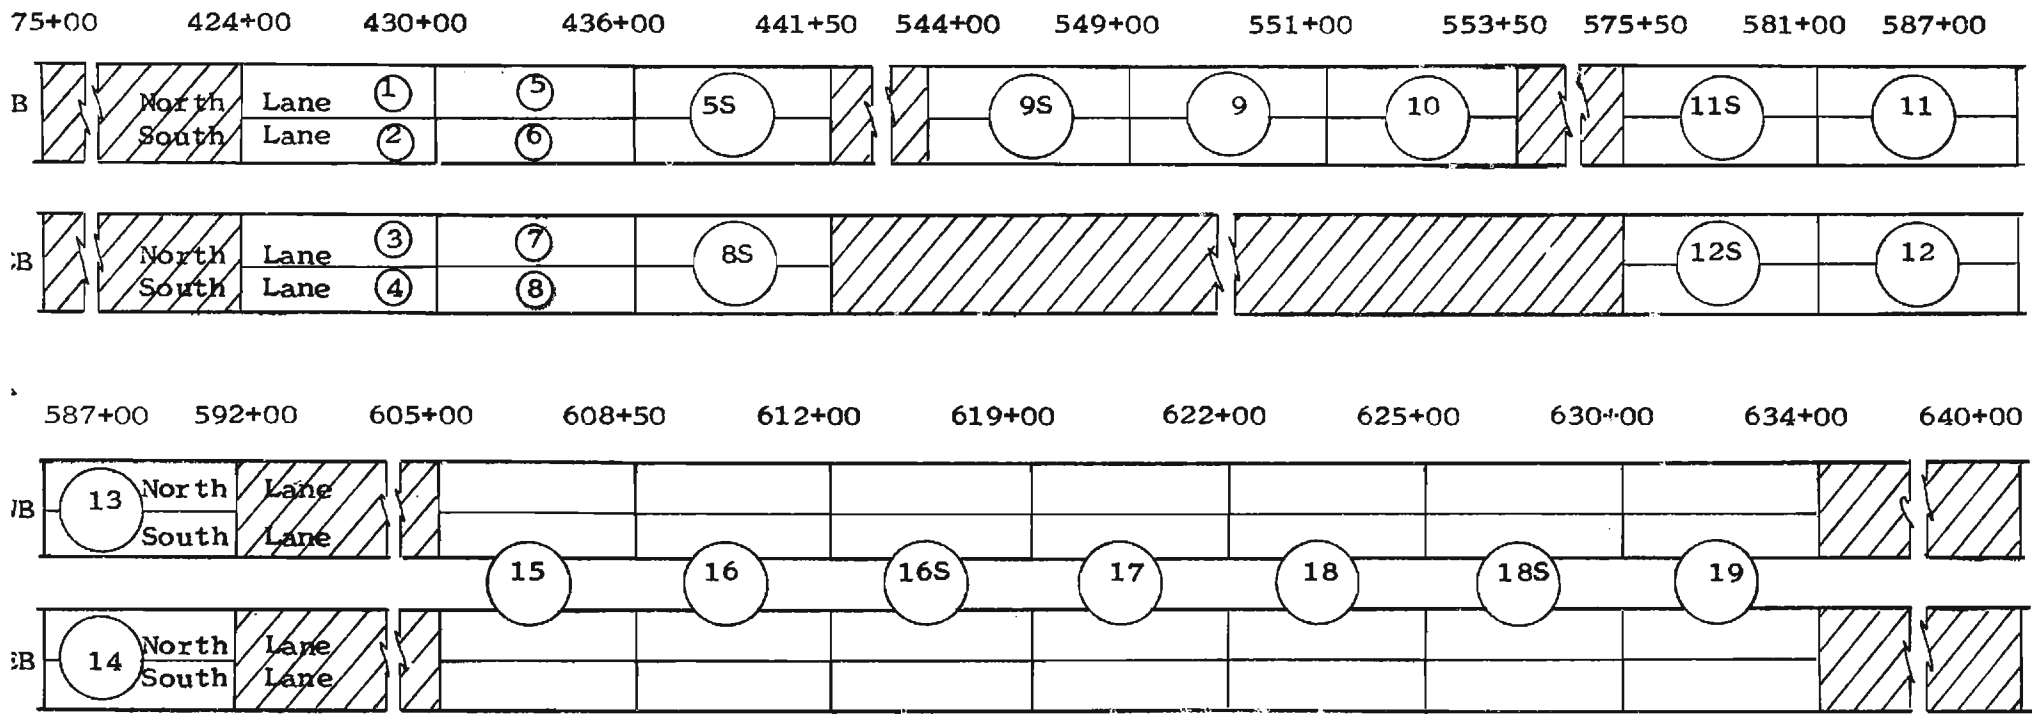
FIGURE 1
TEST SECTION LAYOUT
CLIFTON-HIGHLINE CANAL
EXPERIMENTAL BASE PROJECT
PROJECT NO. I 70-1(14)

The experimental portion of Project No. I 70-1(14) consists of several test sections located as shown in Figure 1. A description of the treatment of the subgrade for each test section is listed.

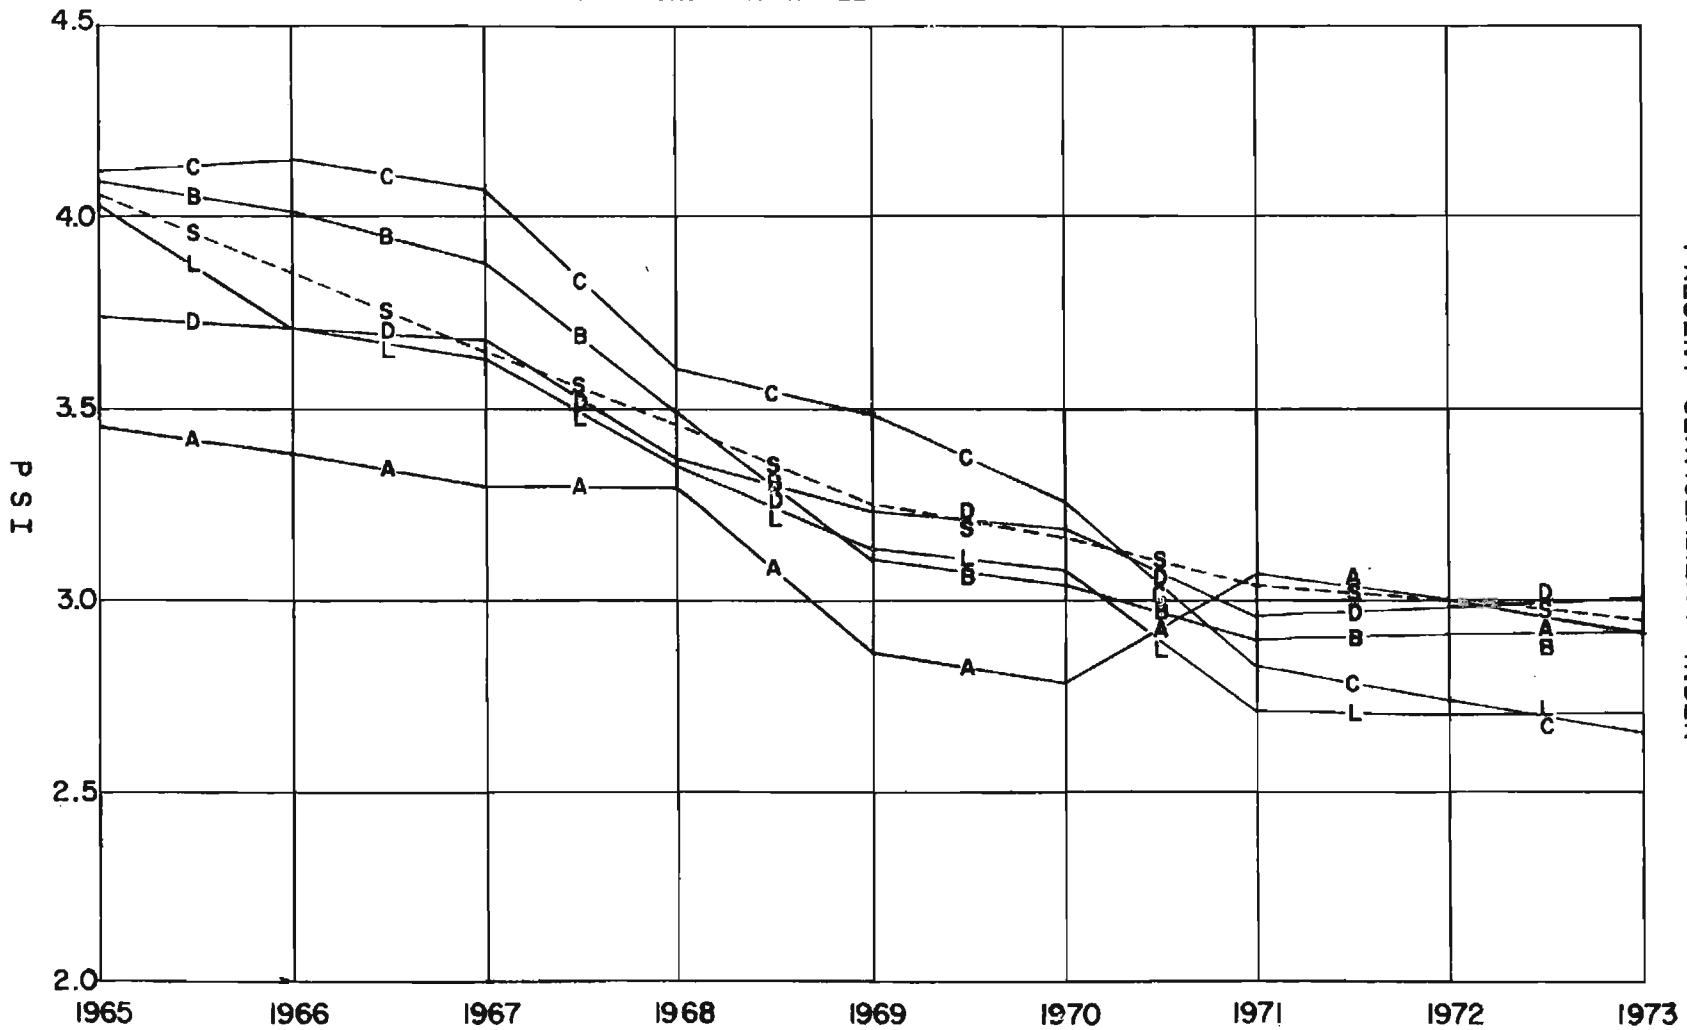
Figure 2

CHLOE Profilometer is sensitive to surface irregularities and small bumps but registers little effect from the long swells prevalent in Mancos Shale cuts. The test sections where the subgrades was excavated and backfilled with granular material (B line in Figure 2) compare very well in PSI with other sections. The rideability in a passenger car at 60 or 70 mph over these same sections is very uncomfortable to the passengers. The amount of swelling in Figure 6 is a better indicator of the rideability at higher speeds. The section with the least swell give the most comfortable ride.

PSI values for the different types of treatments are plotted in Figure 2. The deterioration can readily be seen, and the trend would indicate that major maintenance will be necessary in about five years. The asphalt membrane sections had a relatively low PSI in the beginning but have not deteriorated as much as the others. The PSI of the standard section in cuts (C in Figure 1) is low partly because of the large amounts of cracking.

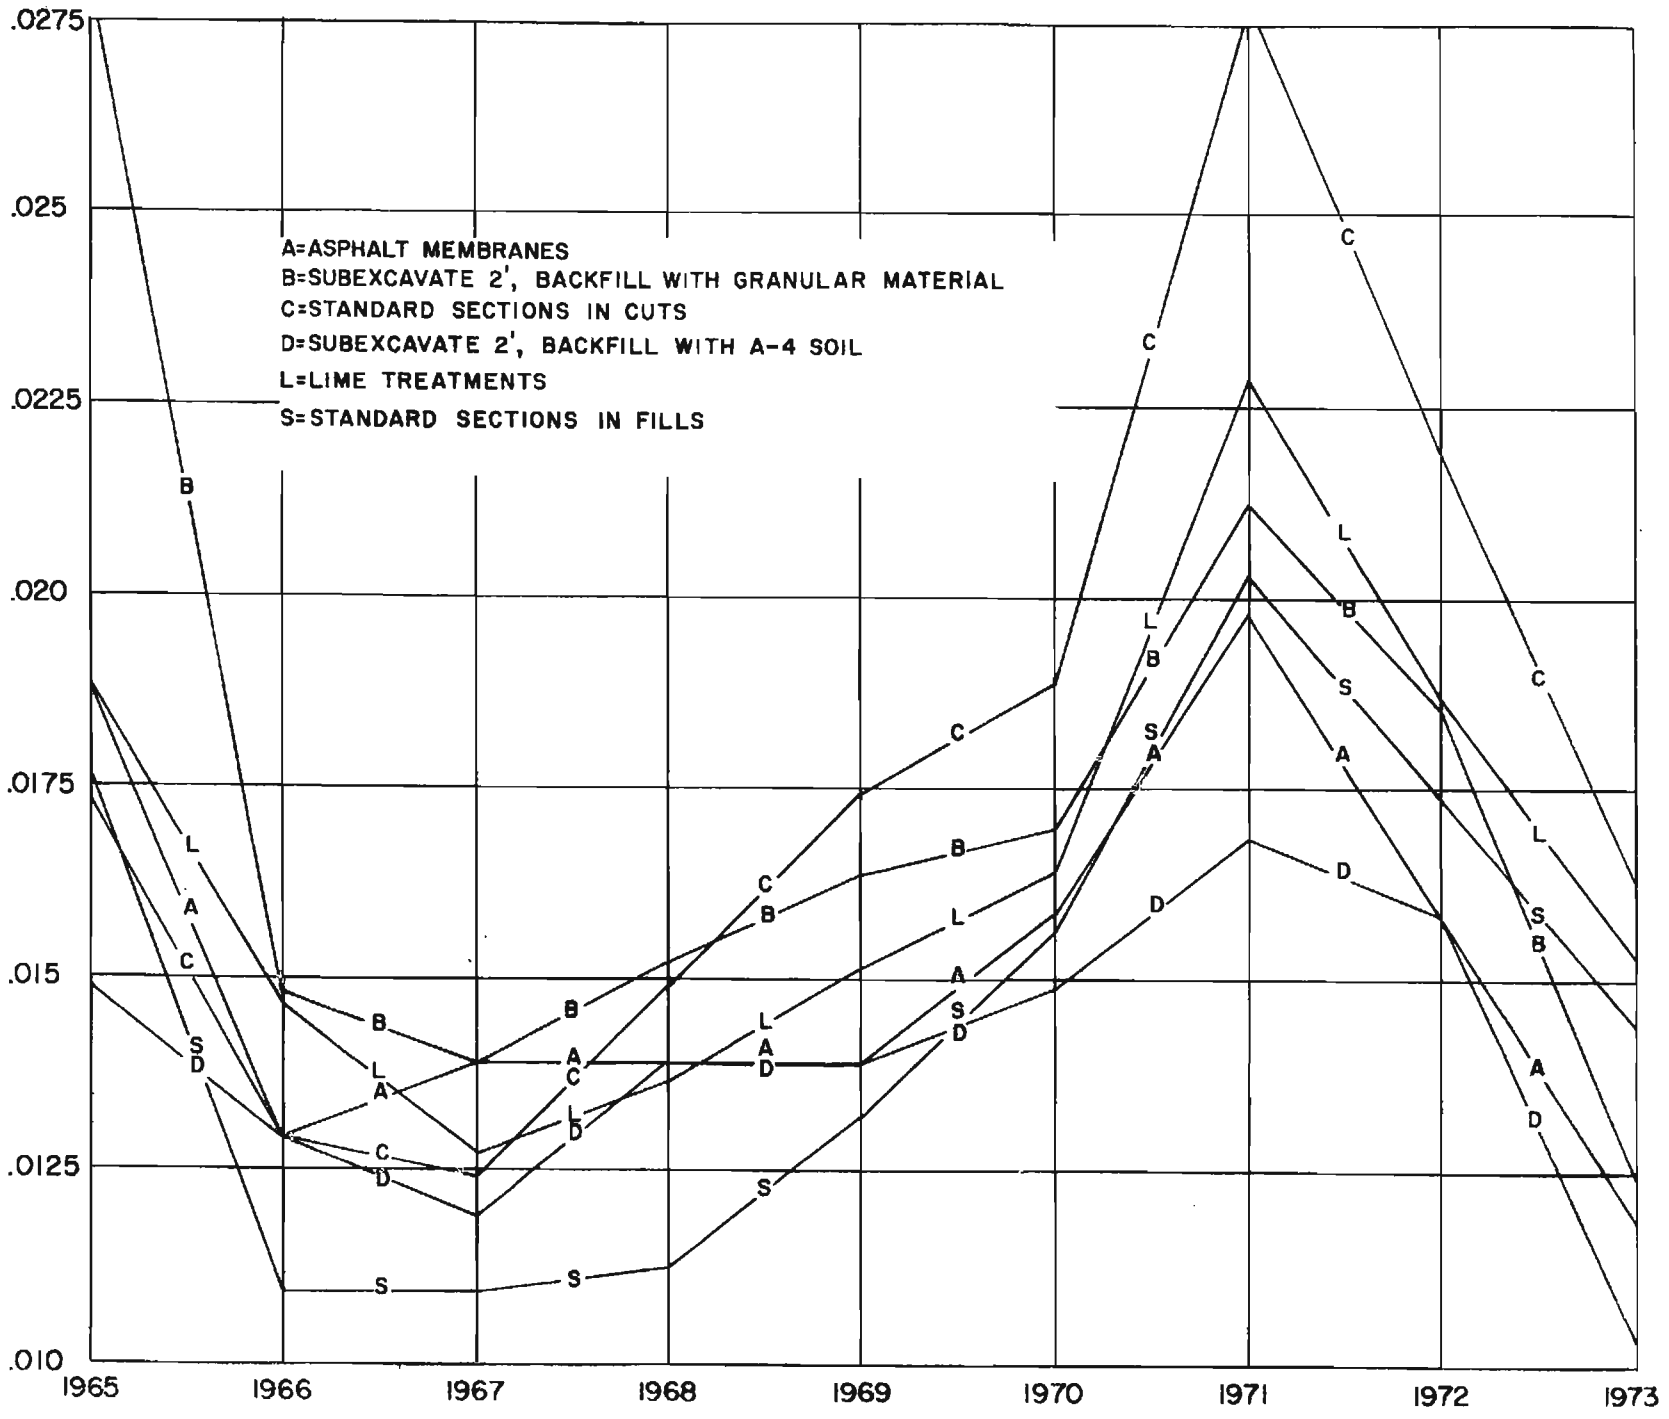
Figure 3

Surface rebound deflections were measured by a Benkelman Beam corrected for temperature and then graphed in Figure 3. Because of the small amount of deflection in the spring of 1973, no pavement failures are indicated.

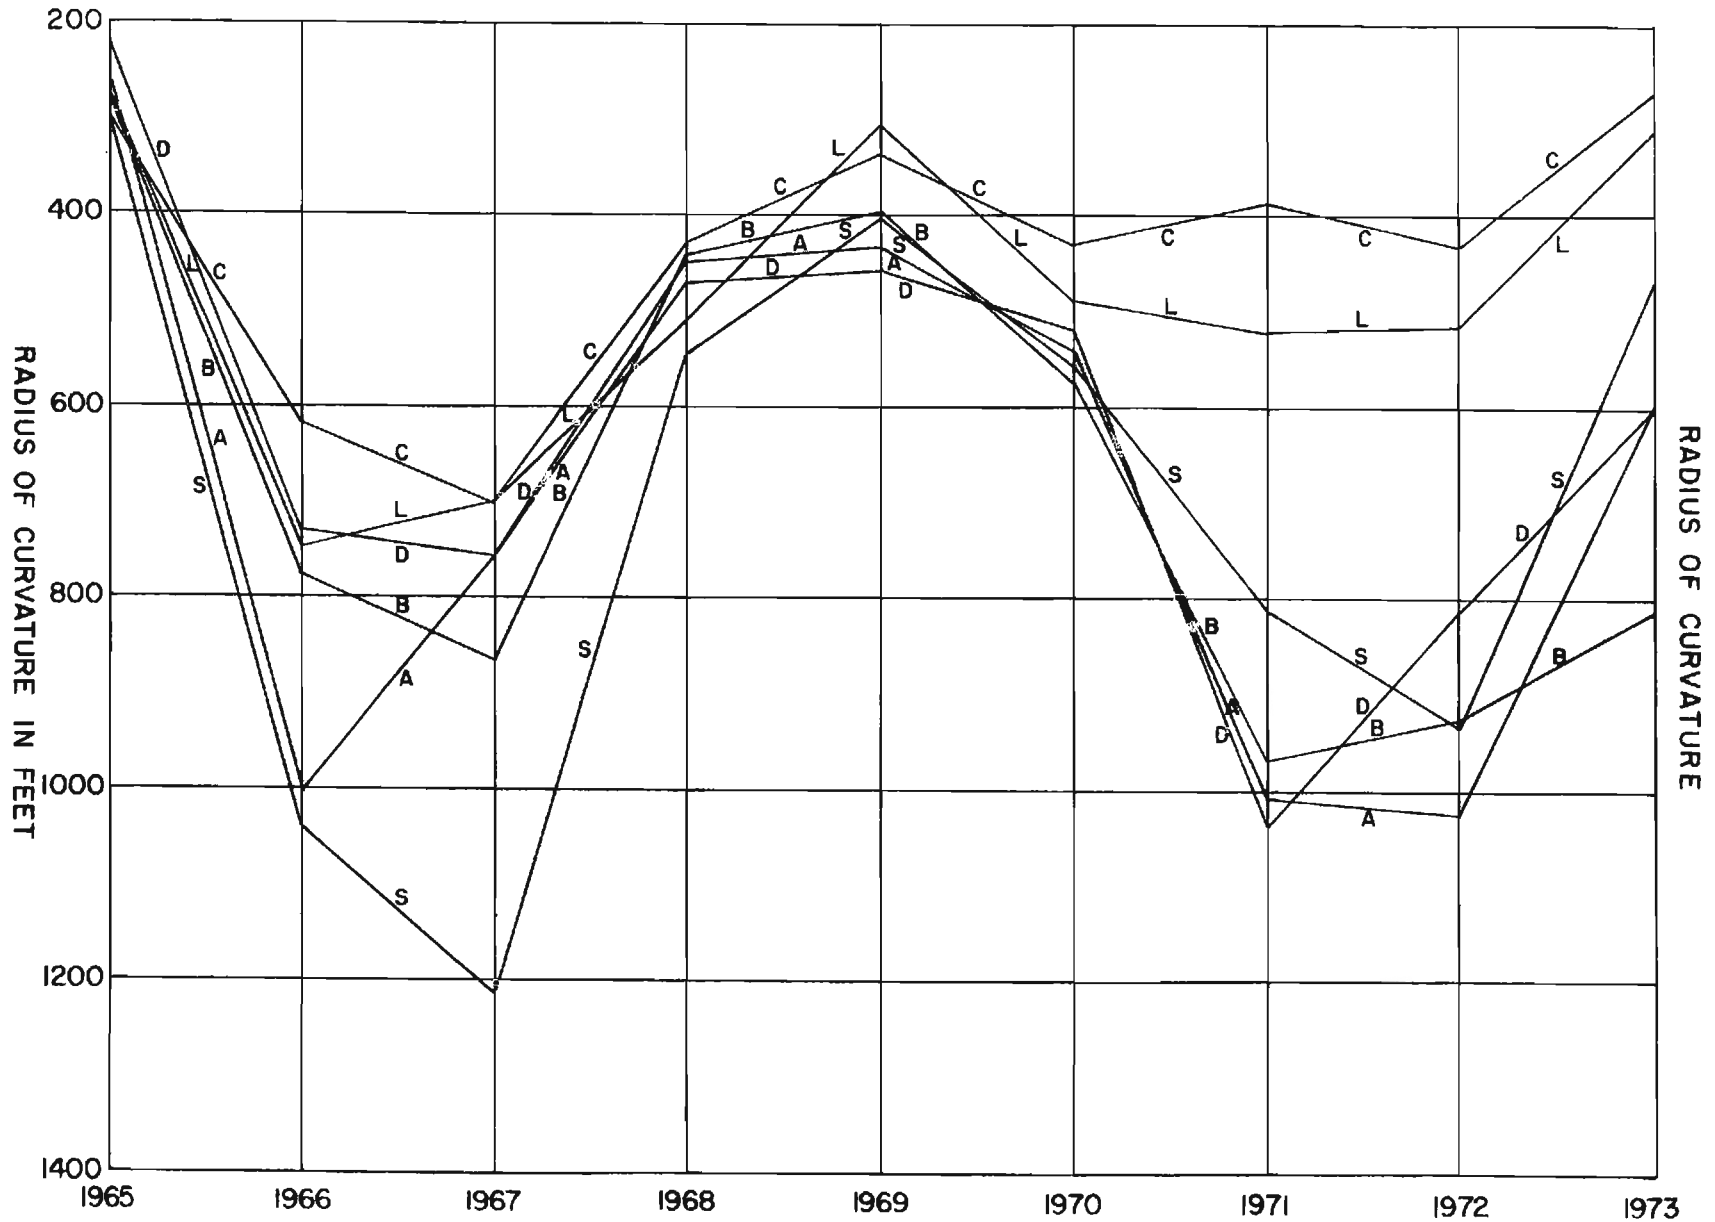
Figure 4

A Dehler Meter was used to measure the radius of curvature of the pavement surface between the dual tires of 9,000 pound load. The results corrected for temperature are indicated in Figure 4. The graphs indicate no loss of strength in the eight years of the life of the road.

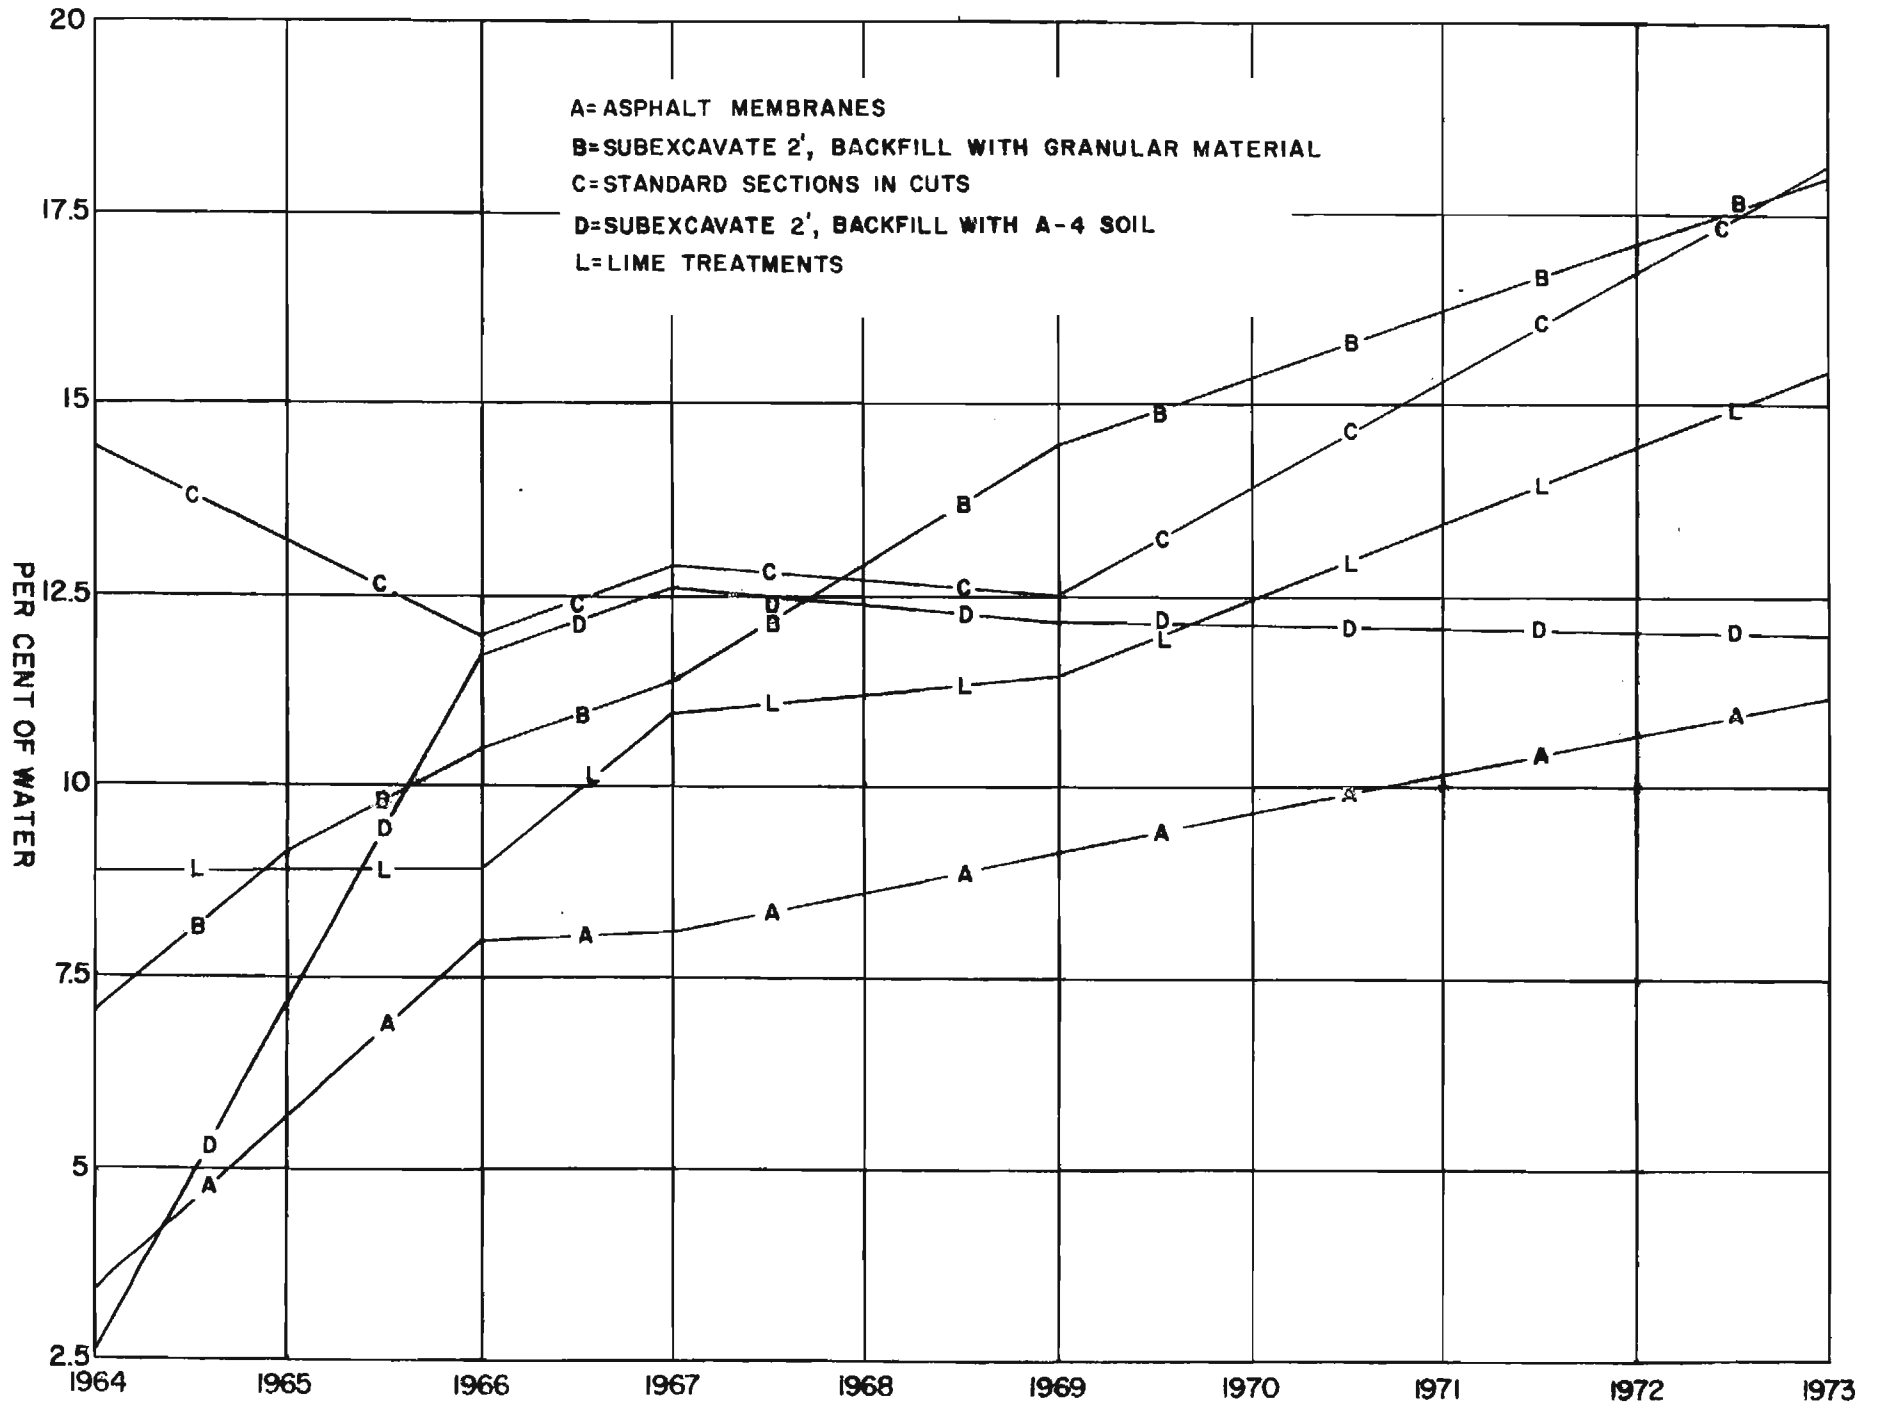
Subsequent sampling was accomplished by removing a portion of the material by auger and drying it in an oven. The results of the moisture tests are in the Appendix. Figure 5 is a graph of the average moisture content of the top of the subgrade of the various types of sections. The C and L sections show a high initial moisture because they were wetted as part of the requirements for those treatments.

There is good correlation between the increase in subgrade moisture content and the amount of swelling. This will be discussed further in the next subsection.

In the spring of 1973, the moisture content in the shale of Section 18 westbound was 15.7 percent. This indicates that there must be a leak nearby in the asphalt membrane. Thus far the swelling here is the least amount in all the sections but may be expected to increase with an increase in moisture.

Even though the standard sections in cuts had as much water in the subgrade as the ones which were subexcavated and backfilled with granular material (see Figure 5), they had significantly less swelling. This is due to the fact that the subgrade was wetted and compacted in the standard section before the surfacing material was placed.

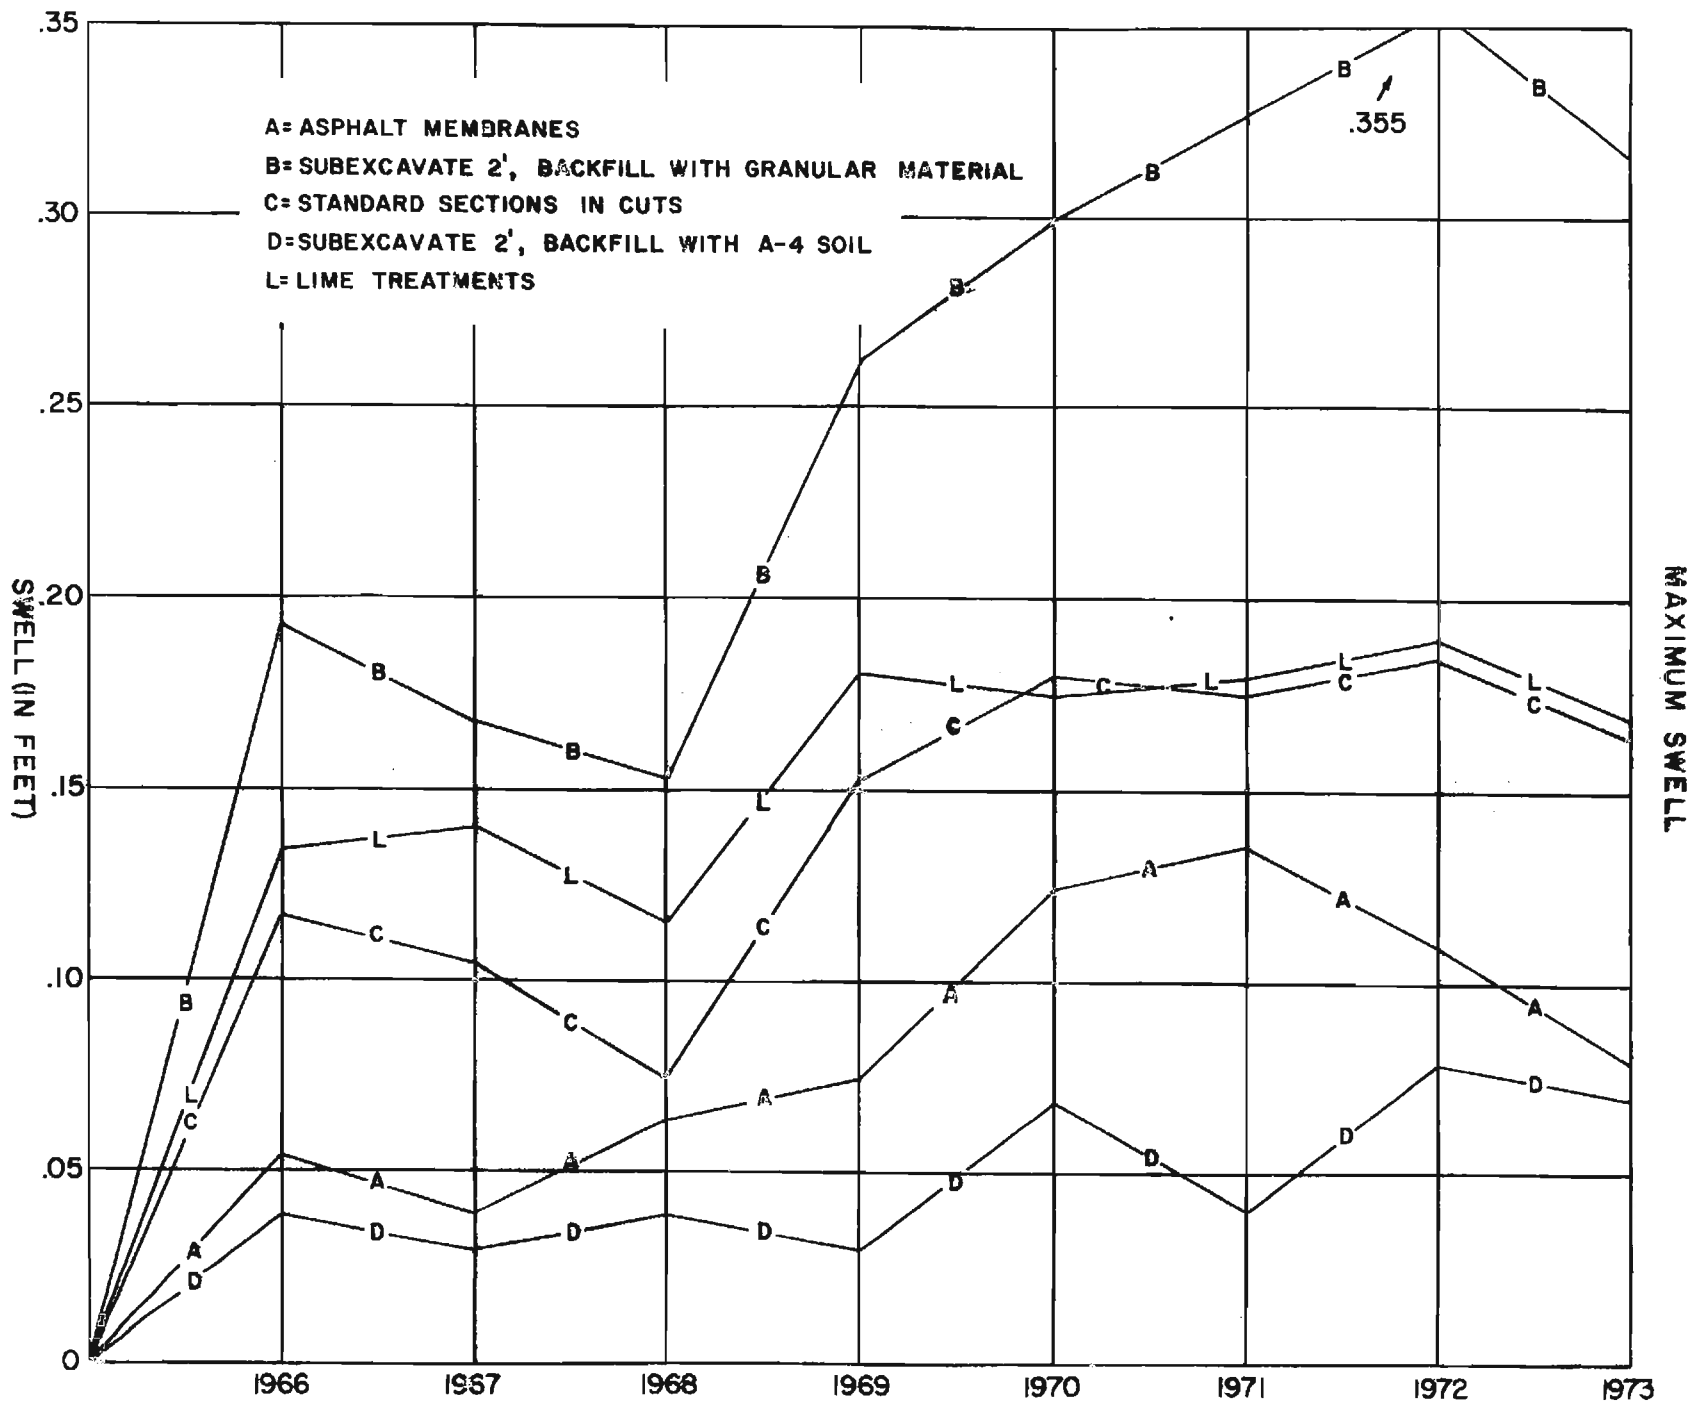
Figure 6

of treatment are plotted in Figure 6. The sections with the most swelling are those which were subexcavated and backfilled with granular material. The one that was backfilled with A-4 soil had the next to least amount of swelling. Even though there was only one section of this type, we feel that the results are fairly typical for this treatment. The same type of work was done in 1968 on another project, and the results are satisfactory at this time. The asphalt membrane has evidently prevented swelling, also.

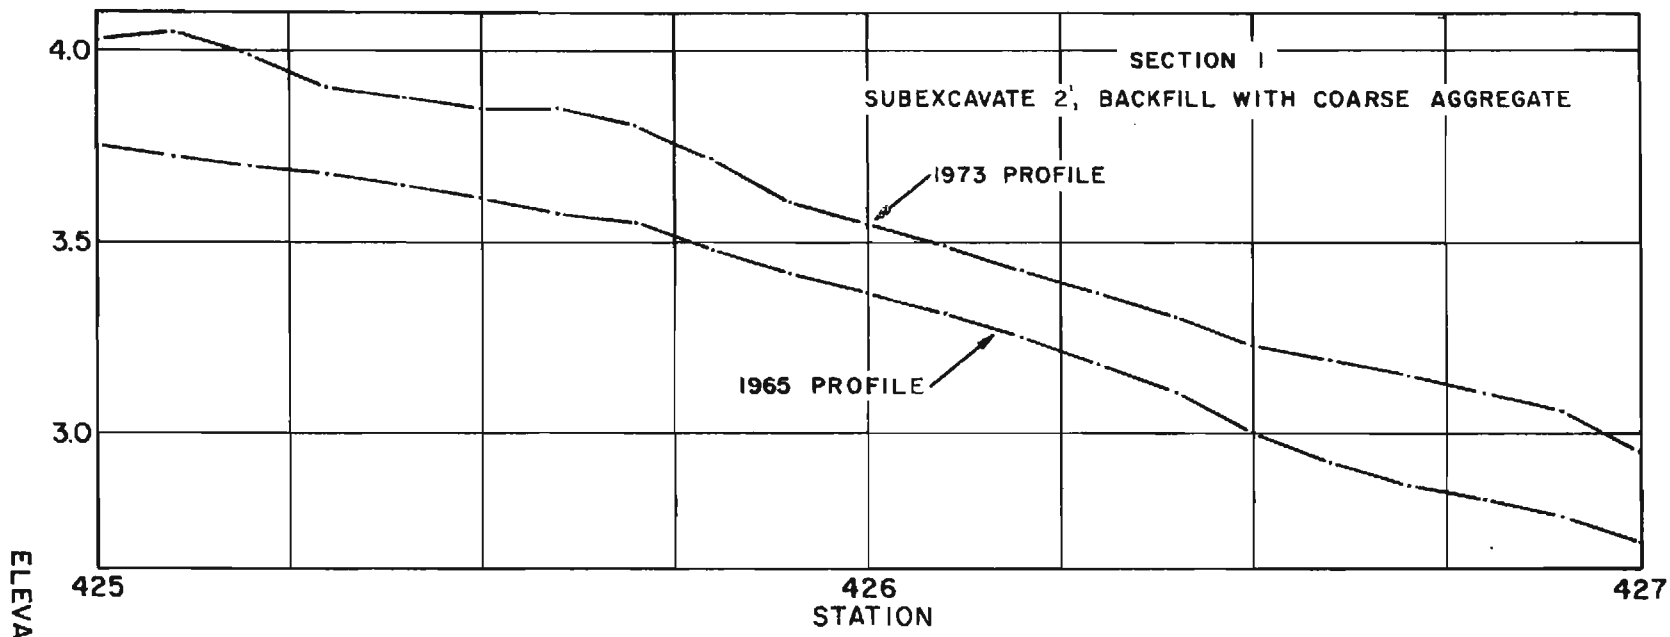
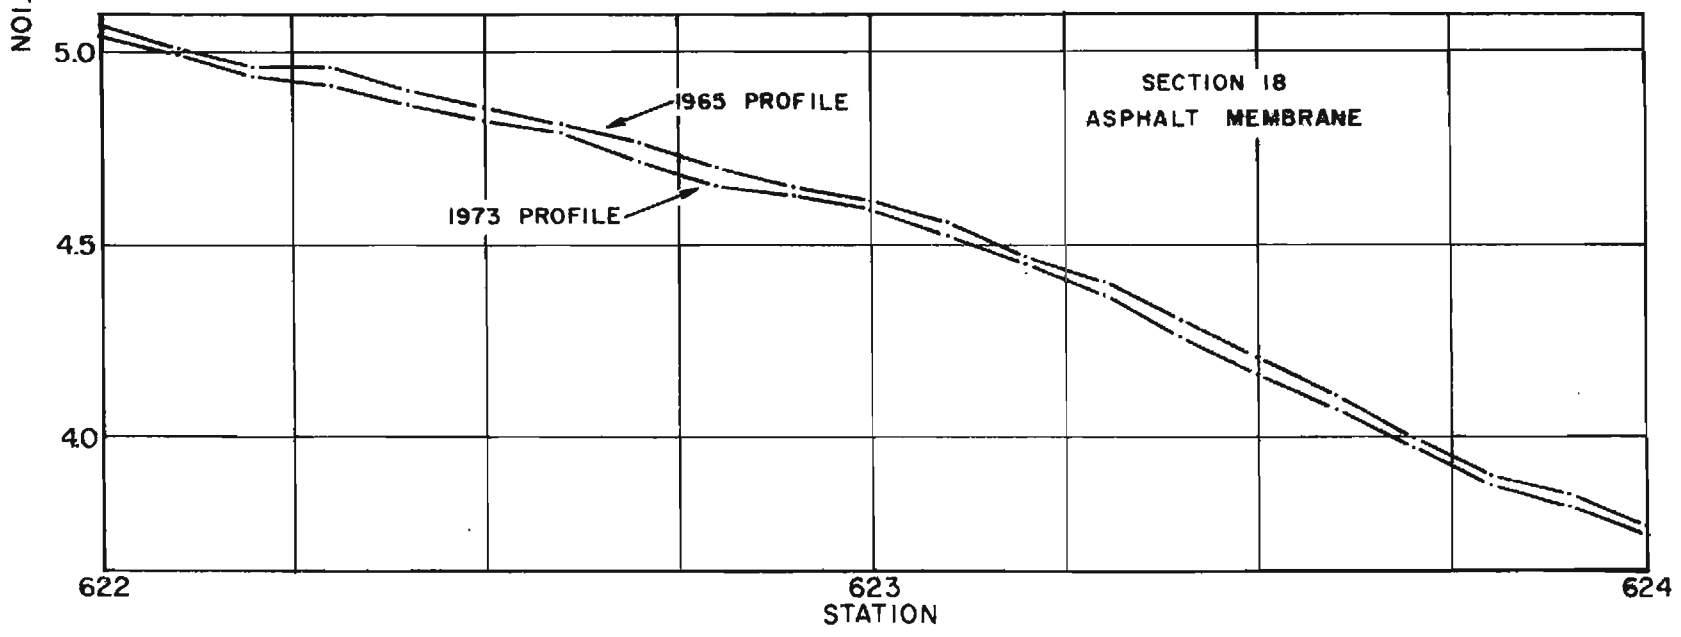
Figure 7 is a profile of a 200 foot length of two test sections. Section 1 is typical of the greatest amount of swelling, and Section 18 is typical of the least. The differential swelling in Section 1 causes an uncomfortable ride to a person in a vehicle which is traveling at 60 to 70 miles per hour.

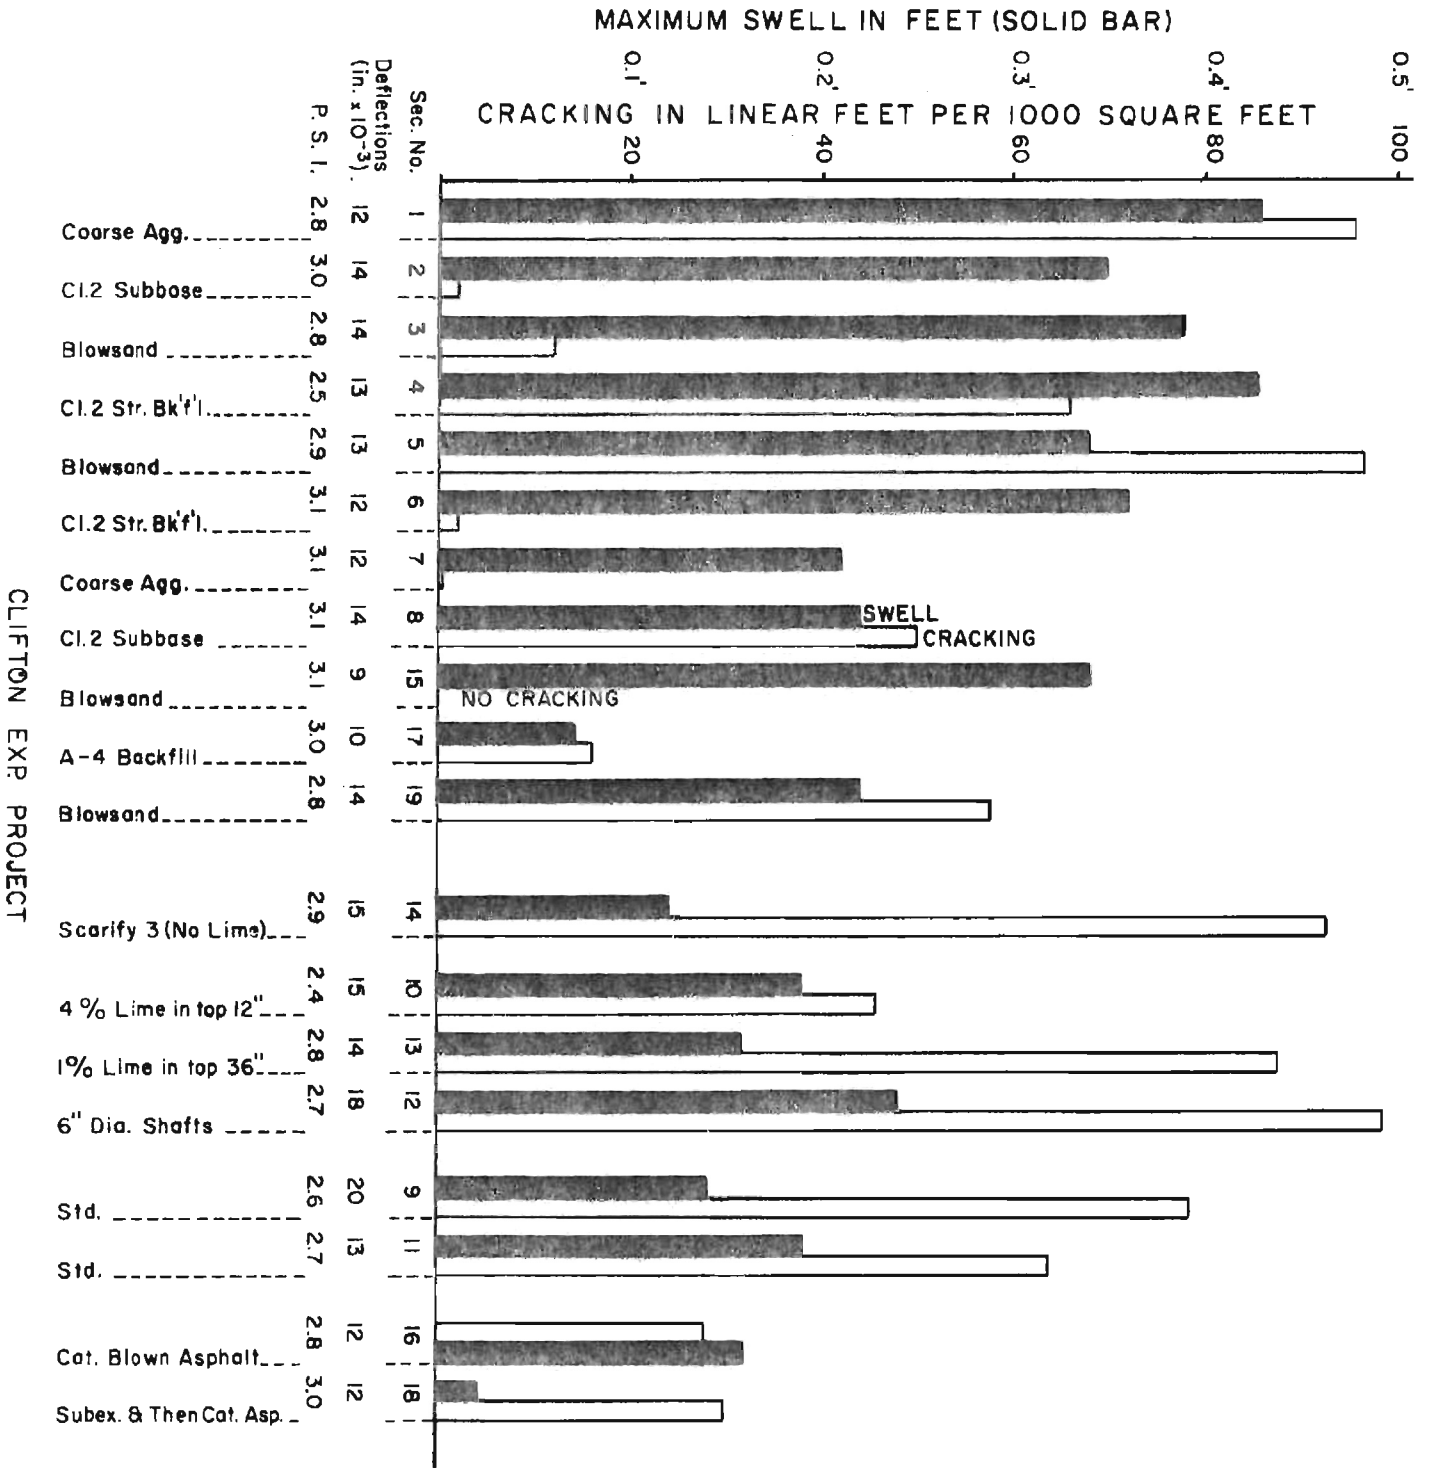
CRACKING AND SWELL

Figure 8 is a comparison of the test sections by swelling, longitudinal cracking, deflections and Present Serviceability Index. About two-thirds of the sections have alligator cracking to various extents. Generally, the alligator cracking is greatest in the sections with the greatest longitudinal cracking.
