REPORT NO. CDOH-DTP-R-80-16

PAVEMENT PATCHING DEMONSTRATION
AND EVALUATION
DOT-FH-11-8188

Herbert N. Swanson
Denis Donnelly
Colorado Department of Highways
4201 East Arkansas Avenue
Denver, Colorado 80222

Final Report
December 1980

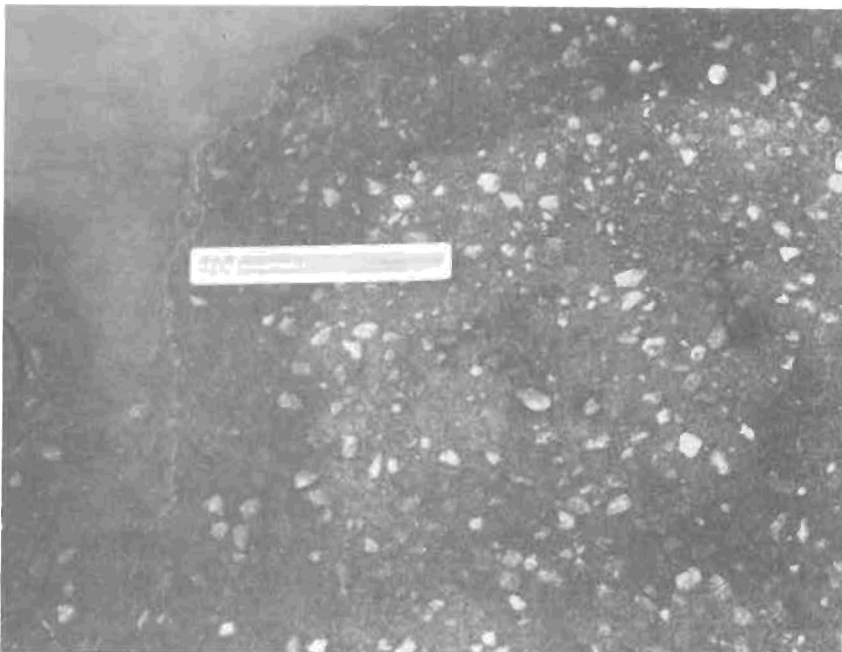
Water is the worst enemy of the maintenance man and the pavement.

The water-softened pavement is easily raveled and spalled by traffic making small potholes larger.

Note the spalling around the edges of this pothole.

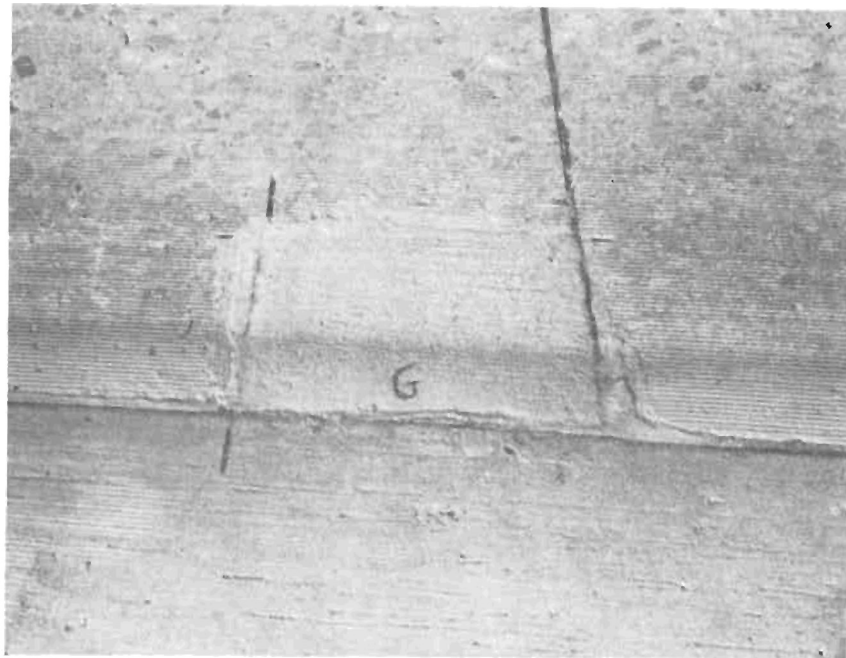
A typical concrete patch which repaired a spalled area at the junction of expansion joints.

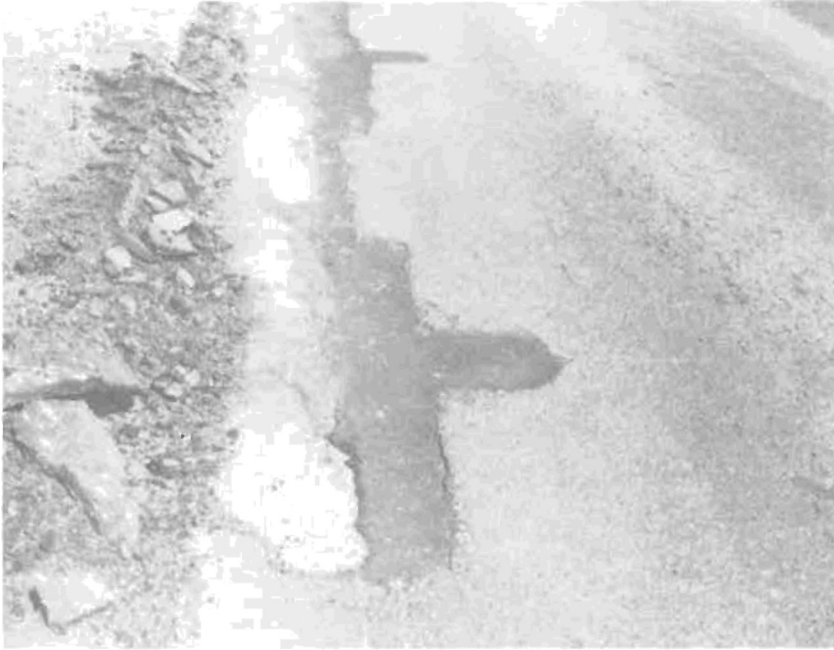
Standard Cold Mix
(MC-70) Patch
(4 Days Old)

These patches were placed under adverse conditions and intended to be temporary.

The thin patch over the concrete pan line has spalled off but the thick part of the patch is still in service. It will be replaced with hot mix when time permits.

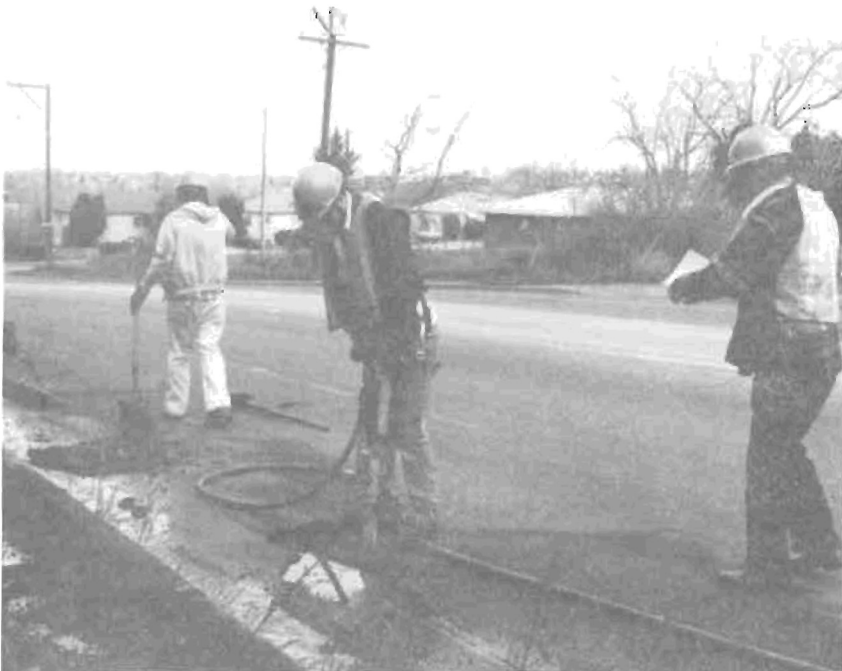
Preparation for a hot mix patch includes removal of old cold mix, squaring the hole, and priming the edges.

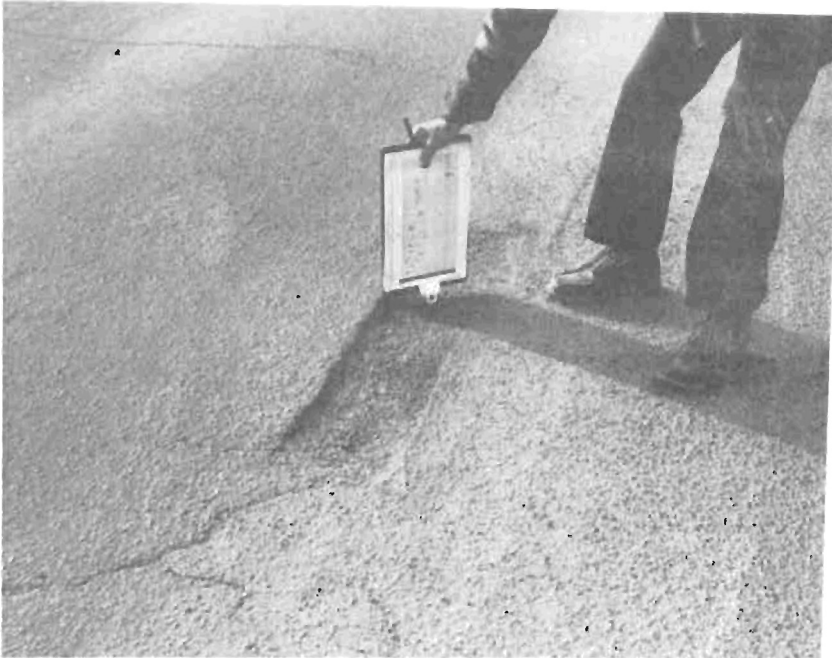
A Pavon patch raveled out to about an inch below the driving surface. This patch was removed and replaced with a permanent hot mix patch.

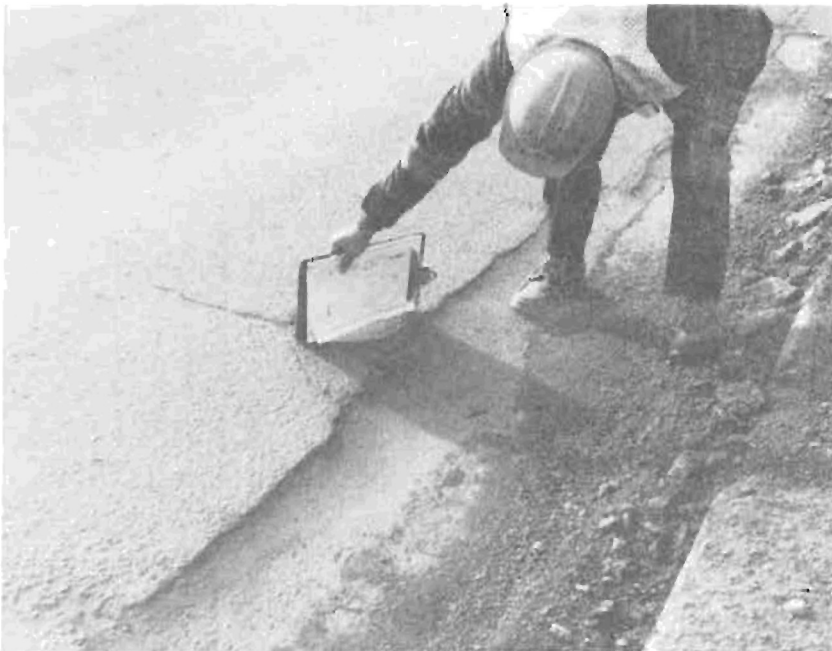
An MC-70 with Hercules fibers has failed because of raveling and shoving.

This material came completely loose during the following storm.

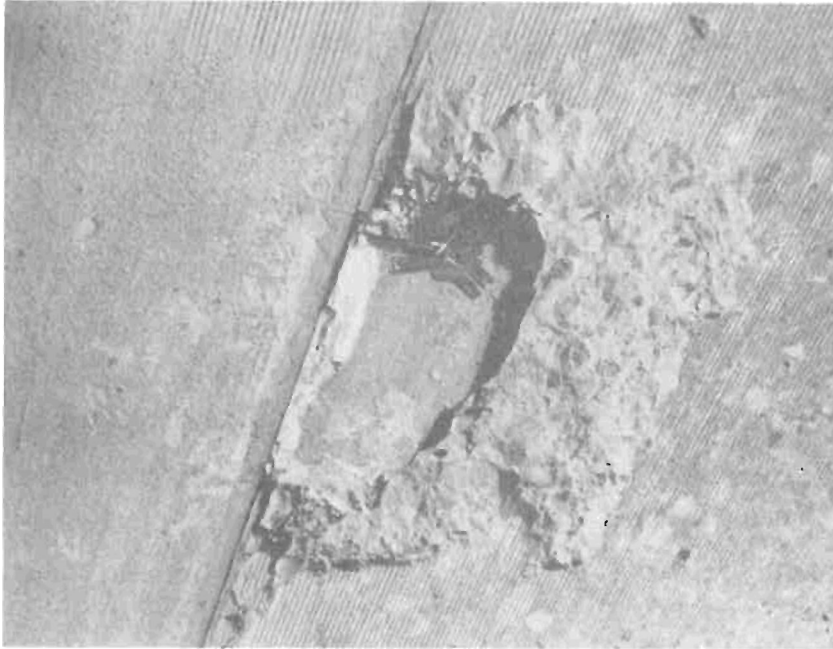
A Speed Crete patch (center) is still in place and at the same level as the driving surface, but it has caused the surrounding concrete to pop out. Differential expansion and contraction is suspected to be the cause of this problem.

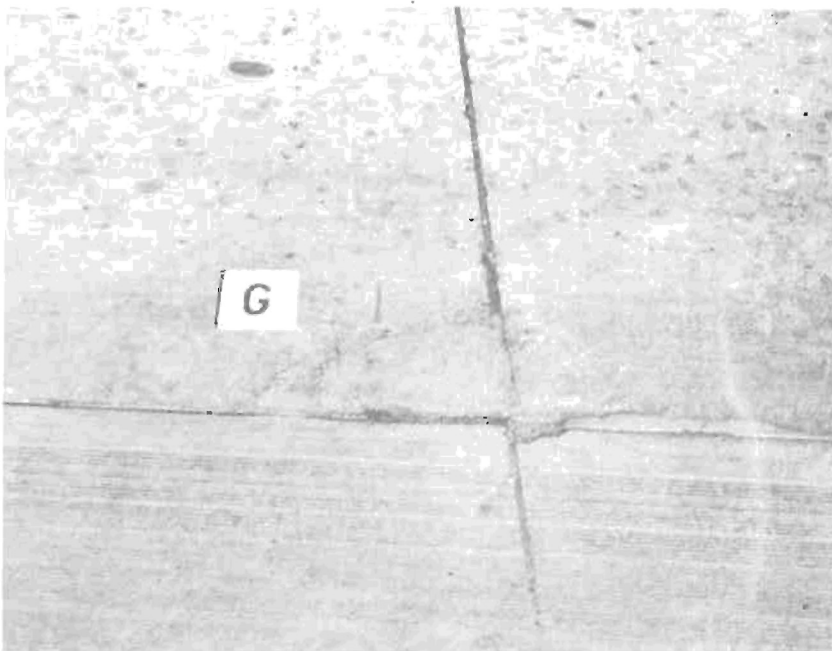
Supreme Grout is in good condition after one year.
