Report No. CDOT-DTD-R-92-3

# GILSONITE, AN ASPHALT MODIFIER

DONNA S. HARMELINK  
Colorado Department of Transportation  
4201 East Arkansas Avenue  
Denver, Colorado 80222

Final Report  
March 1992

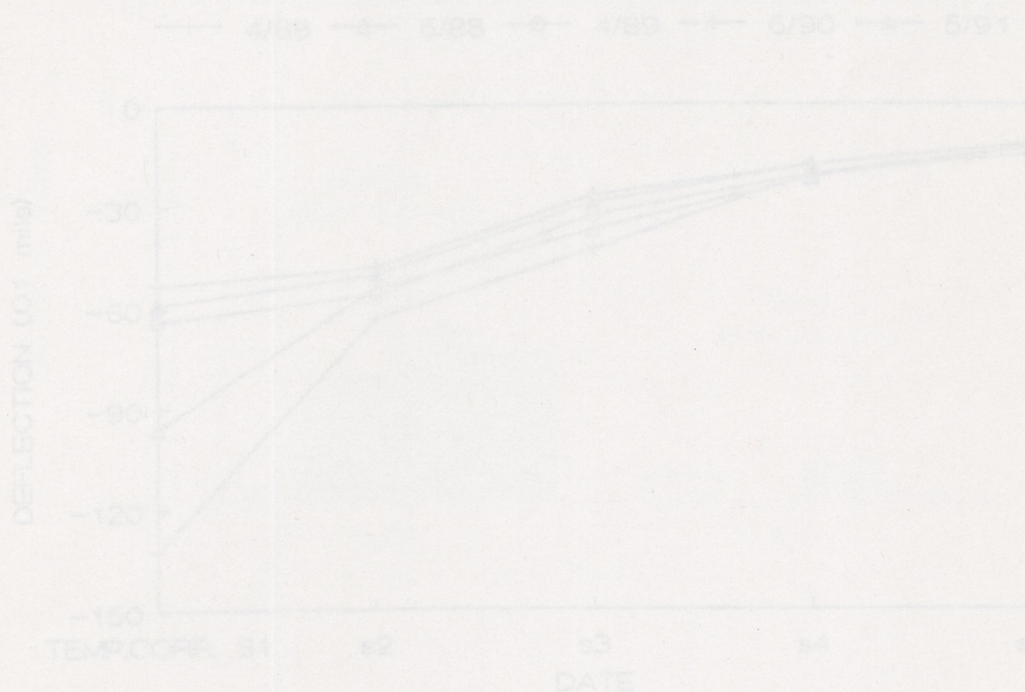
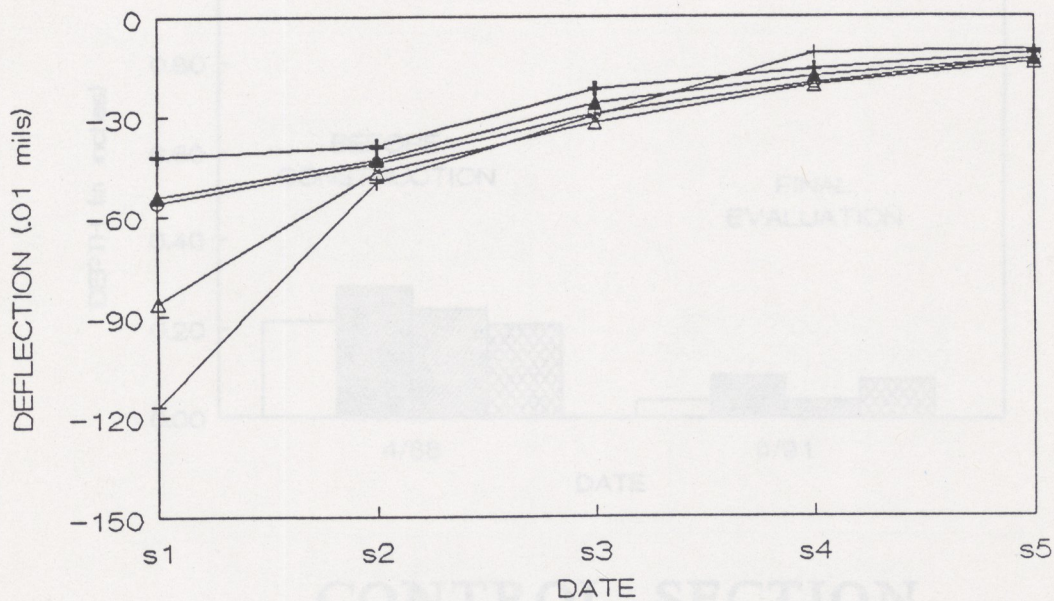
FIGURE 4

The deflection measurements taken prior to construction and over the evaluation period indicate that the load carrying capacity of the pavement section increased slightly following construction. The pavement appeared to become stronger over the first year following construction and then leveled off. There was no significant difference in the overall strength of the pavement when comparing the control and test sections. A graph of the deflection basins for the test and control sections over the evaluation period can be found at the end of this section (figure 4).

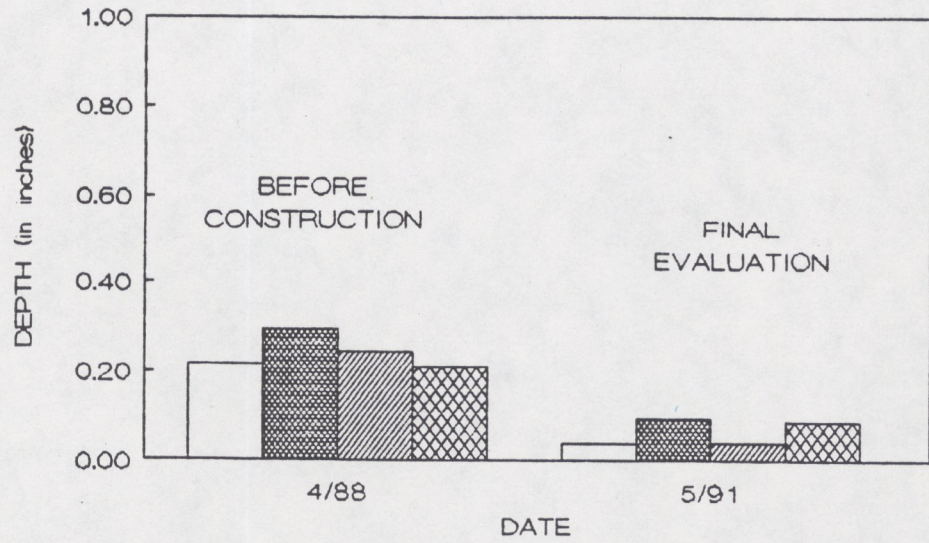
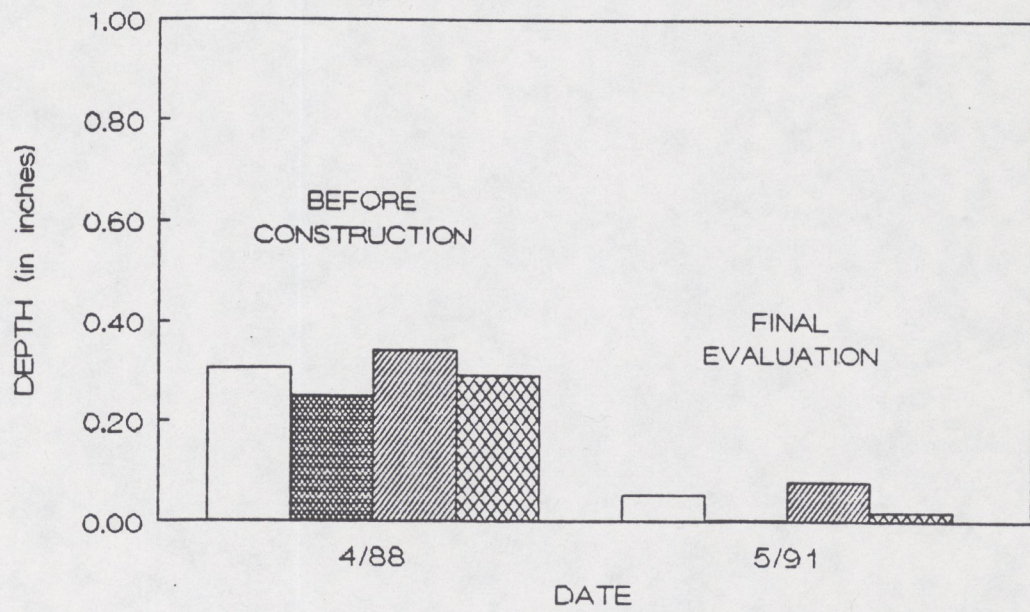
FIGURE 5

Rutting measurements were taken each year. The rutting measurements taken during the last evaluation (spring 1991) indicate that rutting was not a significant problem in either section; however, the Gilsonite appears to be

helping the pavement resist the rutting and shoving action placed on the pavement at the intersection.

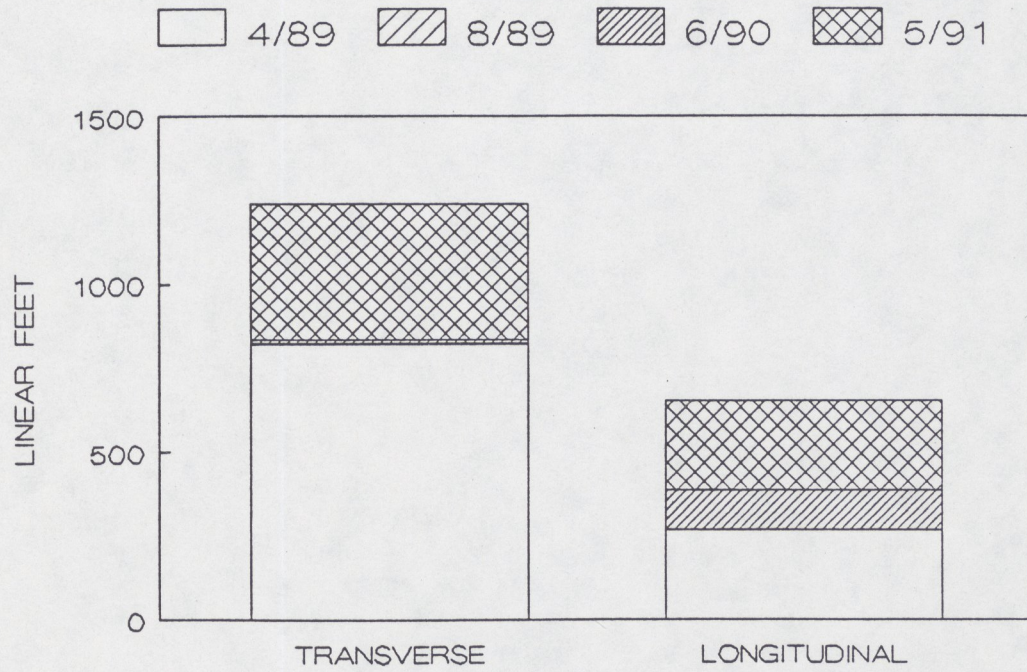
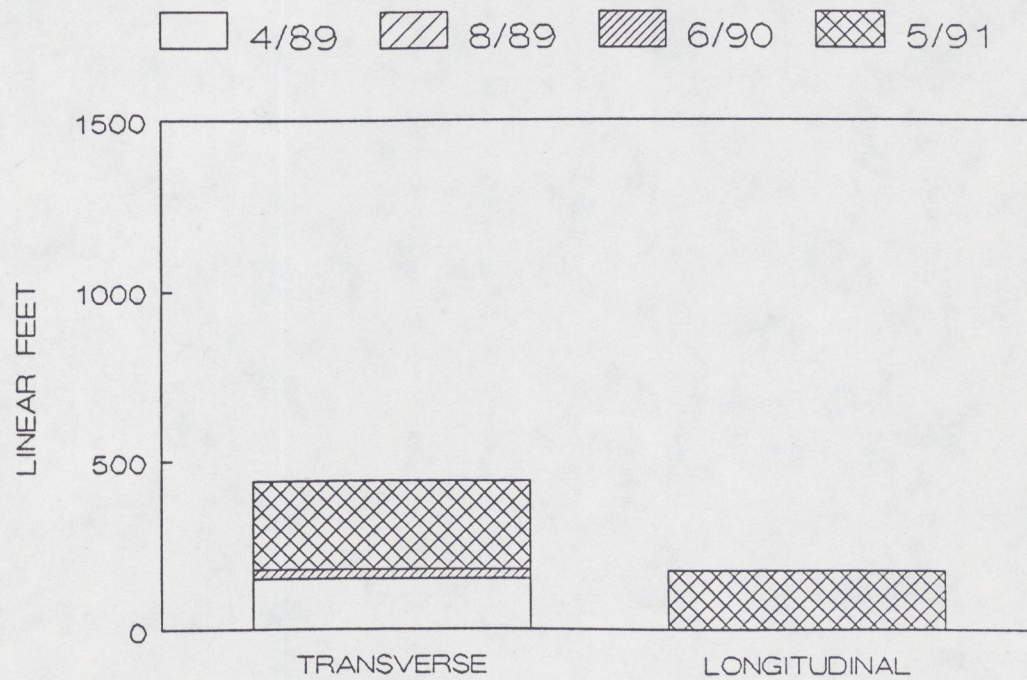
FIGURE 6

Cracking maps were drawn for the test and control section during each post-evaluation. During the first year, the Gilsonite test section developed a longitudinal crack that extended along the center line for nearly one half the length of the test section. Longitudinal cracking did not appear in the control section until three years after construction. In the Gilsonite test section there was approximately six times more transverse cracking than in the control section after the first year.

Following the final evaluation, cracking in the control section was minimal compared to the Gilsonite test section. The total cracking in the Gilsonite test section was approximately three times the amount in the control section. In May 1991, the Gilsonite section had a total of 1864 linear of cracking of which 1240 feet was transverse. During the same evaluation the control section had 567

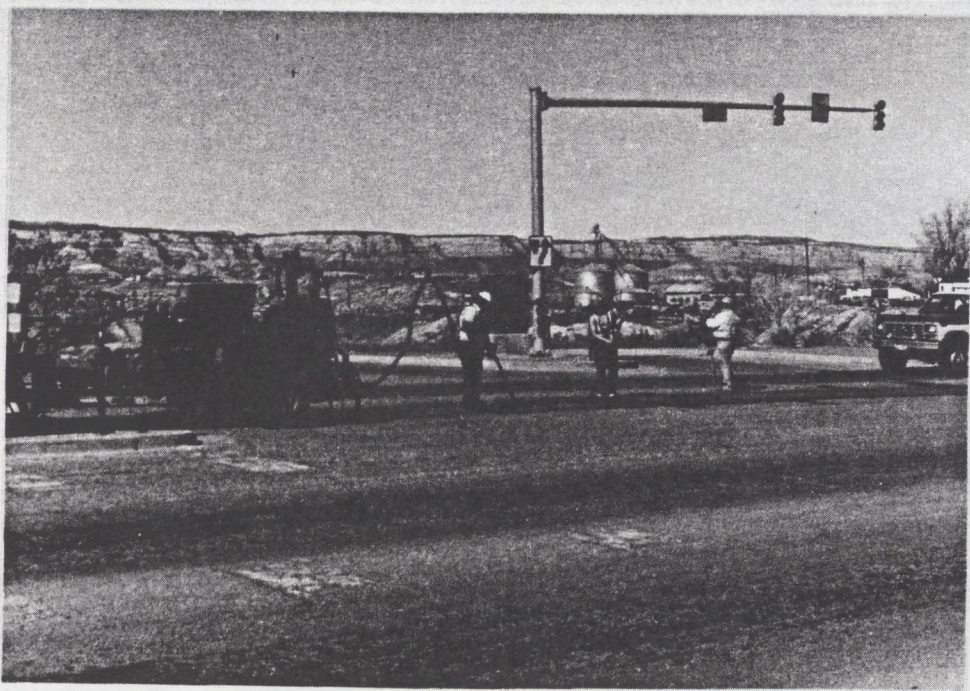
Rutting on the pavement prior to construction ranged from 1/10 of an inch to 1/2 of an inch.

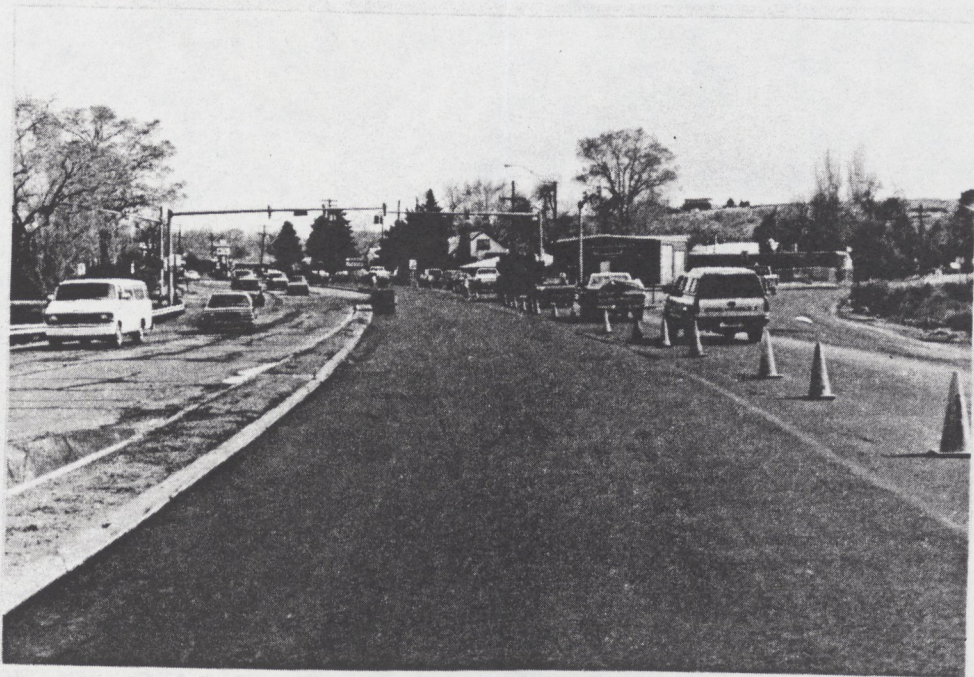
Prior to construction the cracks were cleaned and filled with a scrap rubber crack filler material.

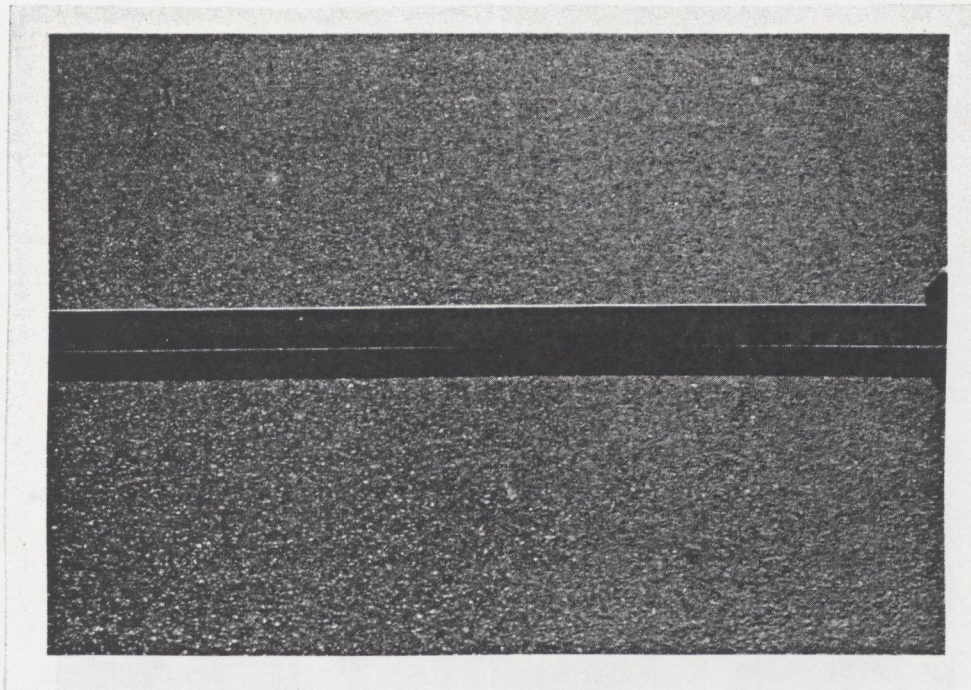
The Gilsonite test section was placed at the UnawEEP intersection.

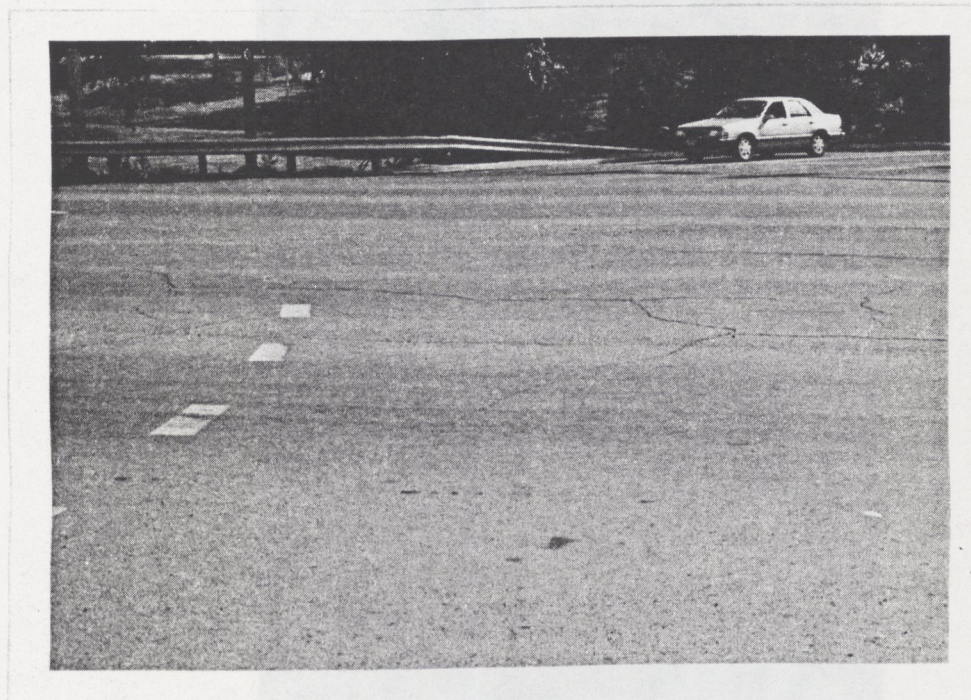
Rutting in the test and control section during the last evaluation was not significant.

Photo taken August 1991.

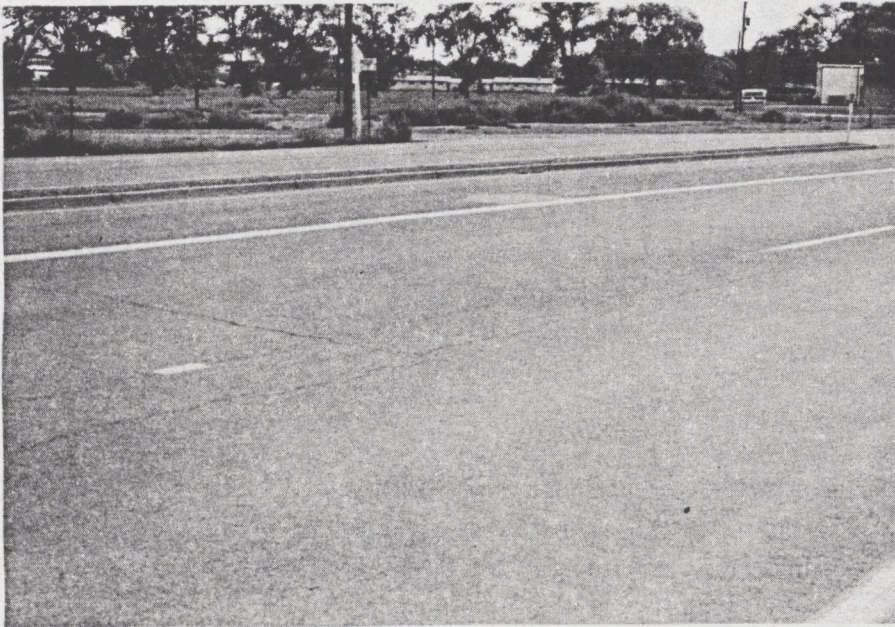
linear feet of which 399 feet was transverse. In addition, the cracks in the Gilsonite test section were wider and were deteriorating at a faster rate than the cracks in the control section. See photos on page B-5 in Appendix B.

This photo shows the amount of cracking in the Gilsonite test section at the last evaluation. August 1991

Based on the performance of this test section, the addition of Gilsonite cannot be justified. The consequence of increased cracking is much more severe than the benefit of the potential reduction in rutting.

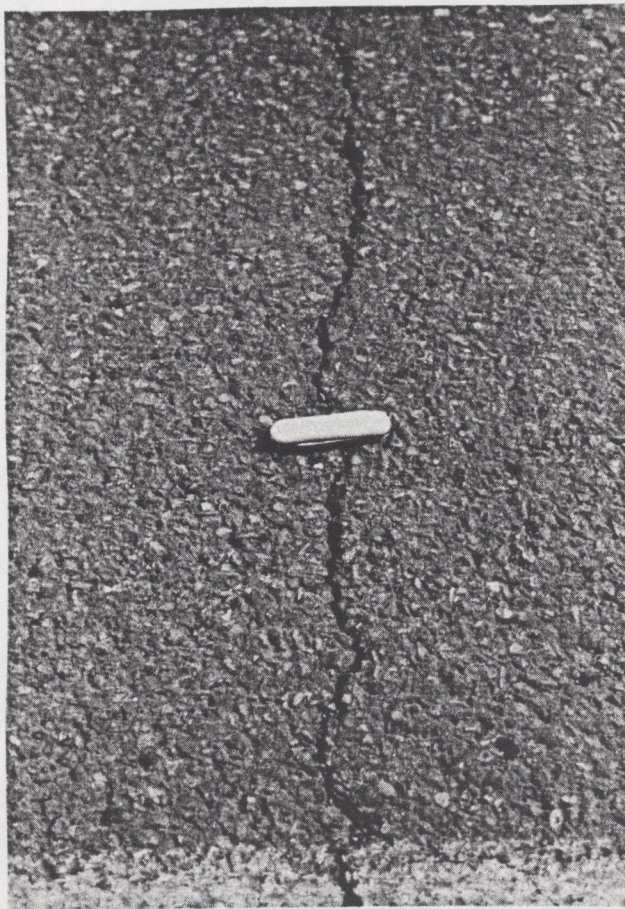
This photo shows a section where cracking has begun to appear in the control section. Photo taken August 1991.

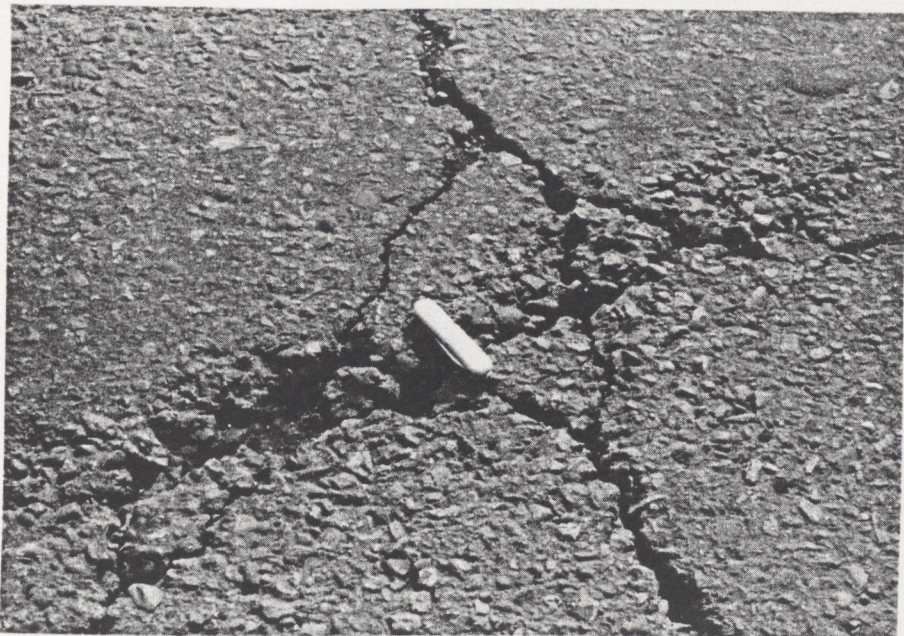
After considering these factors, the data collected over the evaluation period indicated the addition of Gilsonite appeared to reduce or retard rutting, however it tended to harden the pavement creating a structure that was more susceptible to premature cracking. The cracking appeared at a much faster rate and the cracks tended to deteriorate quicker and to a greater extent.

The cracks in the  
Gilsonite section are  
much wider than the  
cracks in the control  
section. August 1991  
Gilsonite section

The cracks in  
the Gilsonite  
section are  
also  
deteriorating  
faster.
