**Report No. CDOT-DTD-R-2004-10  
Final Report**

# **CABLE GUARDRAIL**

**Interim Report  
June 2004**

**COLORADO DEPARTMENT OF TRANSPORTATION  
RESEARCH BRANCH**

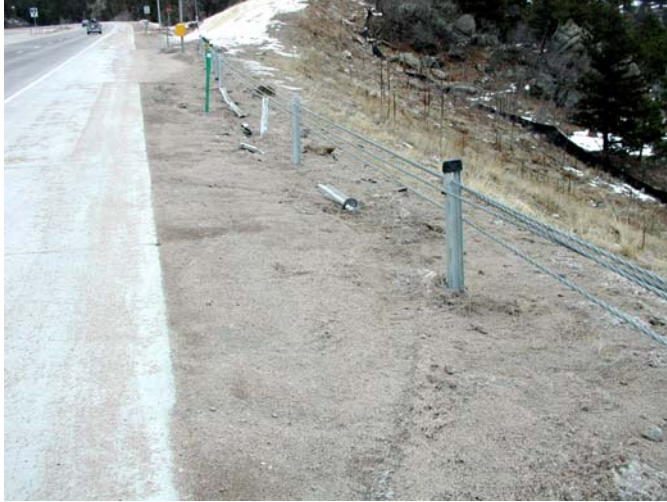
**Figure 1. The most severe hit on the Windy Point systems damaged only six posts.**

on US-285, Research was notified of four hits. Three of them were so minor that the impacting vehicles left without law enforcement being informed. One required replacement of 4 posts; the second, 2 posts; and the third, 3 posts. The fourth hit was more severe. It involved a CDOT engineer from Durango who credits the Brifen WRSF system with saving his life. This more severe accident required replacement of only 6 posts. None of the accidents required replacement or repair to anything other than posts and hardware such as cable locator pegs and post caps.

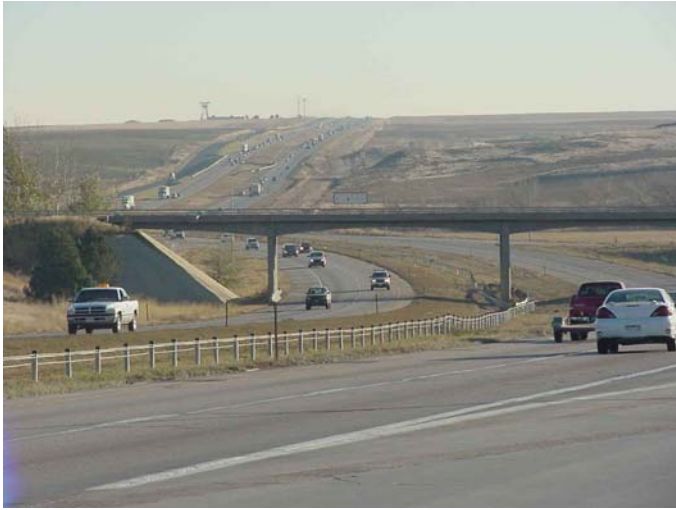
**Figure 3. The I-25 – SH-56 interchange, looking south.**

Three of the accidents occurred on the same day, November 22, 2003, in a period of about an hour, when the area was experiencing icy driving conditions. Two of the accidents were on the system north of SH-56 and one was to the south, beyond the overpass in **Figure 3**.

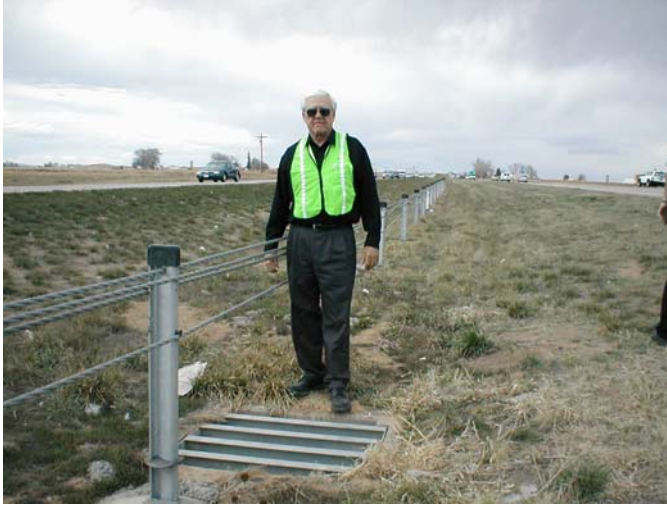
**Figure 4. The cables over this drain inlet are much farther off the ground than the design specification.**

According to the accident report, in addition to the side hit by the southbound vehicle, the Honda was damaged quite extensively on its top. It appears that the vehicle happened to penetrate the cable system at a drain inlet. The depression at the inlet appears to have allowed the vehicle to pass under the cables. The fact that, according to the accident report, there was considerable damage to the top of the vehicle, and that it did not roll, supports this theory. The accident report specifically mentions that there was no damage to the cables or support posts at the point of penetration.

**Figure 4** shows the height of the cables at the drain inlet where it is believed the Honda went under the cable guardrail. About eight inches above the bottom of the post in the foreground there is a flange that is designed to keep debris out of the post socket – that flange should be at ground level. The tension of the woven cables is actually holding the post up partially out of the socket. On the near side of the post the cable can be seen below the locator peg. Normally the lowest cable should be 20 inches above the ground. Because of the depression around the inlet drain in the picture it is considerably higher – enough higher that the Honda mentioned above was able to pass under the entire system. A solution for this problem is discussed in the Recommendations section of this report.

From a design and construction standpoint, correct cable height along outside shoulders is usually easy to establish due to the constant slope of the shoulders. Correct cable height can be more easily established in median installations by running the cable guardrail system a set distance from the shoulder line of one side of the highway, rather than down the center of the median. (Brifen USA recommends 18 feet offset from the shoulder stripe if the median is wide enough, which should accommodate mowing operations. ) By putting the cable in an area where the slope does not vary up and down in short distances, it is easier to maintain a uniform height for the cables above the surface thus preventing high or low areas where the barrier can be more easily under- or over-driven. A barrier that follows the smooth curves of the highway is also more aesthetically pleasing than one in the center of the median that has to wander from side to side to avoid passing directly over depressions at drain inlets.

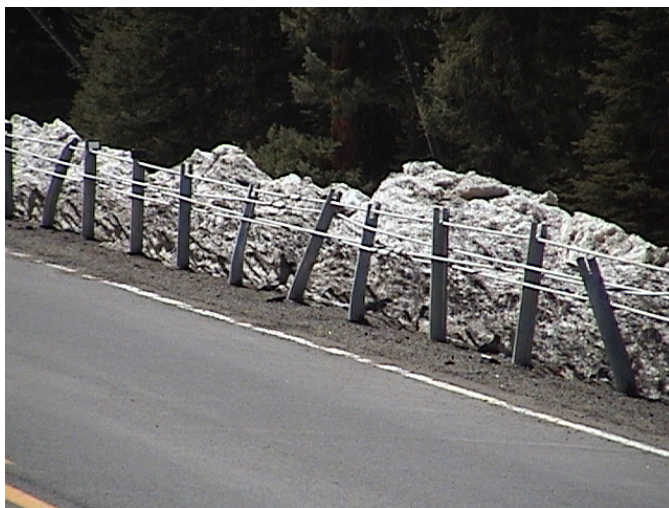
**Figure 5. Posts on SH-65 are bent in all directions, suggesting that the damage is not all caused by snowplows.**

snow. Accumulations of several feet hide the cable system from plow operators, making their jobs more difficult. Some posts are undoubtedly bent by plows. In addition, the weight of the accumulation of snow pushes against the posts, bending others. Many of the posts on SH-65 will need replacement when the snow melts. **Figure 5** shows that the damage to the system is not entirely from plow blades hitting the posts. The fact that some are curved rather than bent over at the base, and some are bent toward the highway suggest that the force of the snow and ice thrown by the plow blades and the weight of the snowbank behind the cables contribute significantly to the damage.

To reduce damage to the cable systems during the winter, it has been suggested that the posts and cables be removed from areas like those described above. Liability issues are one reason that would not be feasible. Maintenance personnel cannot tell when the snow will collect to the point where it will fill in around the guardrail. If they wait too long, they cannot get the system out to storage; if they pull the guardrail too soon they risk leaving a hazard unprotected and incurring a liability situation if there is an accident at that location.

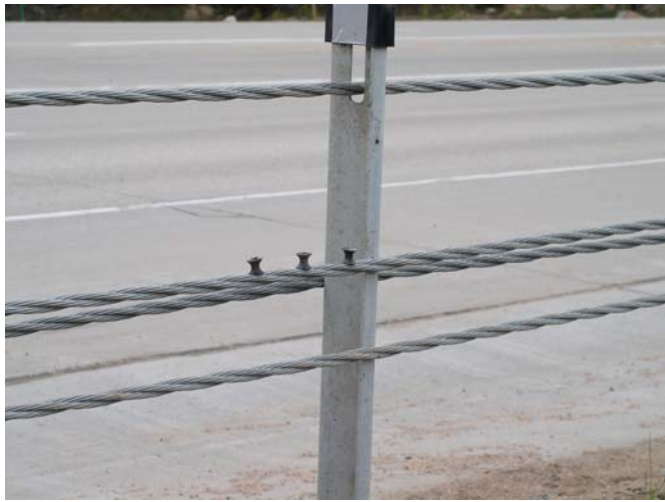
locater pegs to break or pop out of their holes for some distance from the point of impact, even on posts that have not been bent. Cables that are too low or too high are better than no barrier at all. However, as the penetration of the median system on I-25 demonstrates, their effectiveness is reduced.

**Figure 6. Cables positioned lower than design height.**

It is important to maintain the cables at the correct heights set by the locating pegs on the sides of the posts. In areas where heavy snow is thrown over and through the cable system by snowplows, the impact of the snow and ice on the cables and posts may be strong enough to break or pop out the locator pegs, allowing the cables to sag below the design height. It may be necessary to replace the pegs and reposition the cables to the proper height periodically. **Figure 6** shows cables that are lower on the post than the design heights. The three black pegs sitting on the cable in the picture had been broken from their mounting holes and were lying on the ground near the post. In the picture, a black dot can be seen on the side of the post just below the top cable. It is the hole for the upper cable locating peg for this side of the post. This is where the top pair of woven cables should be, with the lowest cable 6-1/2 farther down the post (about where the woven pair are in the picture).

It is very important that the cable height both sides of the impact point be checked whenever accident damage is being repaired. Movement of the cables during impact often causes the
