**Report No. CDOT-DTD-R-2003-7  
Final Report**

# **EXTENT OF TOP-DOWN CRACKING IN COLORADO**

**Donna Harmelink, P.E. CDOT Research Branch  
Tim Aschenbrenner, P.E. CDOT Materials and Geotechnical Branch**

**July 2003**

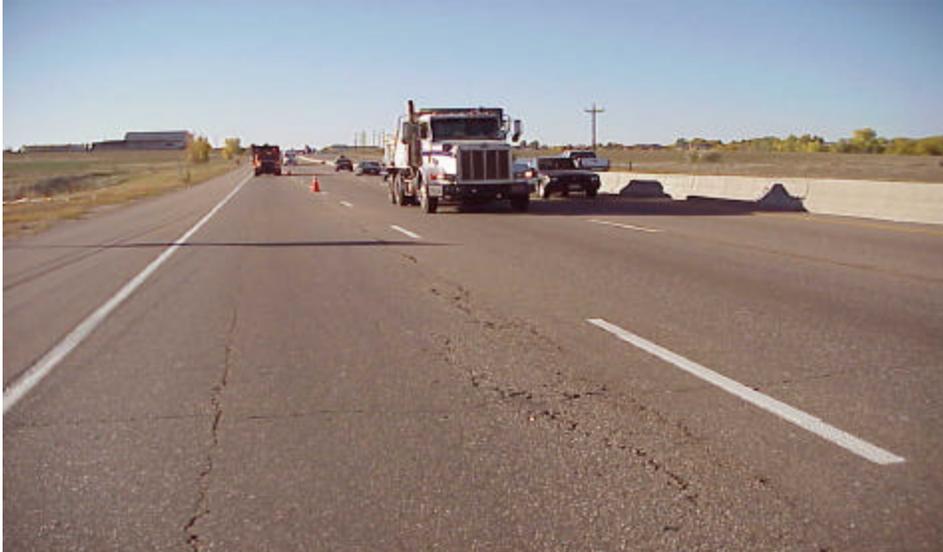
**Figure 1. Longitudinal cracking was found on this project as shown in this photograph. This cracking pattern was consistent throughout the entire length of the project.**

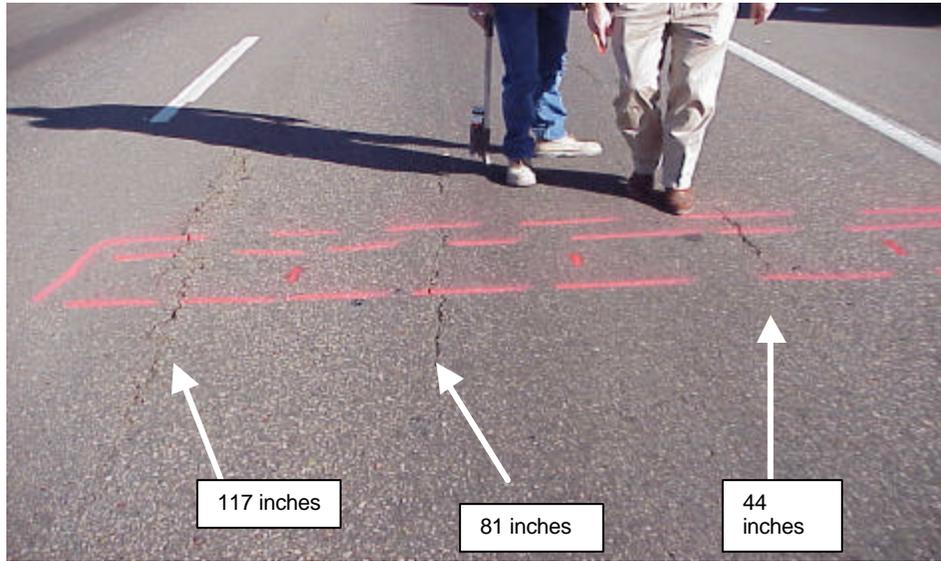
**Figure 2. This photograph shows the location of each crack with respect to the other cracks. The distance is measured from the outside shoulder stripe.**

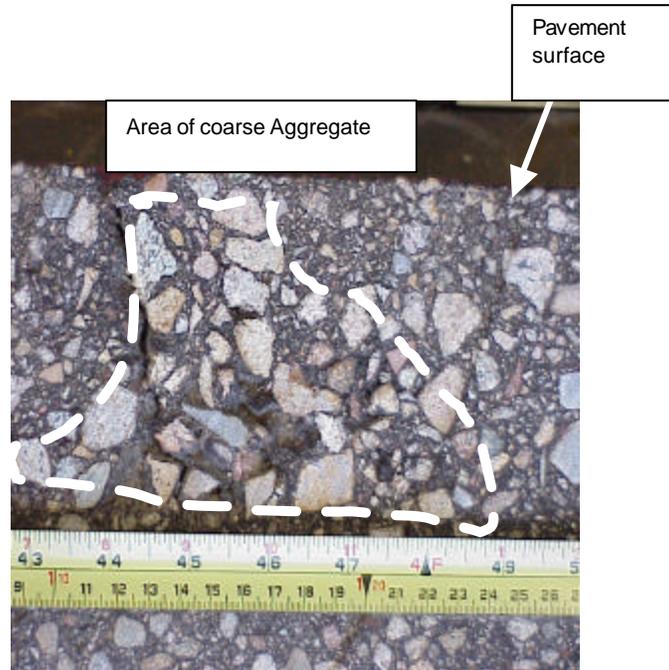
**Figure 3. There was segregation present within the mat at each of the cracks. The segregation was particularly severe at the 44-inch crack.**

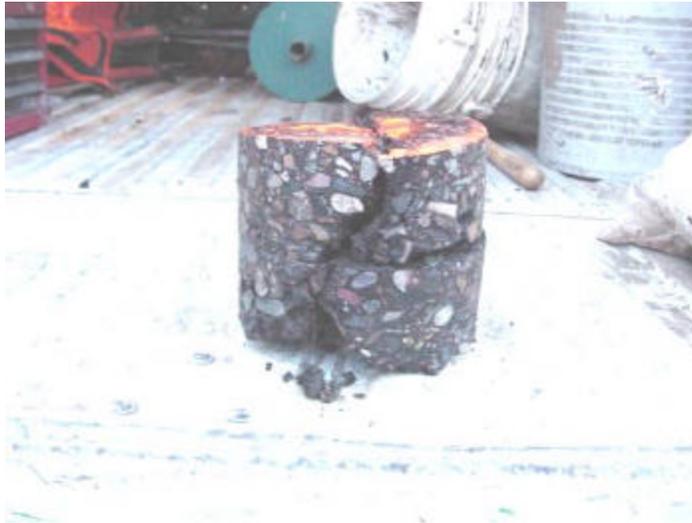
**Figure 6. This crack is reflective, as it goes through the entire thickness of the pavement**

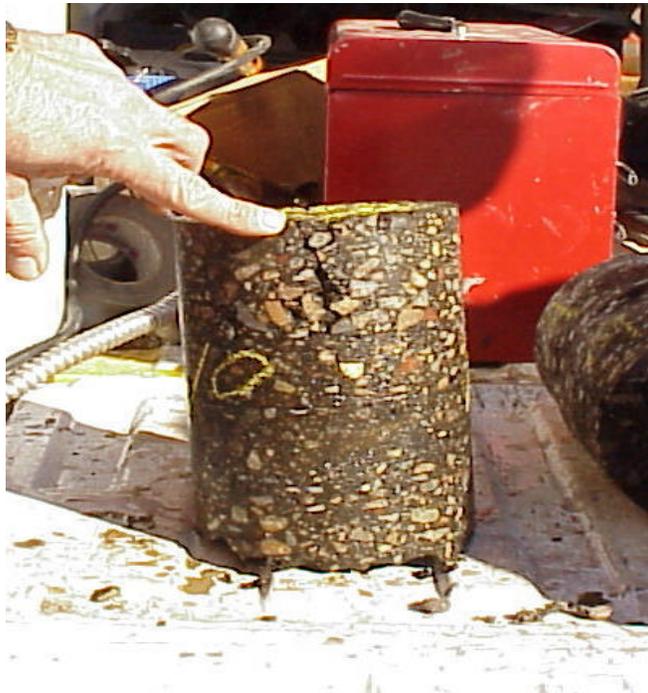
**Figure 7. This crack is top-down as you can see it is only visible in the top lift**

Since approximately 67% of the top-down cracking cores had visual signs of segregation, it is recommended that the cracks be sealed as soon as possible. If moisture is allowed into the pavement through the cracks the segregated areas

will be prone to rapid deterioration. Sealing the crack will prevent moisture from penetrating the pavement and deteriorating the pavement further.

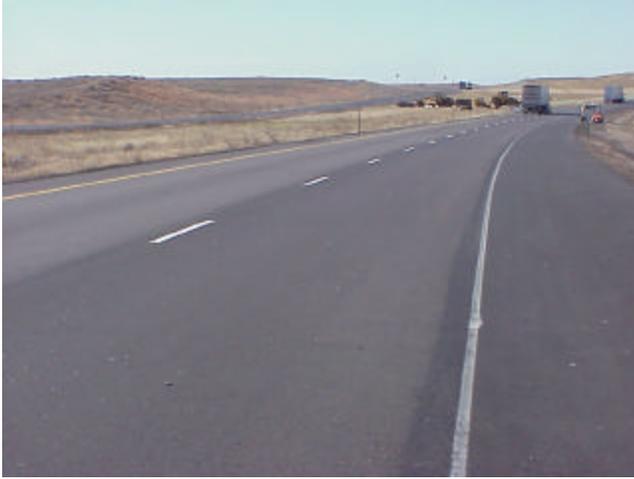
**Figure 10. This photograph shows the project shortly after construction. Segregation on the surface was not apparent.**

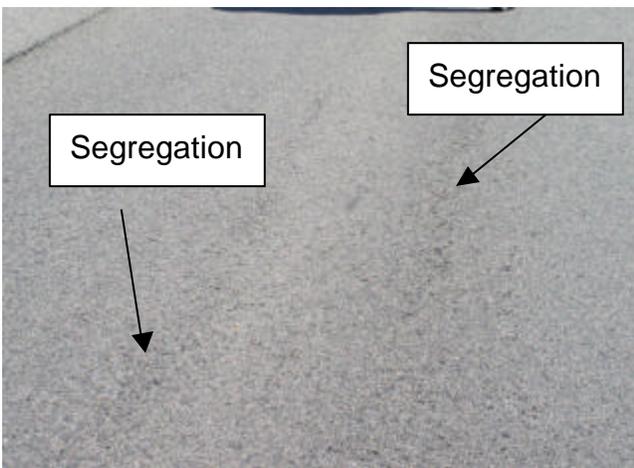
One of the projects that exhibited top-down cracking was a location that was part of another on-going research study. This project was overlaid in 1999. Following construction the surface texture of the pavement appeared to be very tight and uniform. Figure 10 shows the surface texture of the pavement within months after construction. During the evaluation conducted in 2003 it was noted that this same pavement surface was showing signs of top-down cracking in addition to what appears to be segregation on the surface. Figures 11 and 12 show the surface texture as it appears today.

**Figure 11. This photograph was taken 4 years after construction. There are two areas where segregation has begun to appear.**

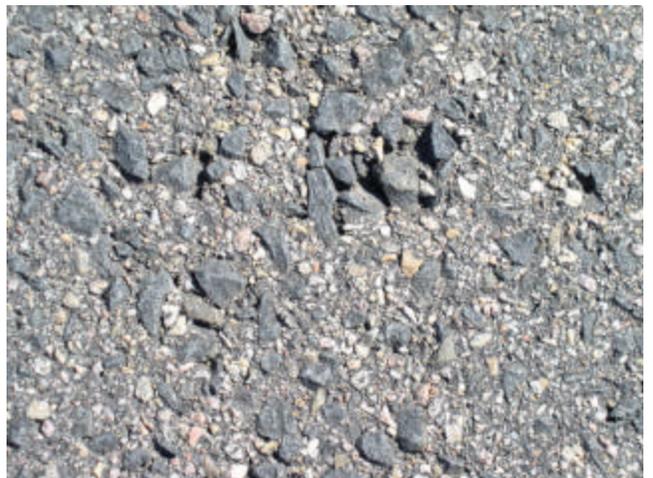
**Figure 12. This is a close-up of the segregated area in Figure 11.**

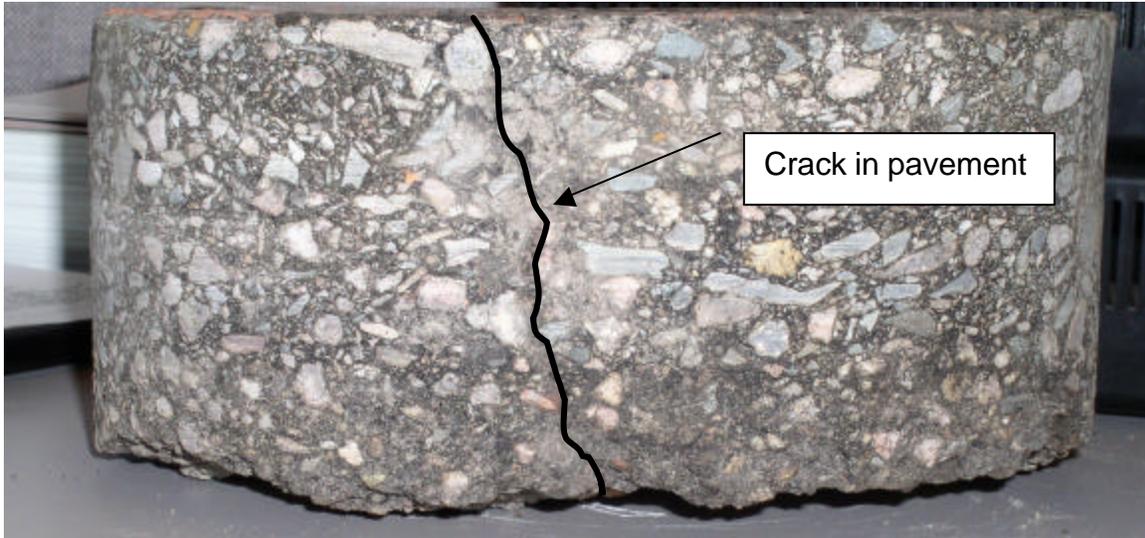
Figure 13 shows a photograph of a core taken from another project that has exhibited top-down cracking. This core was taken centered over the top-down crack. As you can see in the photograph, it is apparent that around the cracked area there are less fines than in the non-cracked area of the core.

**Figure 13. Photograph of core taken over a top-down crack. This crack was only found in the top mat; it was not apparent in the lower mat. Although it is not well defined it does appear that the material around the crack is coarser than the material on either side of the crack.**

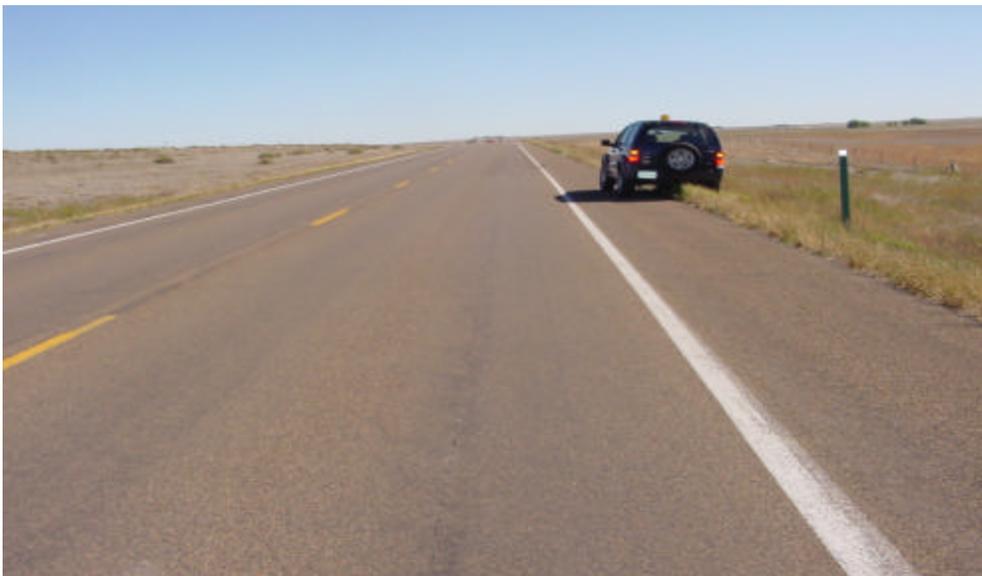
**Figure 14. This distress was a reflective crack. Note the linear straightness and low severity of the crack.**

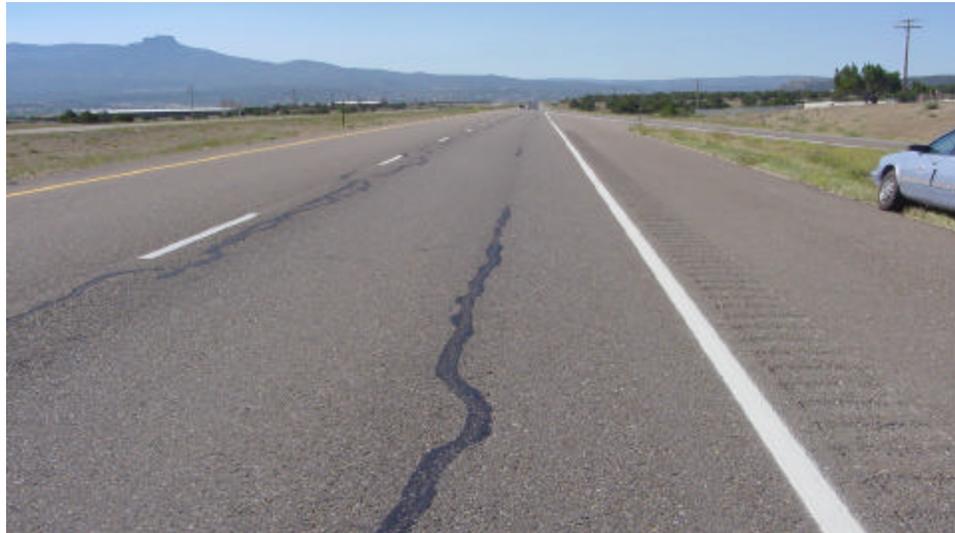
**Figure 15. This crack was top-down. Although the crack is straight, the severity was enough to warrant crack sealing.**

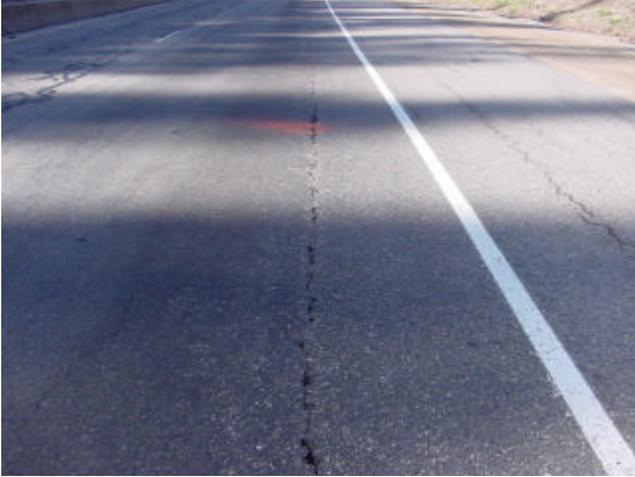
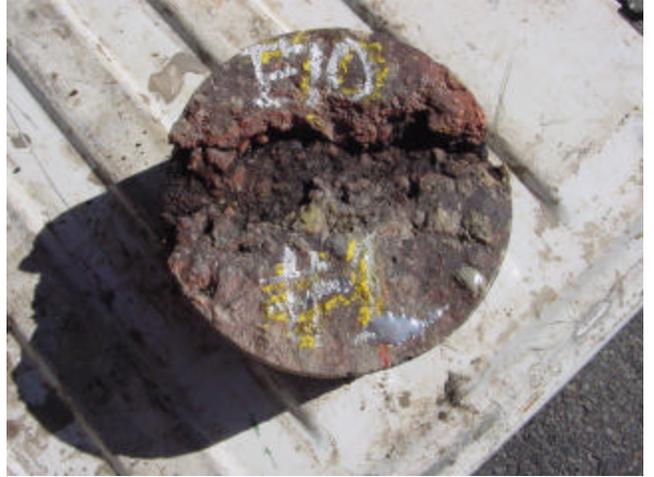
Site 1 (I-70, MP 185.7, Vail Pass)

Top-Down Cracking

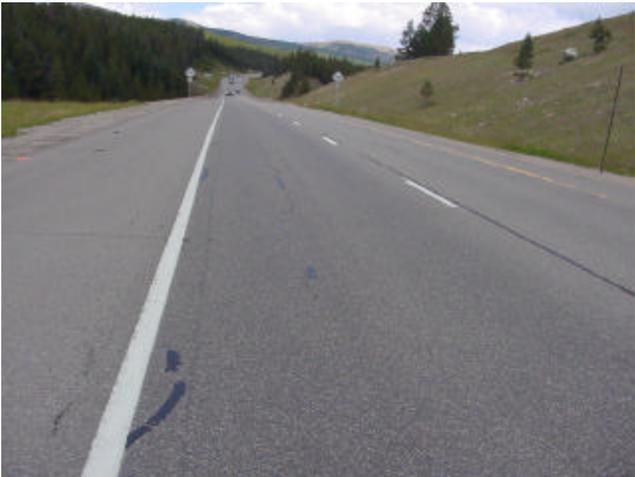
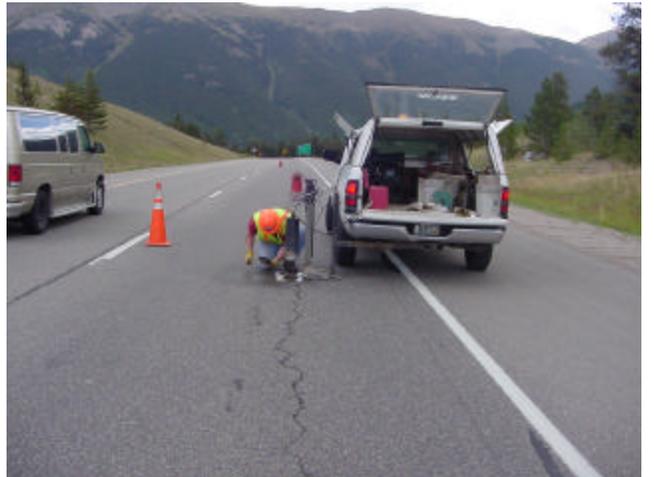
Site 2 (I-70, MP 193.8 – W. of Copper Mtn)

Top-Down Cracking

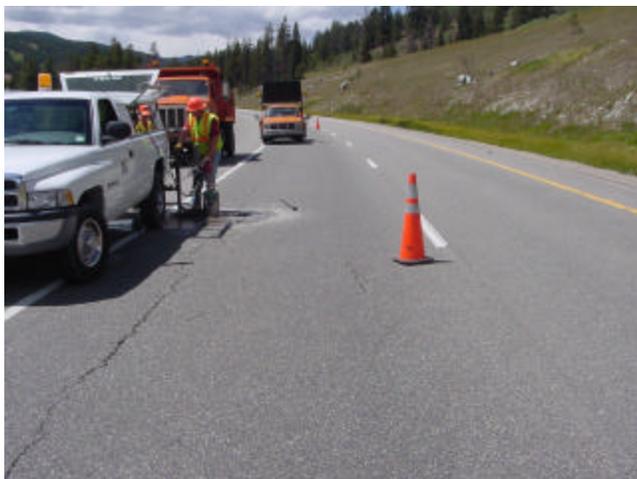
Site 3 (I-70, MP 194.3 W. of Copper Mtn)

Top-Down Cracking

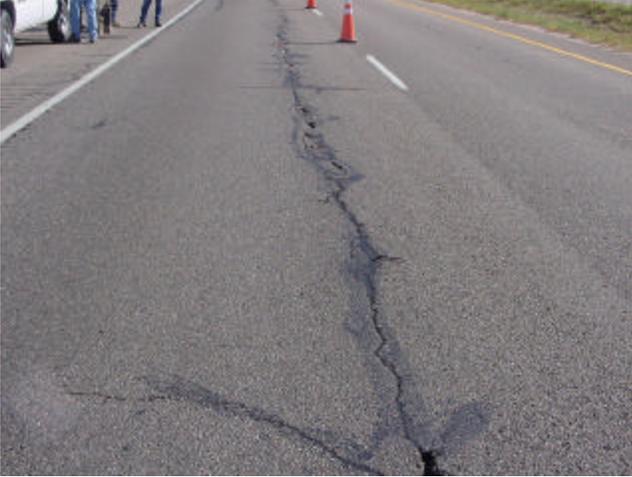
Site 5 (I-25, MP 75.3, Colorado City)

Reflective Cracking

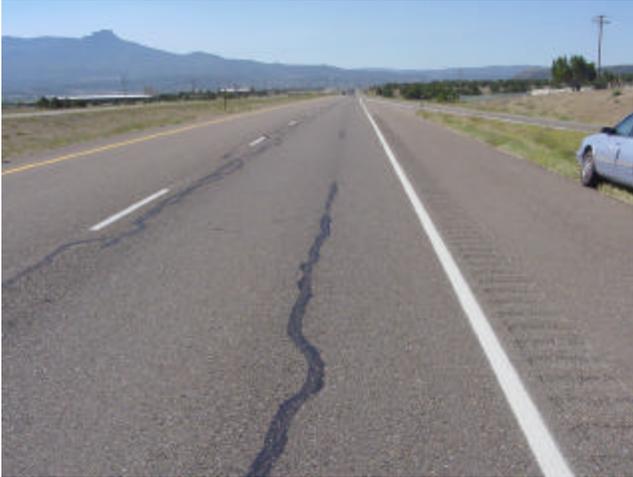
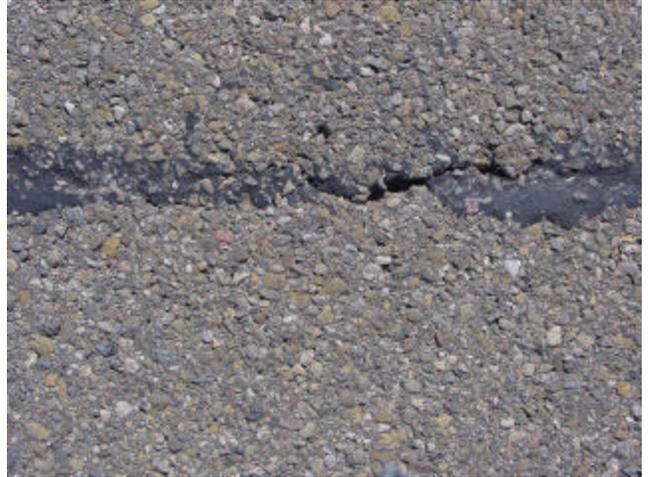
Site 6 (I-25, MP 17.6, N. of Trinidad)

Top-Down Cracking

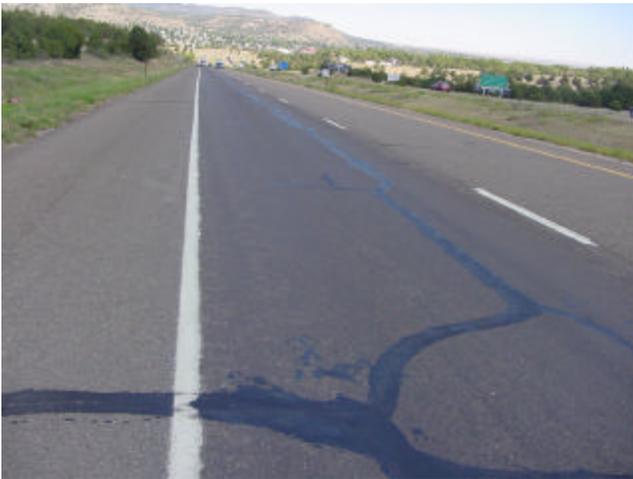
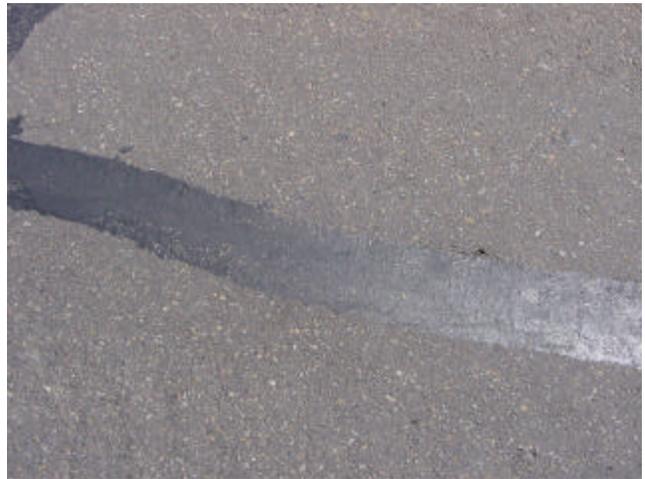
Site 7 (I-25, MP 11.7, S. of Trinidad)

Reflective Cracking

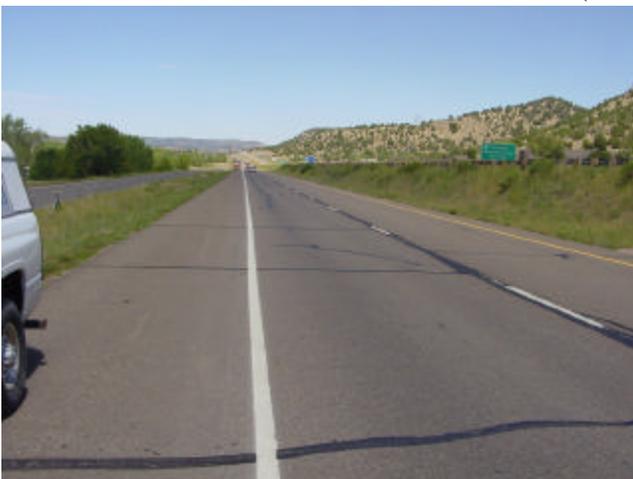
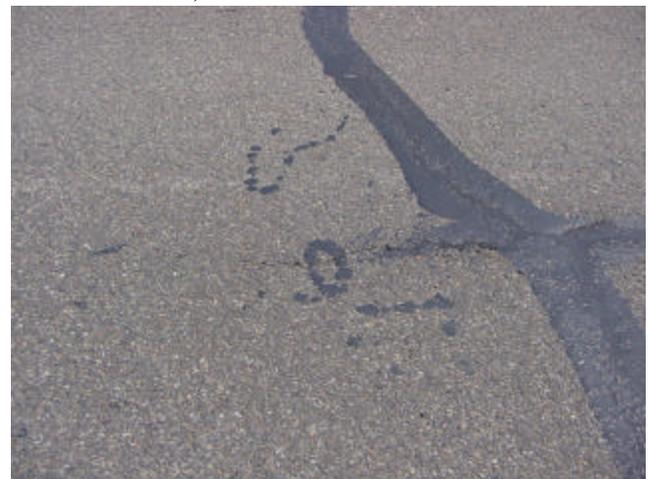
Site 8 (I-25, MP 9.2 Raton Pass)

Reflective Cracking

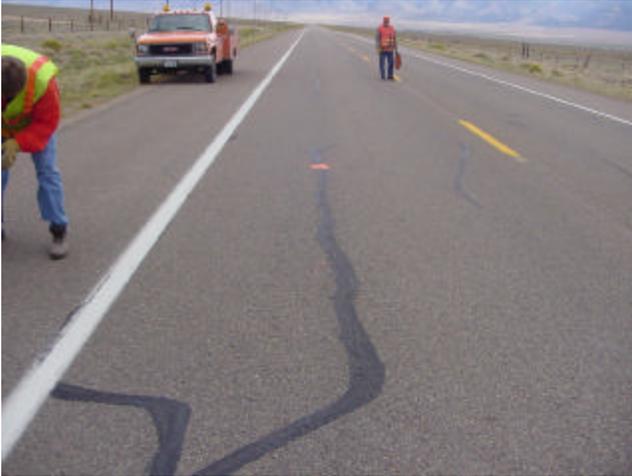
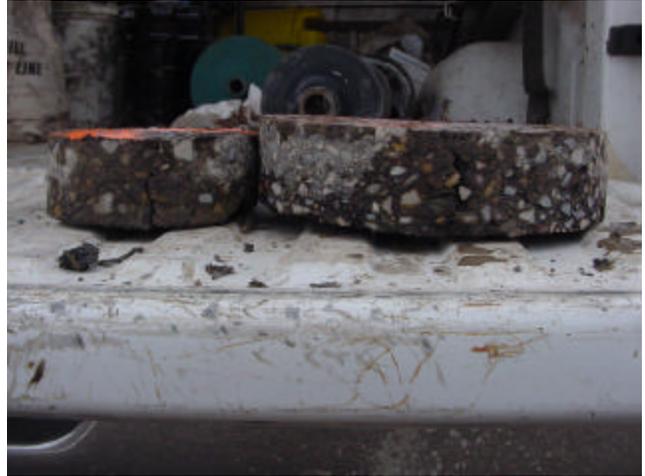
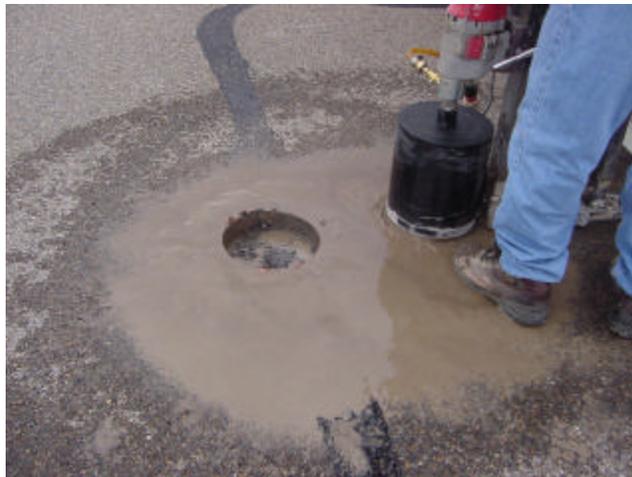
Site 12 (US 285, MP 96.5 – Saquache)

Top-Down Cracking

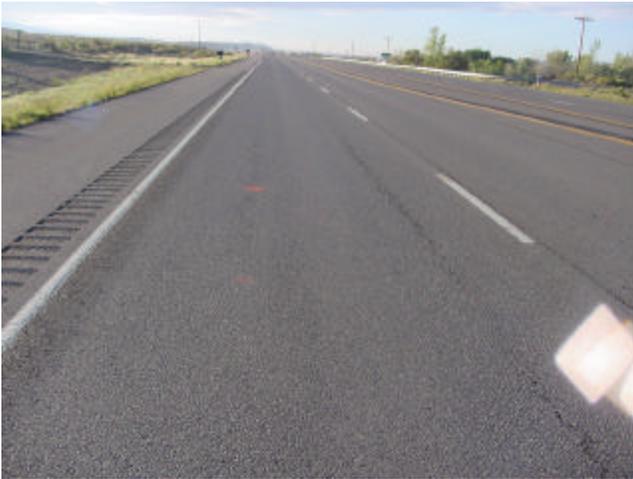
Site 13 (US 50, MP 41.2 – Red Mountain)

Top-Down Cracking

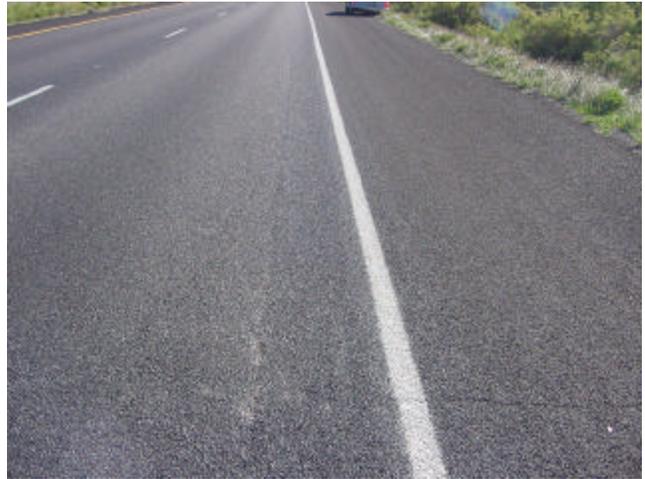
Site 14 (I-70, MP 38.2- Clifton)

Top-Down Cracking

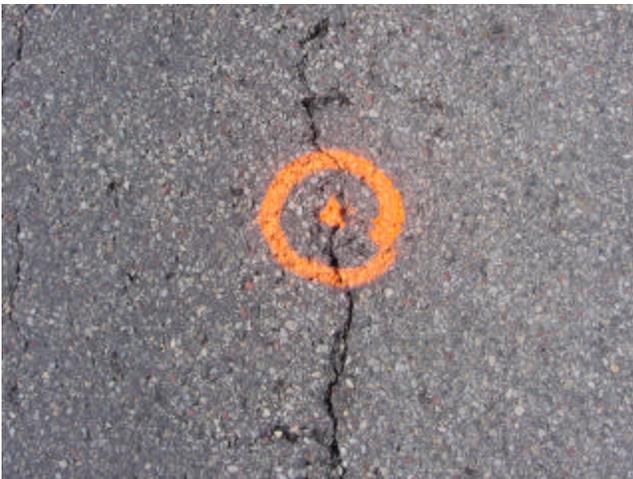
Site 15 (I-70, MP 64.0 – DeBeque)

Top-Down Cracking

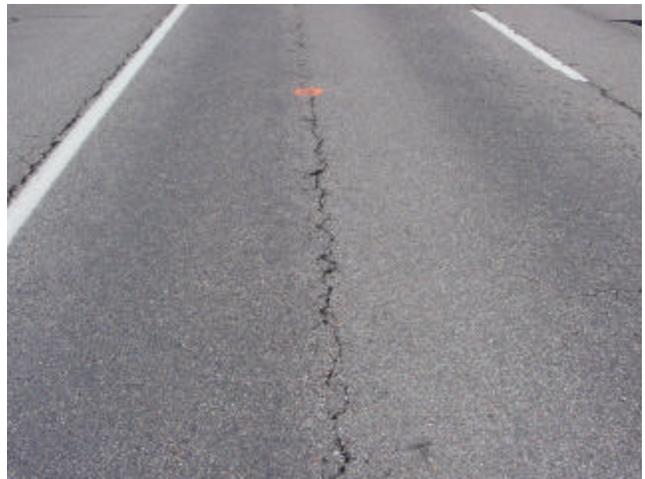
Site 16 ( I-70, MP 74.1 – Parachute)

Top-Down Cracking

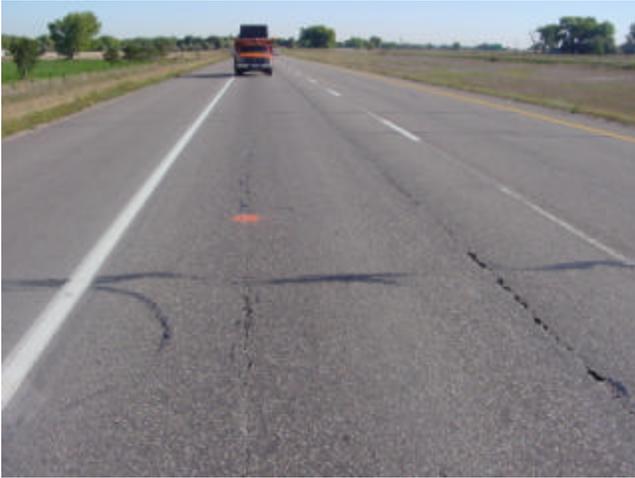
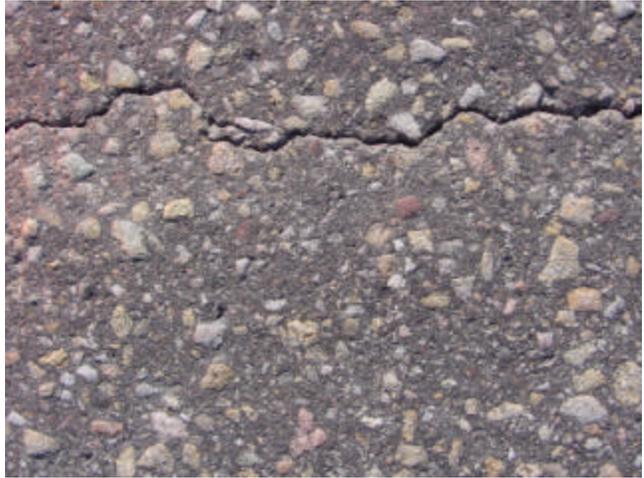
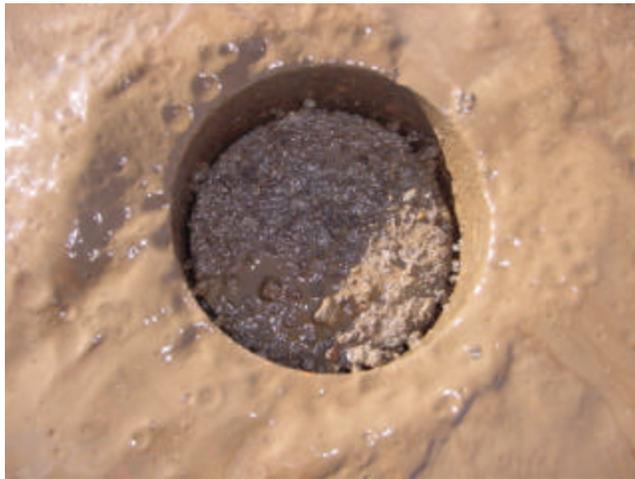
Site 17 (SH 119, MP51.7 – Longmont)

Top-Down Cracking

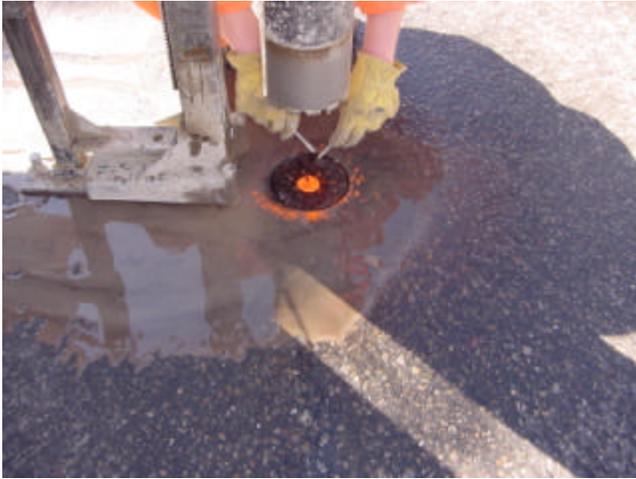
Site 18 (US287, N. of 9<sup>th</sup> Street, Longmont)

Top-Down Cracking

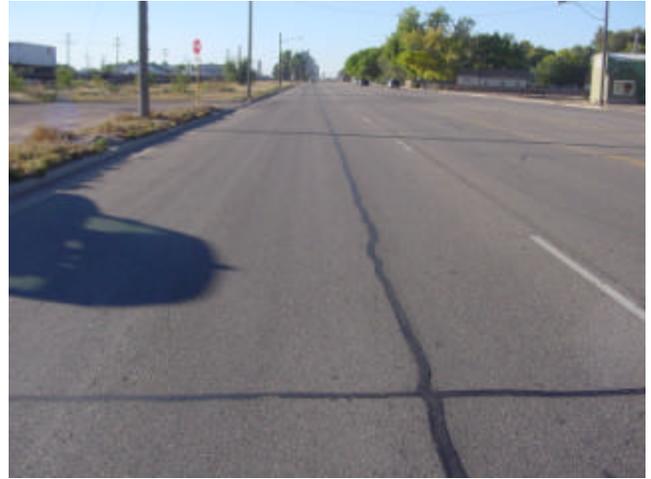
Site 19 (US 85, MP 280.2 – Ault)

Top-Down Cracking

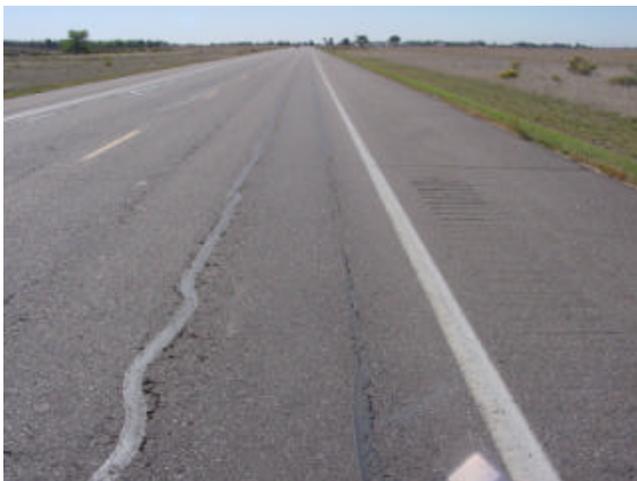
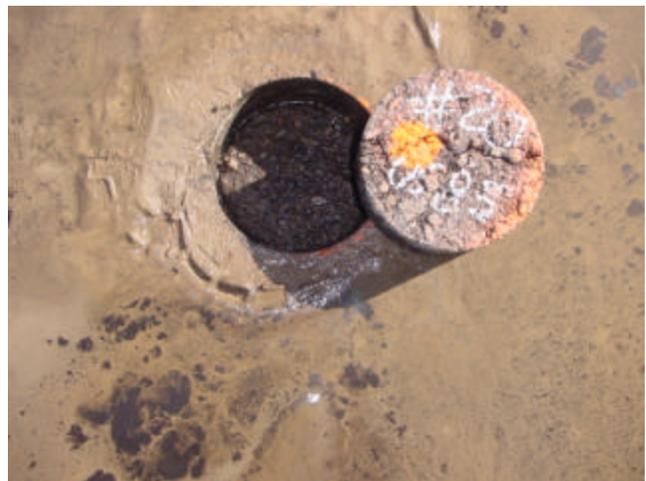
Site 20 (US 85, MP 290.2 – Nunn)

Top-Down Cracking

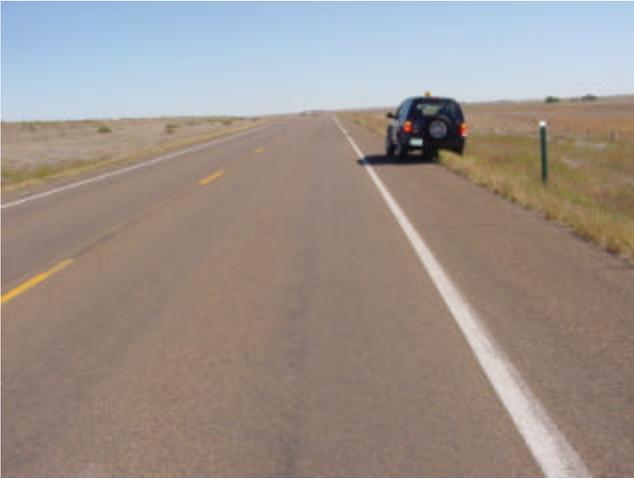
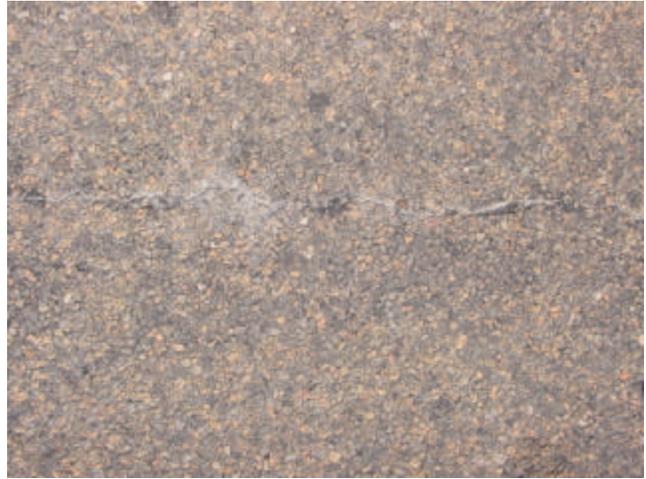
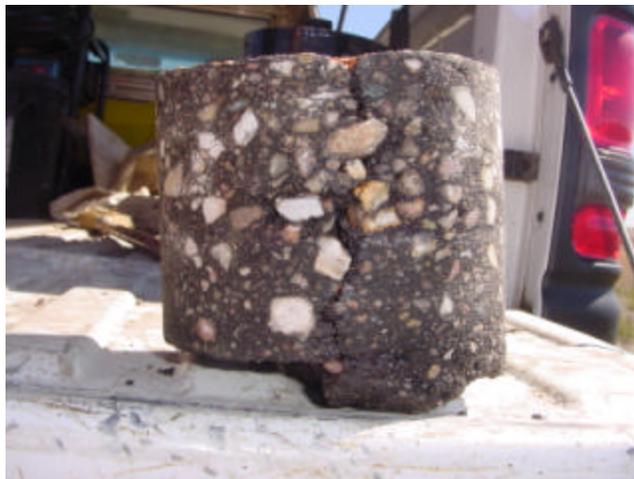
Site 21 (SH114, MP 198.8 – E. of Buckingham)

Reflective Cracking

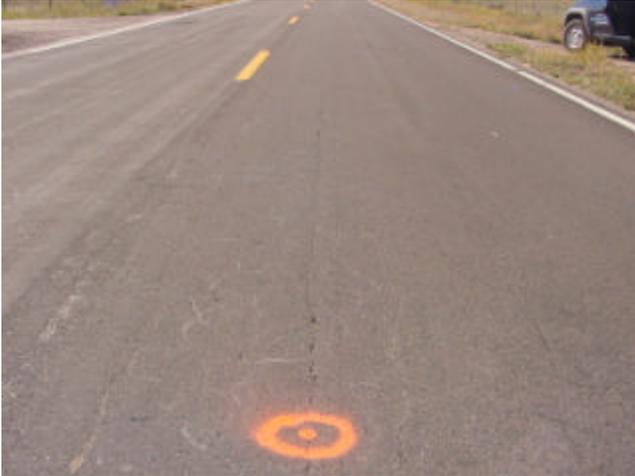
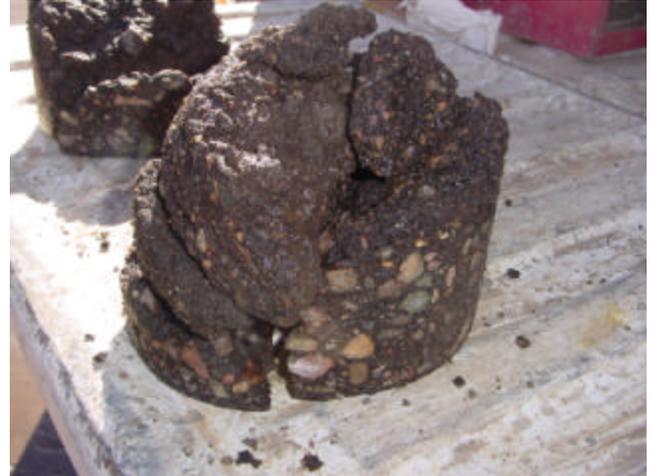
Site 22 (US 385, MP 253.3 – N of Wray)

Reflective Cracking

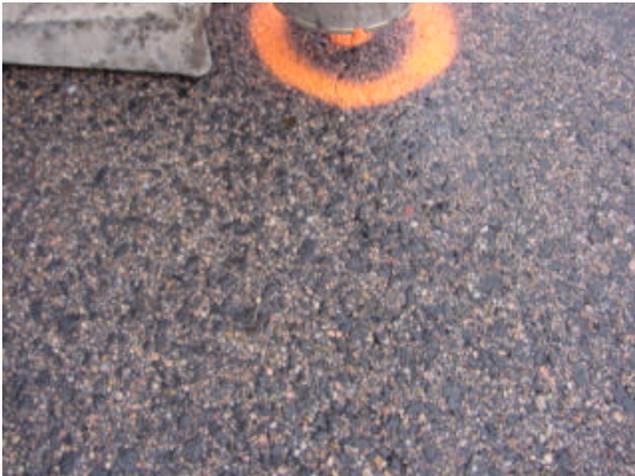
Site 23 (I-76, MP 127.3 – Sterling Rubblization Site)

Top-Down Cracking

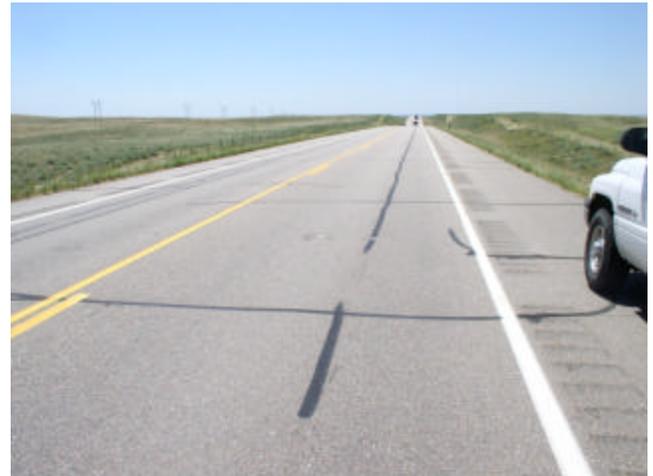
Site 24 (US6, WB, MP 409.2, (Sterling))

Reflective Cracking

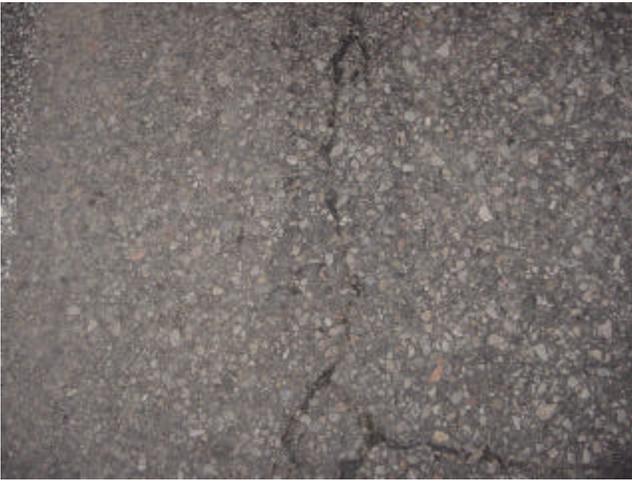
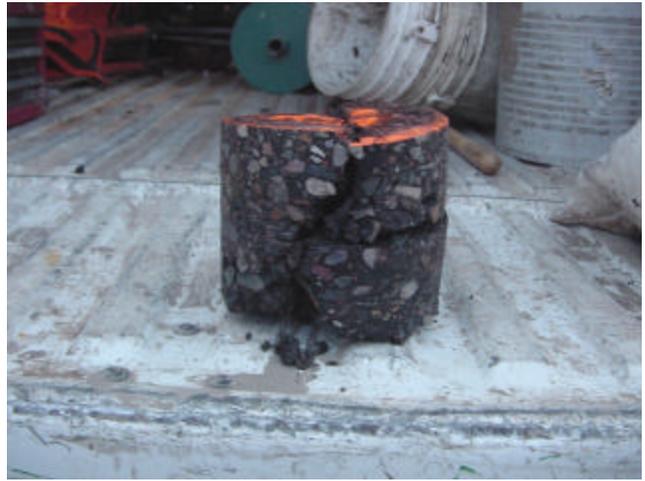
Site 10 (US160, MP87.7, Jct US550 in Durango)

Reflective Cracking

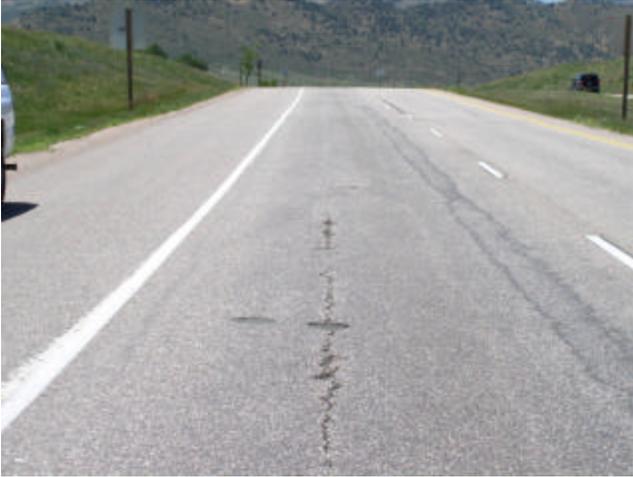
Site 25 (US 285, NB MP 251.3)

Top-Down Cracking

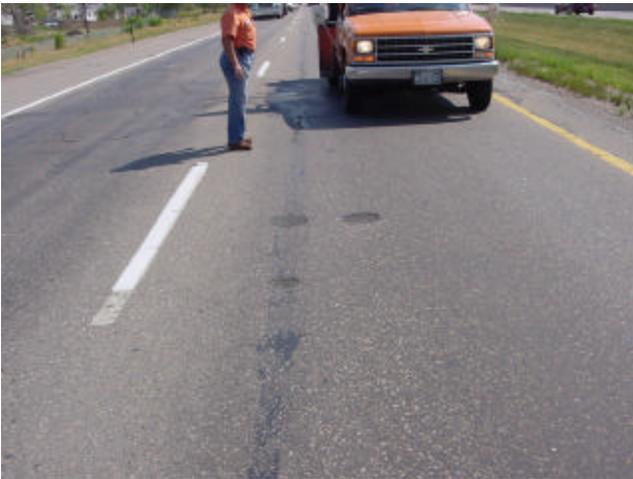
Site 27 ( I-76, WB Passing Lane; MP 1.3)

Top-Down Cracking

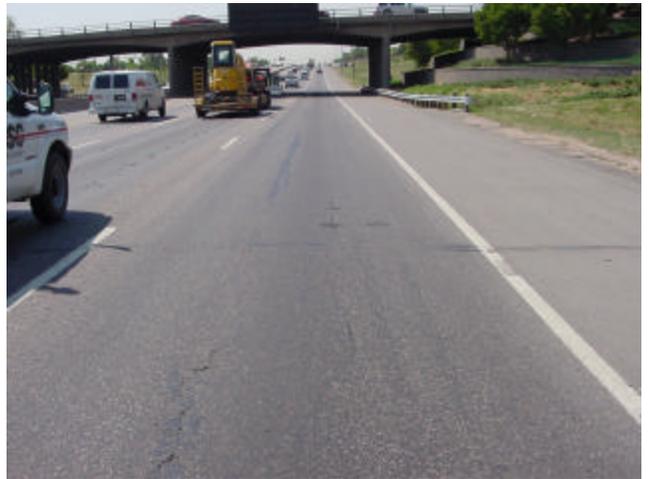
Site 28 (I-25, SB Driving Lane; MP 218.6)

Top-Down Cracking
