**Report No. CDOT-DTD-R-2006-8  
Final Report**

**PRECAST CONCRETE PAVING PANELS:  
THE COLORADO DEPARTMENT OF  
TRANSPORTATION REGION 4 EXPERIENCE,  
2000 TO 2006**

**Gary L. DeWitt, P.E.**

**August 2006**

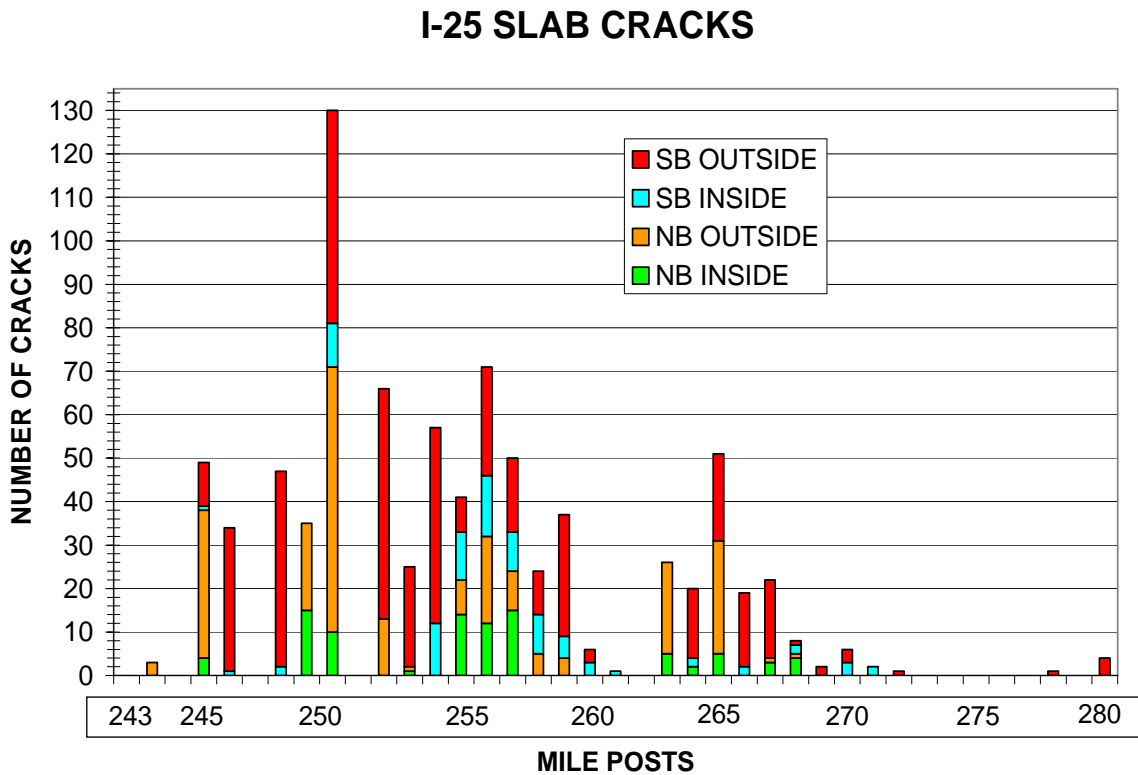
**FIGURE 1 PANELS WITH 3 PLUS FULL-DEPTH CRACKS I-25**

<p><b>TOTALS</b>  <b>Inside slabs .....83</b>  <b>Outside slabs.....352</b></p>
---

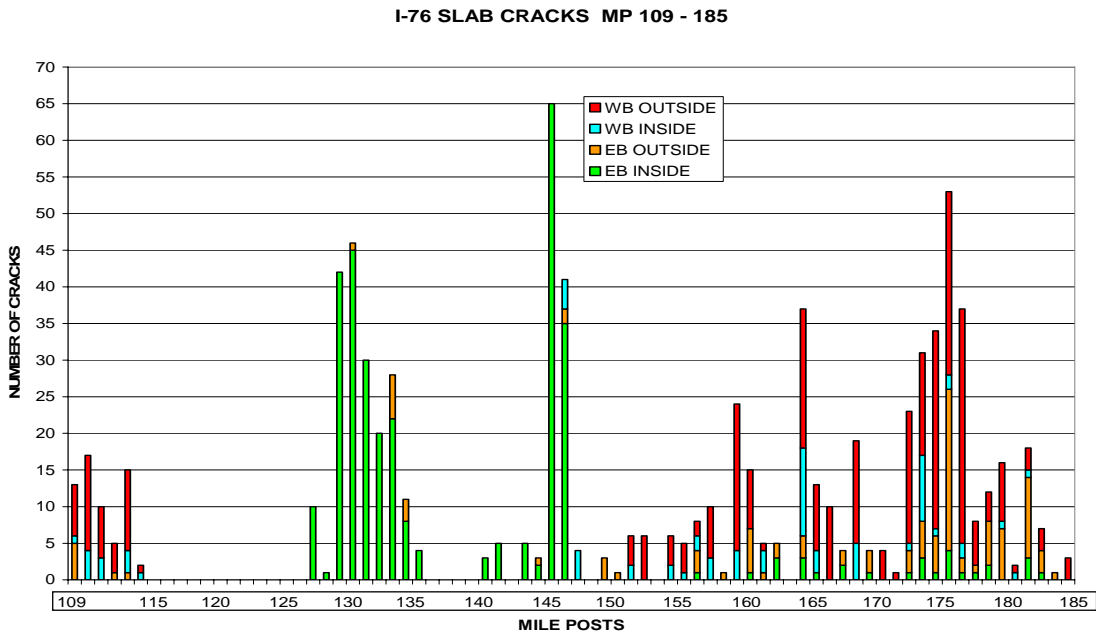
**FIGURE 3  
PANELS WITH 3 PLUS FULL-DEPTH CRACKS, MP 109 TO MP 185, I-76**

<p><b>TOTALS</b>  <b>Inside slabs.....179</b>  <b>Outside slabs.....659</b></p>
---

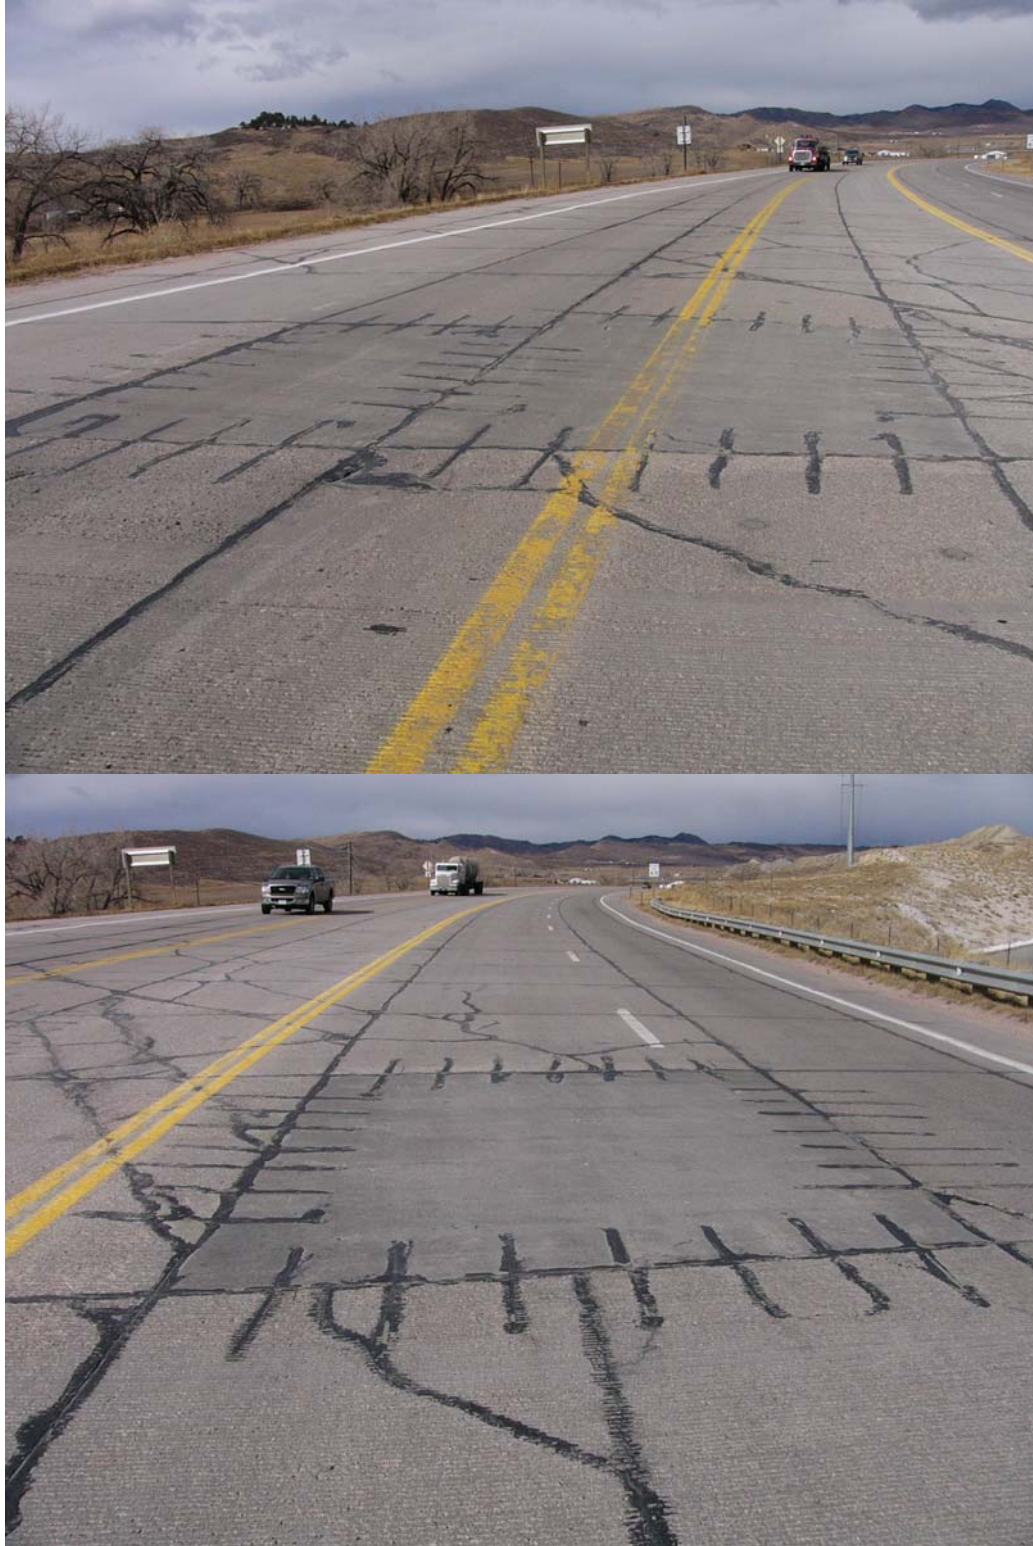
**PICTURES 1 & 2.**

No cracks are apparent from installation, slab remains in same position with no horizontal or vertical movement. Performance rating is excellent.

Precast panels installed November 30 –December 3, 2000 On Hwy 287 MP 350.9

**Performance:** excellent

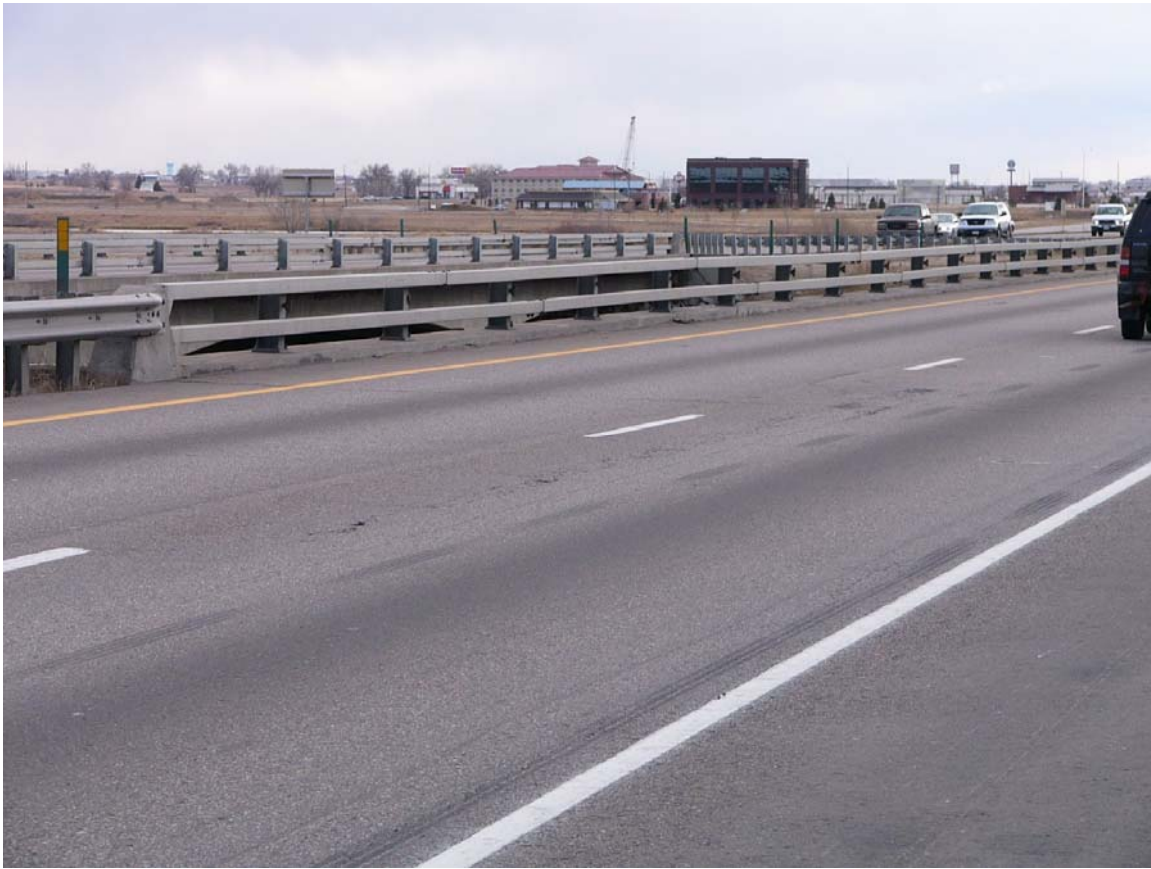
**MTCE 04 --012**                      **PICTURE 3**  
**10 inch precast panels adjacent St Vrain Bridge**  
**under 5 inch HMA. I 25 at MP 241**  
**Performance: excellent**

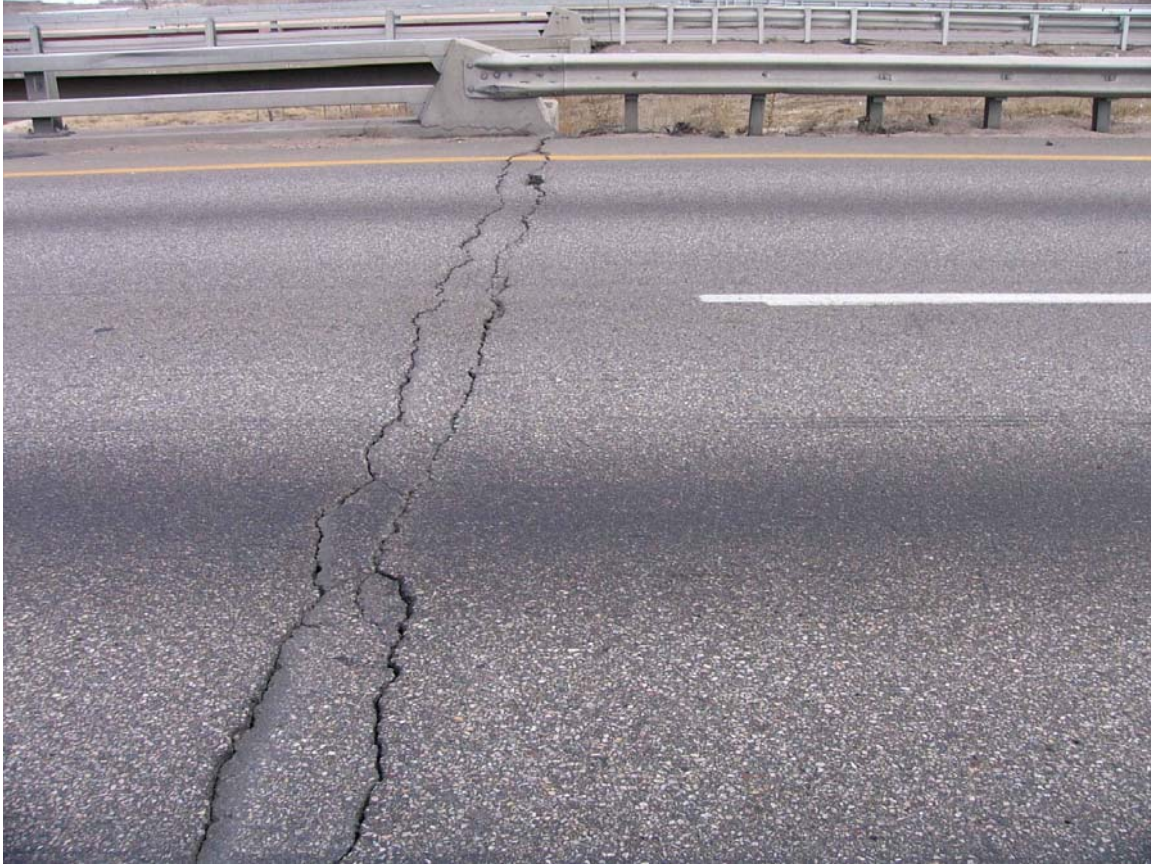
**PICTURE 4**  
**MTCE 04-012 CRACK AT BRIDGE ABUTMENT.** 10 inch precast panels  
adjacent to St. Vrain Bridge. I-25 at MP 241 **Performance:** excellent

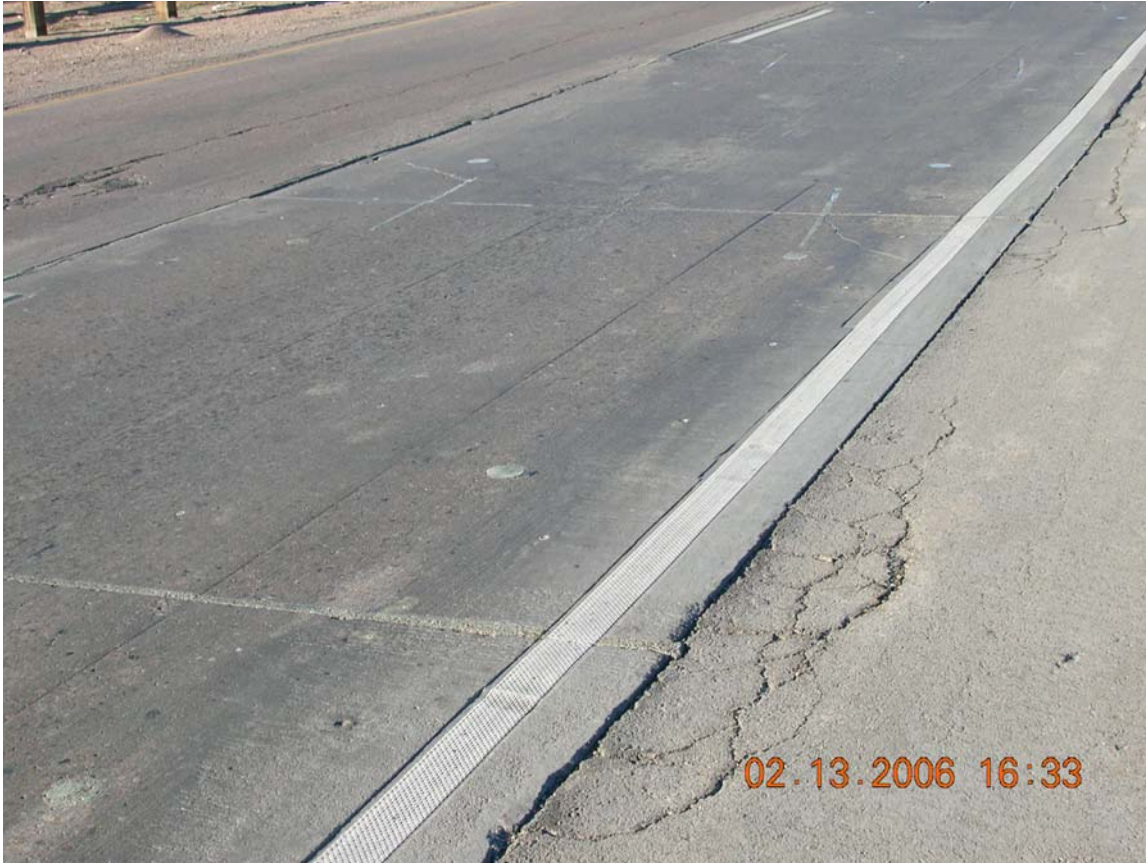
**PICTURE 5**

**MTCE 04-012** 10 inch precast concrete slabs with fiberglass ties skewed  
Hwy 85H in Greeley near MP 1.1

Series of 5 panels that fiberglass ties on transverse joint were not placed parallel with traffic flow. **Performance:** excellent

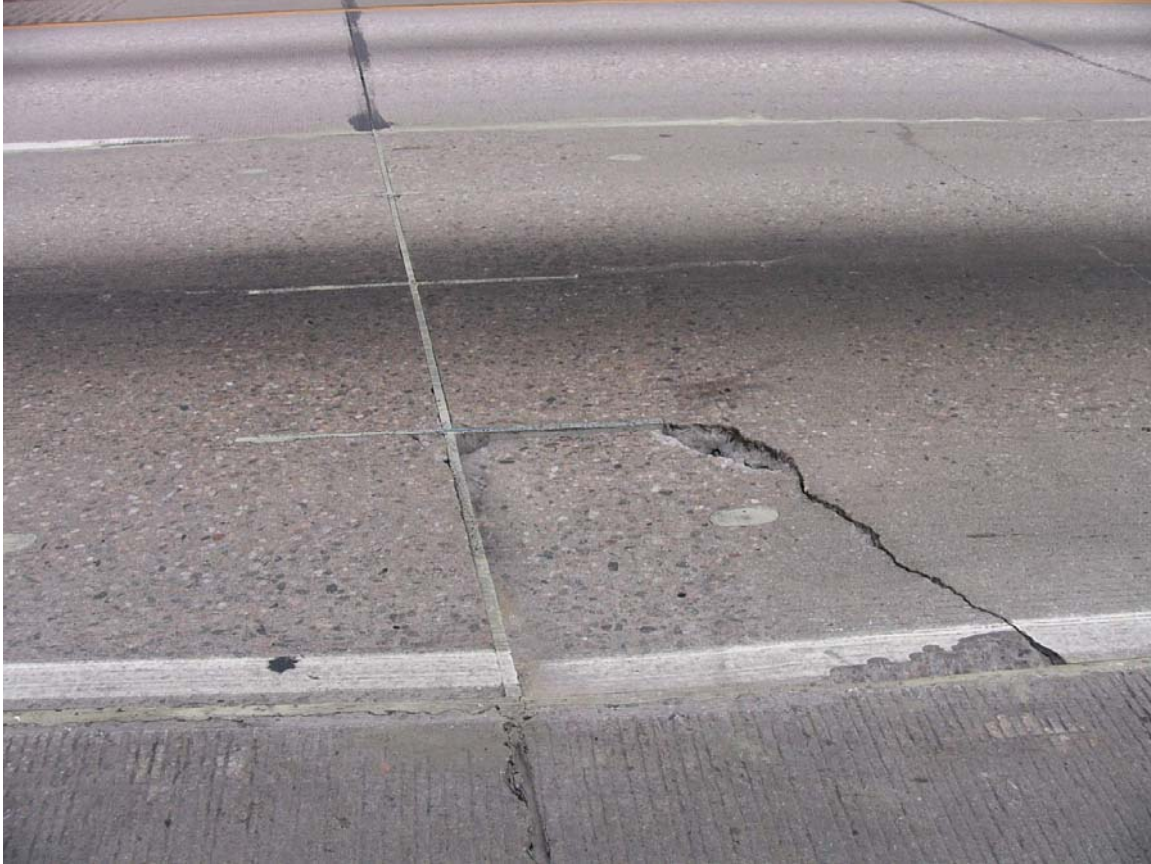
**PICTURE 6**

**MTCE 04-040** Typical crack failure on thin 5” to 7” precast slab  
On the away side (last traffic impact section)... I 25 MP

Traffic moves right to left on the picture. The crack leading to failure has been generally in this location for thin 5 “to 7” panels. **Performance:** poor
