# COLORADO STATE CAPITOL

## HISTORIC STRUCTURE ASSESSMENT

STATE HISTORICAL FUND PROJECT NUMBER  
SHF-2006-T1-001

**December 15, 2006**

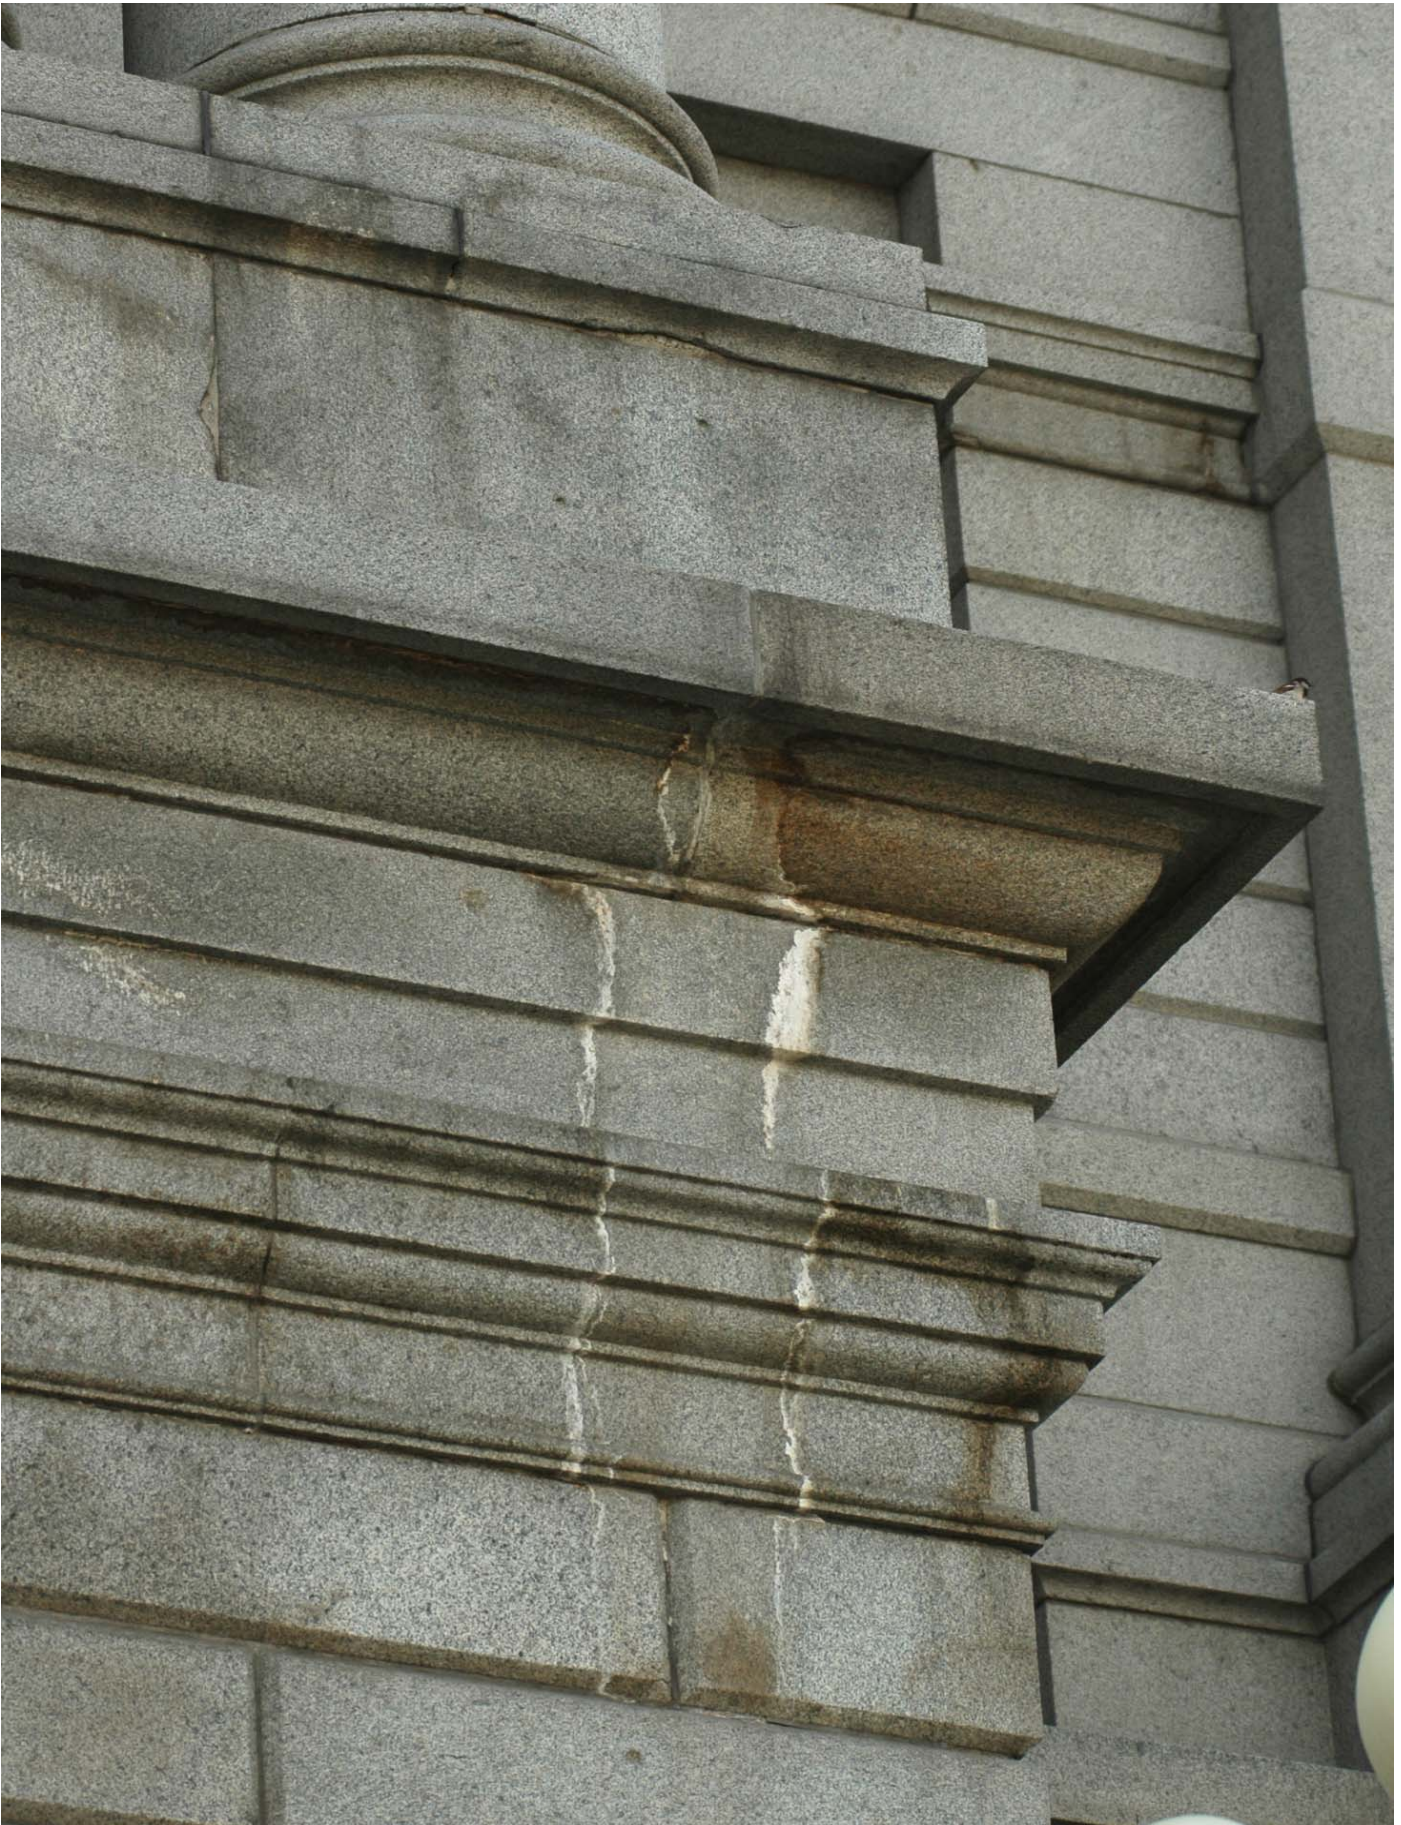
Lime stains on granite facade

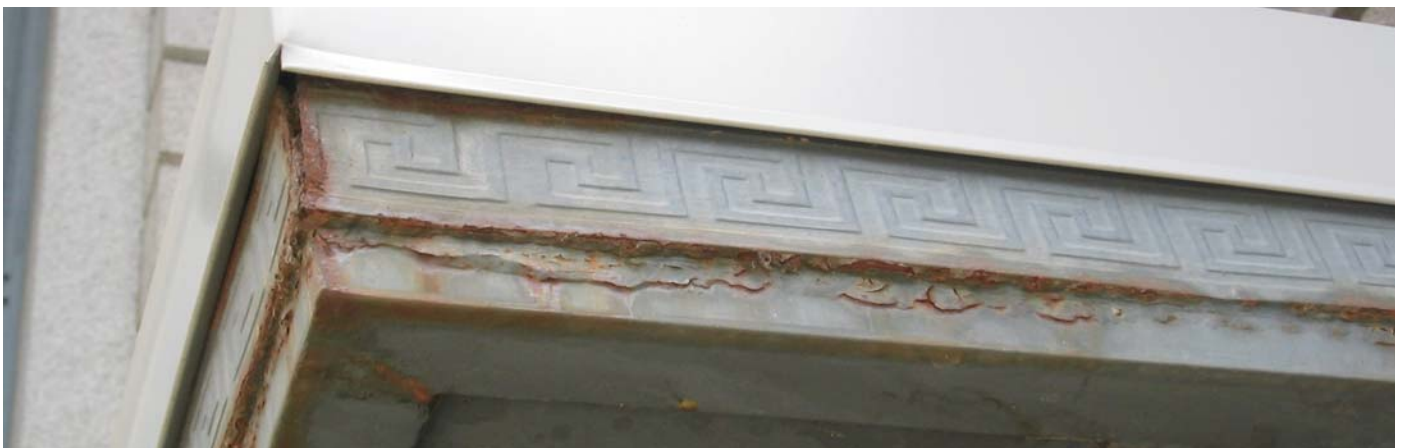
Rust on fascia above Basement entries

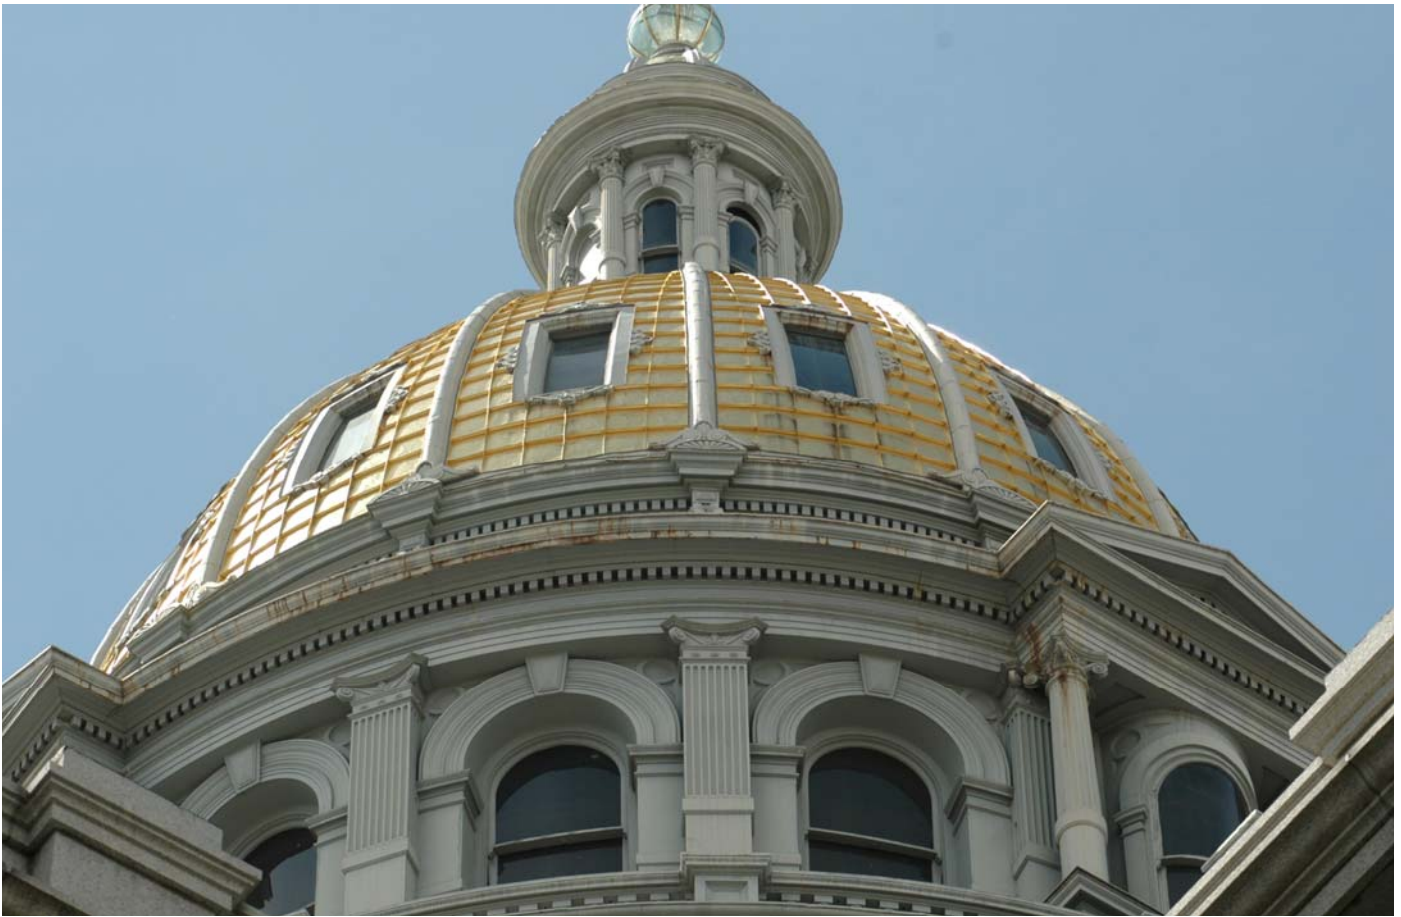
Staining from corrosion on columns and ledges at Dome windows

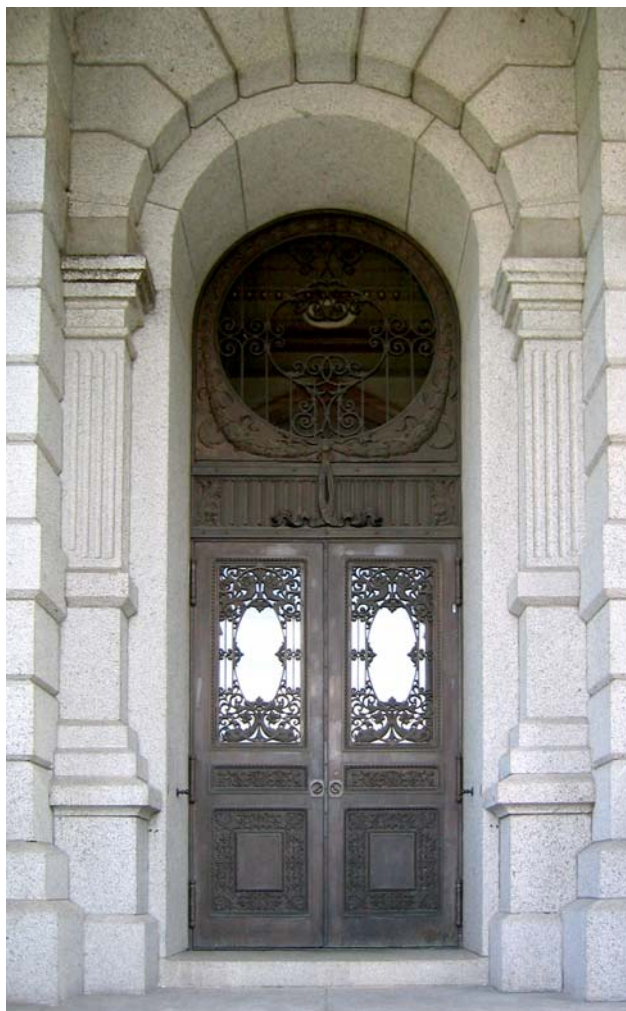
Bronze exterior doors at First Floor

For the First Floor doors, remove non-original locking hardware. Locate and reinstall original ring pulls. Infill unused lock openings with matching material. As part of the Life Safety Project, these doors will be permanently fixed in the open position for exiting purposes.

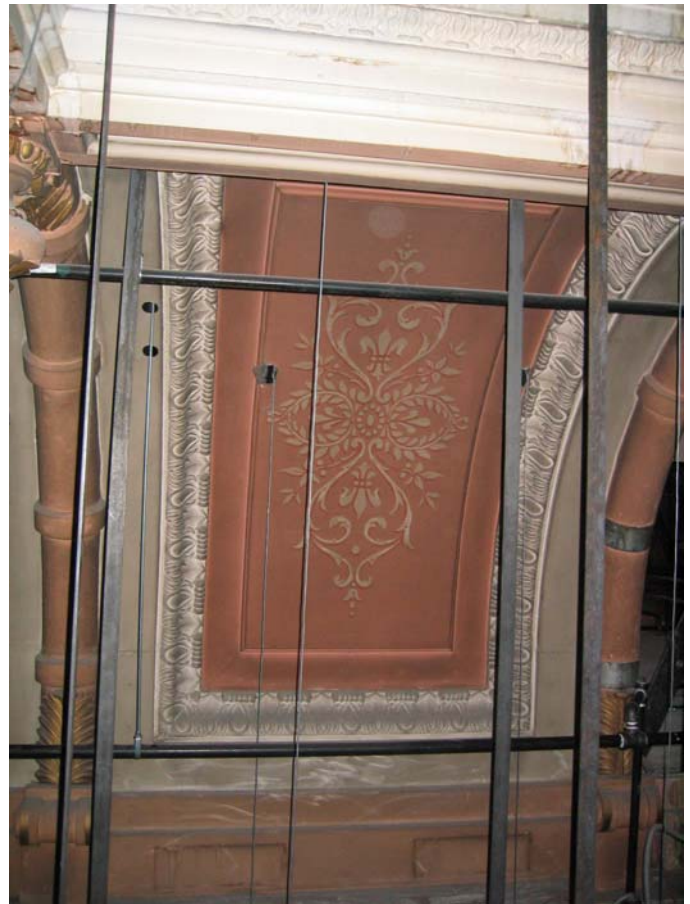
Hand painted pressed tin skylight above Senate Chamber; no longer visible

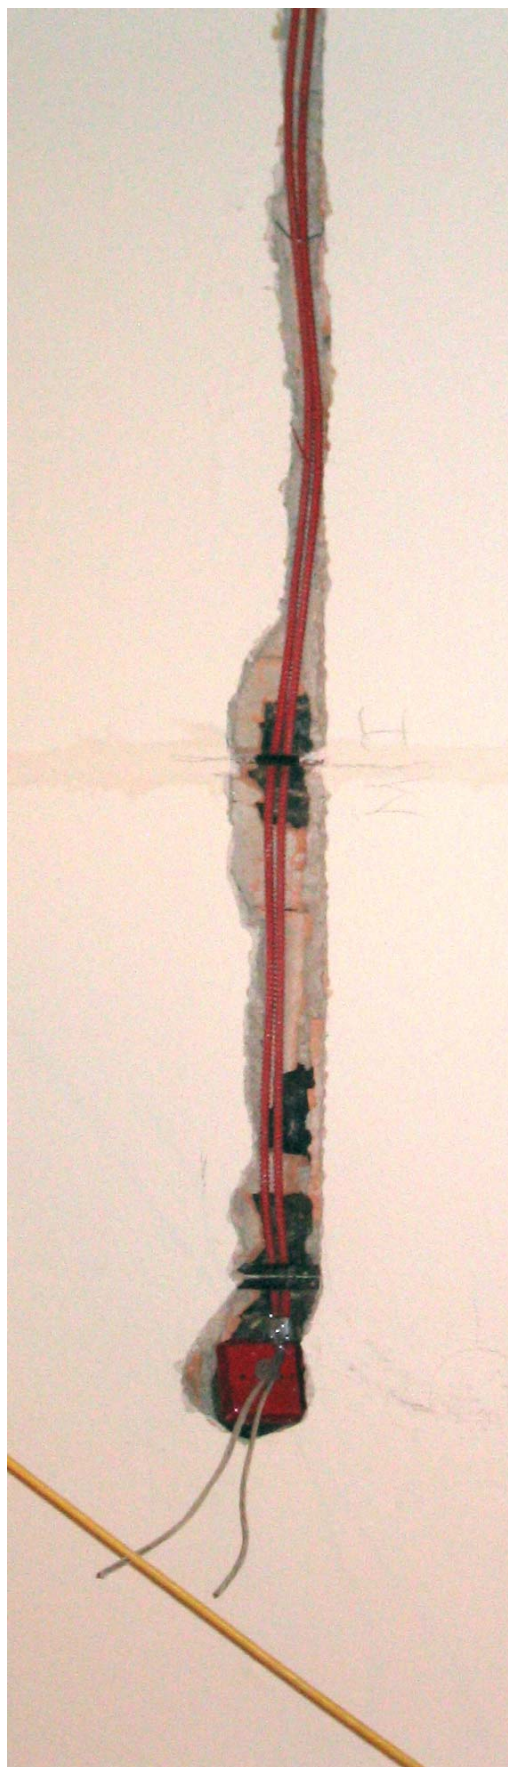
Plaster kerfing for armored fire alarm cable

Complete life safety updates.

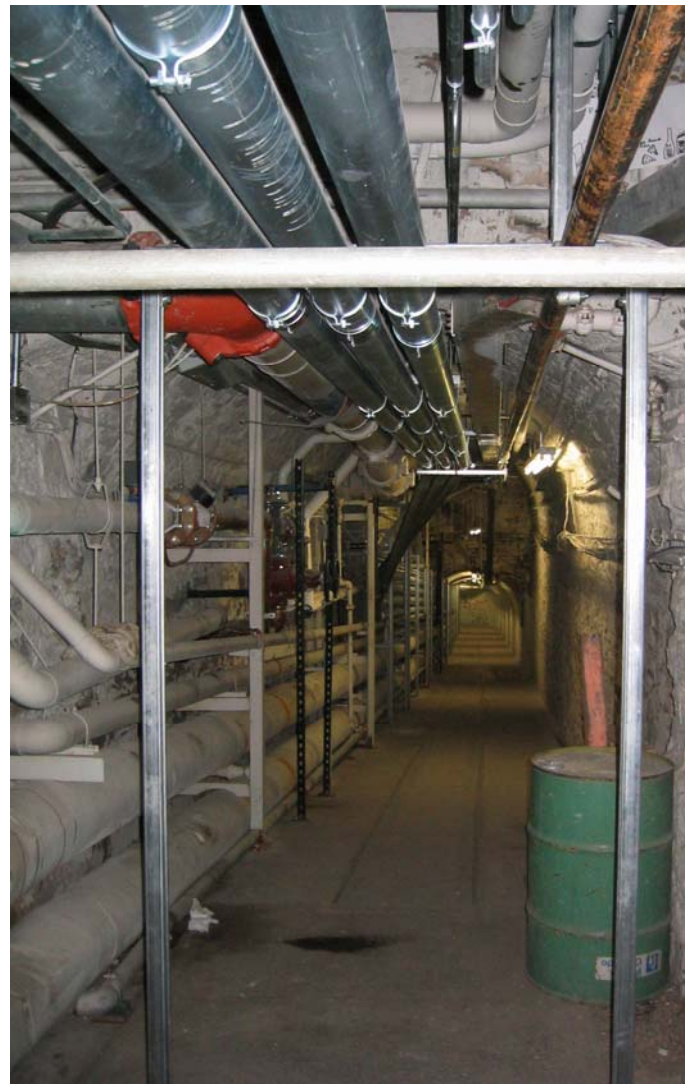
The original brick arch ceiling structure was beginning to fail and was entirely replaced in 2005. One heavily corroded original cast iron column was also replaced as part of the work.

South tunnel

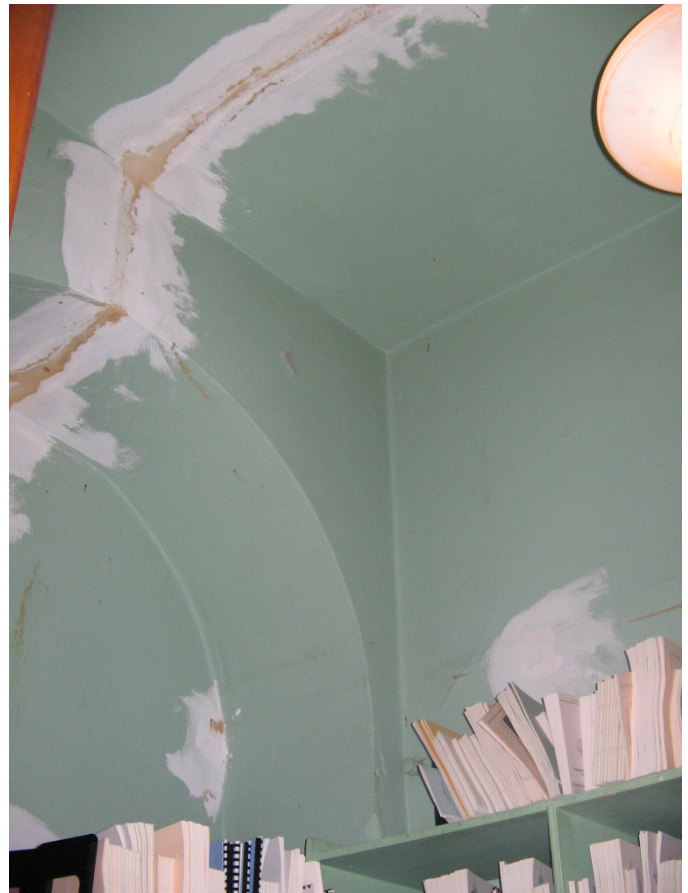
018 In- filled arch opening and poorly patched crack in the plaster

Determine source of water damage and repair if necessary

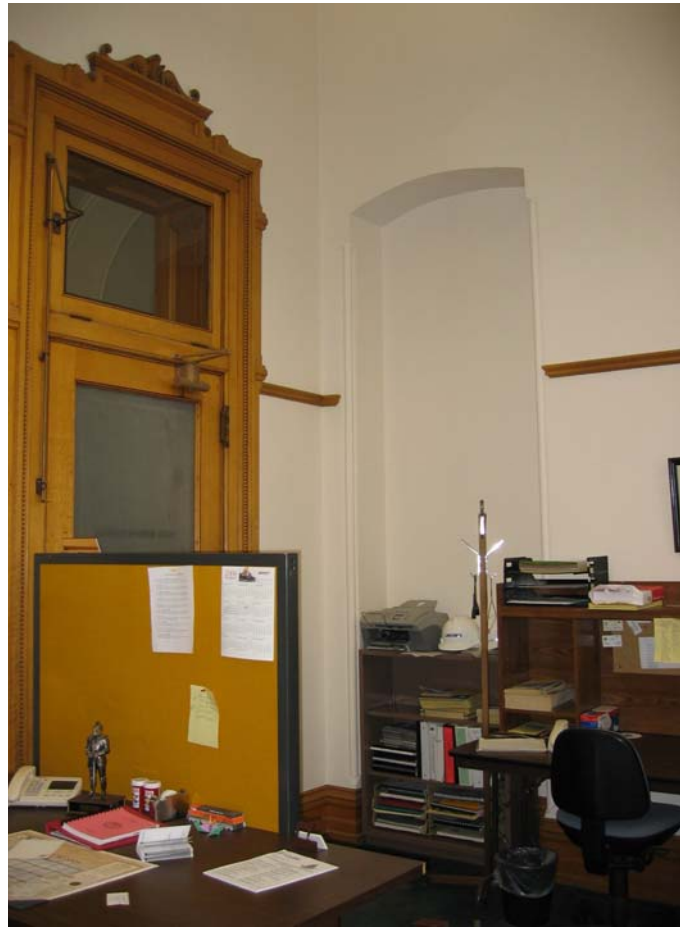
305 Arched in-fill on northwest corner; formerly an access to what was once a laundry area

No preservation work required

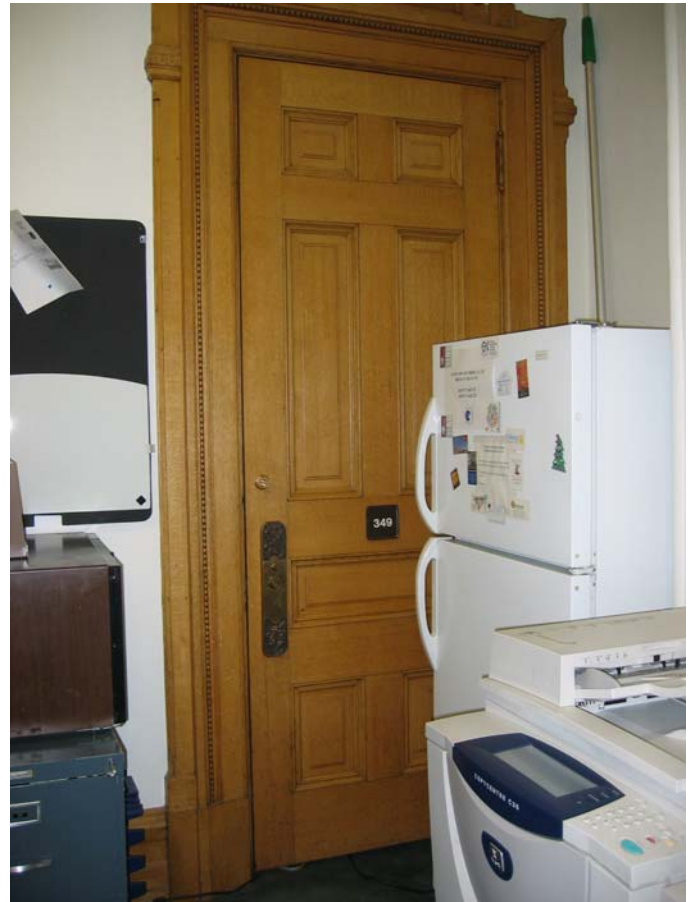
Original door type D2; columbine plate on exterior; knob missing; non original lock added above columbine plate; trim type T2 on exterior

349 Entry door from Room 346
