Report No. CDOT-DTD-R-96-10

Long-Term Performance of Accelerated Rigid Pavements, Project CXMP 13-0006-07

Final Report
October, 1996

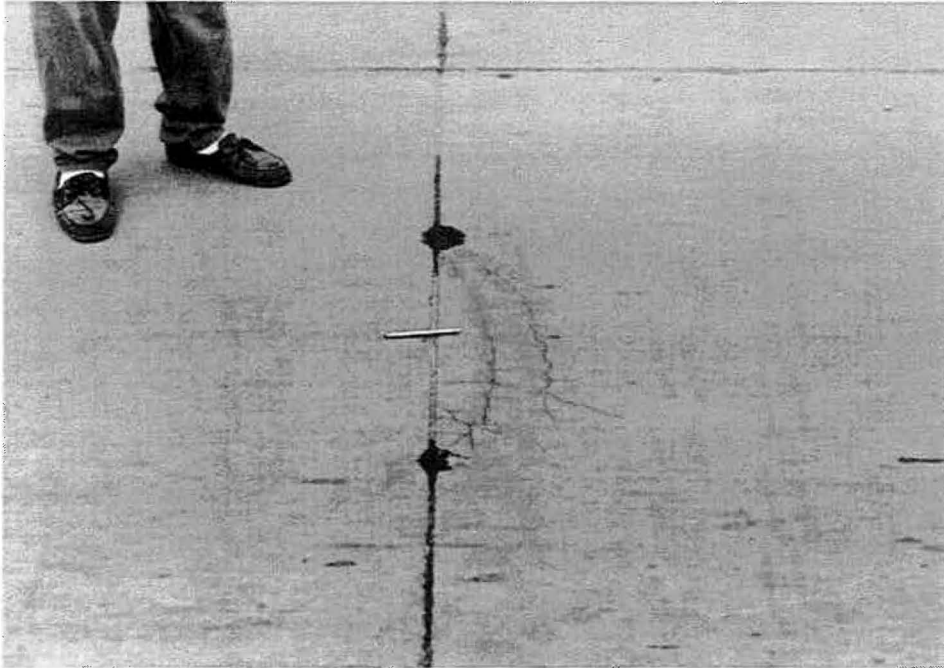
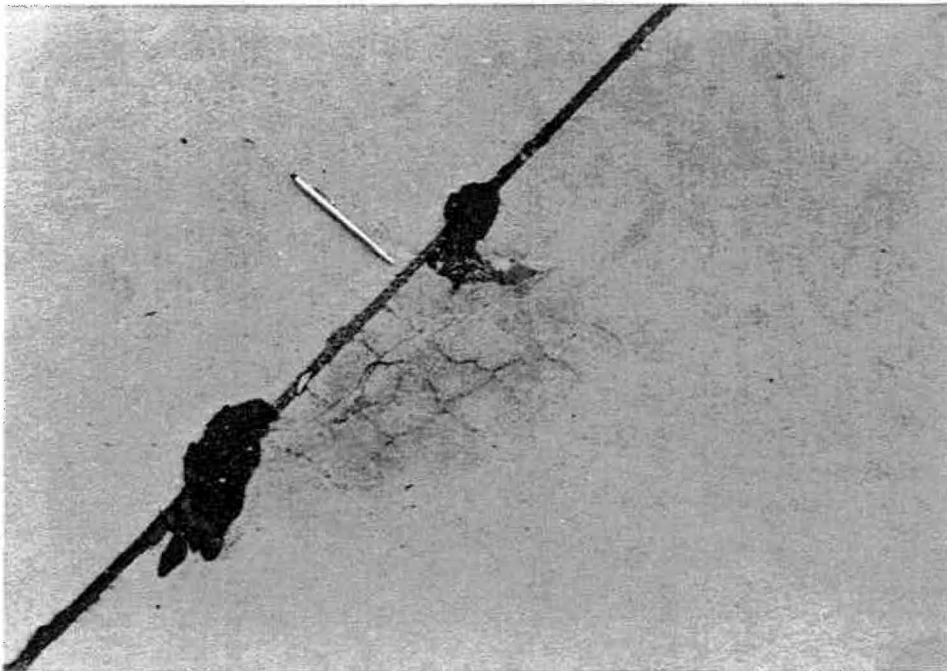
Hairline cracks adjacent and approximately parallel to transverse joints were detected at three isolated locations as shown in Photographs 1 through 3. This type of distresses are primarily attributed to over-working or over-finishing the concrete paste and are referred to as shrinkage cracking. Shrinkage cracks are shallow, fine cracks extending approximately 6 millimeters (1/4 of an inch) through the upper surface of the concrete (3).

Discoloration of the immediate area, surrounding the cracks yield the presence of calcium hydroxide residue.

Photo 1&2: Localized Shrinkage Cracking.

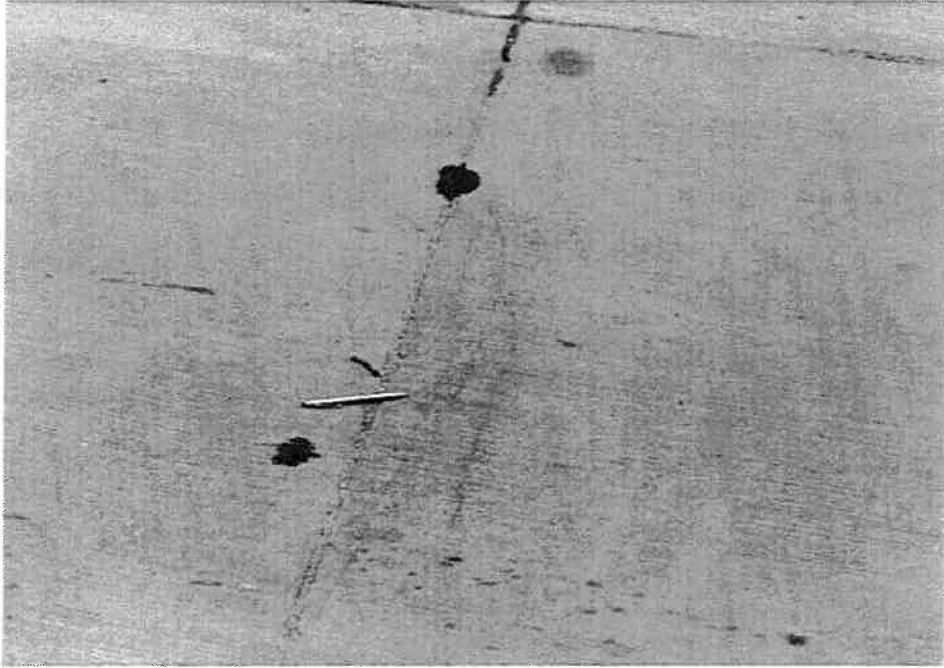
Photo 3: Shrinkage Cracking

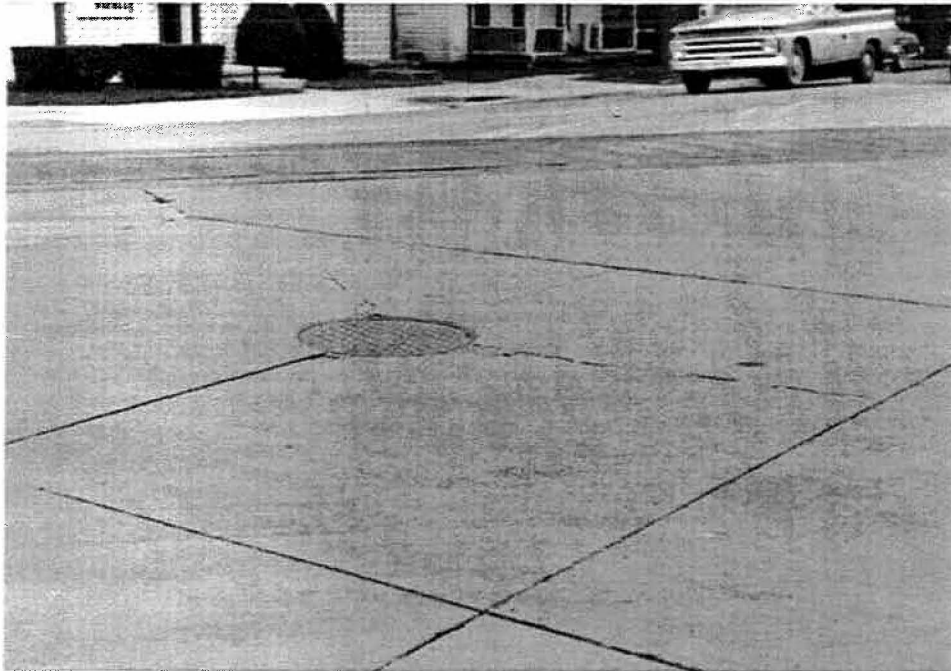
Photograph 4 shows some diagonal cracks which are believed to be caused by the irregular spacing of the joints at the transition between the manhole and the adjacent slabs.

Photo 4: Formation of diagonal cracks due to presence of manhole and/or irregular joint spacing.

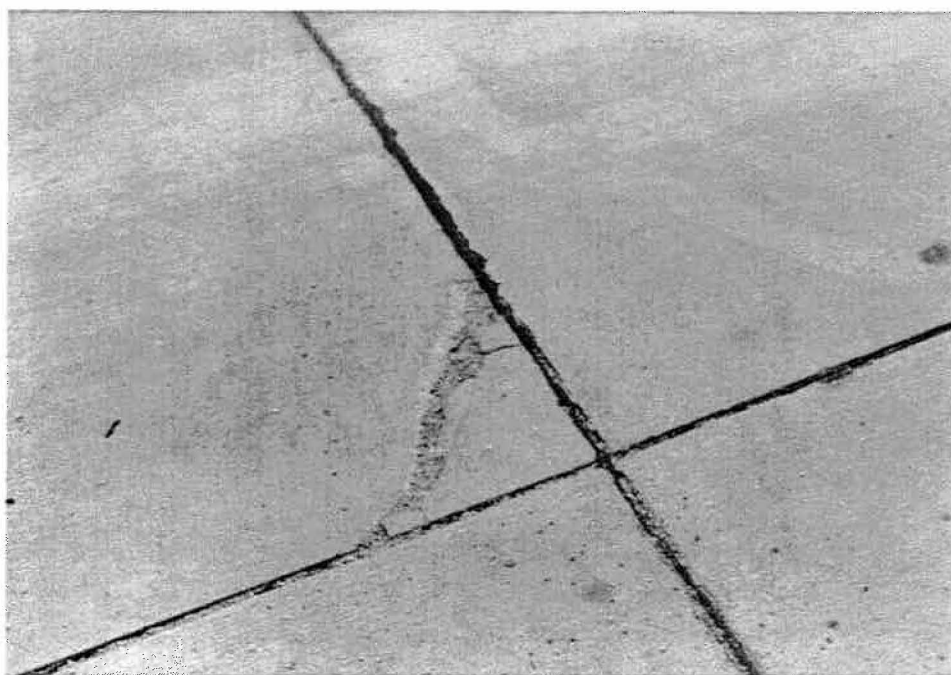
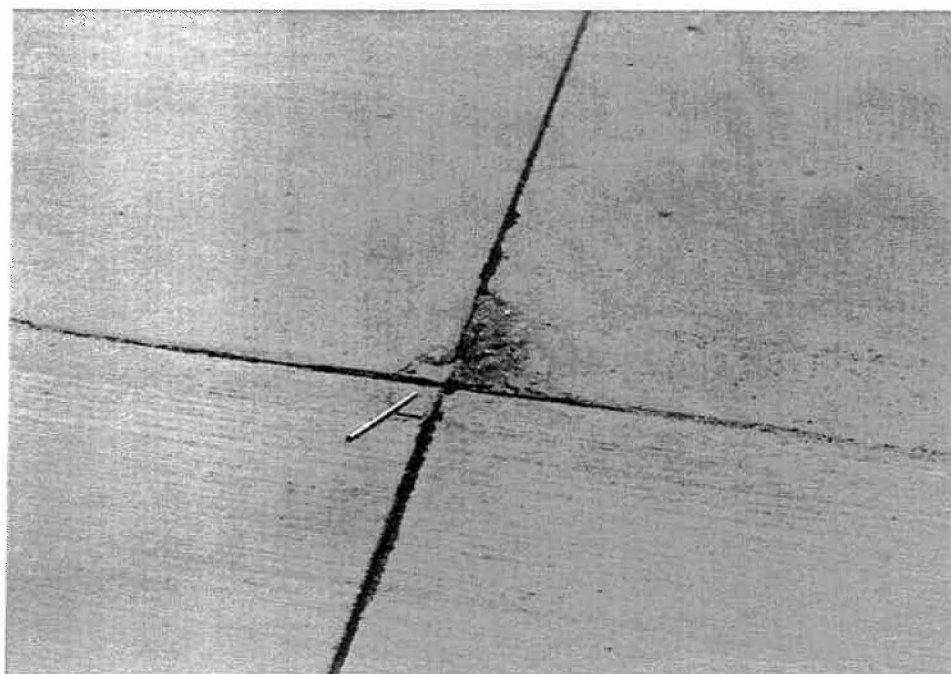
Minor corner breaks were noted at few isolated locations (Photograph 5 and 6). These types of failures are primarily attributed to the lack of support or poor load transfer (non-doweled concrete slabs). It is CDOT's standard practice to not use load transfer devices for facilities with speed limits of less than 45 mph.

Photo 5&6: Minor corner breaks noted at two locations.

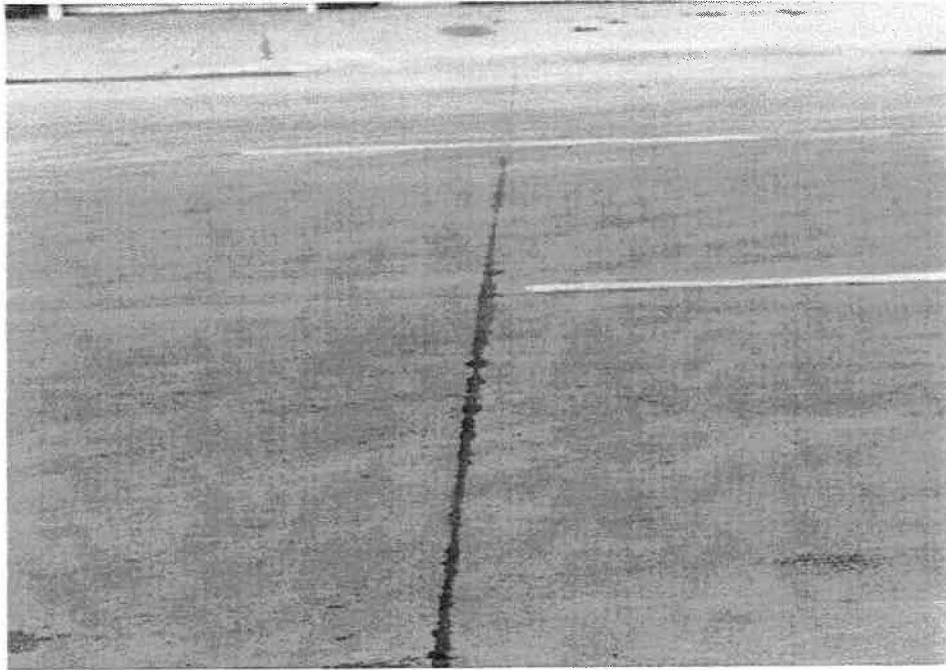
related failures. The joints were overfilled with sealant material in many places (photograph 7). Cohesion, adhesion and extrusion failures were quite evident throughout the project as shown in Photograph 8.

Photo 7: Example of an overfilled joint.

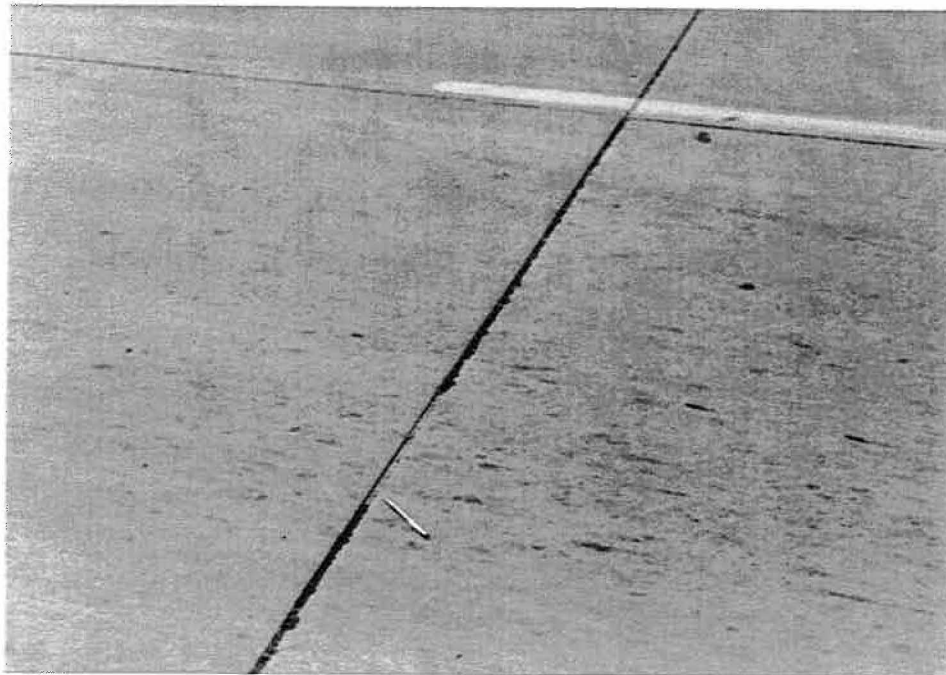
Photo 8: Badly deteriorated sealant materials.

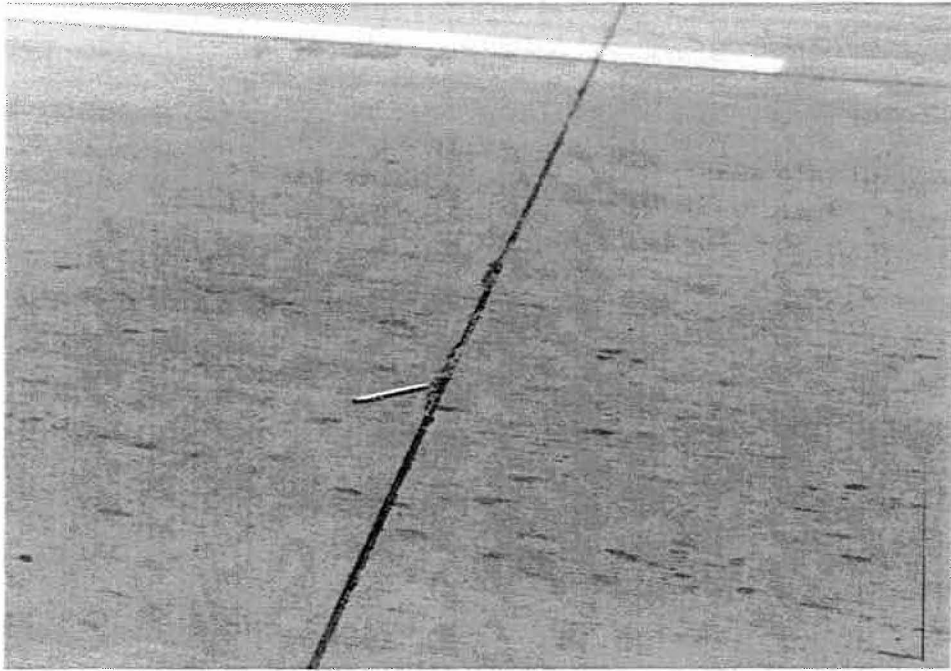
Spall-related failures caused by the intrusion of incompressibles were also evident in few locations (Photograph 9).

Photo 9: Minor joint spalling

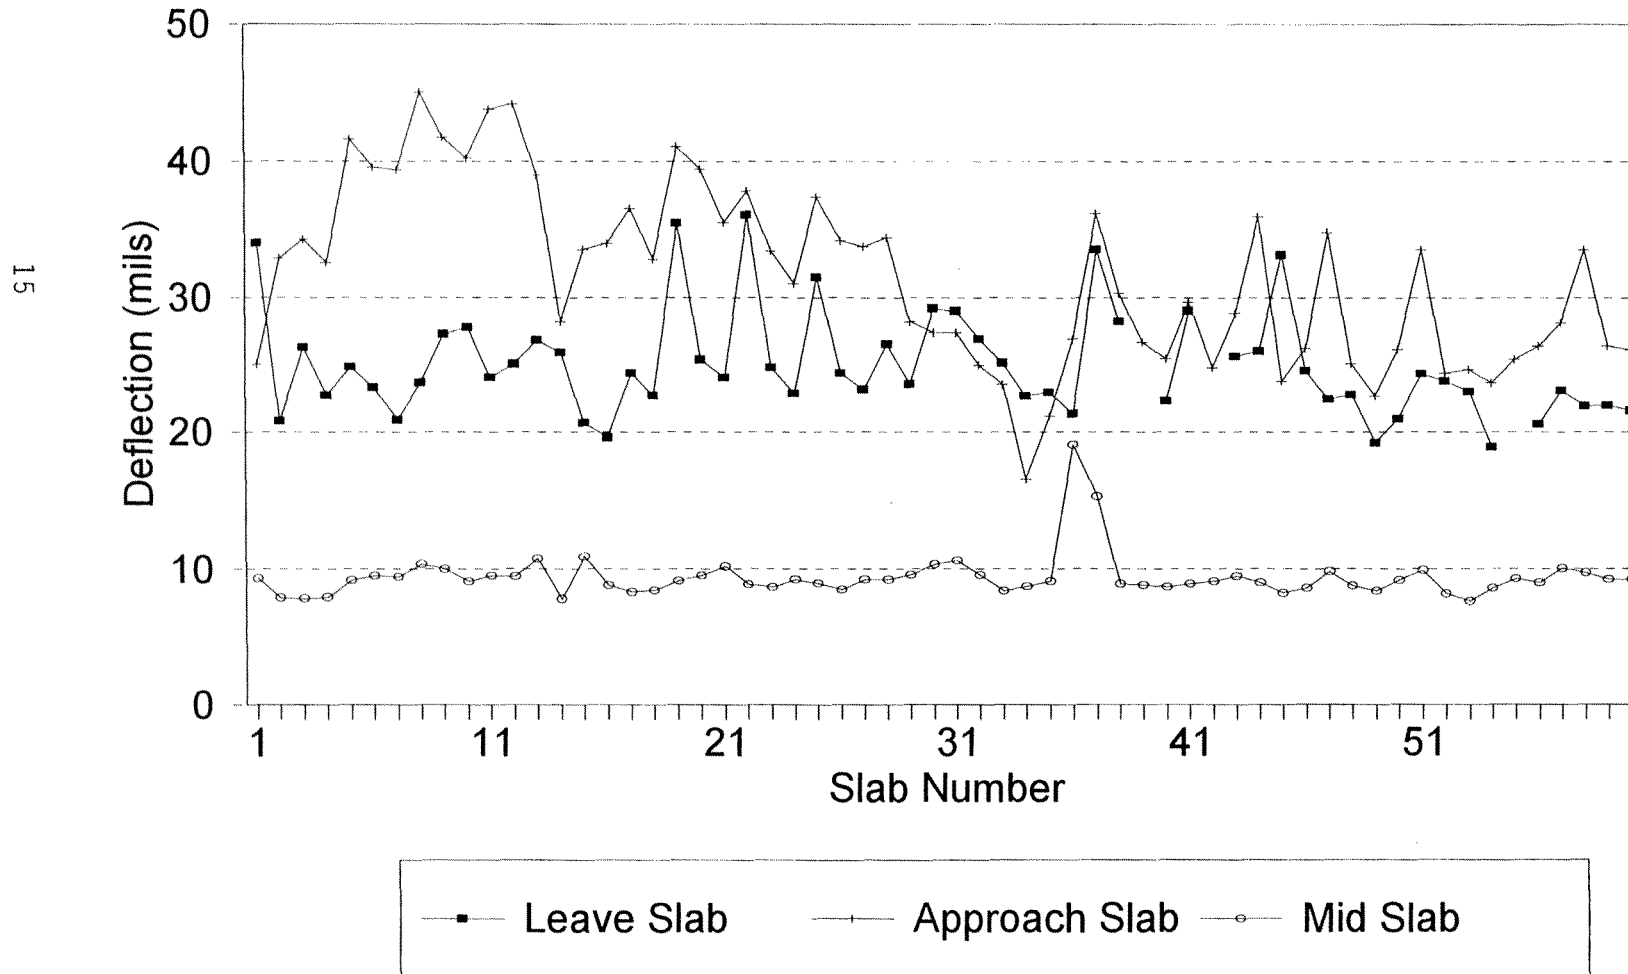
Maximum deflections (normalized to 9,000 lb) and load transfer efficiency rates between the slabs are shown in Figure 2 and 3. It appears that the slabs are structurally sound with an average deflection of 9.4 mils at mid-slabs. However, because the slabs were not equipped with load transfer devices (no dowel bars), the average deflection at the approach and at the leave-slabs measured high (25.0 and 31.5 mils respectively) indicating poor rate of load transfer between the slabs.

AVERAGES: LEAVE SLAB 25.0 APPROACH SLAB 31.5 MID SLAB 9.4

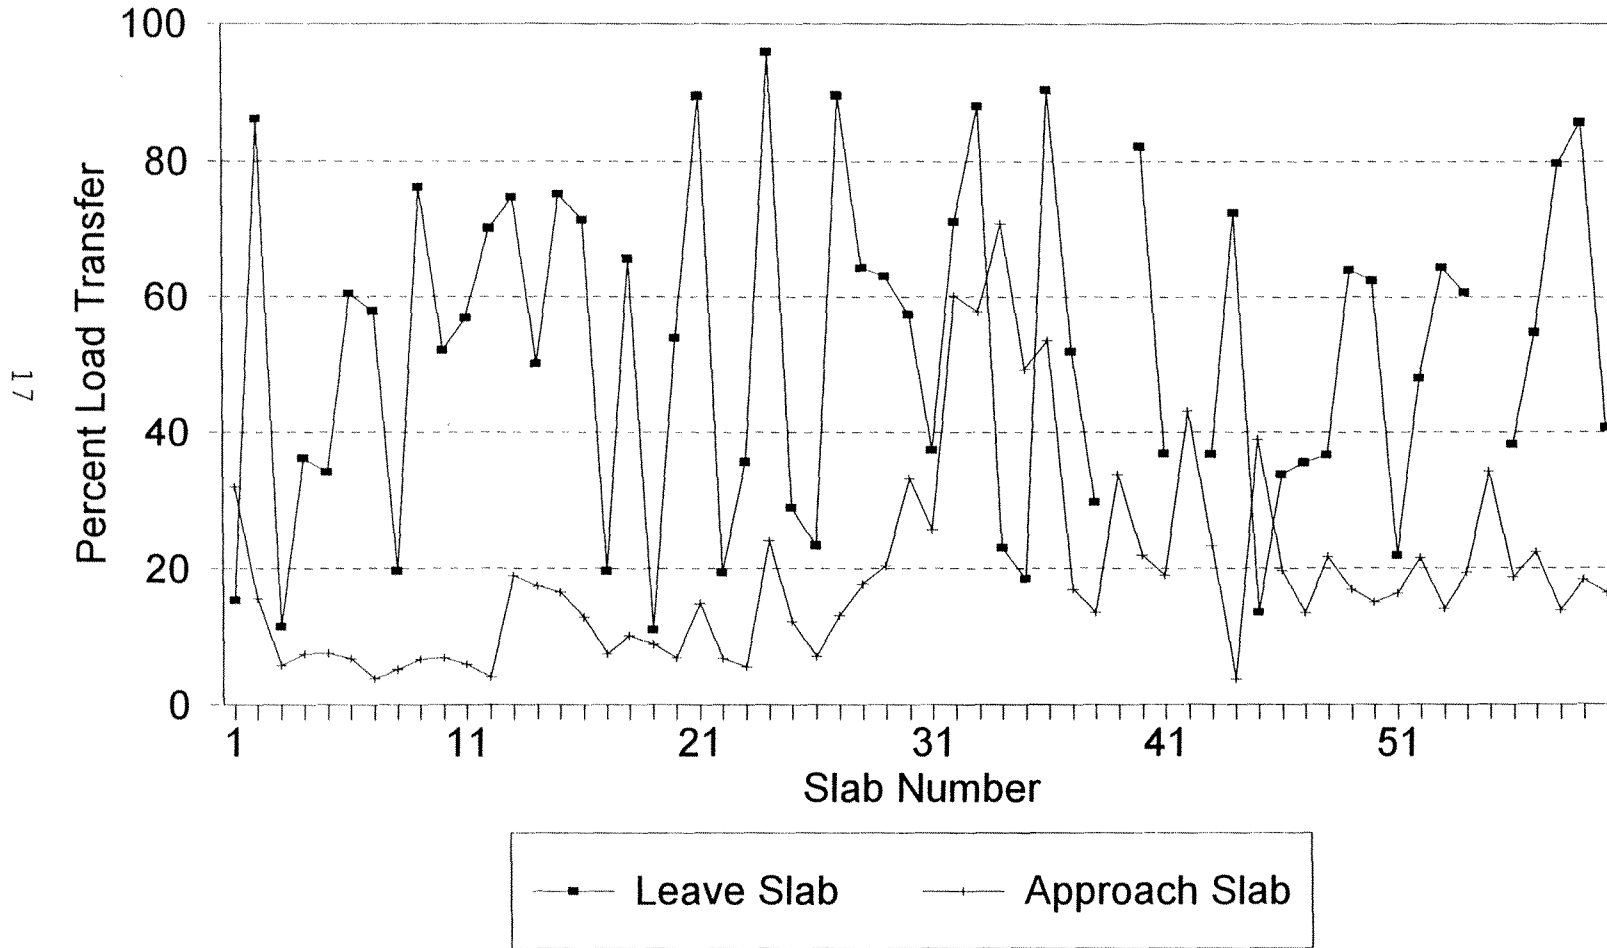
Figure 3

As it can be seen on figure 3 the average rate of load transfer from the leave-slabs to the approach-slabs are approximately 52 percent. The average rate of load transfer from the approach-slabs to the leave slabs were only 20 percent. The poor rate of load transfer between the slabs are primarily attributed to the lack of dowel bars. For a complete review of the maximum deflections and load transfer efficiency rates refer to table 2.

AVERAGE LTE: LEAVE SLAB 52% APPROACH SLAB 20%
