FLOOD DAMAGE SURVEY

Uncompahgre River *2890*

MONTROSE-DELTA COUNTIES

February 1984

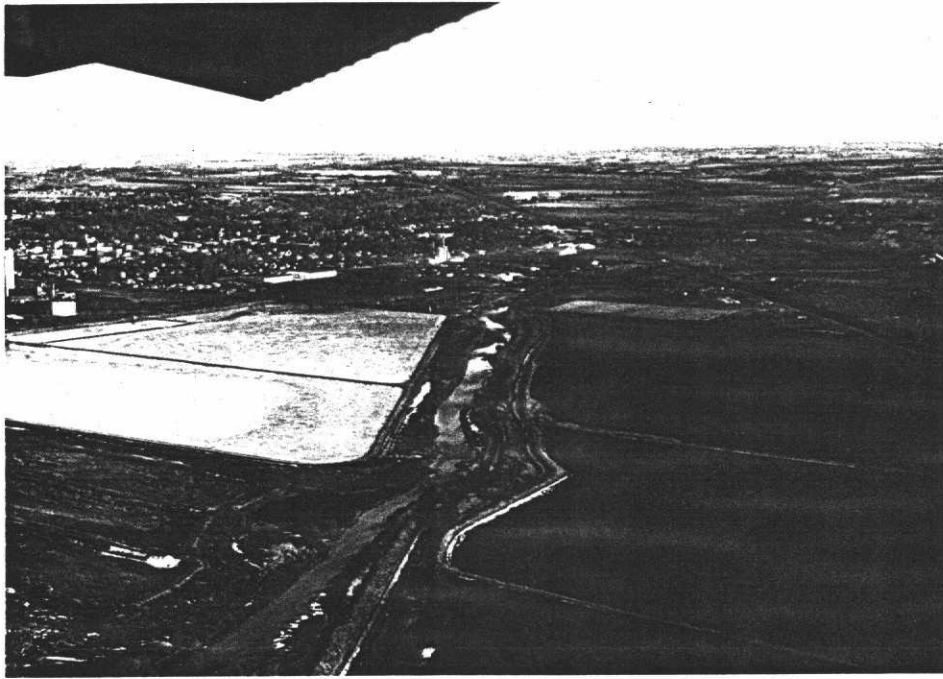
SITE # 1

Uncompahgre River confluence with the Gunnison River - Levee repair on left bank looking upstream.

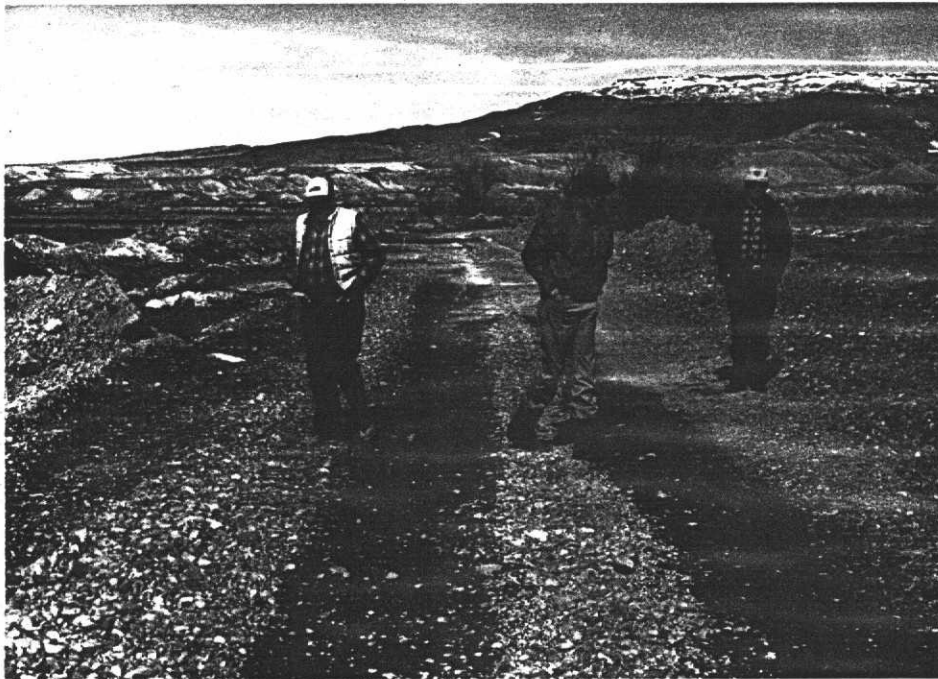
SITE # 2

Levee repair

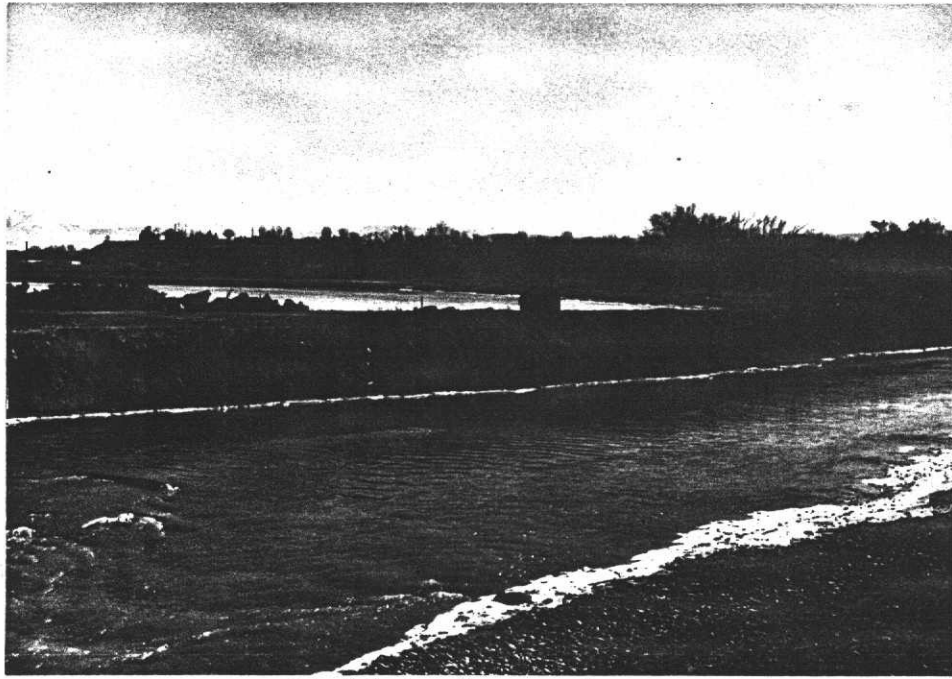
Right bank erosion

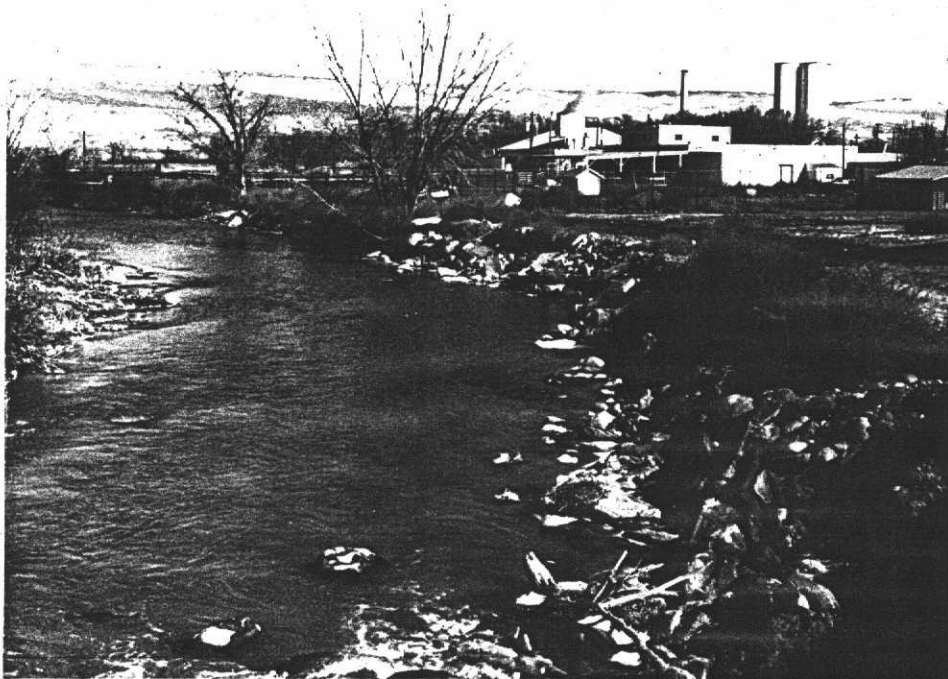
SITE # 3

Right bank erosion - emergency repair during flood.

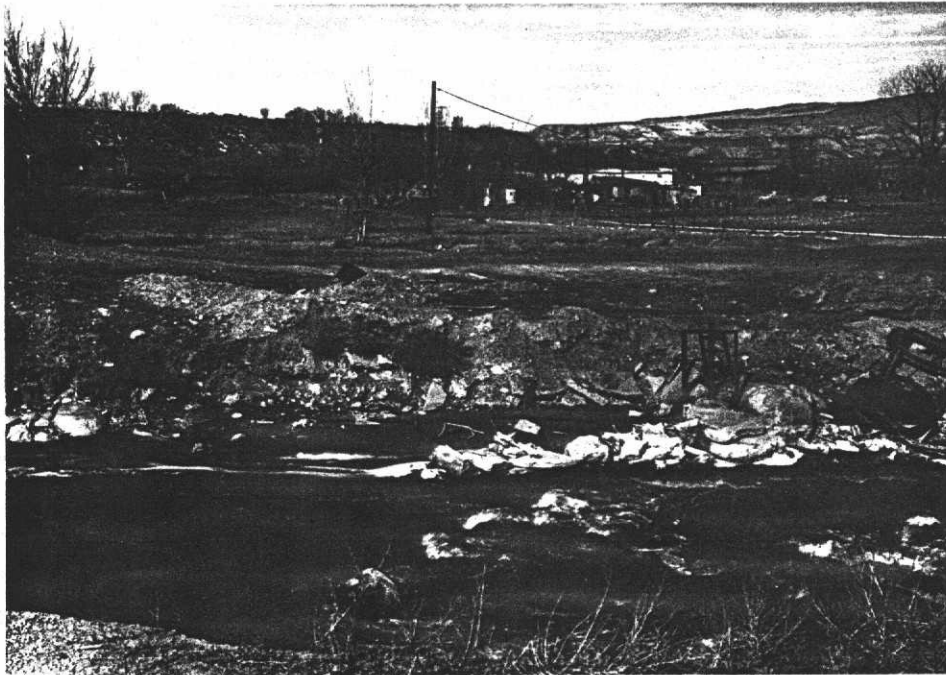
Irrigation diversion structure washed out.

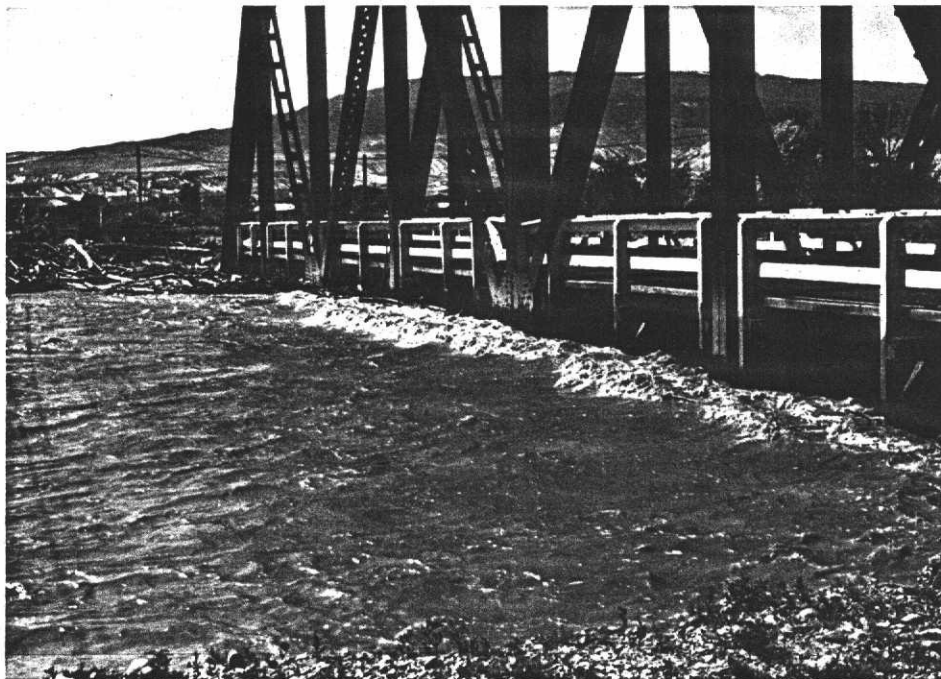
SITE # 5

Denver and Rio Grande Railroad - Trash and debris build-up during June 19, 1983 flooding.

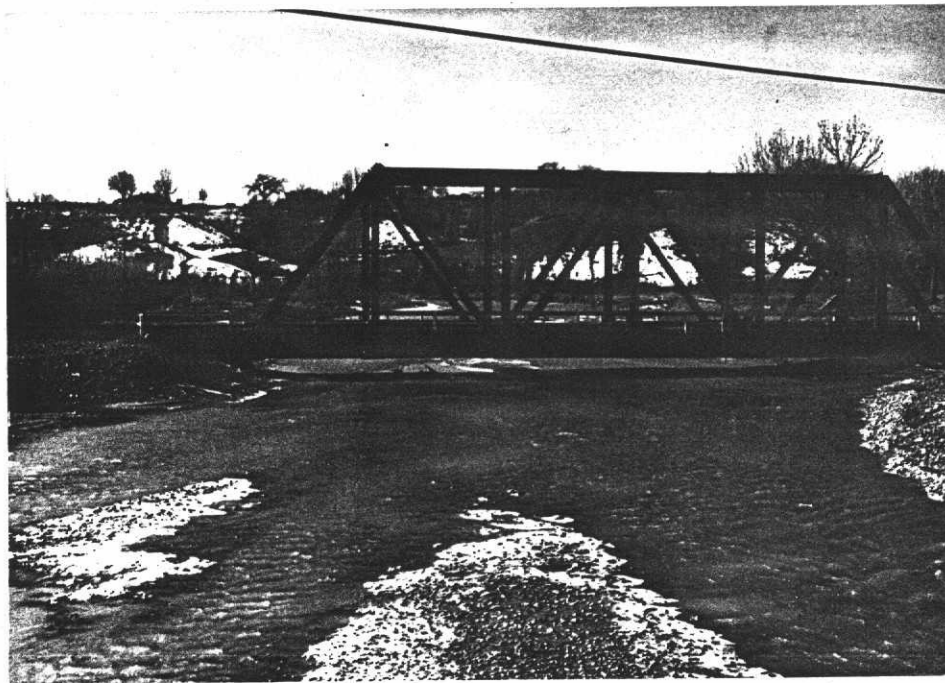
SITE # 5

Sedimentation build-up

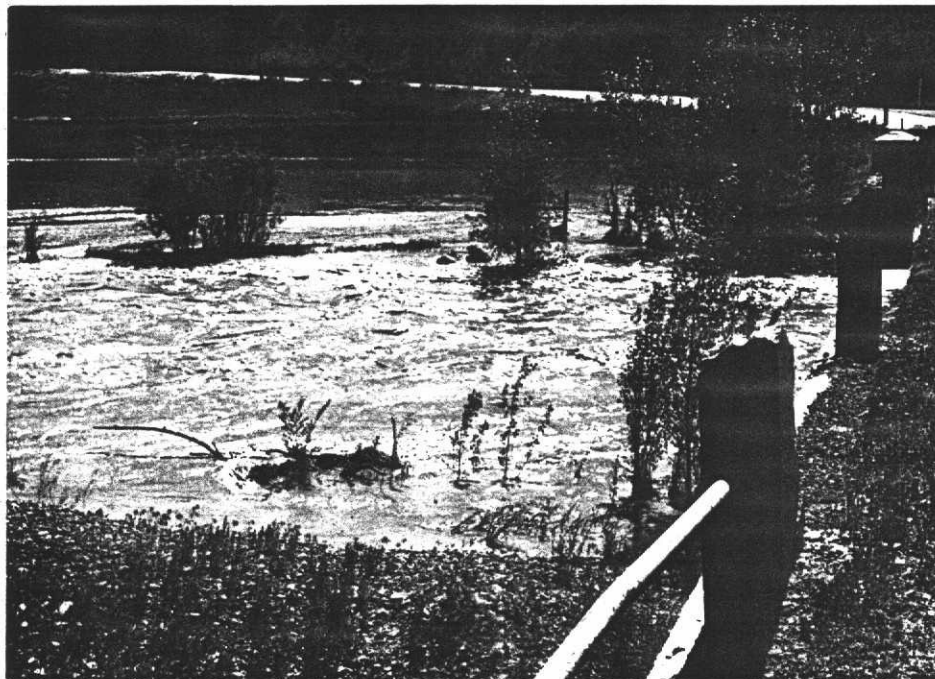
SITE # 6

Flooding upstream of Colorado Highway 348
bridge - June 19, 1983.

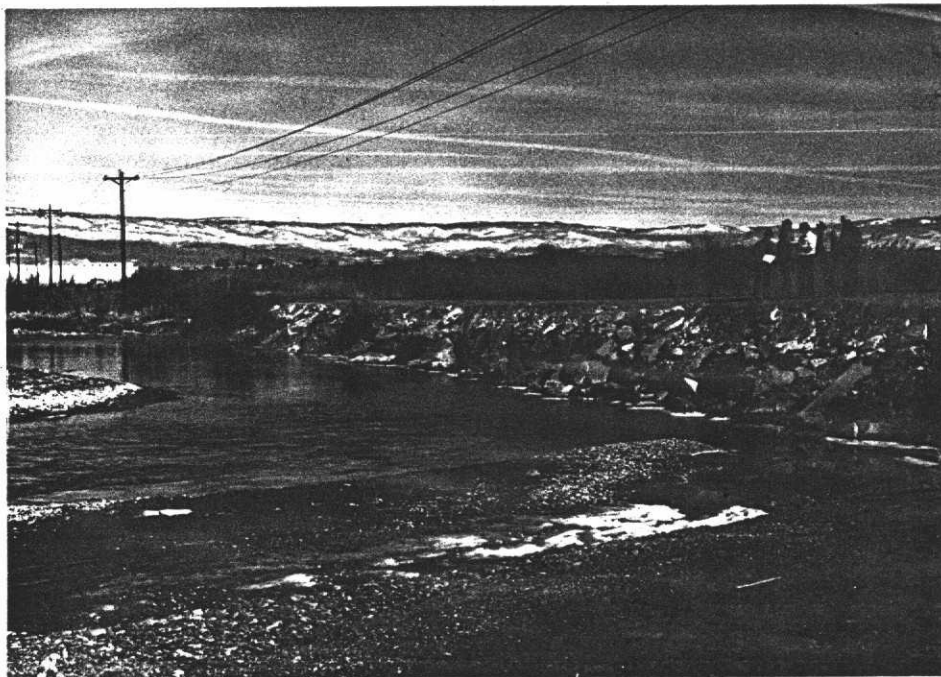
Road repair to County Road 1600 - A cease and desist order was issued by Corps.

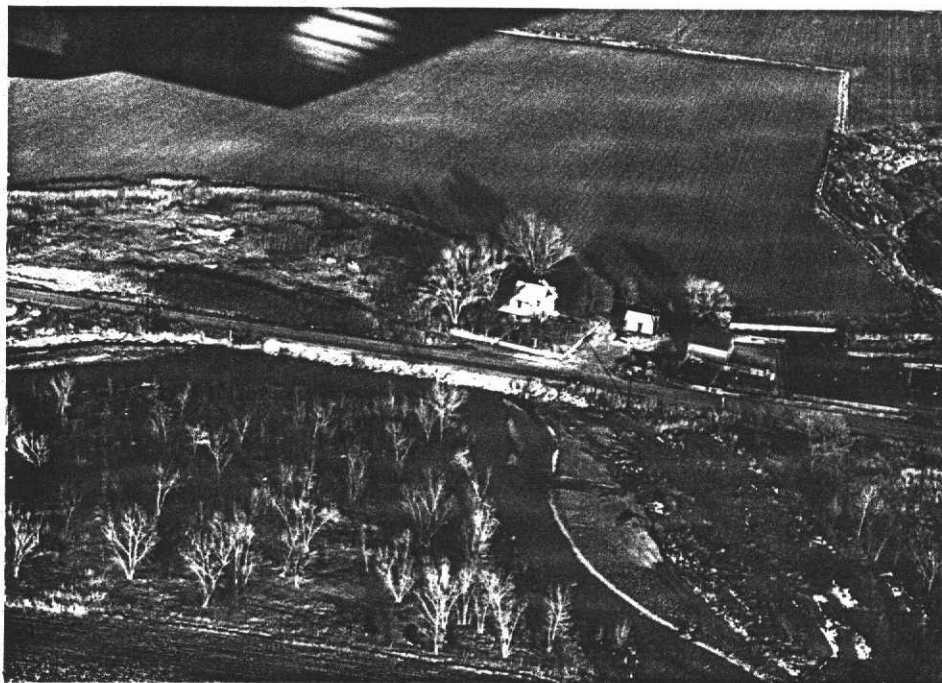
SITE # 7

County Road 1600 repair. Channel alignment work required.

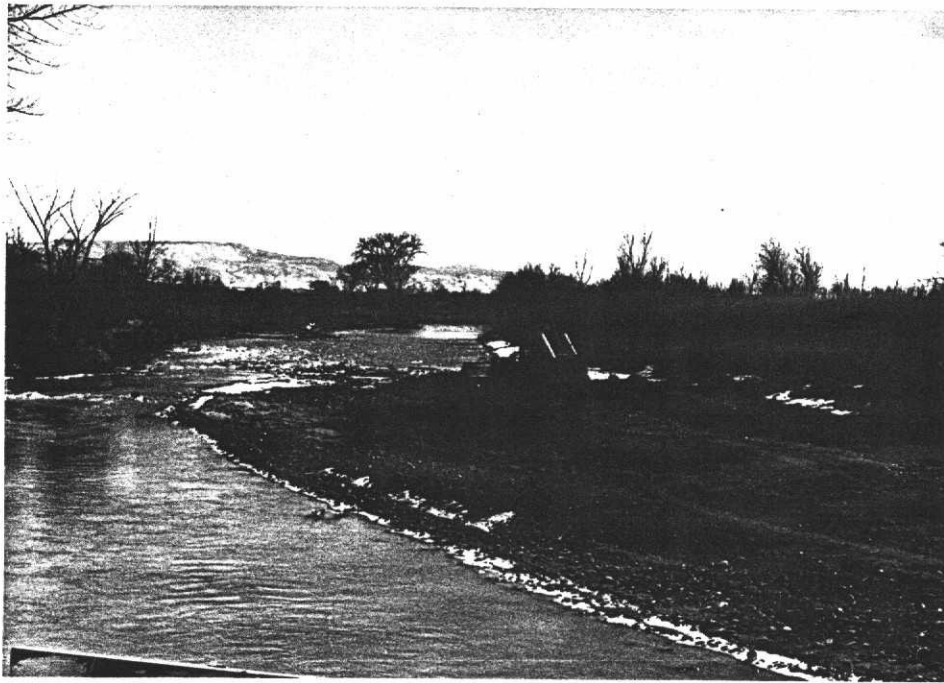
Removal of sand bar with rubber tire equipment.

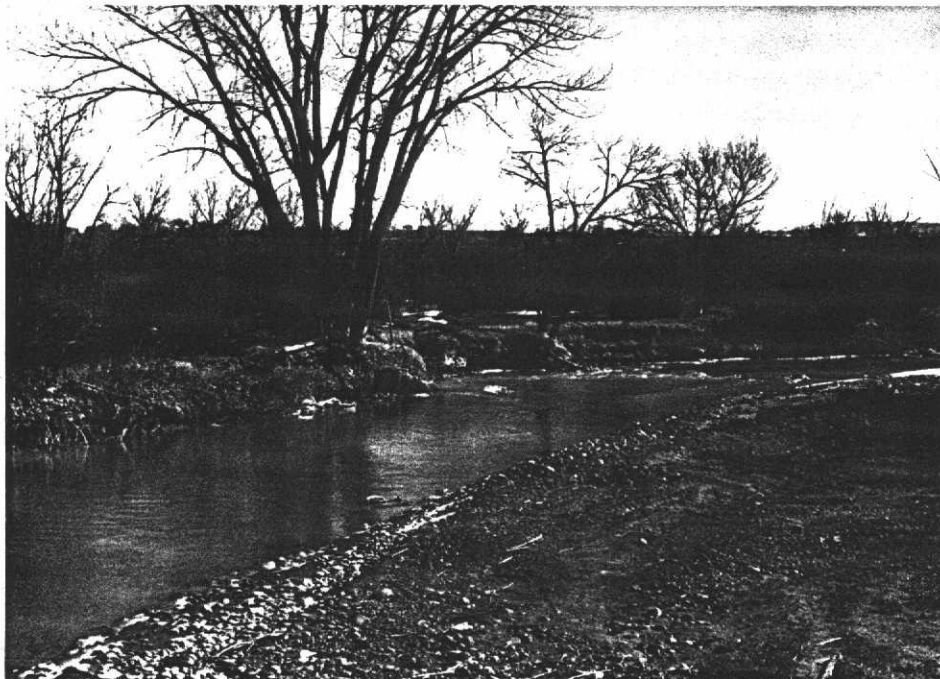
Sand bar causing bank and roadway abutment erosion.

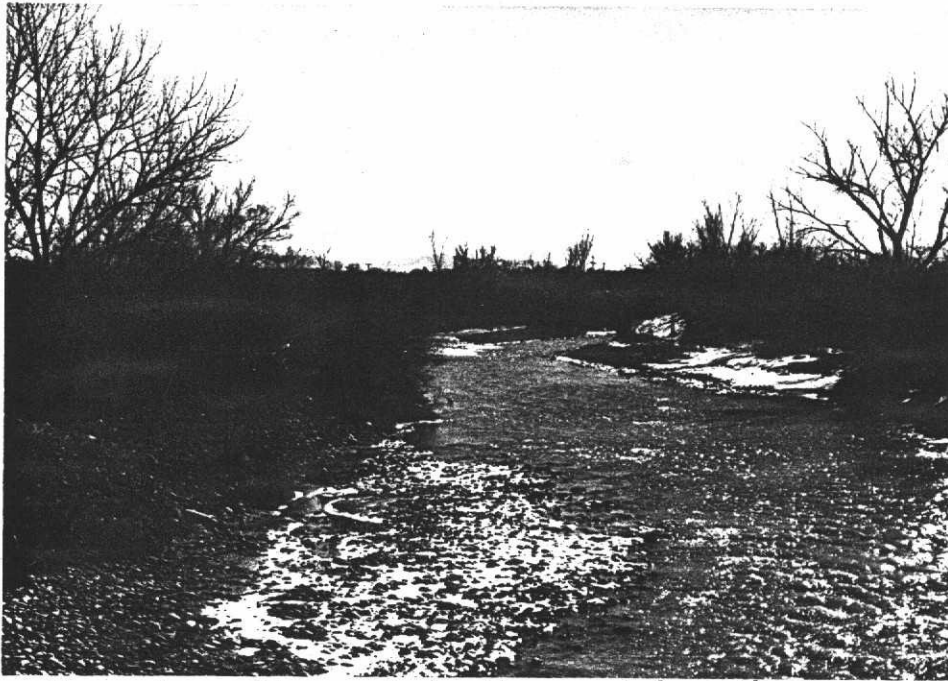
Channel realignment in the past by others.
Channel cleaning needed.

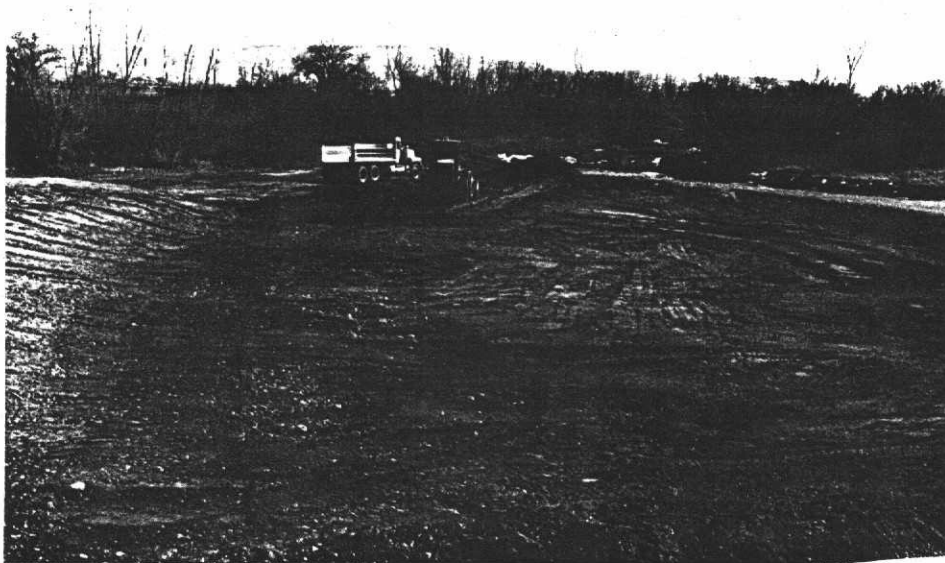
SITE # 10

Upstream of County Road 1700 - A large sand
bar that needs to be removed because the river
is eroding roadway abutment.

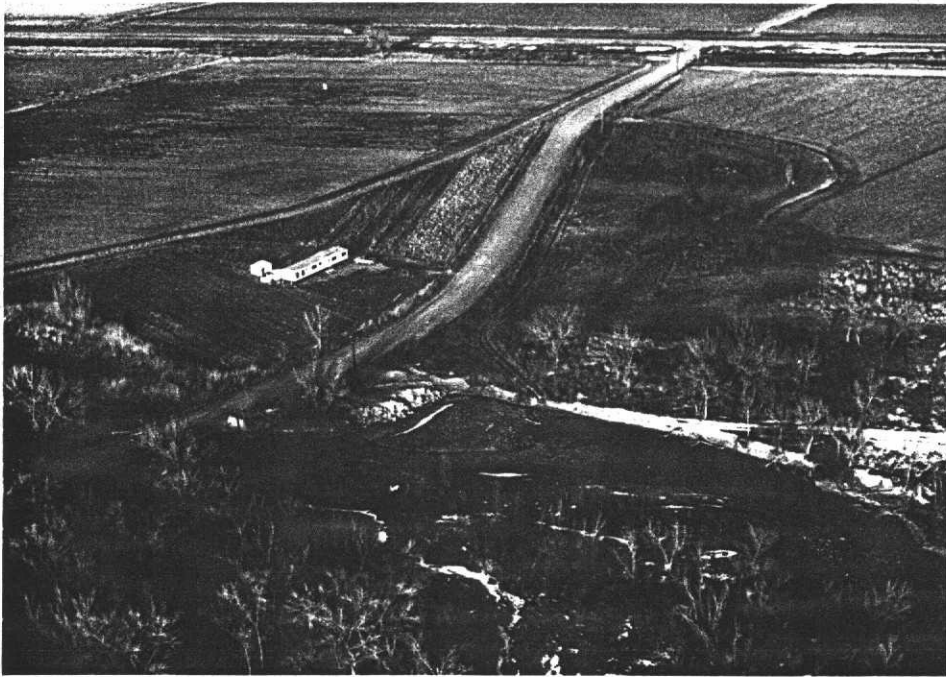
Upstream of County Road B - Erosion of road-way embankment. Riprapping needed.

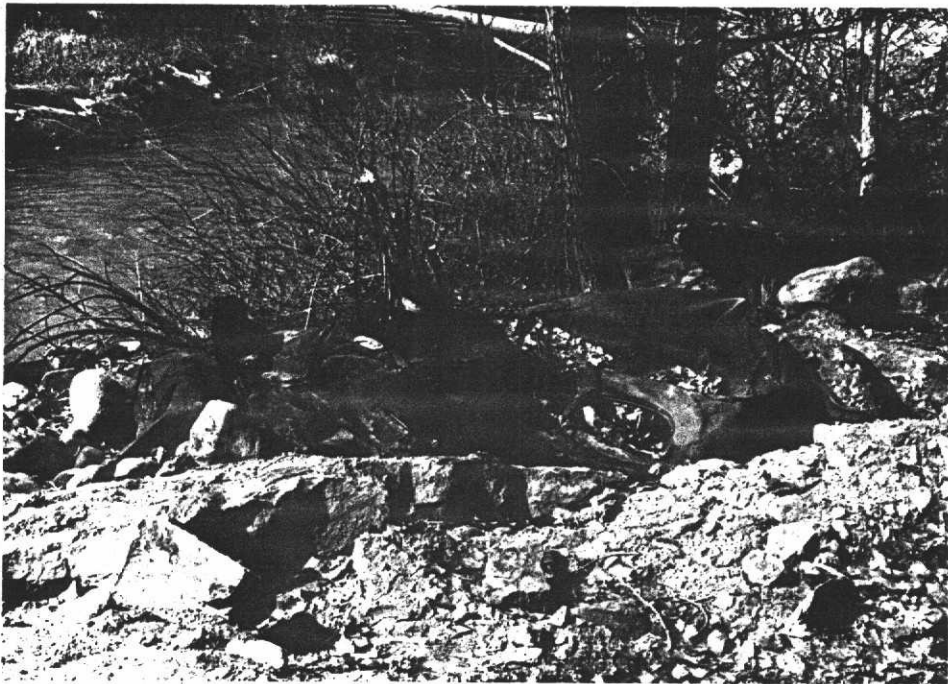
Upstream of County Road B. Three types of rip-rap materials - Sandstone, car body and volcanic rock.

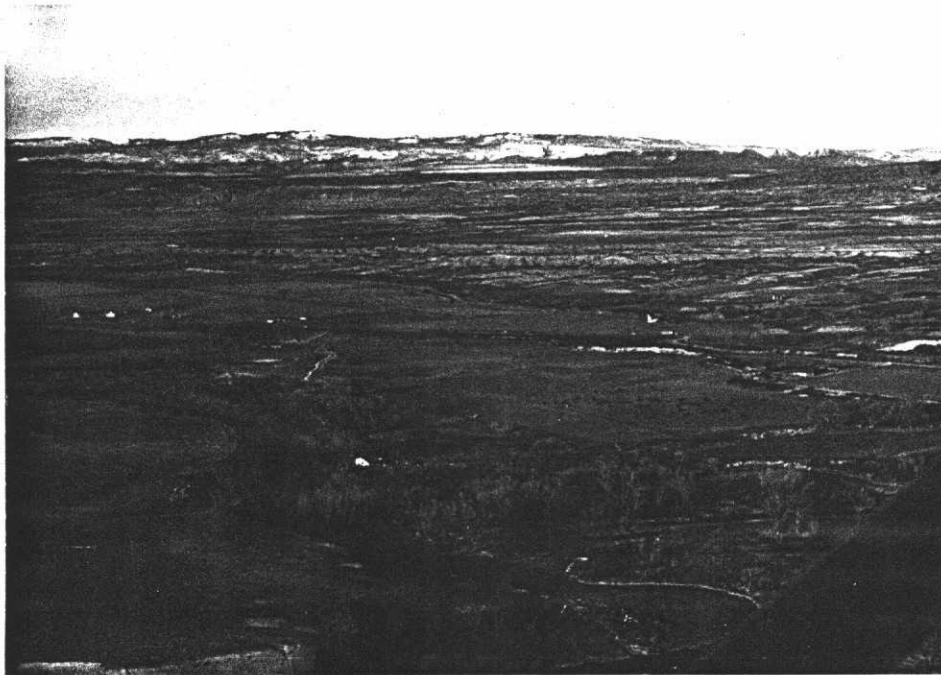
Delta-Montrose County Line. Bank erosion and meandering stream.

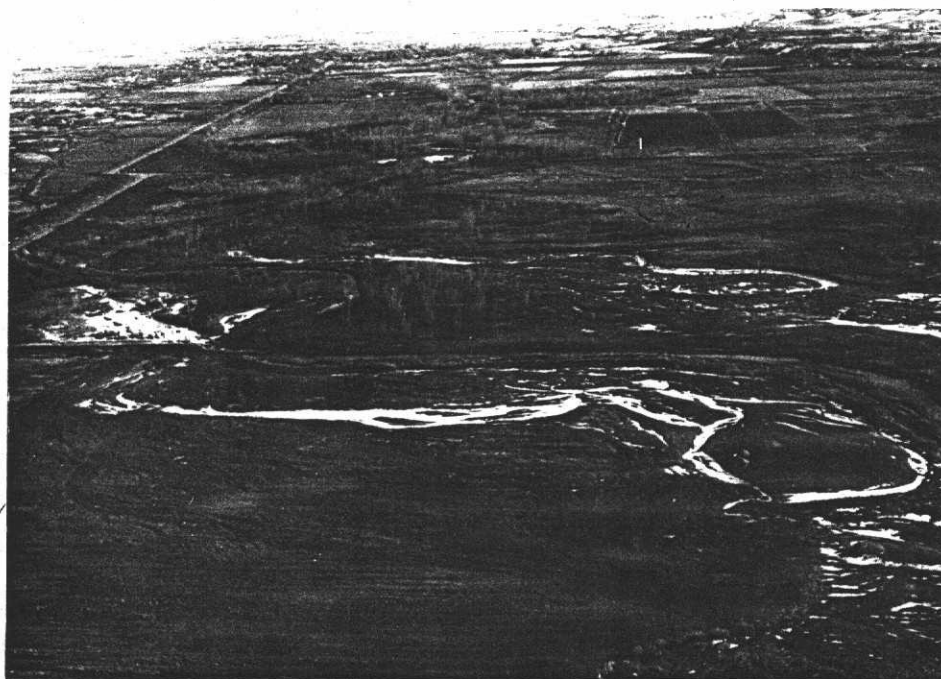
Irrigated farmland damaged by debris and trash.

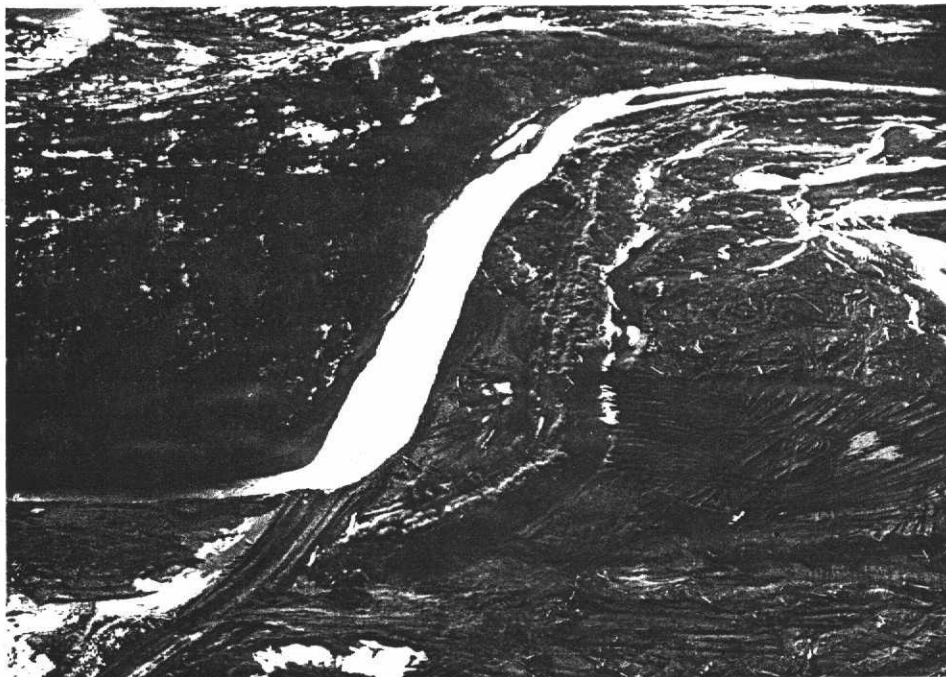
Channel break-out location because of sediment build-up.

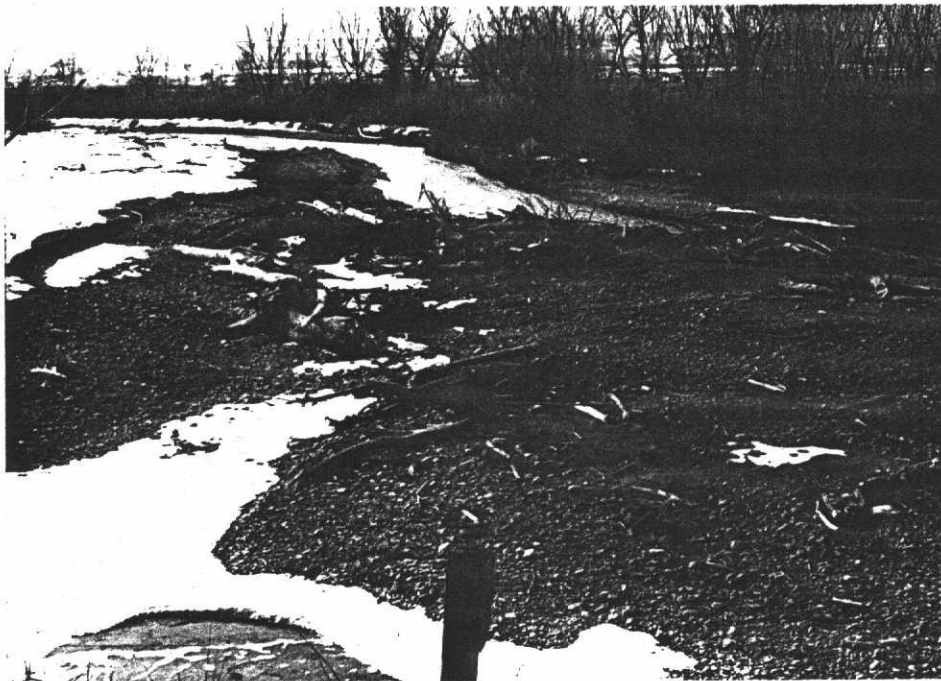
4 - 6 feet of sediment build-up completely clogging channel. Cobble size $\frac{1}{2}$ " to 6".

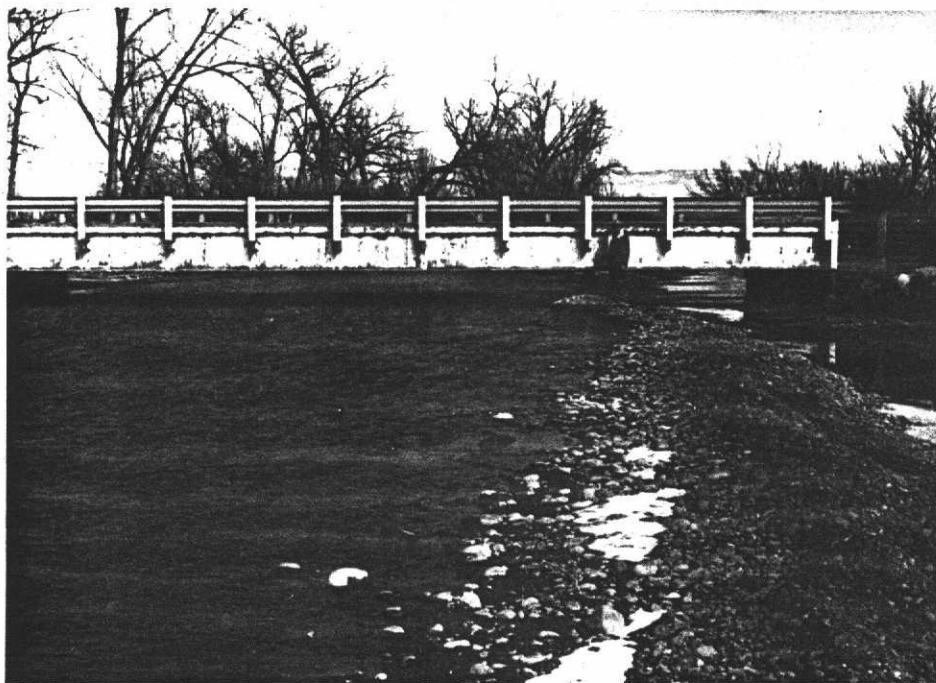
SITE # 15

Upstream of Blossom Road. Sediment build-up
6 feet deep.

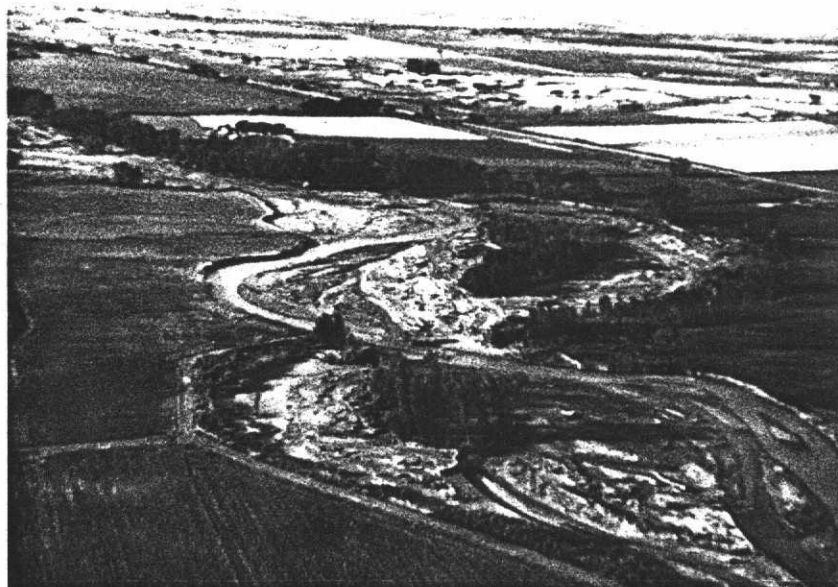
SITE # 16

11 acres of irrigated farmland destroyed.
Valued at \$3000 per acre.

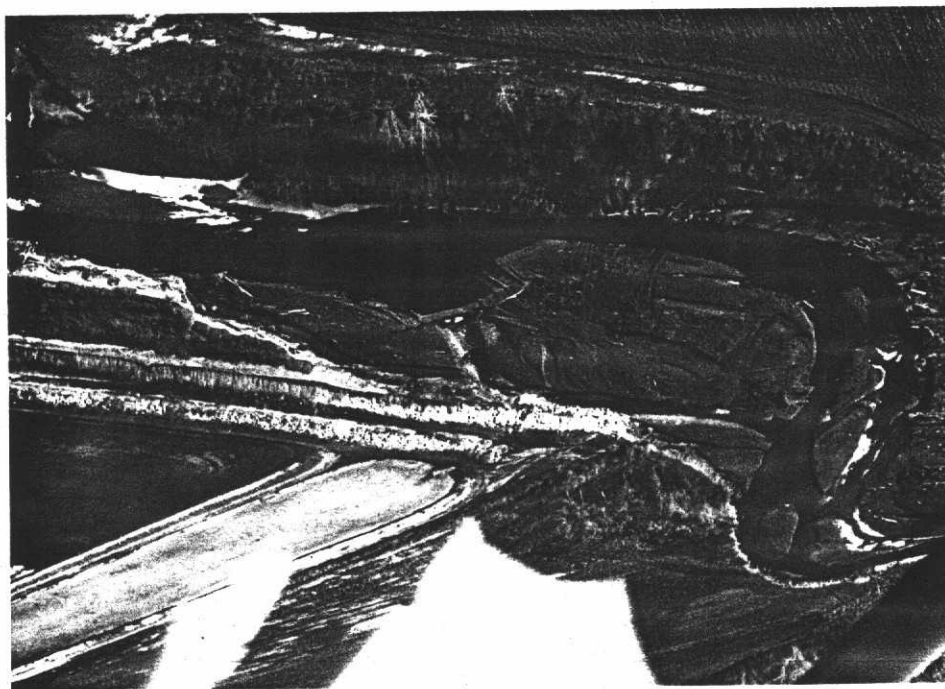
SITE # 17

Erosion of lagoon dikes and channel aggradation.

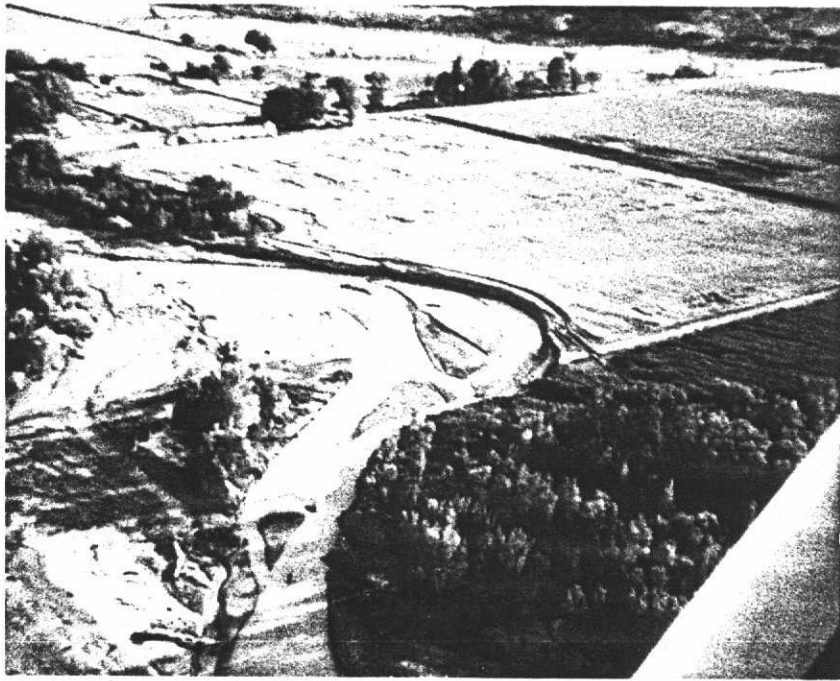
SITE # 18

5 acres of irrigated farmland destroyed. Value \$3000 per acre.

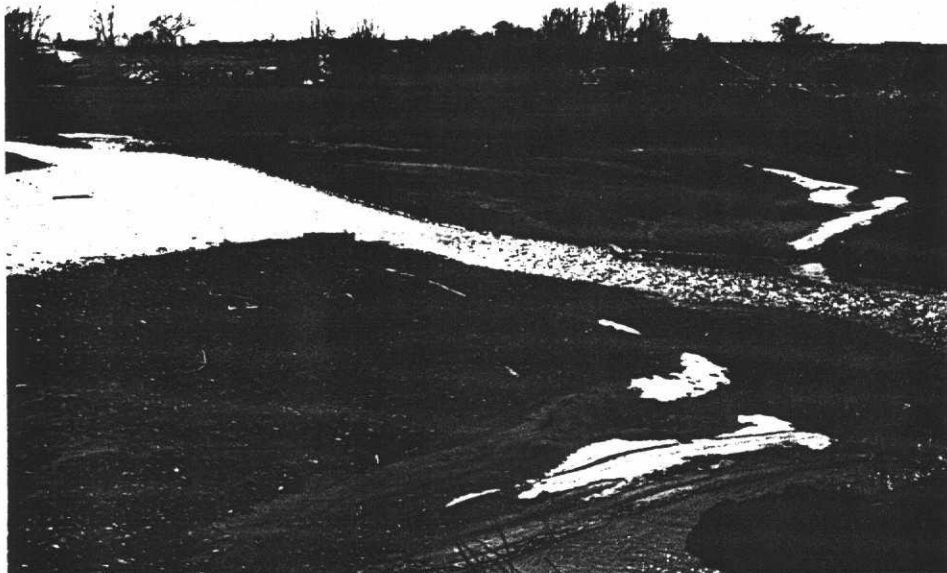
SITE # 18

Looking upstream - 6 to 8 feet of land eroded away.

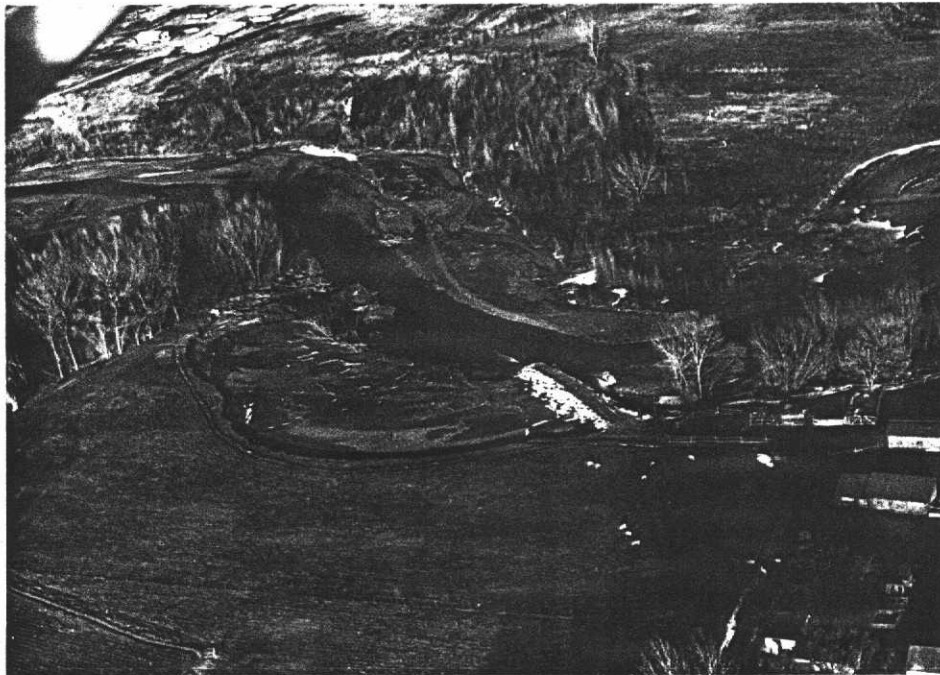
SITE # 19

A rock jetty constructed to place channel in pre-flood alignment.

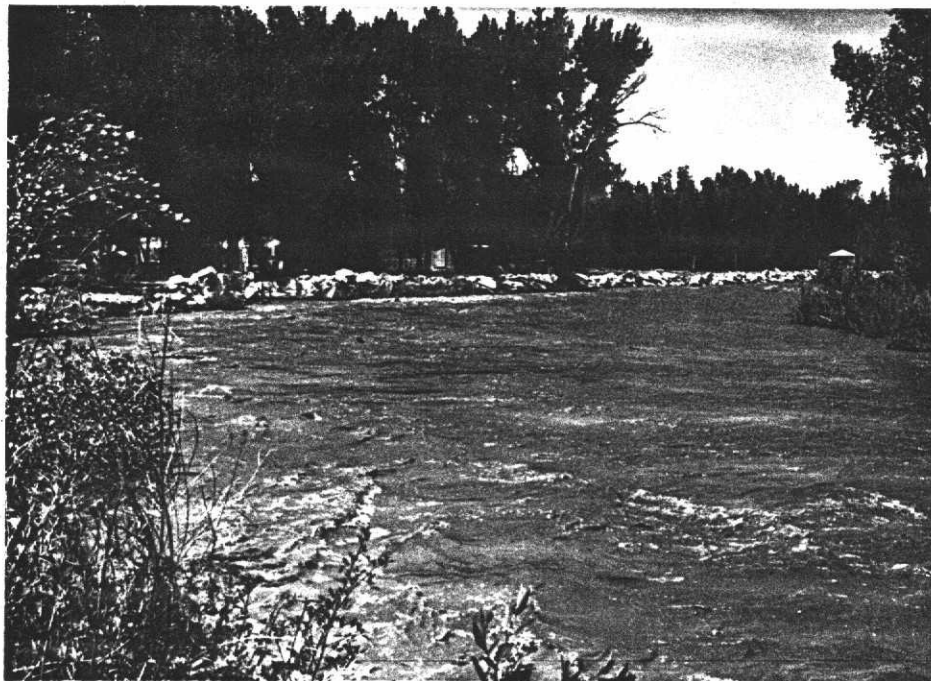
SITE # 20

Left bank stabilization.

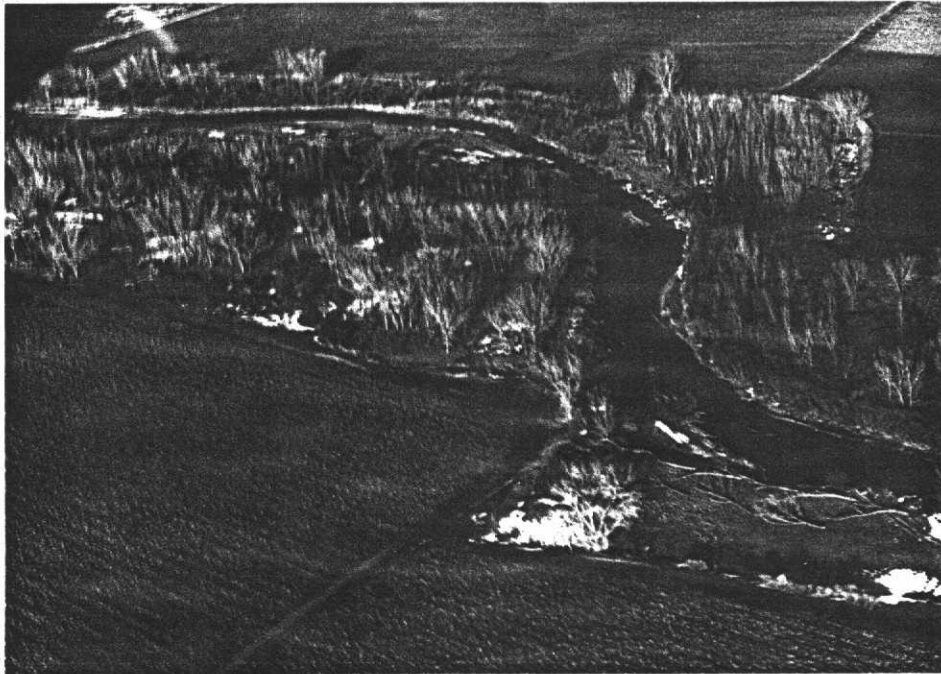
Note fallen trees lying on stream bank.

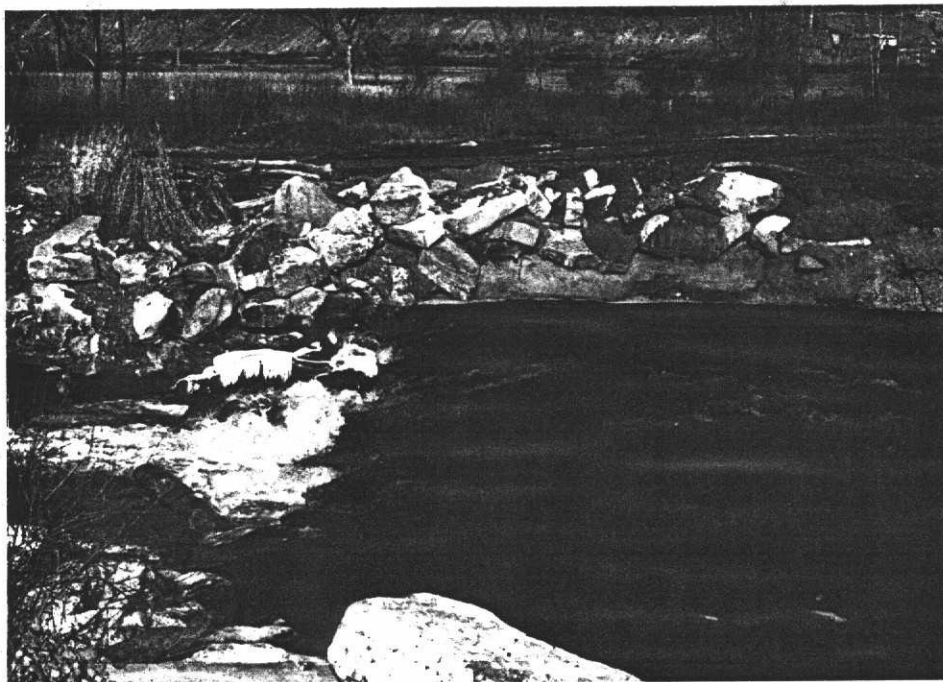
Ironstone irrigation diversion structure and associated erosion. 6-8 feet of large rock placed below structure.

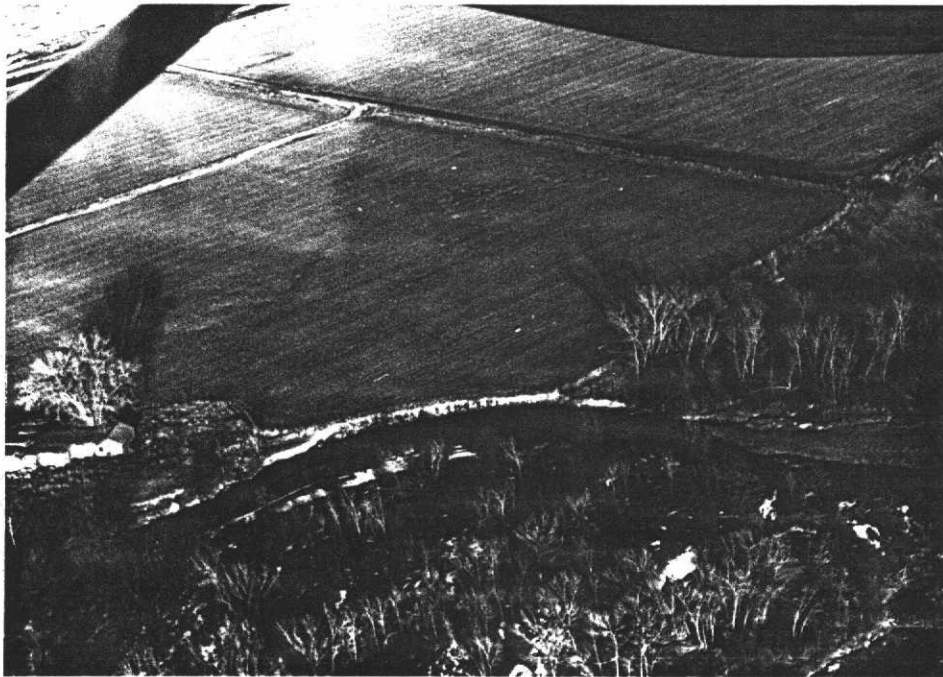
Left bank failure by erosion. Result will be a major channel realignment and flooding of Ironstone canal.

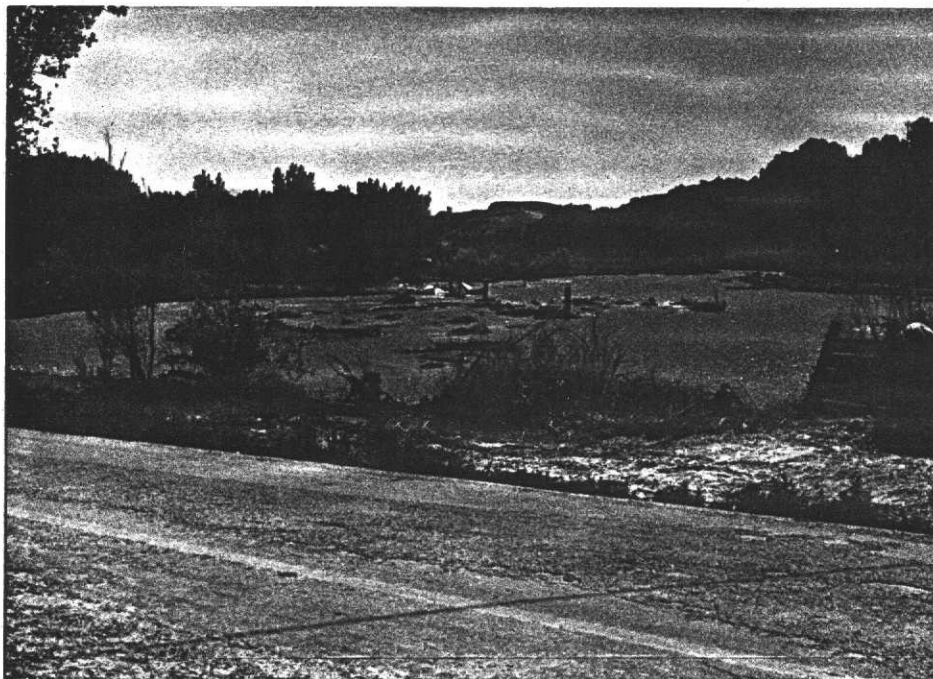
Flooding upstream of Jay Jay Road. Pre-flood channel alignment to the right of the piling in the center of the photo.

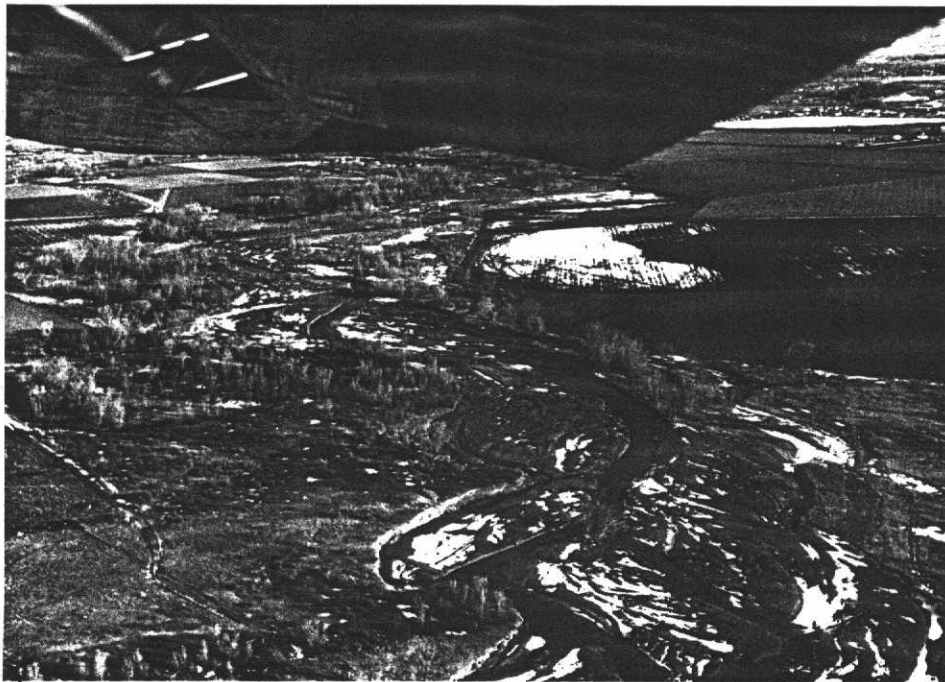
Channel migration upstream of Jay Jay Rd.

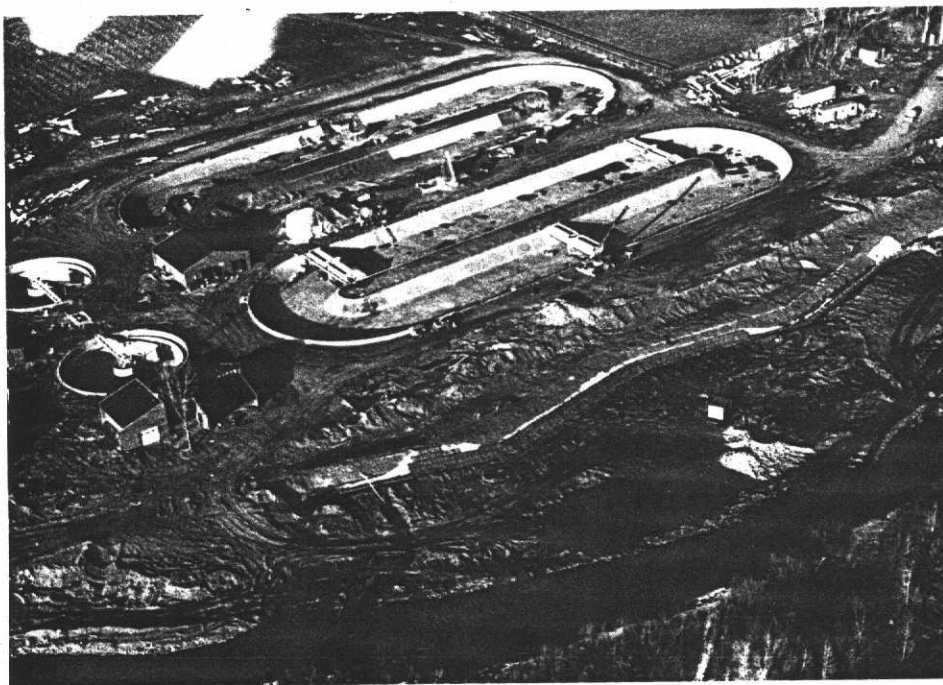
Left bank stabilization required for erosion protection.

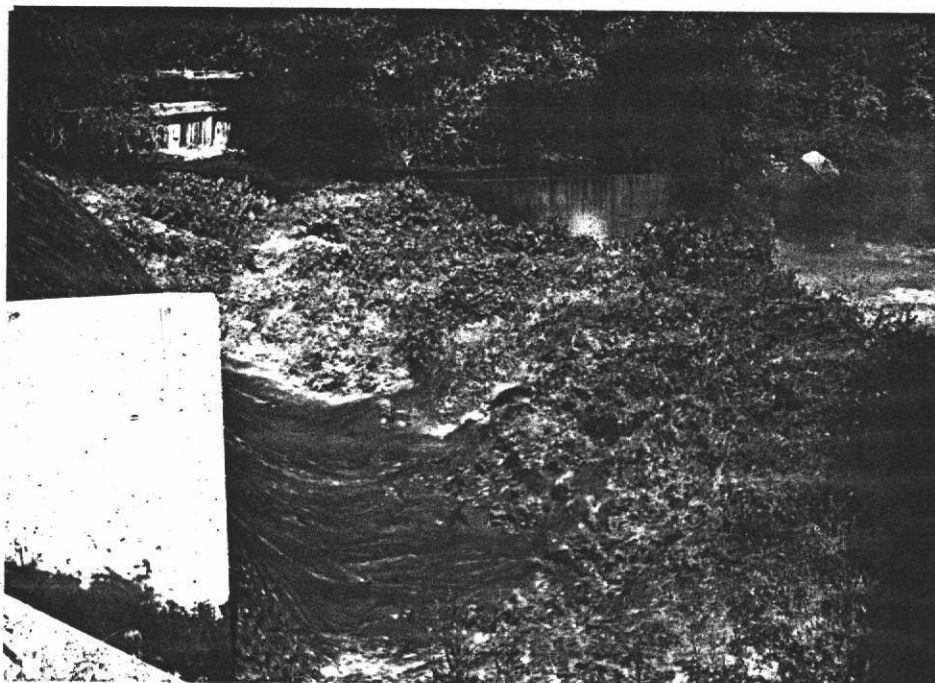
SITE # 27

Selig Canal diversion structure. During high flows, the Uncompahgre River waters are very muddy and turbid.

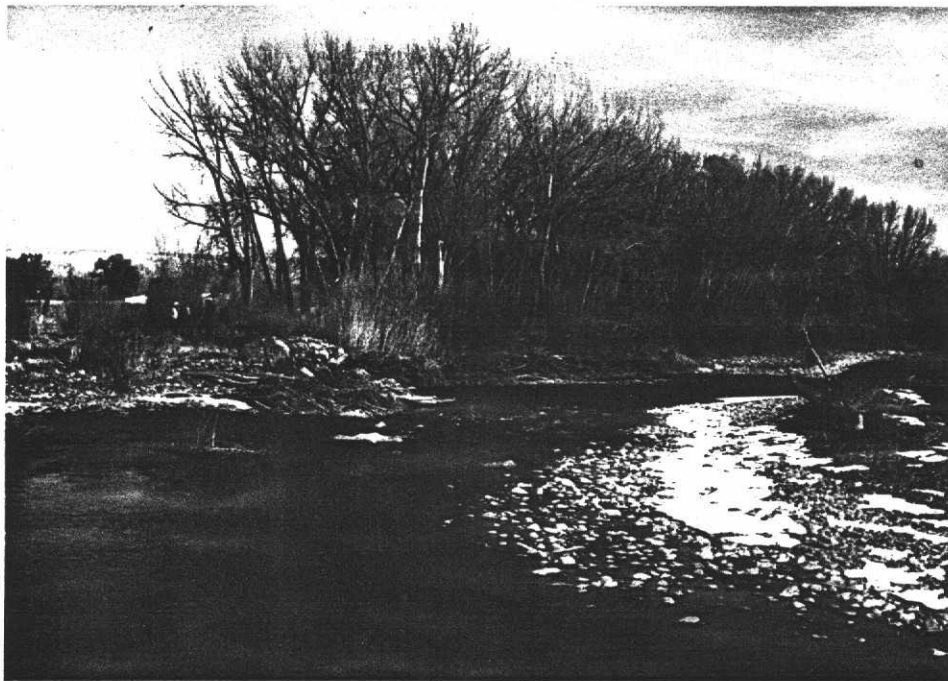
Upstream end of CC Camp project. Channel is eroding around the project.

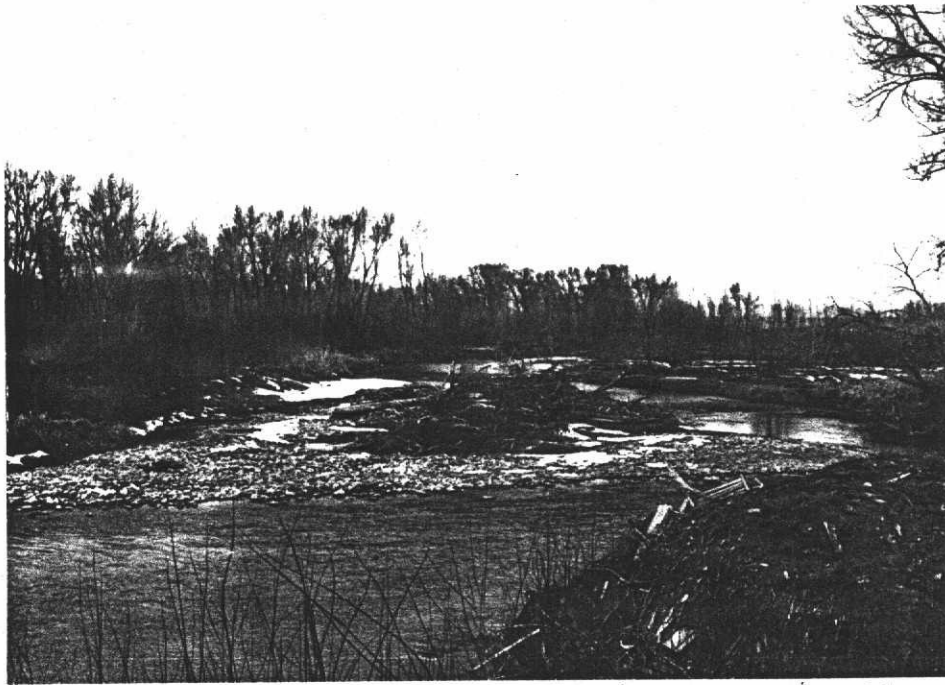
Upstream of LaSalle Road, a large trash pile in the middle of the channel. A number of large trees were uprooted by the flood.
