FLOOD DAMAGE SURVEY

Uncompahgre River *2890*

MONTROSE-DELTA COUNTIES

February 1984

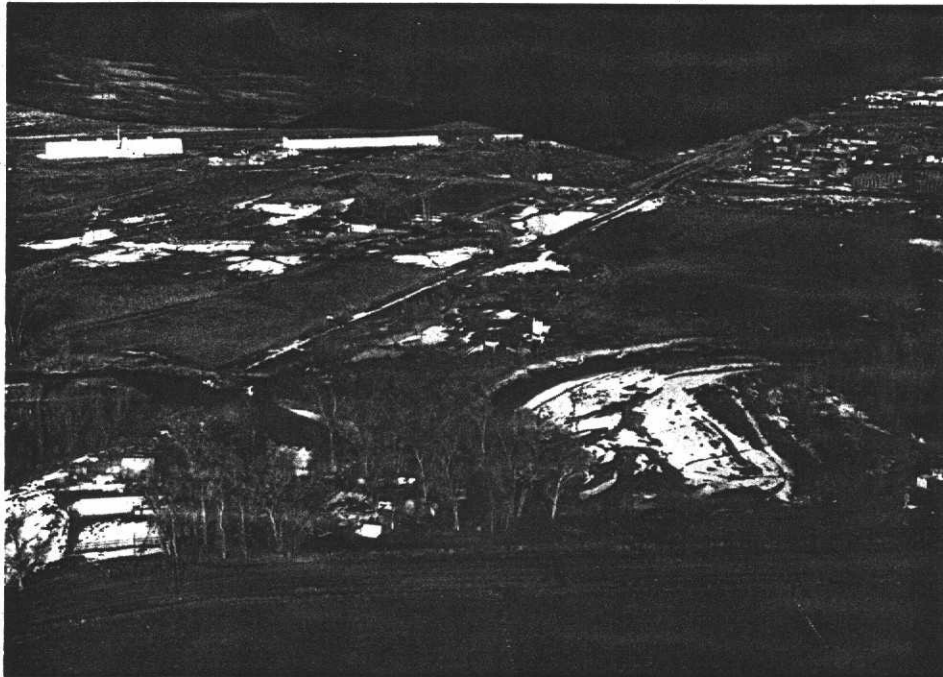
Confluence with Happy Canyon Creek. Active right bank erosion is occurring over 75 feet of the bank.

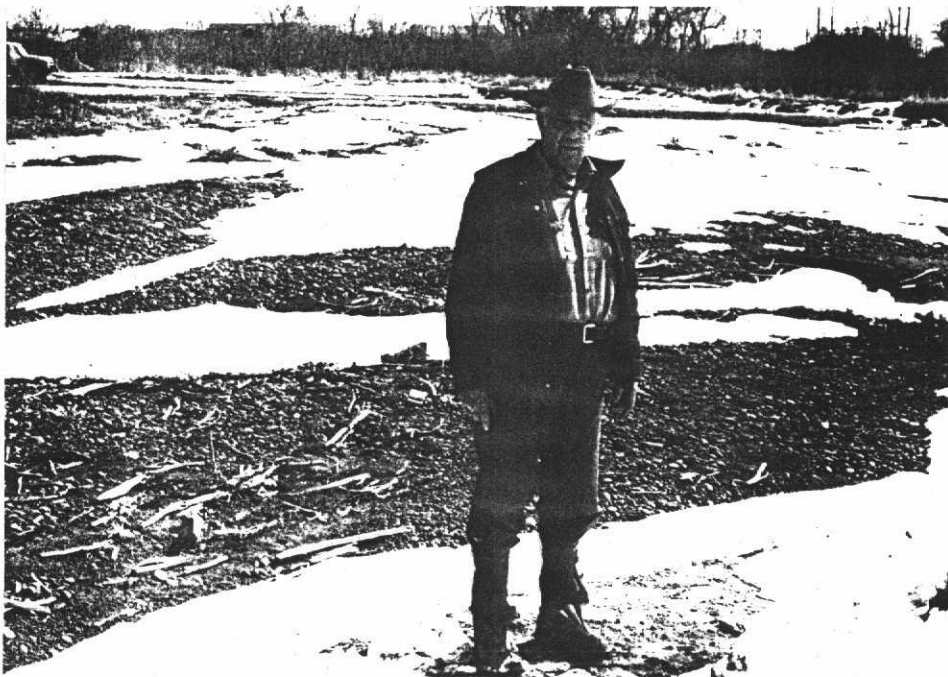
SITE # 31

A Corps approved concrete jetty (man standing on the 6 foot jetty). River has completely rerouted away from the 6 foot stabilization structure. Erosion has resulted from Corps no maintenance policy.

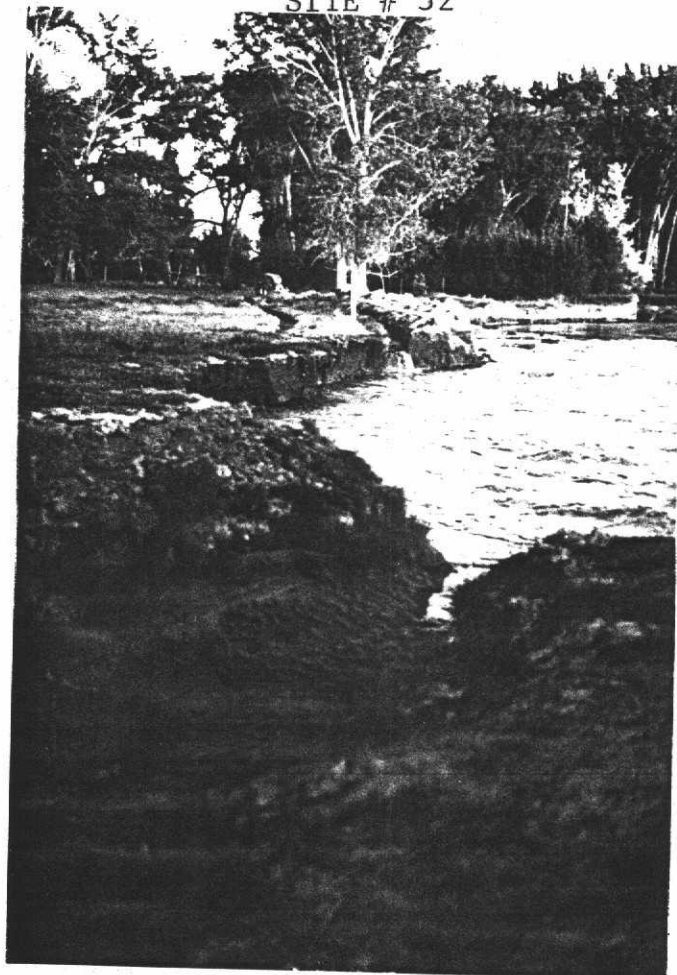
SITE # 32

Private irrigation ditch and diversion structure destroyed on June 20, 1983

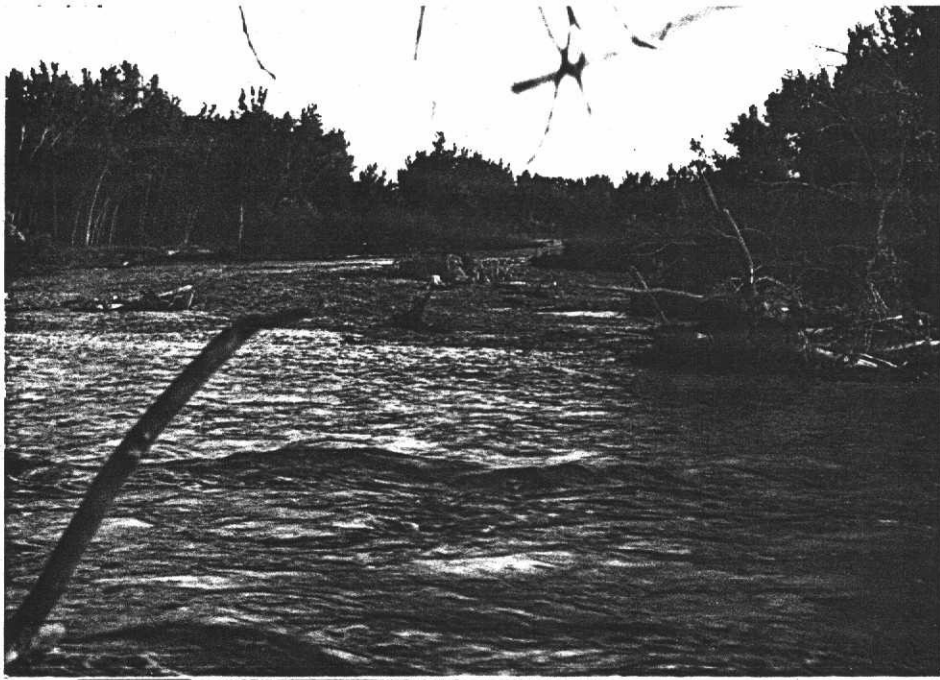
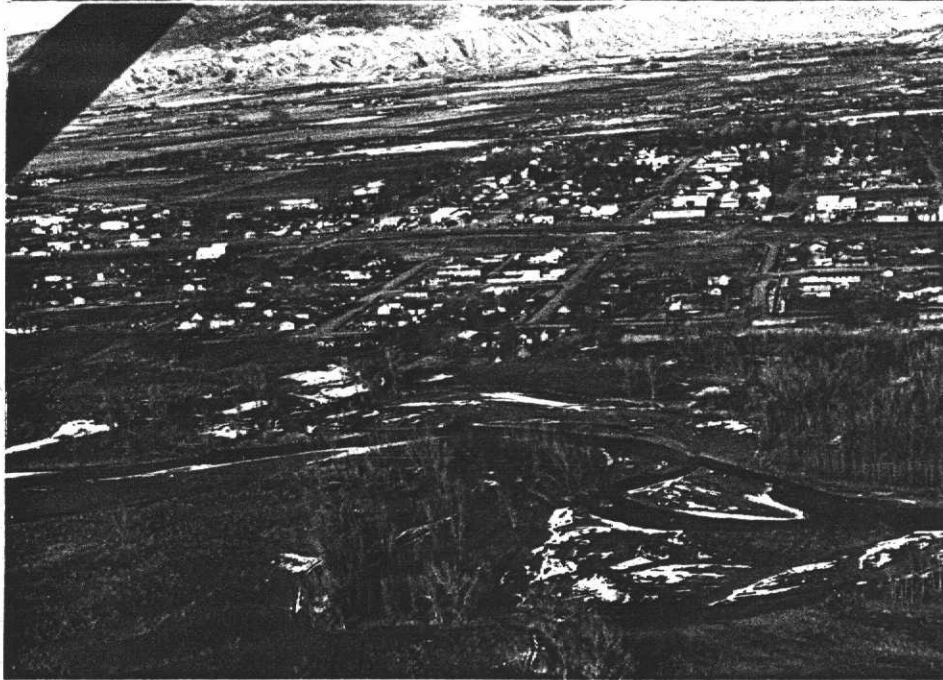
Sedimentation and debris deposition.

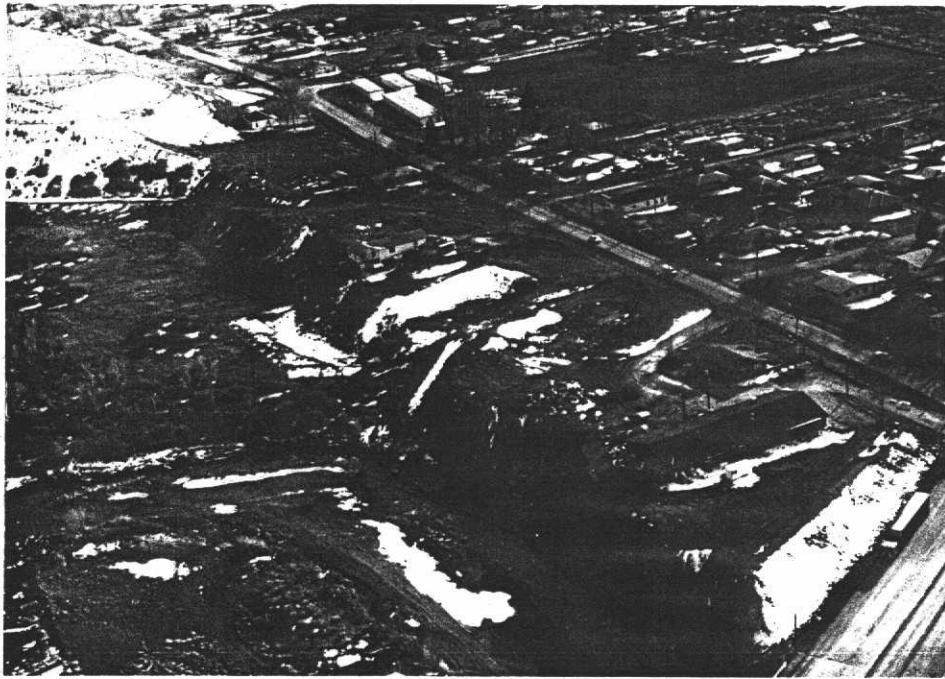
Left bank severely eroded. 75 feet was eroded during the 1983 flood.

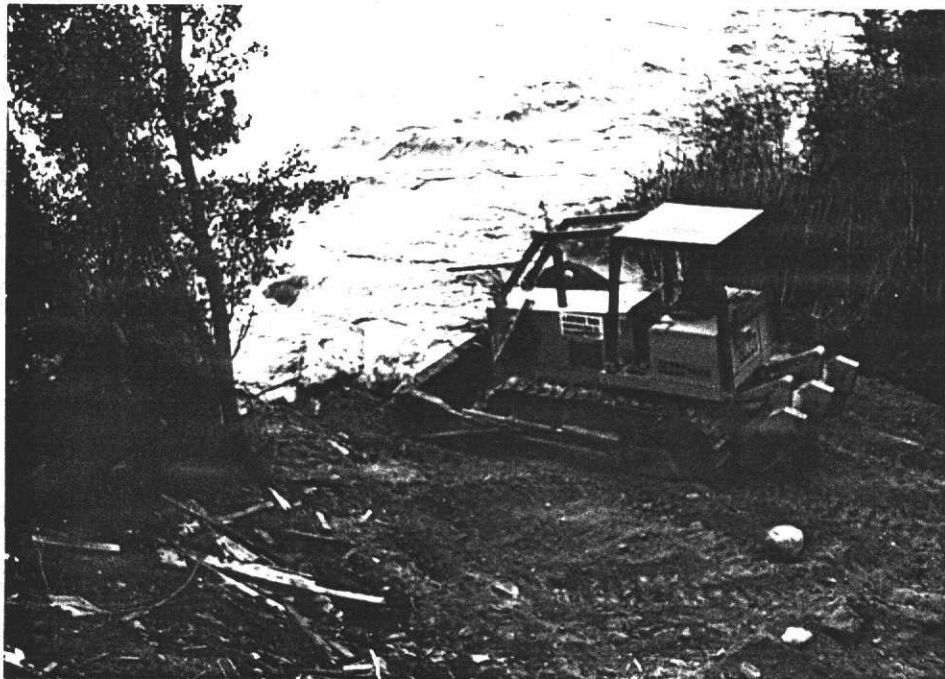
A rock jetty was constructed during the flood to lessen erosion on June 24, 1983.

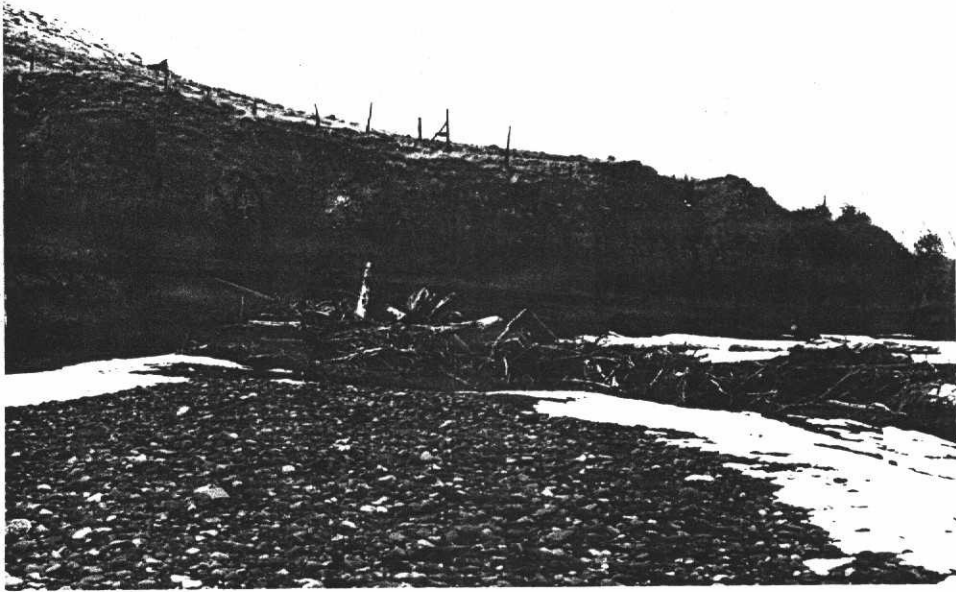
Trash and debris build-up near River Bottom Park.

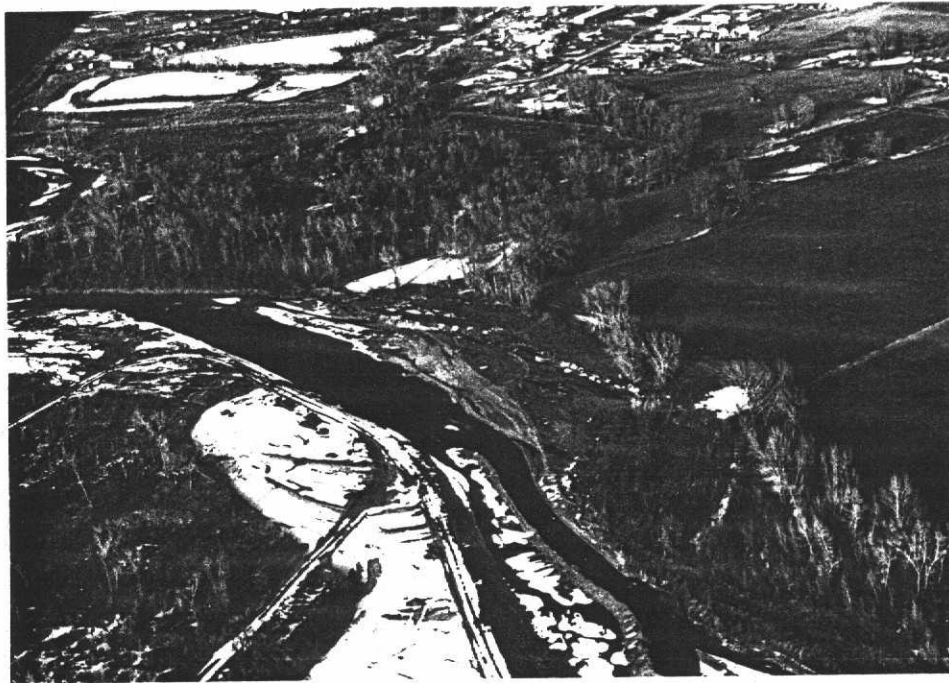
Large deposition area Sediment deposition
could be mined.

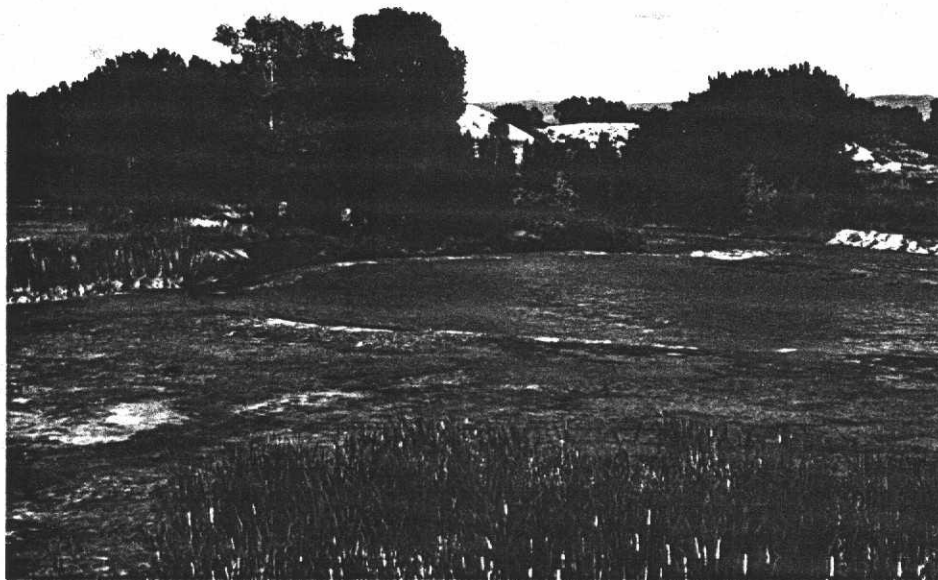
SITE # 37

Lake No. 1 of the Chipeta State Park was
destroyed on June 26, 1983

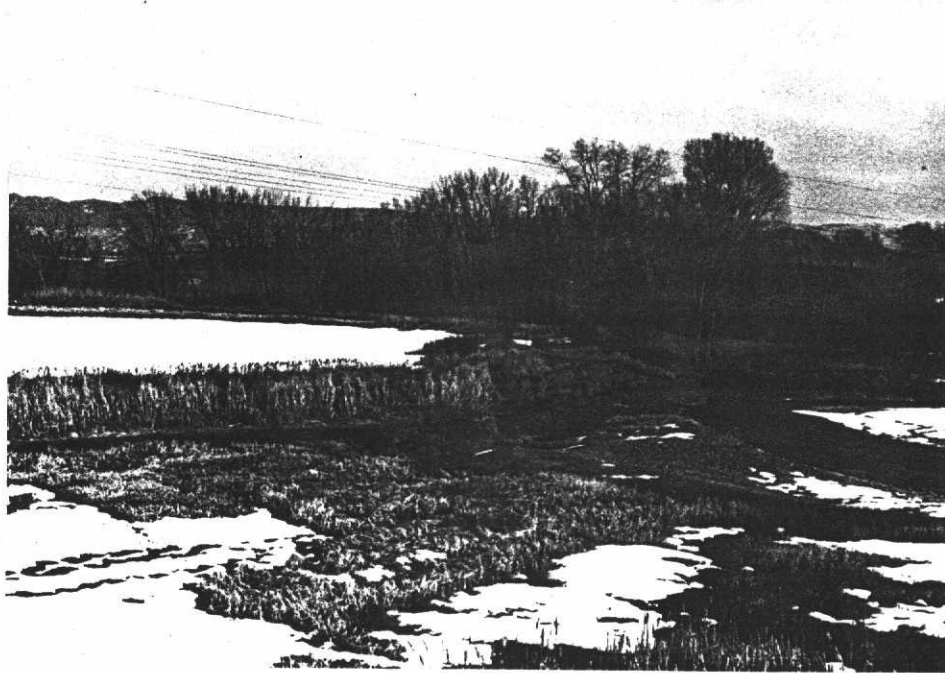
Dike of Lake No. 2 in Chipeta State Park severely eroded.

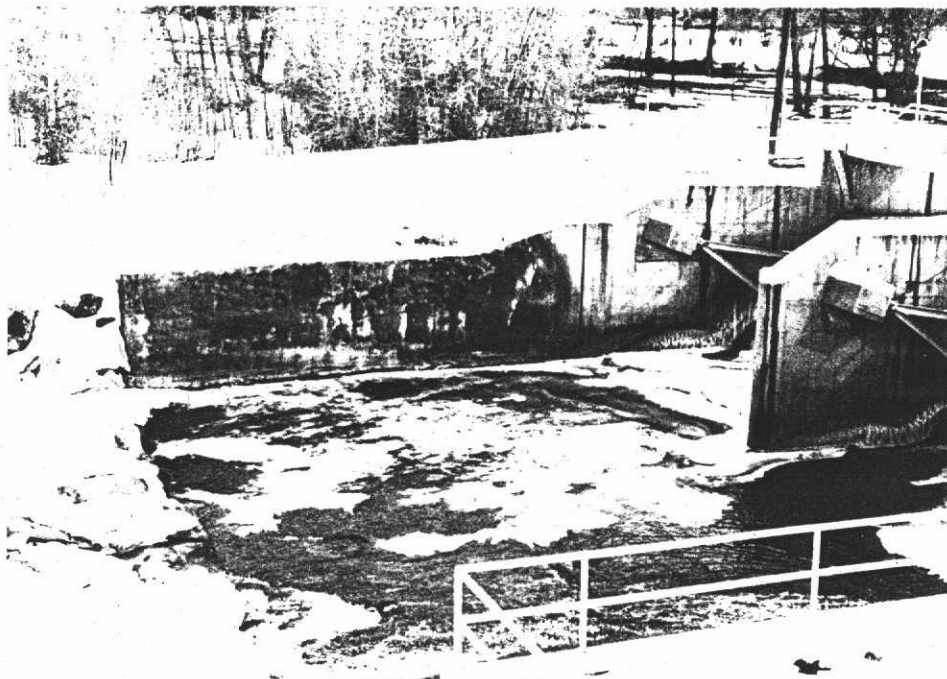
Montrose and Delta irrigation structure. After spring run-off (flooding) the spillway apron was severely undercut. 700 yards of concrete was pumped into the cavity. 200 yards of sediment is dredged daily.

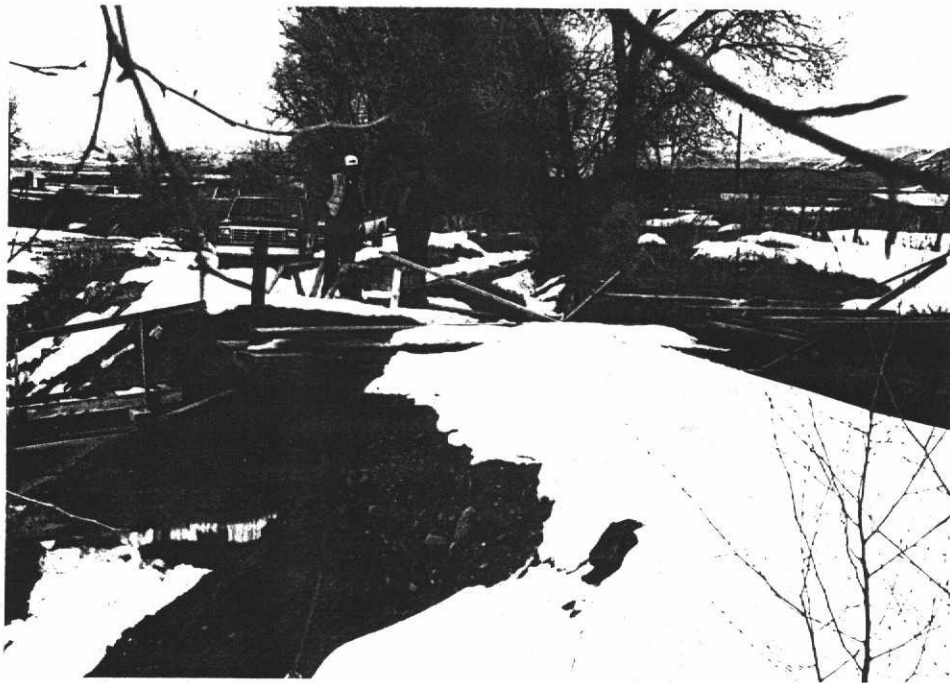
AM lateral irrigation canal spillway severely eroded.

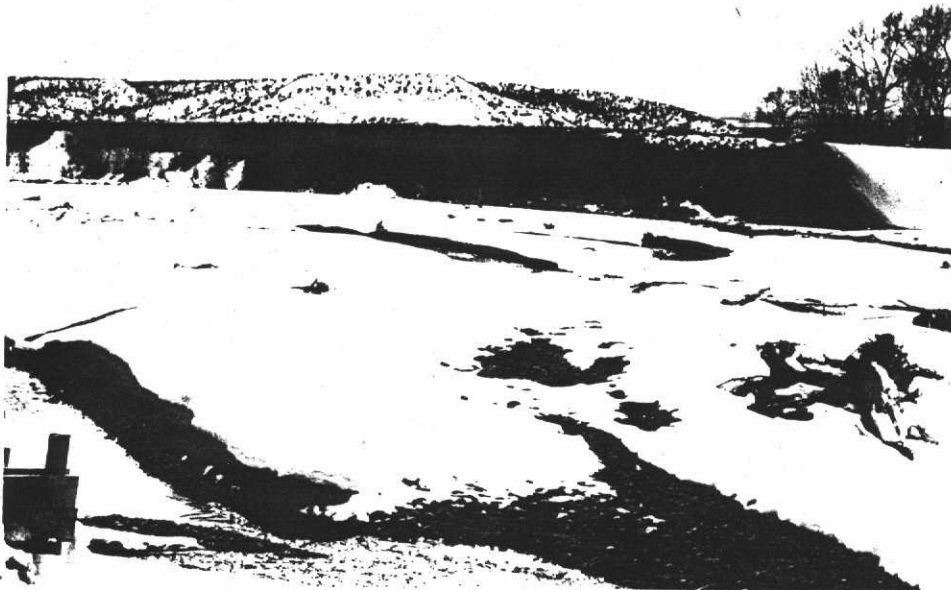
75 feet of Mesa land was eroded in 1983. The embankment is 40 feet high.

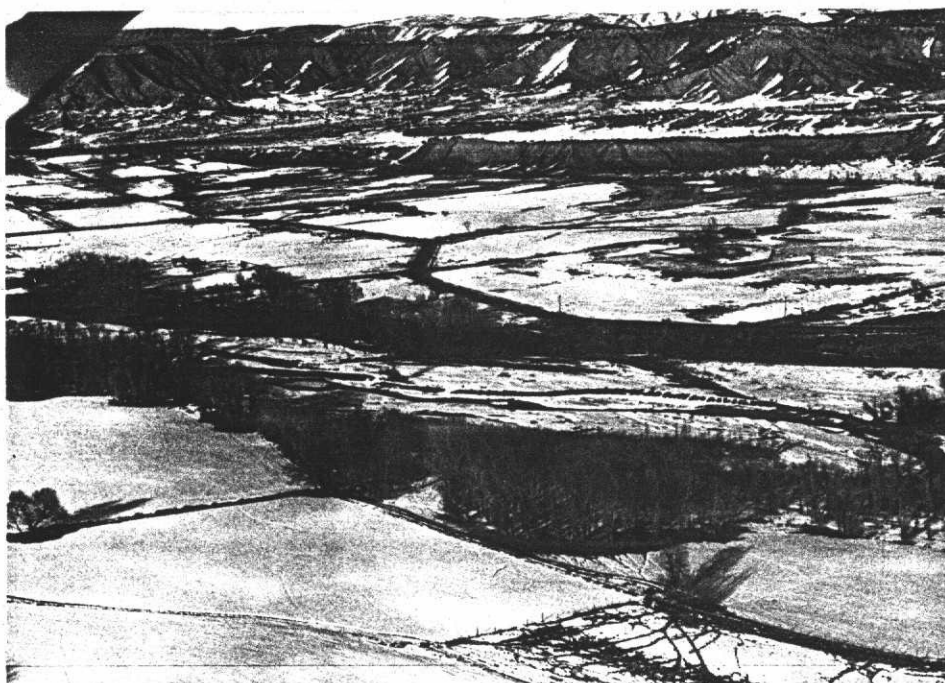
Sedimentation and debris build-up.

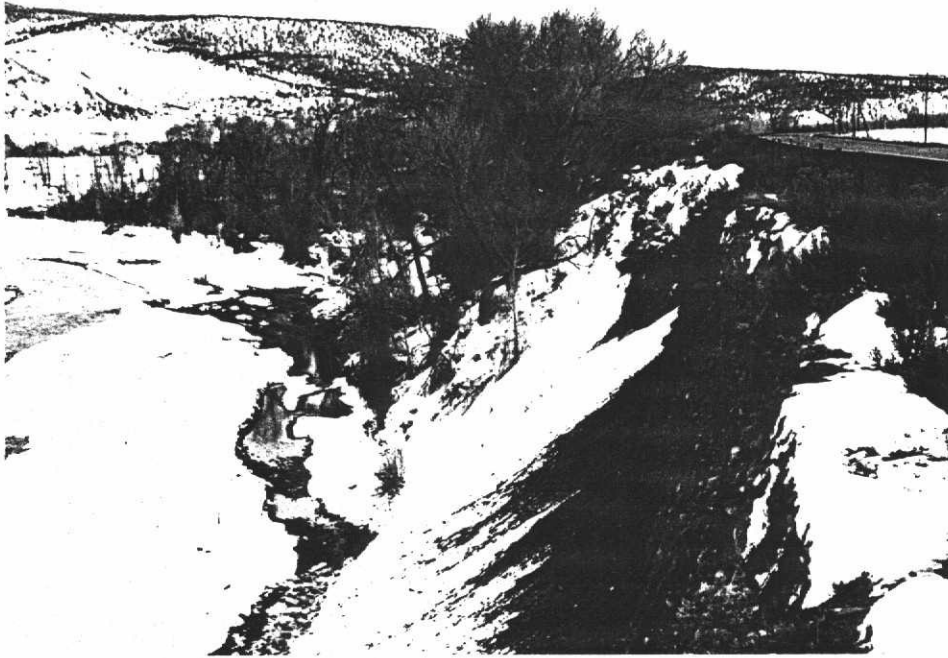
Left bank severely eroded adjacent to Colorado Highway 550.
