REPORT ON THE STATUS OF FIRES AT ABANDONED UNDERGROUND COAL MINES IN COLORADO

COLORADO DIVISION OF MINERALS AND GEOLOGY

JANUARY 10, 2005

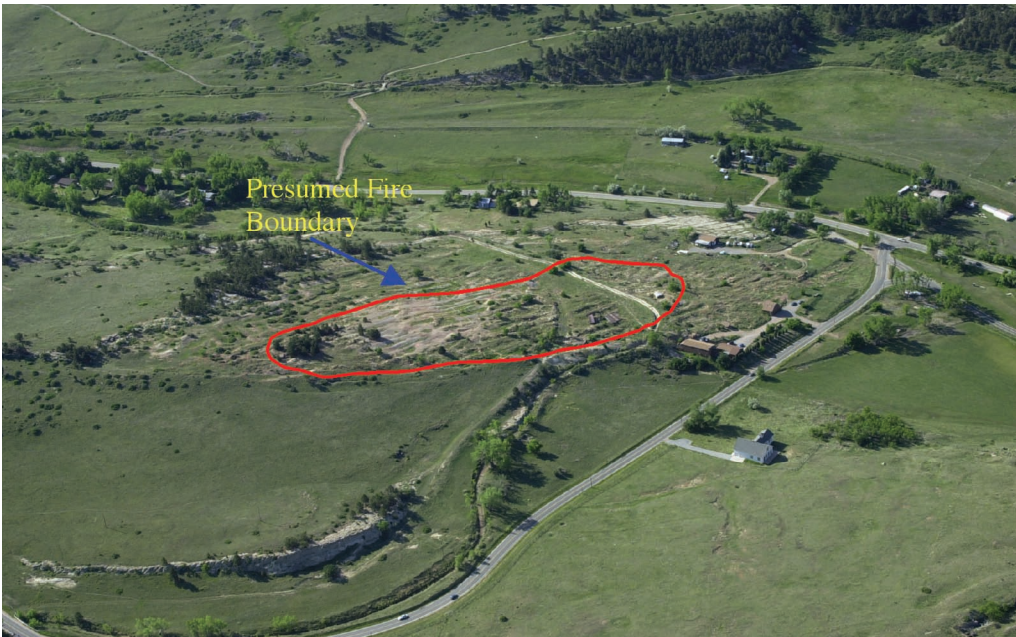
The fire occurs on private property that overlies an area of active subsidence. The owner of the property reports the fire has a cyclic nature, experiencing periods of activity and inactivity. The fire appears to have been relatively inactive for about ten years or longer, yet he has observed that the fire vents steam during the winter months.

Few fire related features were observed at the site during the October 2003 evaluation. However, some fire related vents were observed to occur immediately south of a concrete lined irrigation ditch that crosses approximately east to west through the fire zone. Steam was visibly issuing from an approximately three feet by one foot vent located at 39° 57' 23.1"; 105° 13' 20.1". The ground surface temperature at the vent was 100° in contrast to ambient ground temperatures of 65° to 70°. The vent was partially obstructed by a rock, which displayed some moss growth on its underside. No creosote or sulfur development was observed, while smoke strains were also not present.

Lewis Number 1 and 2 Coal Mine Fire. View toward South.

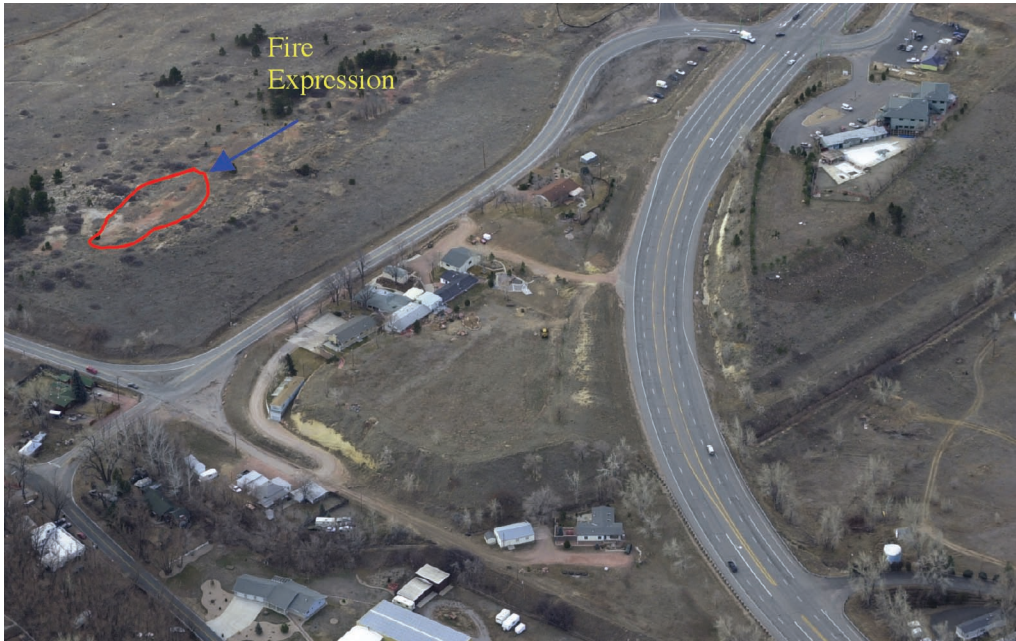
Marshall Number 1 And 2 Coal Mine Fire

Marshall Number 1 & 2 Mine Fire. Highway 170 to left, Highway 93 to right. View to South.

The Marshall Number 1 and 2 fire is a small site, with a surface expression observed at less than one-quarter acre. Not unlike the Lewis Numbers 1 and 2 mine fire, surface subsidence evidence is ample, with numerous depressions observable over a much larger area. Evidence of the fire is observable in tension fractures that border a ridge separating two subsidence depressions. The central portion of this ridge is located at $39^{\circ} 57' 17''$; $105^{\circ} 13' 46''$. The subsidence features appear to be fairly active, as tension fractures bounding the east and south facing slopes are open, do not exhibit significant weathering, and do not support vegetation. The easterly fractures are linear, while the more northerly are concentric, opening toward the south, and apparently migrating toward the north.

The fractures on the east side of the ridge trend approximately north to south, as does the ridge itself. These north / south fractures are approximately 60 to 80 feet in length, and vary between four and eight inches in width. The smell of combusting coal was quite evident at a distance of over 20 feet from the fractures. Ground surface temperatures at the fractures were measured at 118° to 120° . Creosote development was observed to occur at this location. The south facing fractures are more conchoidal than linear, but trend approximately northwest to southeast. Each set of these approximately 20 feet long fractures serve as vents for the underlying fire. These features, the eastern margin of which are situated 20 feet west of the easterly fracture set, exhibit ground temperatures of 130° . No creosote deposition or other fire related alteration was observed at this location. A few scorched yucca roots were observed at the northerly fractures.

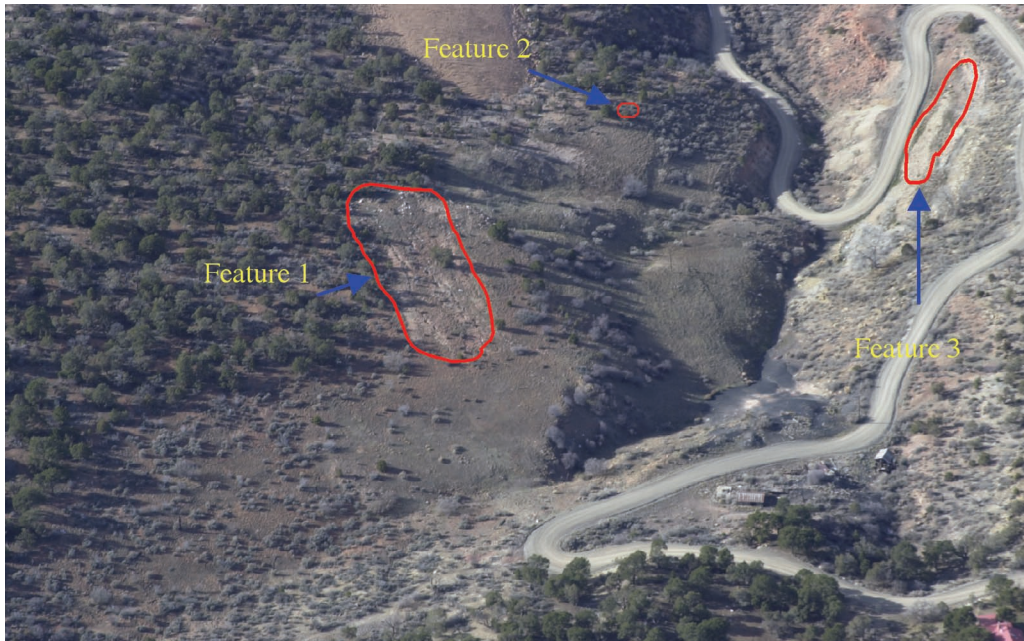
States Coal Mine Fire, view toward Southwest.

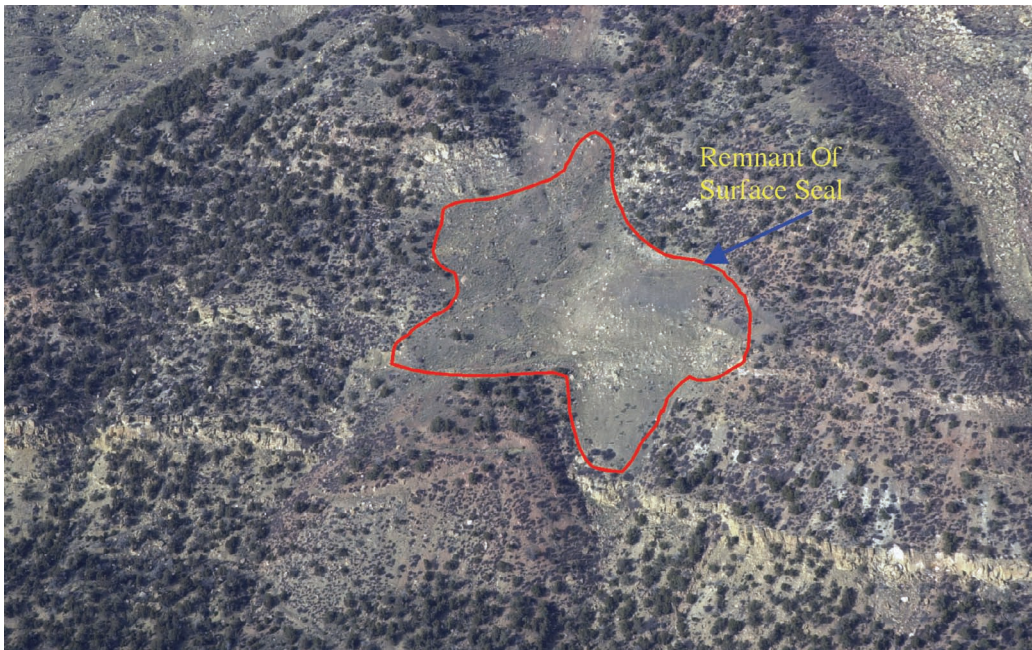
Minnesota Creek Coal Mine Fire

Minnesota Creek Mine Fire. View to North.

The lower portion of the burn zone is a steep slope approximately 400 feet parallel with contour, by about 300 feet perpendicular to contour. Ground temperatures within the lower portion of the burn zone varied from 125° to 150°. No vents or other fire related features were observed.

The upper area is similar, but less steep than the lower area. It is about 600 feet parallel with contour by 300 feet perpendicular to contour. This area characterized by a heavy stand of annual grass, with lesser amounts of shrubs within the burn zone. No vents were observed; however, a few small (four to six inches long) fractures were discovered. Temperatures within these fractures were measured at 160°. No other fire related features were found on the site.

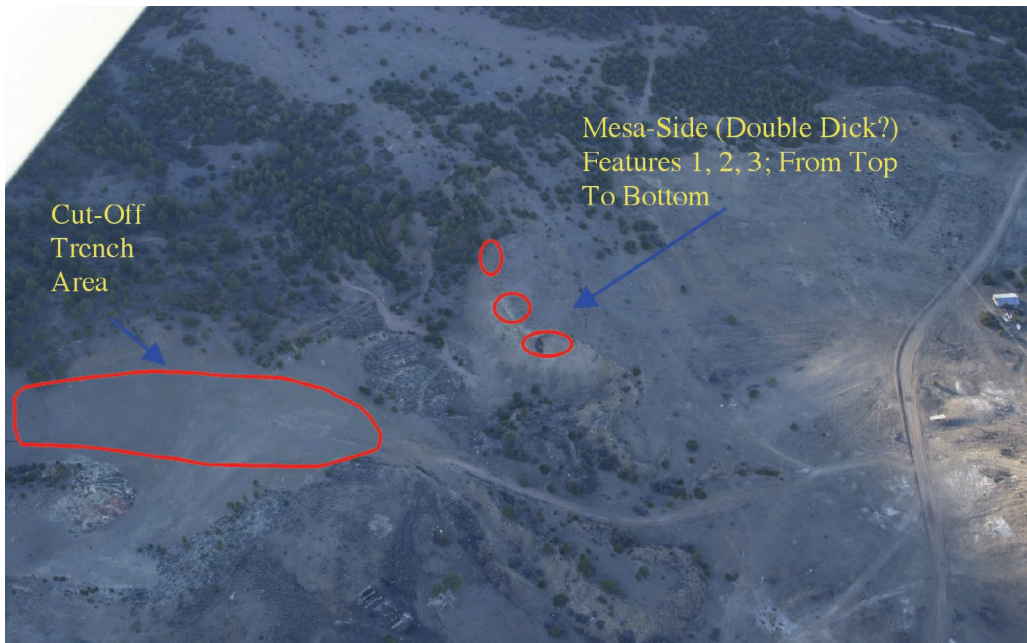
Double Dick Mine Fire Vicinity. Features 1, 2, 3; from top to bottom. View towards North.

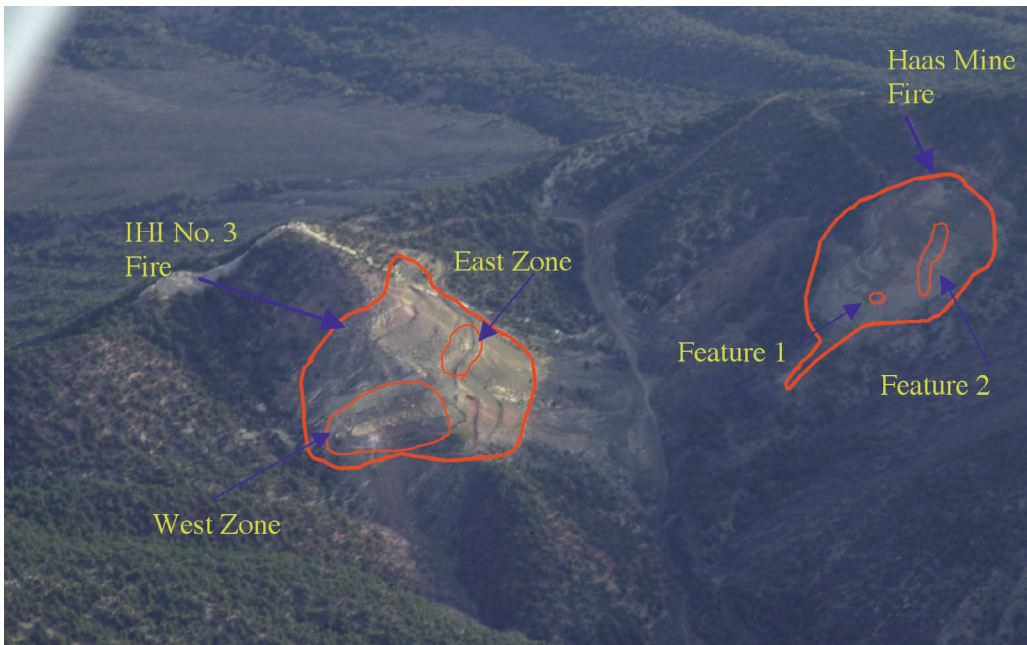
IHI Number 3 and Haas Mine Fires. North at top.

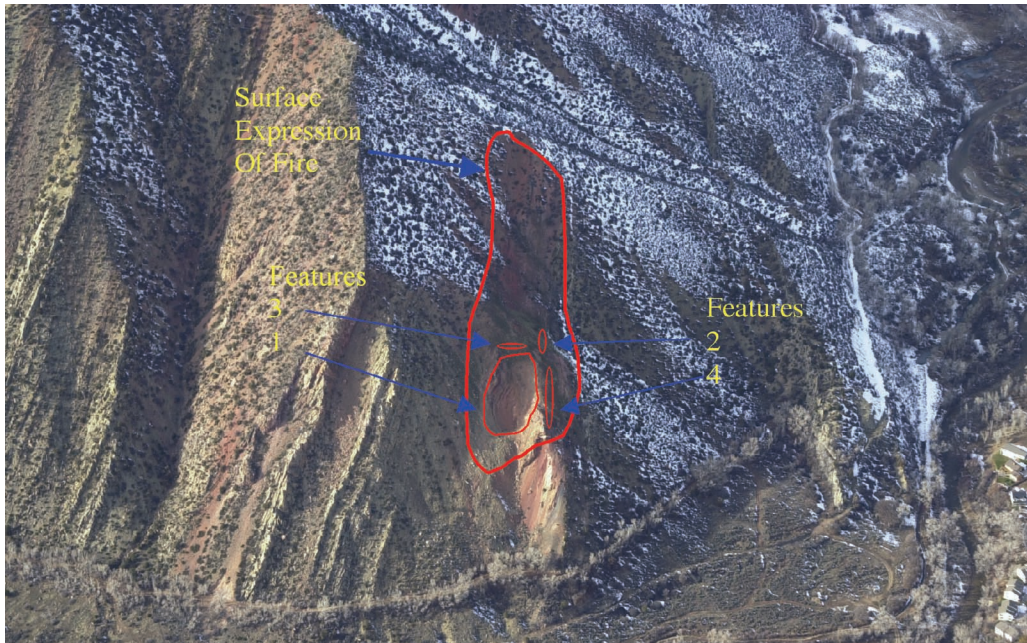
New Castle Number 3 Mine Fire. North at top.

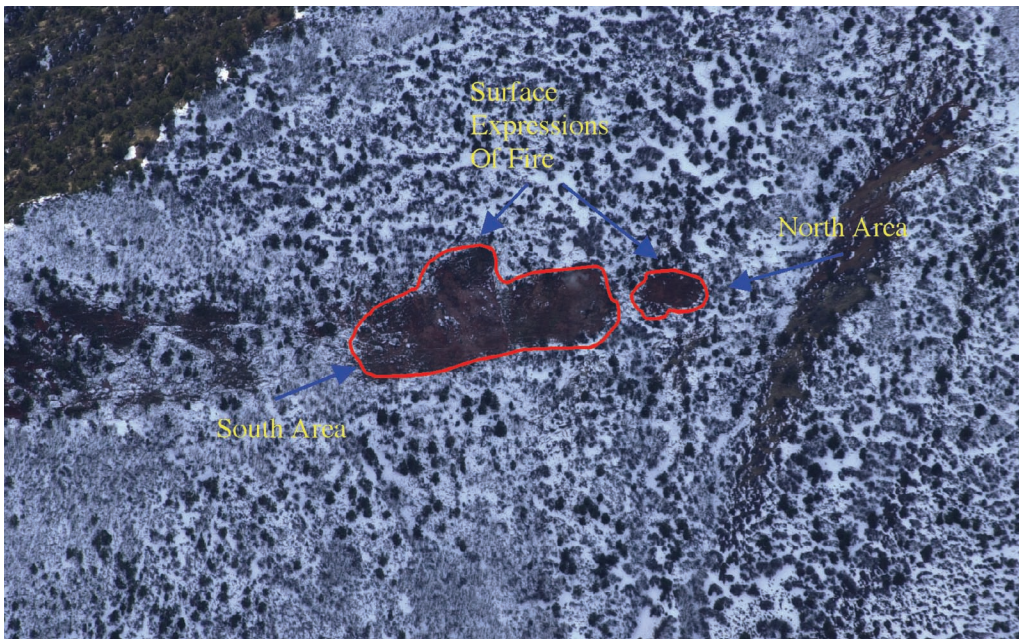
Morgan Coal Mine Fire

Morgan Mine Fire. View toward West.

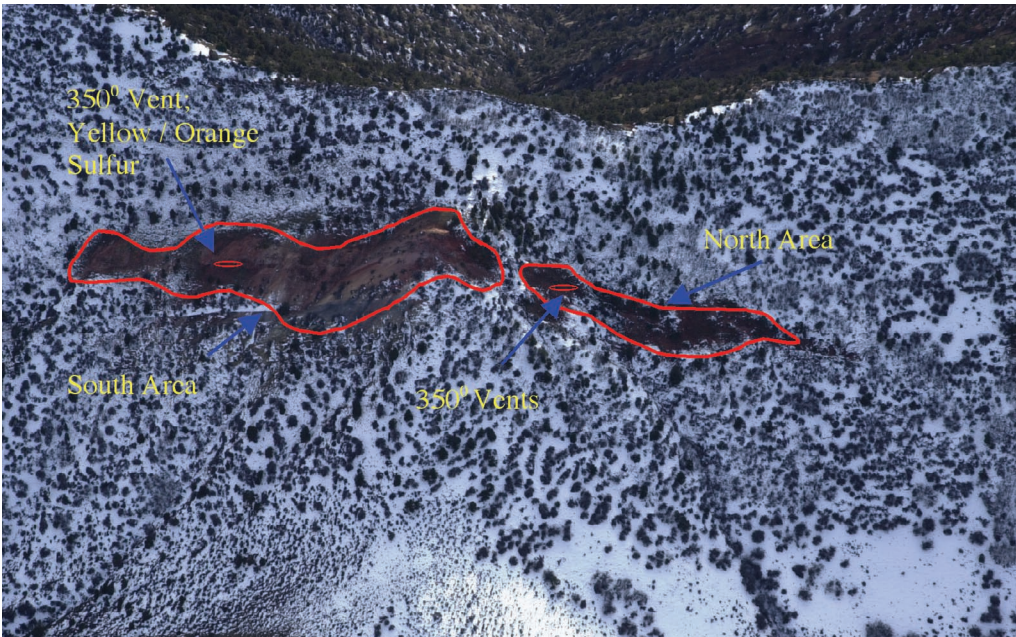
This fire is larger than the Morgan site, expressing itself over perhaps four acres. The fire zone trends parallel with the stratigraphy of the area, and likely vents in shales that overlay an unseen coal seam. From north to south, the fire area begins on the side of a small, transverse canyon near the crest of the Grand Hogback, and follows strike through a ridgeline into an adjacent transverse canyon. The portion of the fire zone within the canyon may be divided into a northerly and a southerly burn zone. The intervening areas are without elevated heat values.

Fire characteristics are first observed about 100 feet north of the ridgeline in the form of small vents and vegetative changes. The center of this area is located at 39° 35' 21.9"; 107° 35' 20.6". The westerly portion of this area displays a significant amount of white, sulfur precipitate around active and abandoned vents. Vents in this area exhibit ground surface temperatures of about 190°. The easterly portion of the area is apparently more active and more efficient. No sulfur was observed in the east vent area, however ground surface temperatures of 350° were observed at some vents.

Elk Creek Mine Fire. View towards West.

Further to the south, a second set of vents occurs. These vents display ground surface temperatures of about 350°. The most significant vent in the area is an eight-inch diameter vent that extends horizontally into the Hogback. Yellow and orange sulphur precipitate was observed at this vent. More typical of the vents at this southerly area are ground temperatures in the 180° to 250° range. The approximate center of the easterly area is located at 39° 35' 20.1"; 107° 35' 15.9".

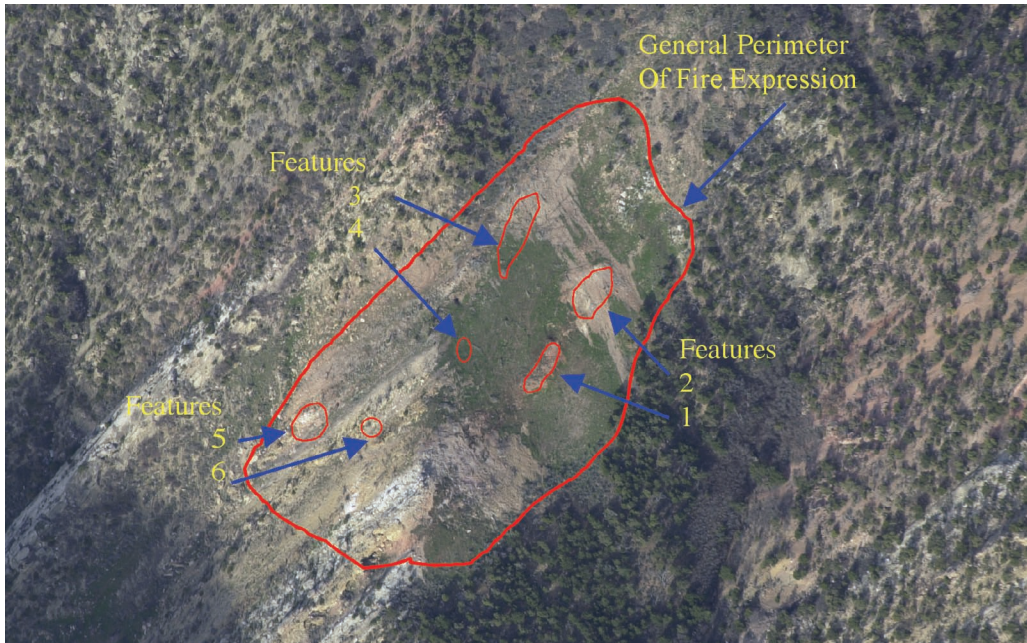
Harvey Gap Coal Mine Fire

Harvey Gap Mine Fire. View to Southwest.

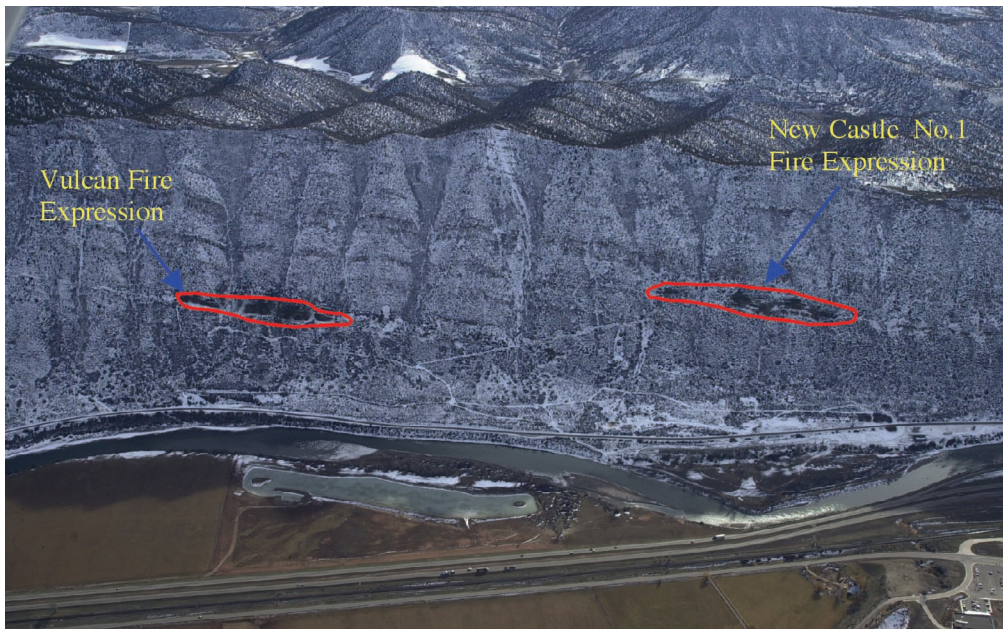
Vulcan and New Castle Number 1 Mine Fires. View toward South.

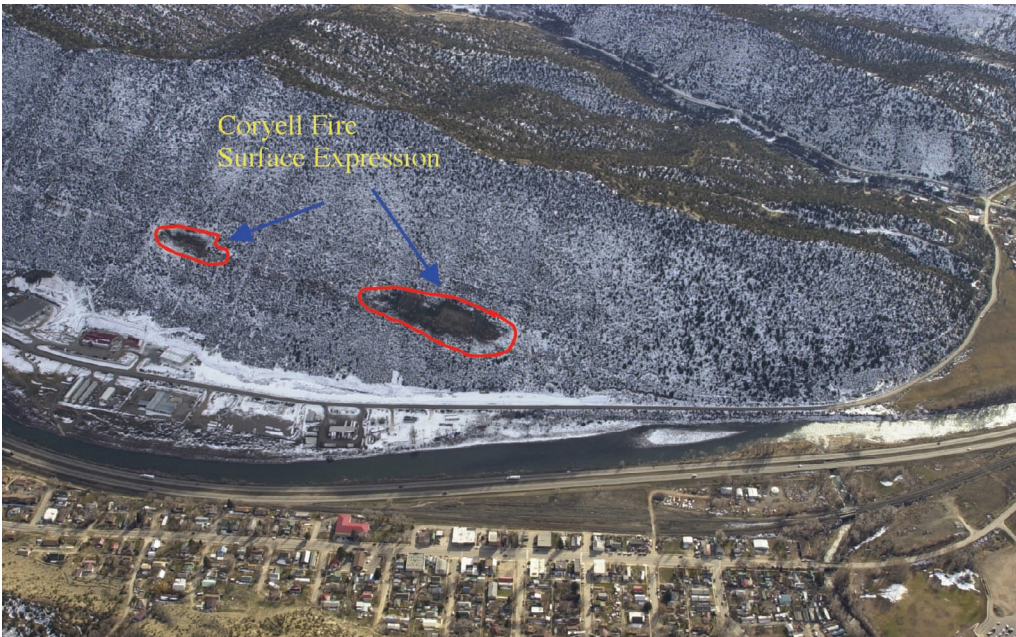
Coryell Mine Fire. View towards South.

colluvial cover movement. It is assumed that other small vents are completely hidden by the colluvial cover. This venting zone extends generally from the location of Feature 3 to a ridgeline located at 39° 34' 03.1"; 107° 31' 54.5".

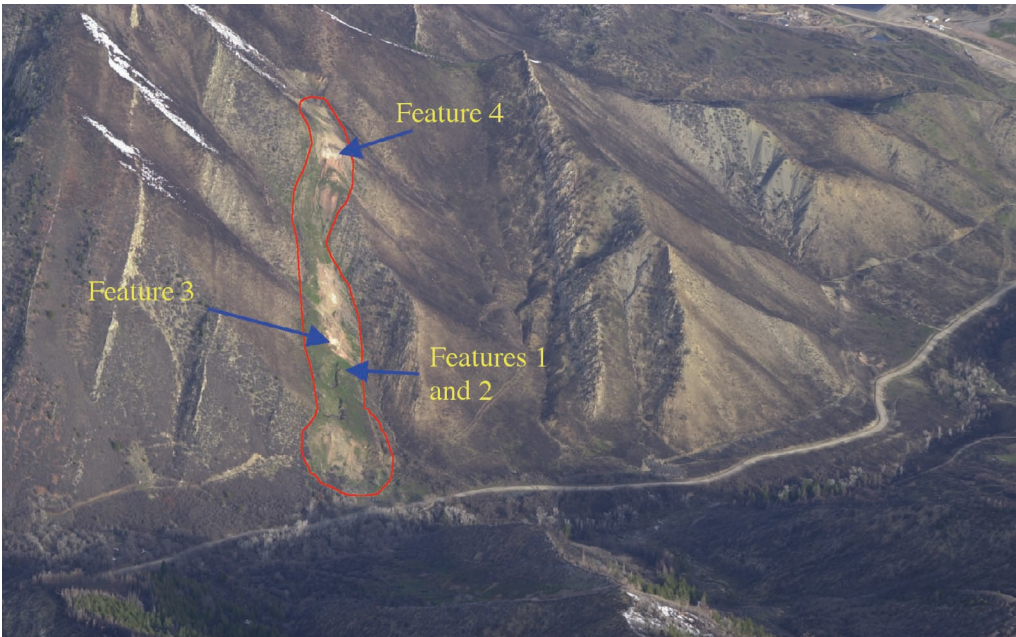
West Burn Zone

South Cañon Number 1 Mine Fire, West Burn Zone.

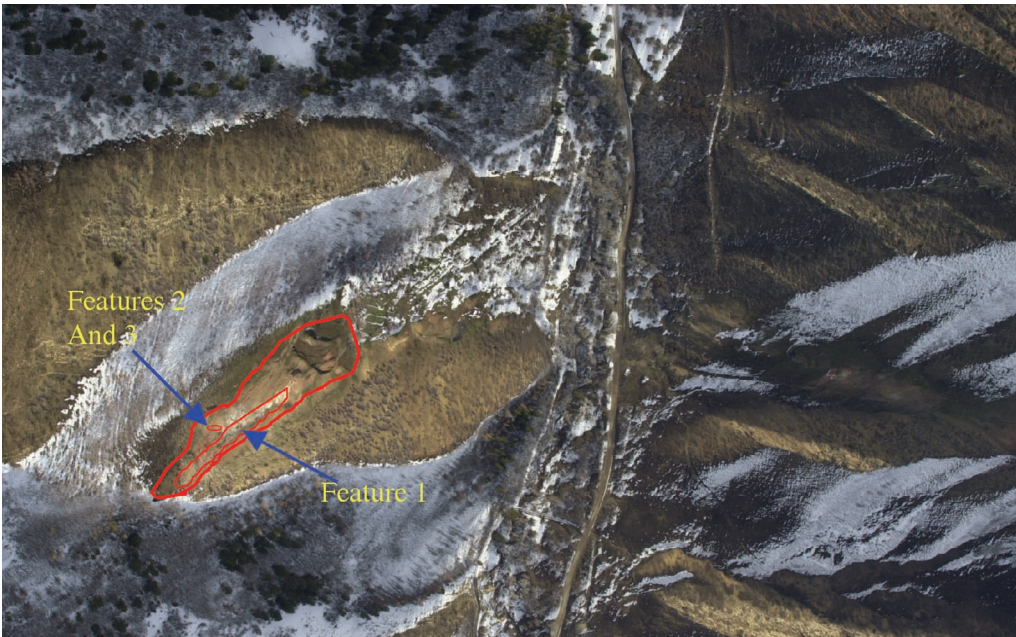
East Burn Zone

South Cañon Number 1 Mine Fire, East Burn Zone.

Feature 2 is a series of eight to ten vents that exhibit ground surface temperatures of 130°, with one vent measured at 180°. Feature 2 is located at the far eastern portion of the fire zone, about 50 feet south east of the central ridge. The central part of this area is located at 39° 32' 31.8"; 107° 25' 56.2". Some sulfur development was observed in this area, while none was observed in the westerly areas. The area surrounding this series of small vents supports substantial moss development, and significant available moisture. This area also supports the “micro-hummock topography” observed at the central ridge area.

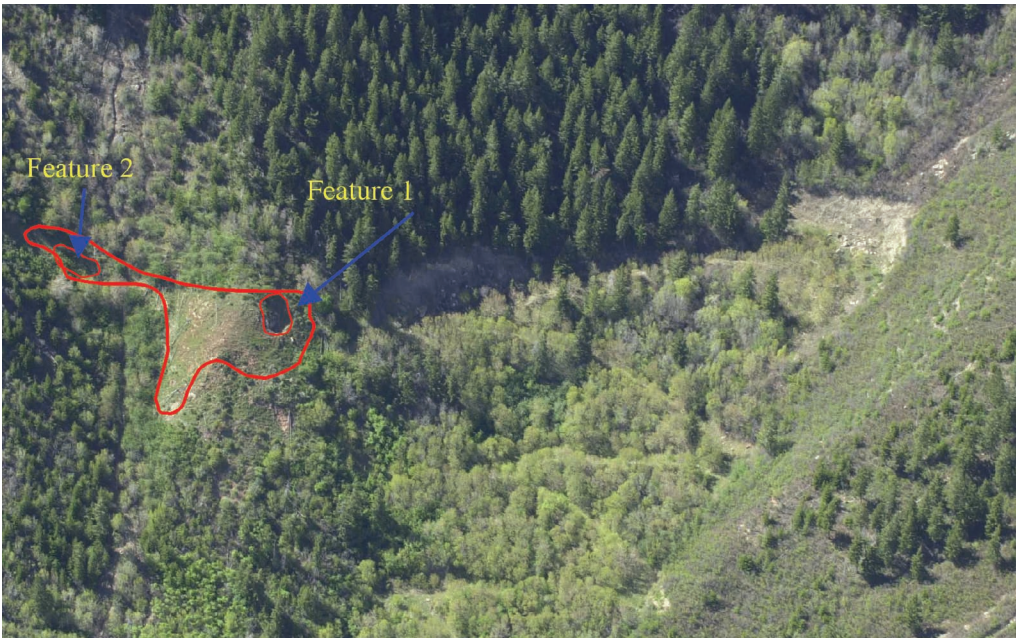
Gem Mine Fire, view towards South.

Areas within the burn zone, but that are not significantly active, support a robust stand of annual grasses. The areas above and below the surface expression of the fire, and particularly in the intervening central draw, support a vigorous stand of Mountain Mahogany and Oak. No elevated heat values were measured in either the adjacent areas or in the central draw.

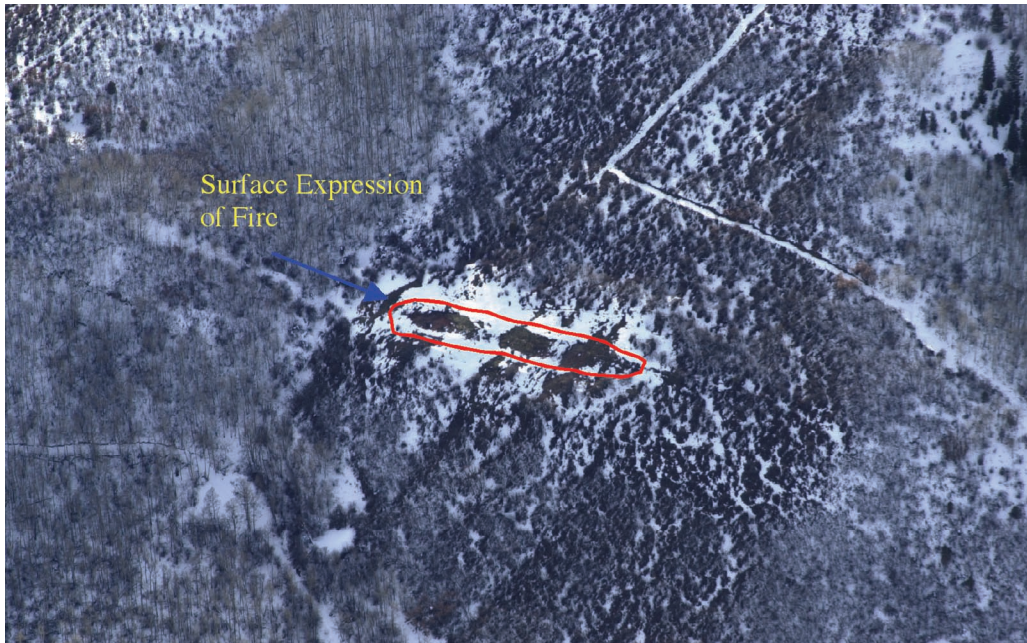
Pocahontas Mine Fire. View towards Southwest

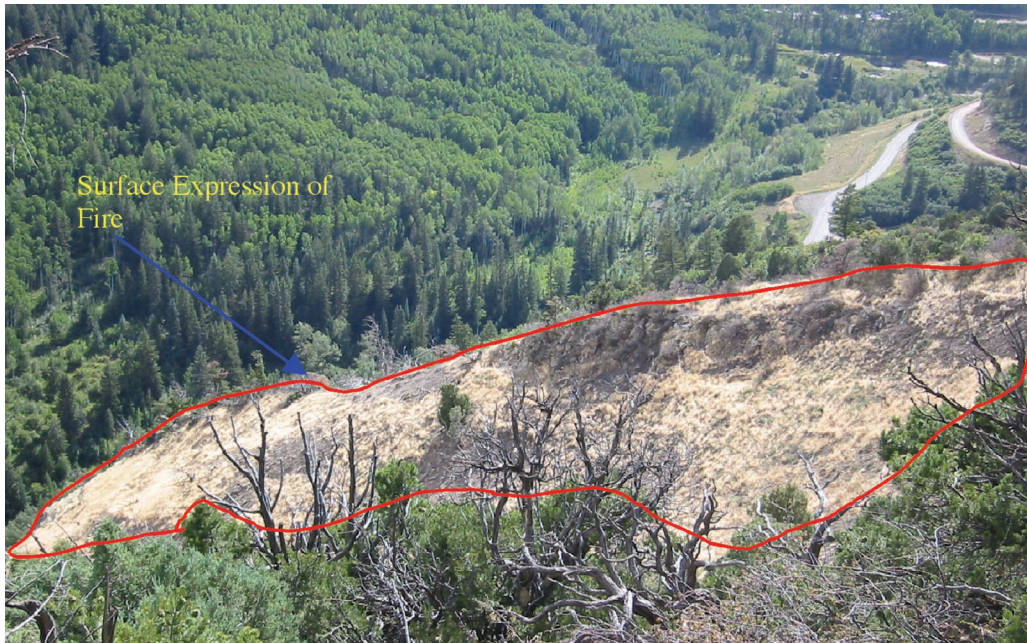
Sunshine Coal Mine Fire

Sunshine Mine Fire. View toward West.

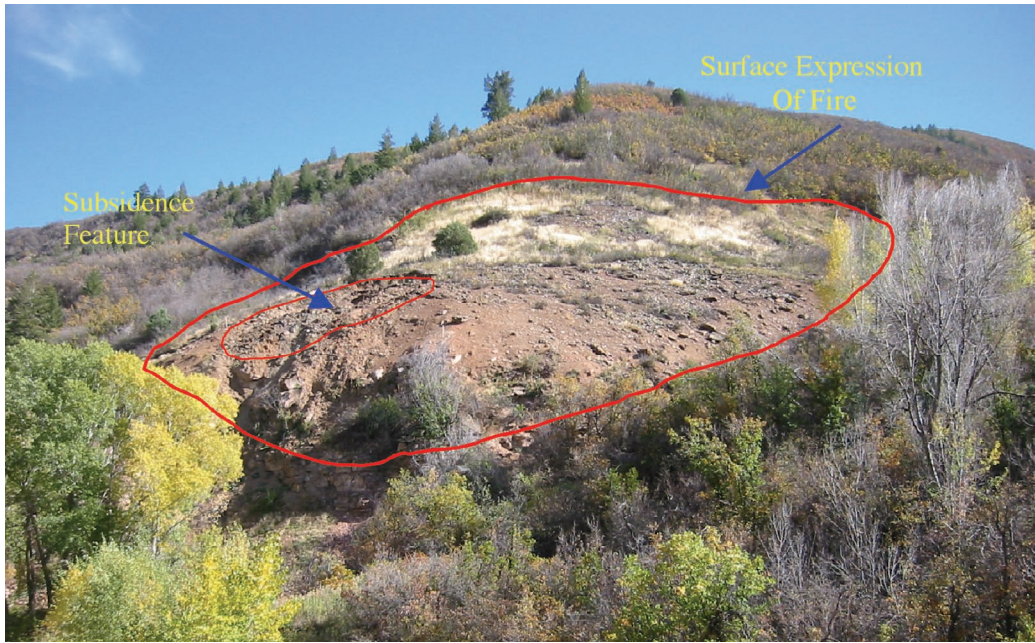
Oliver Mine Fire. View toward Southeast.

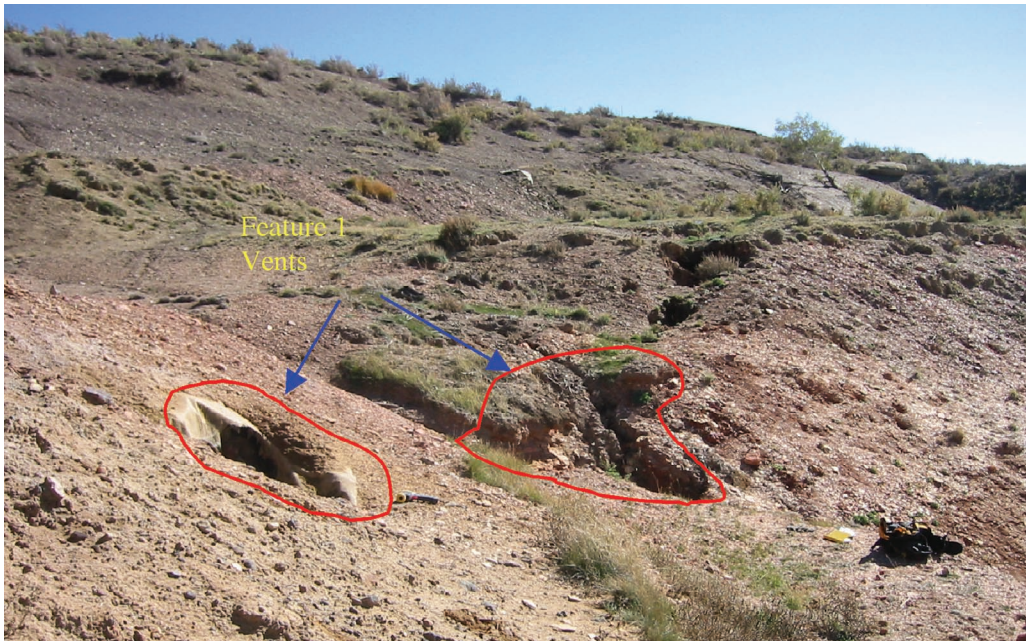
Vents at the Riach Coal Mine Fire. View toward Southeast.

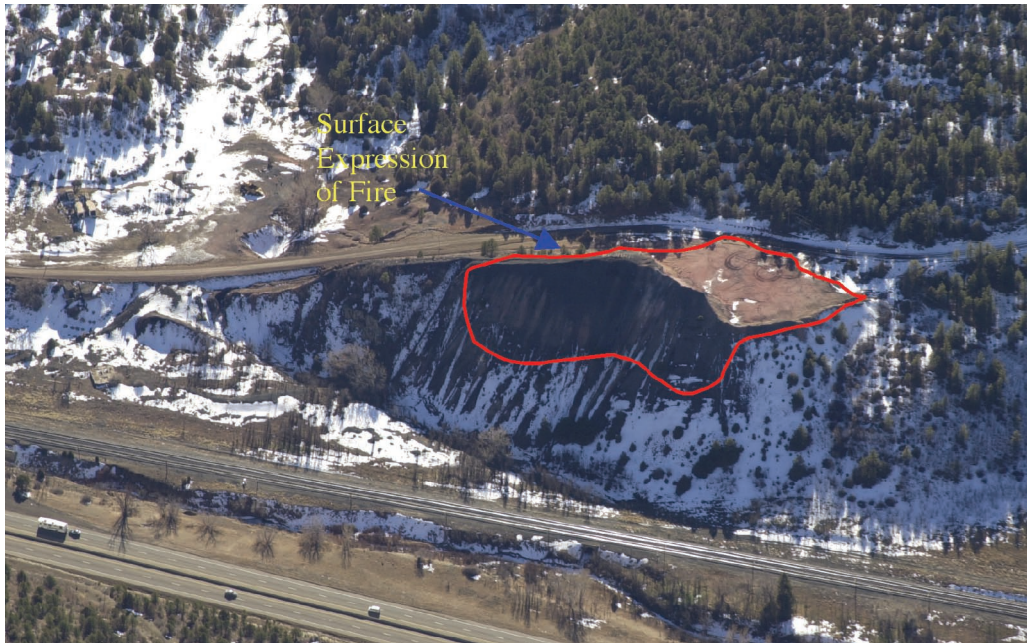
Morley Waste Dump Fire. View to West.

Wildfire hazard is low, given the low surface temperatures and lack of combustible vegetation on the pile.

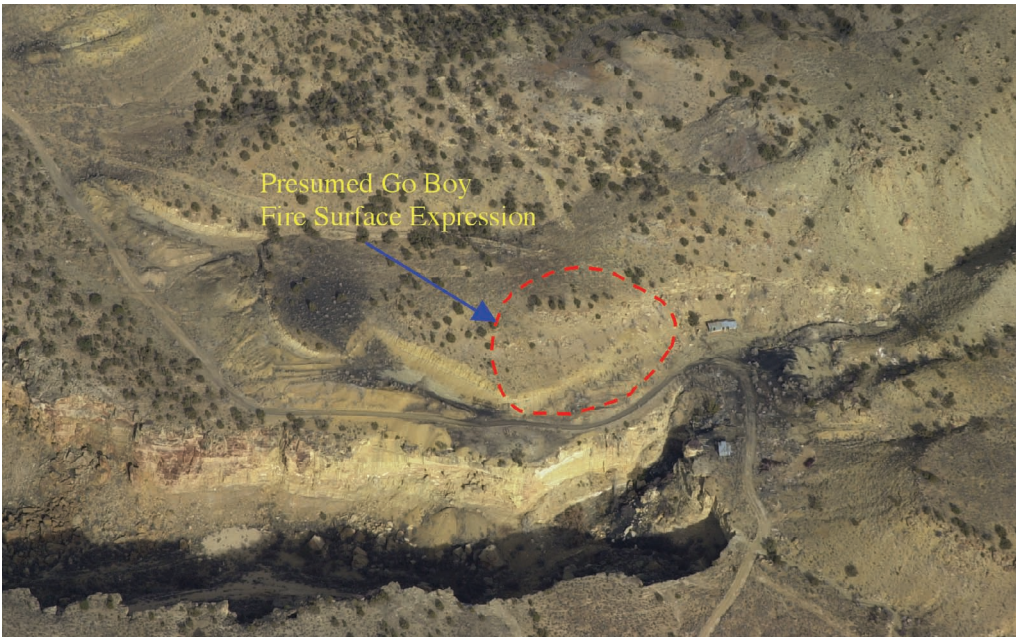
Go Boy Coal Mine Fire. North to Left.

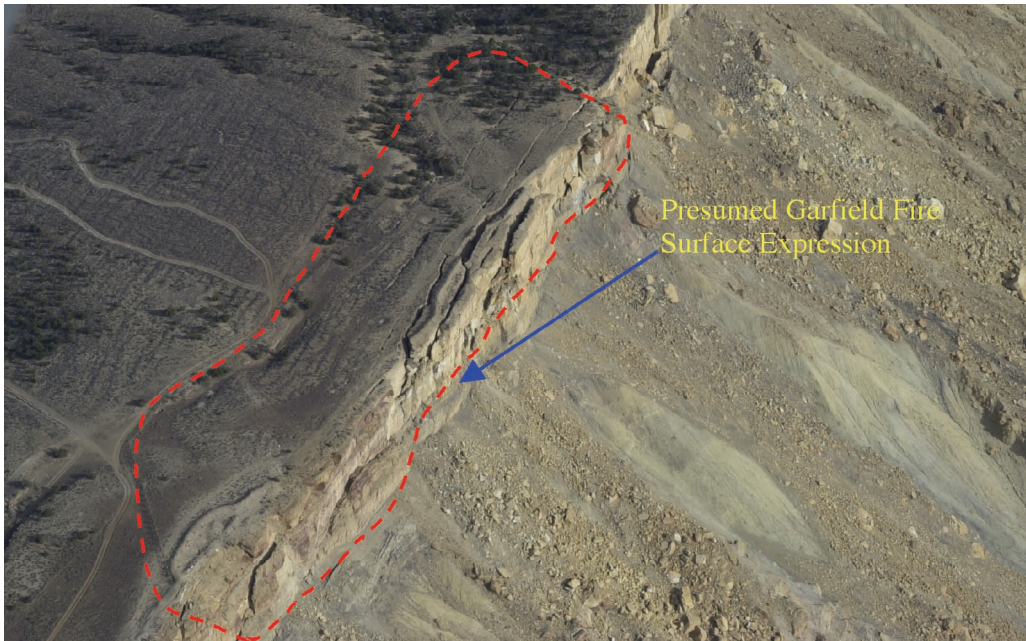
Garfield Coal Mine Fire

Garfield Coal Mine Fire. North to Left.

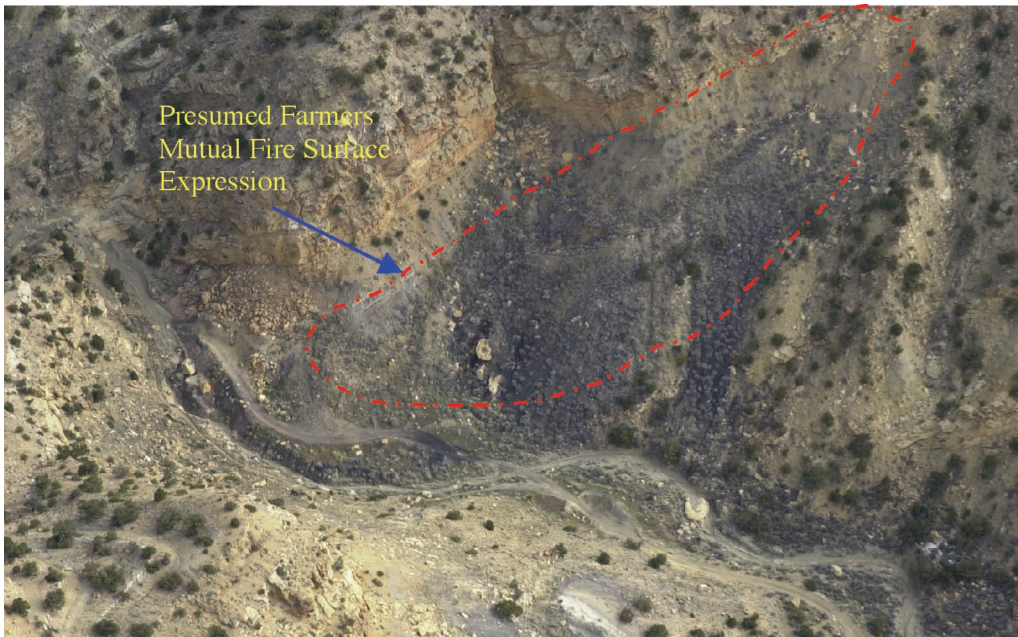
Farmers Mutual Coal Mine Fire

Farmers Mutual Coal Mine Fire. North to left.

The surface features of the fire are generally accessible via an abandoned drill rig access road that bisects the face of the hillslope and the fire zone. The lower portion of the road was reclaimed in the fall of 2001; however, the upper portion of the road is still in existence, and will likely remain so as it is too unstable to route reclamation equipment across. Because the features occur in close proximity to one another, individual numbers were not assigned to the features.

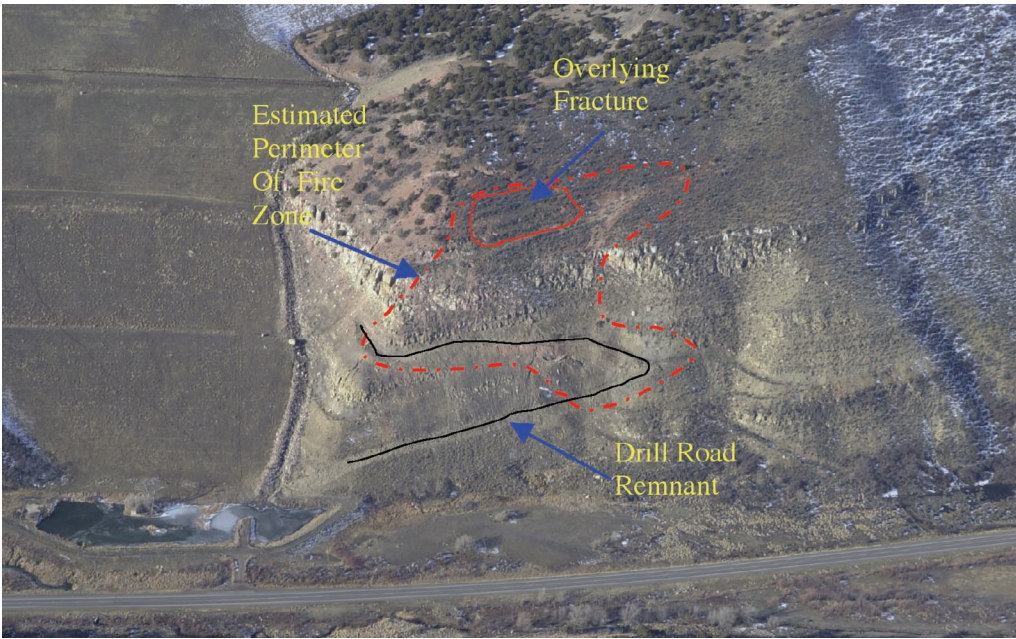
Streeter/Collom Coal Mine Fire. View toward East.

The area where the underground fire expresses itself on the surface begins at the lower most extension of the remaining drill access road, and extends uphill in a south / southwesterly direction for an estimated distance of 250 feet. A large, circular, approximately 20 feet diameter, subsidence-like feature defines the lower portion of the zone. The base of the depression is closed. The feature is located on a hillside, so the lower portion is open to the down-slope side. The temperature of this feature is generally just above ambient conditions; however, this feature is significant because it denotes the furthest northeasterly extension of surface impacts from underground mining. From this point, the road traverses northward to a switchback, and then across the face of the hill in a southerly direction. Walking the road from north to south, beginning at the switchback a number of fire related features are encountered. The outside, or fill slope, of the switchback displays several short, north to south trending fractures that have ground temperatures of about 115° to 160°.

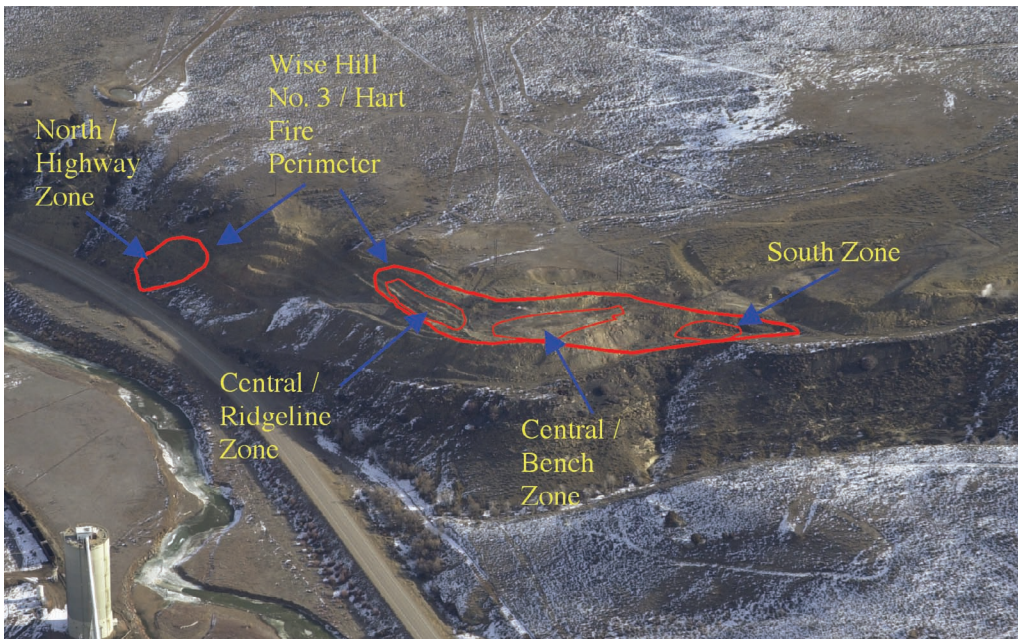
Wise Hill Number 3/Hart Coal Mine Fire. View toward Northeast.

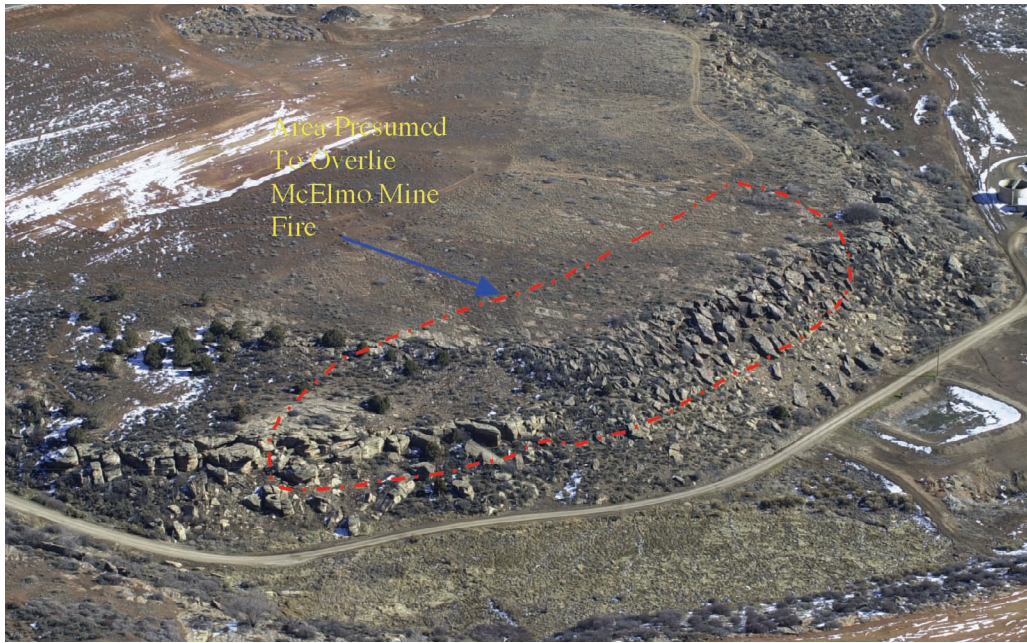
McElmo Coal Mine Fire. View toward East.

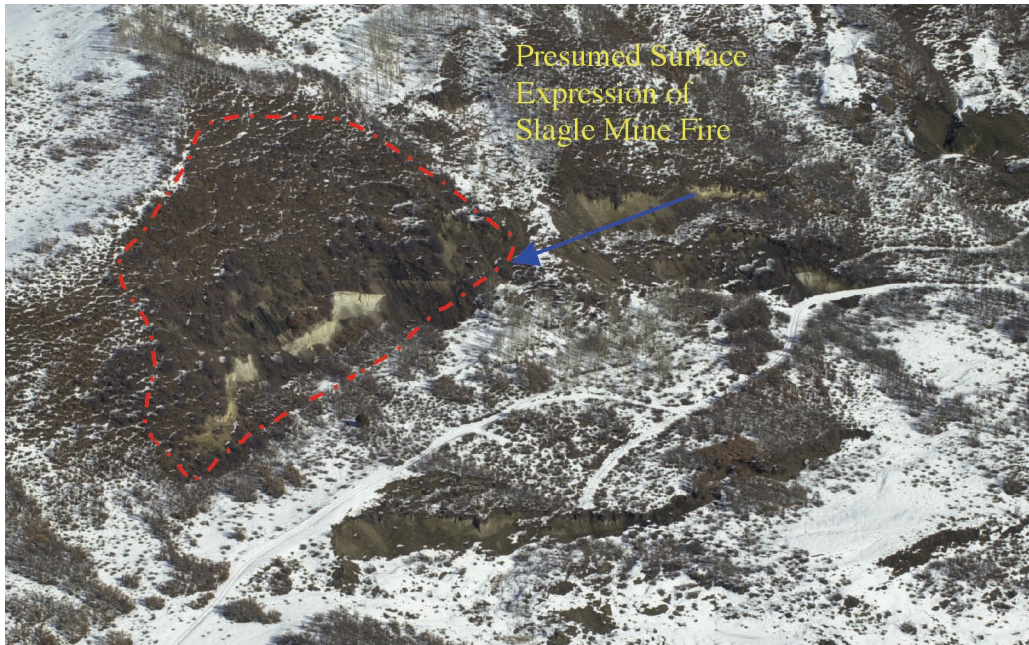
Slagle/Bright Diamond Coal Mine Fire. North to top.

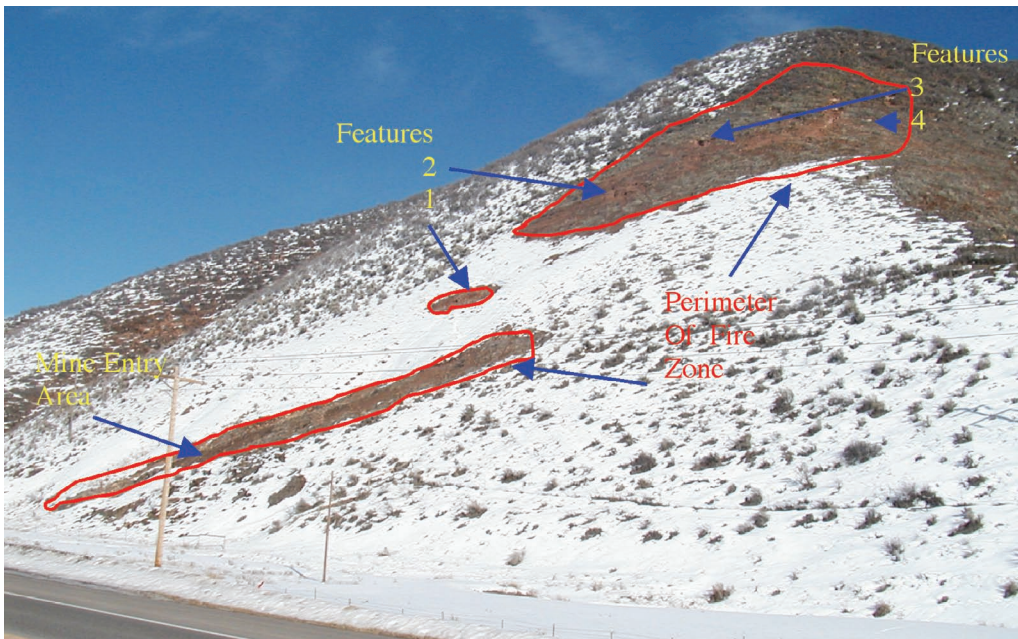
Rienau Number 2 Coal Mine Fire. View toward Northeast.

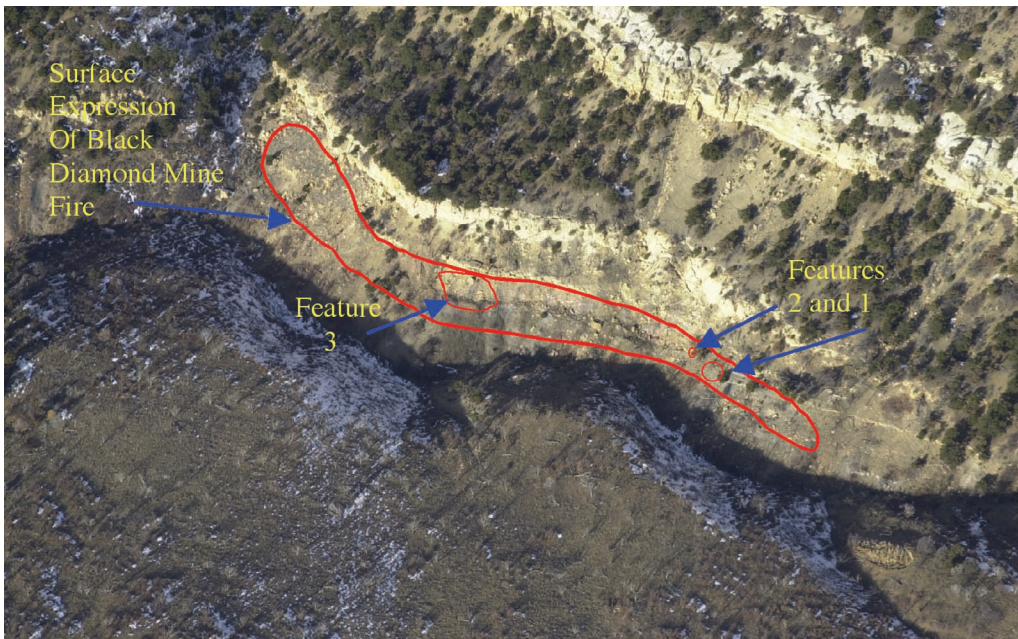
Black Diamond Coal Mine Fire

Black Diamond Coal Mine Fire. North to top.

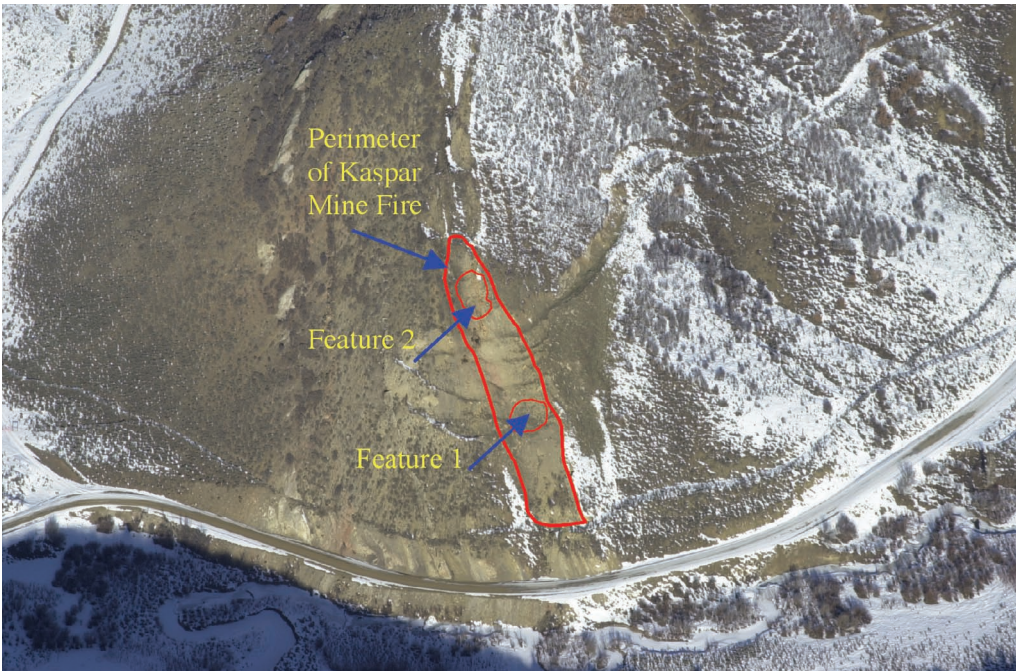
Kaspar Coal Mine Fire. View toward West.
