REPORT ON THE STATUS OF FIRES AT ABANDONED UNDERGROUND COAL MINES IN COLORADO

COLORADO DIVISION OF MINERALS AND GEOLOGY

JANUARY 10, 2005

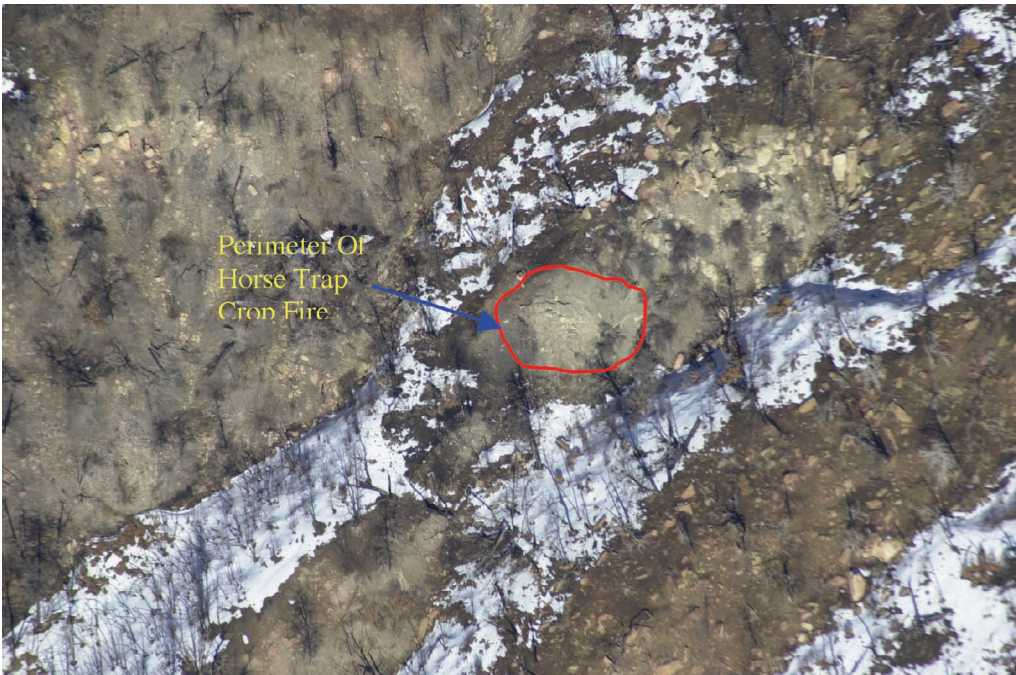
Parallel fractures occur within the active burn zone, and are pronounced immediately uphill of the fire activity. Within the burn zone, the fractures culminate in the facial slump and the two feet tall backwall. These appear to be fire related features, venting the underlying fire. A small vent is located at the most northerly portion of the lower fracture zone. This vent was observed to be exhaling steam at the time of the site visit from a fracture in sandstone material. The temperature of the ground surface at the vent was measured at 120°. The vent exhaust was sampled using hand held multi-gas meters. Oxygen content was 19.2 percent, carbon monoxide was 120 parts per million, and hydrogen sulfide was 3 parts per million.

Horse Trap Outcrop Fire. North to left.

A second vent was observed near the southerly margin of the burn zone. This vent appears to be on-strike, but discontinuous from the other interior fractures. The ground temperature at this location was measured at 200°. The vent exhaust at this location contained an oxygen content of 17 percent, carbon monoxide content of 93 parts per million and hydrogen sulfide at 3 parts per million.

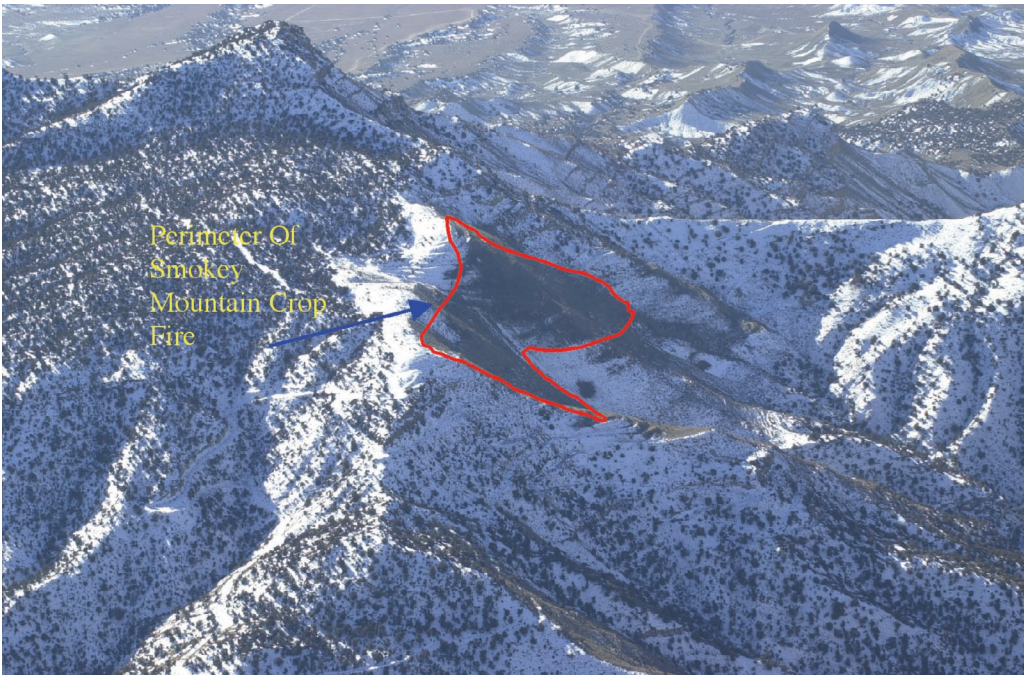
The area was subject to fire suppression activities in the 1960's. A surface seal was installed using cut and fill methods. Evidence of this activity includes at least two access road remnants and some benches from which material was generated to cover the fire zone.

Smokey Mountain Outcrop Fire. View toward Southeast.

Three areas of venting present themselves at Smokey Mountain. The first is located near the northerly margin of the site, about mid-slope within the canyon. The second is located near the southeast margin of the canyon, higher on the canyon slopes. The third is located further south, at about the same elevation as the central area.

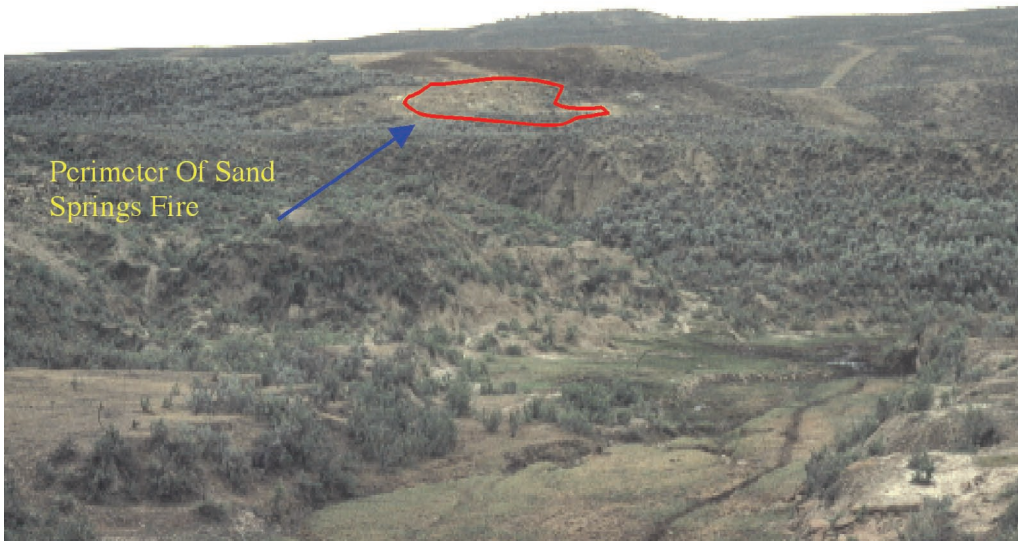
Ground temperatures within fire related fractures were generally in the 1250° range. However, discreet vents within a few of the fractures were measured in the 180° range. These higher temperature vents were generally located further uphill of the subsidence feature. The smell of coal combustion was apparent near the northeast portion of the zone, coinciding with the location of the higher temperature venting. Smoke, steam, sulfur deposition, creosote deposition or thermal alteration of rock were not observed anywhere in the fire zone. Vegetative characteristics above and adjacent to the fire zone were not observed, as a result of the surface fires having removed these materials.

Sand Springs Outcrop Fire. View toward South.

A two to three foot thick coal outcrop occurs on the south westerly facing portion of the ridge. The coal appears to be of poor quality, is well oxidized, and exhibits low strength. It is assumed that this seam is that which is observed to be on fire, approximately three hundred feet to the north / north west of the outcrop. The outcrop is covered by colluvial debris in all other locations.
