# Colorado Underground Coal Mine Fires 2018 Inventory Report

August 2019

**Tetra Tech**  
350 Indiana Street, #500  
Golden, Colorado 80401

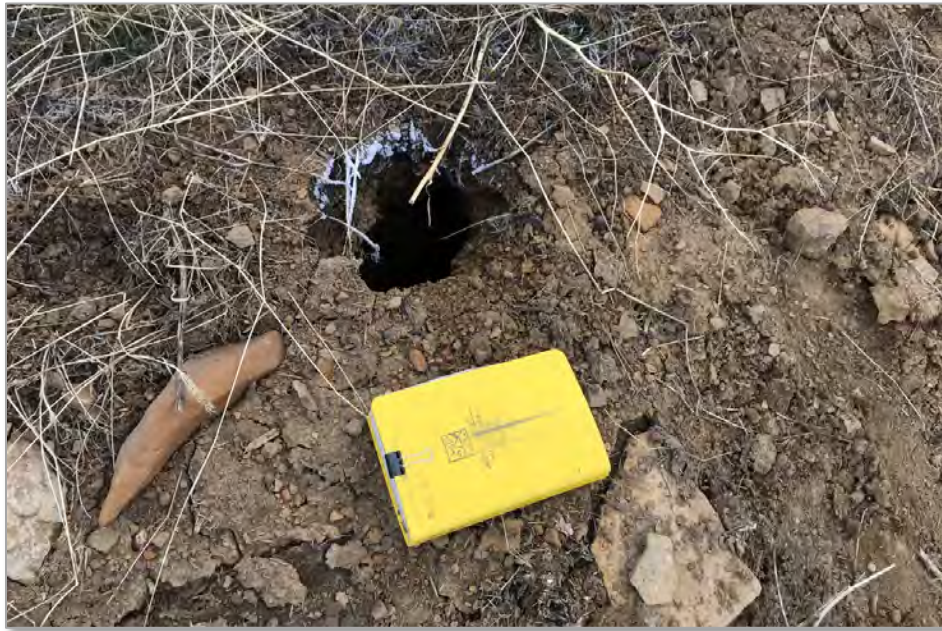
The site was visited many times during the mine fire inventory because of concerning drought conditions. The final inventory visit was performed on November 19, 2018. The lower area was inspected and no elevated ground temperatures were found. One 4 ft diameter subsidence feature was found inside a larger, 80 ft diameter subsidence feature. At the bottom of the feature was a 1 ft wide, 5 in tall intake hole. Additionally, 4 intakes ranging in diameter from 4 to 8 inches were found in a line on the northern end of a large subsidence feature (Figure 4-54). In the upper area, vent temperatures ranged from 551°F to over 678°F. Areas of sulfur crystals and creosote were found at the top of the upper area burn zone (Figure 4-55). The vents along the road cut above the main fire area were 172°F, heavily stained with creosote, and releasing high concentrations of carbon monoxide, indicating that it is the youngest area of the fire.

Figure 4-54 – Intake Hole

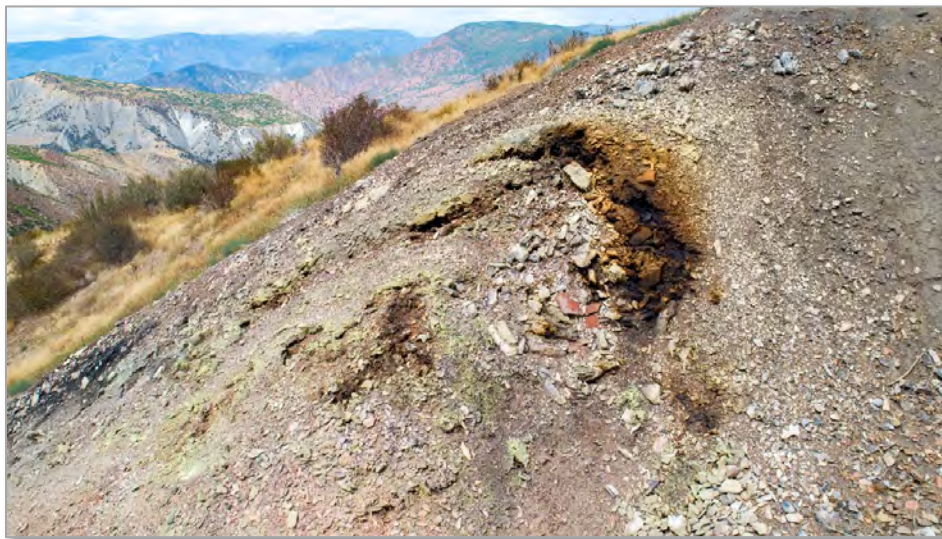
Figure 4-55 – Creosote and Sulfur Build-up at Upper Vents

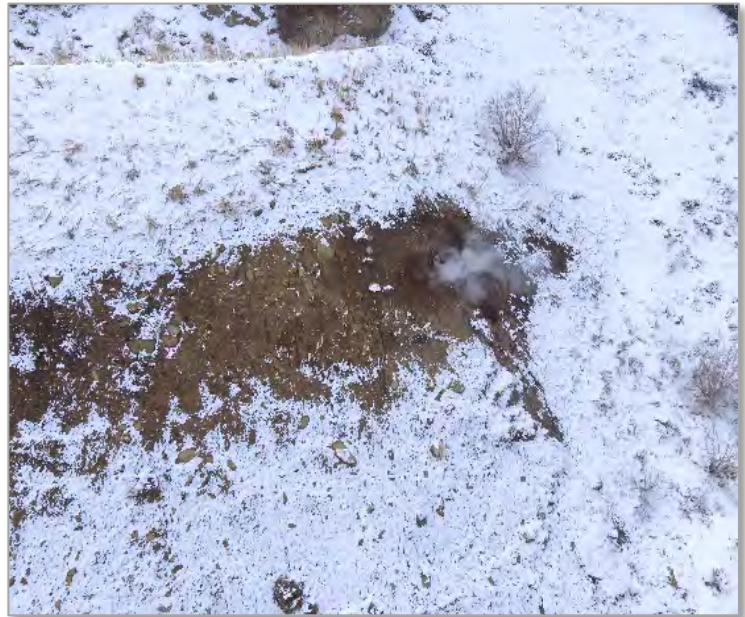
Figure 4-58 – Snowmelt with Westernmost Vent

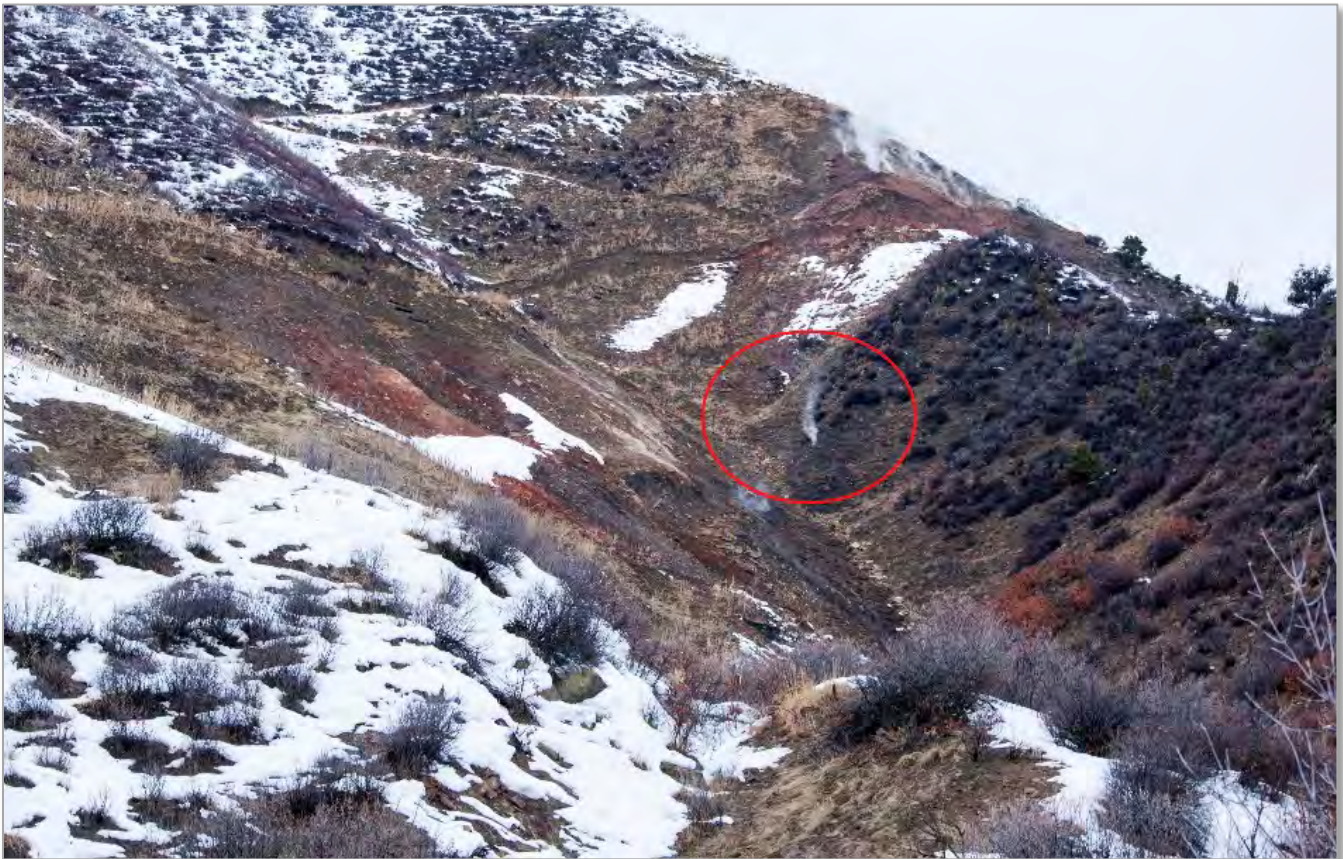
In February 2017, a new vent was found in the lower, Wheeler seam. This 330°F vent developed in an area with little vegetation in the bottom of the gully below the upper fire expression. When revisited on January 25, 2018 the new vent was inactive, though creosote staining could still be seen on the surface. On August 16, 2018 the vent was inactive but ground temperatures in the area were 212°F, 110°F above ambient.

Figure 4-59 – New Vent, February 21, 2017

It is recommended that vegetation be cleared from around the new vent area and that this area be monitored closely for changes in activity.

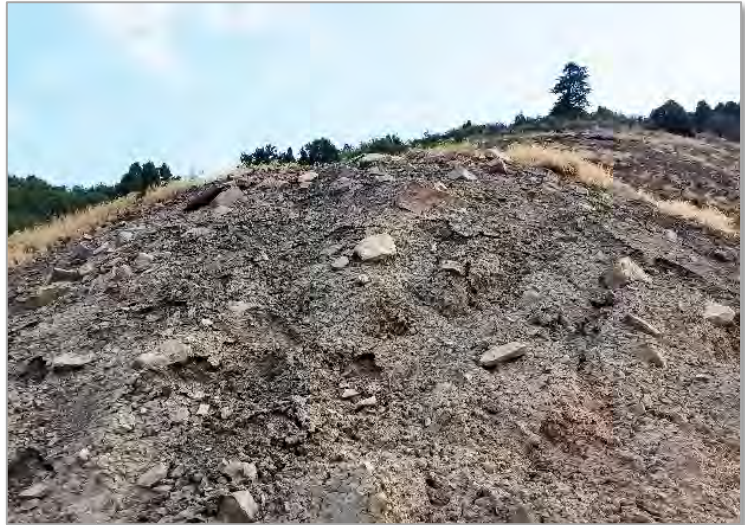
Sandstone outcrop above Pad 1 has many small, low flowrate vents. The exhaust from these vents is 130°F and has a high water-vapor content evidenced by moss growth around the vent openings. The main area of the fire expression occurs 30 ft south of Pad 1 and is a 30 ft by 20 ft area of hot ground measuring 150°F (Figure 4-62). The area is completely bare of vegetation. Another 30 ft south of the large feature is a low-flowrate vent with an exhaust temperature of 300°F. Vegetation was within 2 ft of this vent. The exhaust was hot and dry, indicating an older region of the fire. Another hotspot was inspected that was located at the bottom of a gully 170 ft east of the main fire expression. This hotspot was 153°F and located in an area of no vegetation. This hotspot is believed to be associated with the prehistoric outcrop fire.

Figure 4-62 – Main Fire Expression

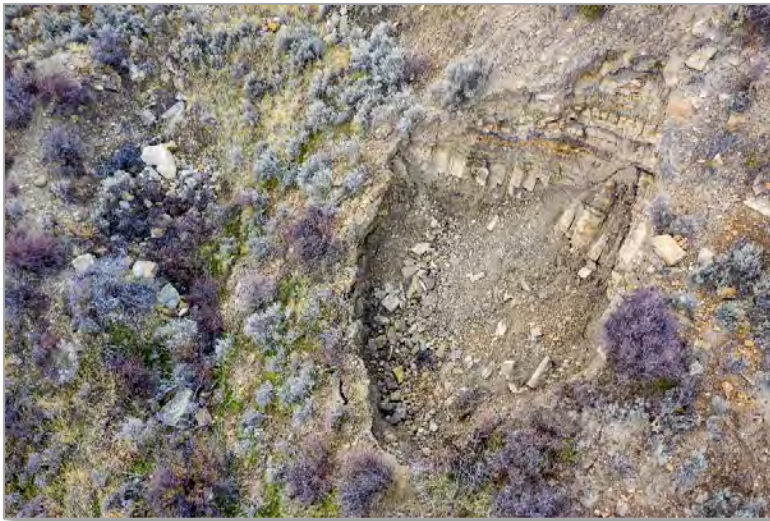
Figure 4-65 – Large Subsidence Feature

It is recommended that access to the area near the 4 ft sinkhole be restricted or the sinkhole mitigated. Subsurface investigations could identify high-risk subsidence zones.

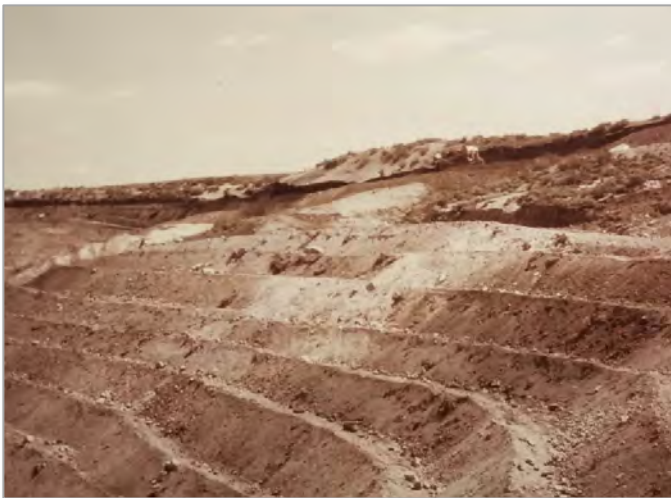
Figure 4-74 – 1974 surface seal

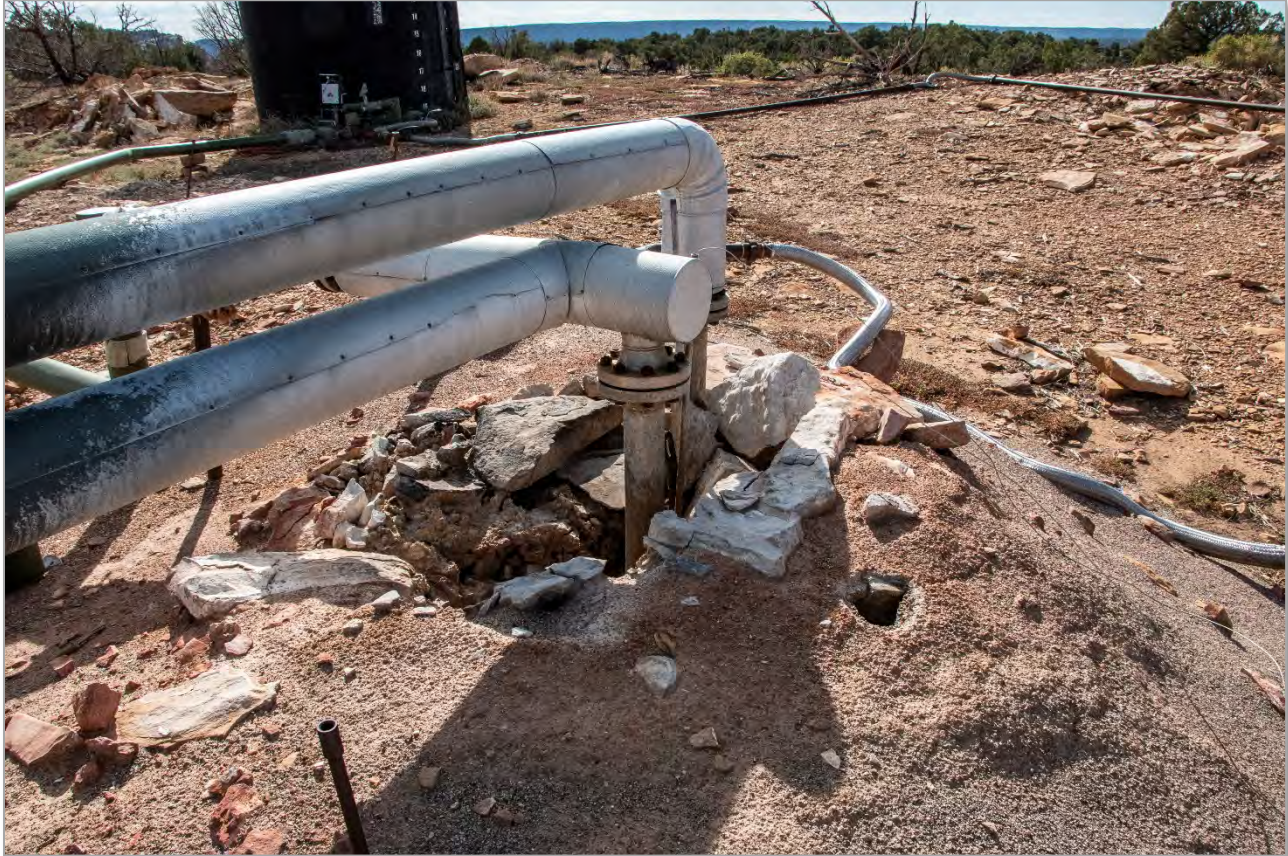
Figure 4-85 – Vent Around Vertical Pipes

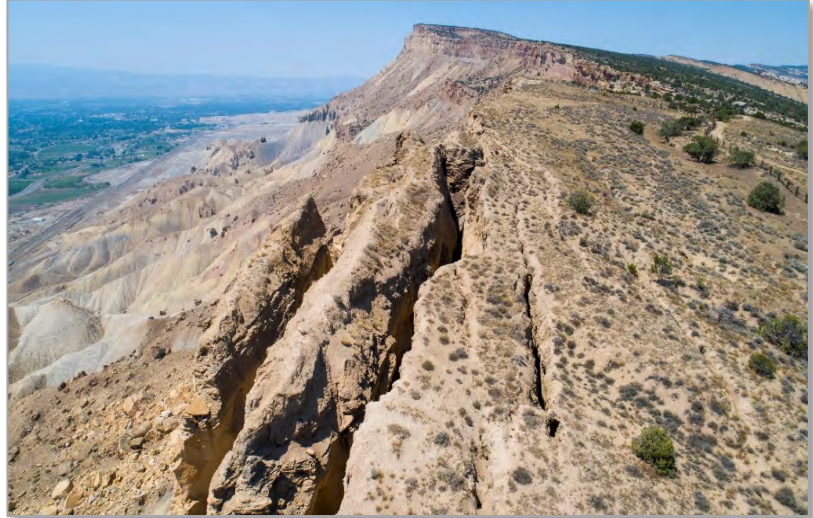
Figure 4-94 – Large Fractures at Cliff Edge

The fire activity at the Garfield Mine Fire site is very low and poses limited risk of wildfire. The subsidence and unstable ground combined with the proximity to the cliff face present the greatest risk to the public. It is recommended that the fence on top of the mesa be fixed and maintained to limit access and signage be placed to inform potential trespassers of the dangers.

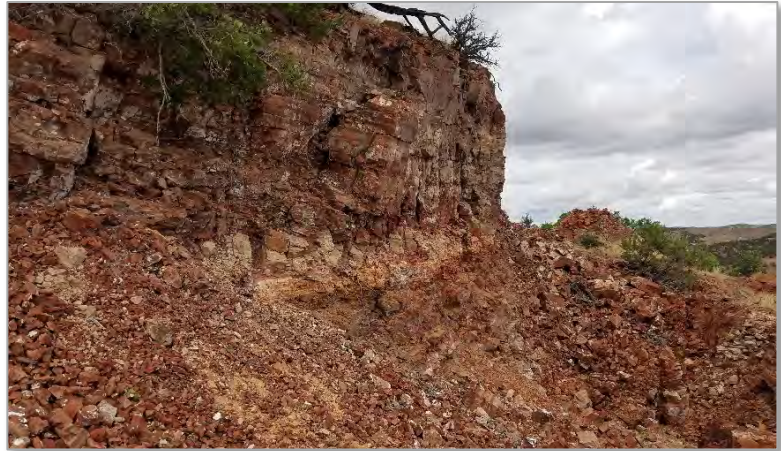
mid-slope line on both the south and east hillsides. More venting occurs on the top of the east hillside. Temperatures from thermocouples that were installed during a 2001 drilling project were recorded. In general, the thermocouples along the lower section of road range from 160°F to 410°F. A thermocouple on the southwest corner of the hillside recorded the highest fire temperature of 860°F. A large fracture that trends north-south was inspected. The rock in the main fracture subsidence area is thermally altered sandstone (Figure 4-99), although no elevated temperatures could be found. Movement in the fracture zone caused by fire activity could be causing rockfall on the southern end of the hillside. Three large boulders measuring approximately 20 ft in diameter have calved from the cliff face in recent years.

Figure 4-99 – Fracture Face and Subsidence Area

It is recommended that survey monuments be installed on the top of the hillside east of the main fracture to measure future movement of this hillside.

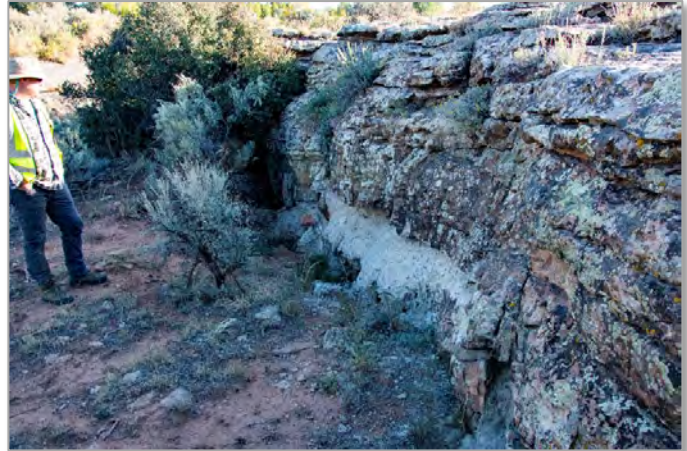
Figure 4-106 – Grout Seal in Sandstone Outcrop

The fire's activity is very low and could be considered dormant if confirmed by a drilling investigation and a winter thermal drone flight. If indeed dormant, this fire does not present risk of wildfire. There is, however, considerable risk to trespassers because of the opening into the coal seam. People entering the confined space—possibly into old workings—could face hazardous mine atmosphere conditions and rock fall. There is also the potential of people unintentionally starting or reigniting a coal fire with a camp fire, since the opening shows signs of repeated overnight use. It is recommended that the mine entry be sealed off.

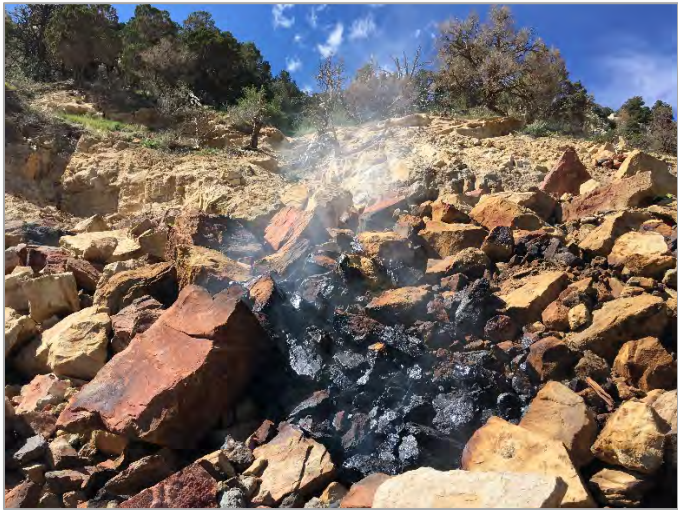
Figure 4-114 – Large vent

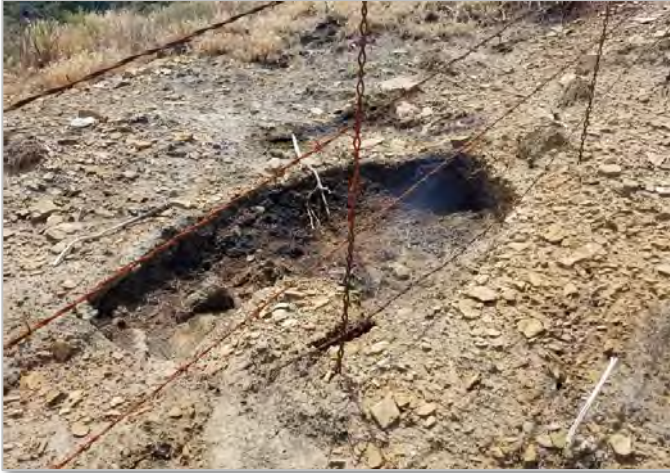
Figure 4-119 – Smoking Subsidence Feature

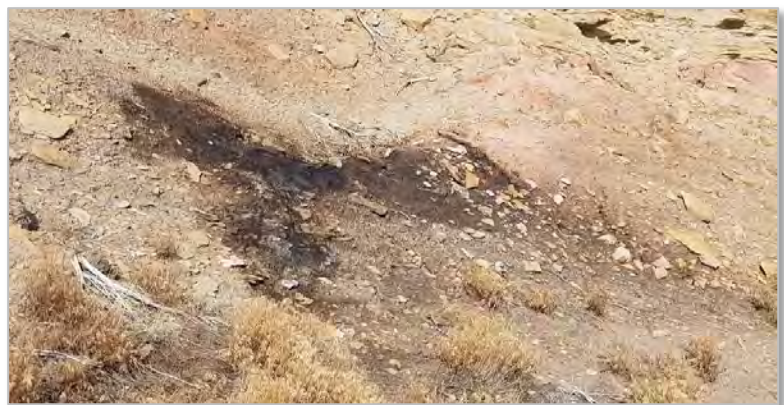
Figure 4-120 – Creosote Stained Soil

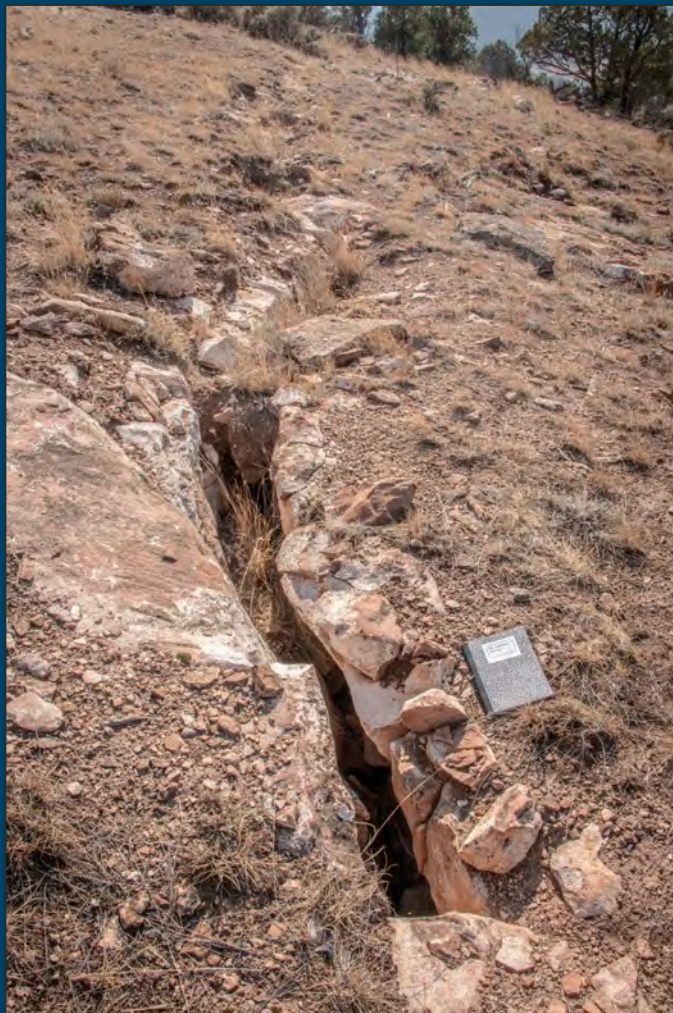
Large fracture, no venting

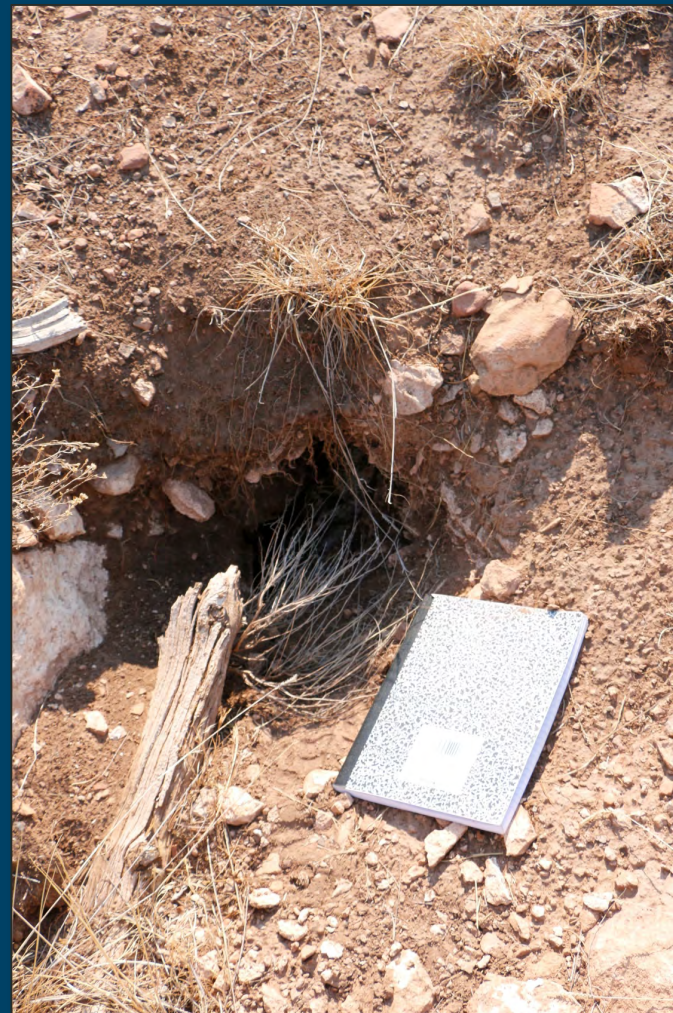
Dormant vent

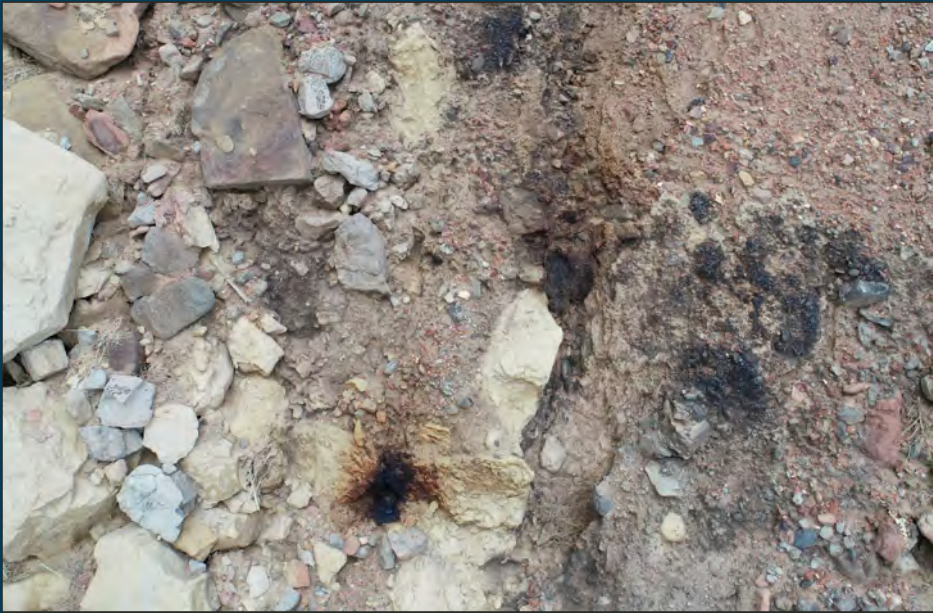
Western vents with creosote staining

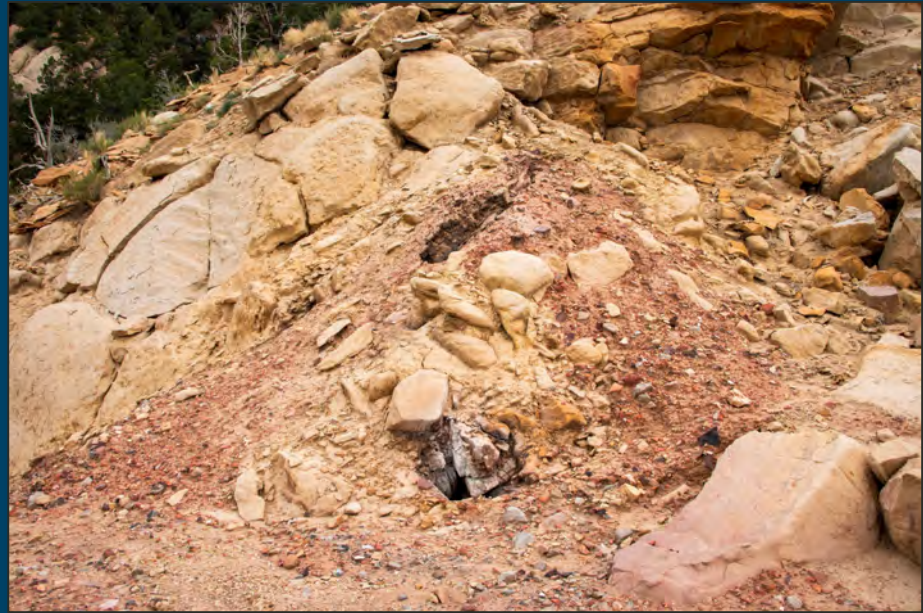
>600 °F vents

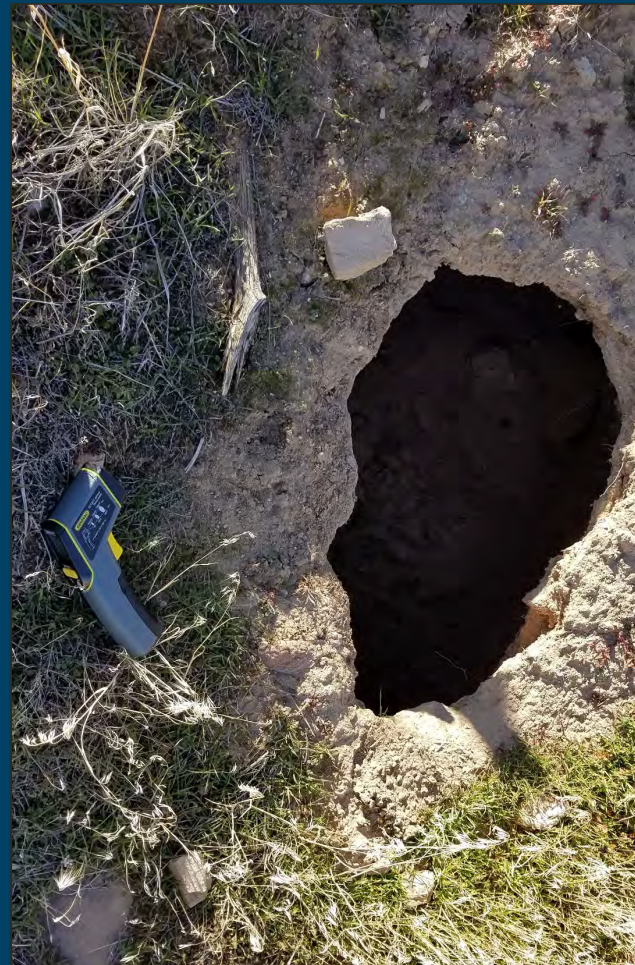
Small subsidence on upper fracture

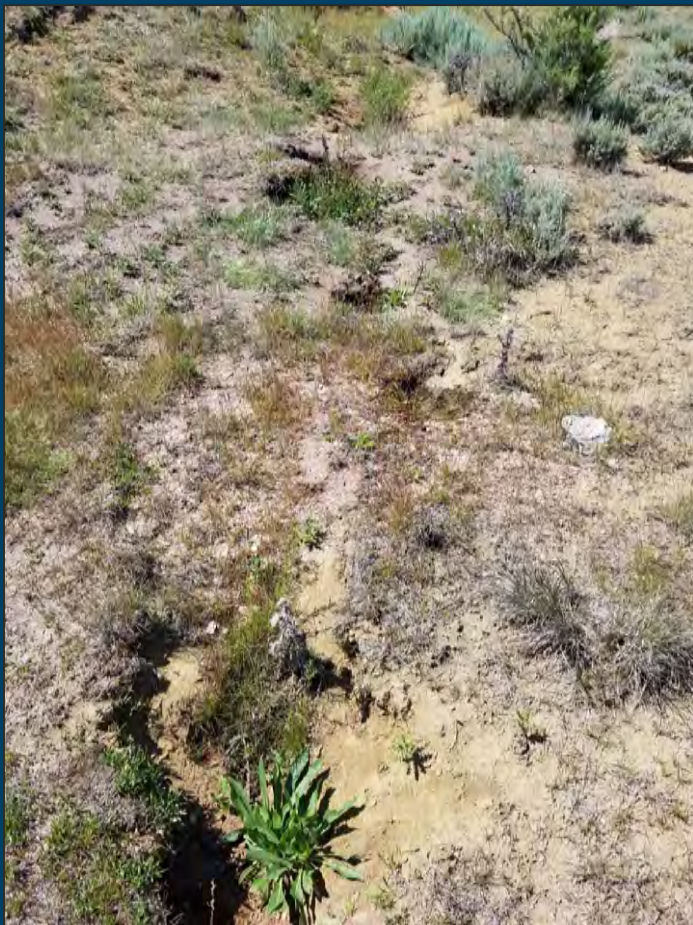
58 °F vents along fracture

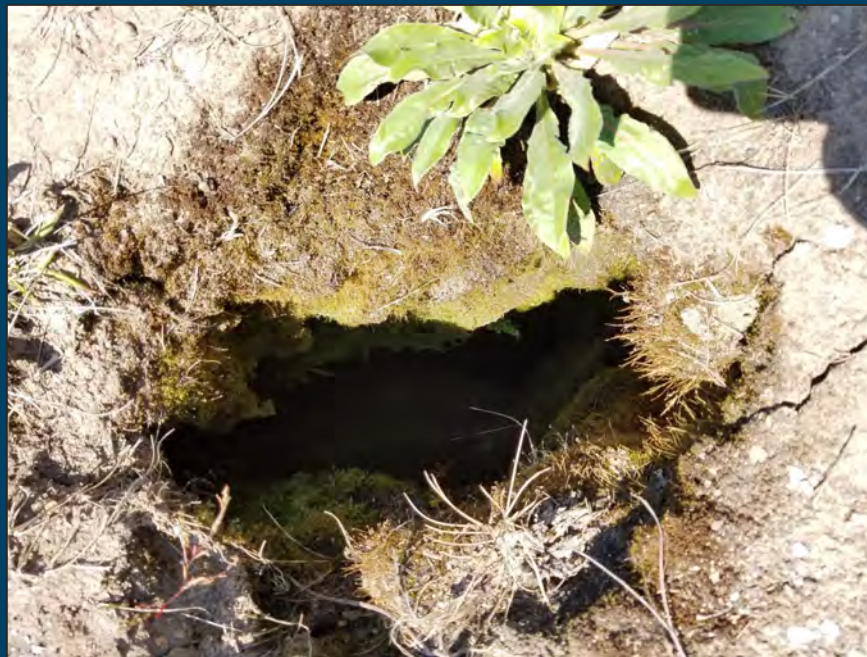
Small moss lined vents

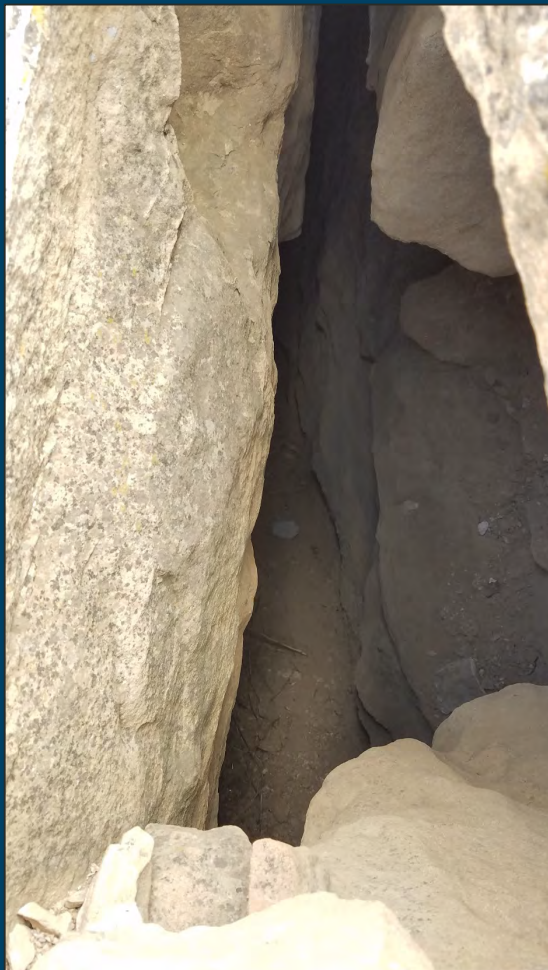
Large fracture

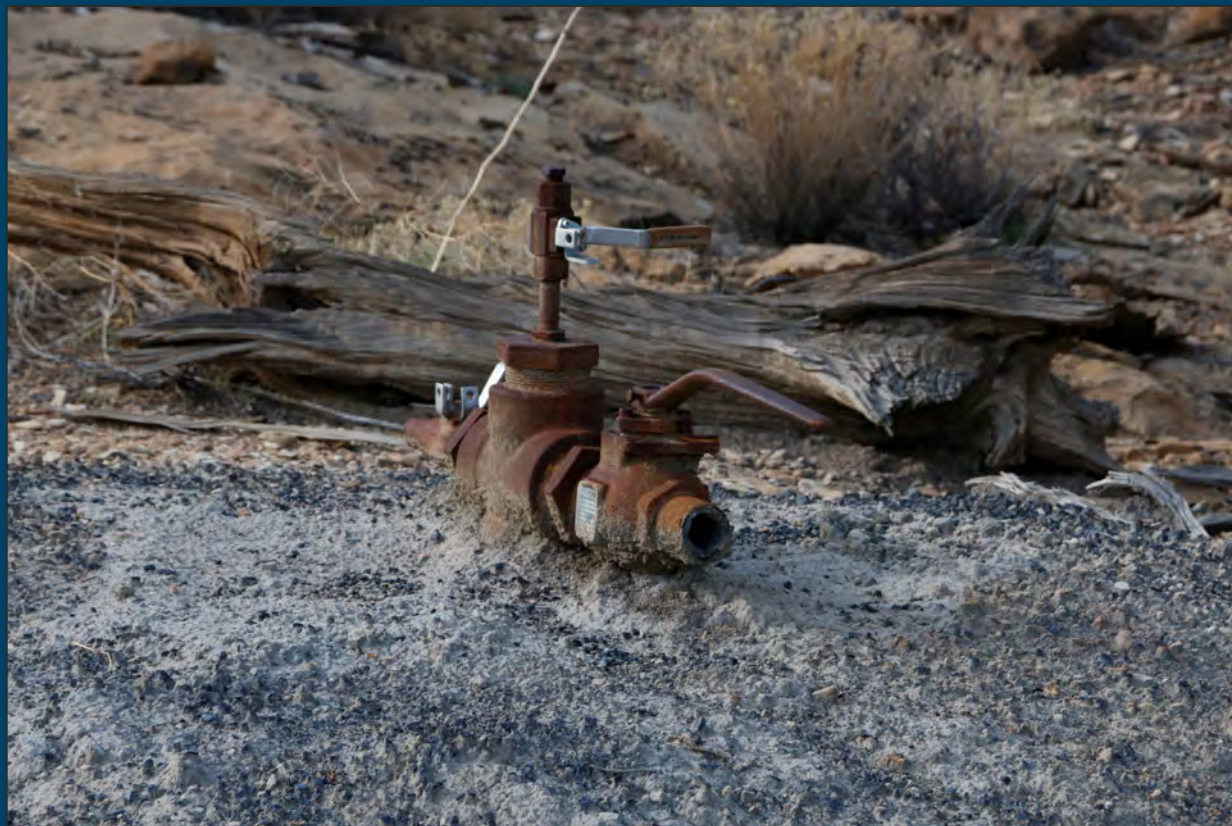
Open wellhead venting H<sub>2</sub>S gas

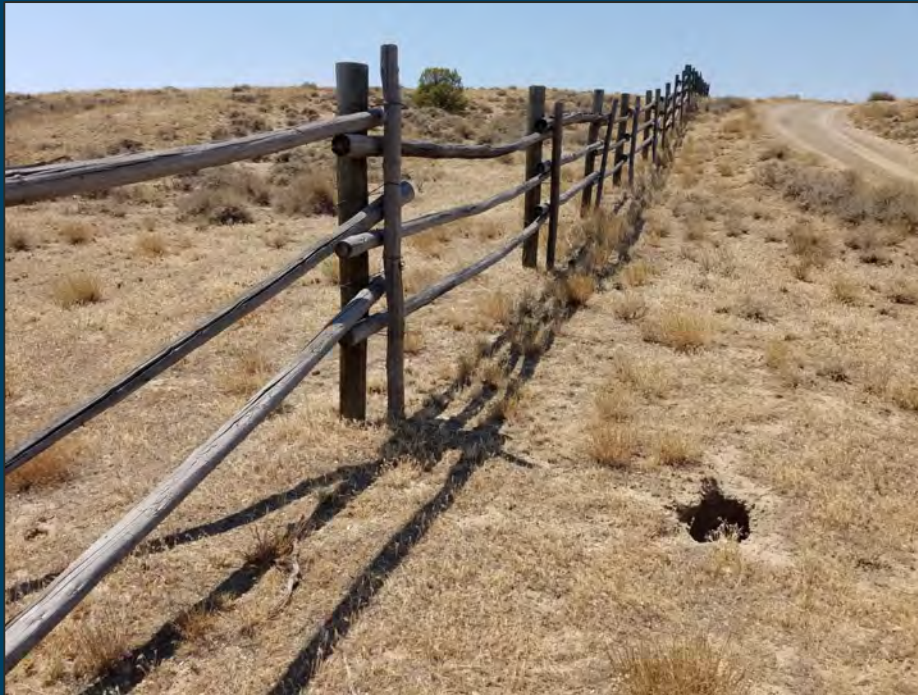
Broken fence and subsidence feature

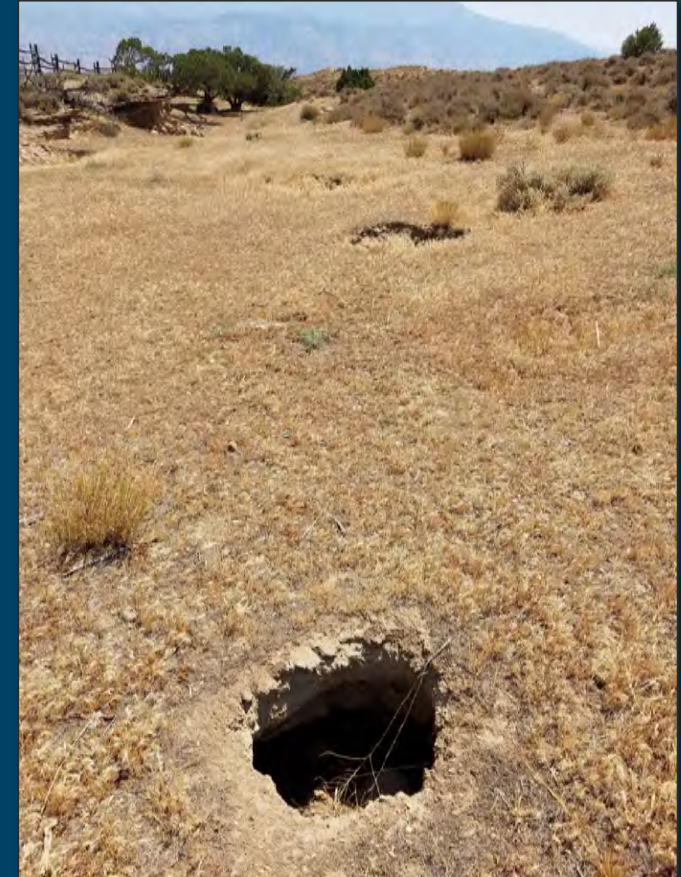
Subsidence within fenced area

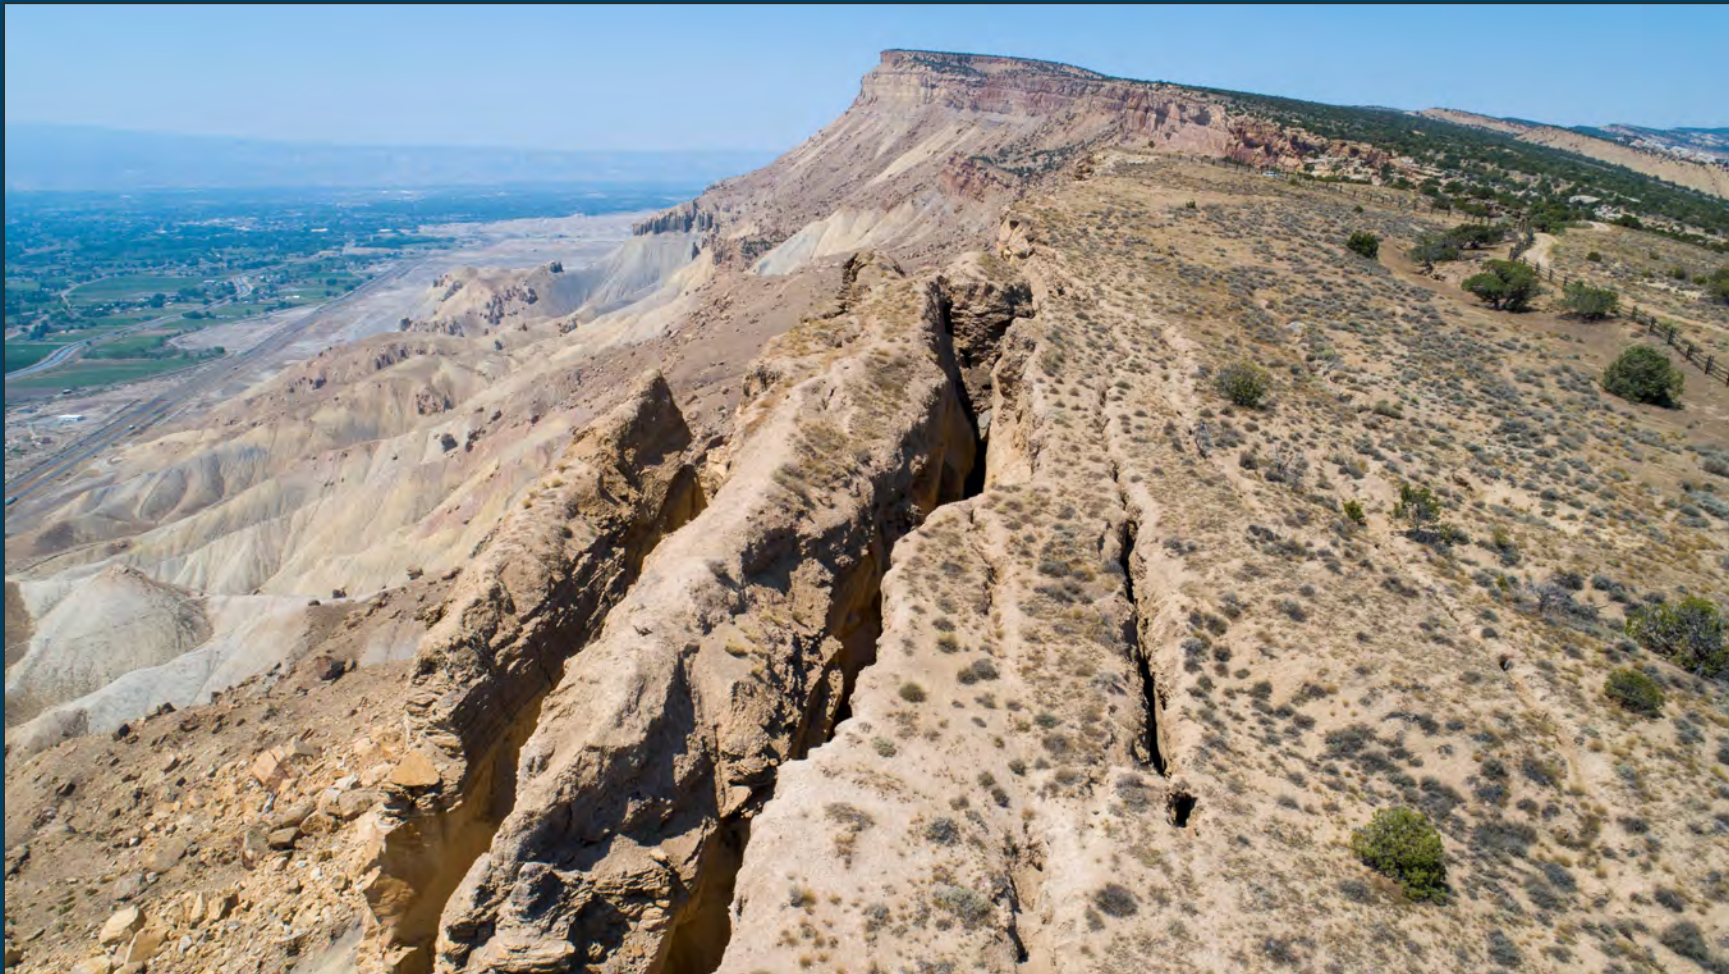
Large fractures

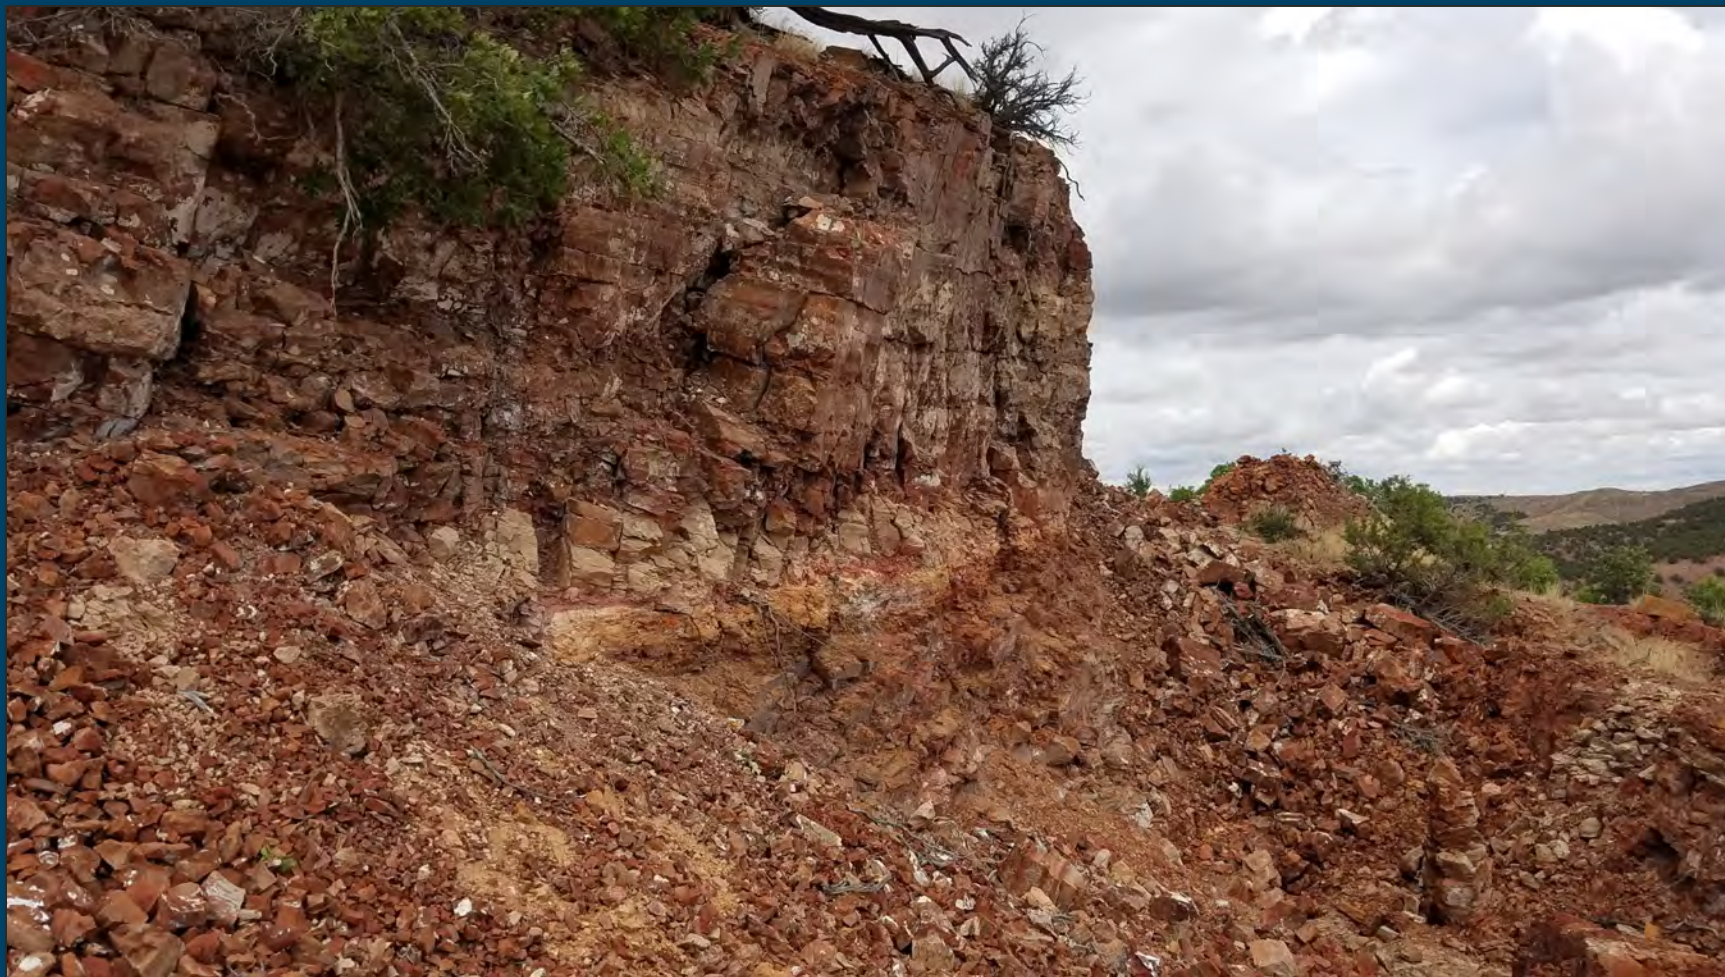
Large fracture looking North

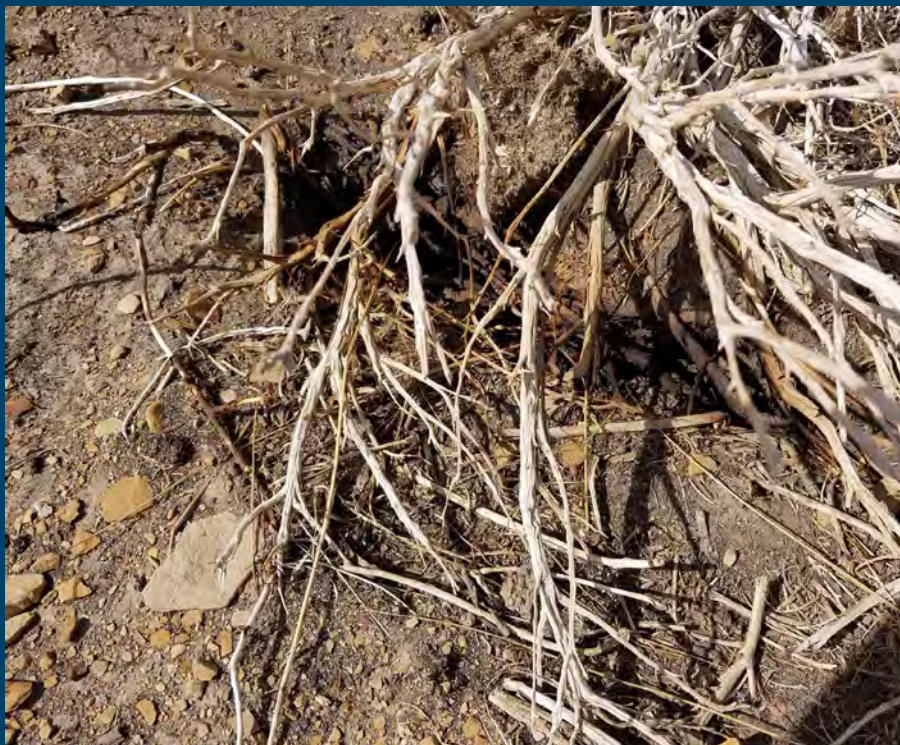
Brush over venting fracture

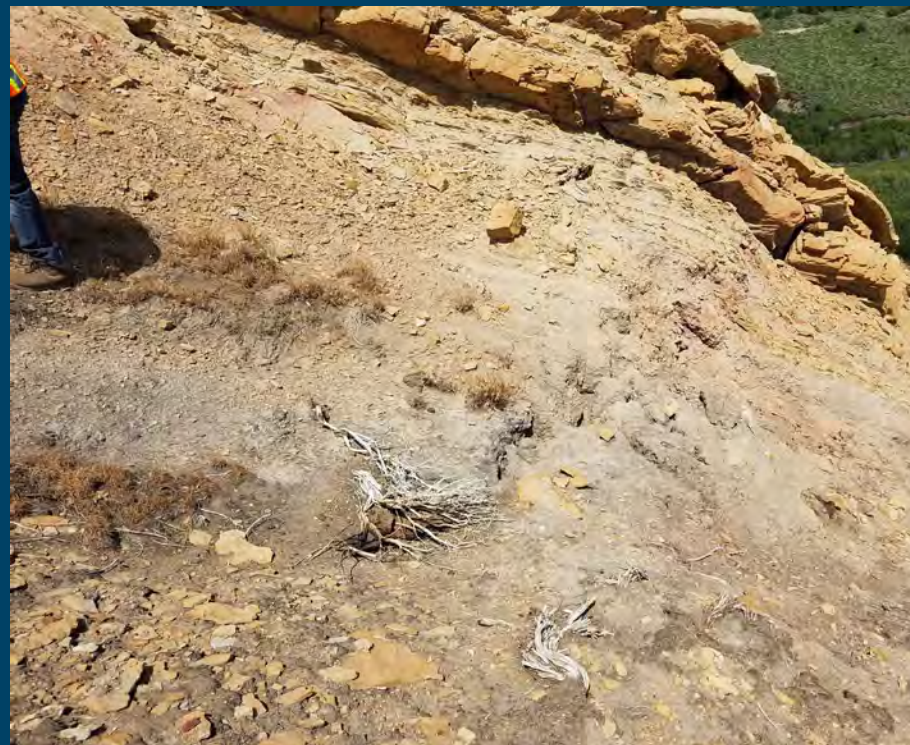
Venting fracture

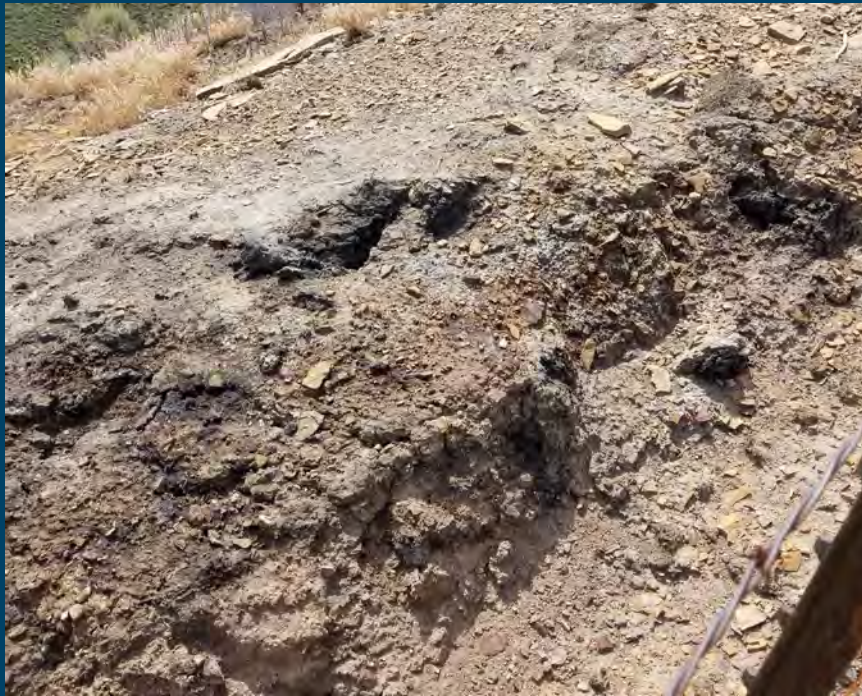
Venting South of smoking subsidence feature

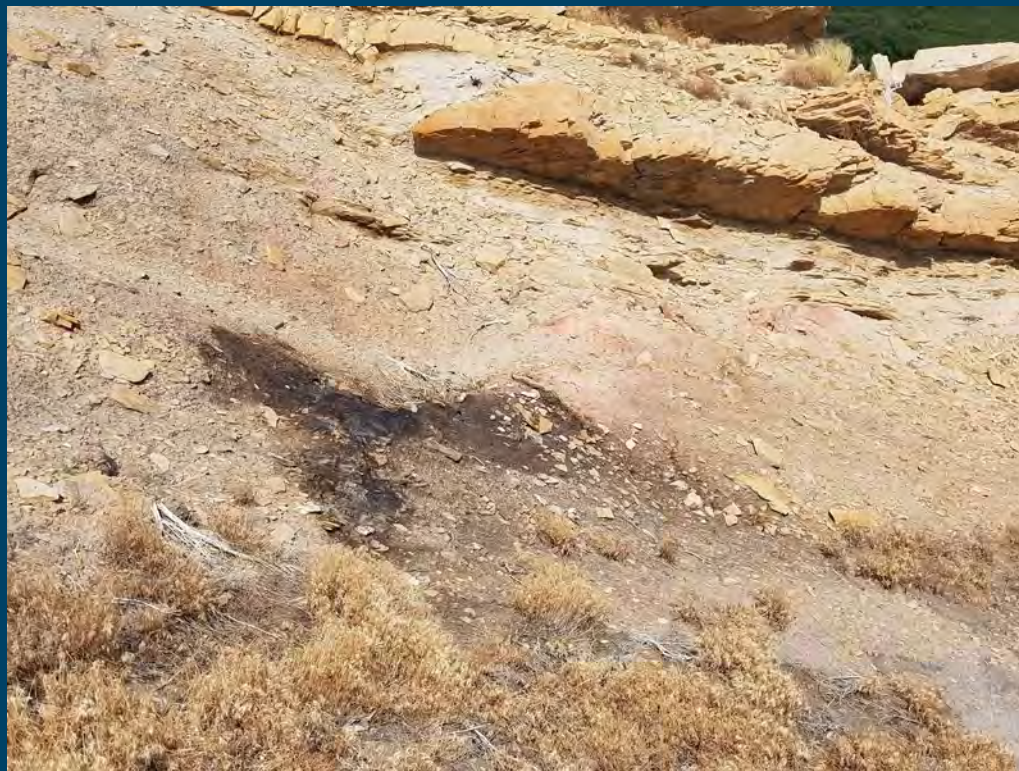
Creosote staining on ground
