Open-File Report 96-4
Field Trip No. 11

The Slumgullion Landslide Hinsdale County Colorado

THE SLUMGULLION LANDSLIDE, HINSDALE COUNTY, COLORADO

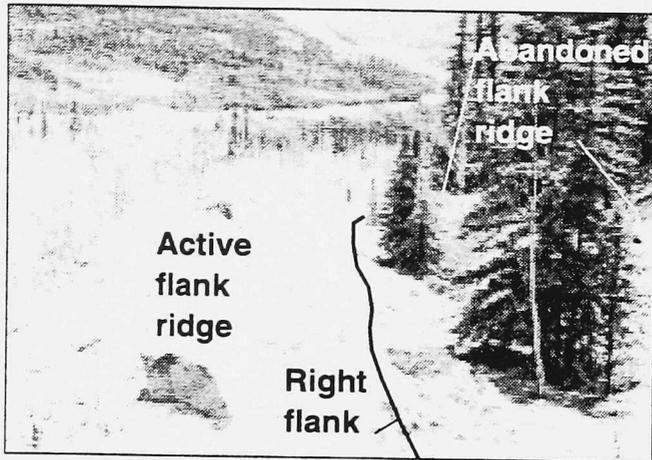
Figure 2. View of flank ridge at downslope end of pull-apart basin on right flank, looking southwest.

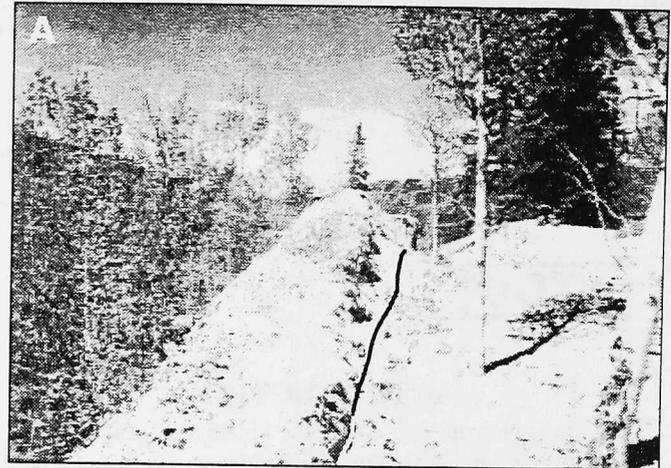
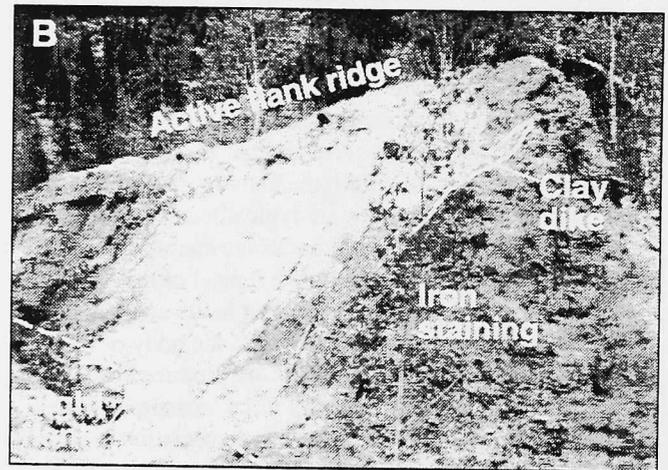
Figure 3. Views of an active flank ridge. A. Uphill end, looking southwest along right flank. Trees to left of ridge have deformed trunks. B. Downhill end looking east (Baum and Fleming, 1996). Exposed shear surface and clay dike inside right flank. A scarp at the outboard side of ridge (light area at center) exposes an emergent part of the lateral shear surface. This shear surface is between the crest and the trace of the right-lateral shear zone (shown by a dashed line). The scarp tapers from a height of about 2 m in foreground to 0 m in the background (about 20 m upslope, beyond left edge of photograph). The taper is consistent with screw-like movement along this part of the flank; the ridge growth is about 0.1 meter per meter of downslope of displacement. Annual movement here is about 3.5 m. The scarp is convex and is covered with sheared, highly plastic, blue-gray clay (liquid limit = 105, plasticity index = 77) that differs in color and texture from the stony, light-brown landslide material in the ridge. Movement at the shear zone has brought a tabular dike of blue-gray clay to the surface and injected the clay into the landslide materials.

We found tabular dikes of highly plastic clay (liquid limit = 110, plasticity index = 75) intruded into the landslide debris at several locations in the active landslide, notably along the strike-slip faults at the flanks (Fig. 3B) (Baum and Fleming, 1996). Similar intruded dikes were reported in the Twin Lake landslide in Utah by Fleming and Johnson (1989). Evidently the clay intrudes the faults during landslide movement. This clay is apparently much weaker than the rocky landslide debris on either side of the fault and intrusions of clay dikes along fault zones could facilitate continued movement by creating a weak, slippery (low angle of internal friction) layer between the active landslide and underlying materials. Creation of such a weak layer could permit the landslide to move in response to smaller loads or pore pressures than existed at the time of its initiation or reactivation.

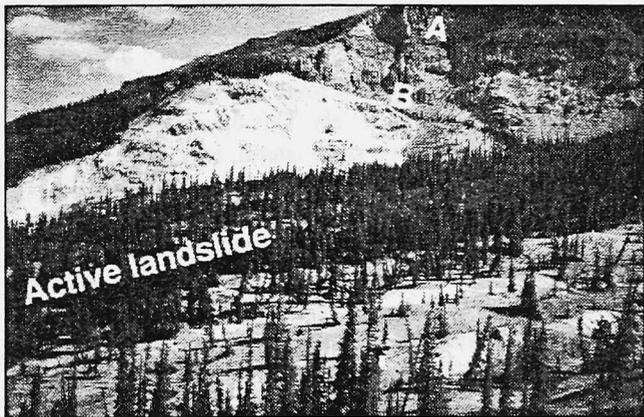
The uppermost fractures that we mapped in the head of the landslide form a narrow zone on a topographic bench below a large pile of coarse talus (Area below **B** in Fig. 8 and near **A-A'**, Fig. 9). The fractures are poorly expressed tension cracks and normal faults; both indicative of stretch-

Figure 8. West part of main scarp, looking north. Collapse that triggered present episode of movement evidently came from area labeled A. Head of active slide directly below point B. Main body of active slide in strip of tilted evergreens in middle of photograph. Axis of active slide curves abruptly from south (roughly toward viewer) at head to west (toward viewers left) near center of photograph.

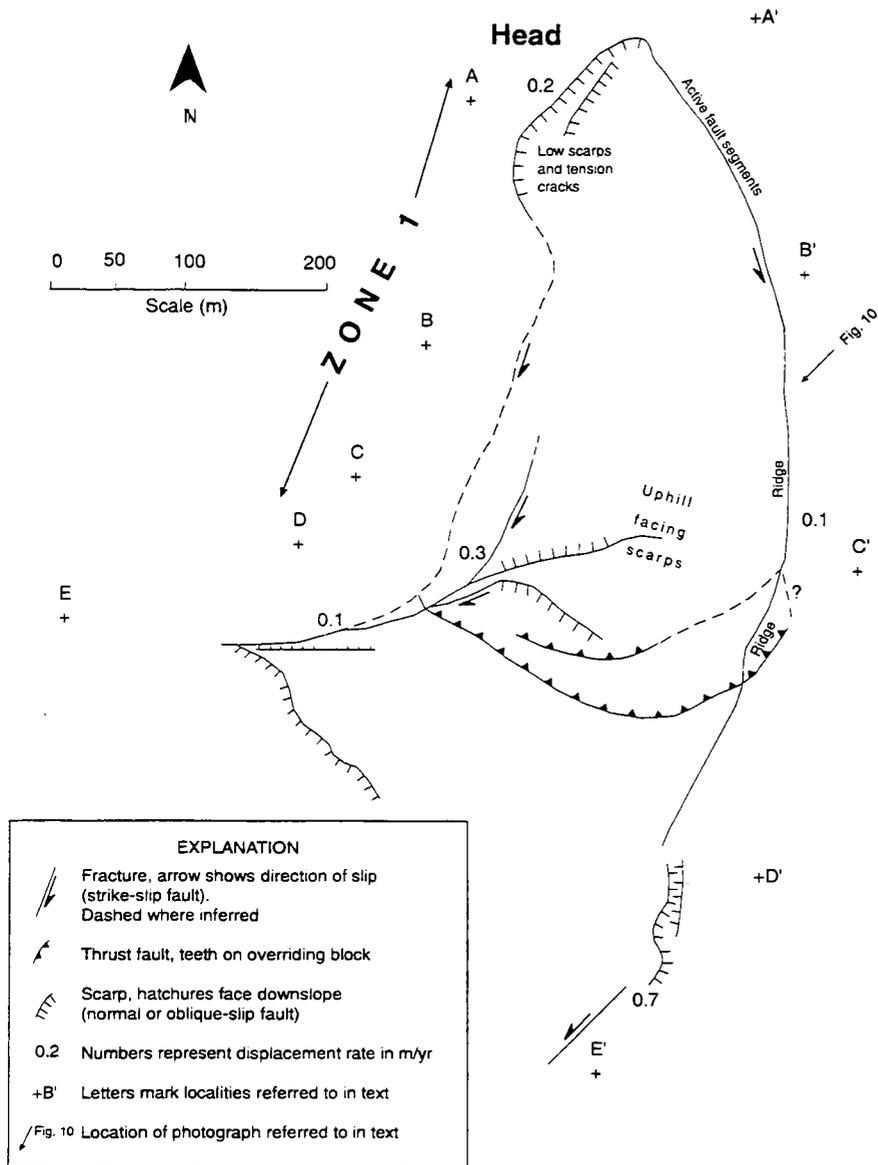
Displacement rates in the head of the landslide are small and the southward movement in the head of the landslide is nearly independent of the westward movement farther downslope. The value of 0.2 m/yr at the uppermost fractures is a minimum because measurement points did not extend across all the fractures. Farther downslope, at a point on the left flank about 25 m uphill from line **C-C'** movement was only 0.1 m/yr. On the right flank, a point

Figure 9. Simplified map of deformational features in Zone 1, Head.

near line C-D' was displaced 0.3 m and a point 110 m downhill from there and due south of D was displaced 0.1 m/yr. These few measurements indicate remnant displacement in the form of a separate, discrete landslide that resulted from a previous episode of main-scarp failure. Indeed, we were unable to find continuous fracturing along the left or right flank directly uphill from D-D', and the interior of the landslide in the vicinity of D-D' has very few fractures of any type that would connect the small landslide between A-A' and D-C' with the larger active landslide farther downslope.

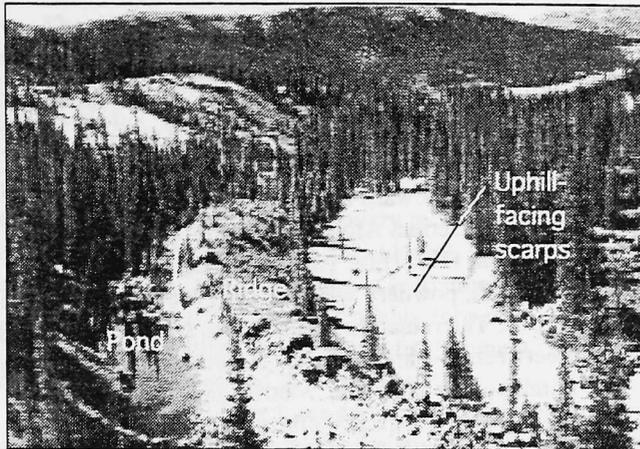
Figure 10. View to south-southwest of flank ridge and uphill facing scarps near 90°-bend in landslide (downhill end of Zone 1).

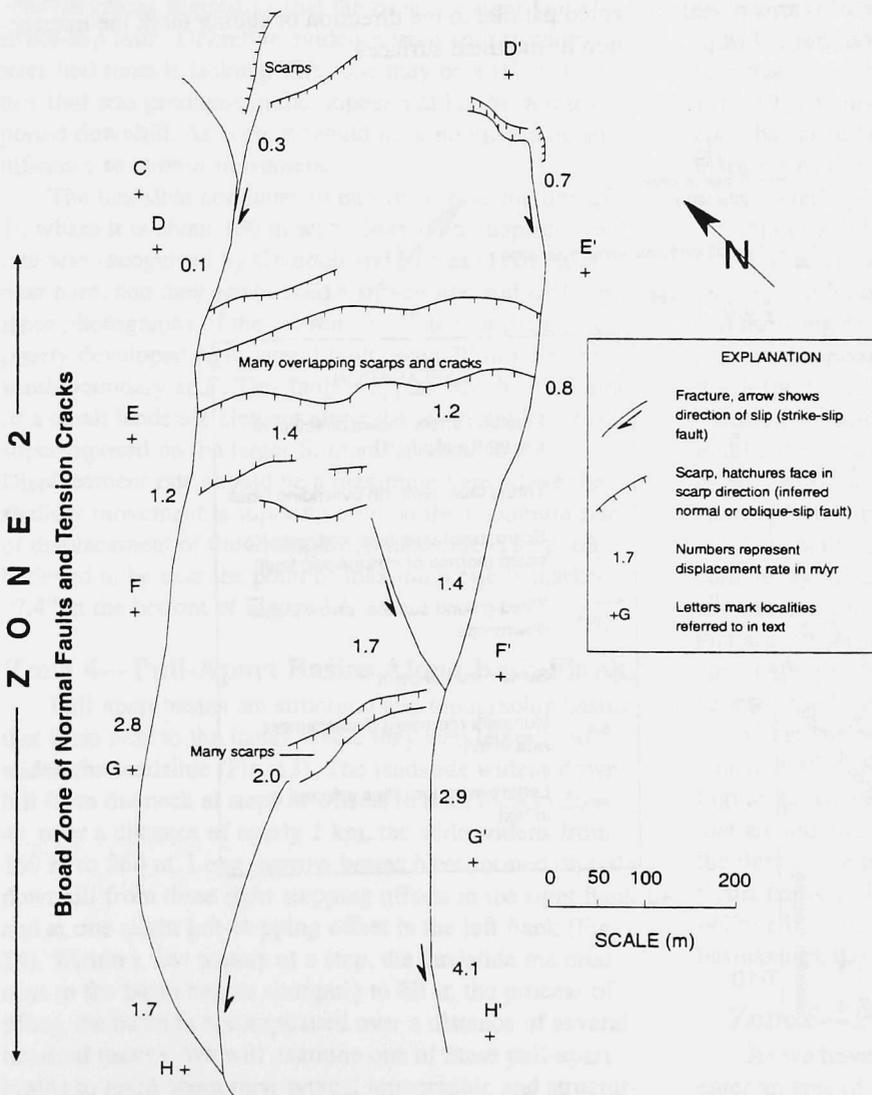
Figure 11. Simplified map of deformational features in Zone 2, Broad Bands of Normal Faults and Tension Cracks.

about 2 m. Displacement at a point 95 m uphill from E' on the left flank is 0.7 m/yr and increases to 0.8 m/yr at a point 110 m downhill from E'. On the north flank, 40 m downhill from E, displacement is 1.2 m/yr.

The difference in displacement of about 0.4 m/yr on the north flank compared to the south flank of the landslide has kinematic significance, because it must be accommodated either by internal distortion or by movement on one or more fault zones. The normal faults and tension cracks terminate in a well defined, left-lateral strike-slip fault zone (near F', Fig. 11) that carries about 0.3 m of the displacement difference between the landslide flanks. The left-lateral fault and adjoining band of normal faults define a block that can move through the 20° bend near F' with relatively little internal distortion, because the block is free to move nearly parallel to the flanks downhill from the bend.

The third band of normal faults extends between F'-H. Here, scarps and fractures are in a band more than 50 m wide that transforms into a right-lateral, strike-slip fault where the band narrows midway across the slide near G. The strike-slip fault approaches the north flank near H (Fig. 11). Displacement rate along the north flank is 2.8 m/yr near G and declines to 1.7 m/yr near H. Meanwhile, displacement increases along the south flank from 2.9 m/yr near G' to 4.1 m/yr near H'. Apparently, there is more than 2 m/yr of displacement across the internal strike-slip fault. The position of this band also corresponds to a sharp bend in the landslide; it turns counterclockwise 30° directly upslope from H.

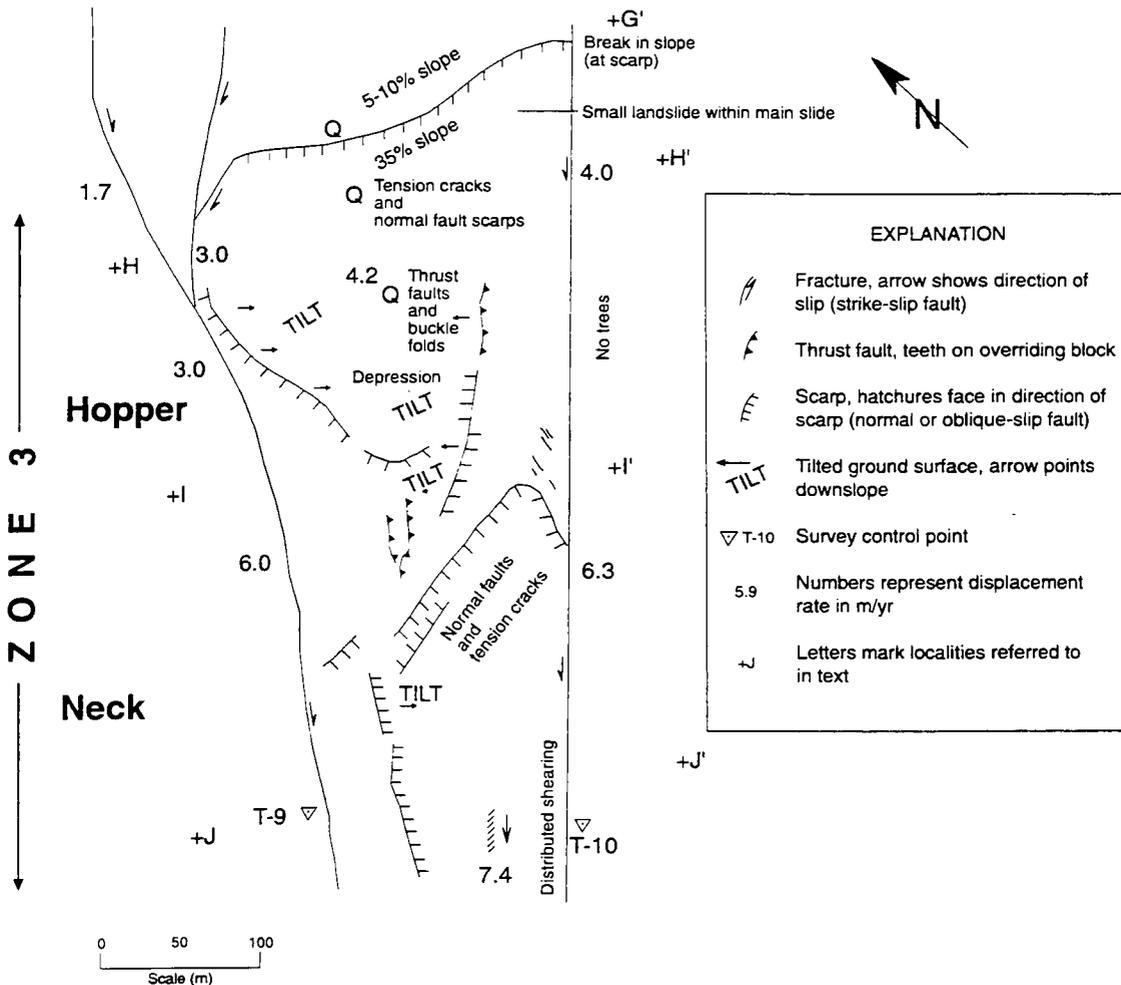
On the north side of the landslide, 30 to 50 m downhill from H, the landslide surface has been tilted toward the center (indicated by "tilt" with arrows on Fig. 12). This tilted area is matched for symmetry by a tilted surface on the south side that extends a little farther downslope than on the north side. The slope of the tilted surface on the north side is as much as 50 percent ($(\Delta v/\Delta h) \times 100\%$) whereas tilt amount on the south side is smaller, as much as 20 percent. The tilted surface on the north side is terminated on its downslope end by a discontinuous line of scarps that extends from the north flank near H obliquely toward I'. Small *en echelon* tension cracks in the line of scarps reveal that the sense of slip is oblique, a left-lateral, normal (dip slip) fault zone.

Figure 12. Simplified map of deformational features in Zone 3, Hopper and Neck.

The downslope end of the hopper-like structure is abruptly broken by a sharp zone of normal faults and tension cracks. The zone begins at I', trends obliquely downhill across the landslide toward J, turns north and intersects the north boundary of the landslide halfway between I and J. Small *en echelon* tension cracks in the well-formed zone about 50 m inside the south boundary at I' indicate that slip is oblique, right-lateral and normal (down). Most of the narrowing of the landslide has been accommodated farther upslope, and this structure has probably formed to accommodate a continuation of increasing displacement rate with distance from the head of the landslide.

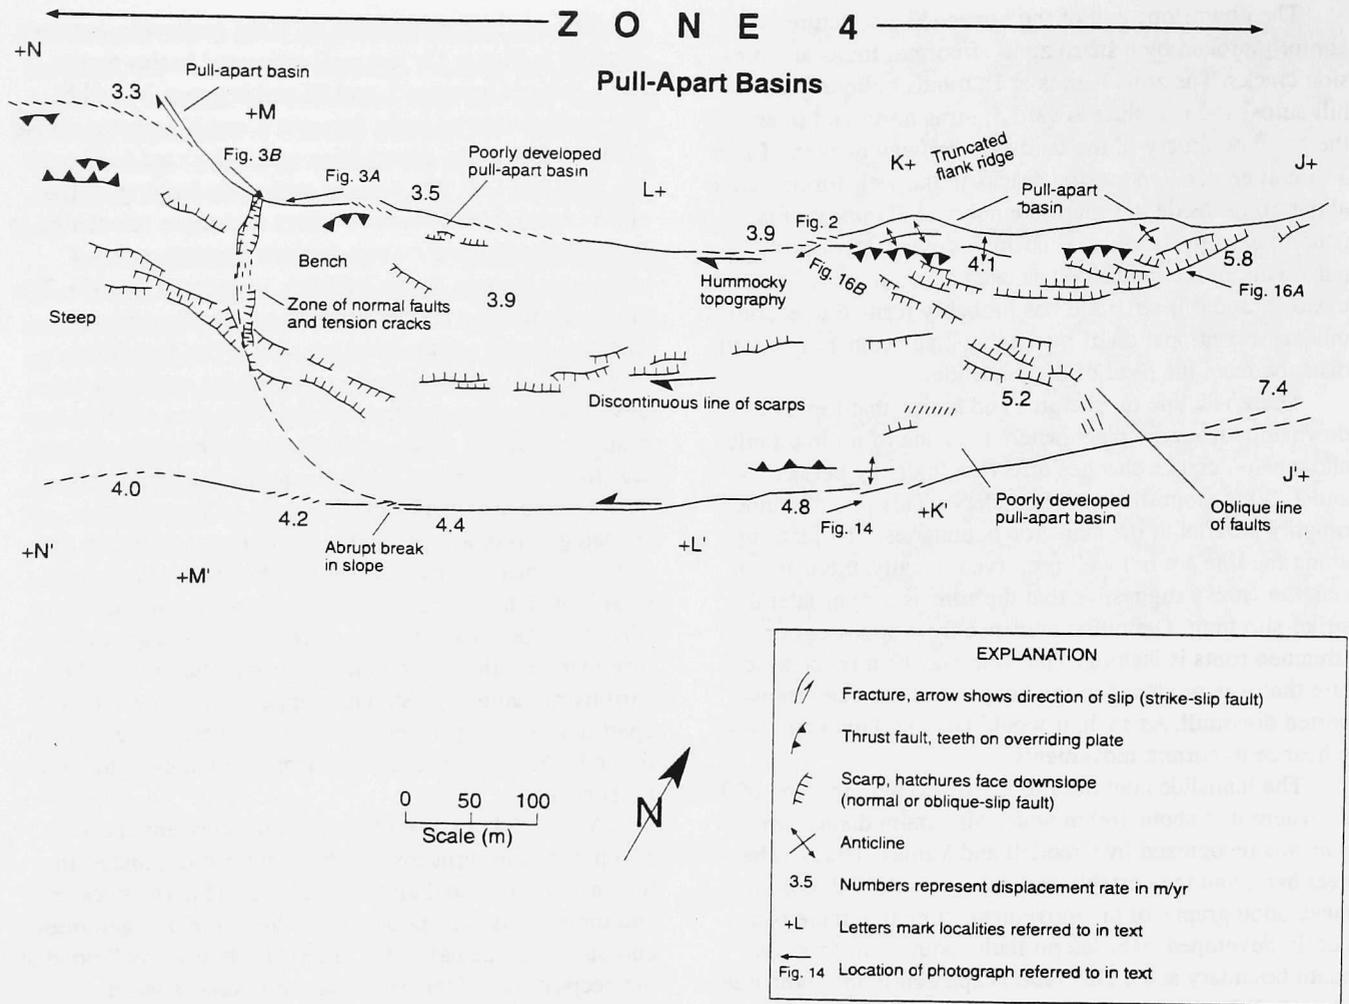
The best expressed basin is on the north side, between J and K in Figure 13; less well expressed basins on the north side are between L and M and between M and N. The well-developed basin between J and K contains all the features seen at the other basins and is depicted in Figures 15, 16A, and 16B. The zone of strike-slip faulting on the north (right) flank bifurcates where it changes orientation at J; one part follows the north flank as a narrow zone of strike-slip faulting on the landslide boundary (Fig. 15). The other part forms a crescent-shaped group of scarps and fractures that gradually turns parallel to the north flank (Fig. 16A). A 5-m deep basin occupies the area between this crescent-shaped group and the north flank. Within the basin and parallel to the landslide boundary, there are several shortening features such as small thrust faults and buckle folds. Rotated blocks bounded by the crescent-shaped group of scarps and the shortening features in the basin are smaller landslides within the overall larger landslide in which material is being transported into the basin (Fig. 15). The crescent-shaped group of scarps are the surface manifestation of oblique-slip (right-lateral- and dip-slip) listric faults. The structure appears analogous to pull-apart basins in larger tectonic settings where movement on listric faults transports material from the flanks of the basin to its center.

Figure 13. Simplified map of deformational features in Zone 4, Pull-Apart Basins Along both Flanks. Note steps or offsets in flanks directly upslope from the basins.

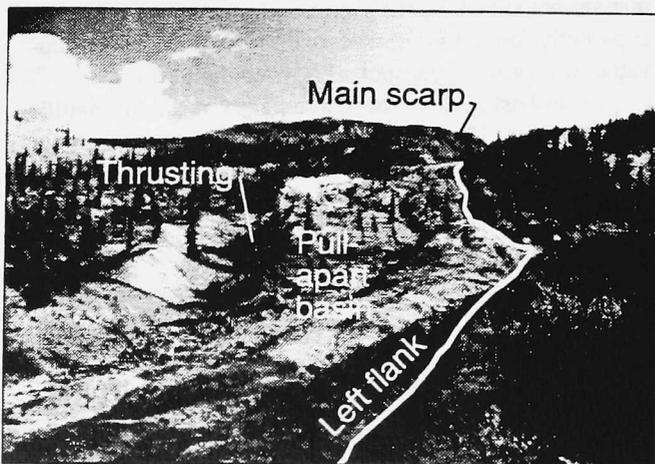
Figure 14. View of poorly developed pull-apart basin along left flank (photograph by Jack Odum, U.S. Geological Survey).

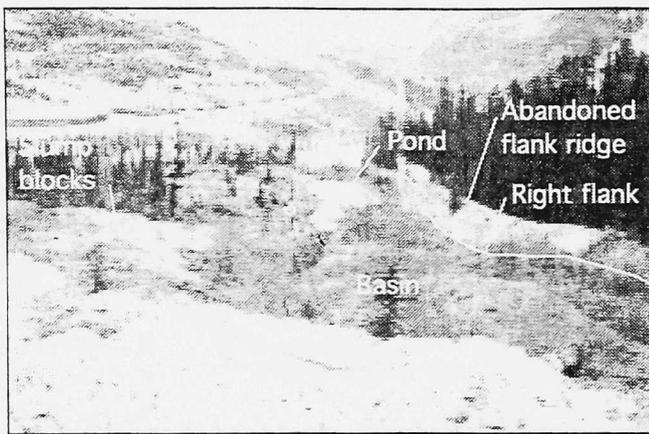
Figure 16. A. View looking southwest into large pull-apart basin on right flank. B. View to northeast from bottom of same pull-apart basin, pond sediments in foreground. Note tilted trees on thrust sheet.

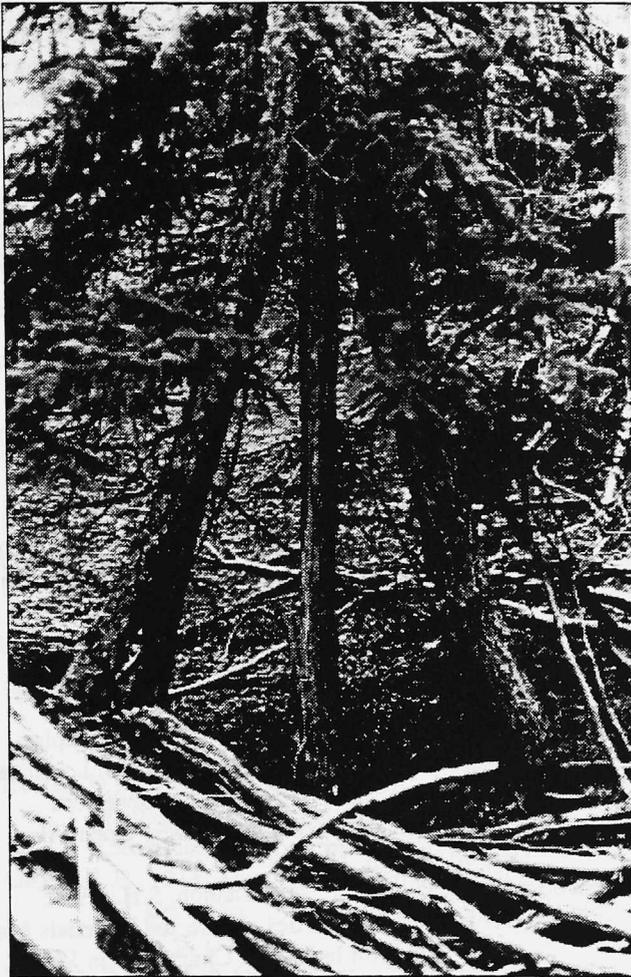
The entire north side of the landslide toe is composed of oblique-slip structures. Deformation across these structures consist of right-lateral slip and opening/spreading. This is well illustrated at a spruce tree that was caught in one of these oblique-slip zones (Fig. 20). The fault zone occupies a small furrow that crosses under the tree. There are no open cracks or fractures; the position of the fault is given only by the furrow and the split tree. The right-hand side of the tree is about 1 m farther downslope than the left-hand side, and the opening normal to the strike-slip direction is about 0.8 m. The split tree is definitive evidence of right-lateral slip together with spreading. There are numerous troughs and furrows in this part of the landslide, and only in a few places, like shown in Figure 20, can they be shown to be locations of active movement.

Figure 20. View of split tree in Zone 6, looking uphill. The tree is broken in four parts by right-lateral and spreading movement. Fault that causes rupture of the tree does not create a fracture at the ground surface, but does form a linear trough about 1 m deep.

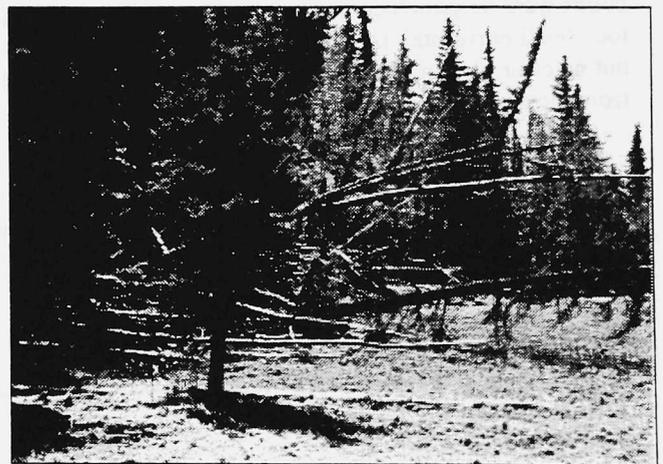
Figure 21. View of north side of active toe (Zone 7) where trees are being overridden by bulldozer-like movement of the landslide. Moving ground on left pushes trees over and buries them.

In the place on the active toe where we were measuring displacement rate by surveying rather than simply taping distances, we were able to determine the displacement vector of the active toe relative to nonmoving ground farther downhill. We expected that the displacement would be approximately parallel to the slope because it is obviously advancing over old landslide debris. To our surprise, we found that the displacement is directed nearly horizontally out of the slope. This condition, which tends to thicken the toe, apparently is the result of accumulation of trees and other debris along the contact between moving and non-moving ground (Fig. 21). Displacement tends to steepen the front of the active toe. Sloughing of materials on the oversteepened face gives rise to a churning of material along the active front and the advance is similar to the motion of the tread of a bulldozer. Continuing movement results in continuing thickening of the toe.
