OPEN-FILE REPORT 78-10

GEOLOGIC HAZARDS OF THE  
GLENWOOD SPRINGS METROPOLITAN  
AREA - GARFIELD COUNTY, COLORADO

PREPARED BY  
LINCOLN-DEVORE  
ENGINEERS AND GEOLOGISTS

1978

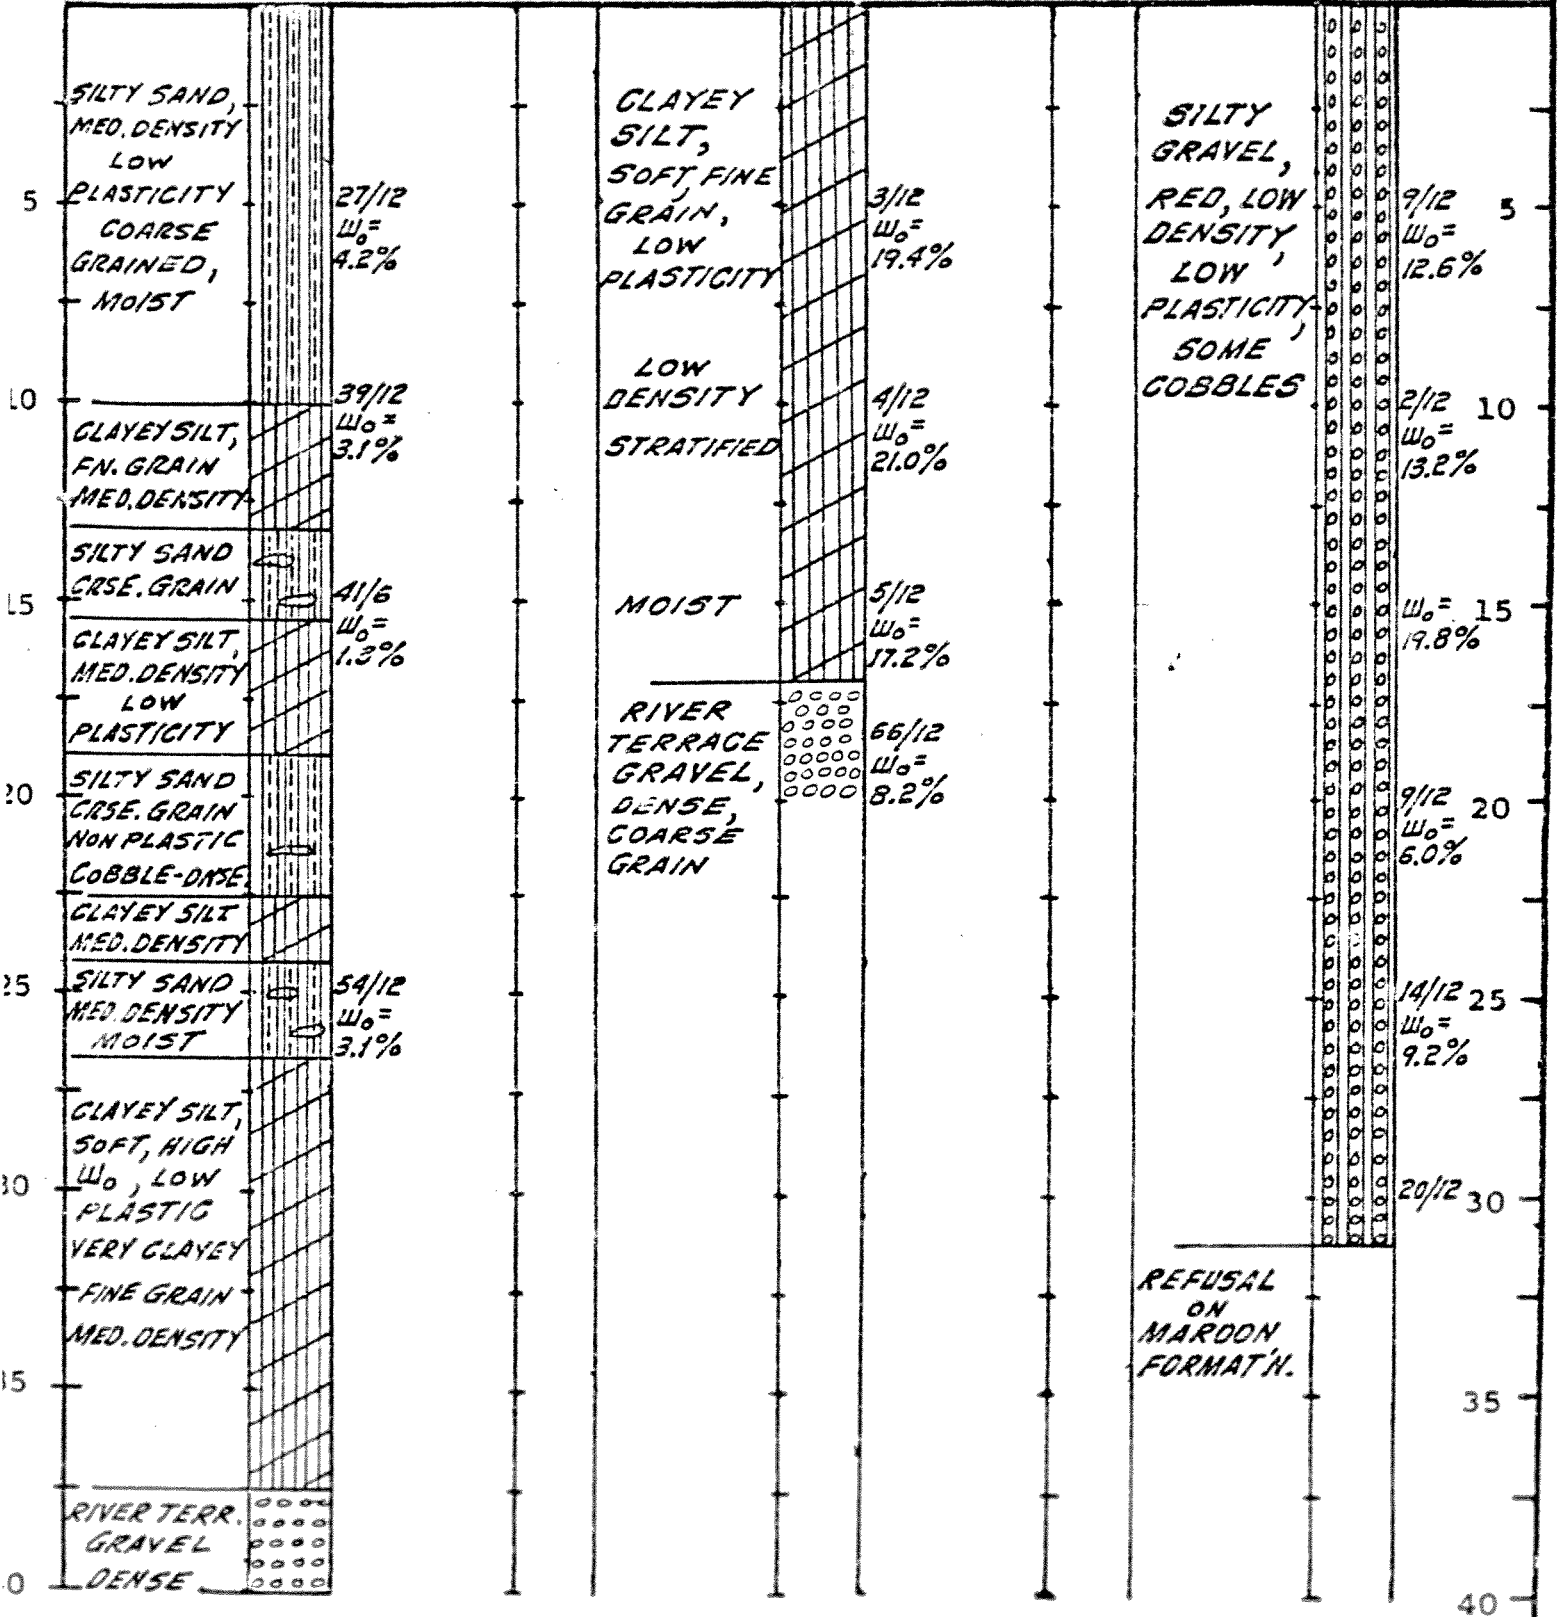
FIGURE 2: TYPICAL SOIL PROFILES (10/12 INDICATES STANDARD PENETRATION TEST RESULTS FOR 12" OF PENETRATION -  $w_0$  INDICATES MOISTURE CONTENT)

The potential for subsidence of all types is shown on Sheets 10, 11, 12, and 13 of the map series. Also, Figure 2b illustrates a typical soil profile in a material subject to complex ground failure over a long period of time. Figure 2c shows a typical soil profile in a material subject to severe, short-term complex ground failure; the very low blow counts shown in parts of the profile may reflect piping erosion.

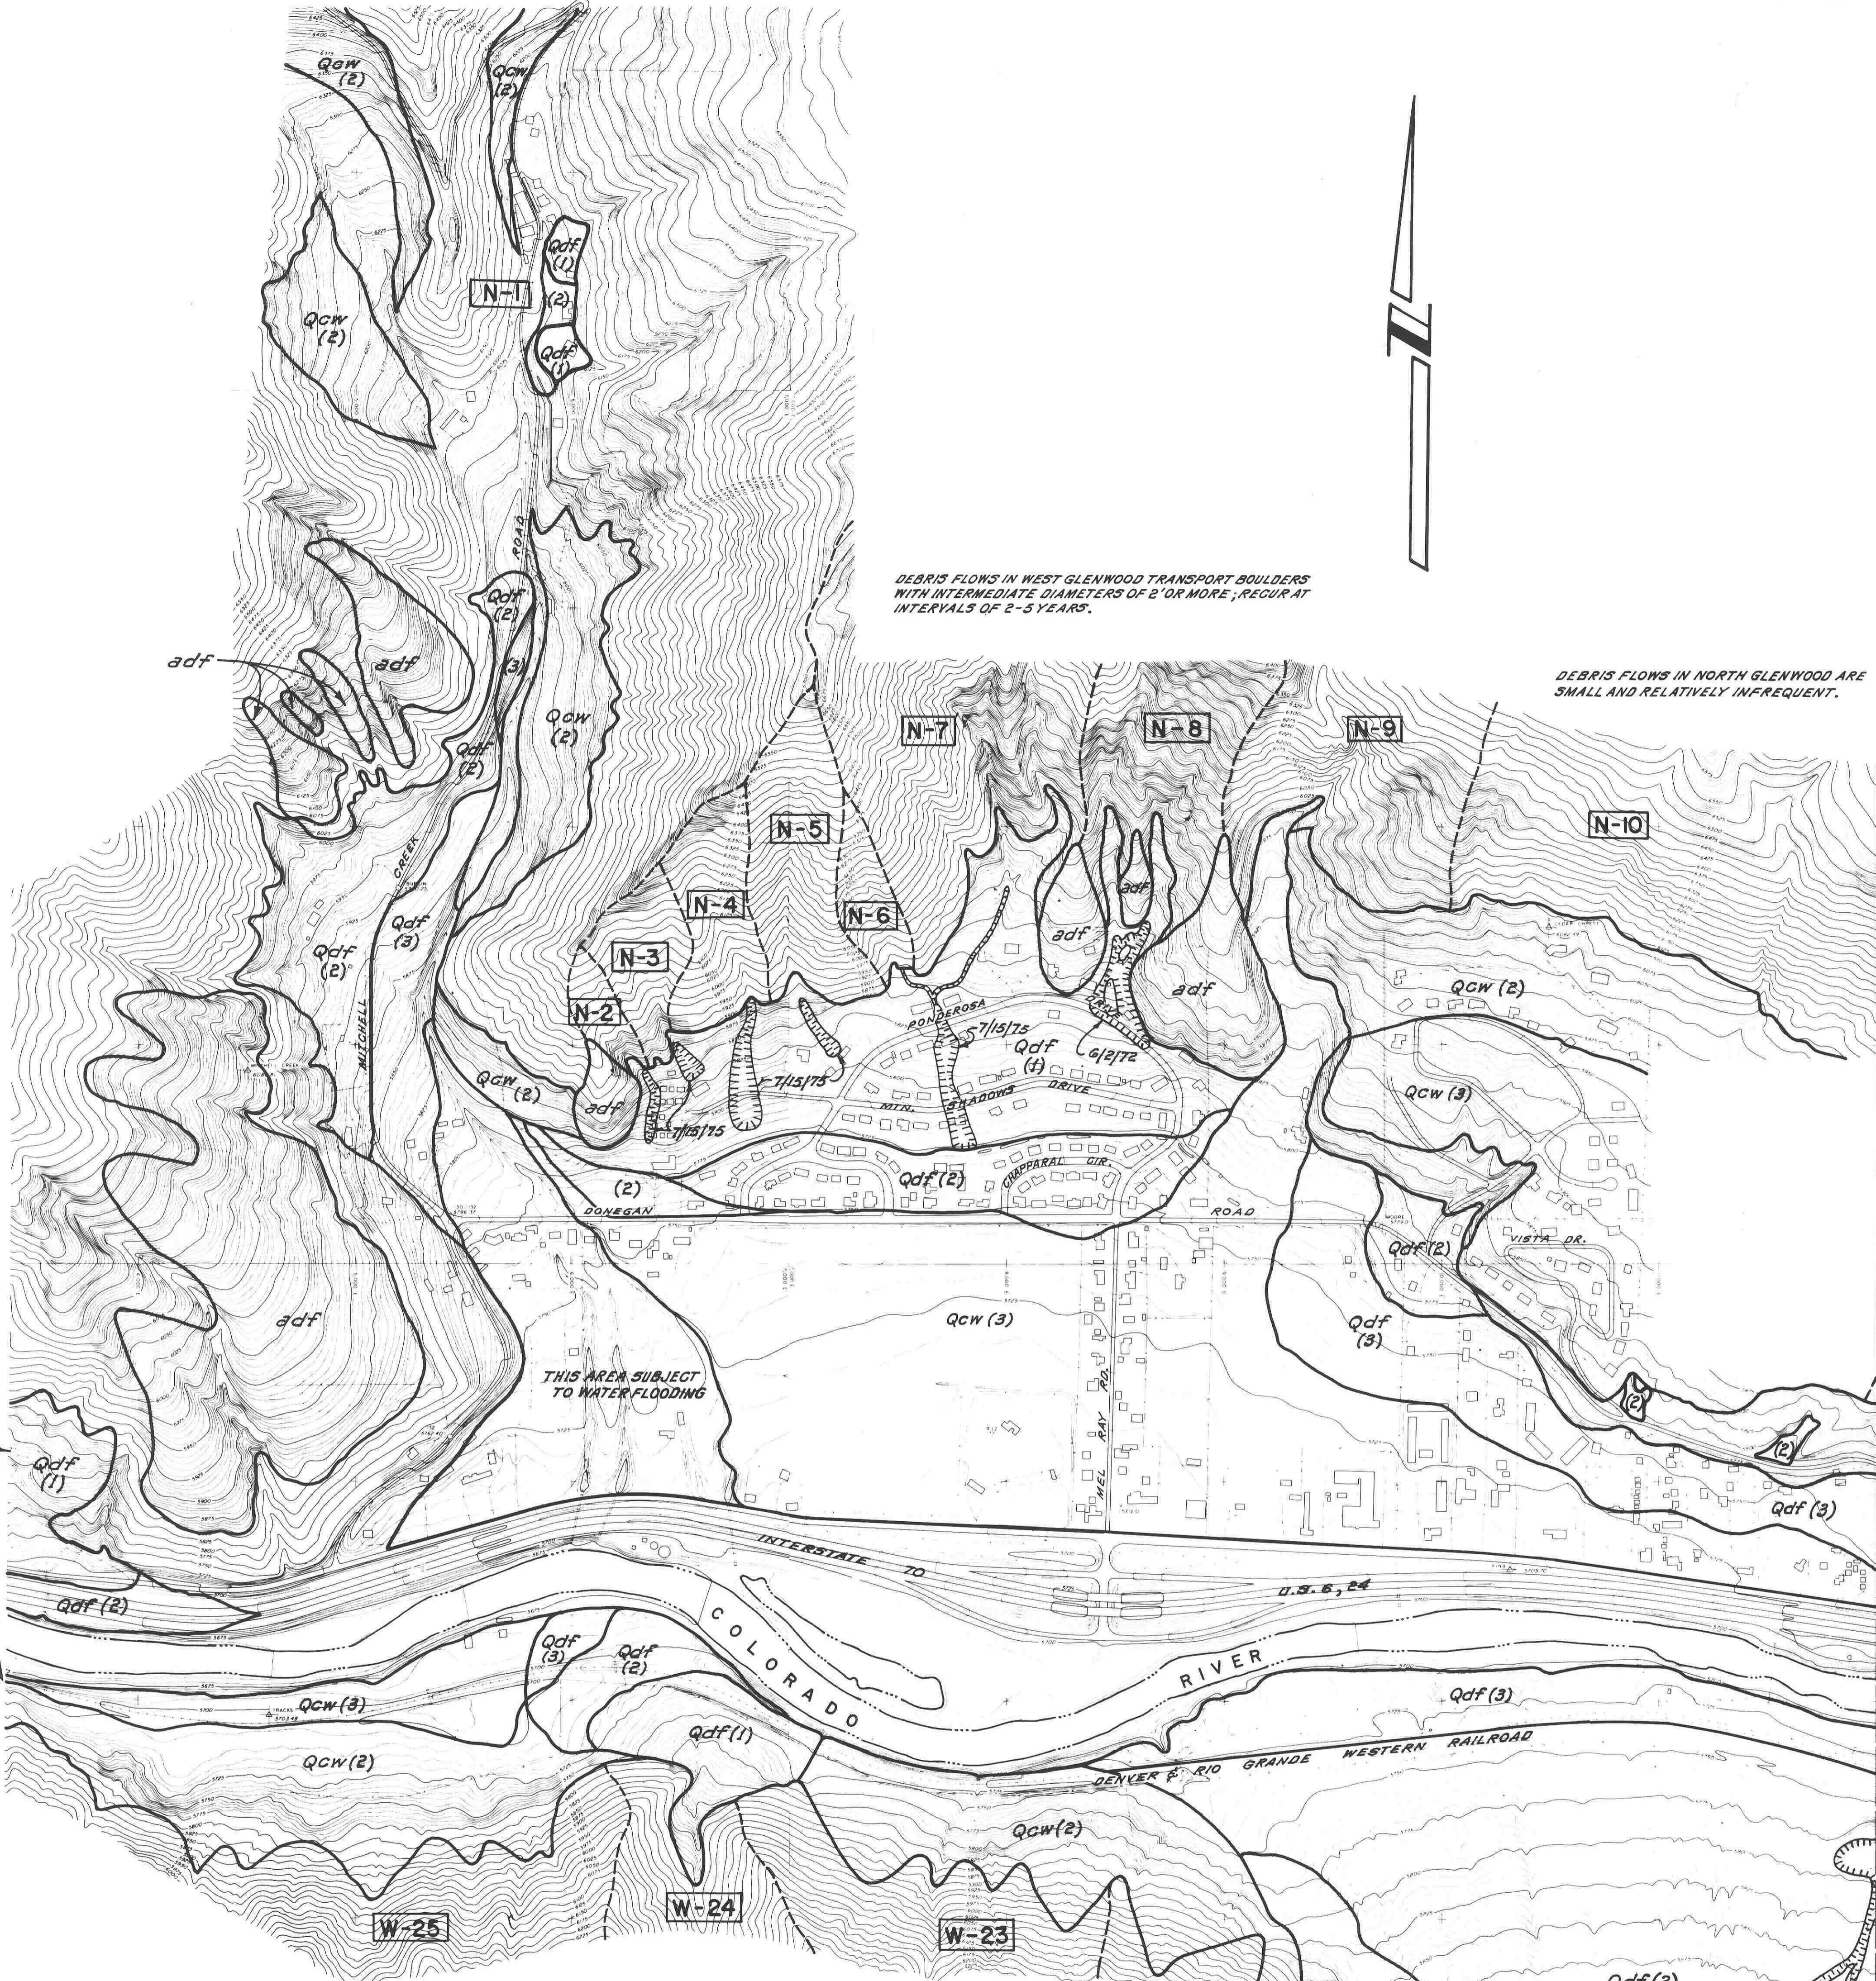
**MAP OF DEBRIS FAN DEPOSITS AND HAZARDS**

DEBRIS FLOWS IN WEST GLENWOOD TRANSPORT BOULDERS WITH INTERMEDIATE DIAMETERS OF 2' OR MORE; RECUR AT INTERVALS OF 2-5 YEARS.

DEBRIS FLOWS IN NORTH GLENWOOD ARE SMALL AND RELATIVELY INFREQUENT.

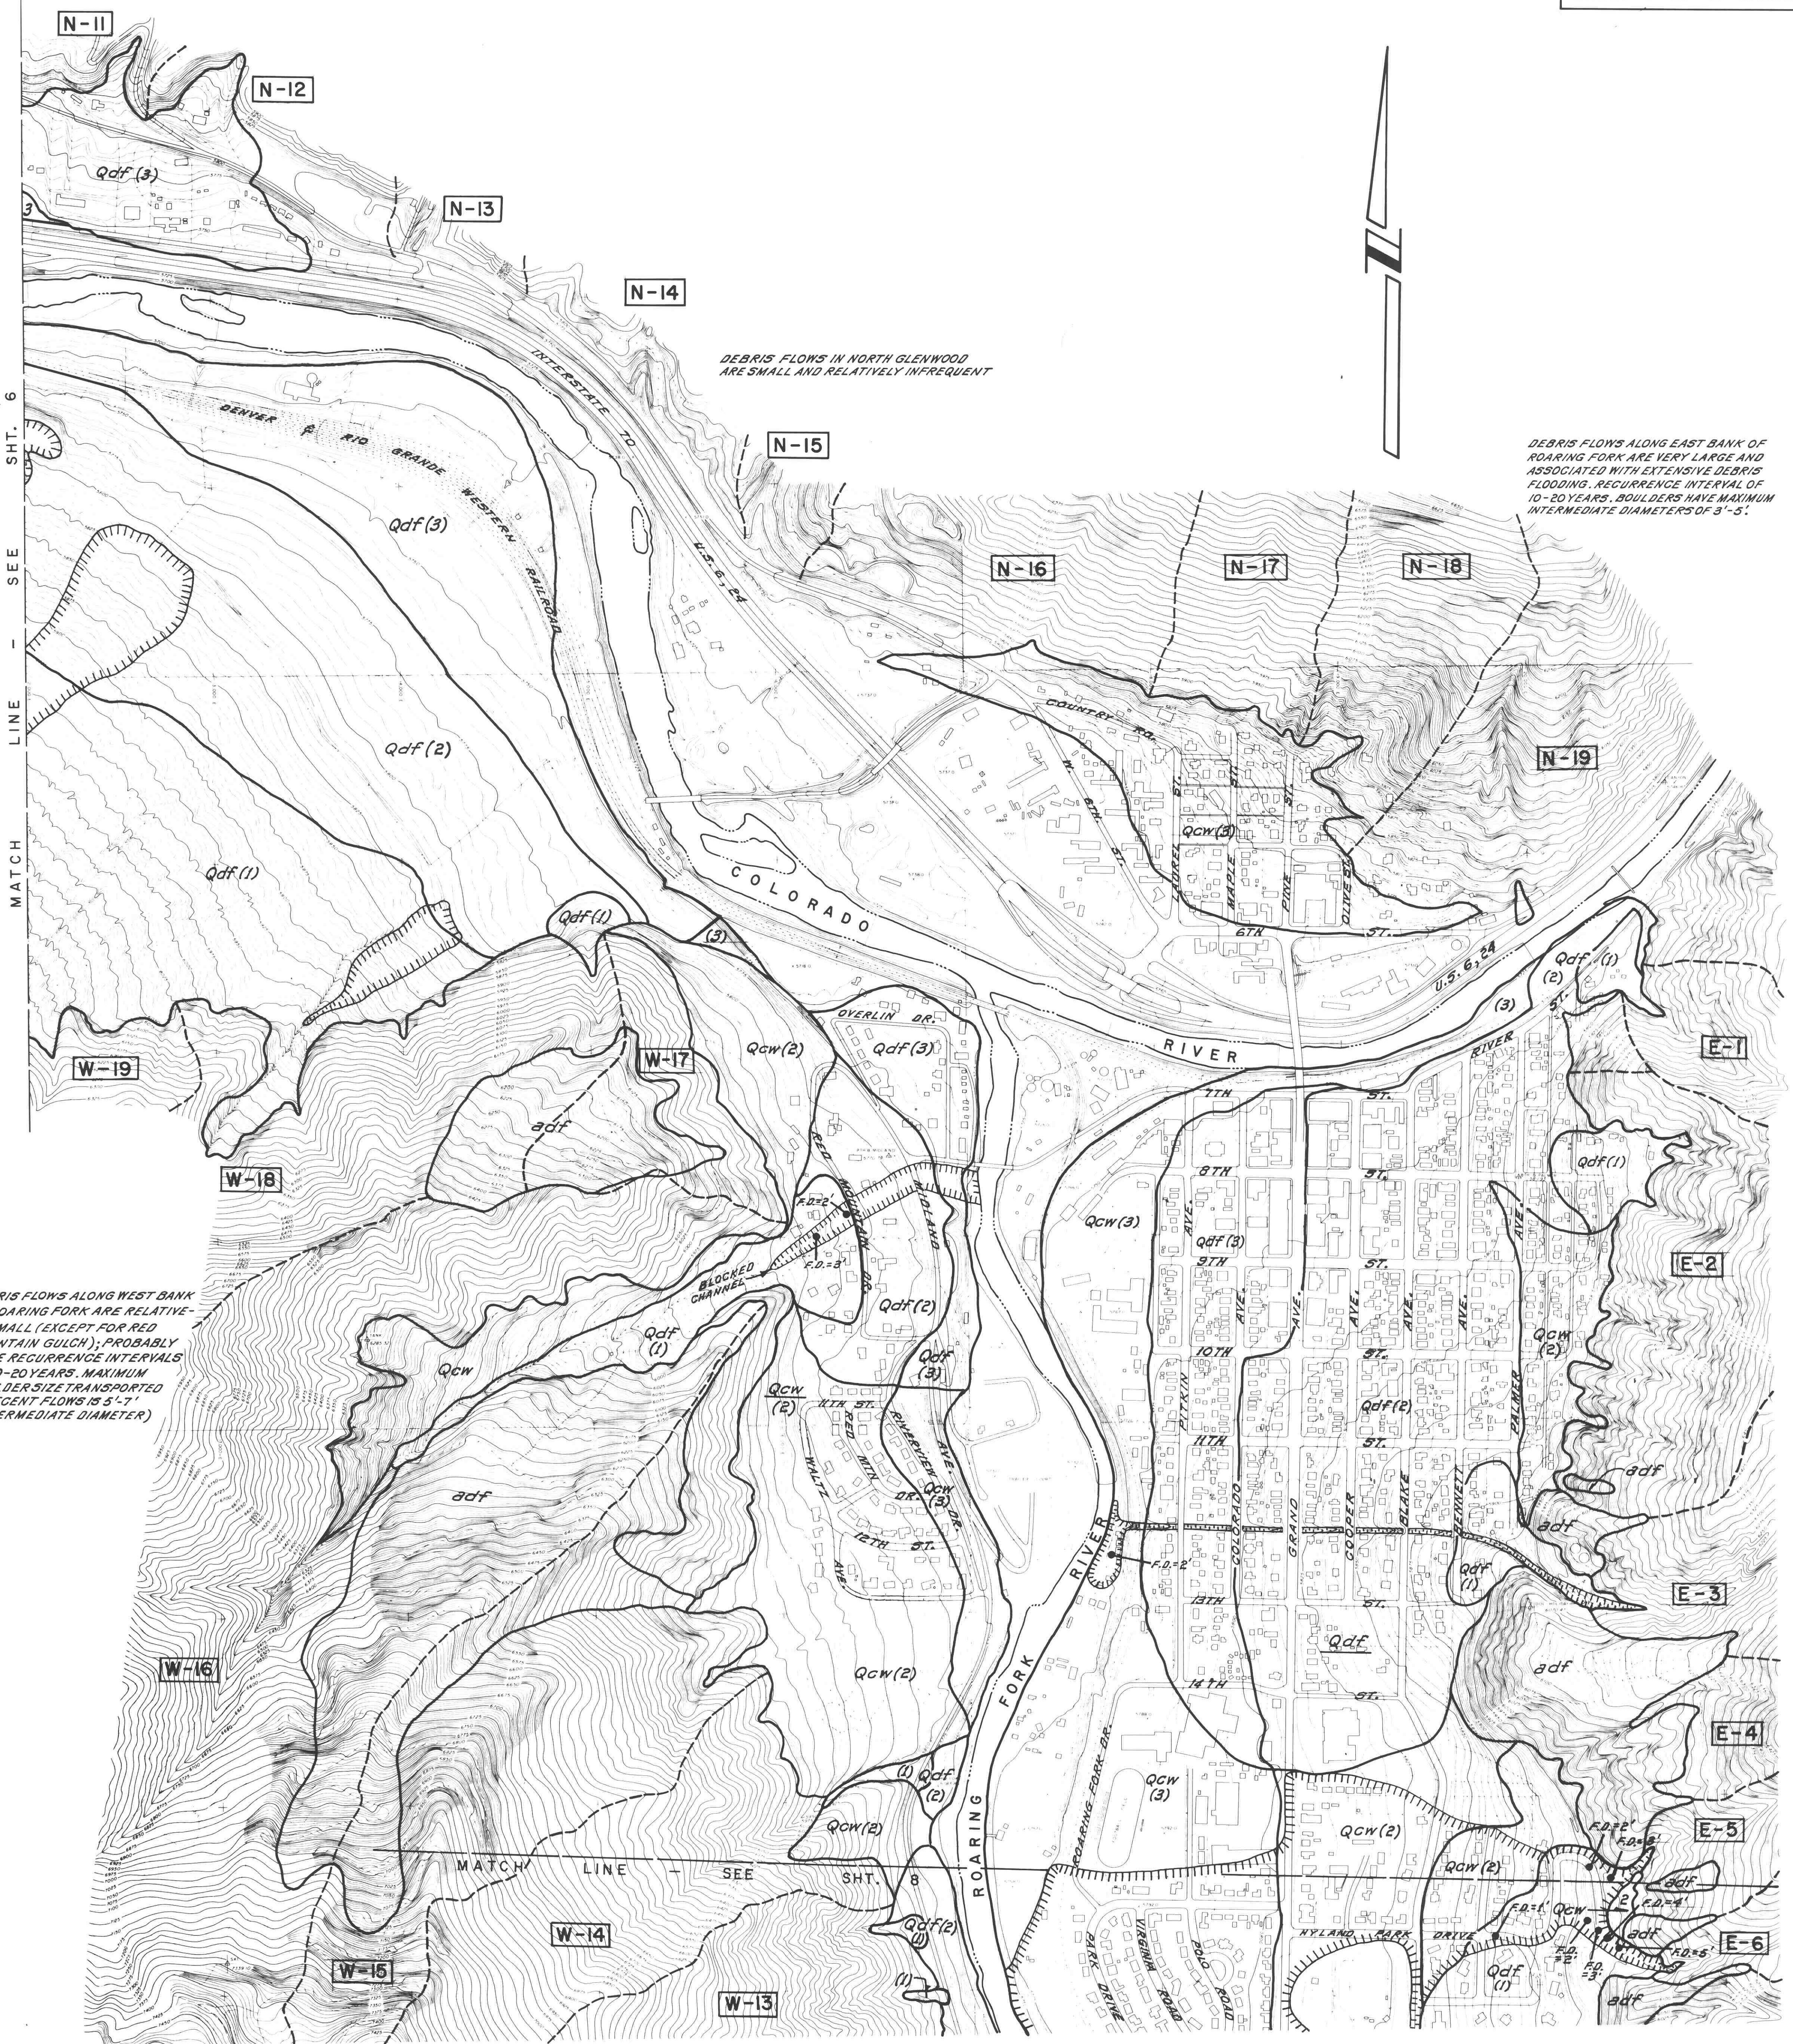
MAP OF DEBRIS FAN DEPOSITS AND HAZARDS

DEBRIS FLOWS IN NORTH GLENWOOD ARE SMALL AND RELATIVELY INFREQUENT

DEBRIS FLOWS ALONG EAST BANK OF ROARING FORK ARE VERY LARGE AND ASSOCIATED WITH EXTENSIVE DEBRIS FLOODING. RECURRENCE INTERVAL OF 10-20 YEARS. BOULDERS HAVE MAXIMUM INTERMEDIATE DIAMETERS OF 3'-5'.

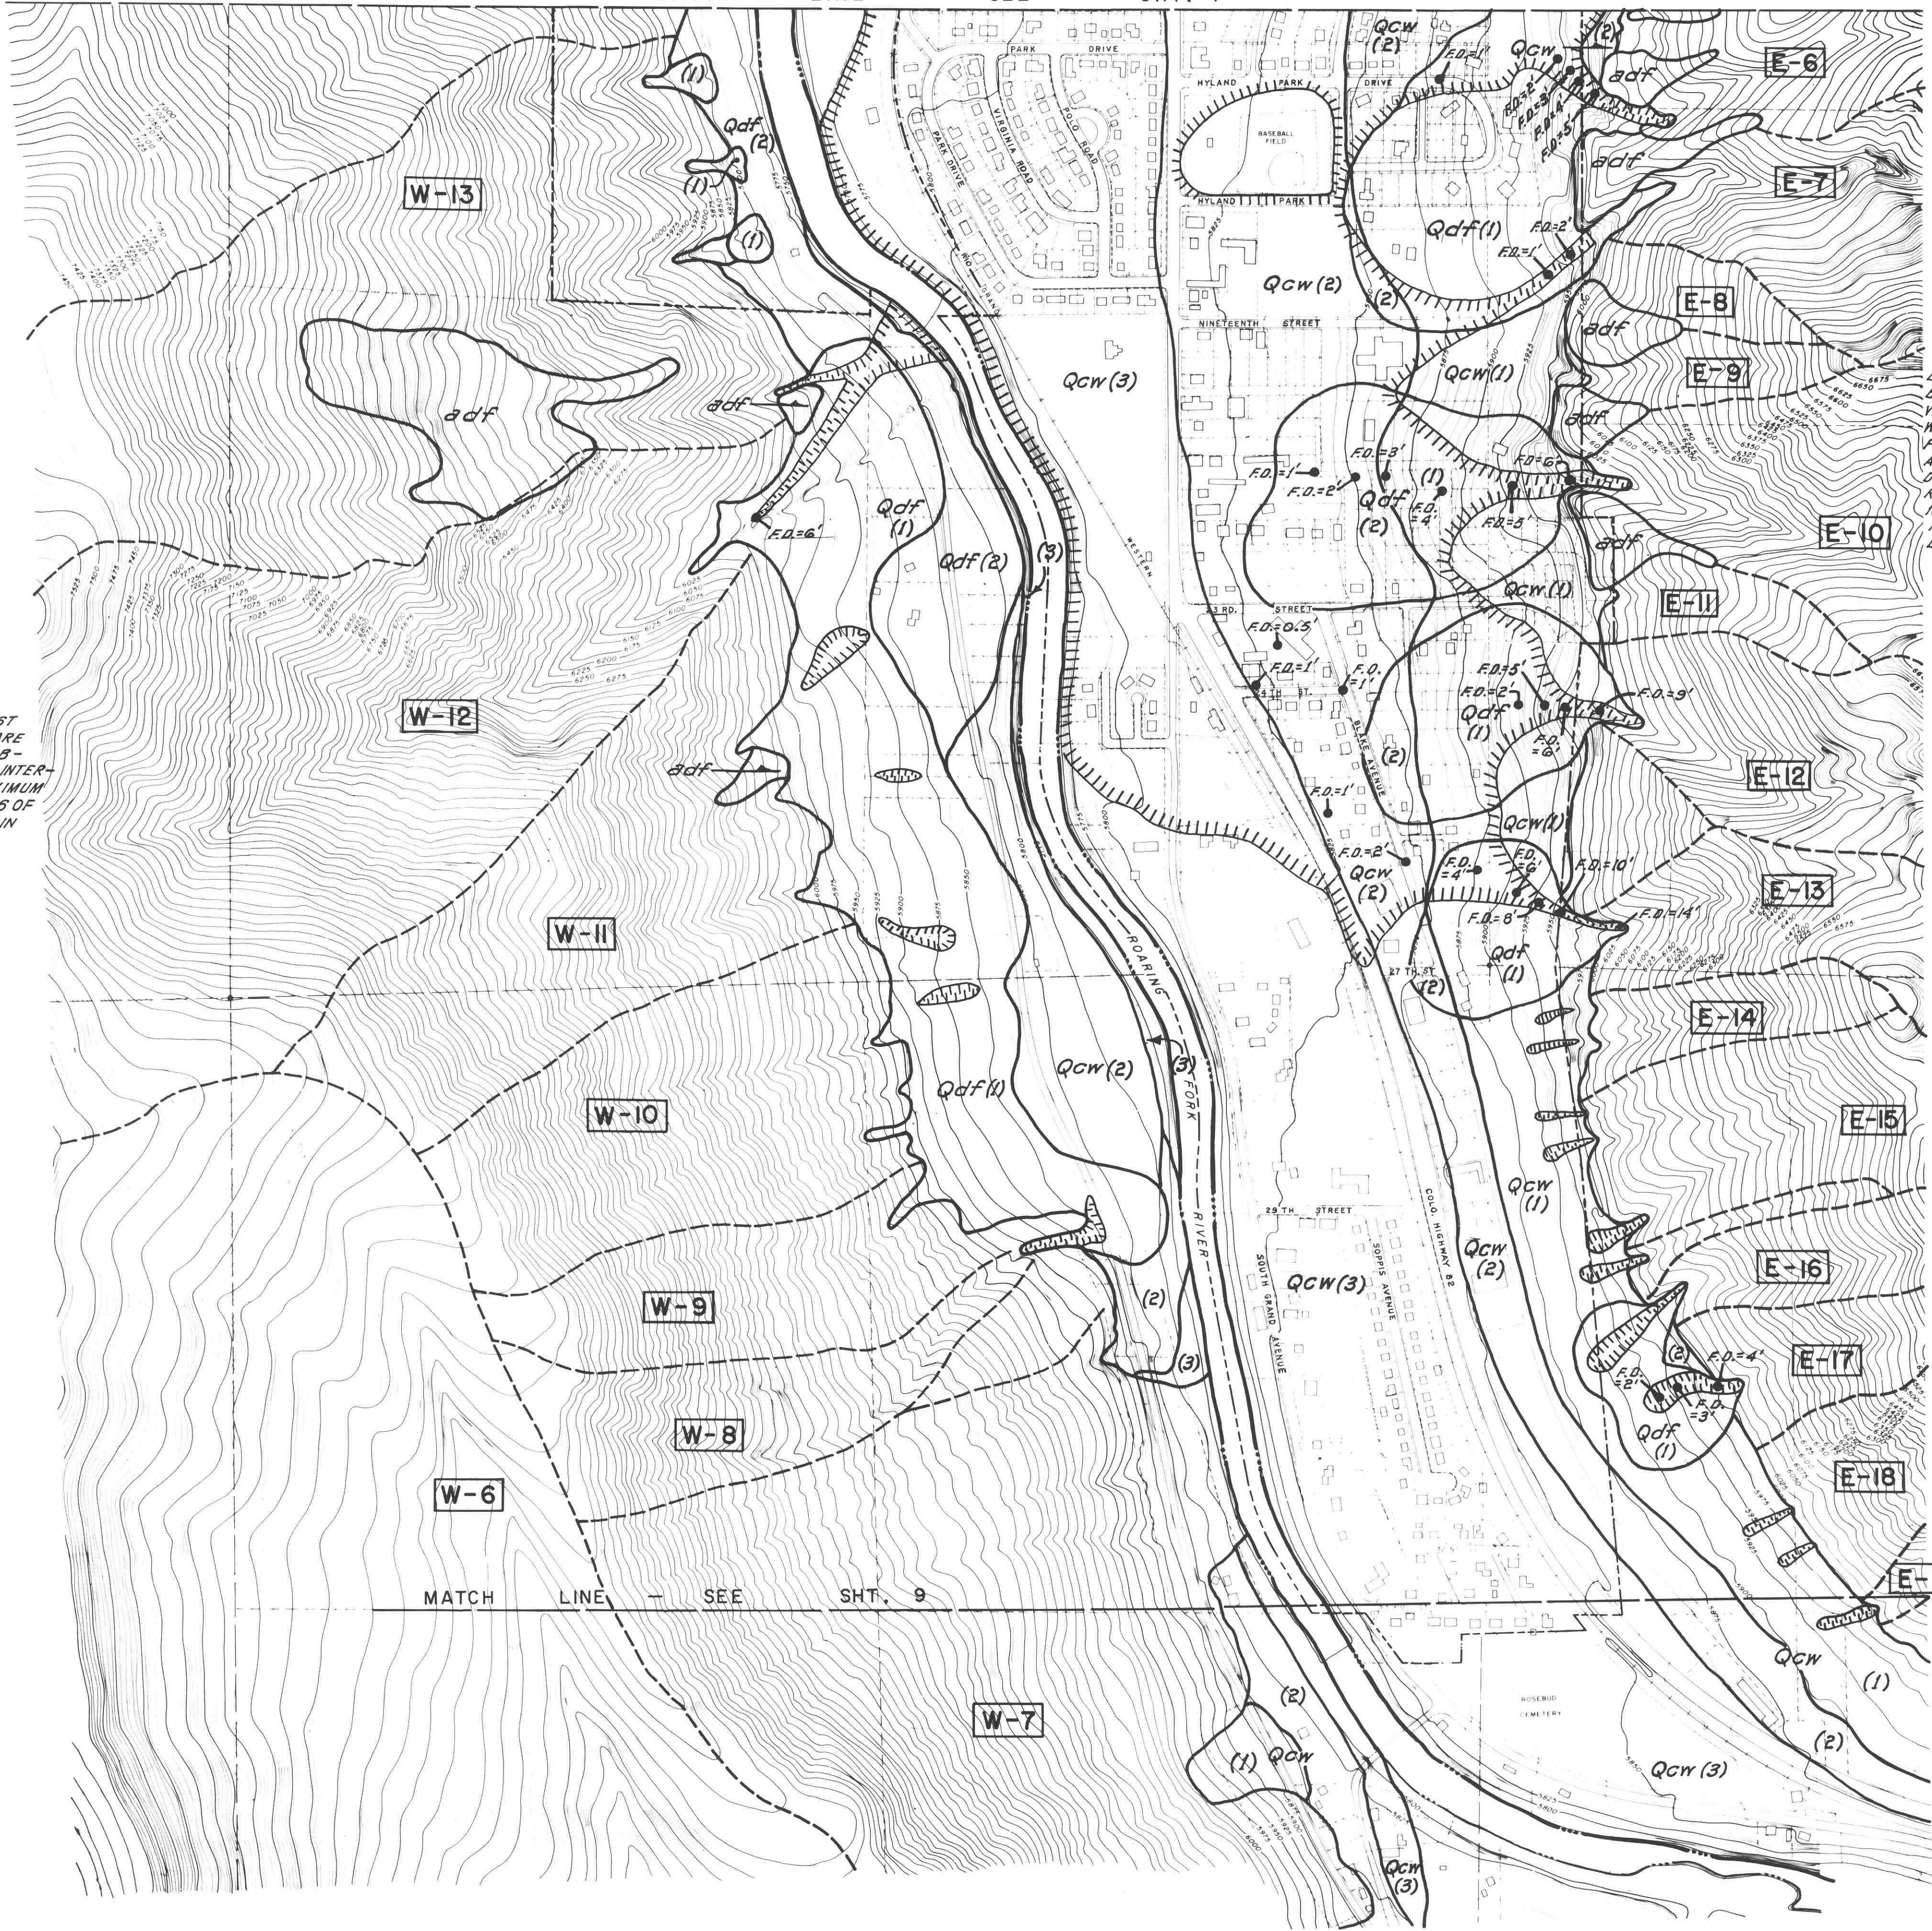
### MAP OF DEBRIS FAN DEPOSITS AND HAZARDS

DEBRIS FLOWS ALONG WEST BANK OF ROARING FORK ARE RELATIVELY SMALL; PROBABLY HAVE RECURRENCE INTERVALS OF 10-20 YEARS. MAXIMUM INTERMEDIATE DIAMETERS OF BOULDERS TRANSPORTED IN RECENT FLOWS IS 5'-7'.

DEBRIS FLOWS ALONG EAST BANK OF ROARING FORK ARE VERY LARGE AND ASSOCIATED WITH EXTENSIVE DEBRIS FLOODING. BOTH FLOW SIZE AND MAGNITUDE OF FLOODING DECREASE TO THE SOUTH. RECURRENCE INTERVAL OF 10-20 YEARS. BOULDERS HAVE MAXIMUM INTERMEDIATE DIAMETERS OF 3'-5'.

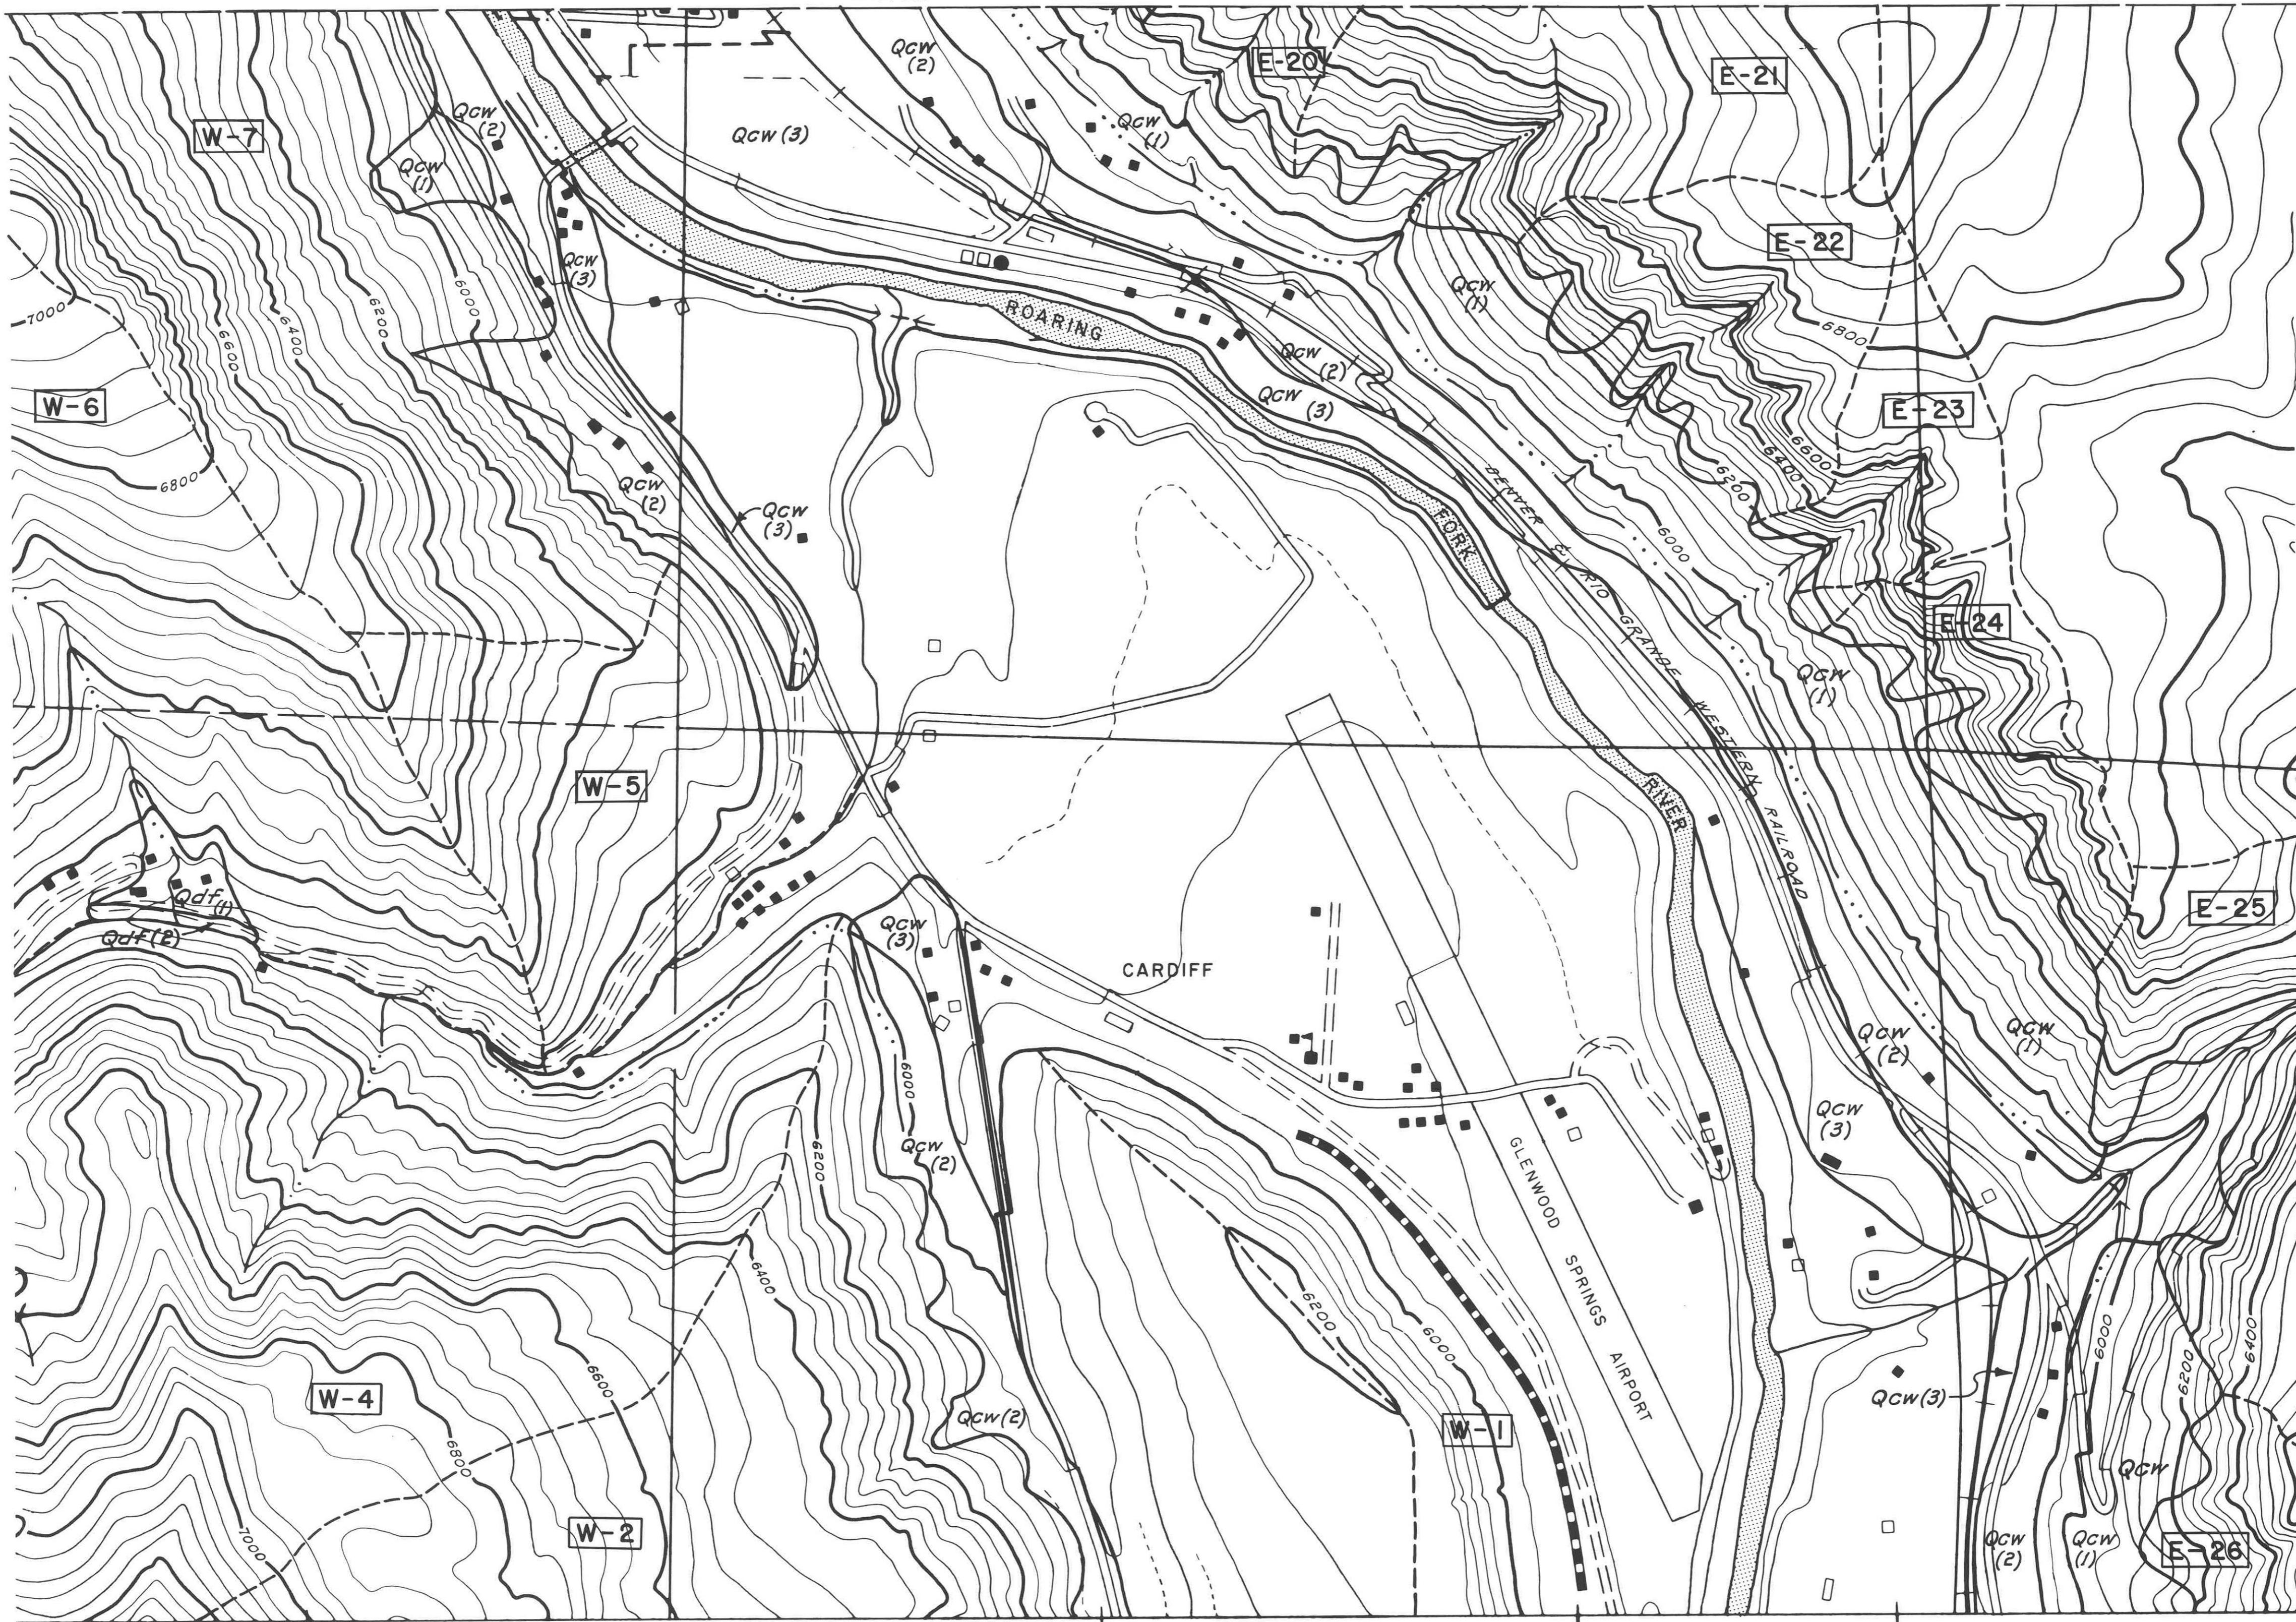
### MAP OF DEBRIS FAN DEPOSITS AND HAZARDS

DEBRIS FLOWS ON THIS SHEET ARE NOT SUPPORTED BY RELIABLE RECORDS.  
HAZARD ZONES ARE BASED ON CHARACTERISTICS INFERRED FROM REMAINDER OF STUDY AREA.
