Survey of Seeps and Springs on Bureau of Land Management lands in northern Hinsdale County 2006-2007

**Prepared for:
Bureau of Land Management, Gunnison Field Office
216 N. Colorado
Gunnison, Colorado 81230**

**Prepared by:
Stephanie Neid, Delia Malone, and Jennifer Jones**

March 1, 2008

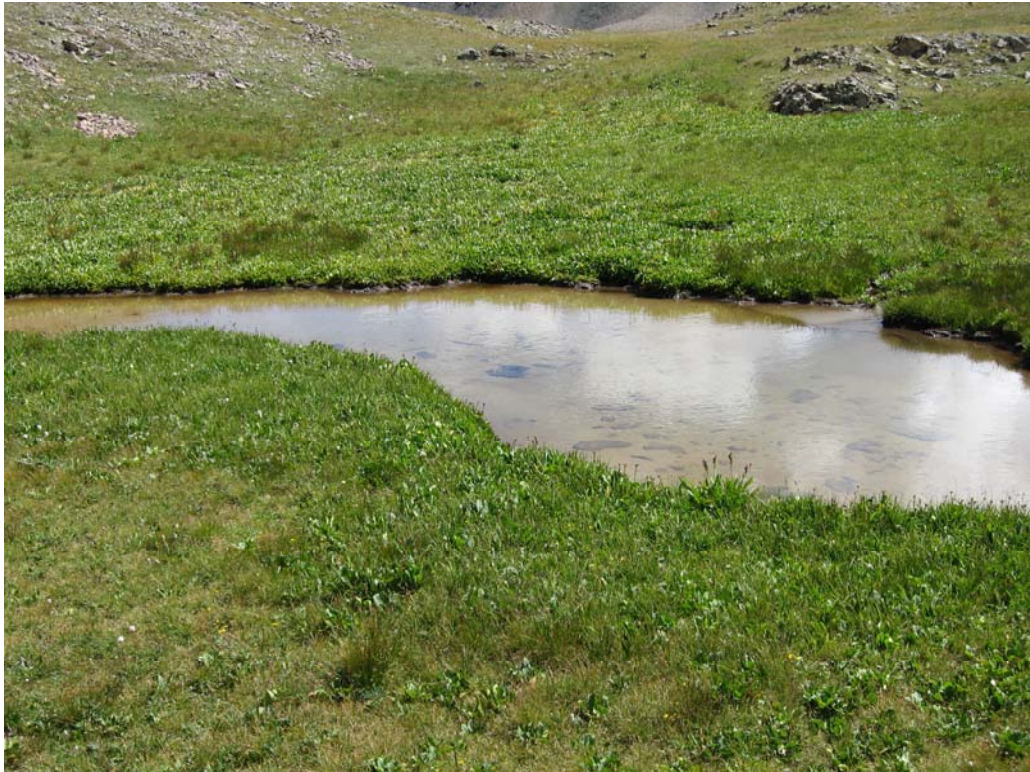
**Upper Snare Creek
Standard Checklist
Proper Functioning Condition**

Potential (ecological status that can be attained without above limiting factors or without limiting factors what is the ultimate goal for assessment area) Wetland is functioning at its potential natural community with no disturbances contributing to unacceptable conditions in the area. Hydrology is stable and wetland vegetation is vigorous.

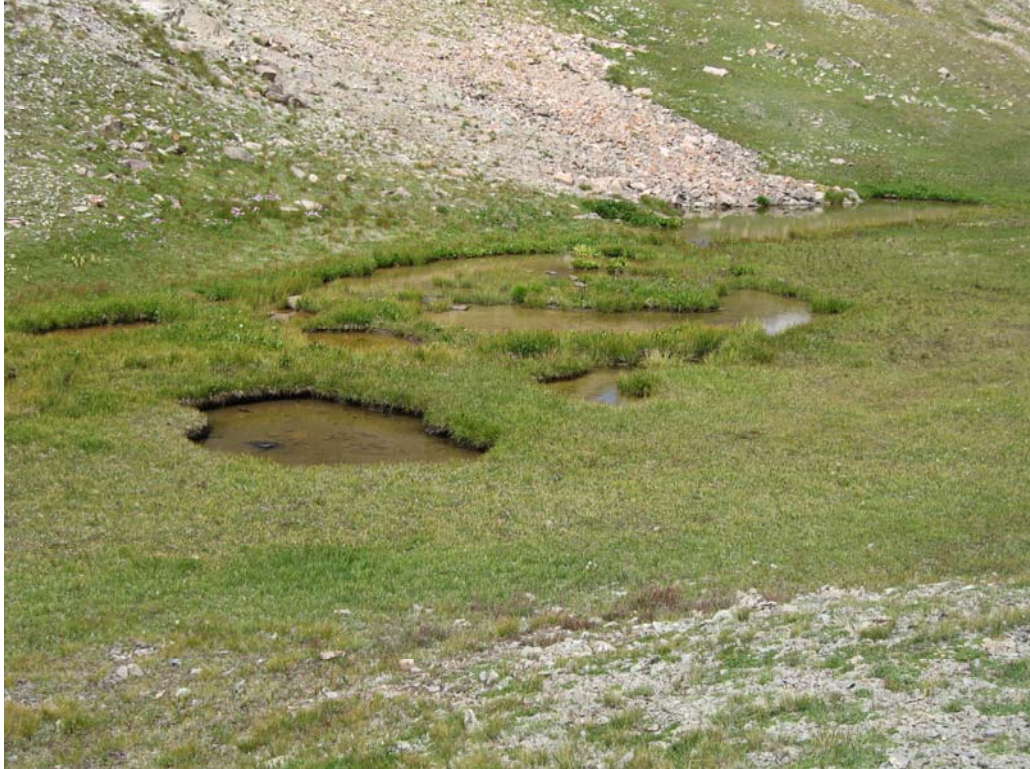
**Powderhorn Lakes
Standard Checklist
Proper Functioning Condition**

Potential (ecological status that can be attained without above limiting factors or without limiting factors what is the ultimate goal for assessment area) Wetland is functioning at its potential natural community with no disturbances contributing to unacceptable conditions in the area. Hydrology is stable and wetland vegetation is vigorous.

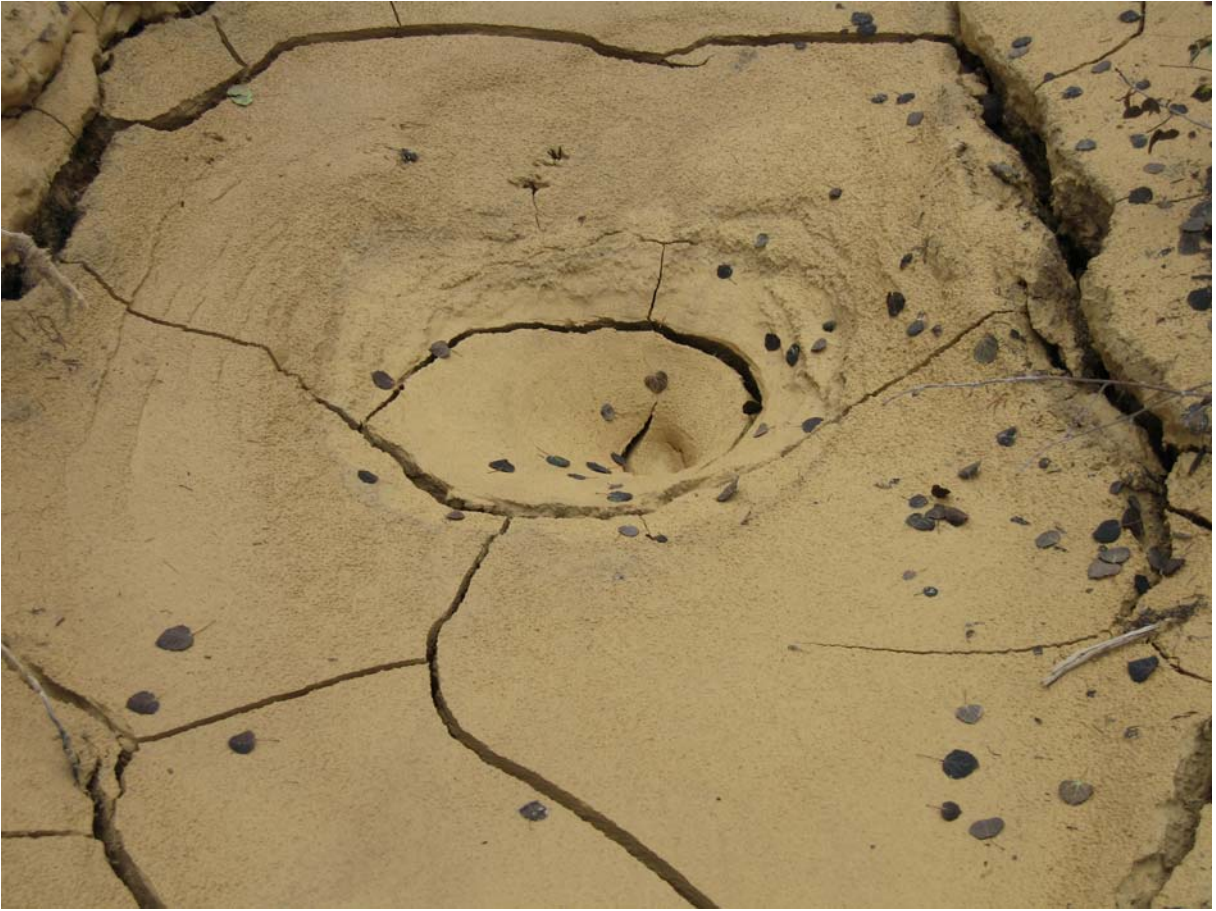
**Red Mountain Seeps
Standard Checklist
Proper Functioning Condition**

Potential (ecological status that can be attained without above limiting factors or without limiting factors what is the ultimate goal for assessment area) Seep indicated by BLM not a functioning wetland. There is no consistent hydrologic regime present and no stable vegetation. Soils are highly erodible with little structure to support wetland vegetation.

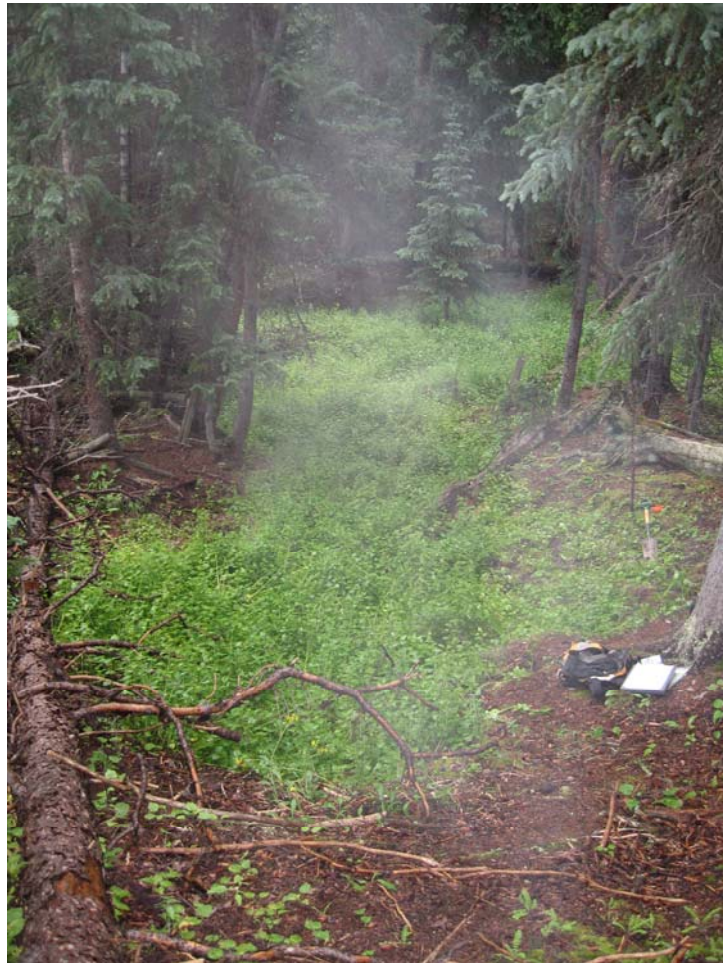
Red Mountain Seeps Standard Checklist Functional – At Risk

Potential (ecological status that can be attained without above limiting factors or without limiting factors what is the ultimate goal for assessment area) Site is functioning at its potential natural community with little disturbance in the immediate area. There are no factors currently limiting the area's potential or causing unacceptable conditions. Off highway vehicle use, old trail/road, and past mining activity in the area may alter site hydrology or alter species composition, but do not appear to be impacting the site at present.

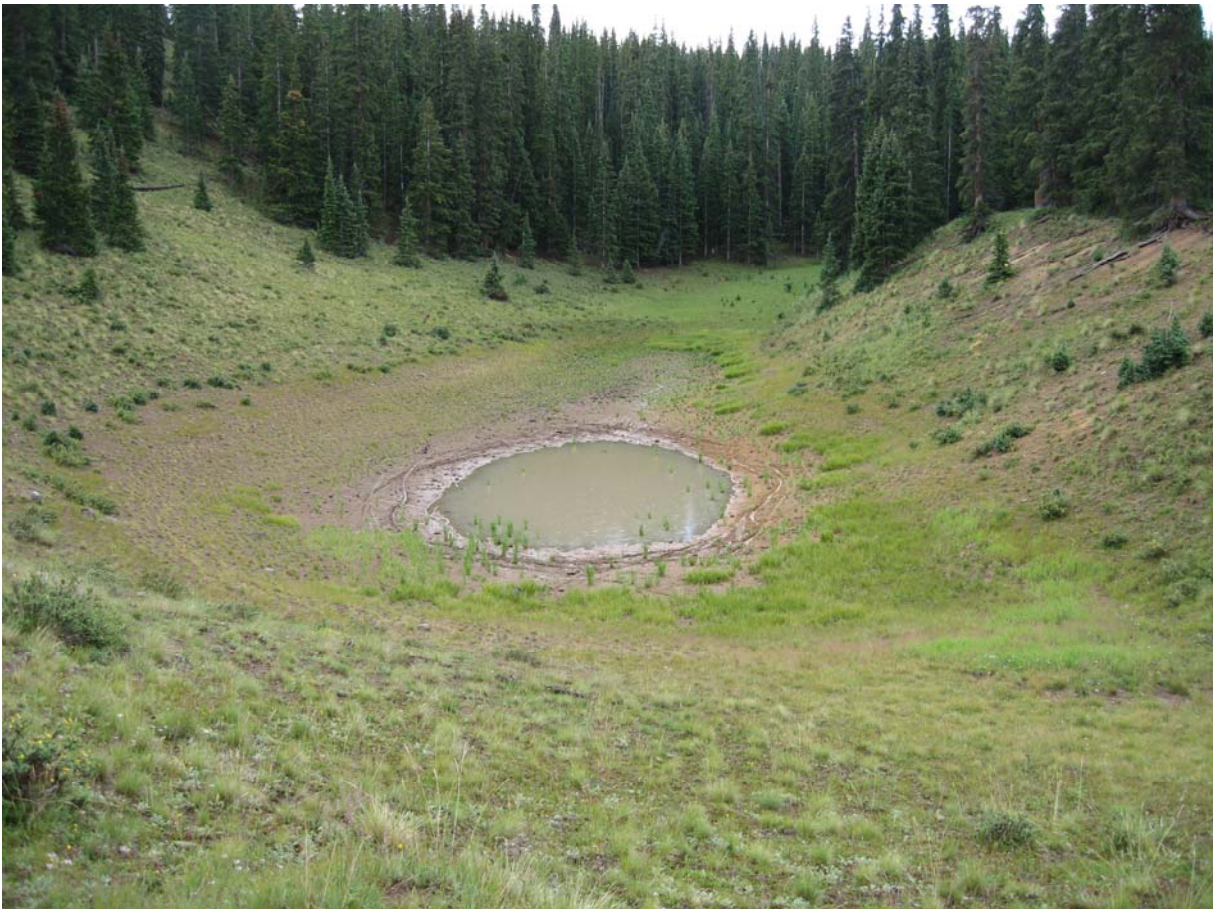
**Red Mountain Seeps
Standard Checklist
Proper Functioning Condition**

Potential (ecological status that can be attained without above limiting factors or without limiting factors what is the ultimate goal for assessment area) Wetland is not functioning at its potential natural community due to impacts from recreational use and drying. Drying does not appear to be from anthropogenic disturbances. Restriction of OHV use in the area may help wetland species become more vigorous and revegetate shores around the pond.

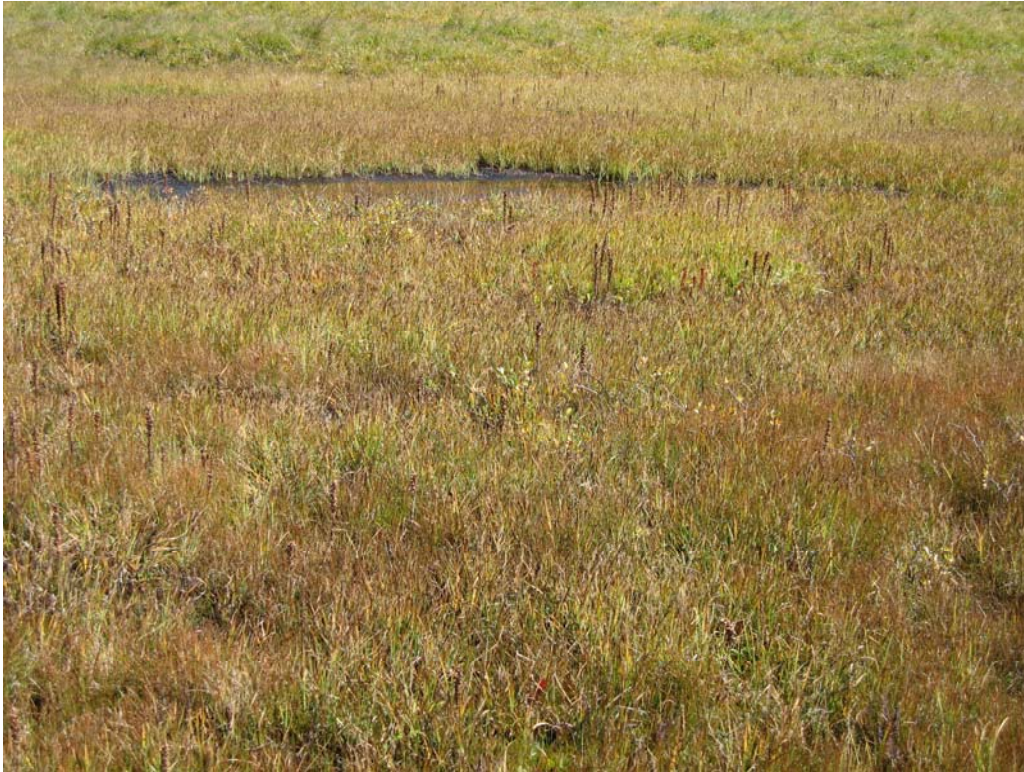
Devils Lake Seeps Standard Checklist Nonfunctional

Potential (ecological status that can be attained without above limiting factors or without limiting factors what is the ultimate goal for assessment area) Wetland is functioning at its potential natural community with little anthropogenic disturbance in the area an no disturbances leading to unacceptable conditions.

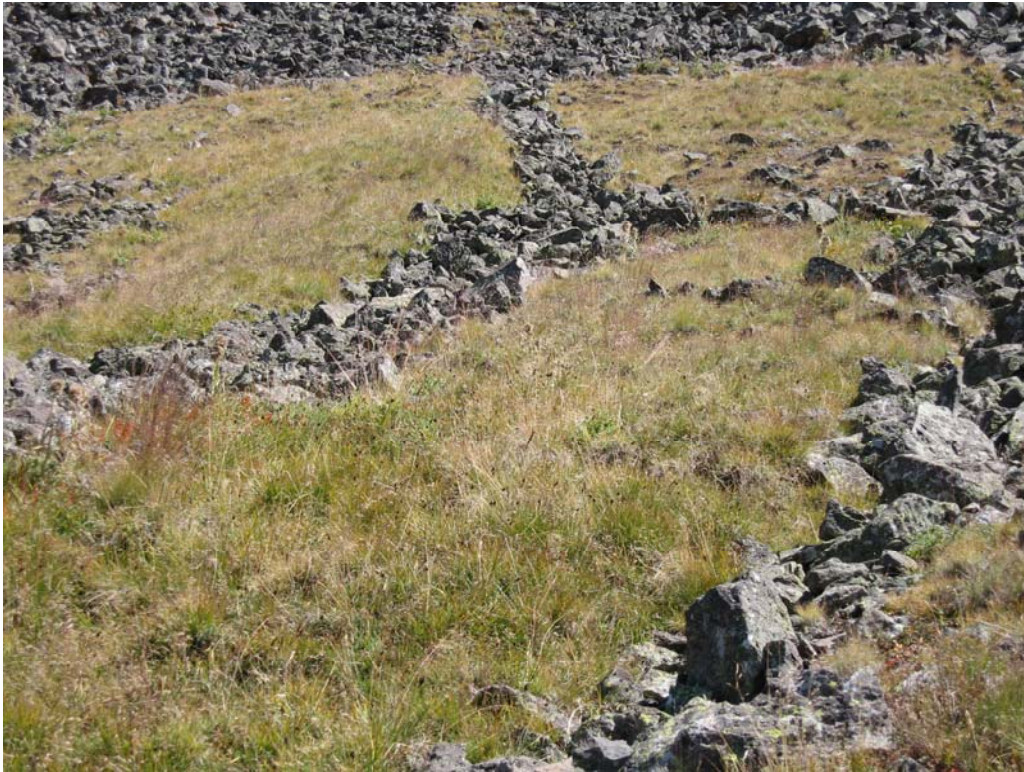
**Devils Lake Seeps
Lentic Standard Checklist
Proper Functioning Condition**

Potential (ecological status that can be attained without above limiting factors or without limiting factors what is the ultimate goal for assessment area) Site indicated by BLM seeps and springs map is not a functioning wetland. The area has few distinctive wetland species, no wetland soils, and likely only short, seasonally wet conditions.

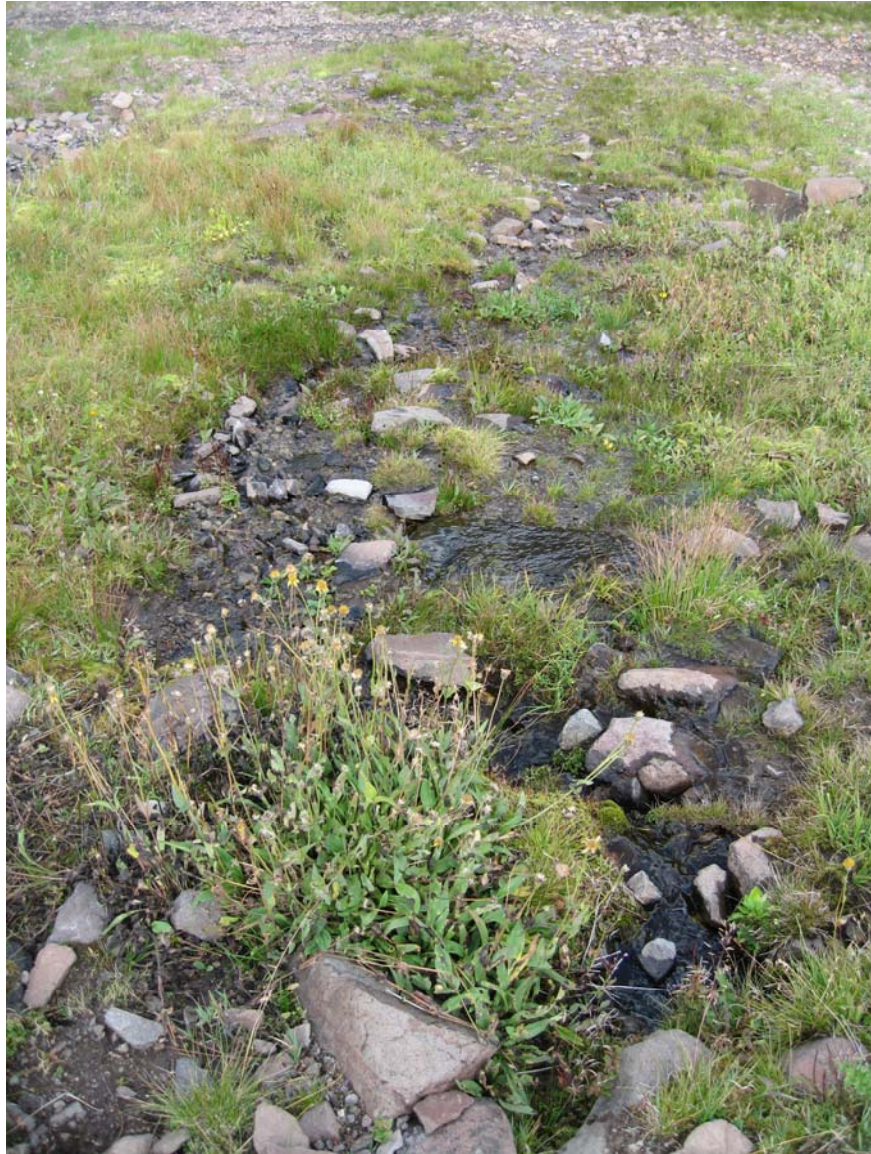
**North Fork of Henson Creek
Standard Checklist
Non-Functional**

Potential (ecological status that can be attained without above limiting factors or without limiting factors what is the ultimate goal for assessment area) Wetland is functioning at its potential natural community with no disturbances causing unacceptable conditions and few disturbances in the area.

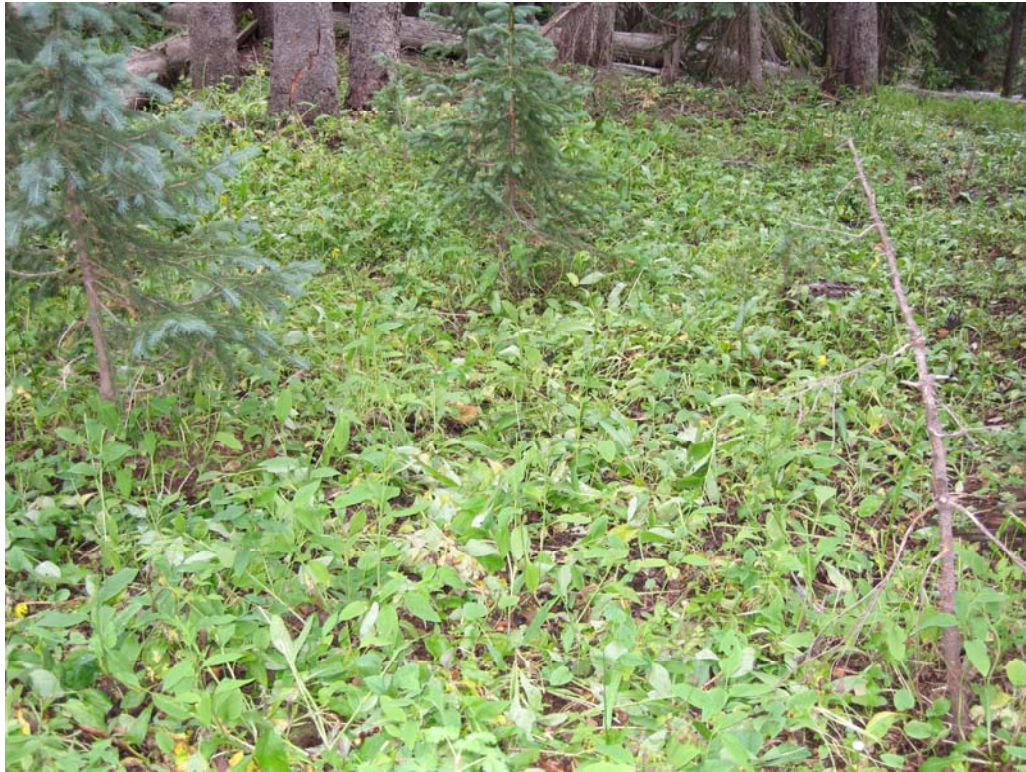
**North Fork of Henson Creek
Standard Checklist
Proper Functioning Condition**

Potential (ecological status that can be attained without above limiting factors or without limiting factors what is the ultimate goal for assessment area) Site is not a functioning wetland with few wetland obligate species, no consistent hydrologic source, and no evidence of recent or recurring inundation.

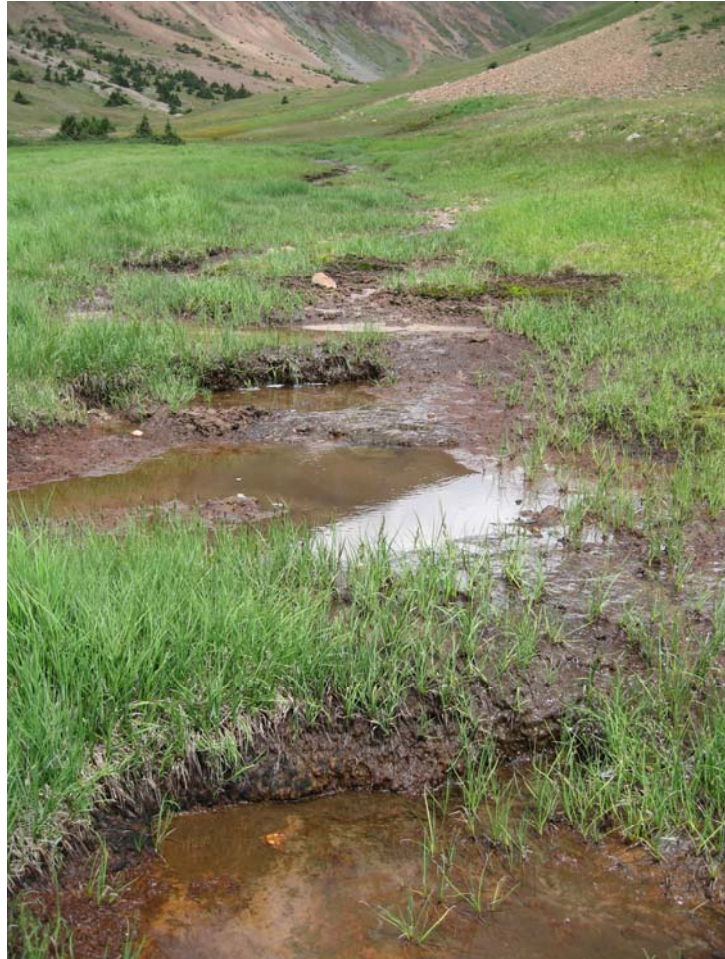
**Upper Snare Creek
Standard Checklist
Proper Functioning Condition**

Potential (ecological status that can be attained without above limiting factors or without limiting factors what is the ultimate goal for assessment area) Site is functioning just below its potential natural community due to bare patches and extensive sloughing of peat in some areas. The causes of sloughing are not evident and may be caused by natural actions such as surface flows, wildlife use, or hydrologic heave. There are few anthropogenic disturbances in the area. Past mining in the watershed may impact site hydrology and water quality, but does not appear to be impacting the site at present.
