**Report No. CDOT-DTD-R-2006-2
Final Report**

**FLOWFILL AND MSE BRIDGE APPROACHES:
PERFORMANCE, COST, AND RECOMMENDATIONS
FOR IMPROVEMENTS**

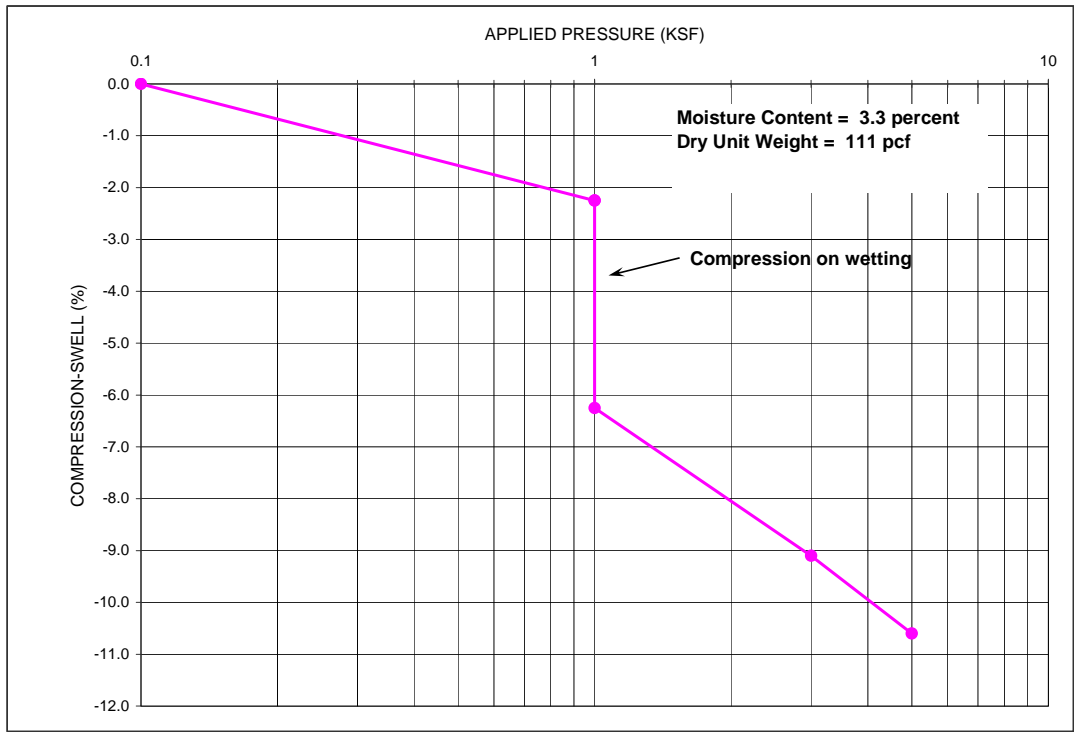
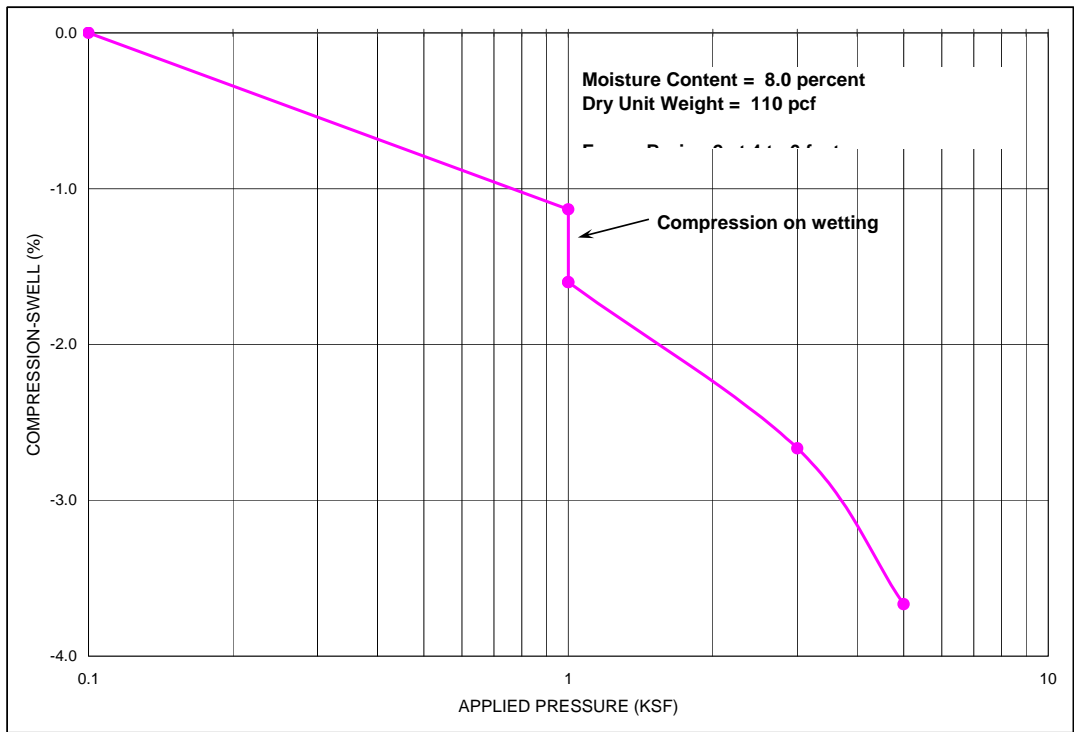
Figure 5.7. Influence of Wetting on a Remolded Soil Sample of Loosely Compacted Class 1 Backfill (Salt Creek Bridge Approaches).

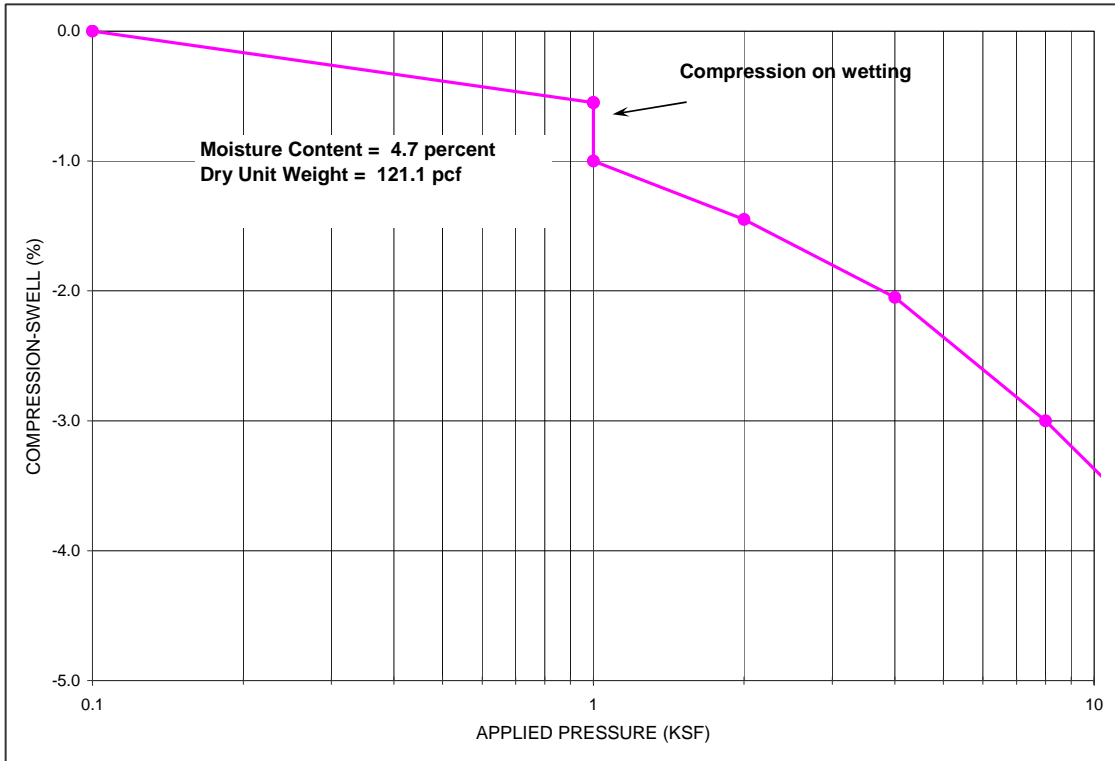
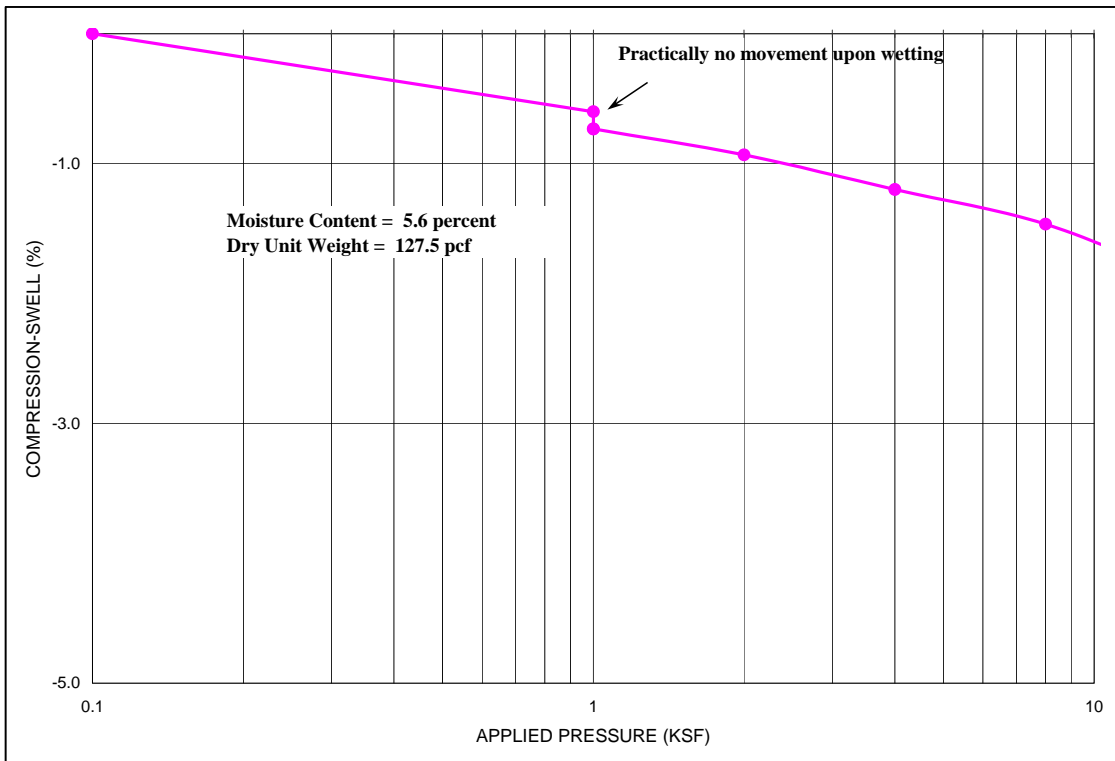
Figure 5.8. Influence of Wetting on a Remolded Soil Sample of Well-Compacted Class 1 Backfill (Salt Creek Bridge Approaches).

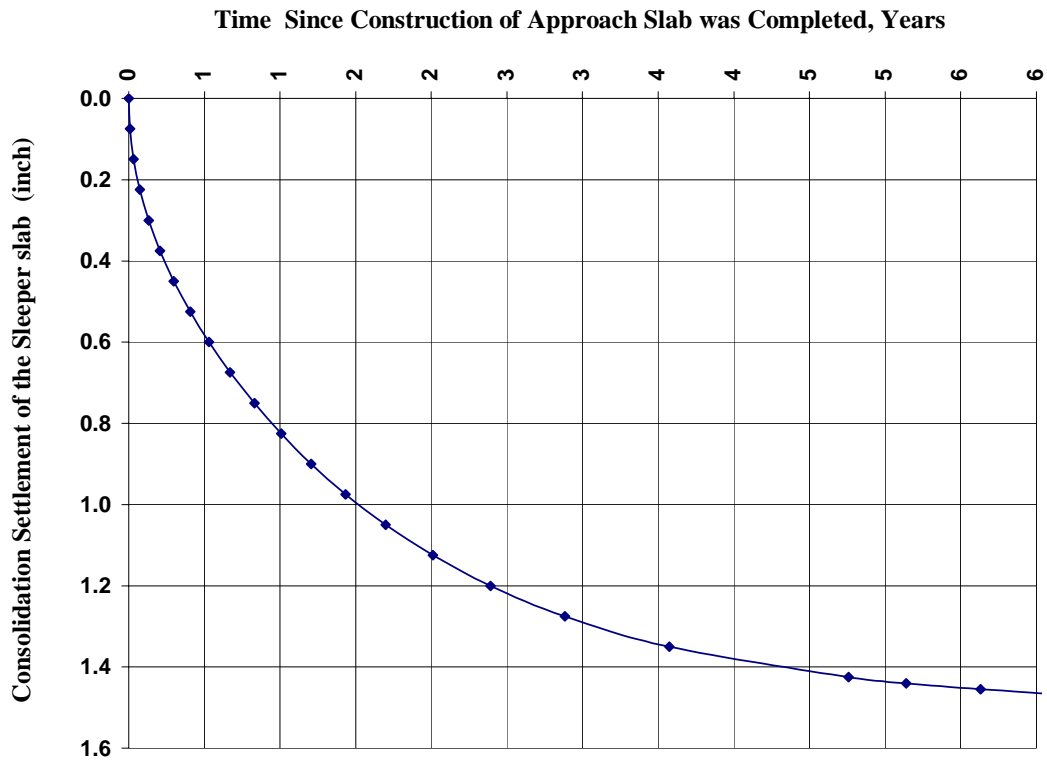
Figure 5.9. Predicted Settlements of the Sleeper Slab Due to Consolidation of the Foundation Clay Layer (Salt Creek Bridge Approaches).

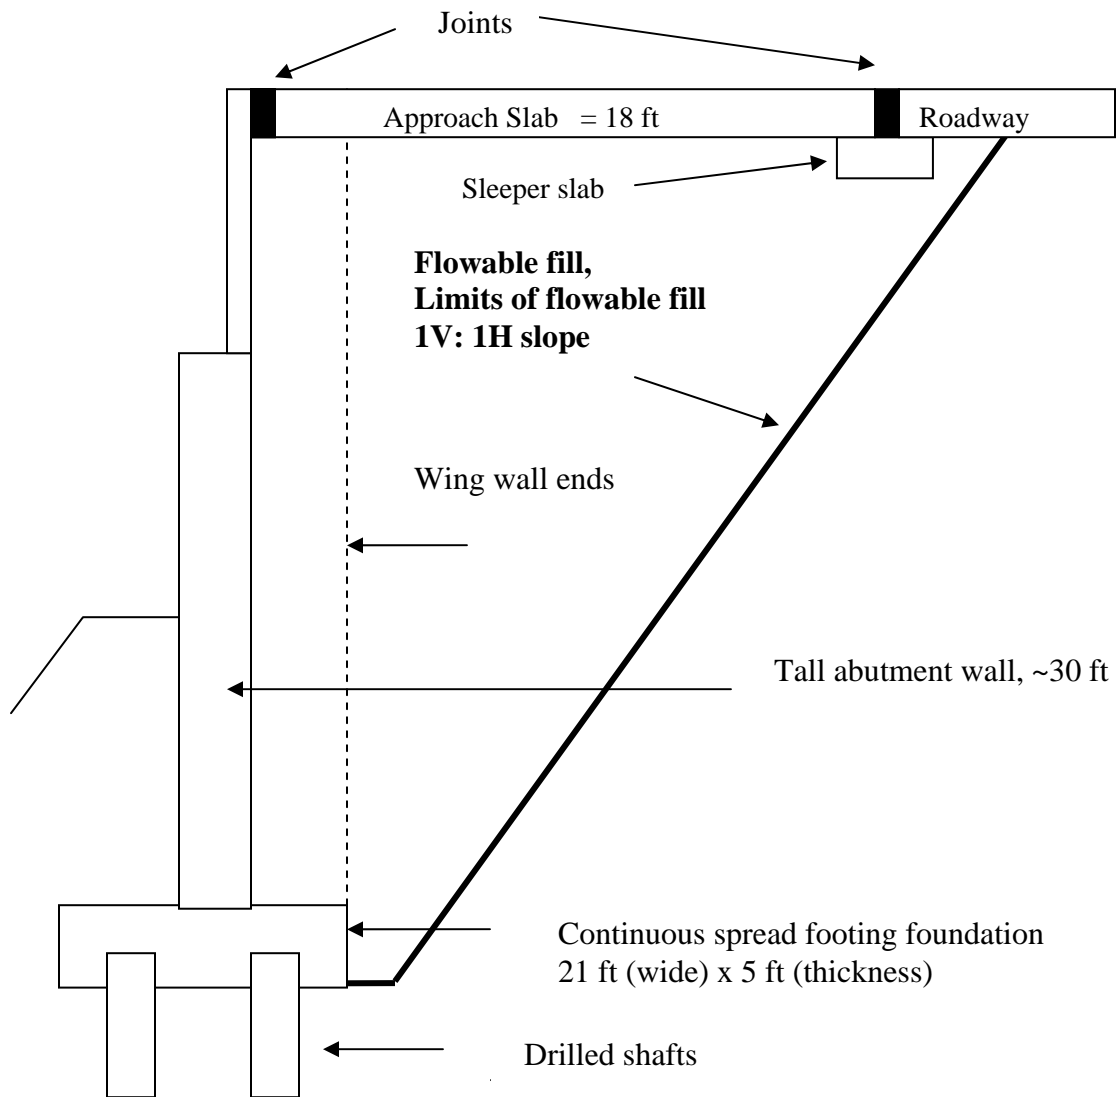
Figure 5.10. Details of the Eastern Abutment of the WB I-70 to SB I-225 Bridge.

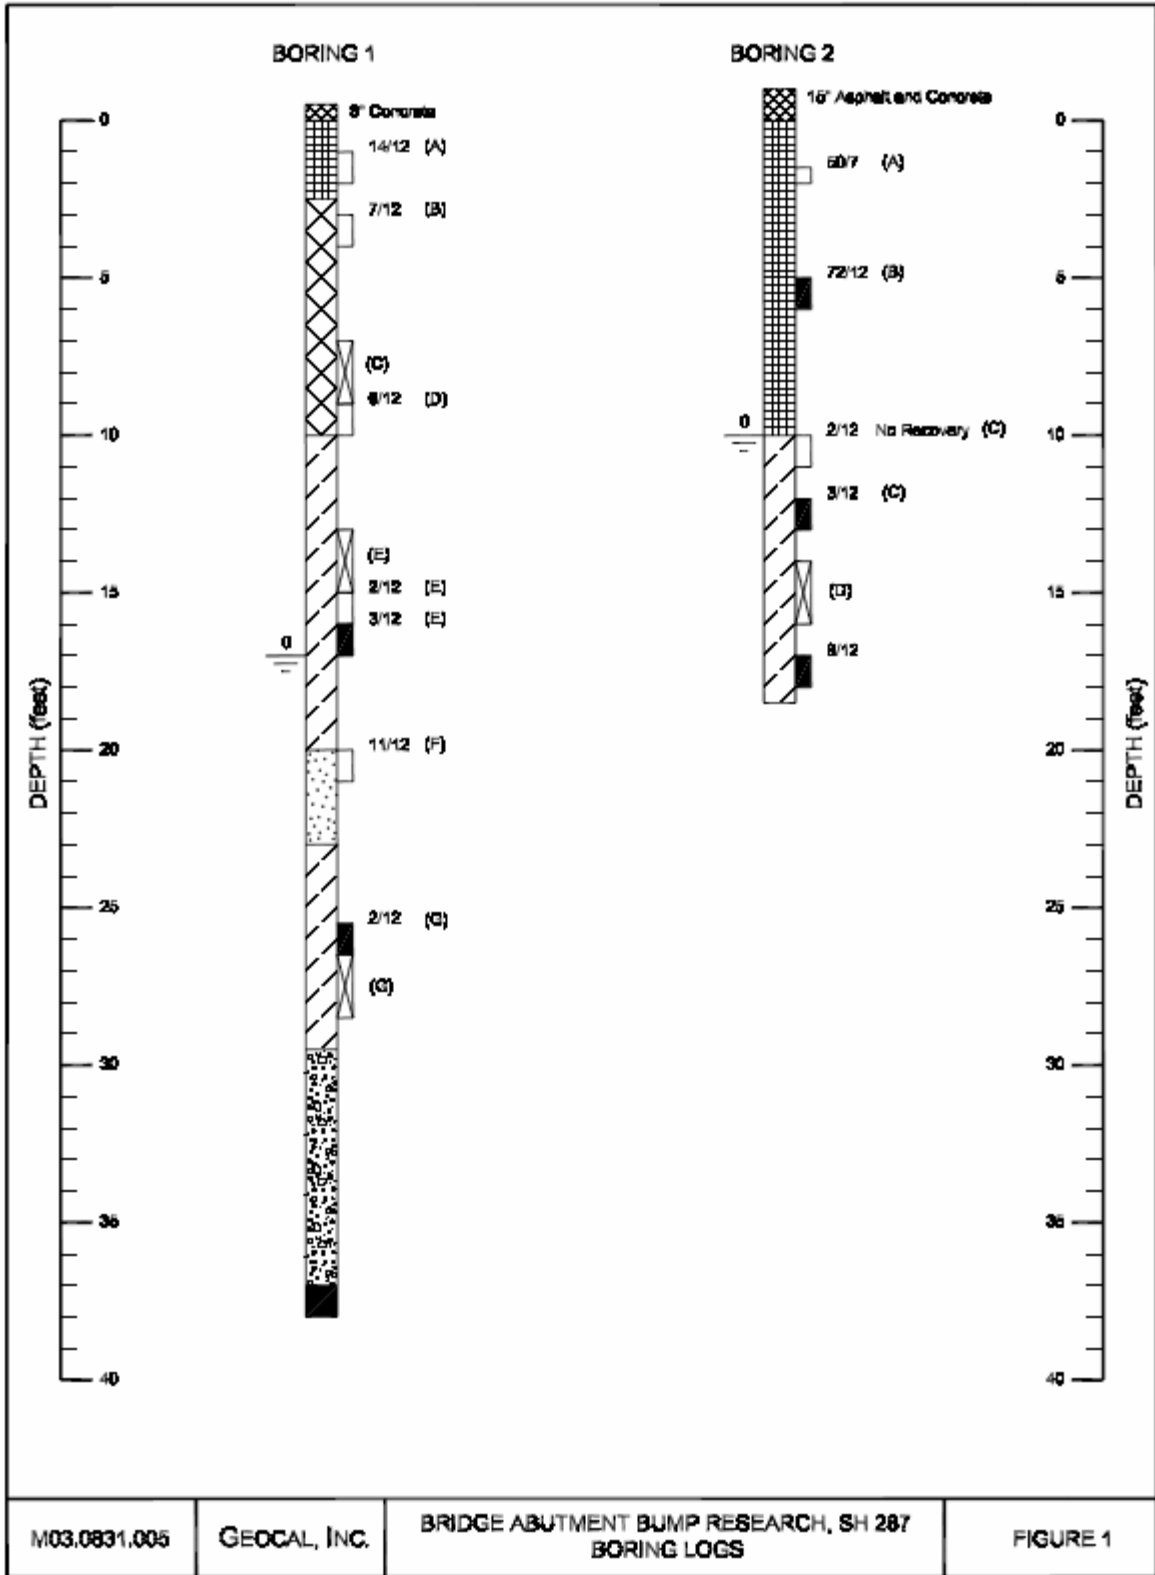
- Settlement of the sleeper slab is controlled by the embankment material and the foundation soil layers placed beneath the sleeper slab, not the abutment fill layer. This is because the abutment fill extends just 4 ft below the sleeper slab. If this 4 ft layer was Class 1 backfill it would be compacted and considered overconsolidated with relatively high stiffness value, not much less than the stiffness of the flowfill. To reduce the potential for approach settlements, more of the high quality abutment fill should be placed around and below the sleeper slab.*

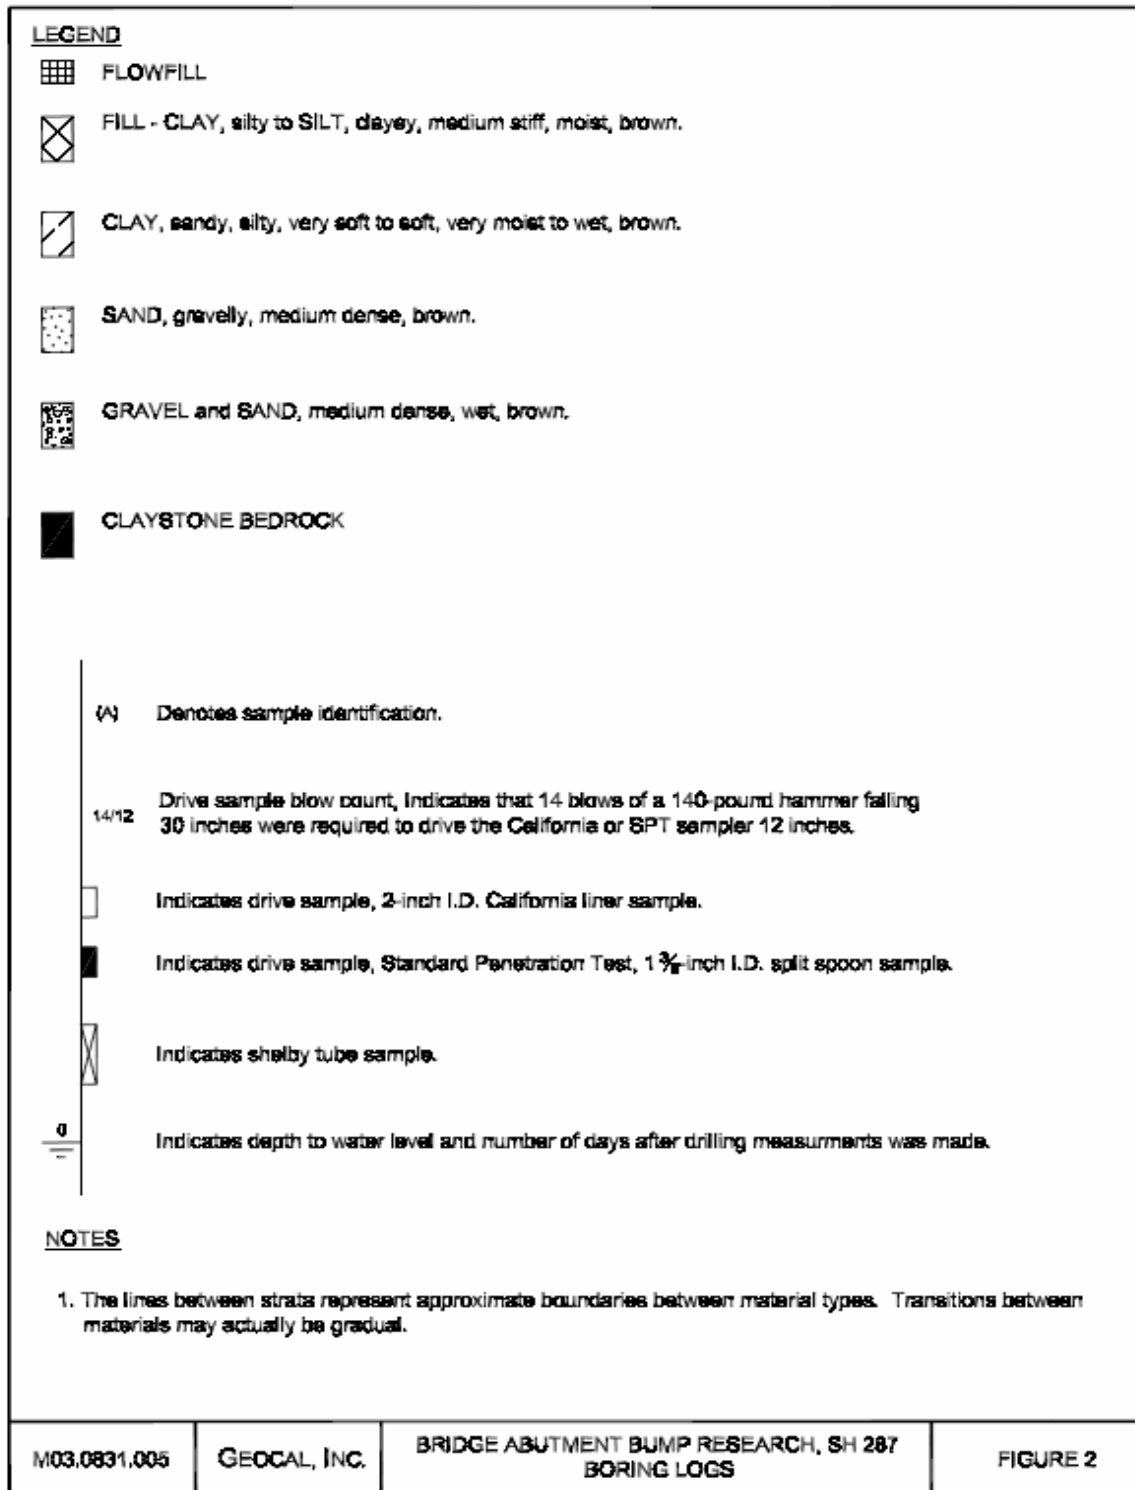
Figure 5.15. Boring Log for the SH 287 Structure

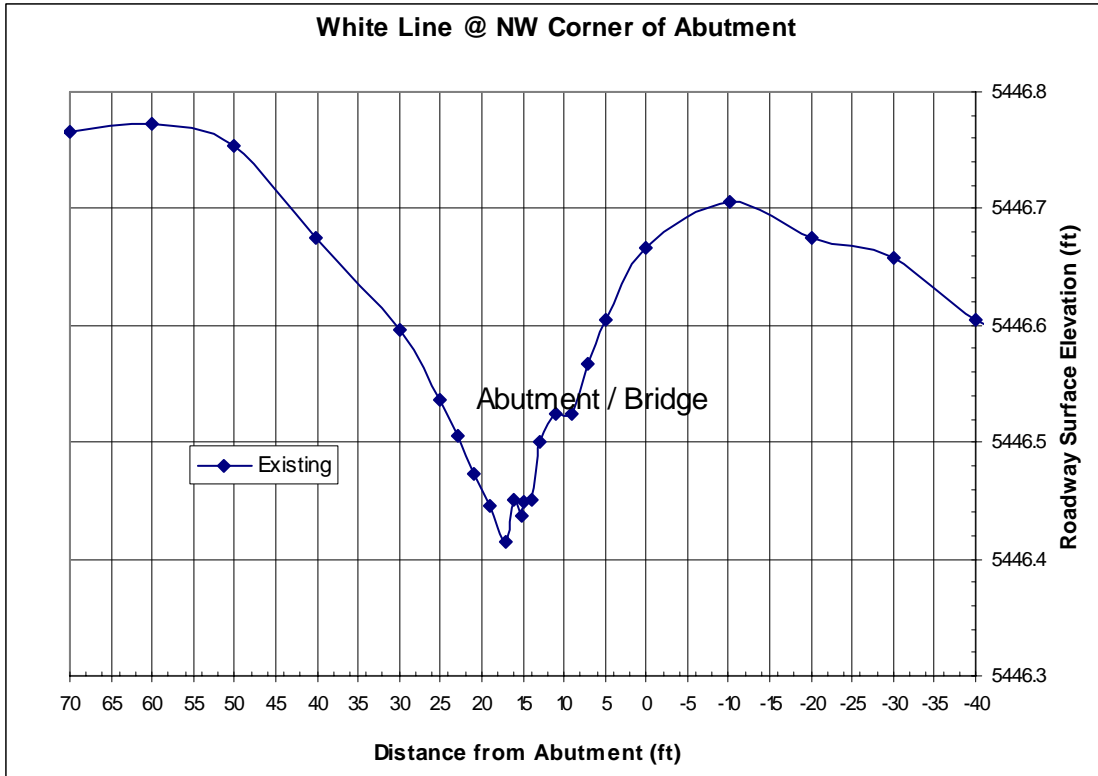
Figure 5.17. Elevation Profile of the Approaches of Structure E-19-Z Before It Was Repaired.

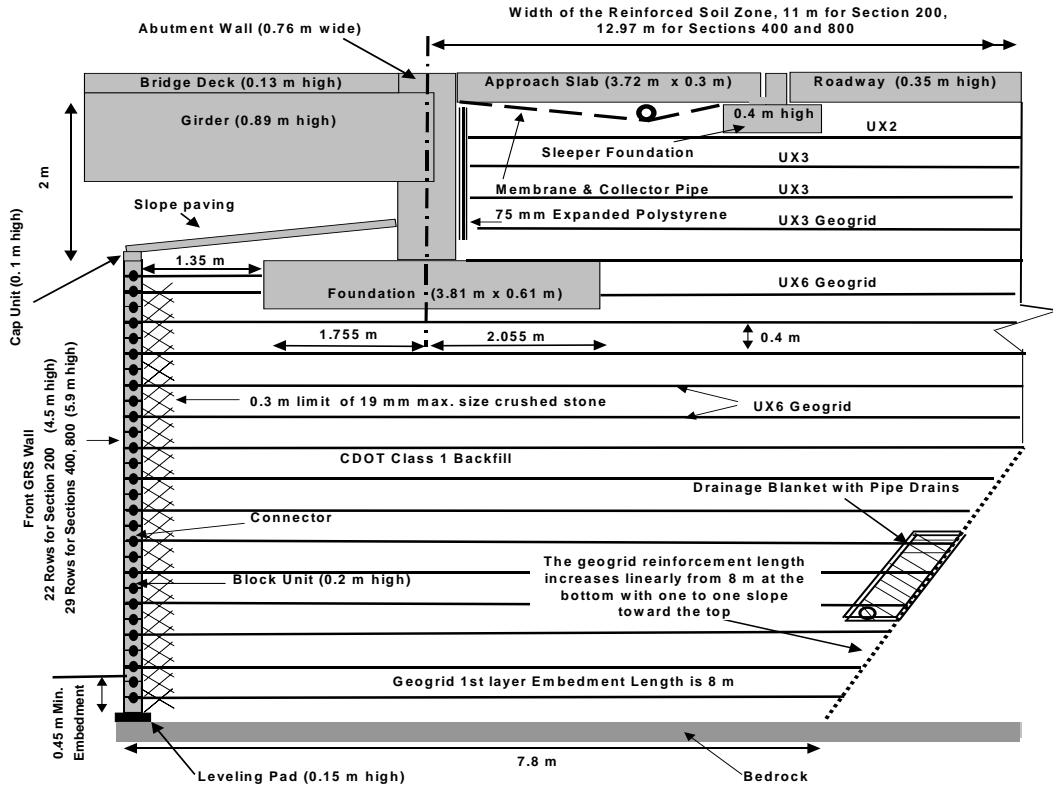
Figure 6.1. Typical Section through Front and Abutment GRS Walls of the Founders/Meadows Bridge Structure.

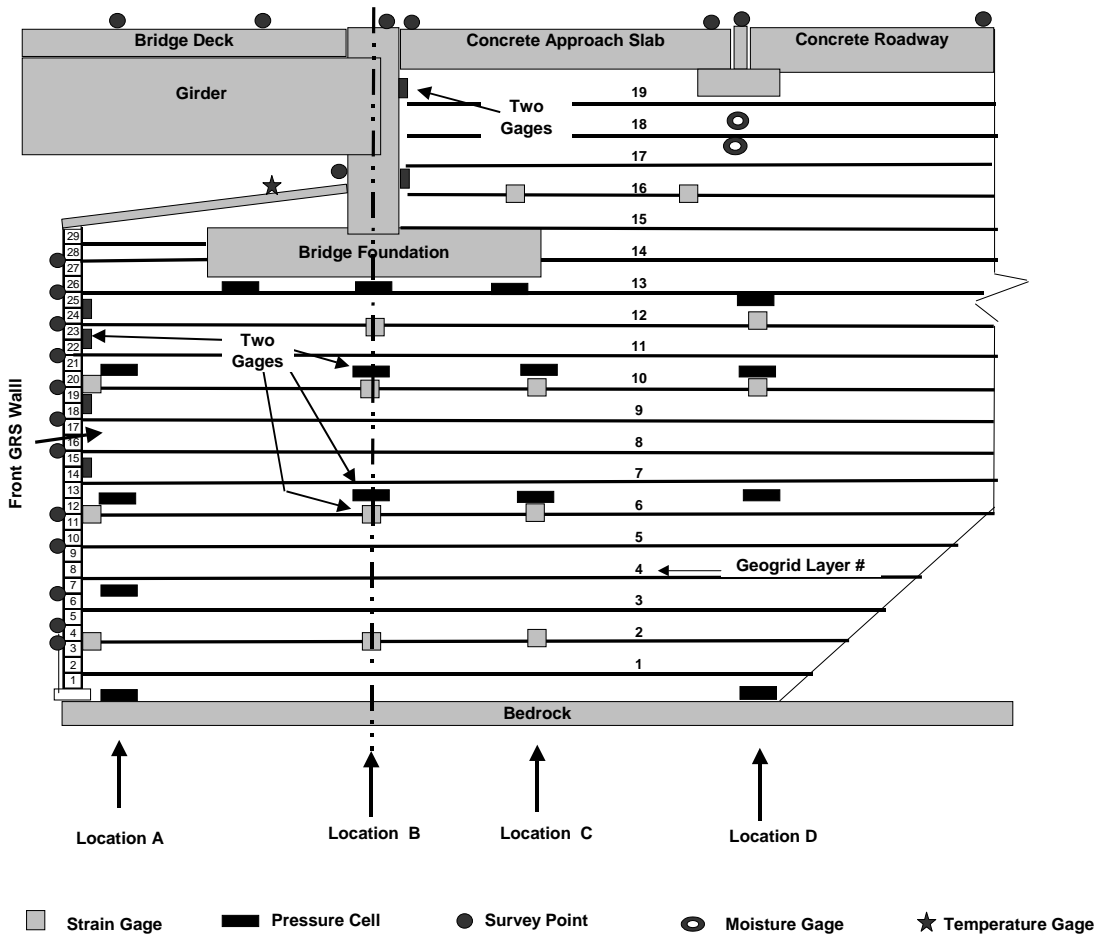
Figure 6.2. Instrumentation Layout of Section 800 of the Founders/Meadows Bridge Approaches.

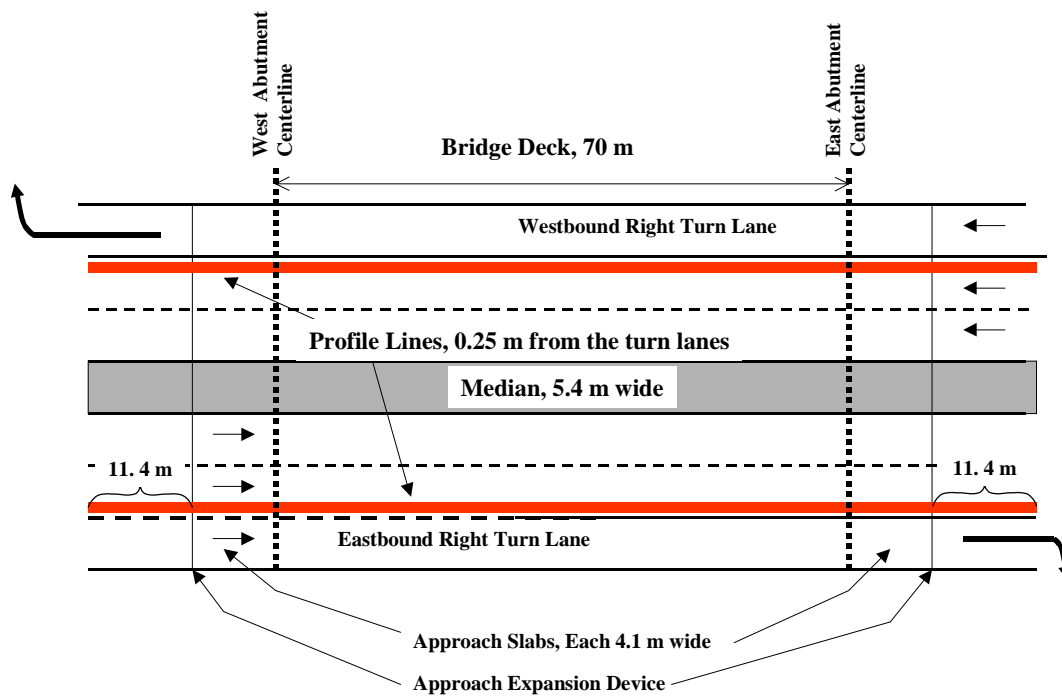
Figure 6.3: Locations of the Profiles Lines in the Founders/Meadows Bridge Structure.

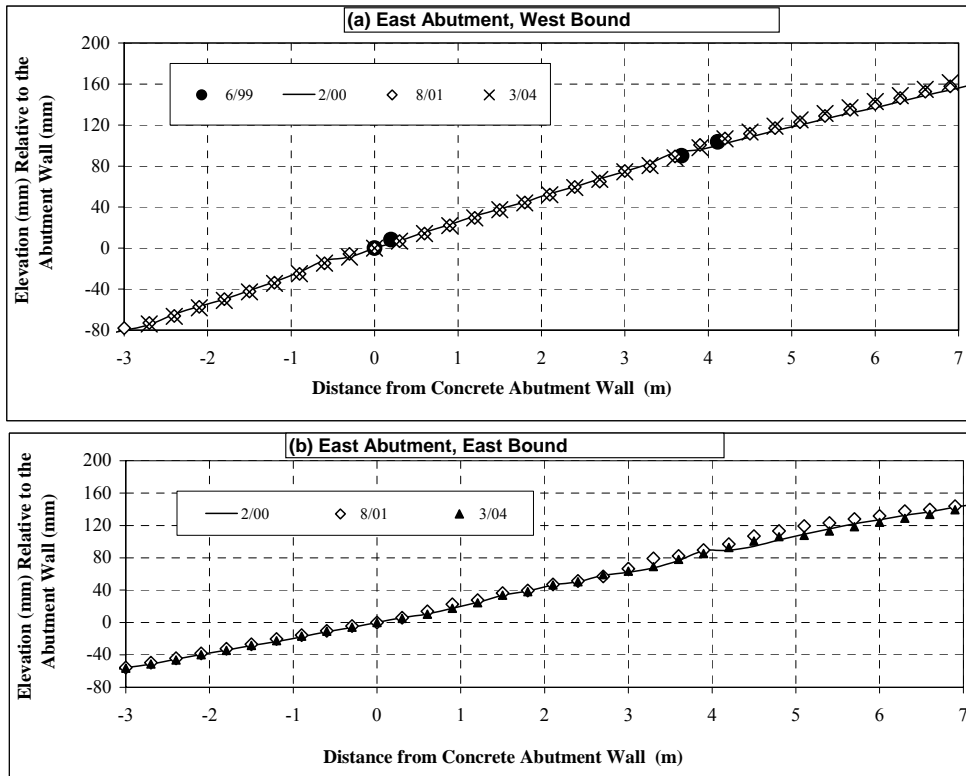
Figure 6.4: Measured Elevation Profiles Relative to the Bridge Abutment for Two Lines over the East Abutment along the Traffic Direction (Note: Distance from bridge abutment is + towards the approach slab and is - towards the bridge deck).

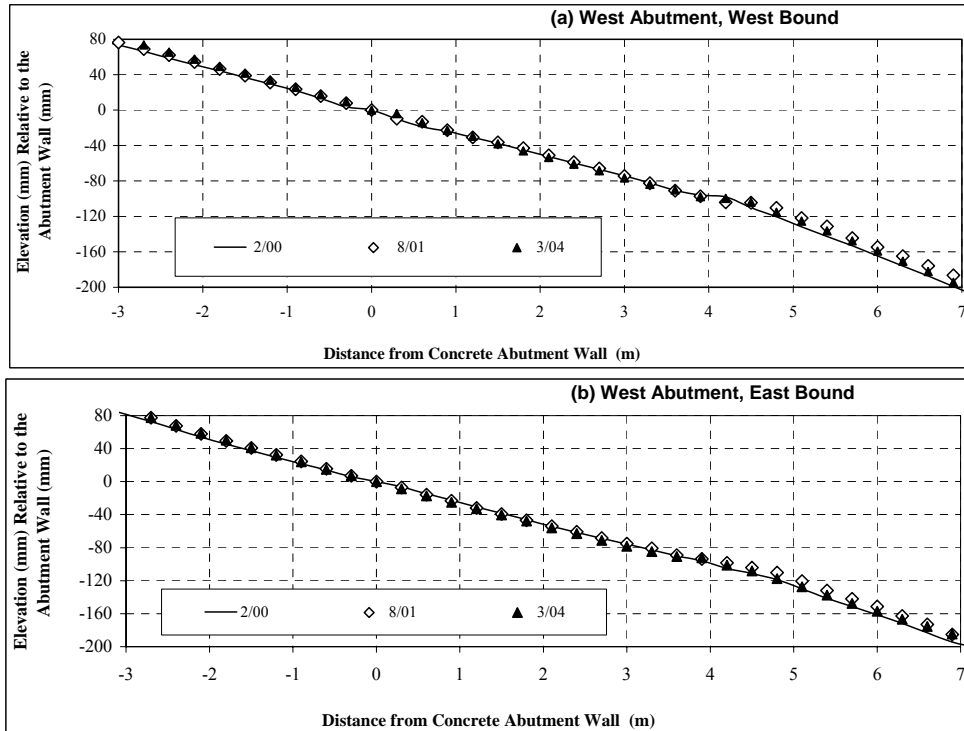
Figure 6.5: Measured Elevation Profiles Relative to the Bridge Abutment for Two Lines over the West Abutment along the Traffic Direction (Note: Distance from bridge abutment is + towards the approach slab and is - towards the bridge deck).

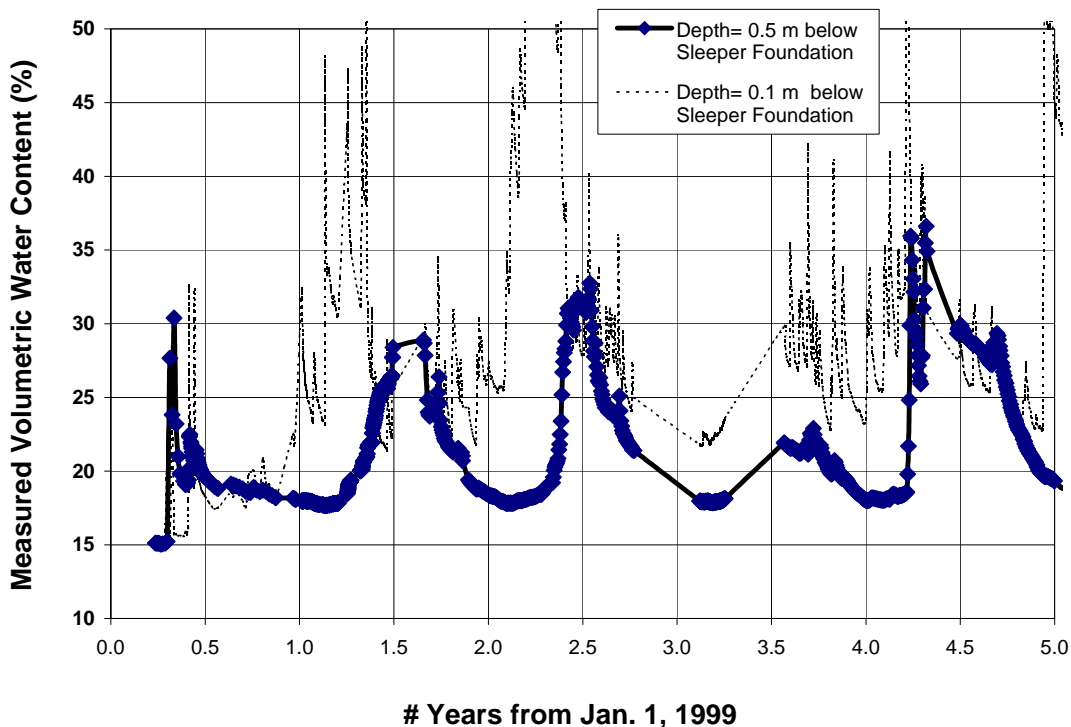
Figure 6.6. Measured Changes in Soil Moisture Before and After Placement of the Drainage Protection System.

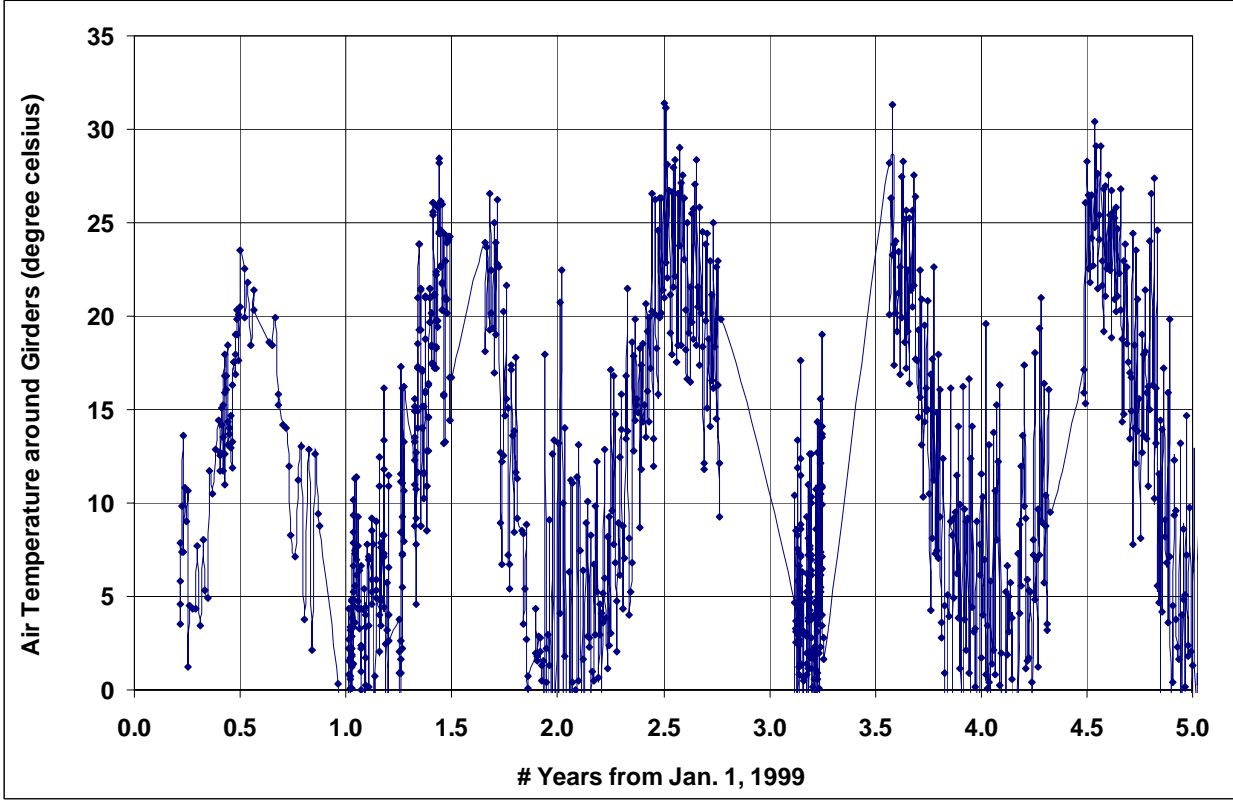
Figure 6.7. Measured Air Temperatures below Girders of the Founders/Meadows Structure.

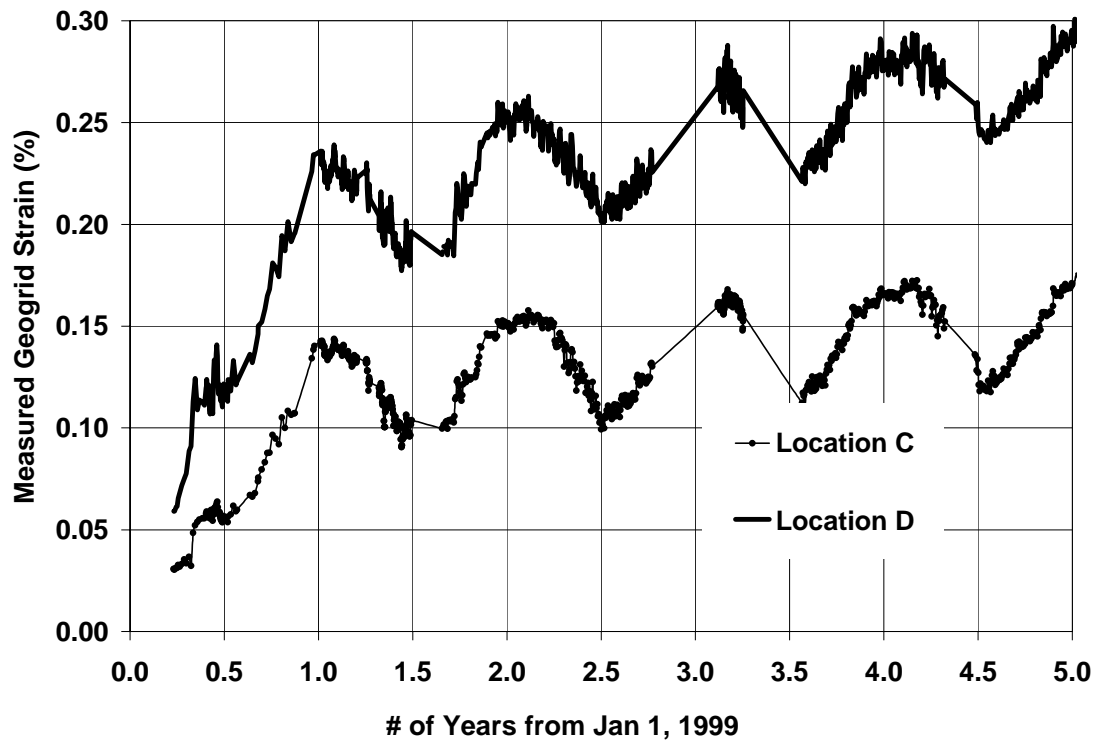
Figure 6.8. Measured Geogrid Tensile Strains at Various Times from Gages Placed in the MSE Abutment Backfill Behind the Abutment Wall as Shown in Figure 6.2 (Construction was completed 0.5 year from Jan. 1, 1999).

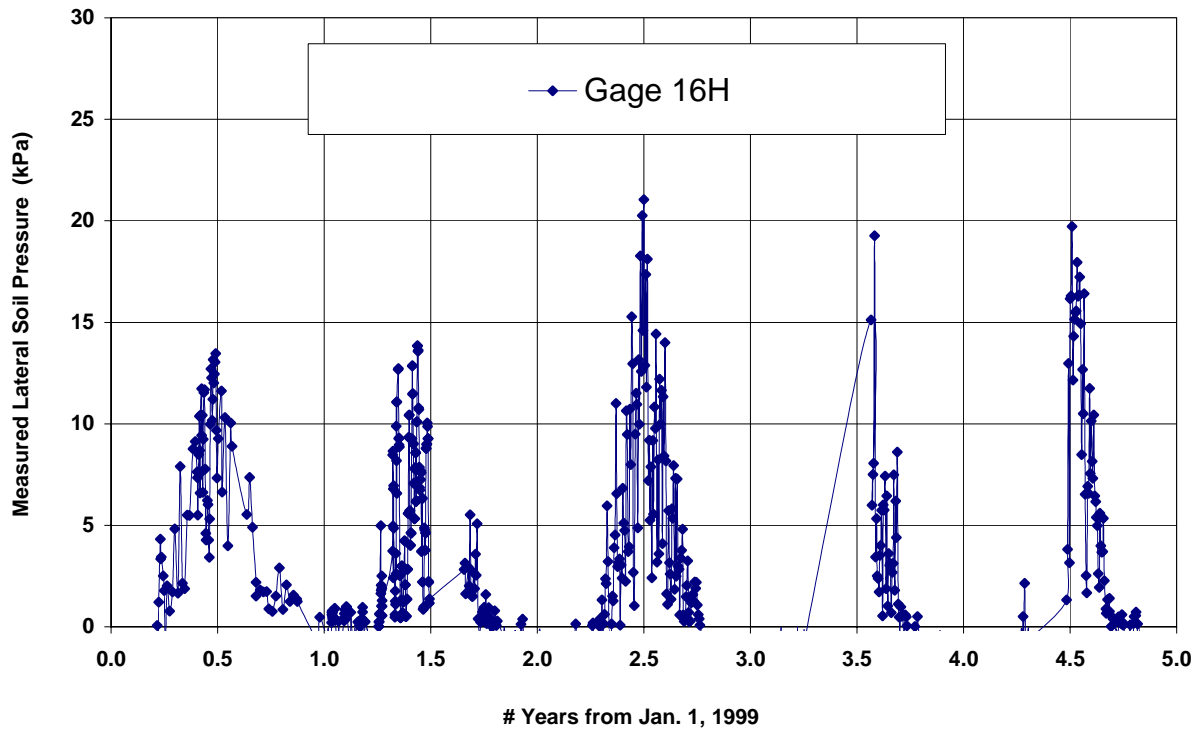
Figure 6.10. Measured Lateral Earth Pressure Against the Lower Portion of the Abutment Wall of the Founders/Meadows Bridge (see Figure 6.2) during Various Times.

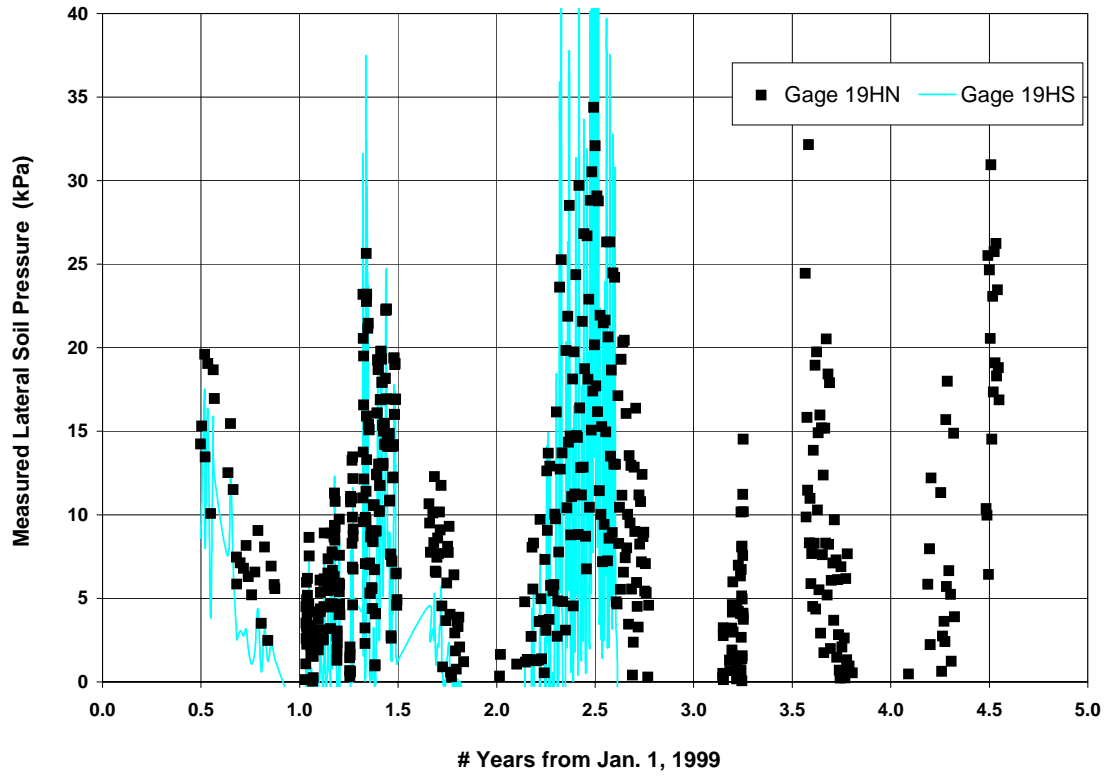
Figure 6.11. Measured Lateral Earth Pressure Against the Top Portion of the Abutment Wall of the Founders/Meadows Bridge (see Figure 6.2) during Various Times.

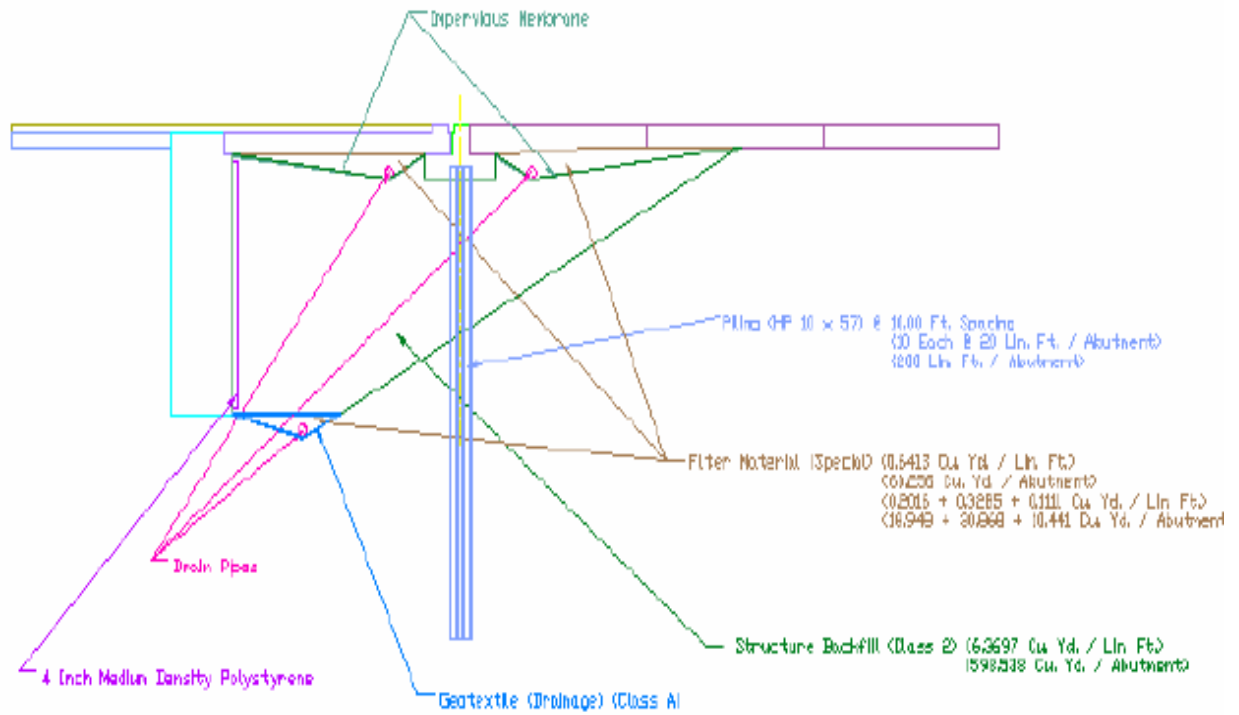
Figure 7.1. The Driven Pile System Proposed for the 120th Project Bridge Approaches.
