Colorado 1999 Flood Documentation Study

March 2001

prepared for the
Colorado Water Conservation Board

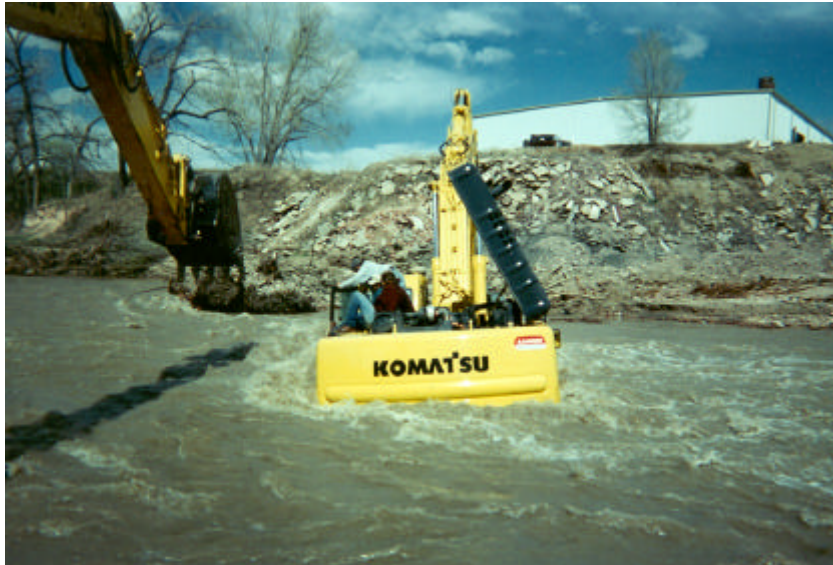
Emergency operations in Fountain Creek to repair 30-inch sanitary sewer break east of I-25 and north of Highway 85.

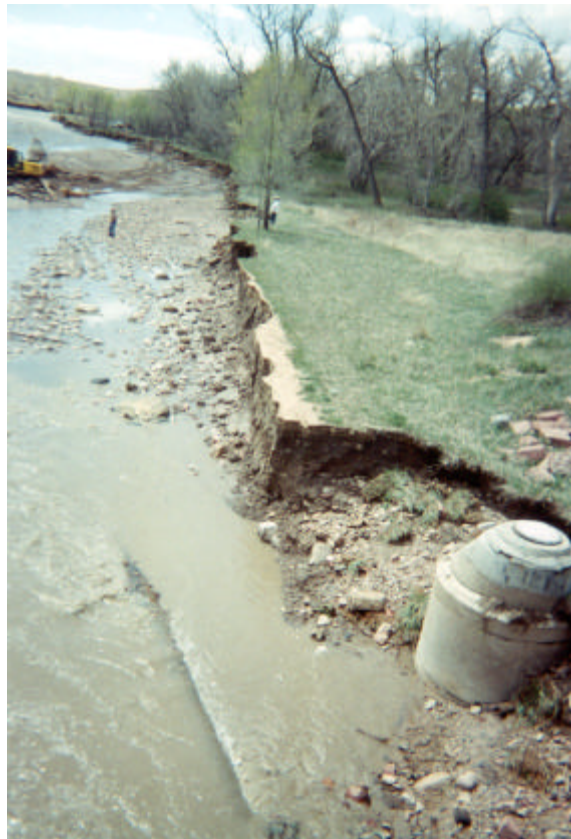
Erosion along Fountain Creek exposed 30-inch sanitary sewer force main and eventually ruptured the line.

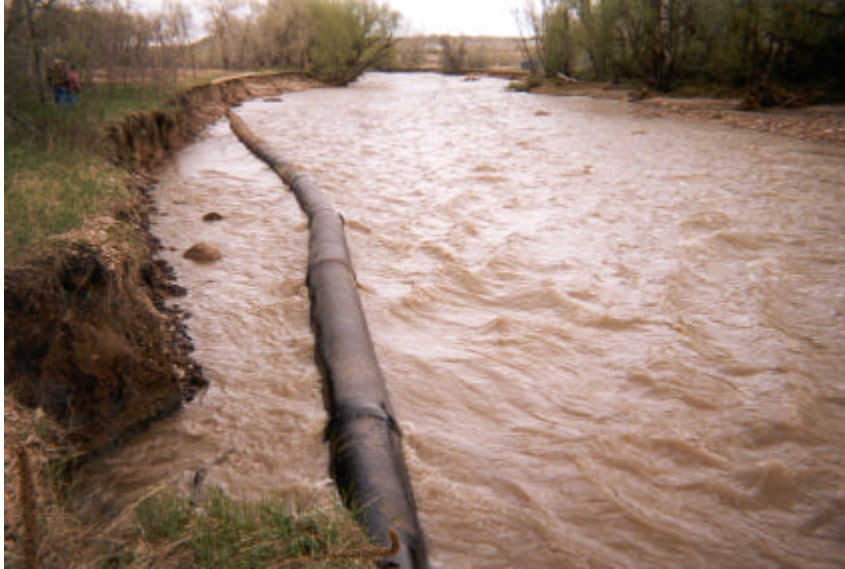
Erosion along Fountain Creek exposed a 30-inch sanitary sewer south of Circle Drive but did not cause a break.

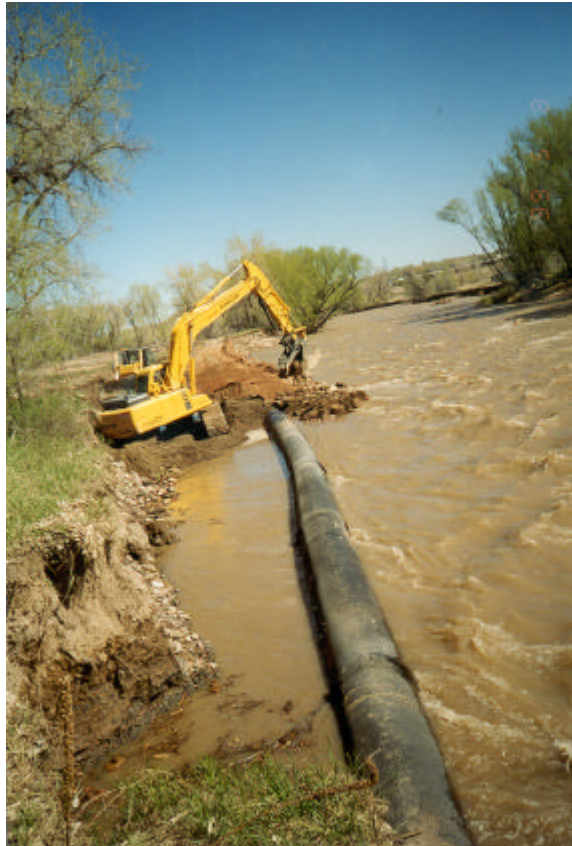
Emergency work to rebury the 30-inch sanitary sewer south of Circle Drive and stabilize the creek bank.

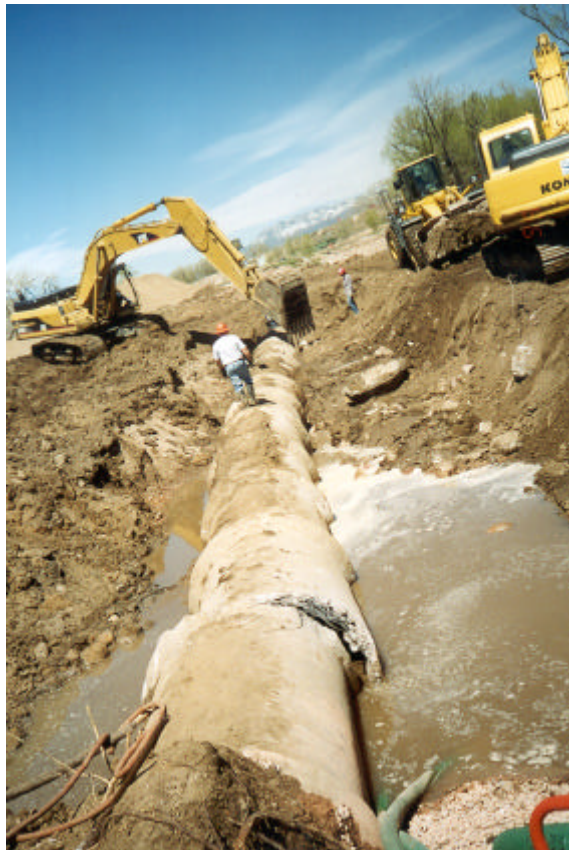
Ruptured 48-inch sanitary sewer interceptor along Fountain Creek.

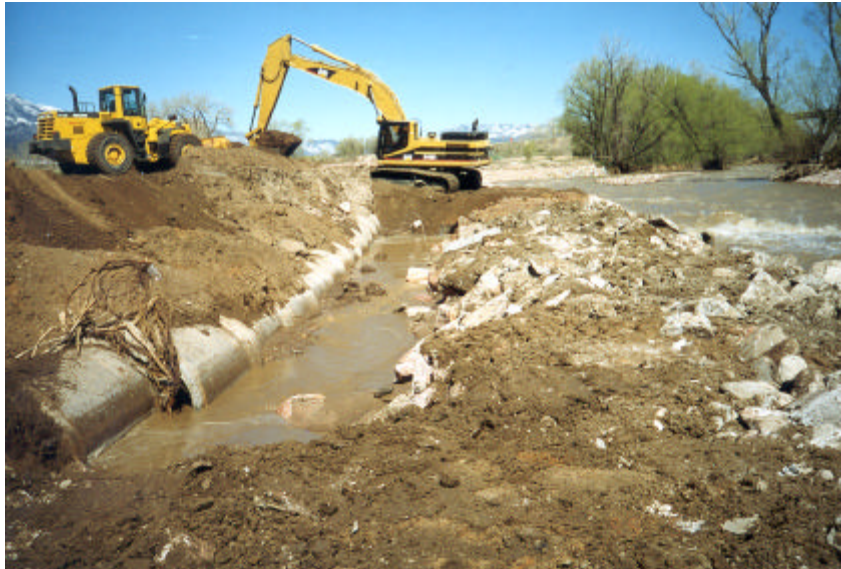
**Emergency work to repair the 48-inch interceptor and stabilize Fountain Creek bank.
Location is south of Circle Drive and east of Janatell Road.**

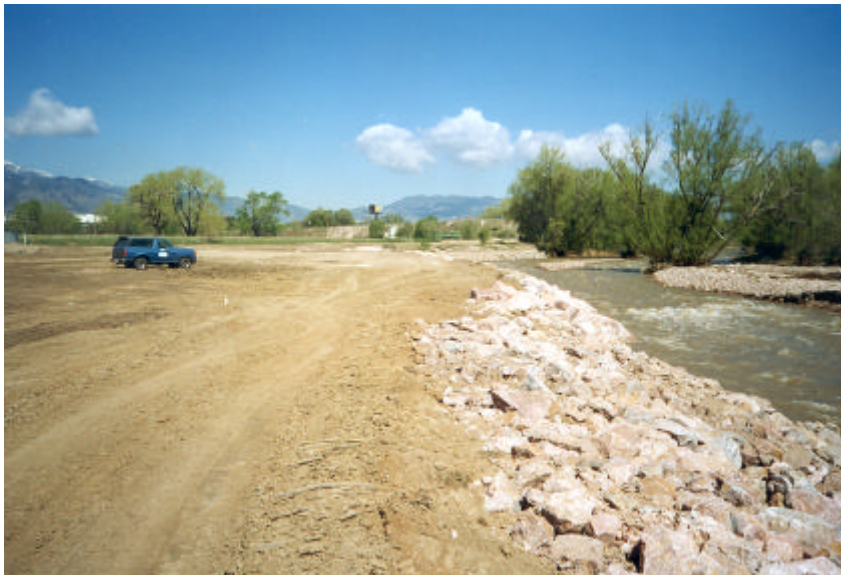
**Emergency work to repair 48-inch interceptor south of Circle Drive and east of Janatell
Road after completion.**

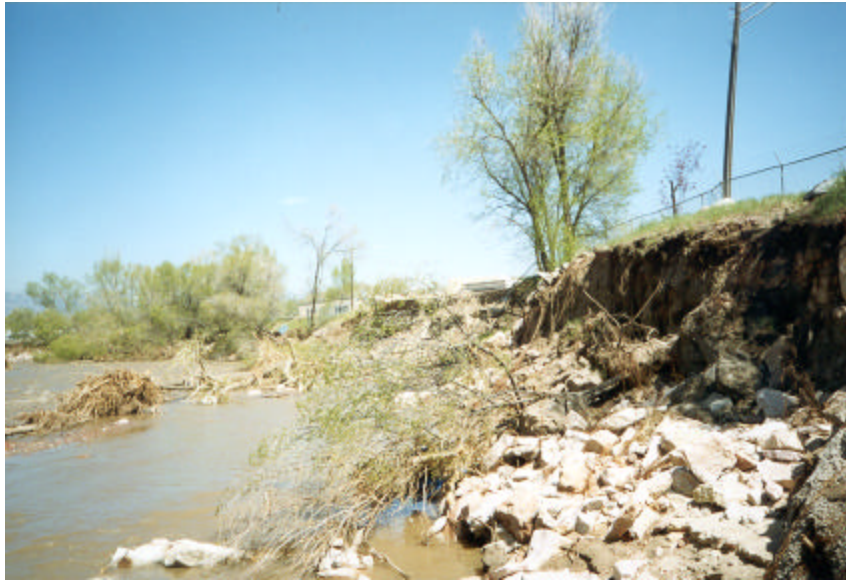
**Fountain Creek erosion adjacent to the Las Vegas Street
Wastewater Treatment Plant.**

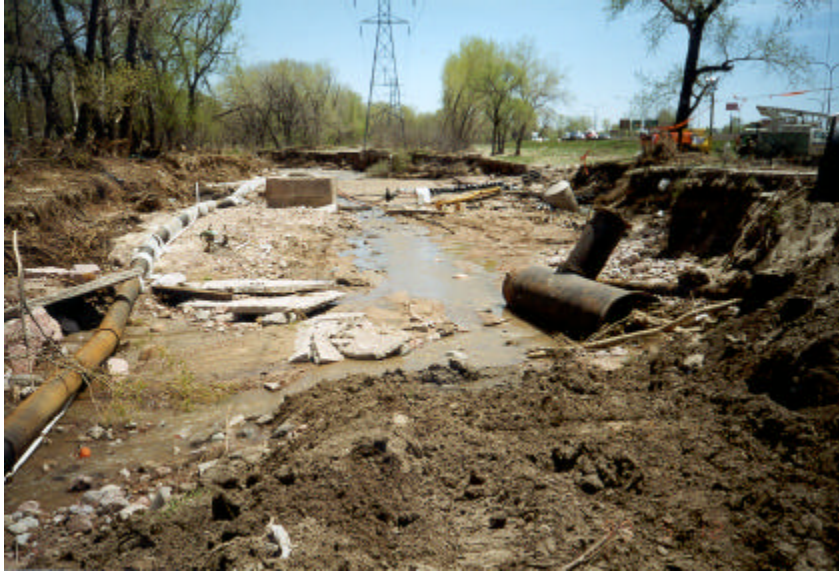
Erosion damage by Fountain Creek to 2,300 feet of 16-inch DIP non-potable water main between I-25/Nevada Street off ramp and Colorado Avenue.

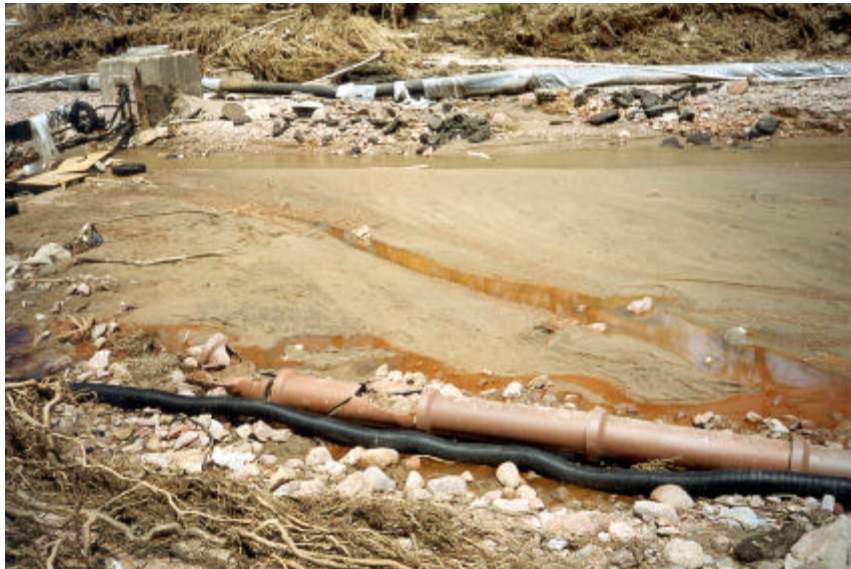
Damaged 16-inch non-potable water main in background and broken 12-inch sanitary sewer line in foreground. Area between I-25/Nevada Street off ramp and Colorado Avenue.

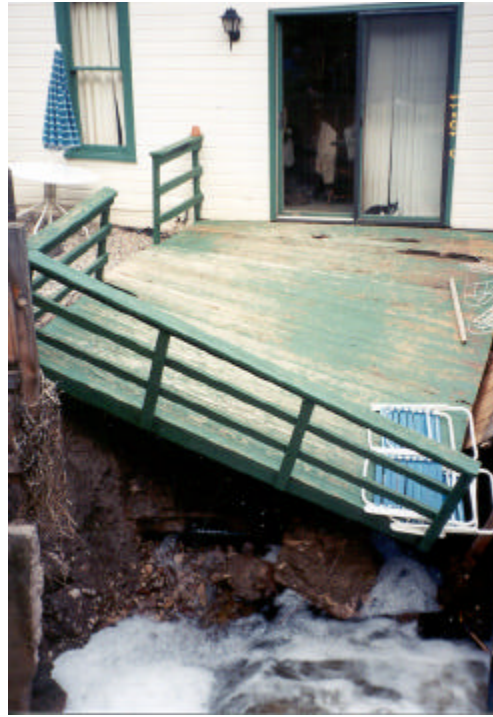
Deck lost to erosion along Williams Canyon in Manitou Springs.

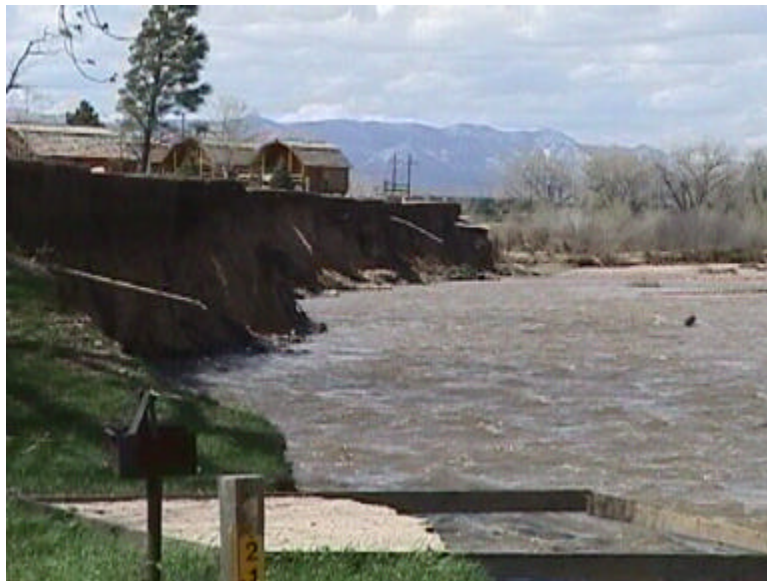
Damage to KOA campground along Fountain Creek south of Colorado Springs.

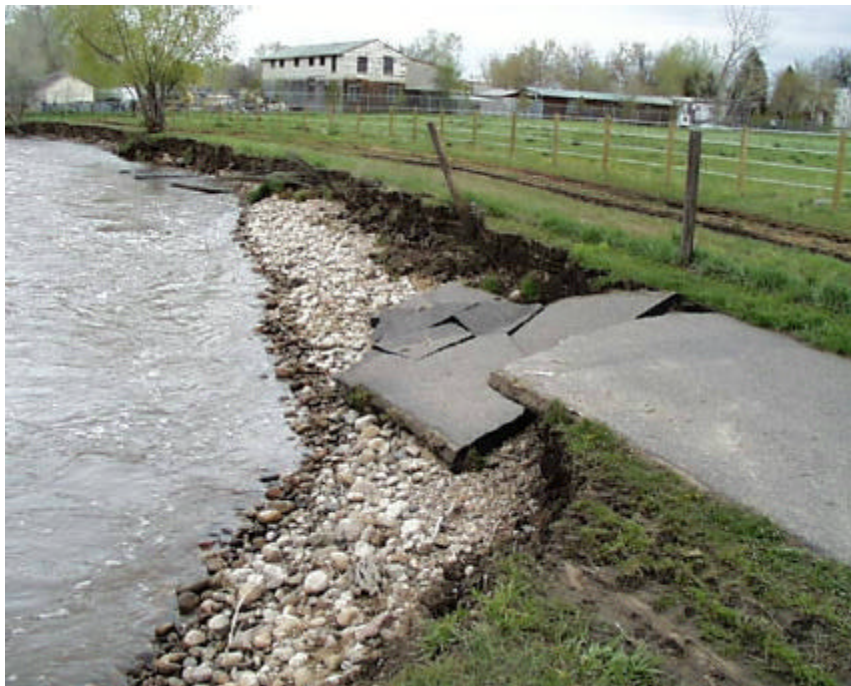
Damage by Poudre River to bike path near Shields Street in Fort Collins.

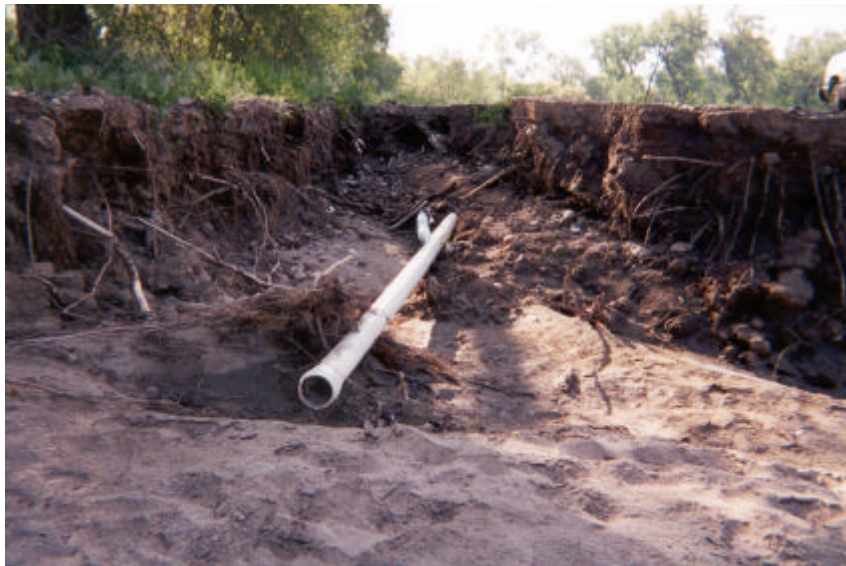
Damaged to pressurized sewer line at the BSD facility.

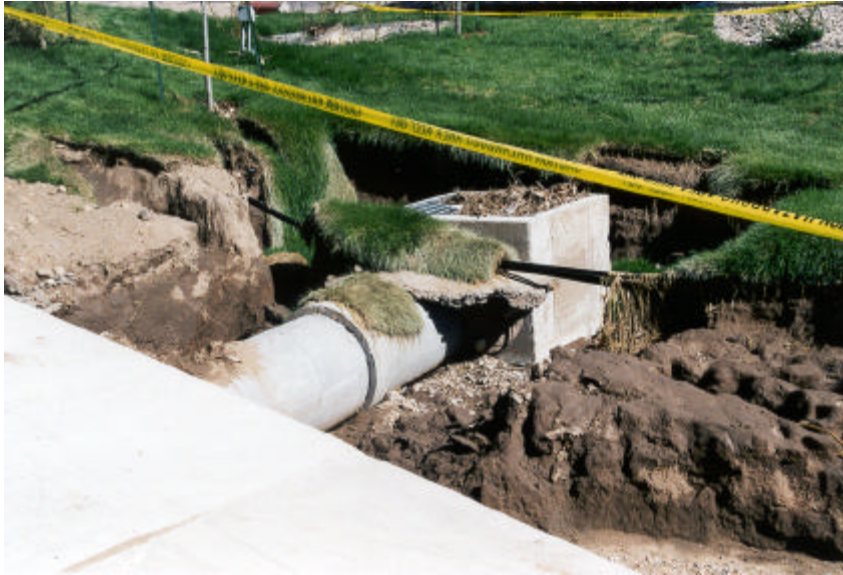
Erosion damage to storm drain inlet at Highway 287 and the Big Thompson River in Loveland.

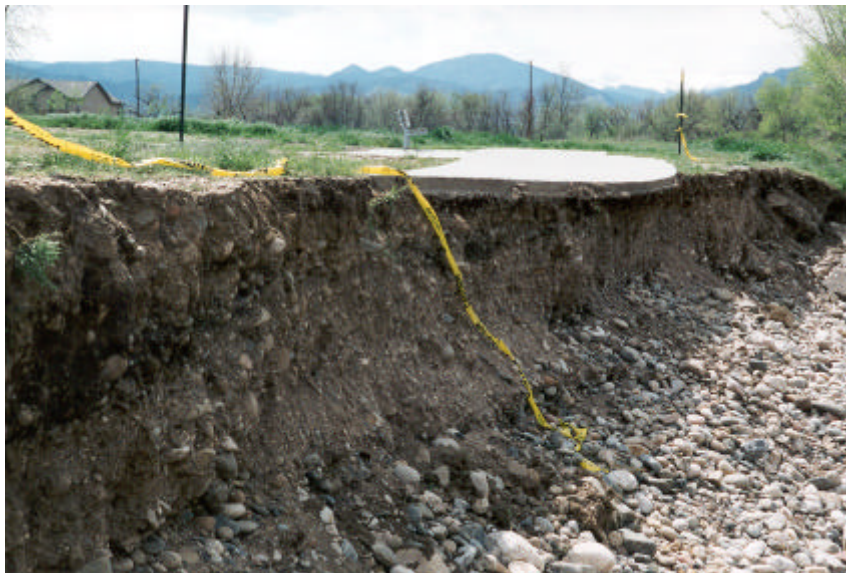
Bike path washout near Taft Avenue along the Big Thompson River in Loveland.

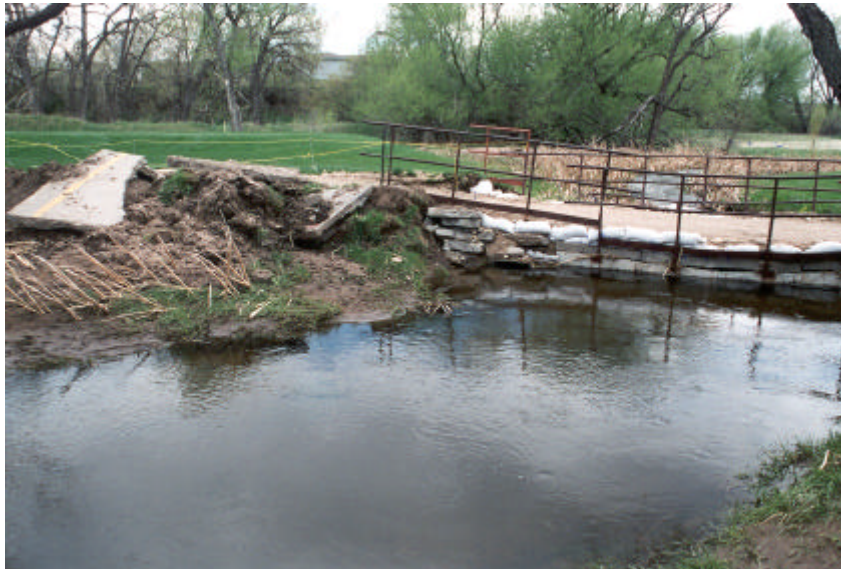
Temporary repair to cart path at the Mariana Butte Golf Course in Loveland.

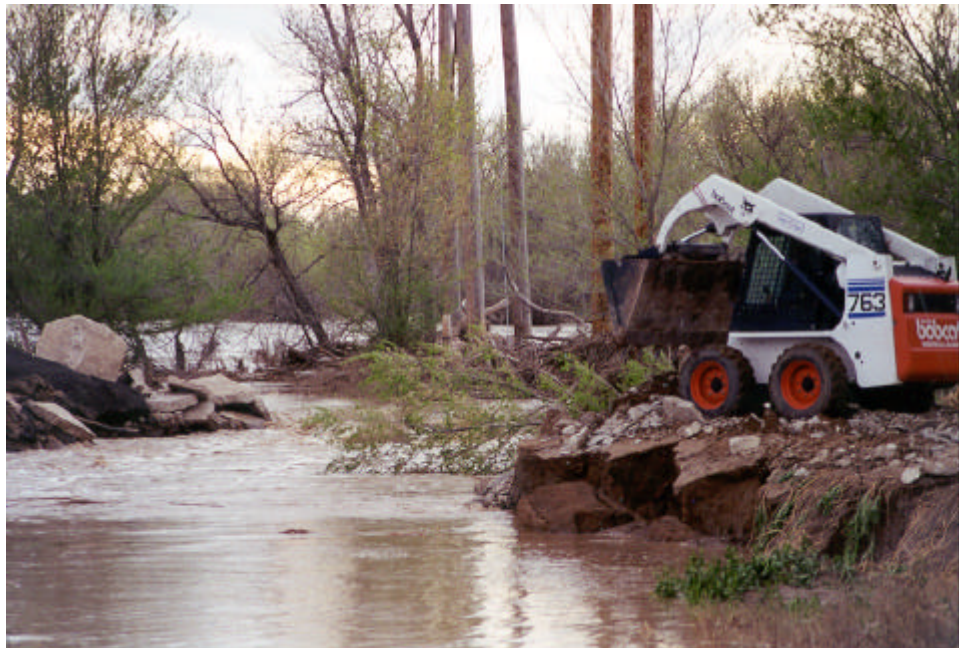
**Repairing a levee break in North La Junta.
May 3, 1999**

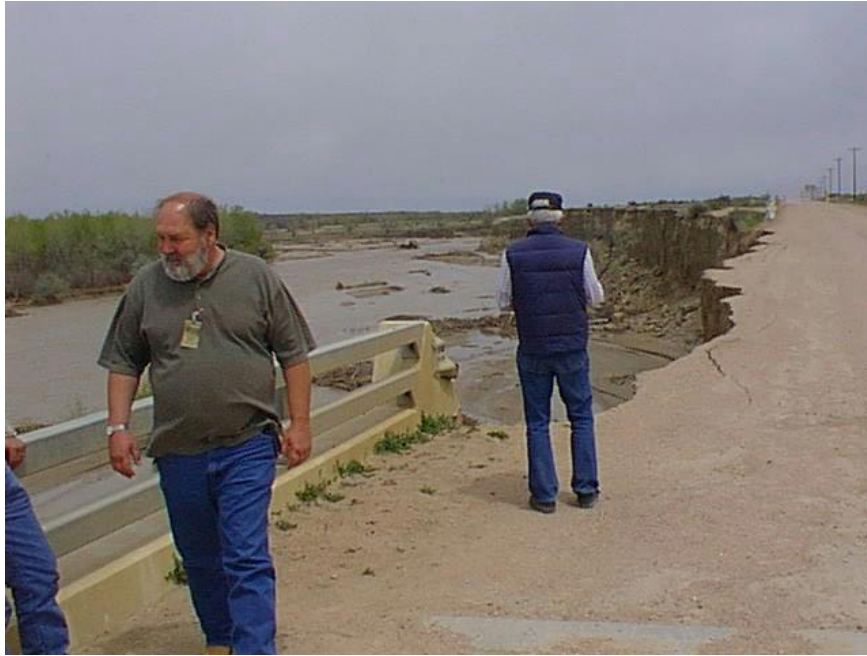
Erosion damage to Overton Road Bridge along Fountain Creek.

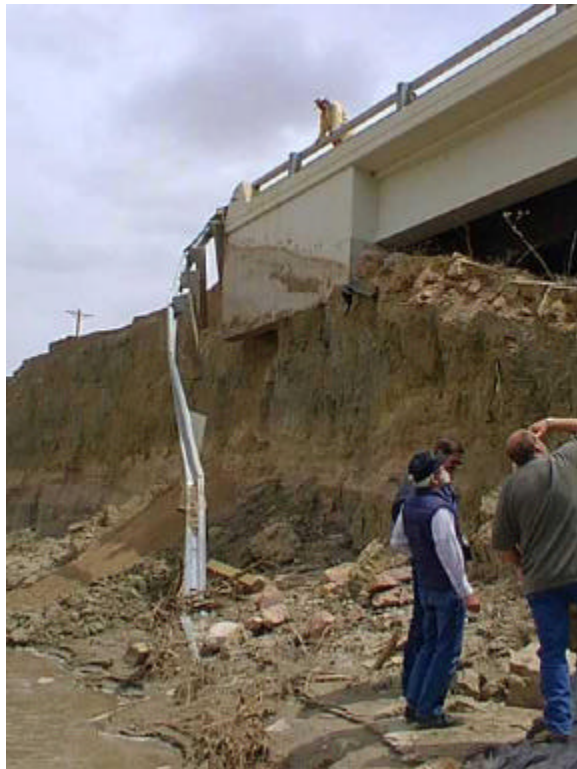
Erosion damage to Overton Road Bridge along Fountain Creek.

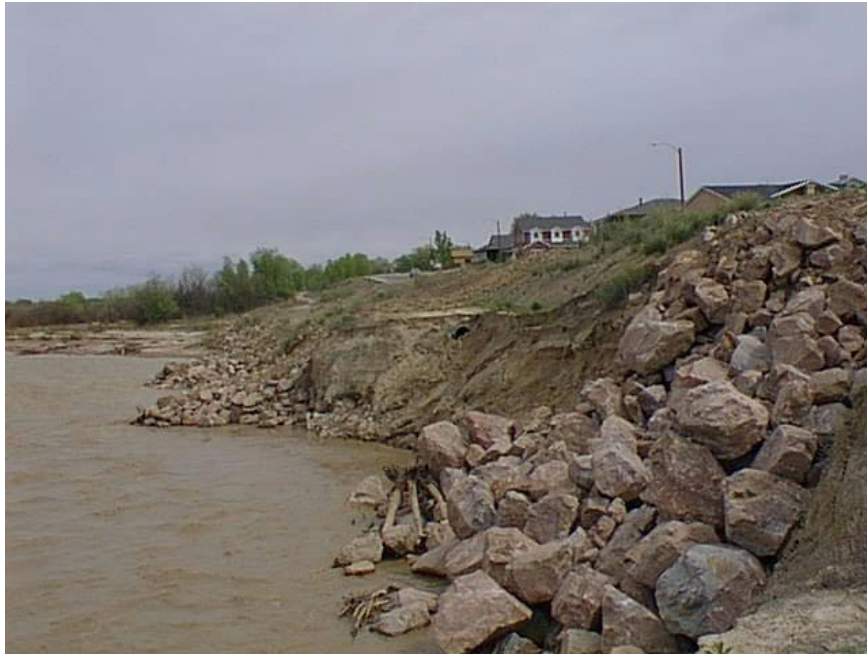
Chinook Lane at Fountain Creek in Pueblo looking upstream (bike path and sanitary sewer line washed out, large riprap placed later to hold remaining bank).

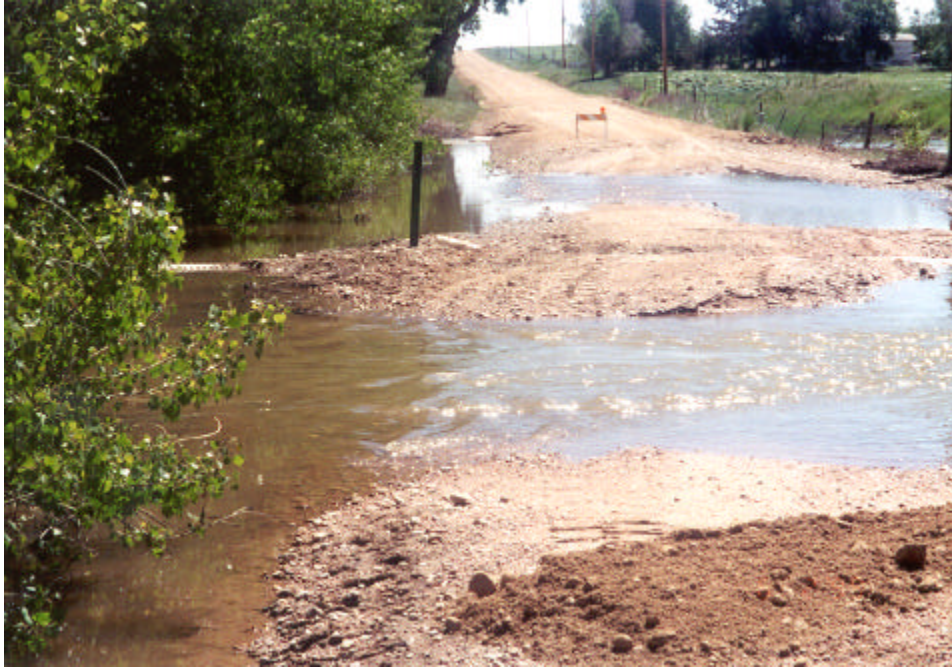
Road surface damage on WCR 74 from Crow Creek floodwaters between WCR 392 and 79.

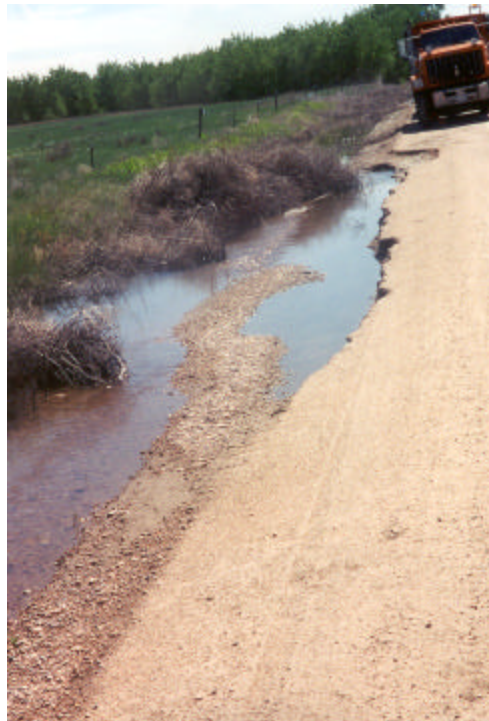
Shoulder erosion on WCR 74 from Crow Creek floodwaters between WCR 392 and 79.

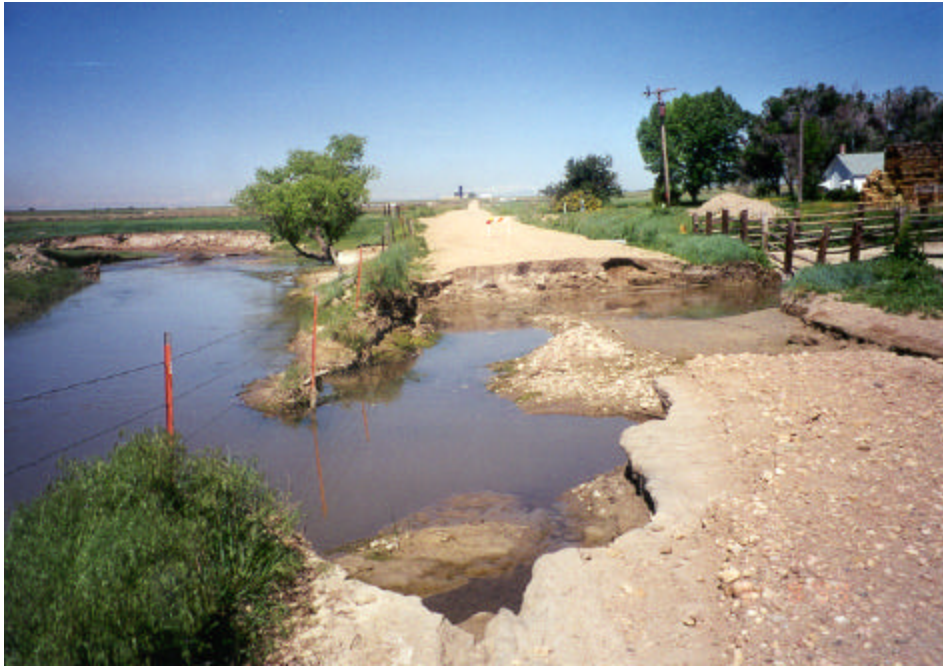
Erosion damage to WCR 64 from Crow Creek floodwaters between WCR 57 and 59.

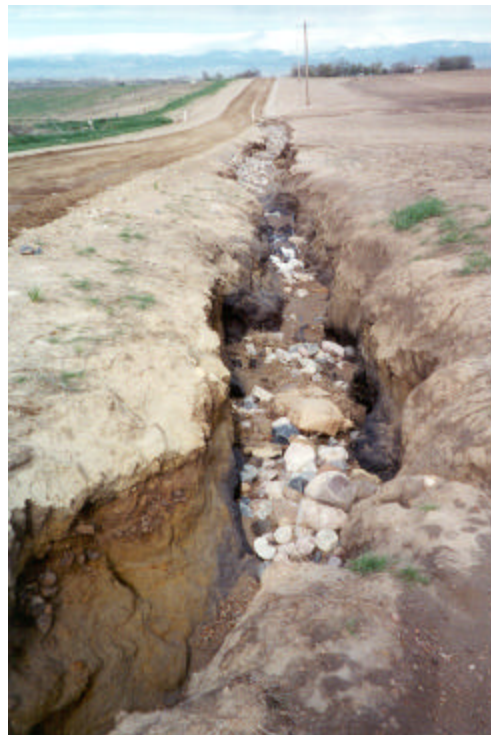
Borrow ditch on WCR 30 between US 85 and WCR 31 eroded by local runoff to a depth of 4 feet.

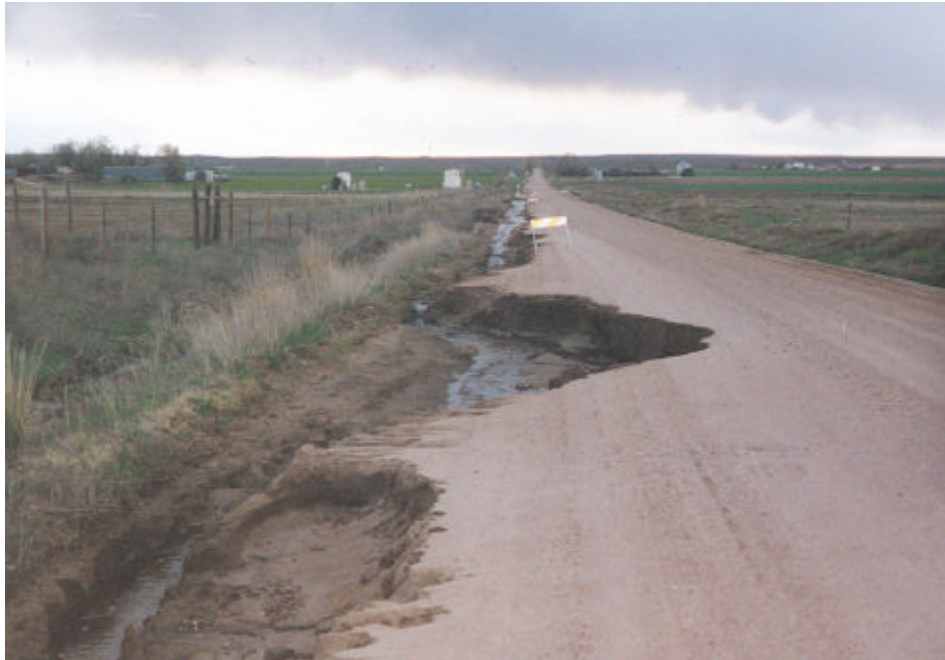
Erosion damage by local runoff to WCR 36 between WCR 49 and 53.

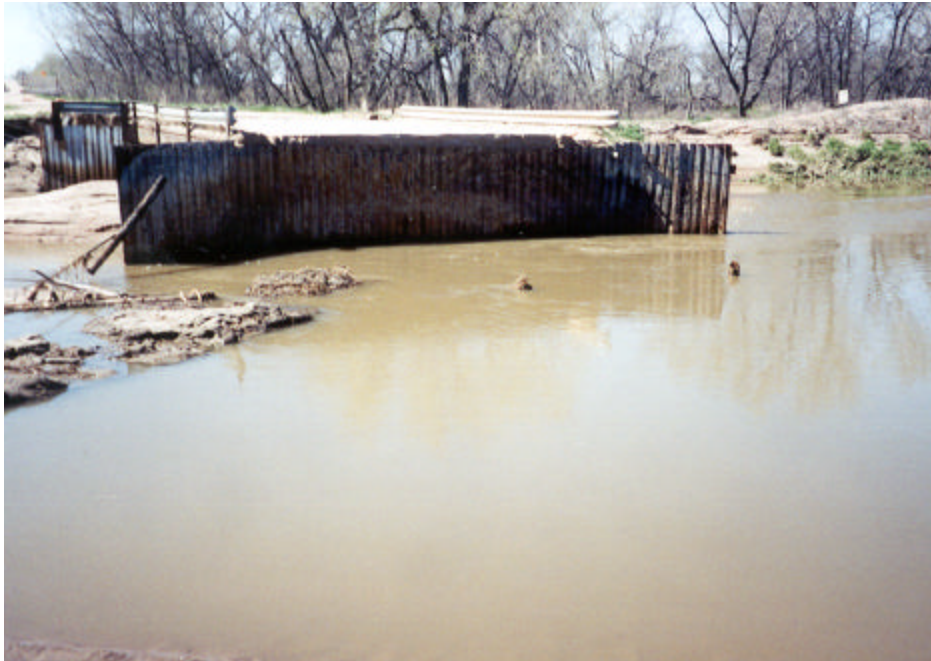
WCR 87 crossing of the Poudre River between WCR 42.5 and 44.5 where floodwaters washed out both approaches to the crossing.

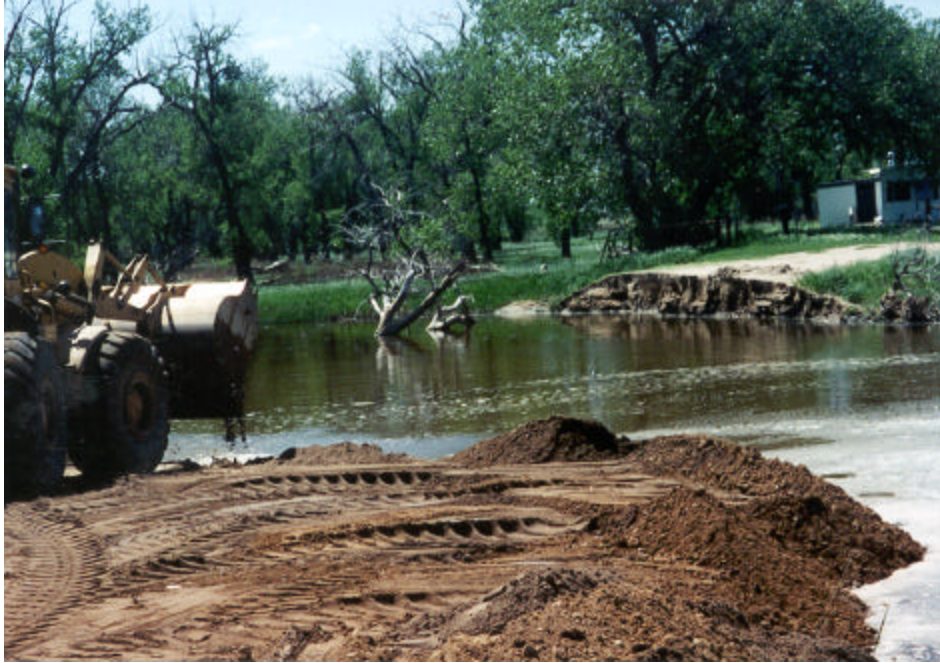
Repair work at the WCR 87 crossing of the Poudre River between WCR 42.5 and 44.5.

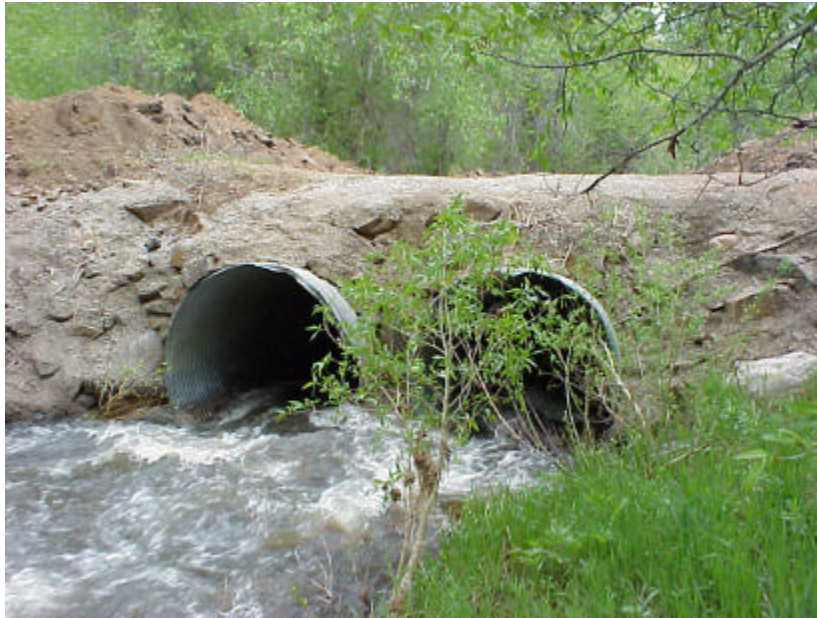
Completed repairs to County Road 389 culvert crossing.

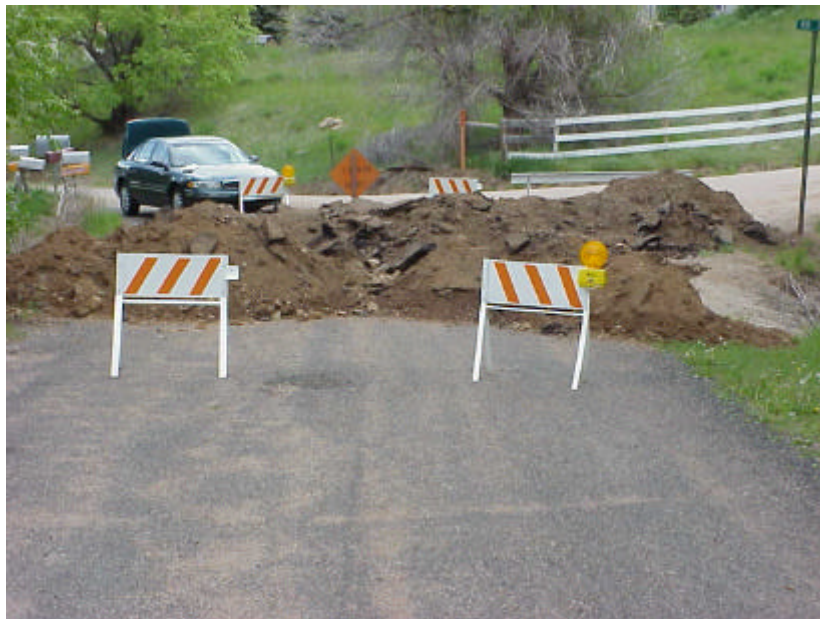
Washed out County Road 389 crossing.

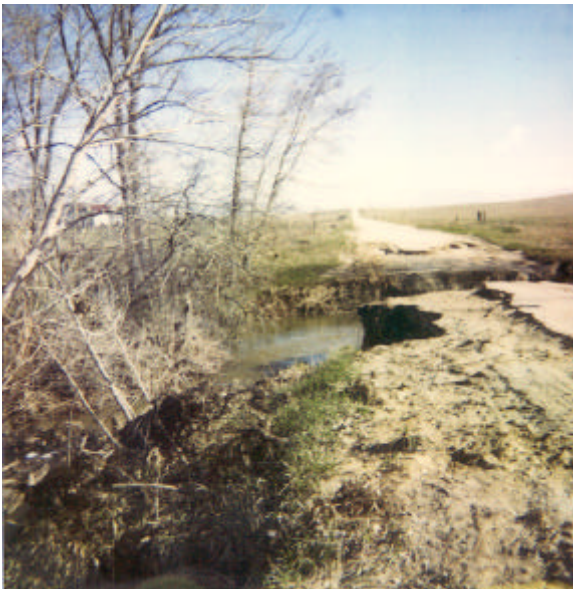
Washout caused by flooding of Big Sandy Creek on CR 149 near the town of Matheson.

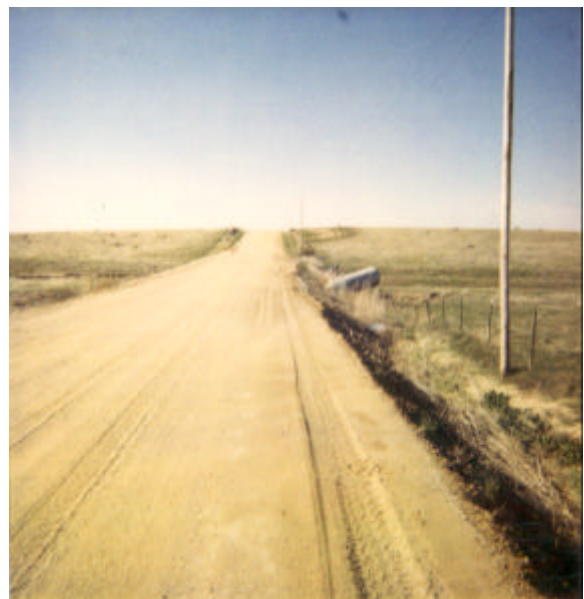
48-inch diameter culvert bent upward by fast flowing flood water from Middle Rush Creek, 2 miles south of CR 66 on CR 149.

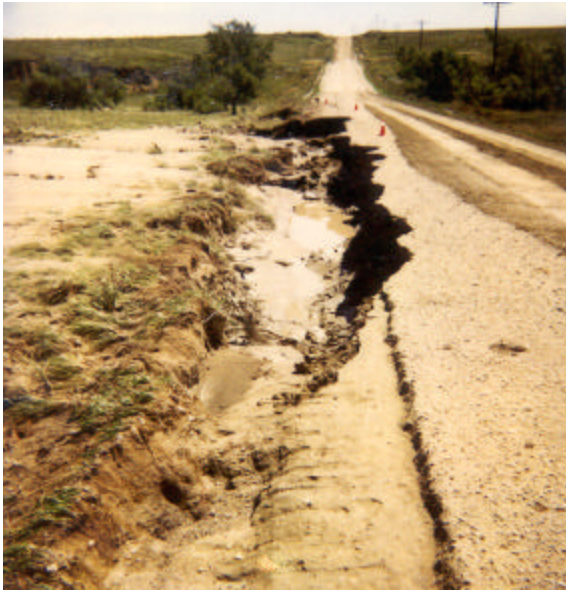
Washout on CR 154 caused by flood waters in Middle Bijou Creek.

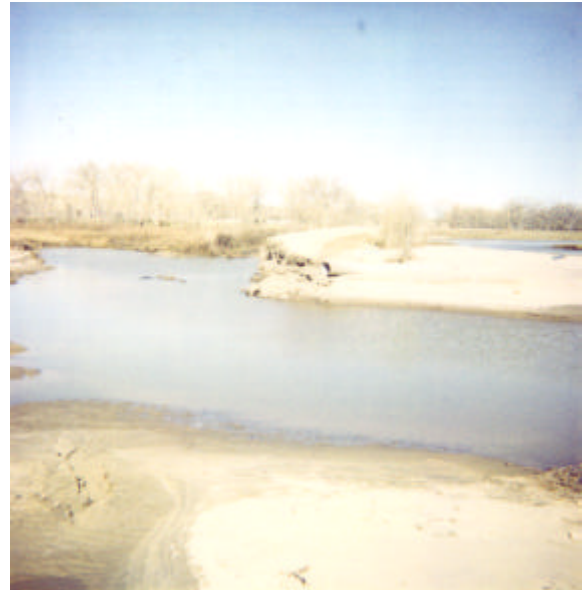
CR 118 east end was damaged by flood waters from Big Sandy Creek.

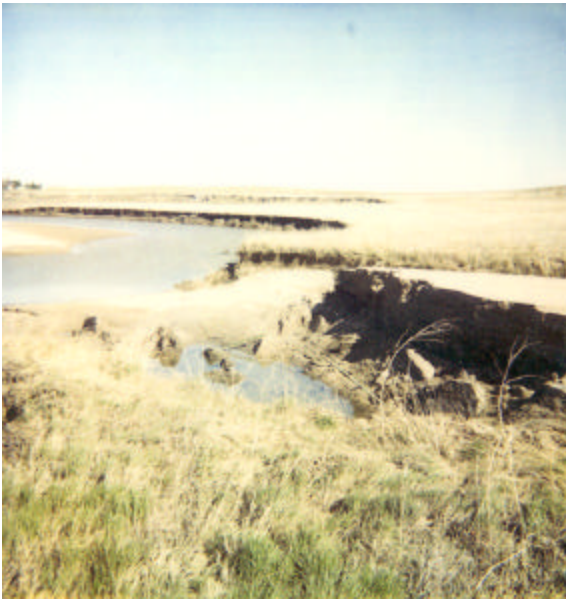
CR 118 east end washed out by flood waters in Big Sandy Creek.

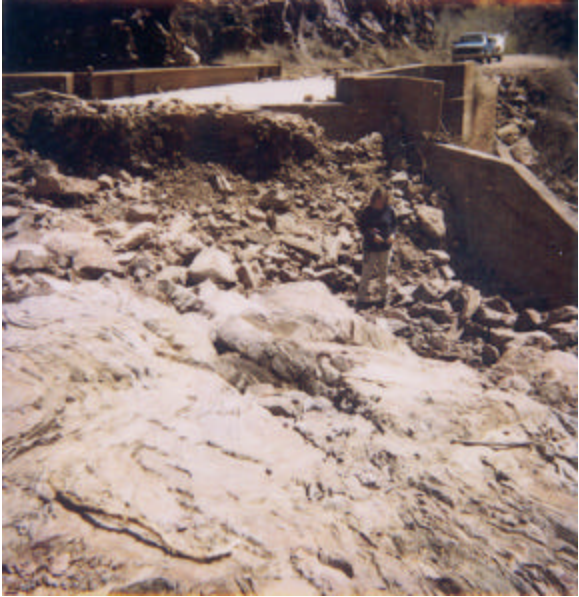
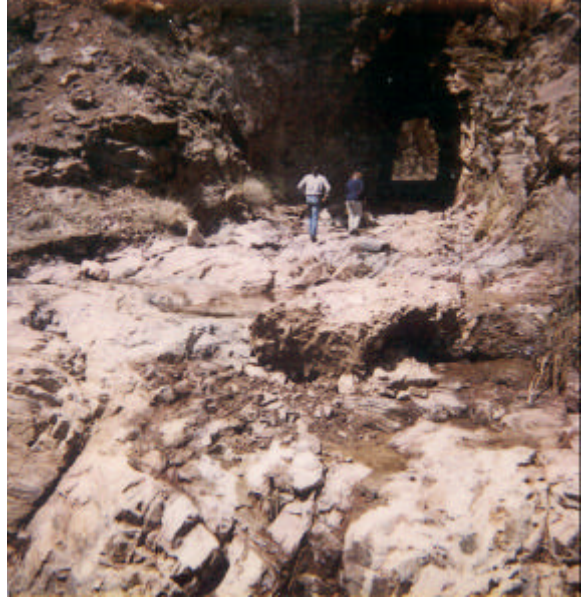
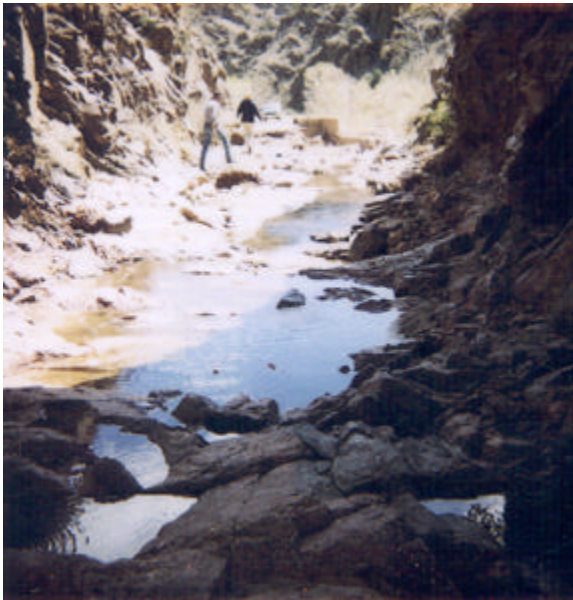
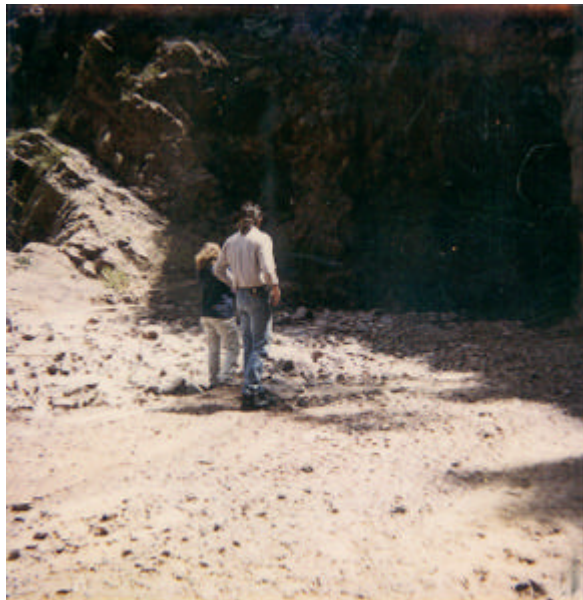
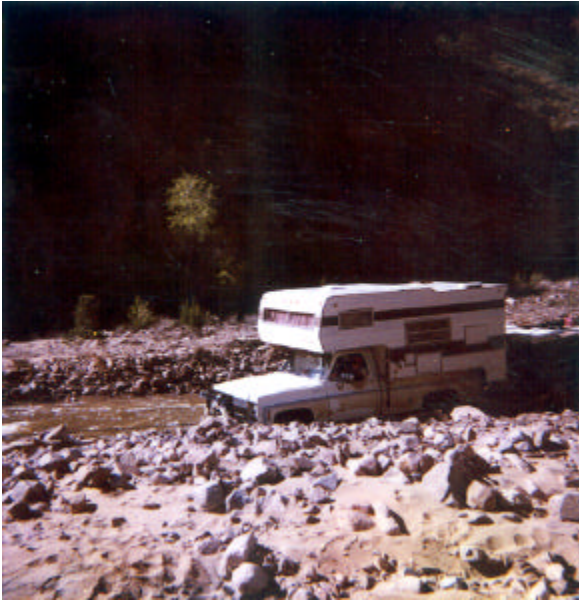
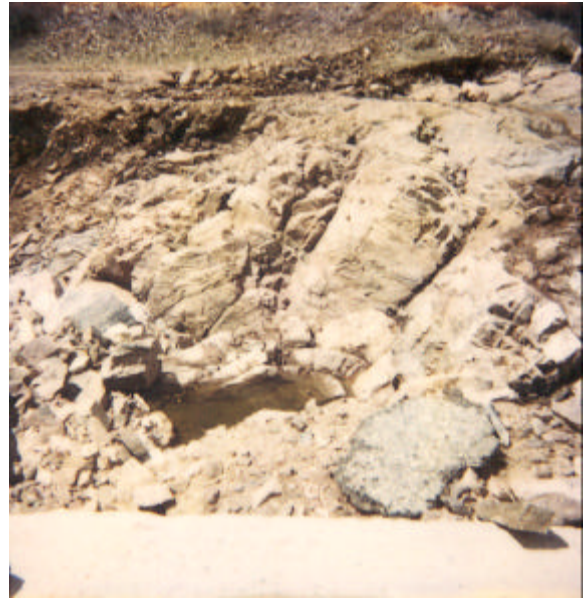
Damage to County Road 67, Phantom Canyon.

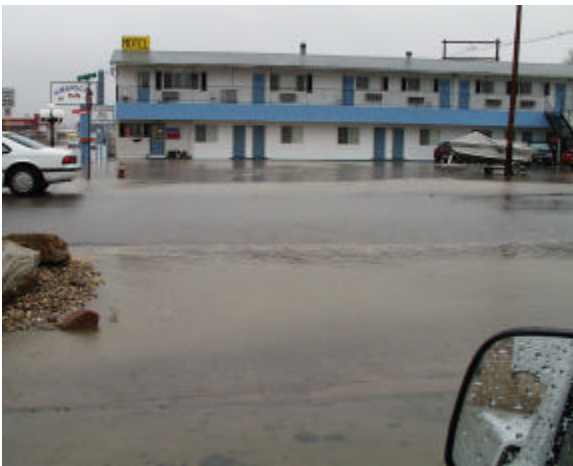
Northwest corner of Royal Gorge Boulevard (Highway 50) and 13th in Cañon City. This is typical flooding at this location even after moderate rainfall.

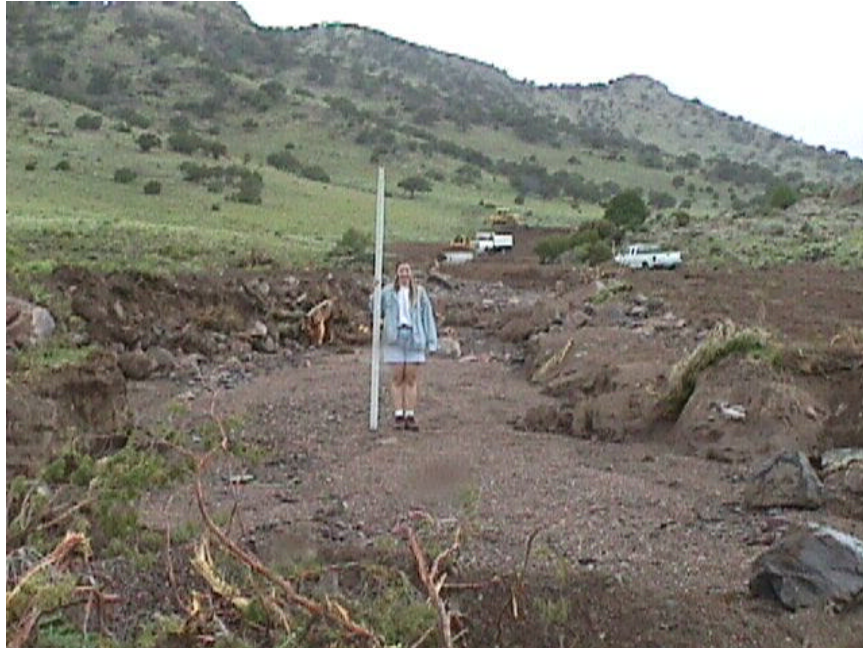
Flood and Erosion Damage on Cabin Draw just u/s of Middle Creek (note County crews rebuilding destroyed road in background).

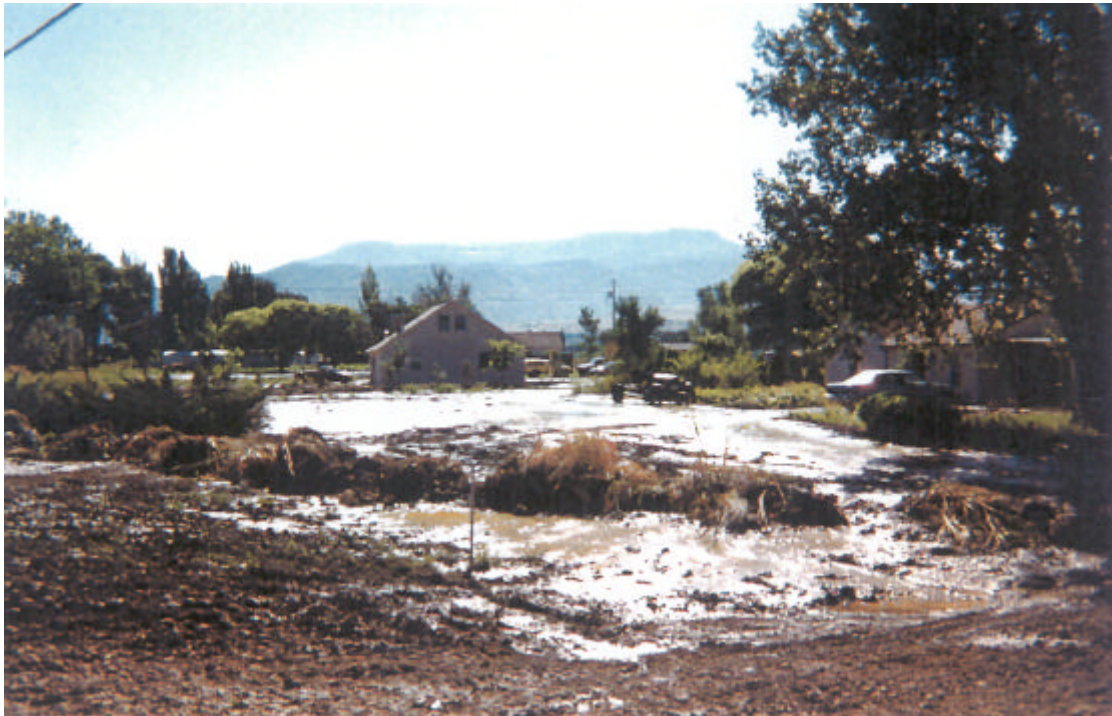
Storm damage (August 11, 1999).
