Big Thompson disaster recovery planning report

BIG THOMPSON DISASTER RECOVERY
PLANNING REPORT
(PHASE A)

May, 1977

PREPARED BY: Toups Corporation
1966 West 15th Street
Loveland, Colorado 80537
(303) 667-8690
Contact Person: Curt Smith

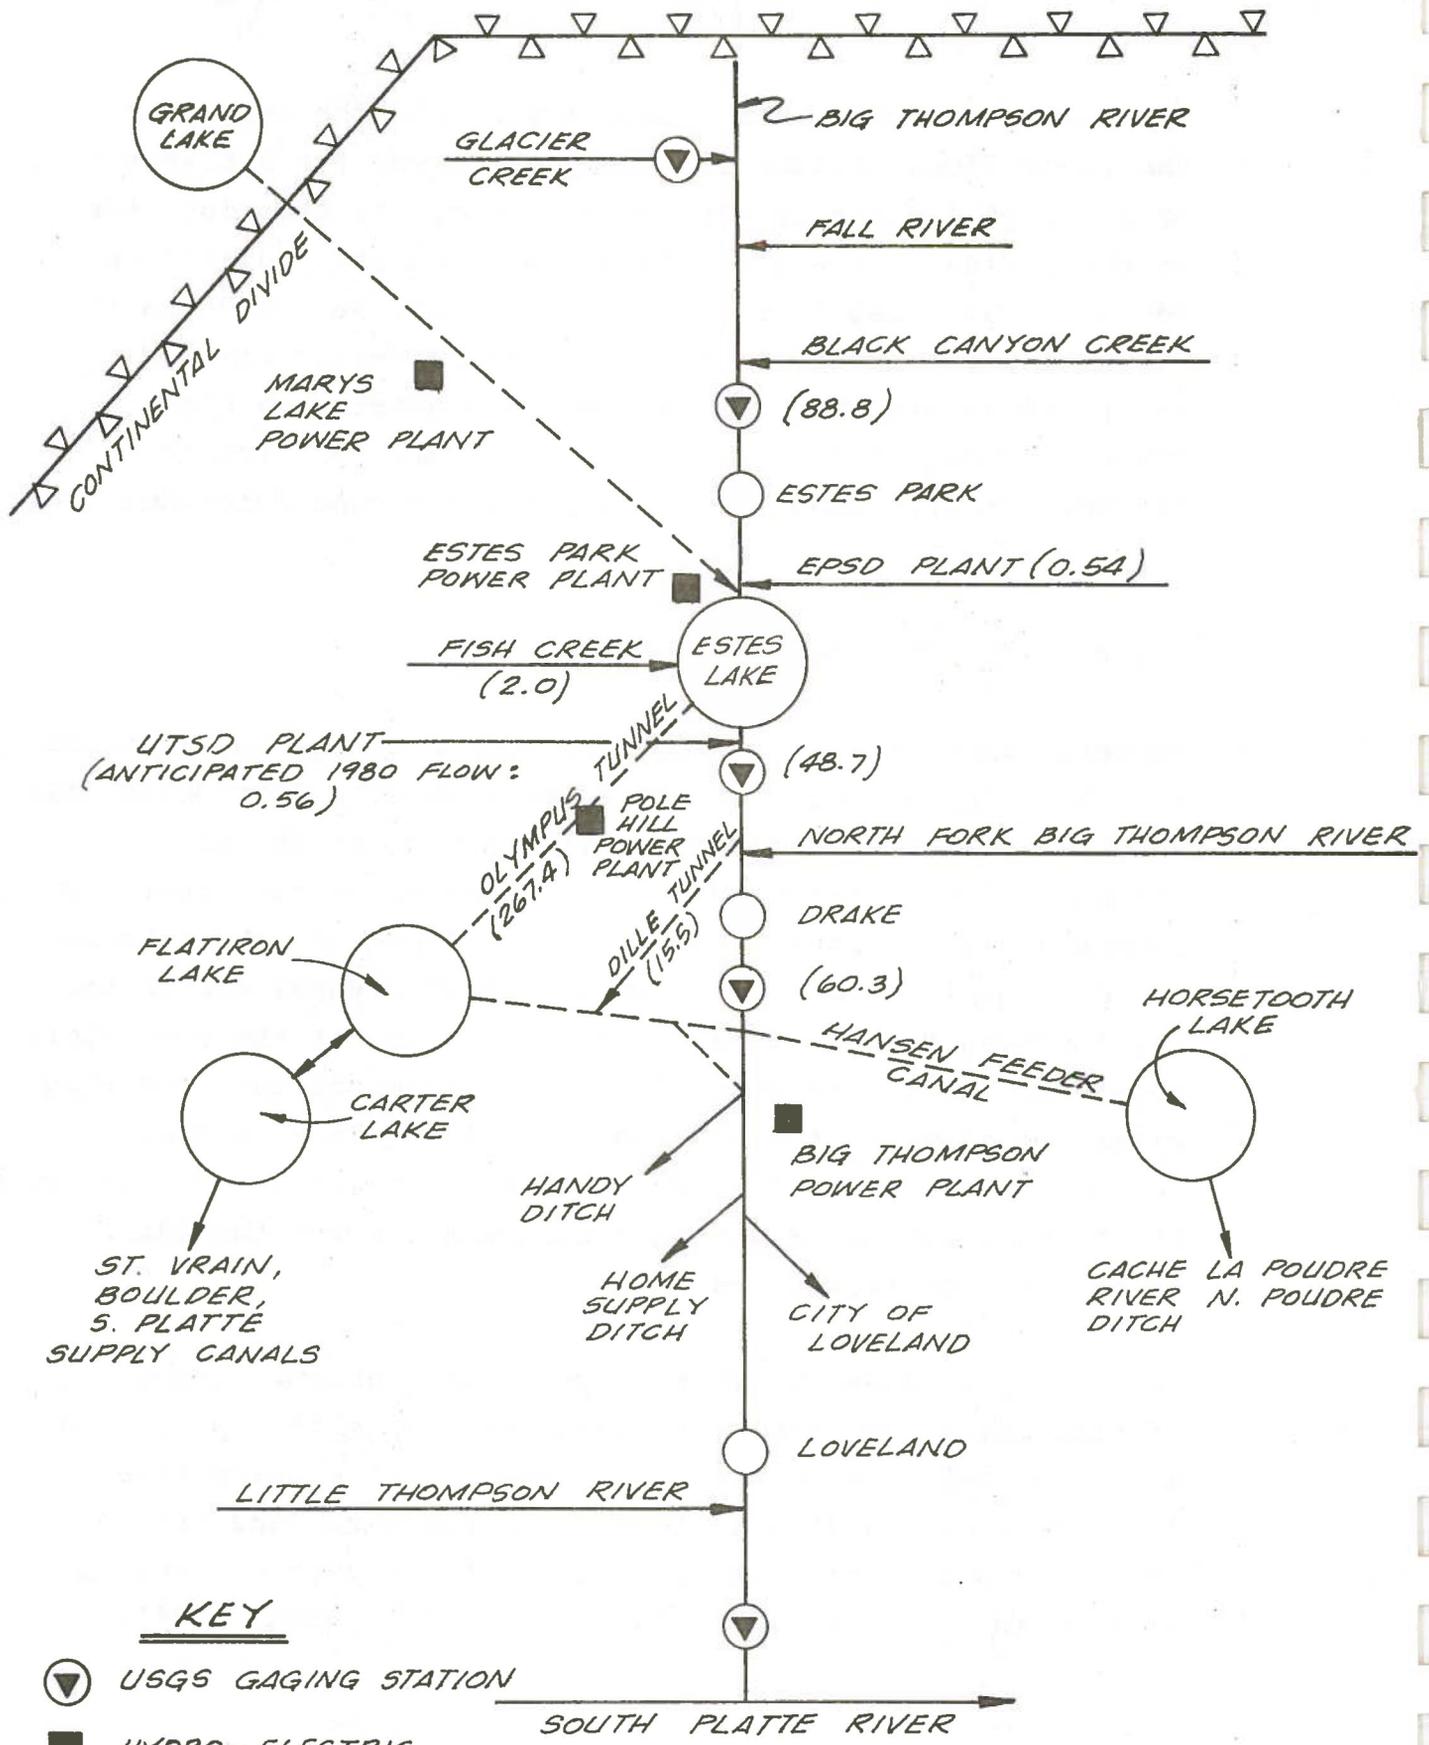
- KEY**
- ▽ USGS GAGING STATION
 - HYDRO-ELECTRIC POWER PLANT
 - TOWN

FIG. 8 SCHEMATIC DIAGRAM OF PRINCIPAL FLOWS OF THE UPPER BIG THOMPSON RIVER AND THE C-BT PROJECT WATER YEARS 1966-1975 (1000 AF/YR.)

Western Slope waters collected by components of the Colorado-Big Thompson Project are routed northeasterly from Grand Lake and Lake Granby to the hydrologic drainage of the Big Thompson River. Major hydrologic features of the upper Big Thompson River system are depicted in Figure 8. Lake Estes was originally formed by construction of Olympus Dam on the Big Thompson River. In addition to serving as the regulatory reservoir for all Project flows, Lake Estes is the receiving water for flows in the Big Thompson River, in Fish Creek, and for the Estes Park Sanitation District discharge. The bulk of the lake inflow is diverted eastward through the Bureau of Reclamation facilities.

Lake Estes is essentially a flow-through system. Study of Lake Estes has determined that the reservoir experienced an annual exchange rate of 120 times, or once every three days [Ecco Corp., 1972]. Lake Estes has a surface area of 185 acres and a total capacity of 3,100 acre-feet. Active storage is on the order of 2,700 acre-feet [USBR, 1974].
