Open-File 86-3

**Surficial - Geologic  
and Slope Stability Study  
of the  
Douglas Pass Region**

**By  
B. K. Stover  
Colorado Geological Survey  
1985**

**Folio #2 Geologic Hazards**

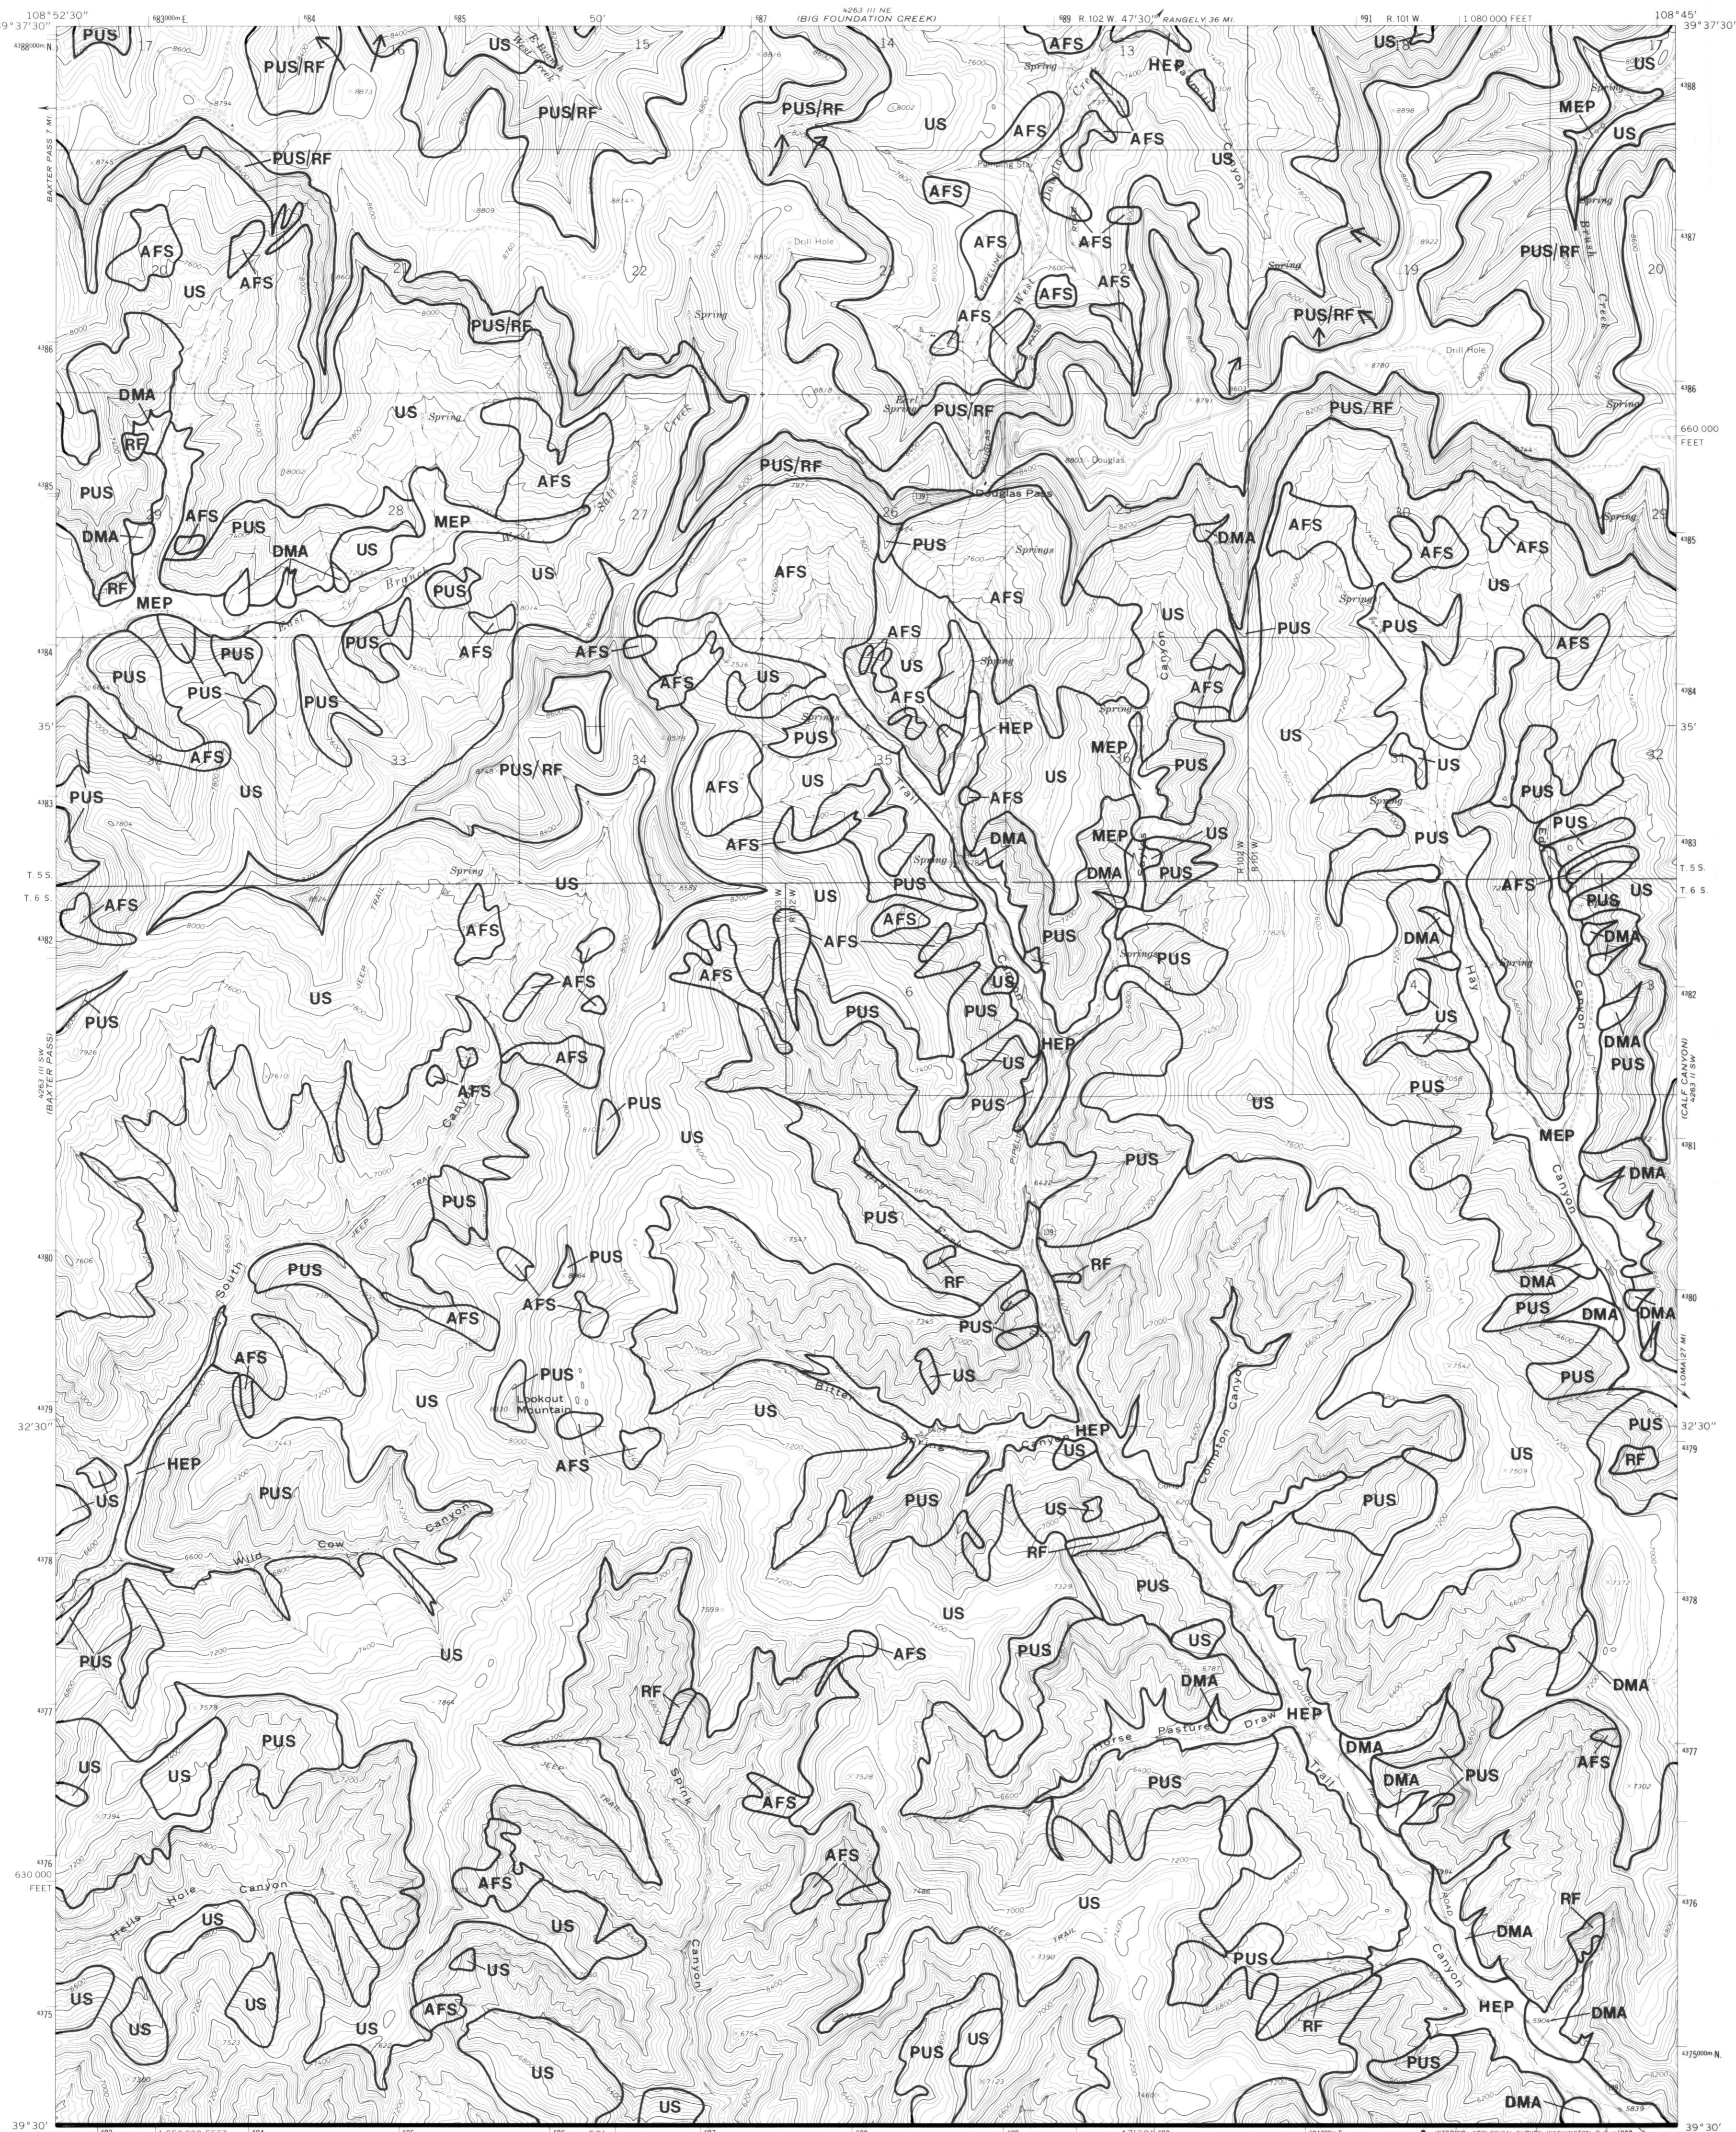
DOUGLAS PASS, COLO.

areas along highway 139 are shown as of spring 1985. Several new **AFS** areas have probably occurred along the highway even since that field work was completed.
