MAP SERIES 42

**COLORADO SPRINGS LANDSLIDE
SUSCEPTIBILITY MAP,
EL PASO COUNTY, COLORADO**

By Jonathan L. White and T.C. Wait

Colorado Geological Survey
Division of Minerals and Geology
Department of Natural Resources
Denver, Colorado
2003

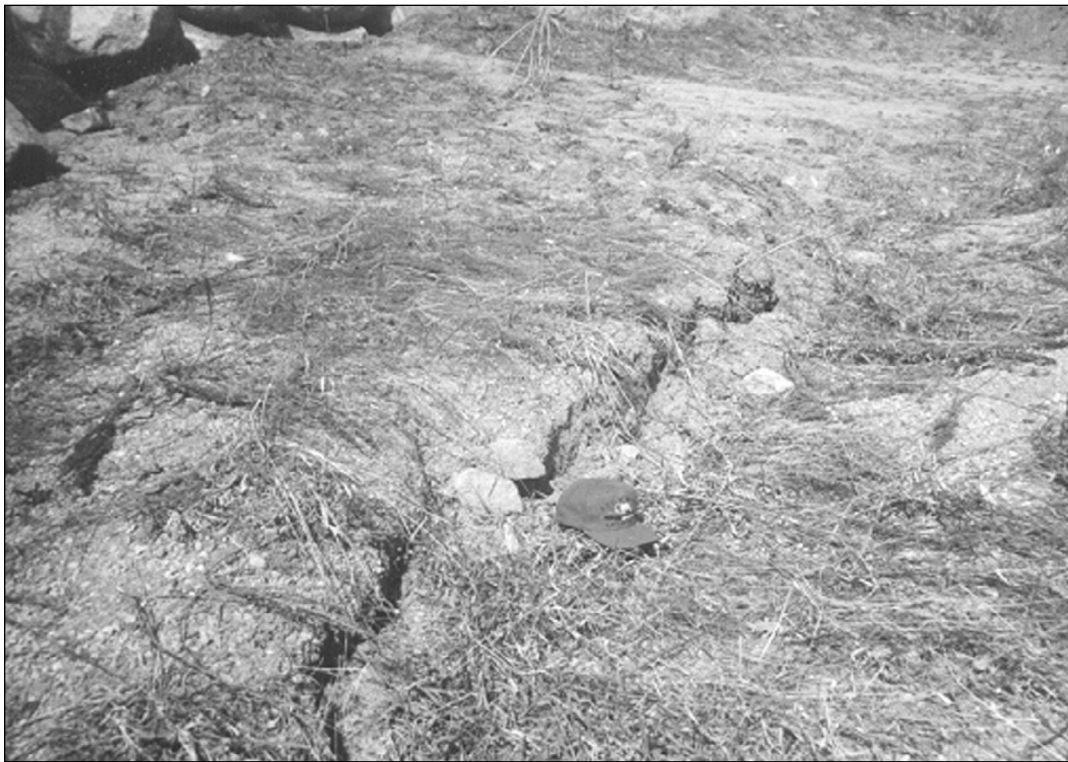
Figure 5. Ground crack and beginning of landslide scarp in the Broadmoor area in 1998. Note hat for scale. Photo by J. White.

cracks can sometimes be seen that show subsurface strain (e.g., extensional movements); such tension cracks are the visible precursor of a landslide (Figure 5). Cracks that show any vertical offset are considered scarps. In some cases, the slope may in fact be moving but the soil materials stretch or compress rather than break or tear, and slope movement can only be determined by detailed surface surveys and/or subsurface monitoring devices. This type of behavior in landslides generally occurs only briefly at onset of movement before displacement is evident and seen at surface. In cases where shallow soils and weak rock move and remold without defined slide planes, the movement is generally considered to be creep.

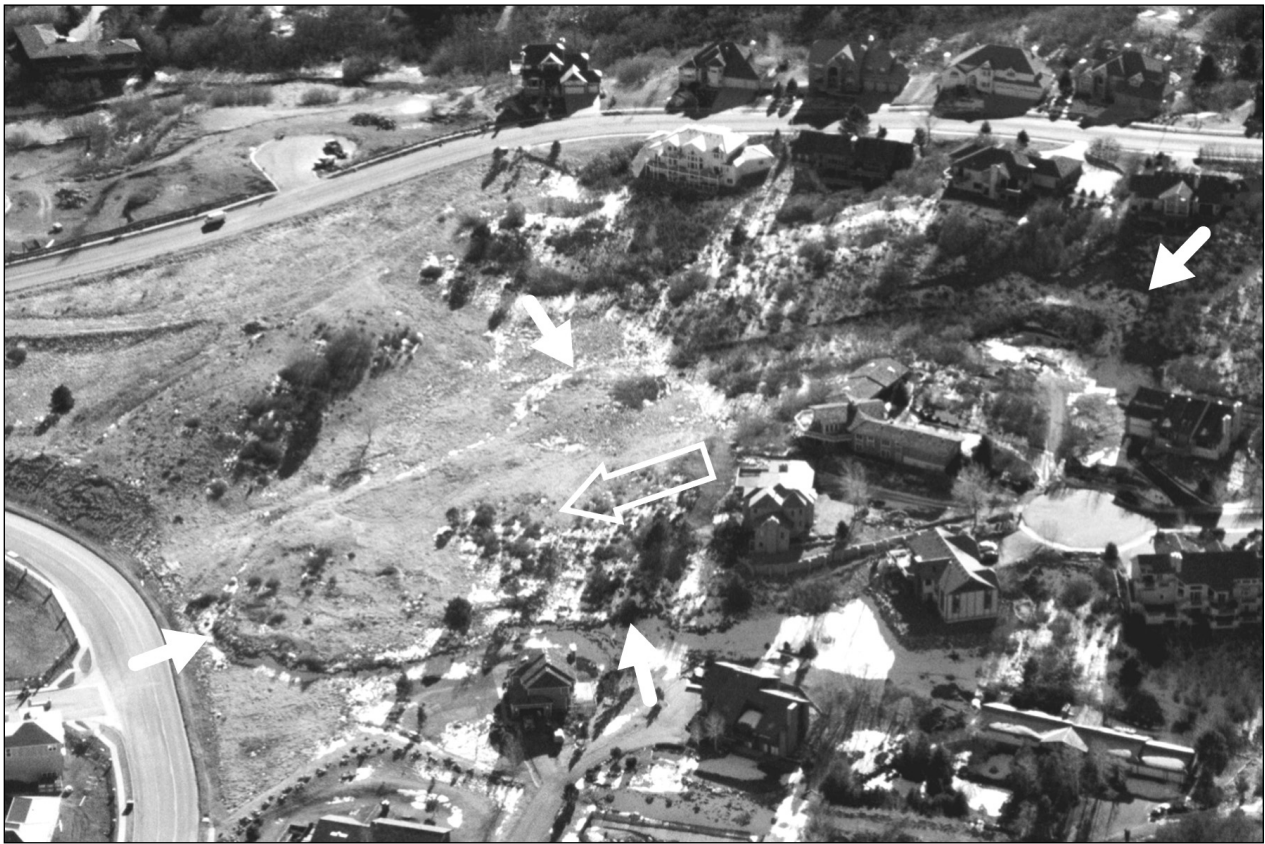
Figure 8. Regency Landslide in the Broadmoor area. White arrows delineate landslide boundary. Hollow arrow points in the movement direction. One home near head scarp that is shown below was condemned and demolished before this photo was taken, only broken foundation and driveway from cul-de-sac show on this photo. Note landslide toe formation in small field near lower road. Photo taken in 1999 by M. Squire.

New landslides and reactivations of older, existing landslides occurred during the wet spring of 1995 (e.g., Broadmoor Mountain Golf Course and Regency Drive); see Figures 7, 8, and 9. A brief flurry of media attention occurred after the landslides of that wet spring. Shortly thereafter, in 1996, the Colorado Springs implemented a geologic hazard statute in their planning review process (City of Colorado Springs, 1996 and 1999), and areas of susceptibility were briefly discussed in a field trip guide book (Himmelreich, 1996) and visited during a CGS-sponsored geological hazards conference in Colorado Springs. In 1998, CGS began planning their mapping program of 1:24,000-scale geologic quadrangle maps of the Colorado Springs and El Paso County area. See the index map in Plates 1-3 for the key to the completed, current, and proposed geologic mapping in this program.

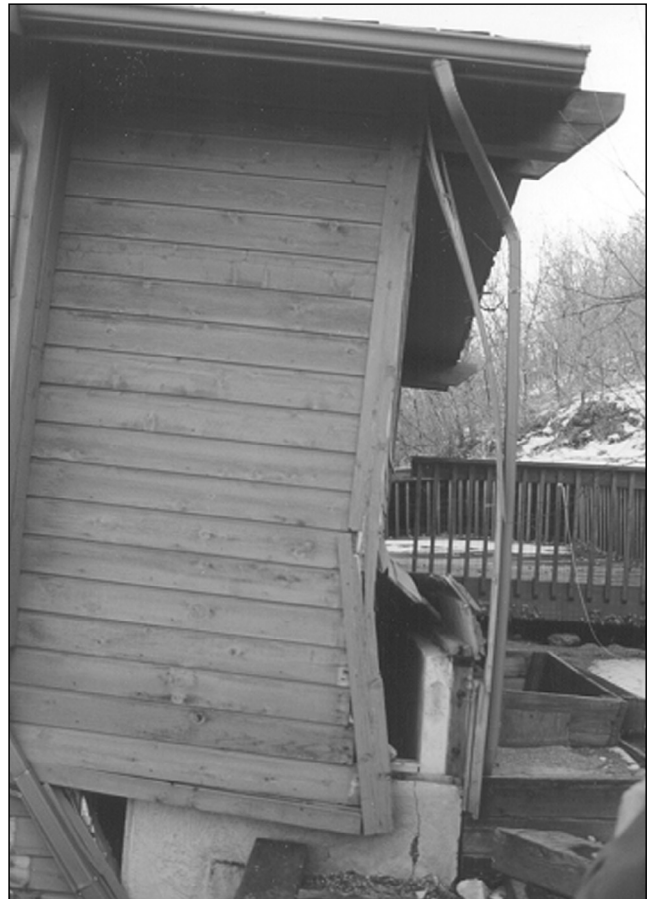
Figure 9. Catastrophic home damage near head scarp of Regency Landslide in 1995. This home was subsequently demolished. Photo by J. White.

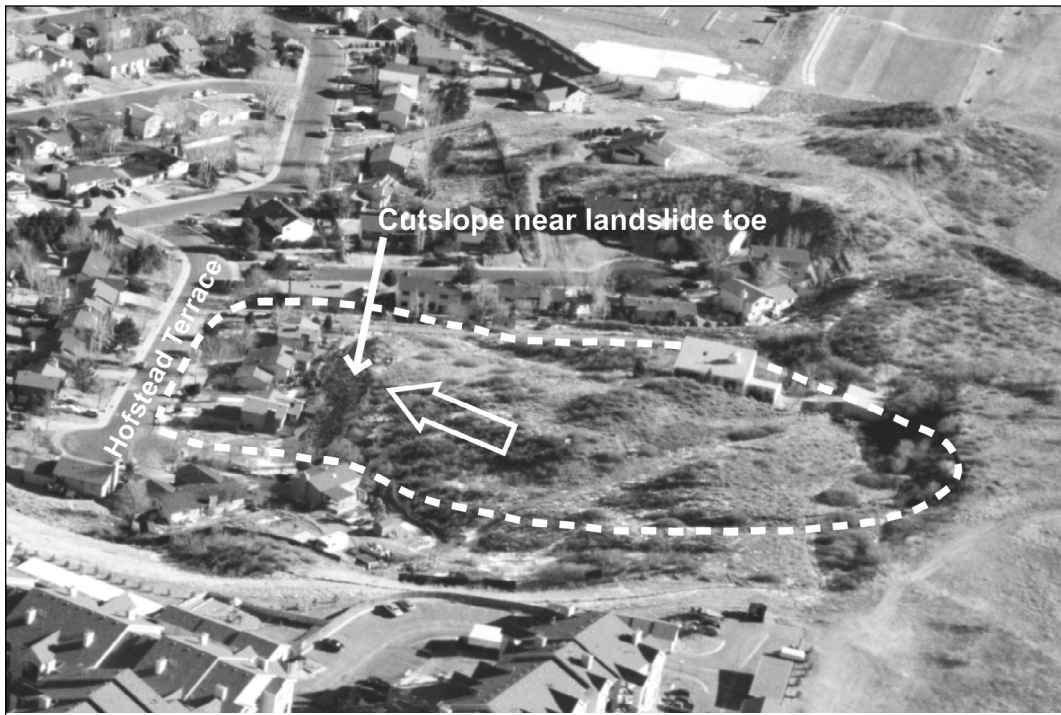
Figure 10. Oblique aerial view eastward of Hofstead Landslide on the flank of “The Mesa.” This site was a pre-existing landslide that re-activated in 1999. Note improper excavation at toe of landslide for residential development. Dashed line shows extent of re-activation and hollow arrow shows movement direction. The residence shown at lower left corner of landslide shows extreme distress by the landslide movement, note the perceptible tilt in the back half of the home near the cutslope. These homes have been subsequently demolished. Photo by M. Squire.

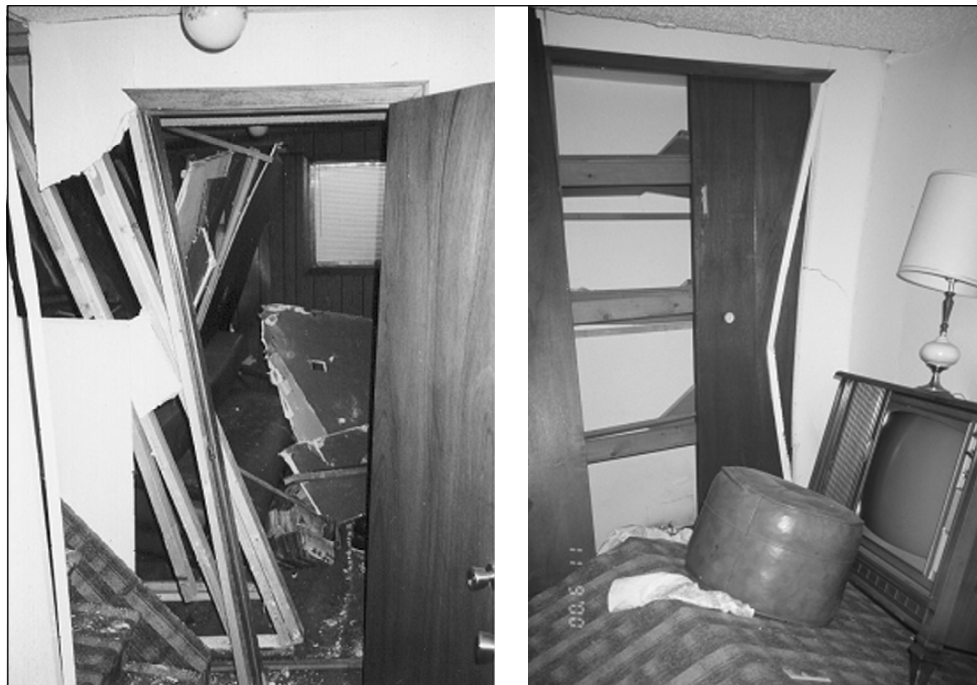
Figure 11. Ground movement caused this interior damage of a residence in the Hofstead Landslide in 1999. This home was condemned and later demolished. Photos courtesy of Hofstead Emergency Landslide Protection (HELP) Coalition and M. Squire.

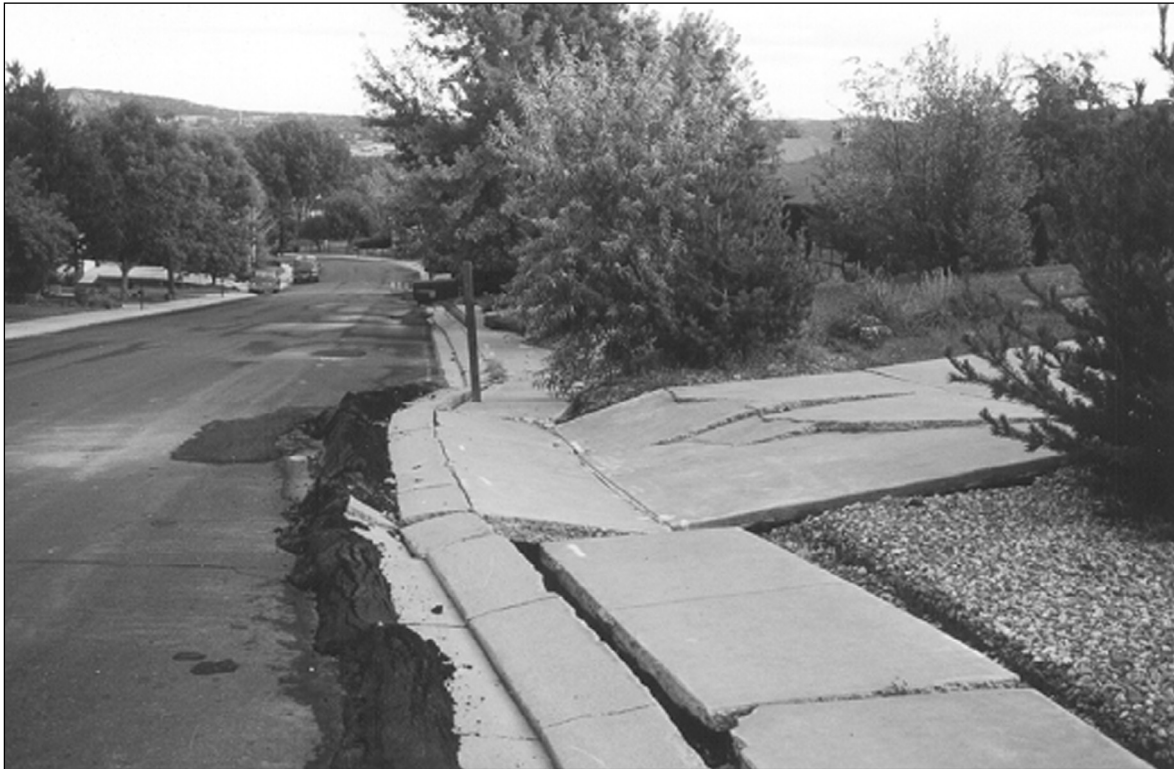
Figure 12. Damage to Hofstead Terrace roadway pavement, sidewalk, and driveway by lateral movement of landslide toe at Hofstead Landslide in 1999. Photo by J. White.

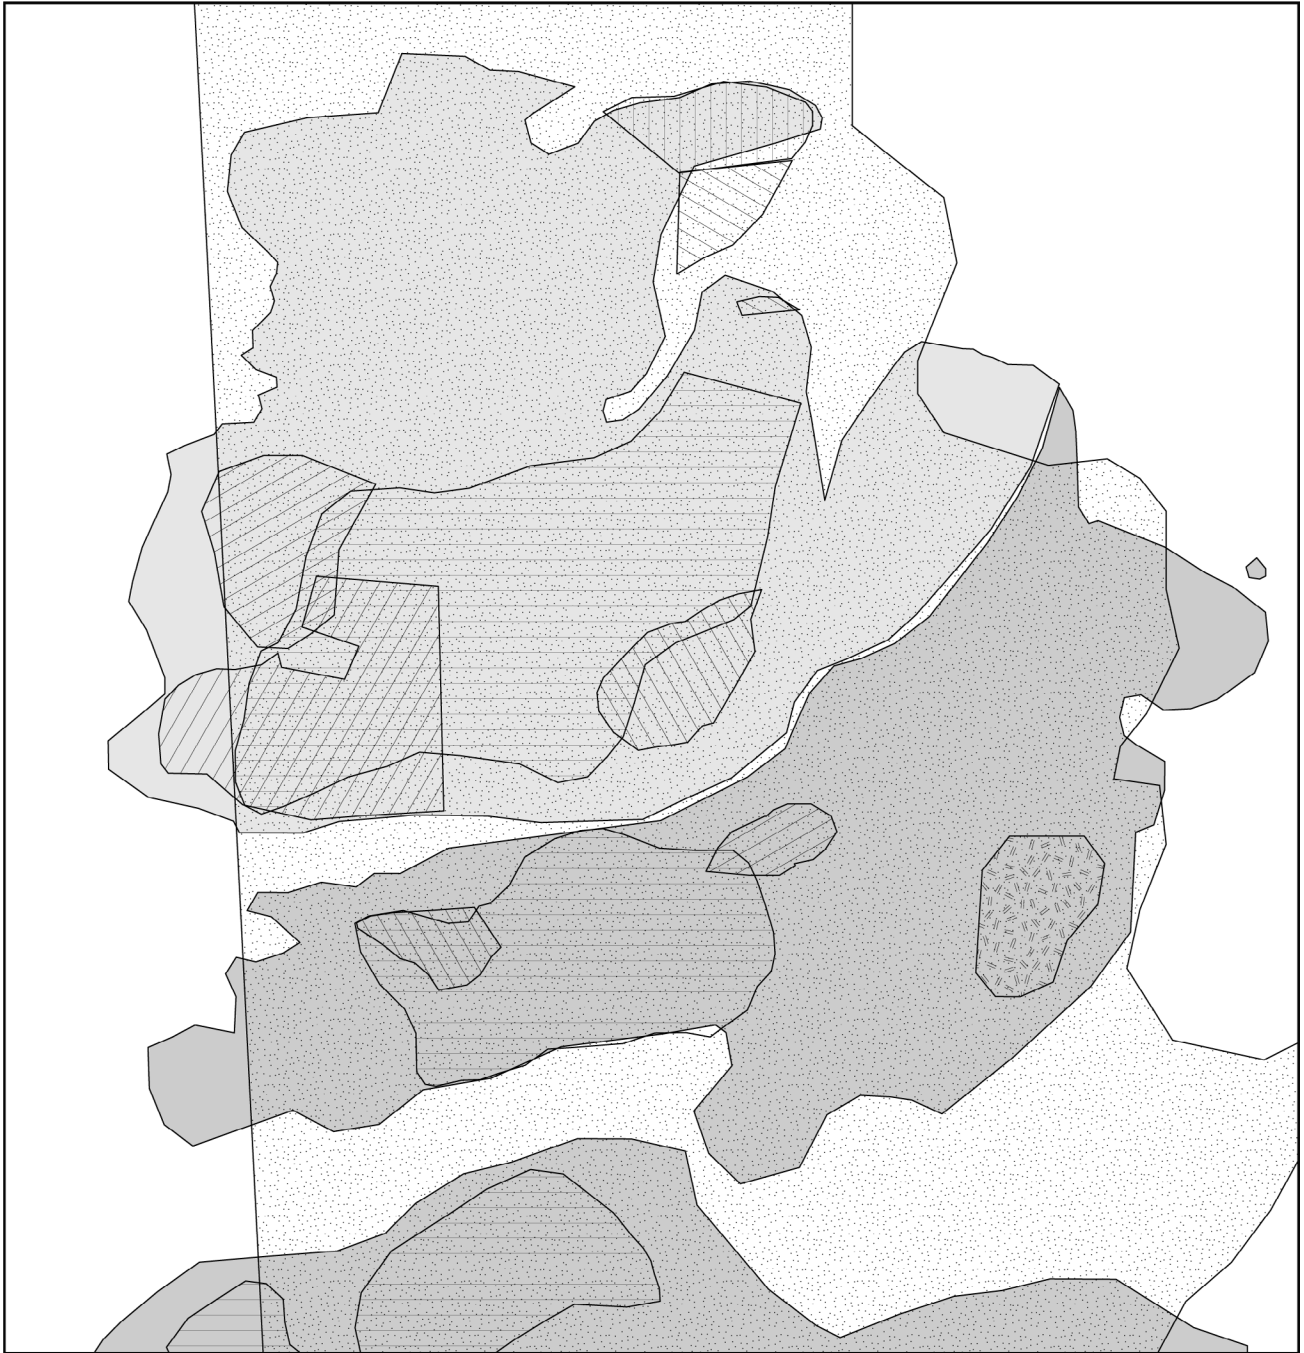
Non-Published Reference Sources for Boxed Area Shown on Plate 3

Figure boundary corresponds to box outline shown on Plate 3.

Explanation numbers correspond to ID number shown in blue table of Non-Published Sources on Plate 3.
