I-70 IN A MOUNTAIN ENVIRONMENT

Vail Pass COLORADO

FHWA-TS-78-208

PREPARED BY THE COLORADO DEPARTMENT OF HIGHWAYS
FOR THE UNITED STATES DEPARTMENT OF TRANSPORTATION,
FEDERAL HIGHWAY ADMINISTRATION OFFICE OF DEVELOPMENT,
IN COOPERATION WITH THE UNITED STATES FOREST SERVICE,
UNITED STATES DEPARTMENT OF AGRICULTURE.

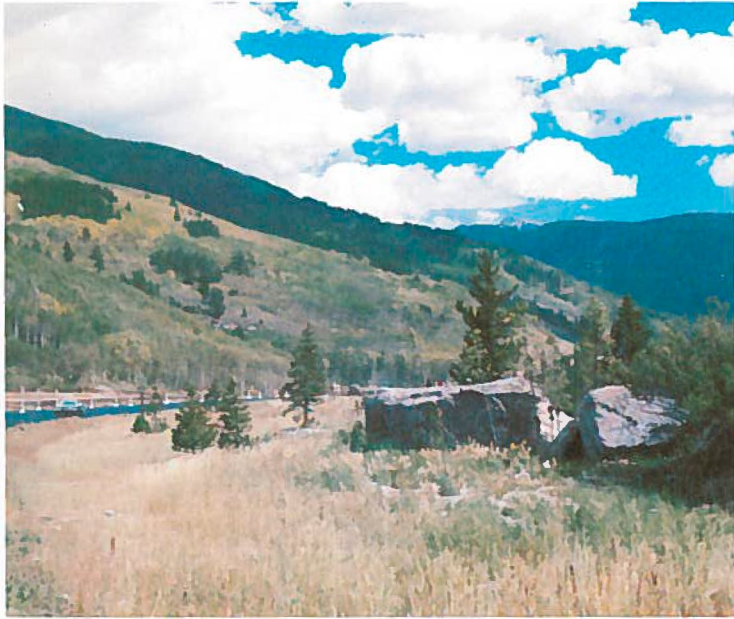
Landscape treatment showing grading into natural topography, seeded grasses, tree planting and incorporation of rocks to achieve blending between the disturbed and natural area.

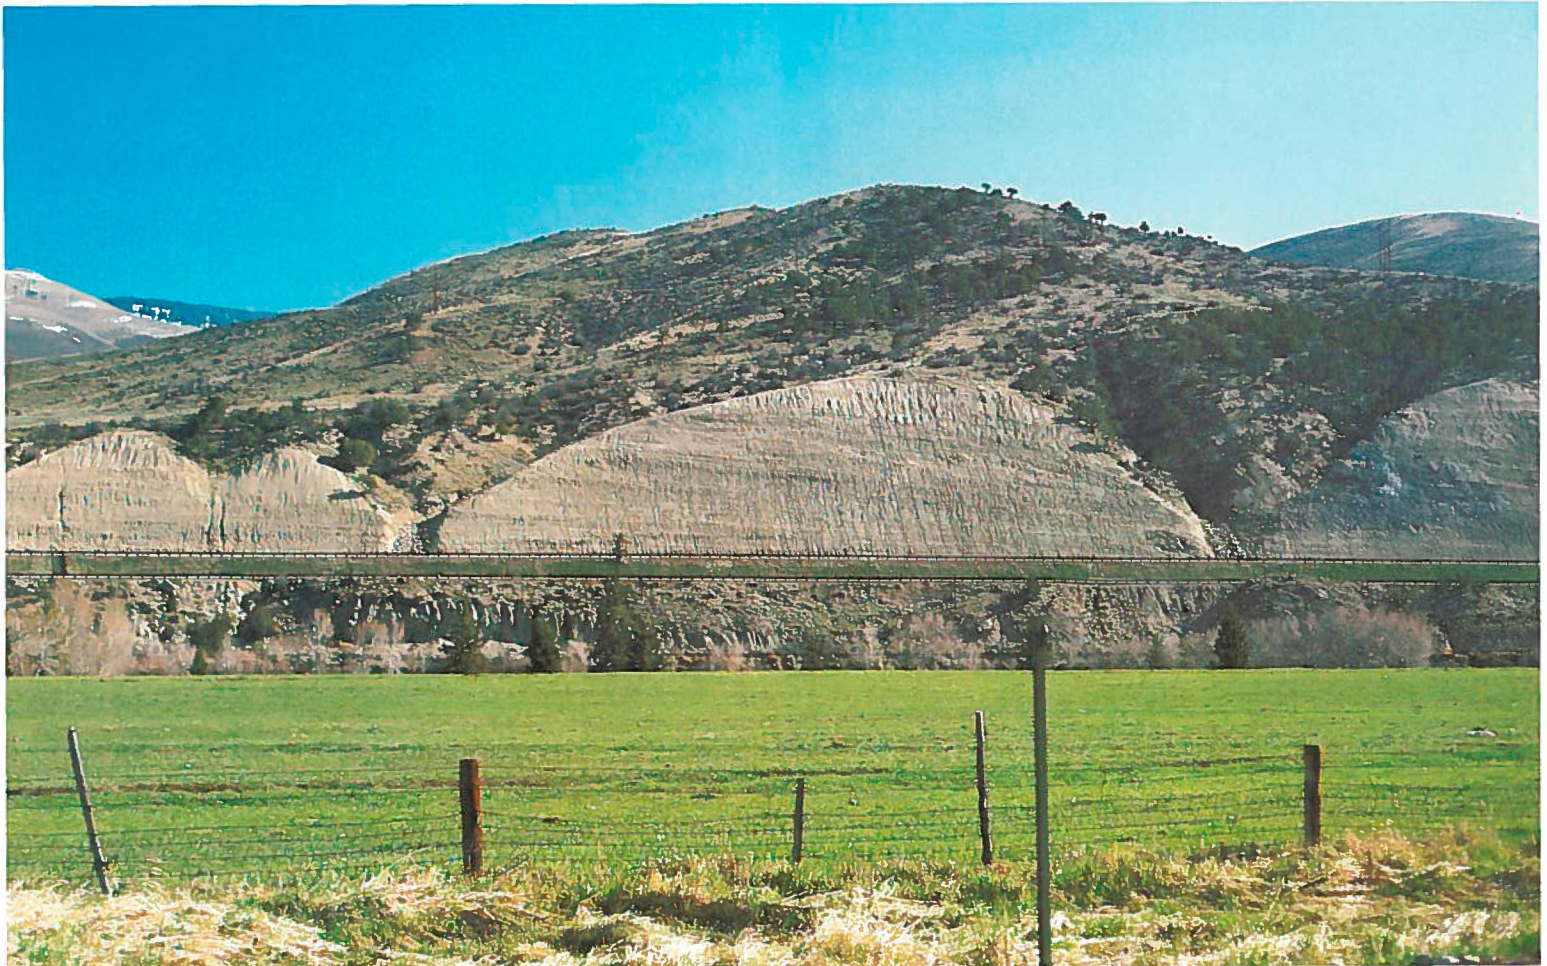
All of these slopes look artificial, no attempt was made to blend them into the natural topography. Slopes shown are too steep for revegetation and will continue to erode, creating major maintenance problems.

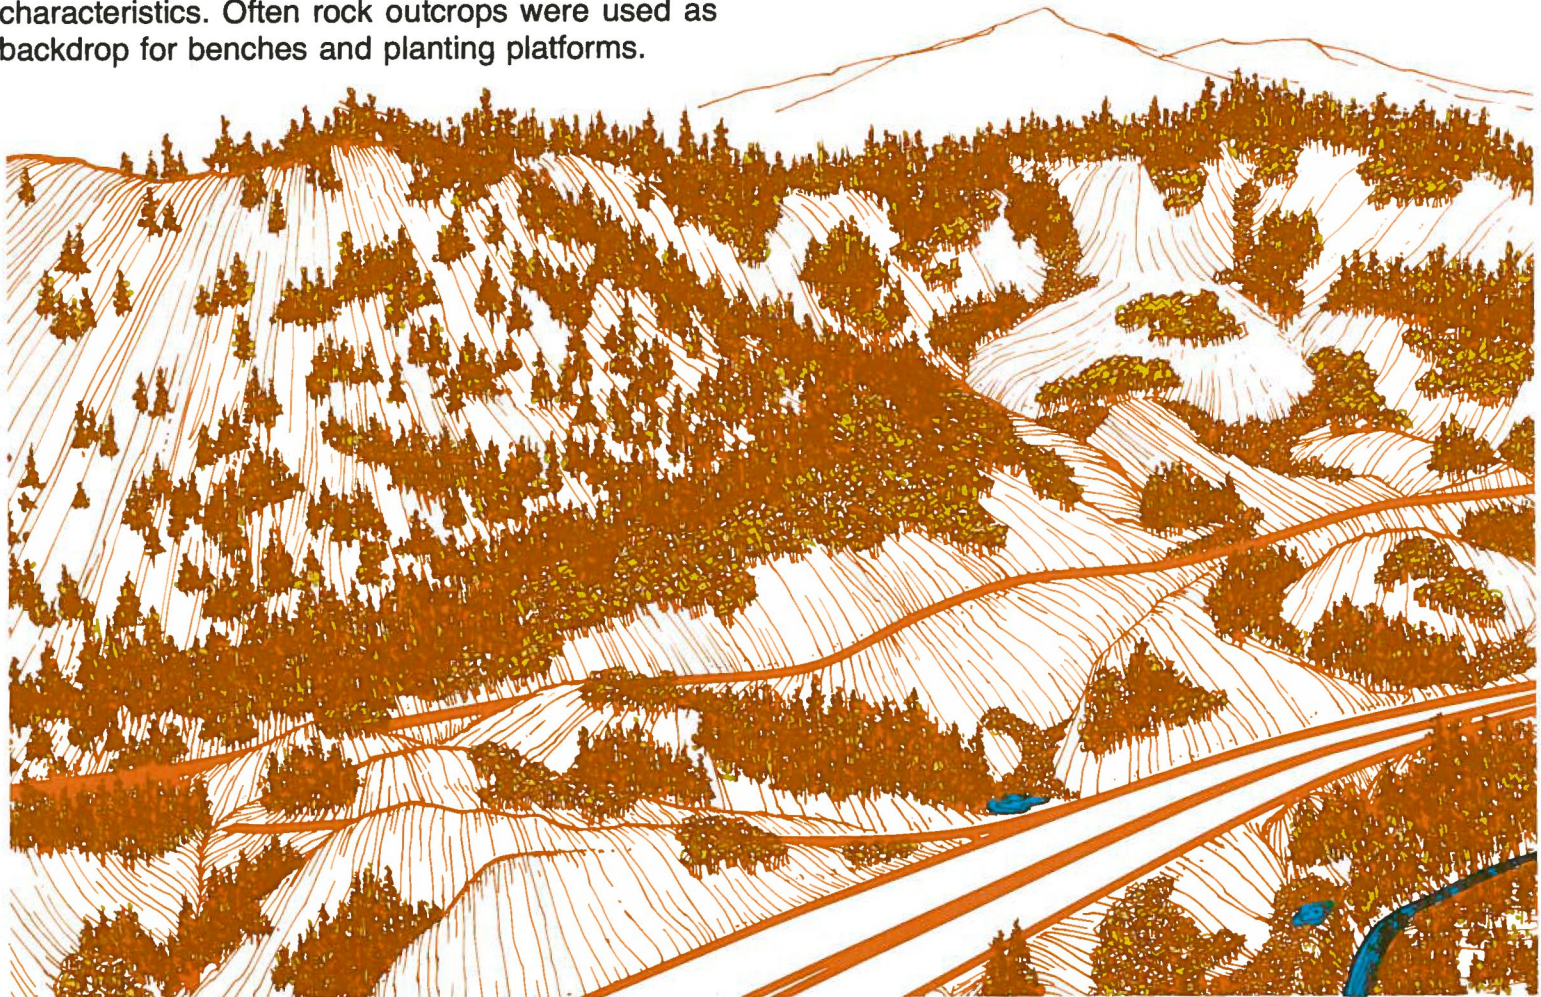
Landform diversity, vegetative edge treatment and use of on-site rocks create the needed diversity for a natural appearing highway slope.

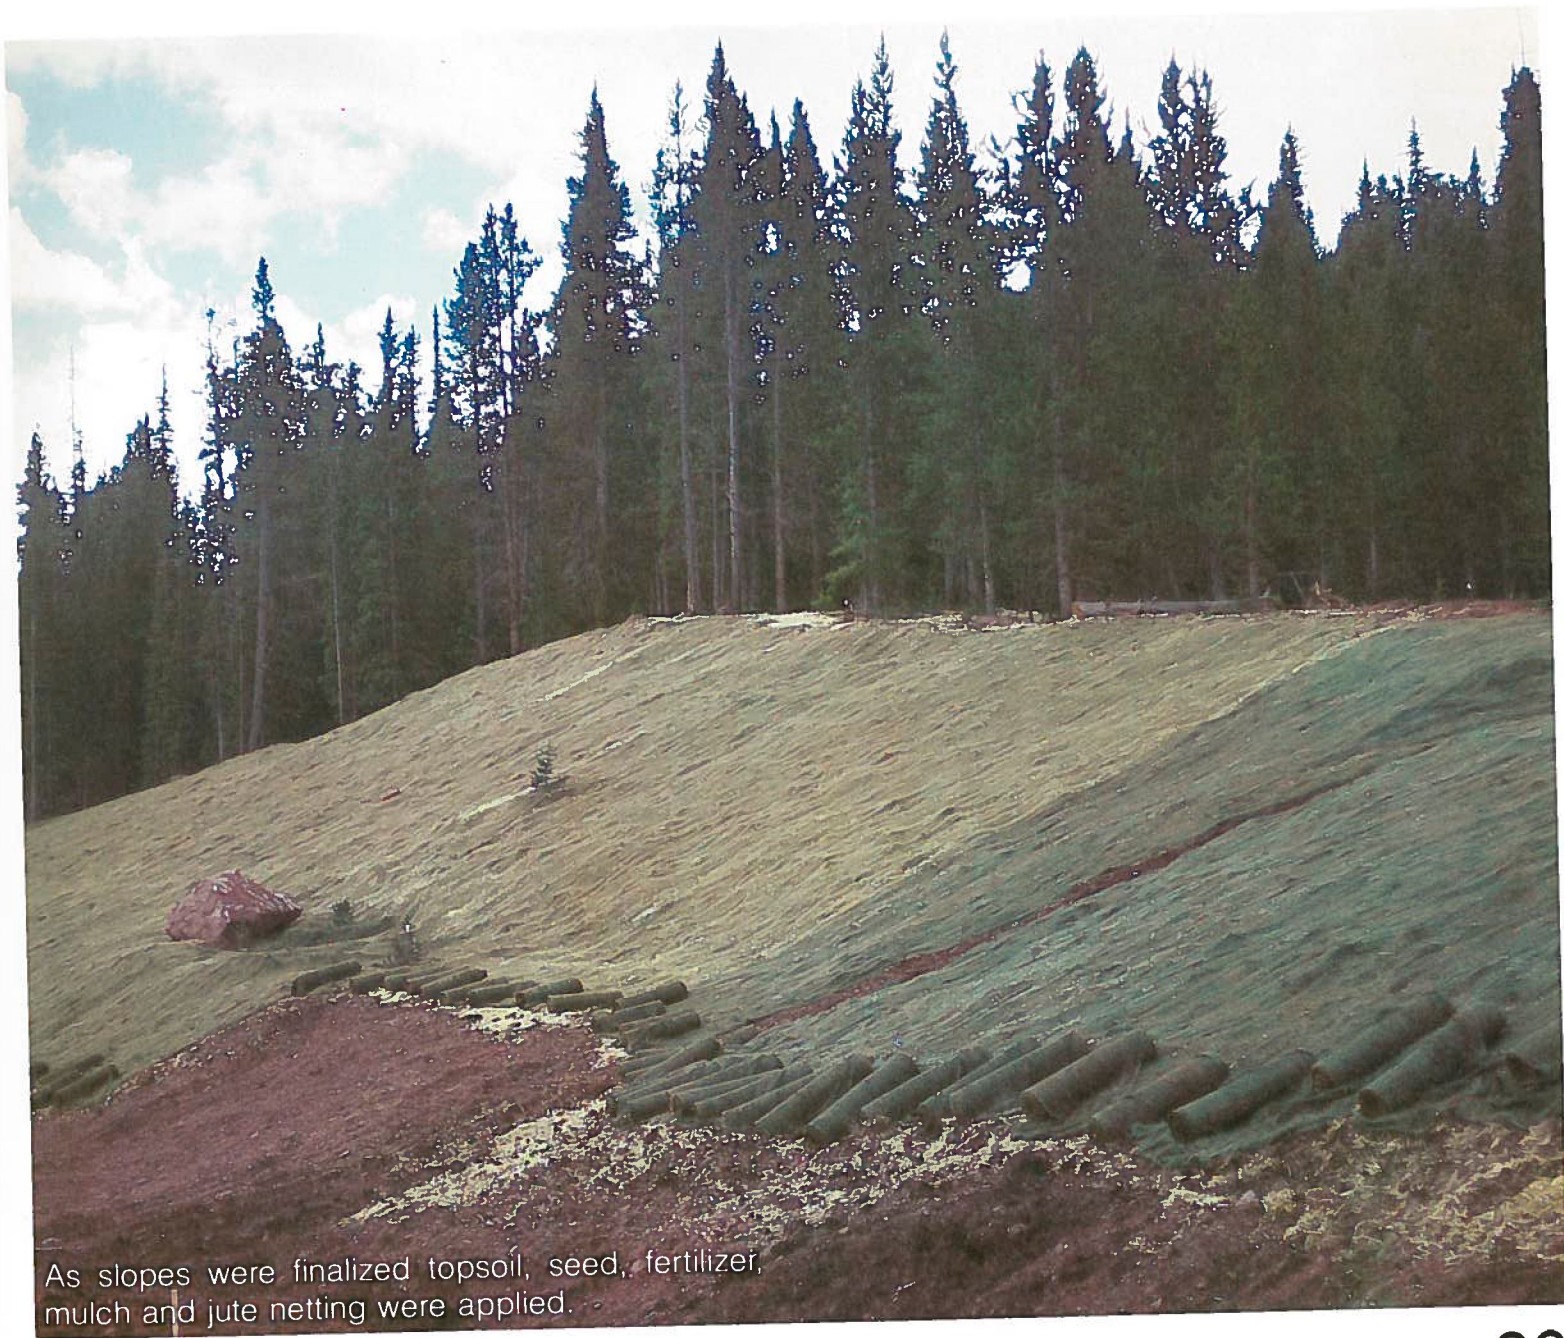
As slopes were finalized topsoil, seed, fertilizer, mulch and jute netting were applied.

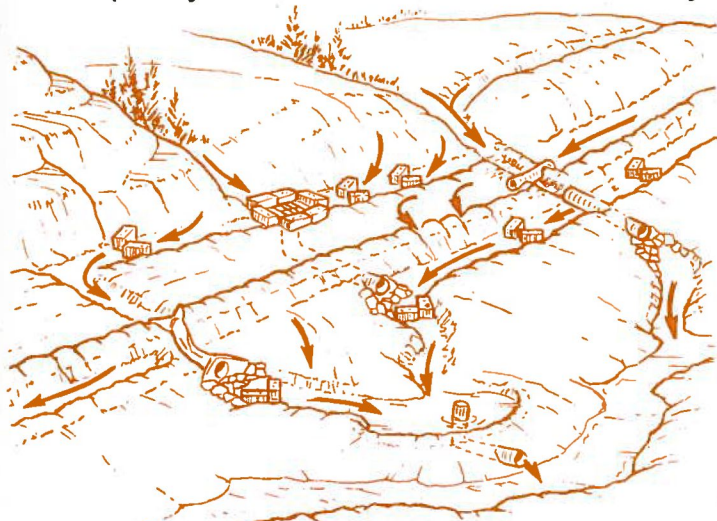
Without a comprehensive erosion control program, soil erosion from disturbed land into the stream would result. This drawing shows how clear water is diverted from the project area and how dirty water is treated before discharge into the stream.

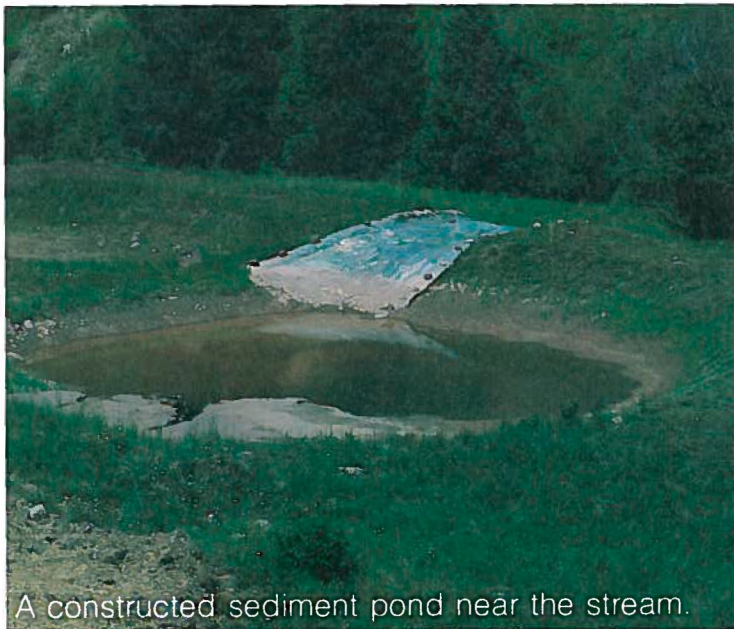
A constructed sediment pond near the stream.

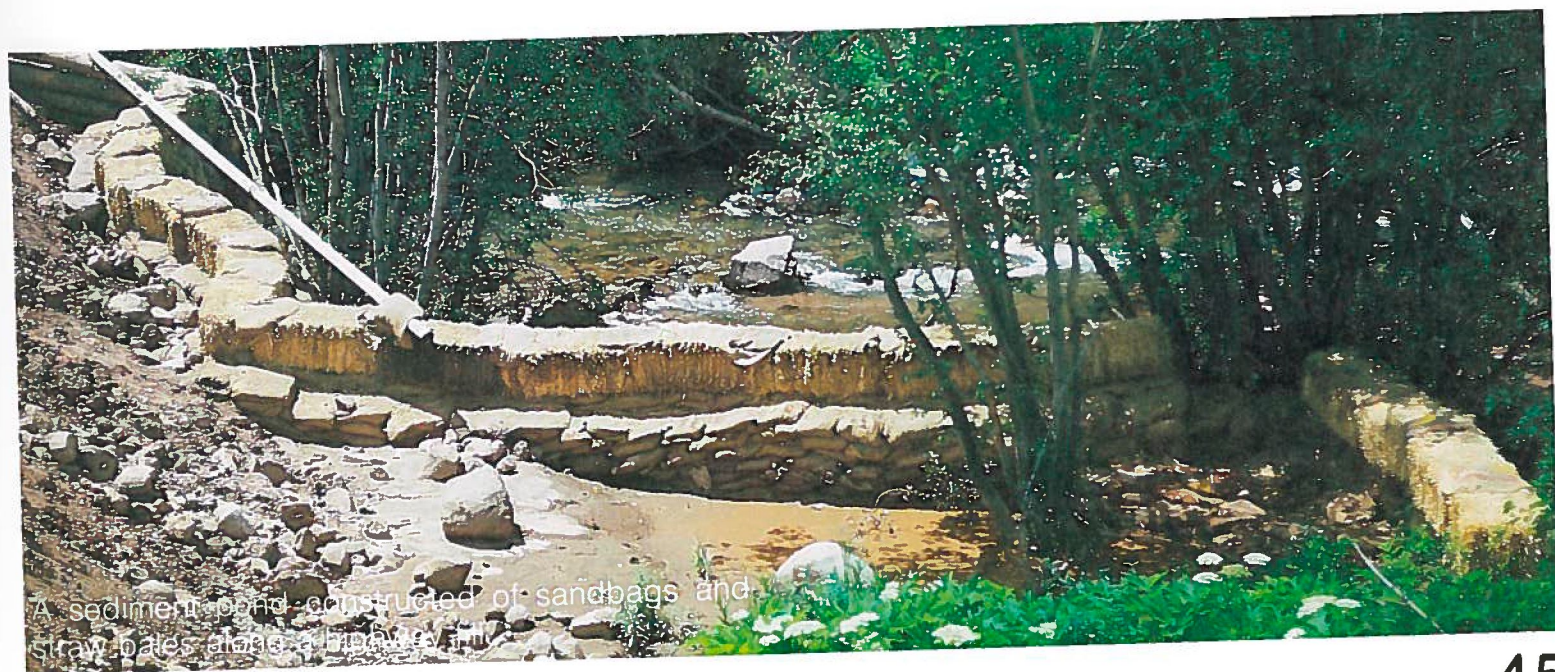
A sediment pond constructed of sandbags and straw bales along a highway fill.

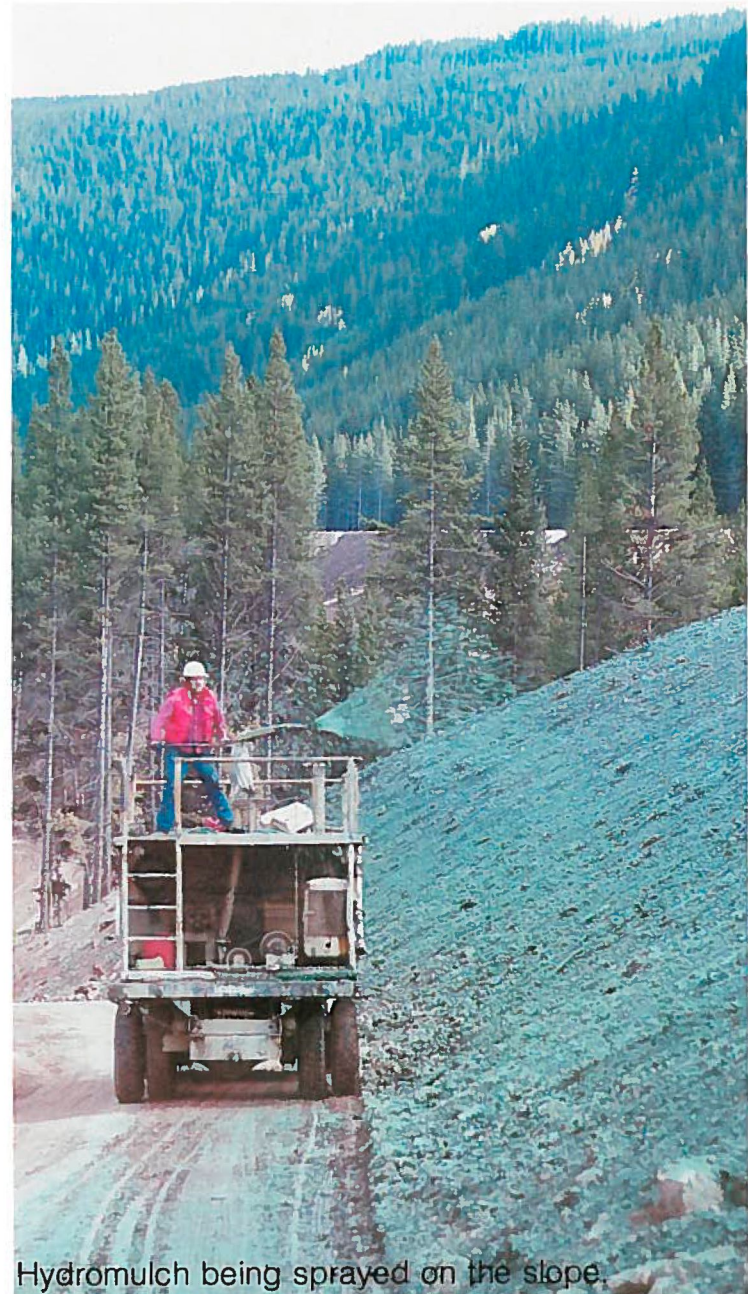
Hydromulch being sprayed on the slope.

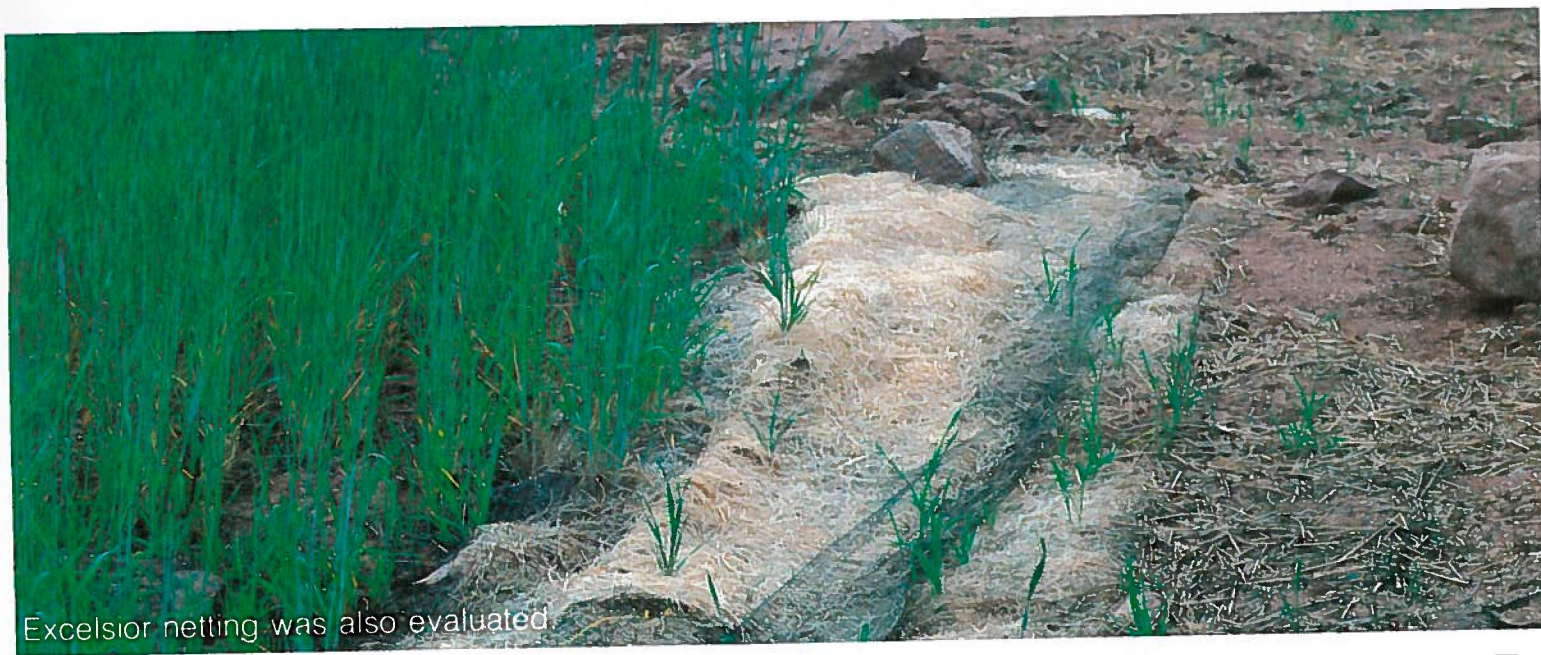
Excelsior netting was also evaluated.

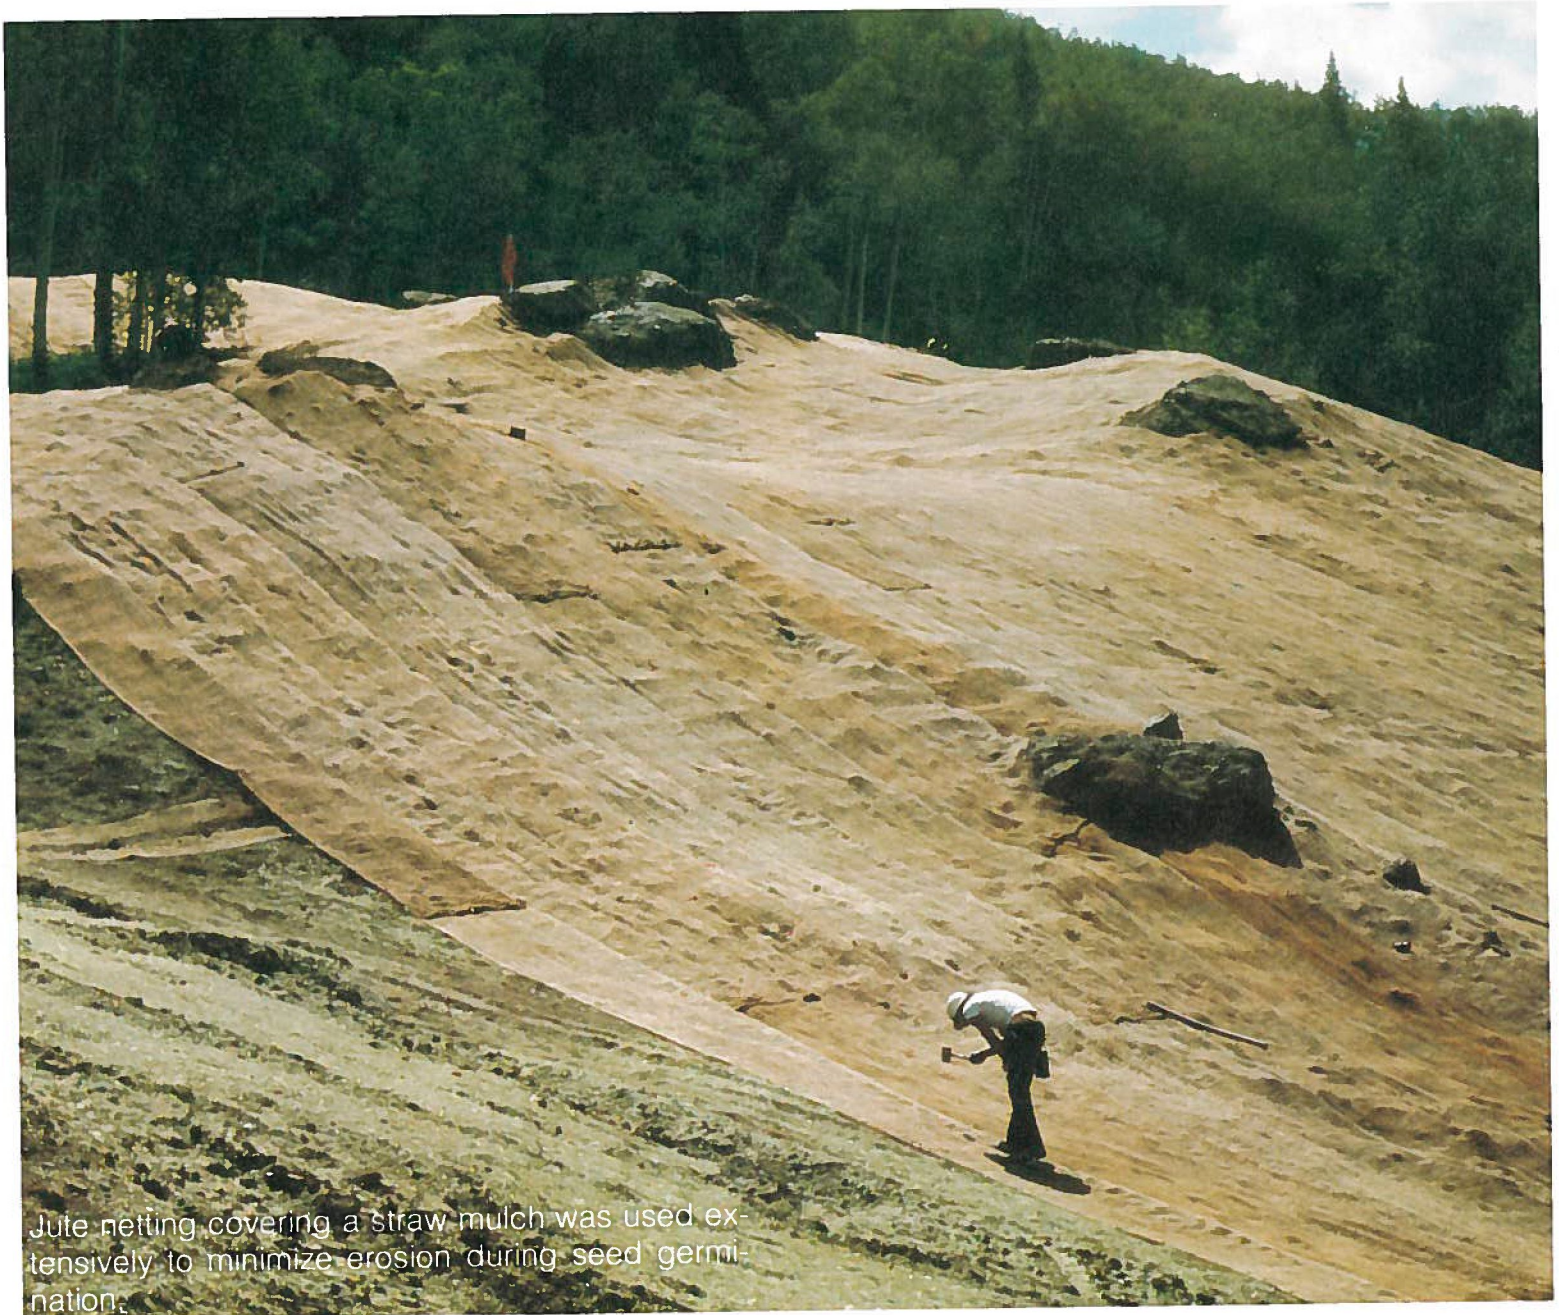
Jute netting covering a straw mulch was used extensively to minimize erosion during seed germination.

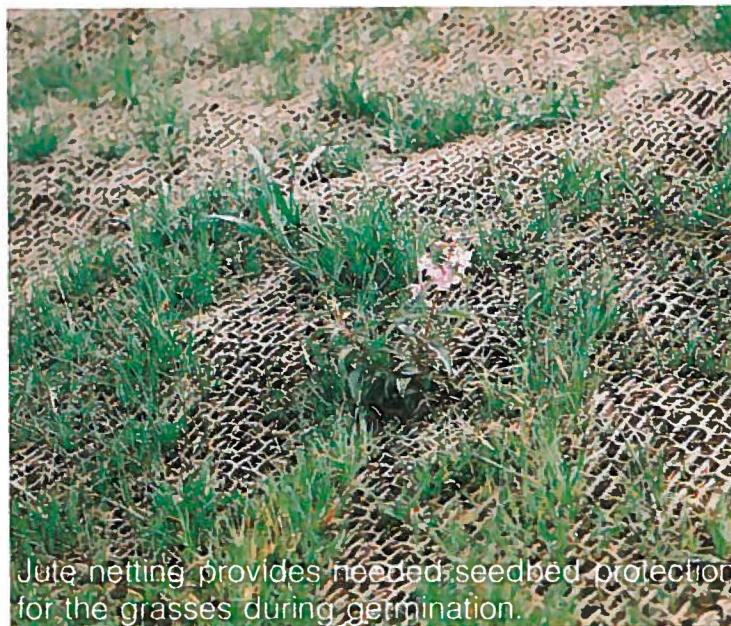
Jute netting provides needed seedbed protection for the grasses during germination.

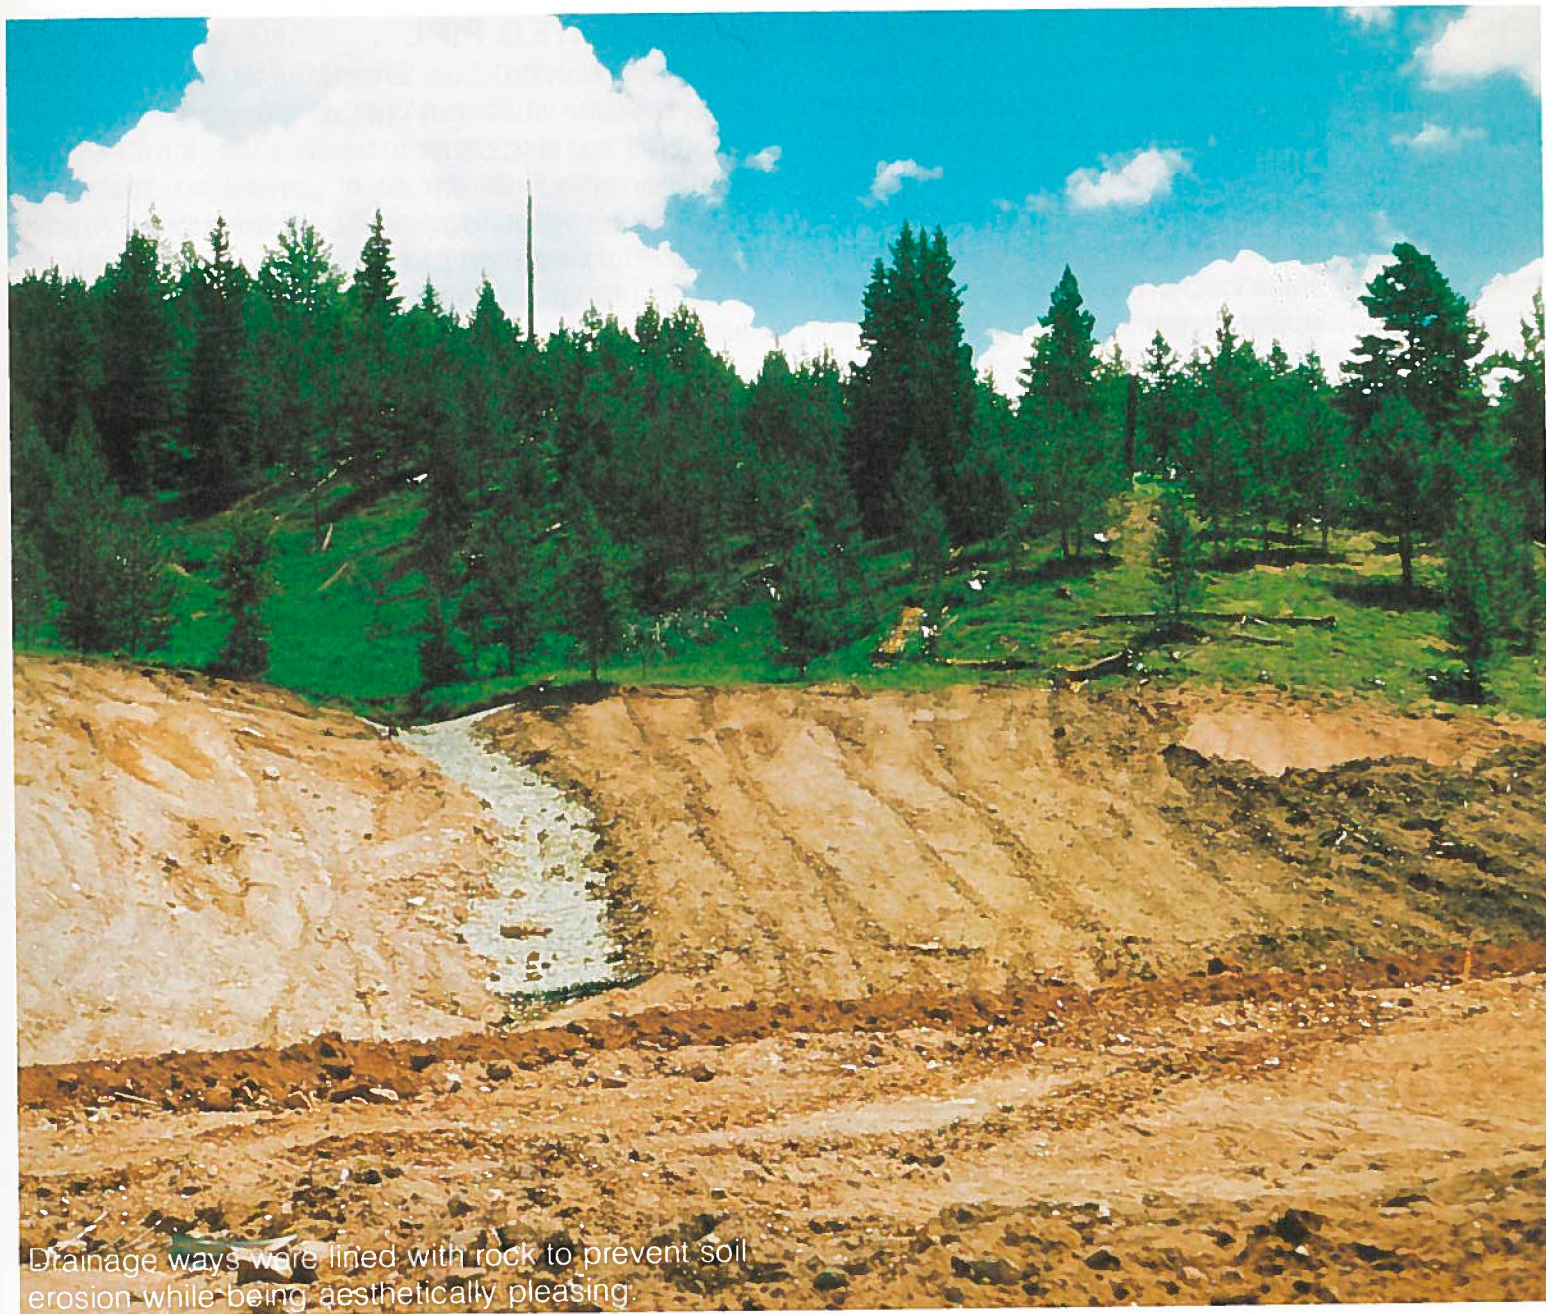
Drainage ways were lined with rock to prevent soil erosion while being aesthetically pleasing.

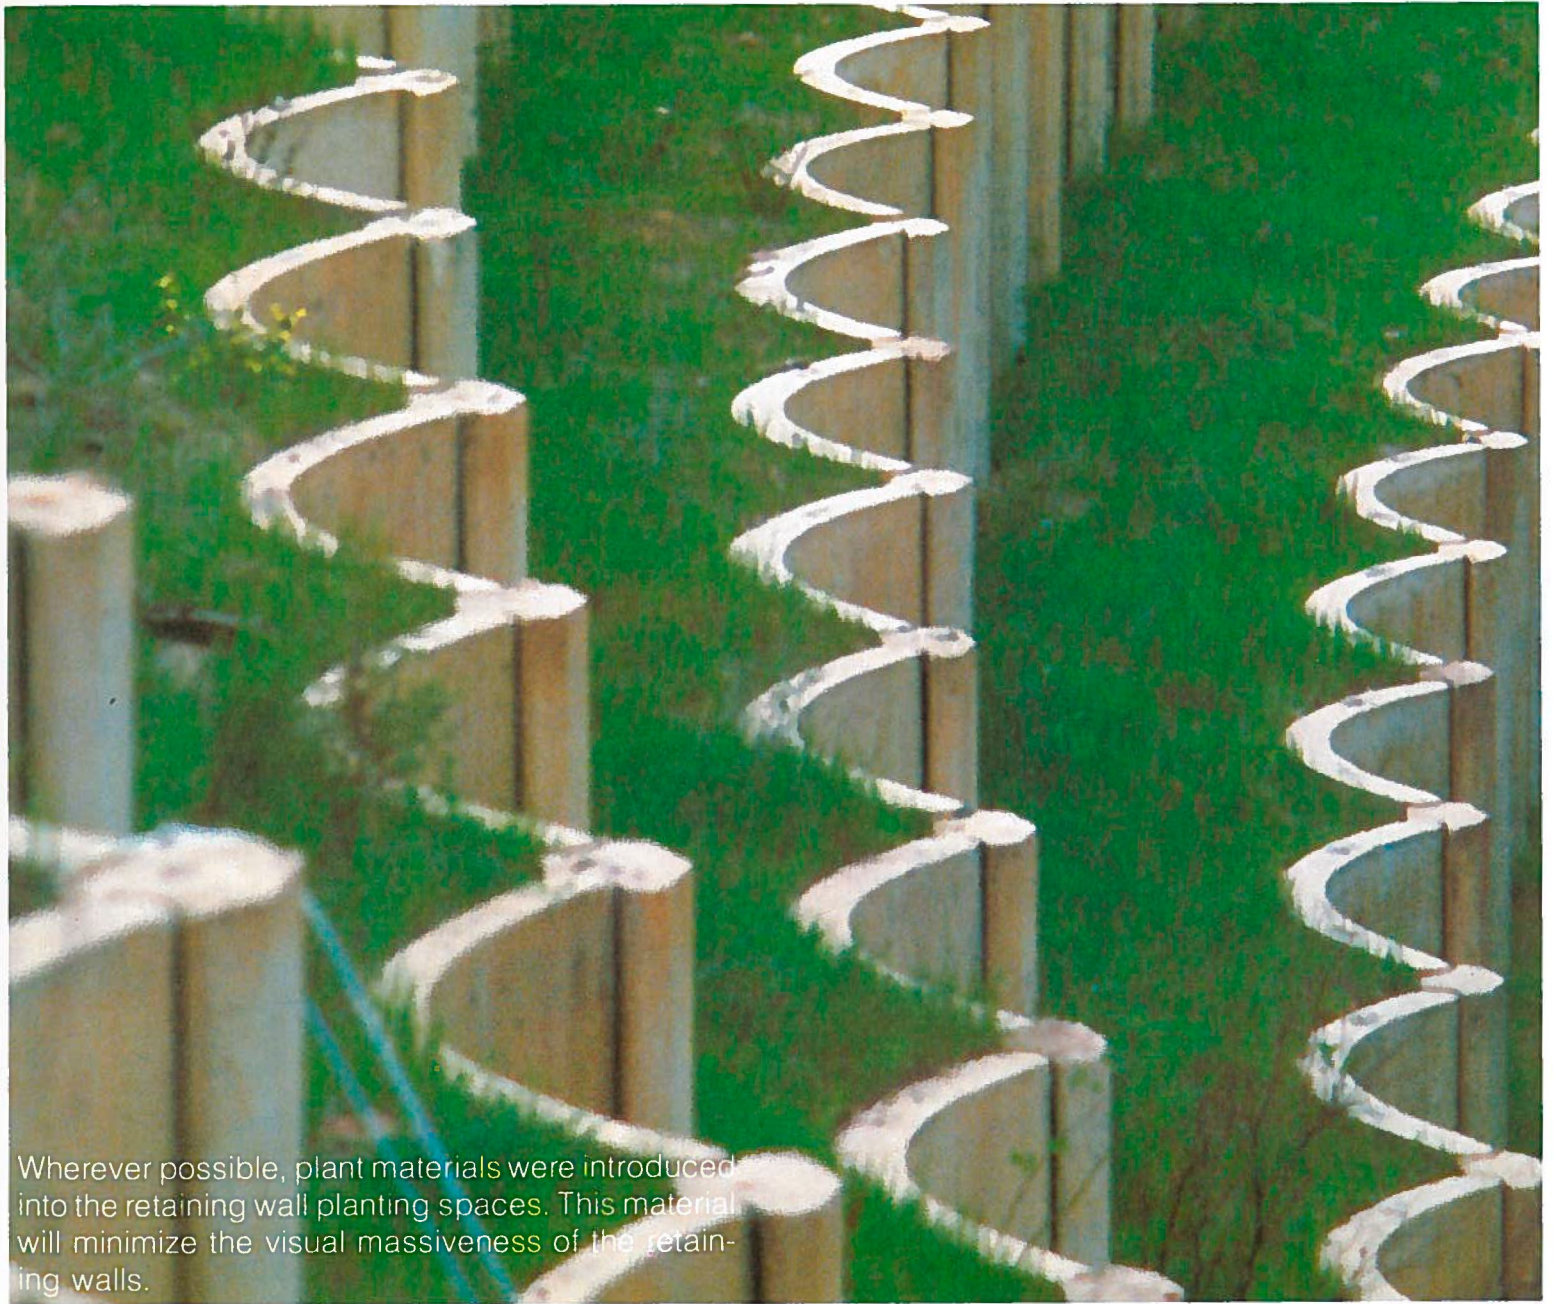
Wherever possible, plant materials were introduced into the retaining wall planting spaces. This material will minimize the visual massiveness of the retaining walls.
