U HOLD-GRO EROSION CONTROL SYSTEM 4

Lowell B. Steere
Colorado Department of Highways
4201 East Arkansas Avenue
Denver, Colorado 80222

Final Report
October 1978

HOLD-GRO EROSION CONTROL SYSTEM ON VAIL PASS
PROJECT I 70-2(51)193

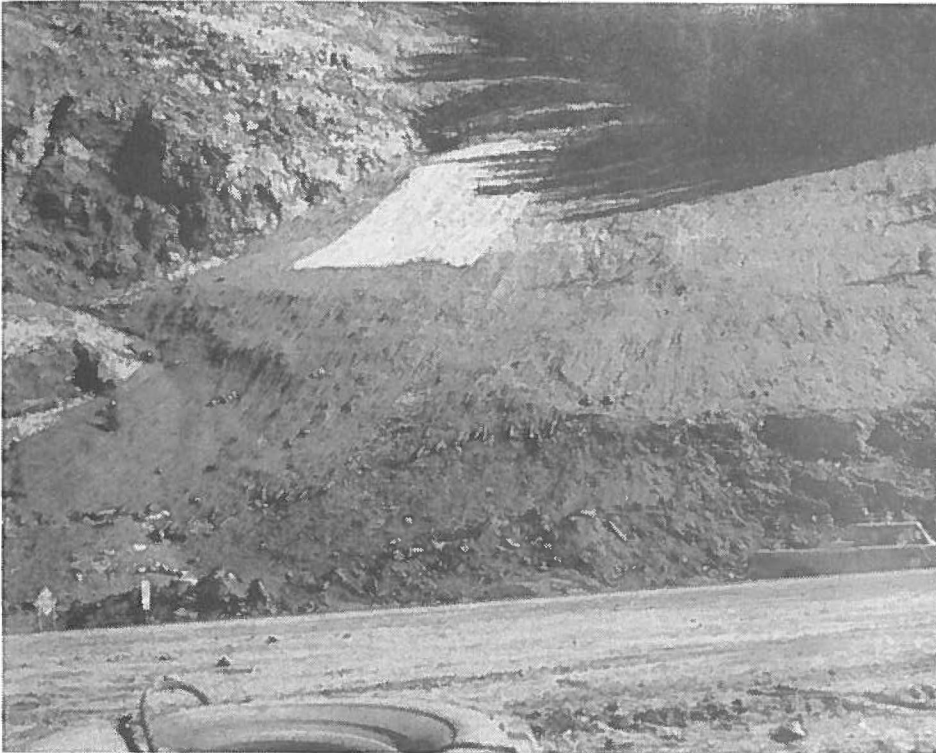
Photo No. 1 Taken 10/14/76
Vail Pass Hold-Gro Sta. 614+50
Installation Date - 10/12/76
(White rectangle upper center)

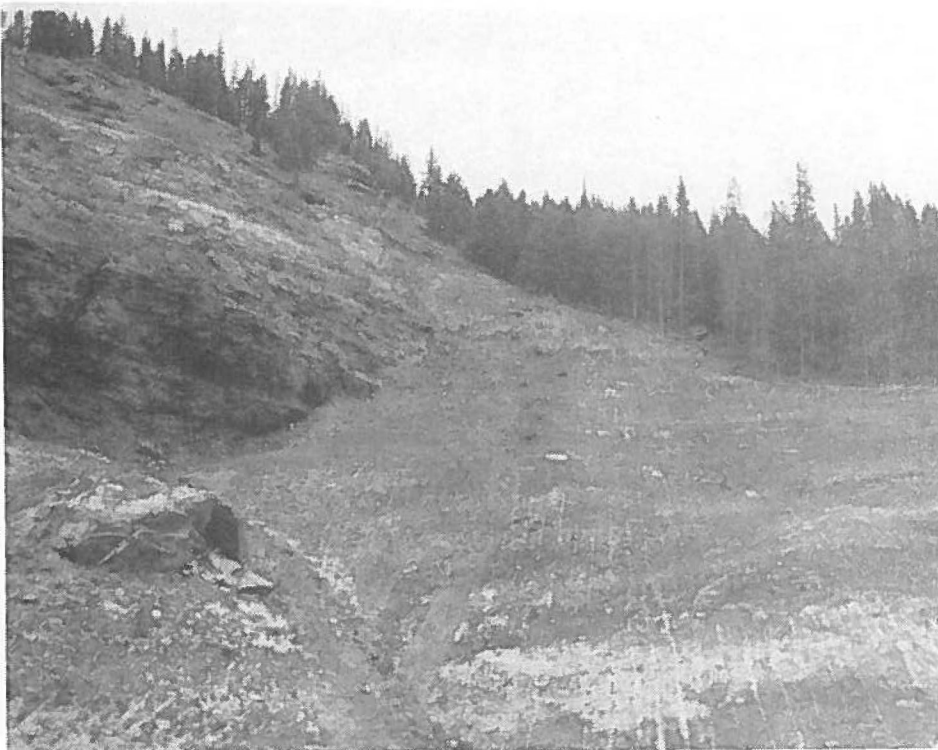
Photo No. 2 Taken 6/27/78
Same site as Photo No. 1
Shows rock and mud slide from
above partially covering test
site

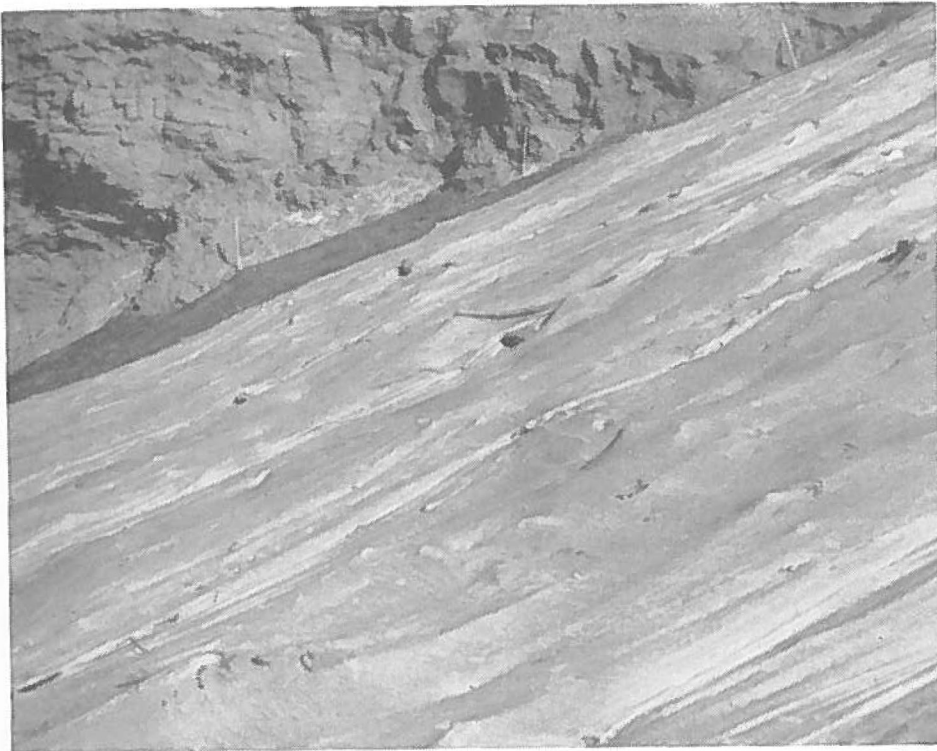
Photo No. 3 Taken 10/14/76
Same site as Photo No. 1
close up. Dark strip in
background is standard jute.

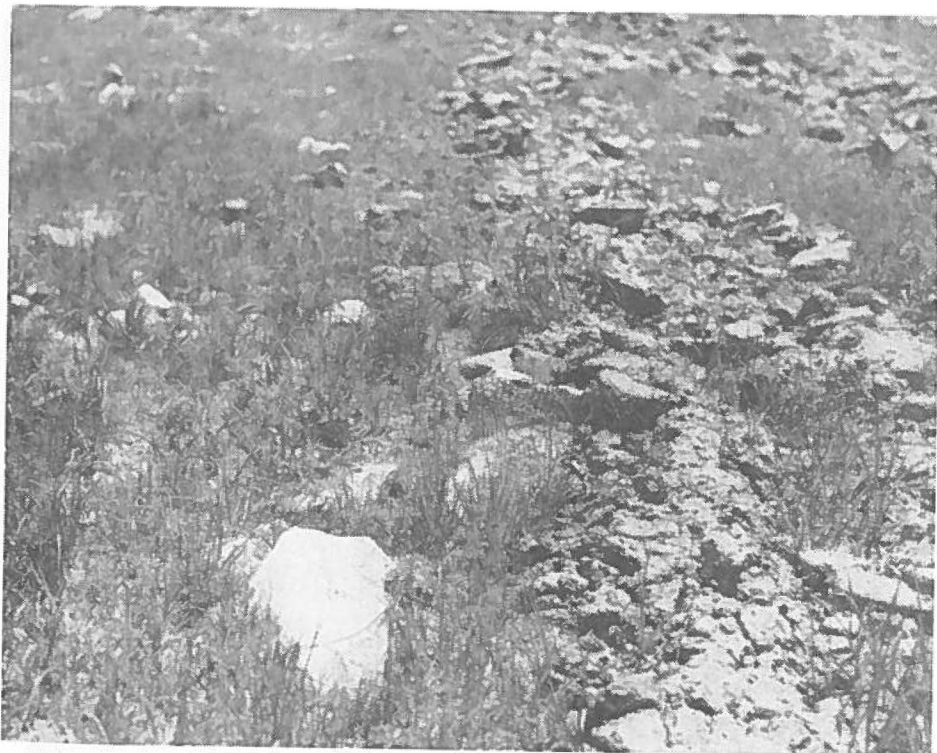
Photo No. 4 Taken 6/27/78
Same site as Photo No. 1.
Rock and mud slide deposit is
visible on right side. Hold-
Gro paper has disappeared
completely.

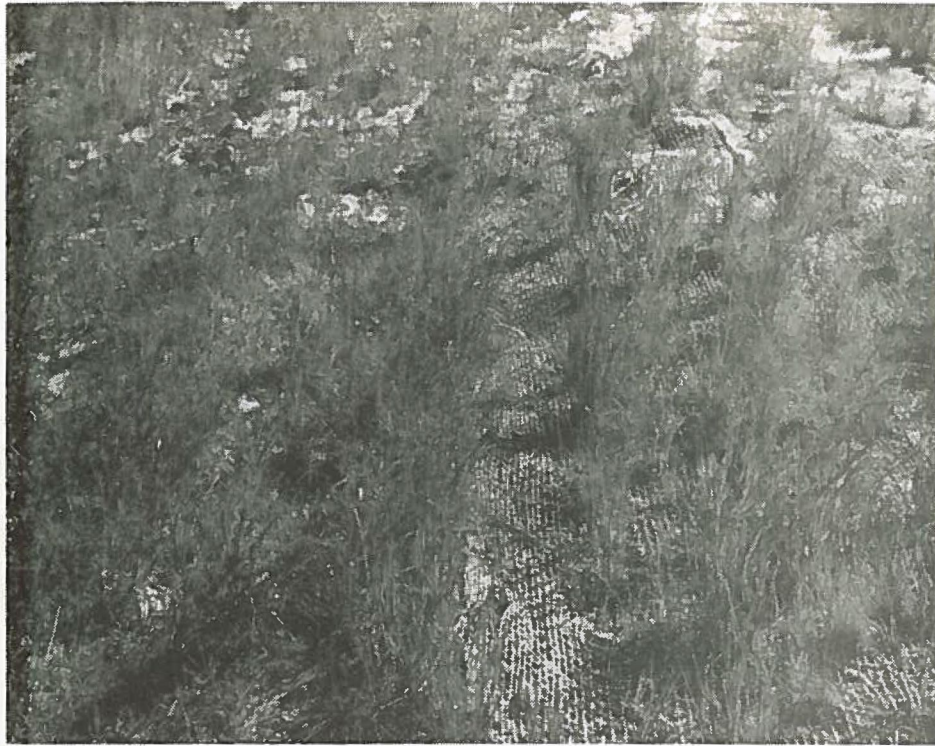
Early growth through jute appears to be faster and stronger but tends to form "tufts" or "bunches" through the grid pattern of the jute (see Photo No. 5). When the paper portion of HOLD-GRO dissolves, the growth through it soon equals the growth through standard jute in height and exceeds it in fullness and consistency of cover, (see Photo No. 8). Erosion of soil beneath both the HOLD-GRO and the standard jute was not a problem. Both products performed equally well in this respect.

Photo No. 5 Taken 7/24/78
Vail Pass Hold-Gro, Sta. 645+50
Installation Date: 10/15/76.
Hold-Gro is on left and
standard jute on right.

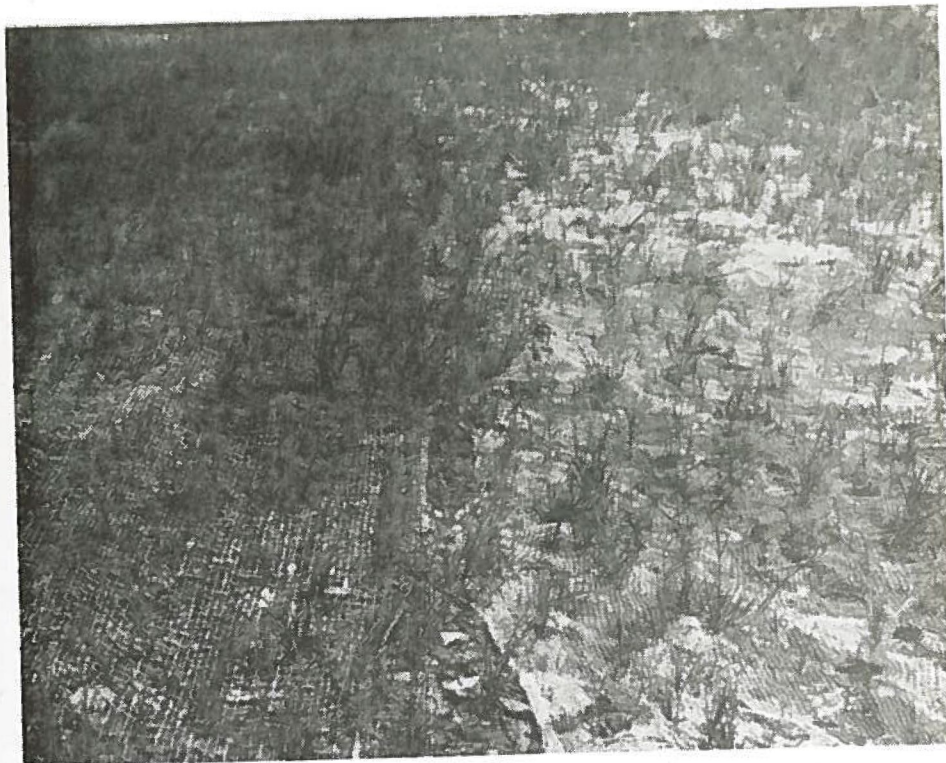
Photo No. 6 Taken 9/12/78
Vail Pass Hold-Gro, Sta. 654+1
Installation Date: 8/25/77
Standard jute on left, Hold-G
on right.

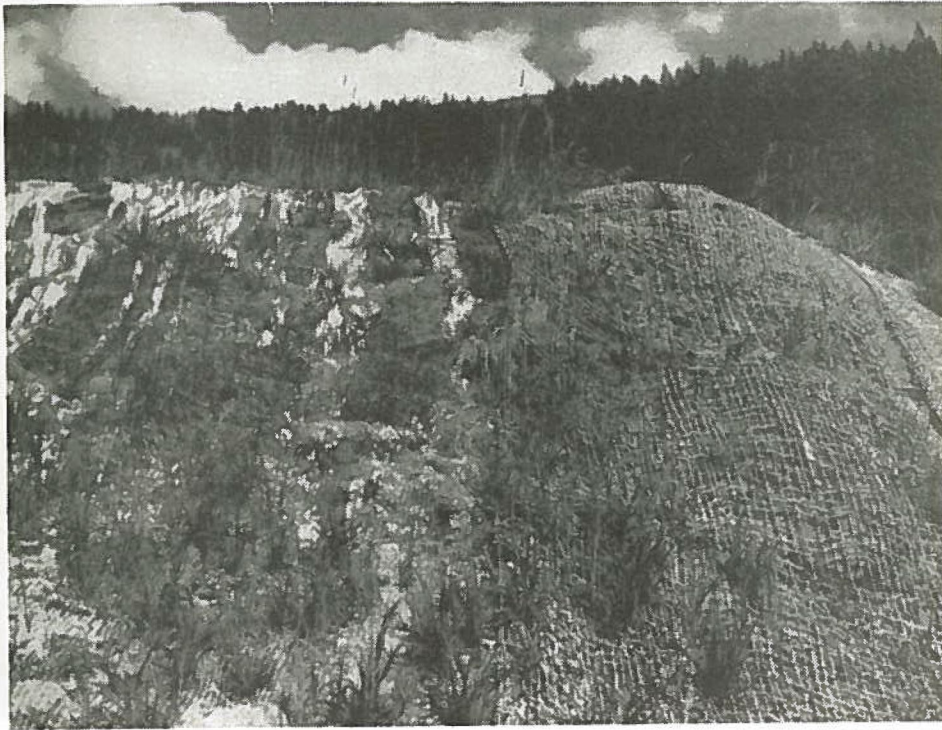
Photo No. 7 Taken 9/12/78
Vail Pass Hold-Gro, Sta. 654+50
Installation Date: 8/25/77
Hold-Gro on left, standard
jute on right. Rocky knoll at
top of medium fill slope.

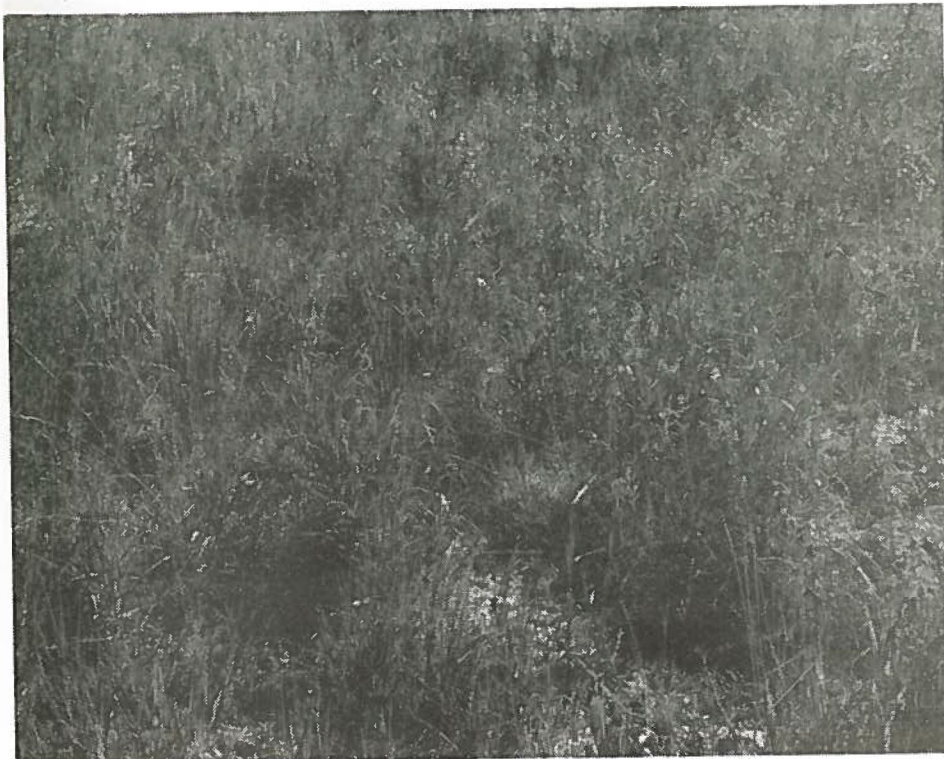
Photo No. 8. Taken 7/24/78
Vail Pass Hold-Gro, Sta. 645+50
Installation Date: 10/15/76
Hold-Gro on left, standard
jute on right, junction just
left of center of photo.

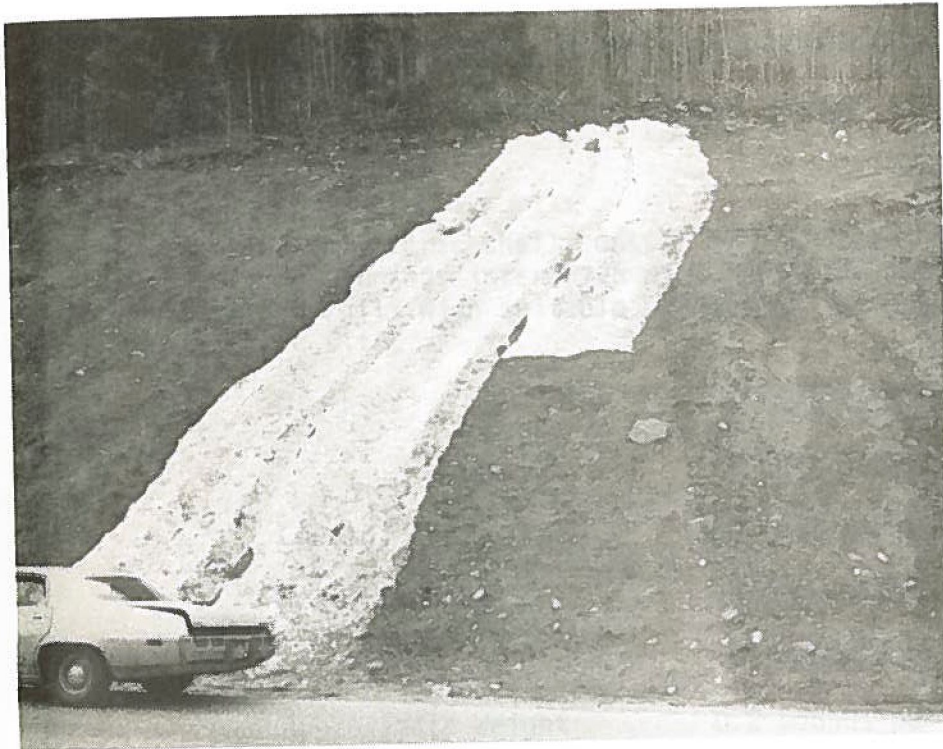
In the summer of 1976 a small installation (approximately 3600 square feet) of HOLD-GRO was placed on a medium cut slope near the foot of Berthoud Pass west of the village of Empire on Project RF 040-3(5). Again performance of the HOLD-GRO was at least equal to adjacent untreated and plastic mulch net covered areas. Photos Number 9 and 10 show this installation.

Photo No. 9 Taken 4/1977
Installation Date: Summer 1976
Near Berthoud, Colorado

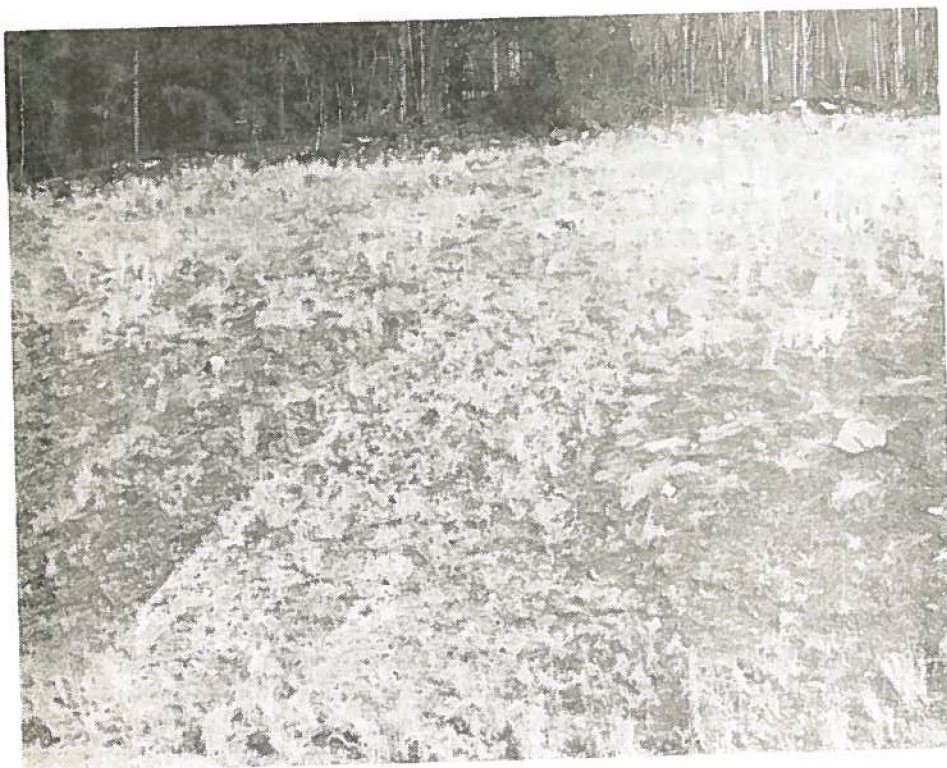
Photo No. 10 Taken 11/1978
Same location as 9 above.
