SELF-CONSOLIDATING CONCRETE REPAIRS ON INTERSTATE 25 BRIDGE ABUTMENTS NORTH OF MEAD

July 2013

COLORADO DEPARTMENT OF TRANSPORTATION
DTD APPLIED RESEARCH AND INNOVATION BRANCH

Report No. CDOT-2013-1

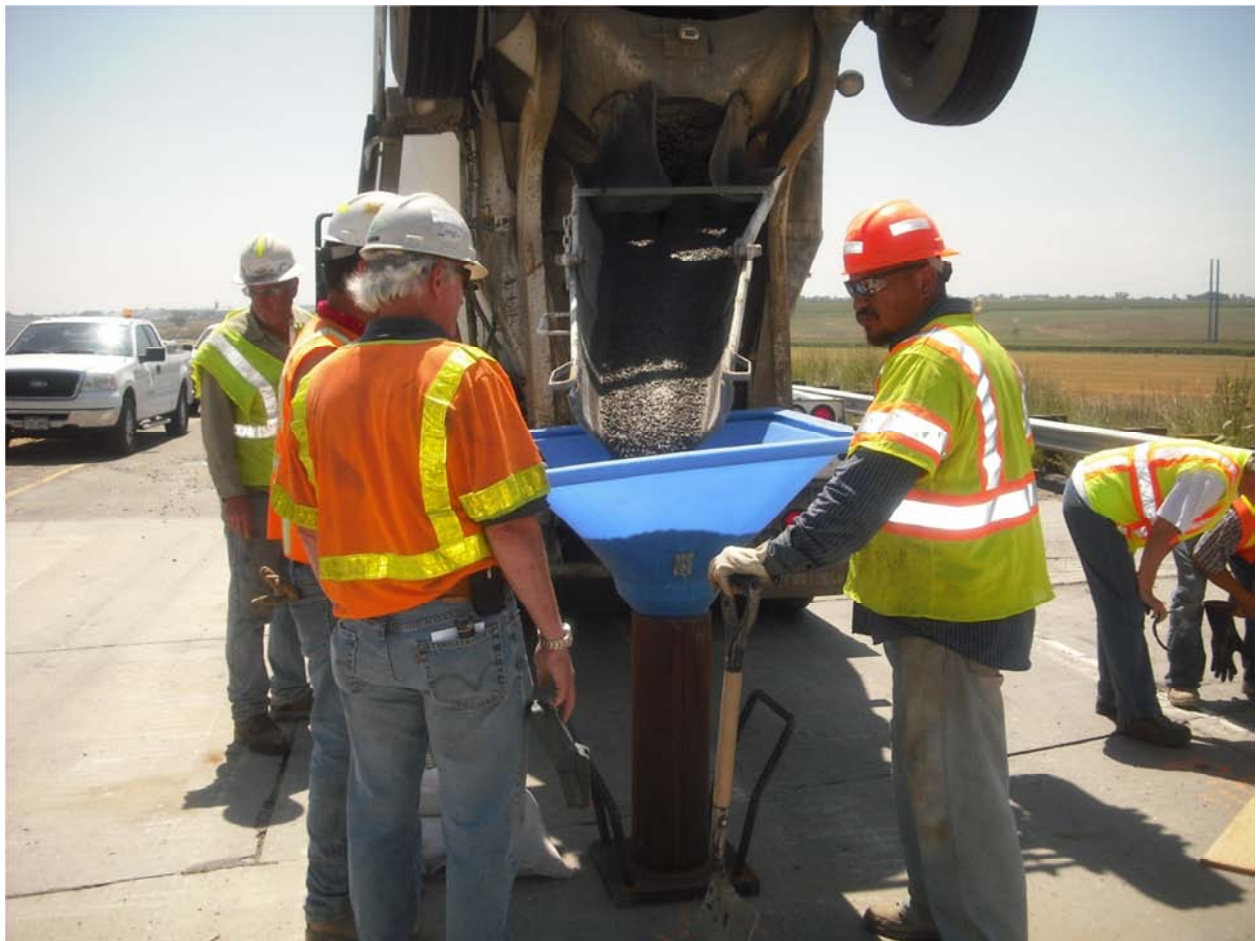
Figure 2: SCC Placement Funnel

The second repair operation aimed, similarly, to encase the girder ends in the southern abutment. This task was accomplished by placing SCC through the existing deck, and filling the abutment area between the girders. Holes were cored through the deck into each of the bays between the girders and above the overhangs. SCC was then poured from the trucks down into the holes, through the funnel system shown in Figure 2, filling up all bays with SCC.

Due to the cross slope of the deck and abutment, it was decided to begin placing the SCC near the transverse center of the bridge, allowing it to flow outwards in both directions. The east-side holes were at slightly higher elevation. Placing the SCC at the eastern-most hole and allow gravity and the concrete flowability to fill up all space was considered. However, it was decided to start the placement of the SCC at the central hole to reduce flow travel and avoid potential segregation. At the early stages, the SCC flowed both towards the lower end, as well as the

After the SCC reached the top of the placement hole, the funnel was moved to a hole at a higher elevation and placement resumed. During the relocation of the funnel, the covered holes were checked for SCC height and it was found that the SCC had lowered below the height of the deck. It was then decided to continue pouring until all holes were filled, including the highest elevation hole over the eastern overhang.

When the eastern overhang hole had SCC at its brim, the placement through the funnel was stopped. Each hole was checked for SCC height. It was found that all of the holes had a small drop of the SCC level. This was expected due to the self-leveling of the SCC. However, the placement hole (at the highest elevation) was full and no further SCC could be poured without spilling and getting the SCC to push up in the other bays. Thus, it was decided to finish off the tops of the lower holes by placing SCC in from the top AFTER tamping with a rod to avoid the formation of a cold joint between the two different concrete placements. It should be point out here, that SCC has a thixotropic characteristic, where it appears to set fairly quickly (within a few minutes). However, a small vibration or disturbance by rodding returns it into its more fluid state. This property was used when the holes were topped off to avoid cold joints.

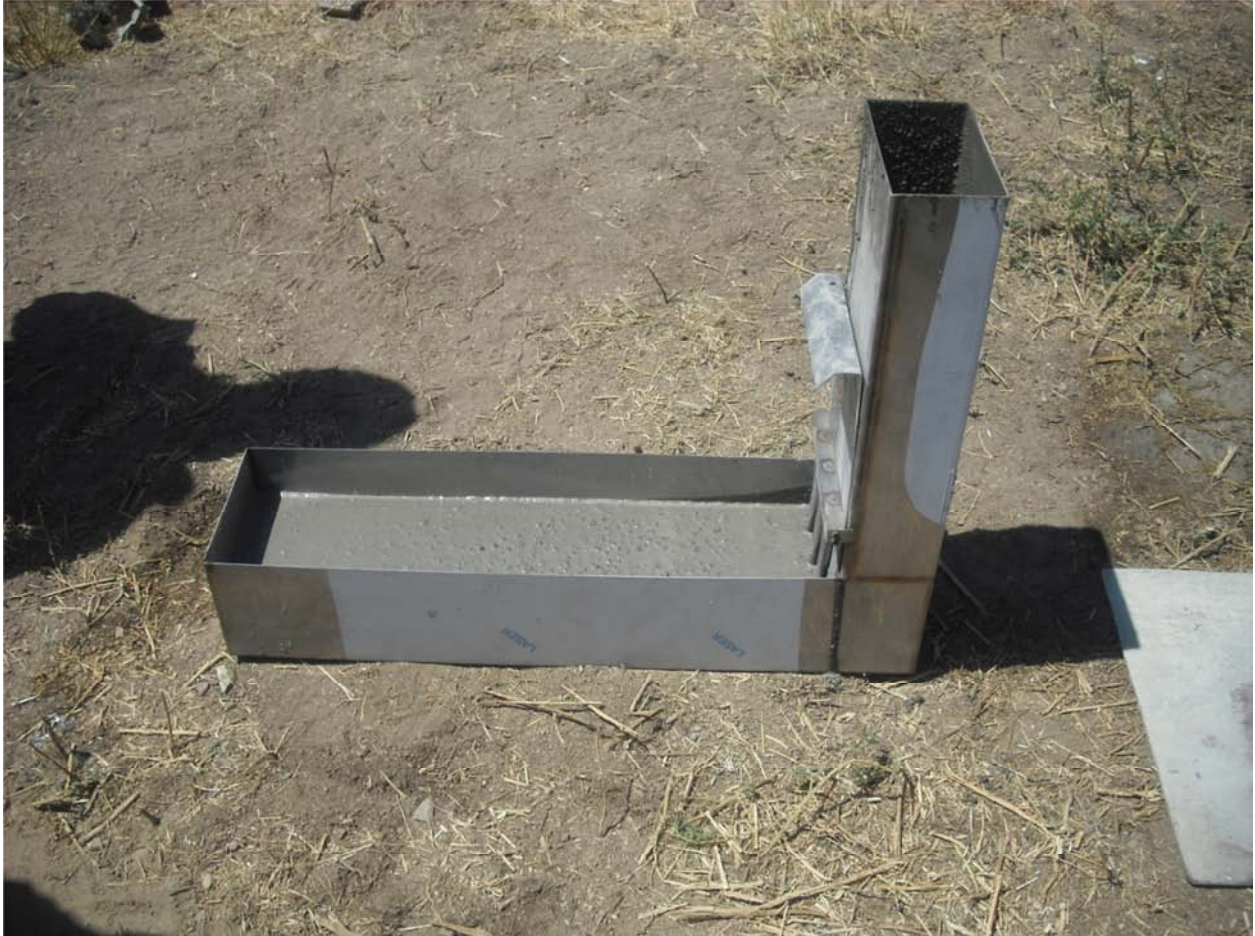
Figure 5: SCC L-Box Test

The L-Box test is used as another indication of SCC ability to pass through tight spaces and retain its self leveling attributes. As demonstrated in Figure 5, the SCC delivered for the project did not show any indication of being restricted in the L-box test and was approved on-site.
