# Upper Slate River Watershed Plan

**Prepared For:**  
The Coal Creek Watershed Coalition  
Upper Slate River Steering Committee  
PO Box 39  
Crested Butte, CO 81224  
[www.coalcreek.org](http://www.coalcreek.org)

**Prepared By:**  
Ashley Bembenek  
Alpine Environmental Consultants LLC

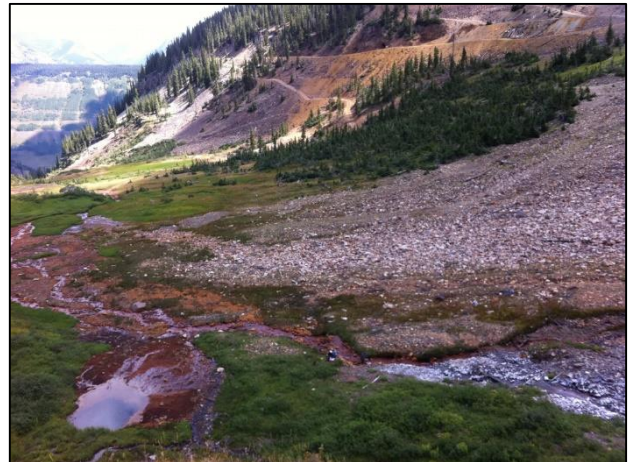
A view of Redwell Basin. The orange slopes on the upper right of the photo are a part of the Daisy Mine, the drainage tunnel is located in the lower portion of the mine waste. In the lower right of the photo, flow from the Drill Hole enters Redwell Creek. The Redwell is in the lower left of the photo. Photo Credit: Nicki DeVanni (2011).

In the early 1970s, many holes were drilled to characterize the molybdenum deposit beneath Mount Emmons. In Redwell Basin a drill hole, located in the upper portion of the basin, was improperly abandoned. The Drill Hole penetrates the molybdenum deposit and allows water to flow under pressure to the surface. It delivers poor-quality groundwater to Redwell Creek. At the Drill Hole, metal concentrations increased dramatically over upstream locations in Redwell Creek.

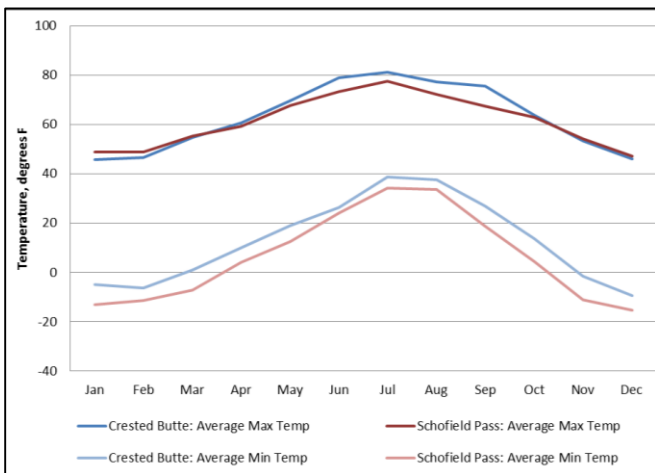
**Figure 3.** Average monthly minimum and maximum temperatures in degrees Fahrenheit from the Crested Butte and Schofield Pass SNOTEL sites.

The warmest average temperatures, which range from 72 to 81 degrees Fahrenheit, occur in June, July, and August at both climate stations (Figure 3). From November to March the average low temperature remains below zero (Figure 3). The average low exceeds freezing (32° F) in June or July (Figure 3). The average monthly low temperatures do not exceed 40 degrees Fahrenheit at any point during the summer (Figure 3). Which indicates that, on average, frost is possible most days of the year.

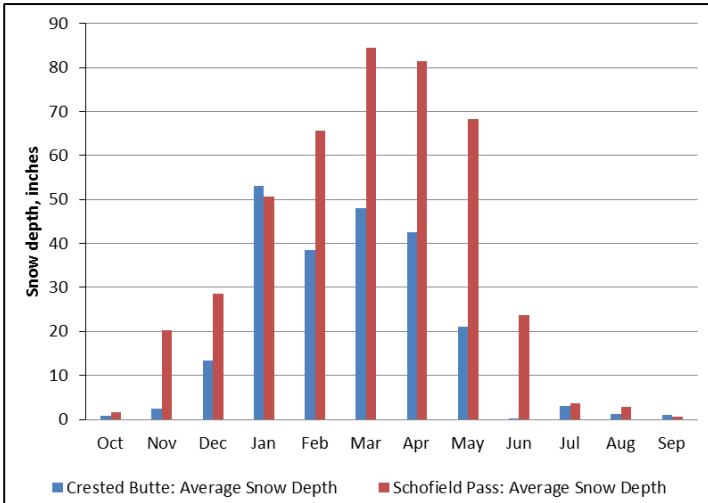
**Figure 4.** Average monthly snow depth, in inches, from the Crested Butte and Schofield Pass SNOTEL sites.

In most years the snowpack remains present at the climate station or snow falls at some point during each month (Figure 4). The Crested Butte site is on a north facing slope and the Schofield Pass area typically has a large “snow plug” that persists through most of the summer. The snow plug is created by avalanche debris from the shoulder of Mount Baldy. So, the summer snowpack found at these sites is not particularly representative of conditions through out the Watershed. But there are certainly snow fields at selected elevations on leeward slopes or where avalanche debris accumulates (Photo 3).

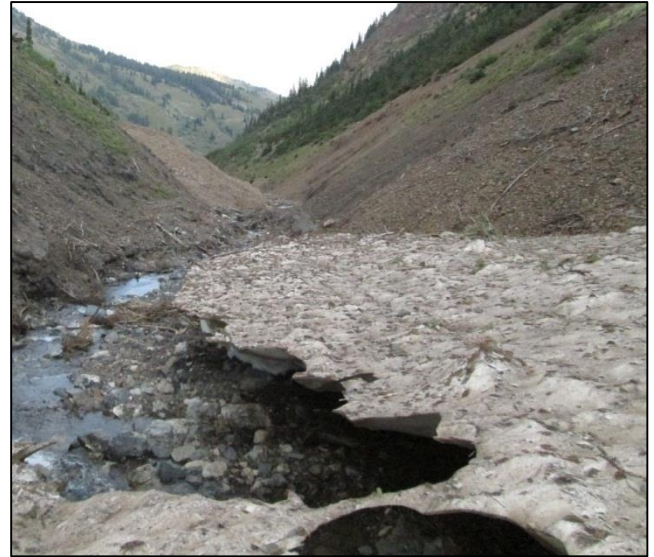
**Photo 3.** Avalanche debris forms snow and ice bridges over the headwaters of the Slate River. This photo was taken on August 8, 2012; which demonstrates that even during drought snow can linger in certain places in the Watershed.

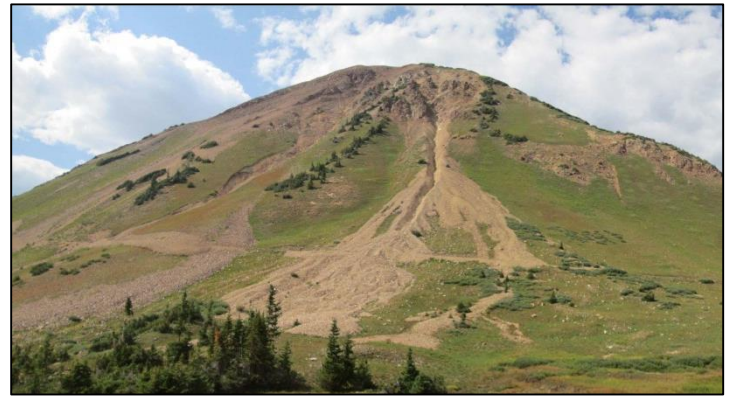
**Photo 4.** Evidence of mass erosion on the slopes of Cinnamon Mountain in the headwaters of the Watershed. Photo courtesy of Alpine Eco.

Due to the steep slopes and the materials found on the slopes, hillslopes in the headwaters areas are naturally susceptible to mass erosion which includes landslides, earth flows, debris avalanches, debris flows, torrents, and snow avalanches. These sporadic events provide massive and natural sediment sources (Photo 4). Evidence of recent mass erosion is very common throughout the headwaters area. These events form the background that human impacts must be evaluated against.

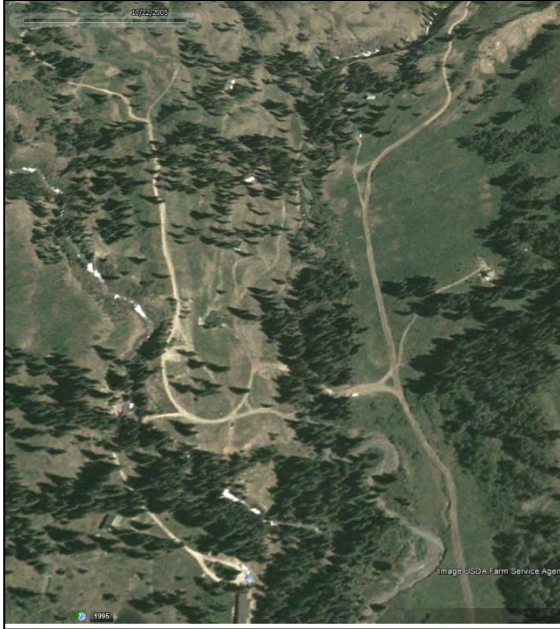
**Photo 5.** The Slate River near Poverty Gulch in 2006. Note where the river exits the canyon and enters the broad valley near the top of the photo. At this time the conifer stand above the Poverty Gulch Road crossing was alive and the river channel passed through the center. Image courtesy of Google Earth and the USDA Farm Service Agency.

“The magnitude of the deposition in the Slate River near Poverty Gulch is dramatic, yet it is very likely natural” -Alpine Eco (2012).

Previous reports suggest that the Slate River Ranch, a piece of private property about one-third of a mile below the Poverty Gulch Road crossing, was mined for gravel (HRS, 1995). Whether or not the property was actively mined, the river channel was realigned, excavated, and an artificial pond was installed. The channel realignment caused channel incision on the reach which may have traveled upstream and likely led to sediment deposition in downstream reaches (HRS 1995; Alpine Eco, 2012). Livestock grazing and other management activities have shifted the riparian vegetation from woody shrubs to primarily grasses and forbs. Together these activities have contributed to downstream and upstream channel change and sediment deposition (HRS, 1995; Alpine Eco, 2012). Alpine Eco (2012) noted that this reach was one of the only reaches in the Watershed where riparian vegetation has been heavily disturbed.

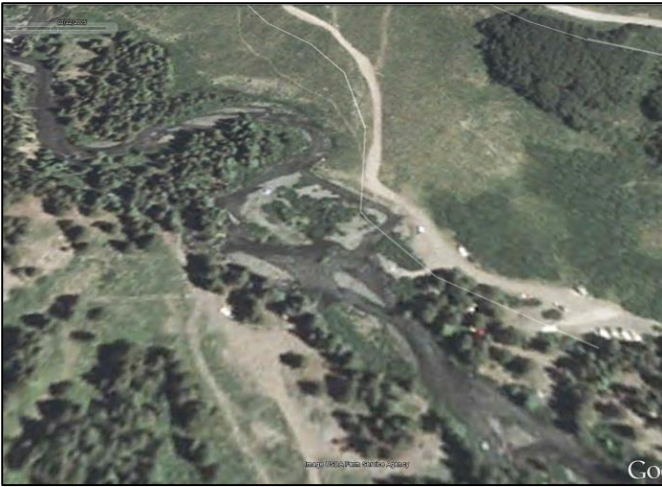
**Photo 7.** The Slate River near the Oh-Be-Joyful Campground in 2005. Note the large meander bend and complex braided channel near the Campground. Image courtesy of Google Earth and the USDA Farm Service Agency (2005).

In 2011 the Slate River and adjacent areas continued to adjust to the new channel alignment. It became apparent that several large trees in the Campground were likely to be lost to the river as well. This stretch of river is an incredibly popular recreation site. The Campground is consistently full during the spring, summer, and fall. The river ford allows hikers and other recreationists improved access to the Oh-Be-Joyful Pass Trail, which is a popular access point to the Raggeds Wilderness Area. Given the value of this recreation site, the BLM initiated a bank stabilization and improvement project in the fall of 2012. Large boulders were used to stabilize the river bank in several areas (Photo 7) especially adjacent to the Campground. The river ford was realigned and improved to prevent channel widening (Photo 7), which is sometimes associated with river fords. Although the ford is a direct in-channel feature, Alpine Eco (2012) indicated that the effects on the river are minimal. Signs and dedicated parking areas are used to reduce excess traffic in other areas near the river (Photo 7).

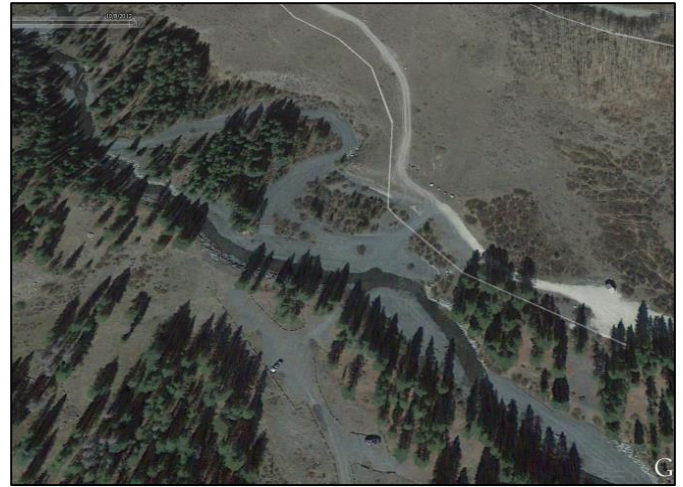
**Photo 8.** The Slate River near Oh-Be-Joyful Campground in 2012. Note the new channel alignment through the forest; flows no longer pass through the meander bend, and large boulders armor the banks along the new channel in the forest and the Campground. Image courtesy of Google Earth and the USDA Farm Service Agency (2012).

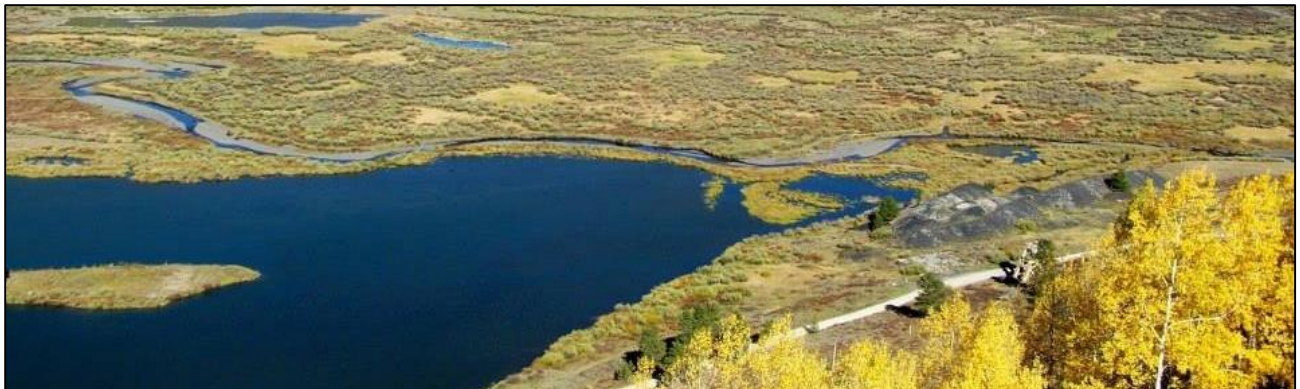
**Photo 9.** The Slate River near Peanut Lake; note the thin section of land that separates the river from the lake. Photo by Chad Martens.

The channel incision that originated near Wildbird, continues as the Slate River approaches Peanut Lake (Alpine Eco, 2012). Like the incised reach upstream, the assessment indicated that excessive bank erosion, channel enlargement and sediment deposition are likely and further degradation is possible (Alpine Eco, 2012). Over time, these channel instabilities have pushed the Slate River west toward Peanut Lake (HRS 1995; Alpine Eco, 2012). A narrow strip of beaver dams, organics, and fragile land, which is just 15 to 20 feet wide in places, currently prevents Peanut Lake from draining into the Slate River.

Human-induced instability is a source of sediment pollution and a serious risk to Peanut Lake (Alpine Eco, 2012). Due to these factors, a prediction level assessment (PLA) was recommended. In 2014, a PLA was completed in the area from Wildbird to downstream of Peanut Lake. The data will clarify the source of instability and help determine the best way to stabilize or restore the reach. As the landowner, CBLT is leading the project, and will seek partnerships as needed.

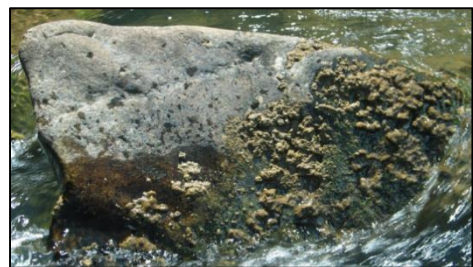
**Photo 11.** Didymo, also called rock snot, occurs in some portions of the Slate River. Photo courtesy of Clancy Brown.

**Didymo (*Didymosphenia geminata*):** are algae that prefer cold water streams and rivers. Didymo does not present a human health risk, but reduces the quality of stream habitat. Didymo forms large mats that cover most of a streambed. Didymo attaches to the streambed by a stalk. These stalks have a rough texture, and look somewhat like toilet paper when dry (Photo 10). Widespread didymo infestation degrades the overall health of a stream and may increase the risk associated with other invasive species or diseases. The best way to prevent the spread of didymo is to prevent transport. Clean equipment that may have been exposed to didymo and thoroughly dry it before returning to the water. First, while near the water check for didymo on your footwear, clothing or equipment. Remove any visible algae and leave it at the site. Second, clean or thoroughly dry your equipment. Cleaning solutions can be made with two percent bleach or five percent dish detergent or salt. If you dry the equipment rather than wash it, allow it to

dry thoroughly for a minimum of 48 hours. Absorbent materials like waders, life jackets, kayak skirts, etc. may require additional time to completely dry (EPA, 2006). Didymo occurs in some areas of the Watershed.

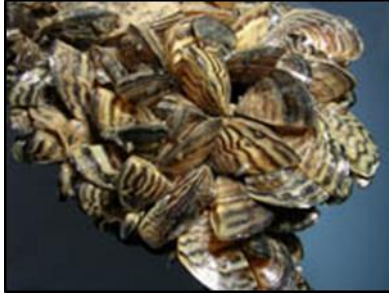
**Photo 12.** Zebra and quagga mussels grow in dense colonies on hard surfaces. Each mature mussel is about one inch in length. Photo courtesy of David Britton, USFWS.

**Zebra and Quagga Mussels (*Dreissena polymorpha* and *Dreissena rostriformis bugensis*):** are small mussels that attach to hard surfaces found in waterbodies. These invasive mussels originally hail from Eurasia and are incredibly problematic in North America, where they lack predators. To date, zebra and quagga mussels have spread from the Great Lakes Region to the 100<sup>th</sup> Meridian in the United States (ANS Task Force, 2013). The mussels have been found in selected lakes or reservoirs in the west; where the water is sufficiently warm and calcium-rich. Due to the cold temperatures and generally low calcium concentrations, waters in the Watershed are not at an especially high risk for infestation. However, we all need to be aware of the ecological threat posed by these invasive mussels. Locally, the

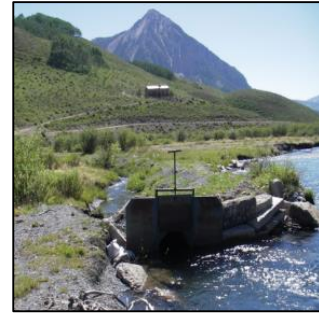
**Photo 20.** An irrigation head gate in the Slate River.

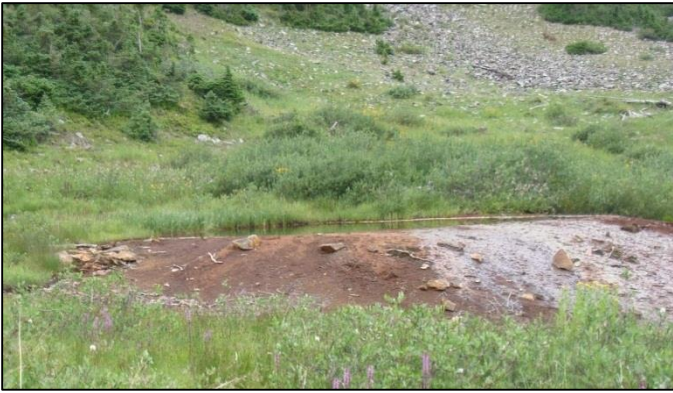
**Photo 21.** The Redwell, the namesake of Redwell Basin, is sampled at RW-5. Due to the shallow, dispersed flow that exits the lower side of the Redwell it is virtually impossible to measure flow at this location. Notice the wetland vegetation and seeps on the hillside in the background of the photo. Photo by Ashley Bembenek.

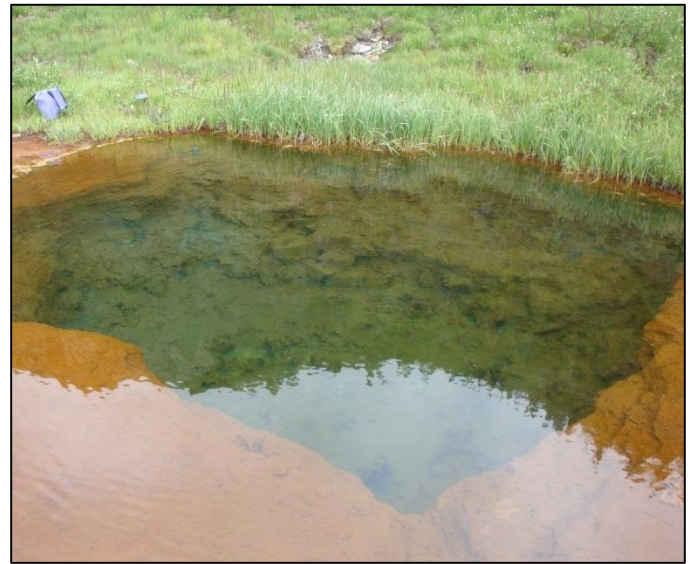
**Photo 22.** A view into the Redwell, the red-orange iron deposits, called ferricrete, on the edges of the pool have been age dated. The Redwell is at least 2,800 years old and predates any human activity in the basin (Fall et al., 1997). Photo by Ashley Bembenek.

The Redwell is the naturally-occurring namesake of Redwell Basin. The Red Well is approximately 2,800 years old. The age was established by analyzing an iron oxide, called ferricrete, collected from the edge of the Red Well. The age indicates the feature is natural, not man-made. Metal concentrations measured at the Red Well are elevated, and occur in ratios similar to those found at the Drill Hole, but in lower concentrations. This suggests the two features share source waters, groundwater associated with the molybdenum deposit and the adjacent mineralized fracture network, but additional dilution occurs at the Red Well. Small seeps and wetland vegetation up-gradient of the Red Well indicate the area is saturated regularly. Given the hydrology of wetlands, some dilution with surface or groundwater is likely at the Red Well.

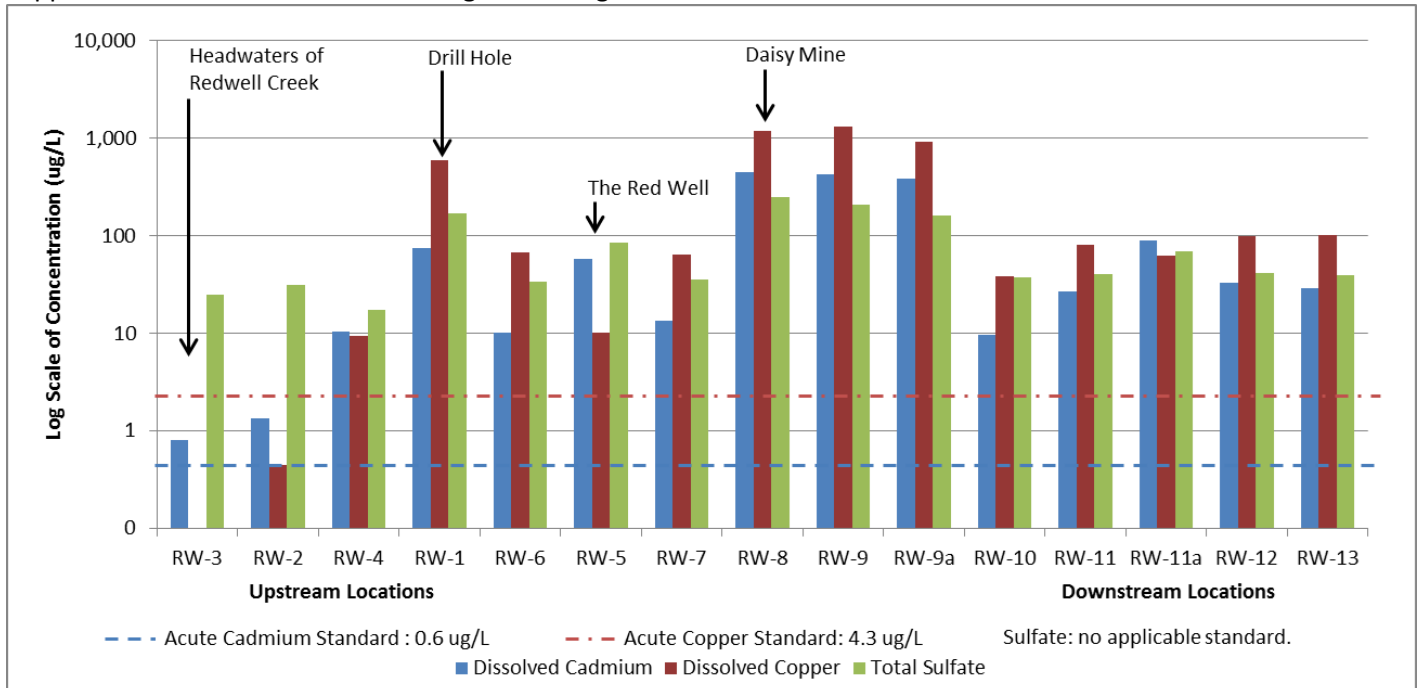
**Figure 13.** Median dissolved cadmium, copper and total sulfate concentrations in Redwell Basin. The cadmium and copper standards were estimated using the average hardness measured at locations in Redwell Creek.

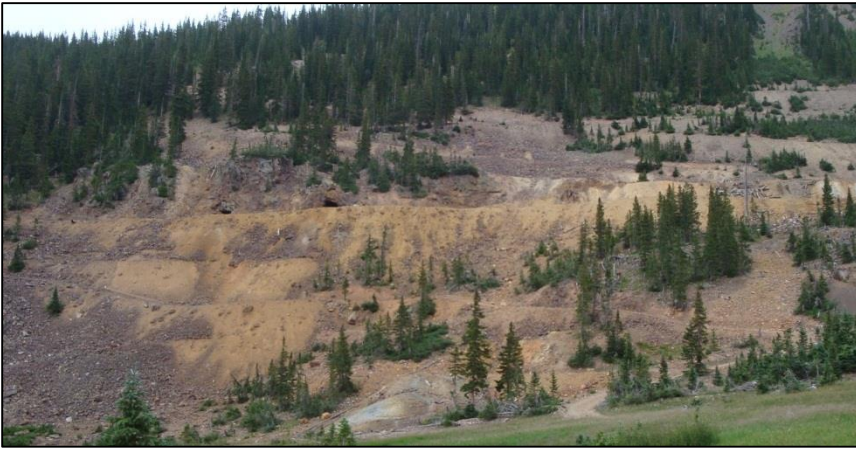
**Photo 23.** The Daisy Mine in Redwell Basin. The collapsed adit is in the foreground of the photo. An access road to the Peeler Lake Trail passes through several waste rock piles. Gunsight Pass Road is near the top of the photo. Photo courtesy of Ashley Bembenek.

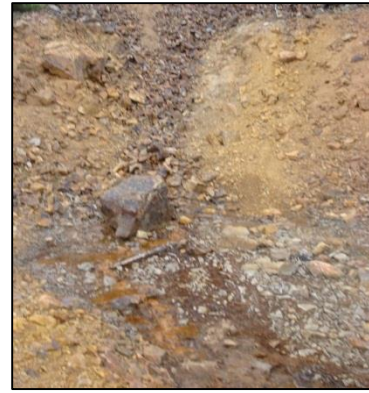
**Photo 24.** Flow from the collapsed tunnel at the Daisy Mine forms a small channel that reaches Redwell Creek about 300 feet from the tunnel.

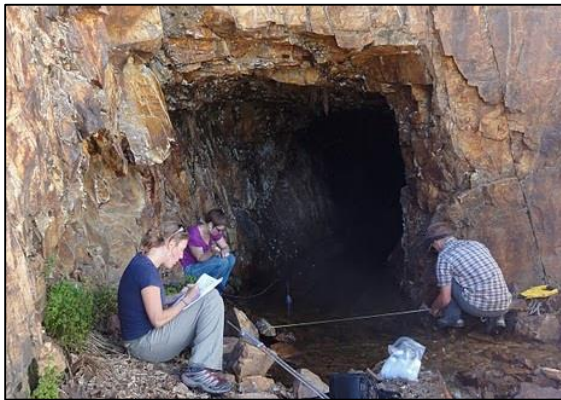
**Photo 26.** CCWC volunteers collect data from the Augusta Mine Portal in July 2011.

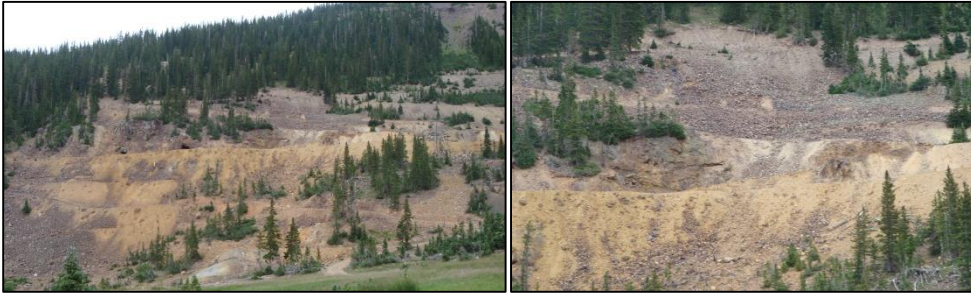
**Photos 28 a and b.** The road to Peeler Lakes Trail passes through mine waste near the collapsed tunnel of the Daisy Mine (Left photo). The right photo illustrates the variation in waste types. Some of the material is fine and heavily weathered and some is coarse and less-weathered.

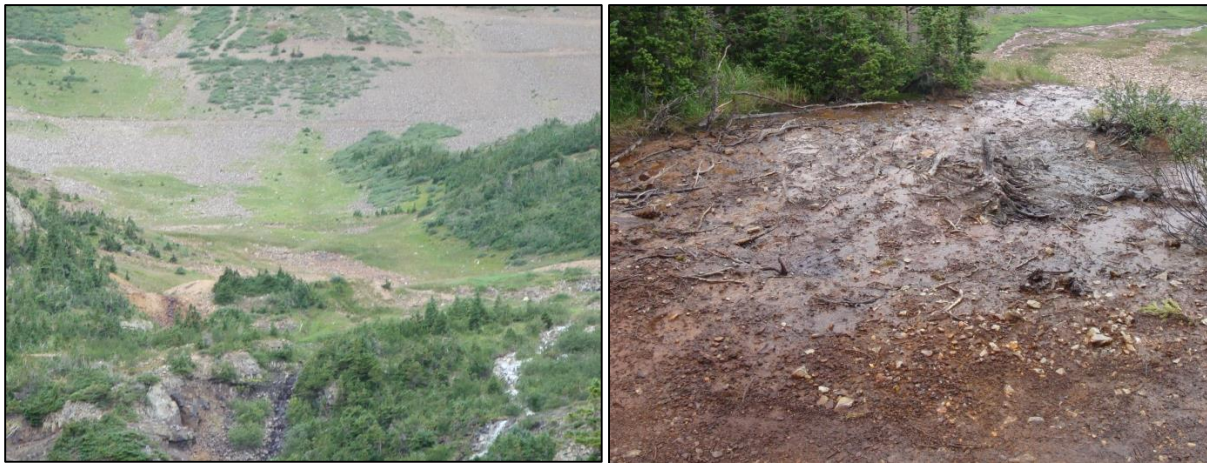
**Photos 29a and b.** Small abandoned mine features litter Redwell Basin and most are a part of the Daisy Mine (right Photo). Flow from the collapsed tunnel passes through waste en route to Redwell Creek (left photo).
