Scour Critical Bridge Plan of Action and Recommendations
for
SH 30 (Havana Street) Bridge over Cherry Creek
Structure F-17-AE

Prepared for FHWA & Colorado Department of Transportation

Prepared by Region 6 Hydraulics Unit

September 2009

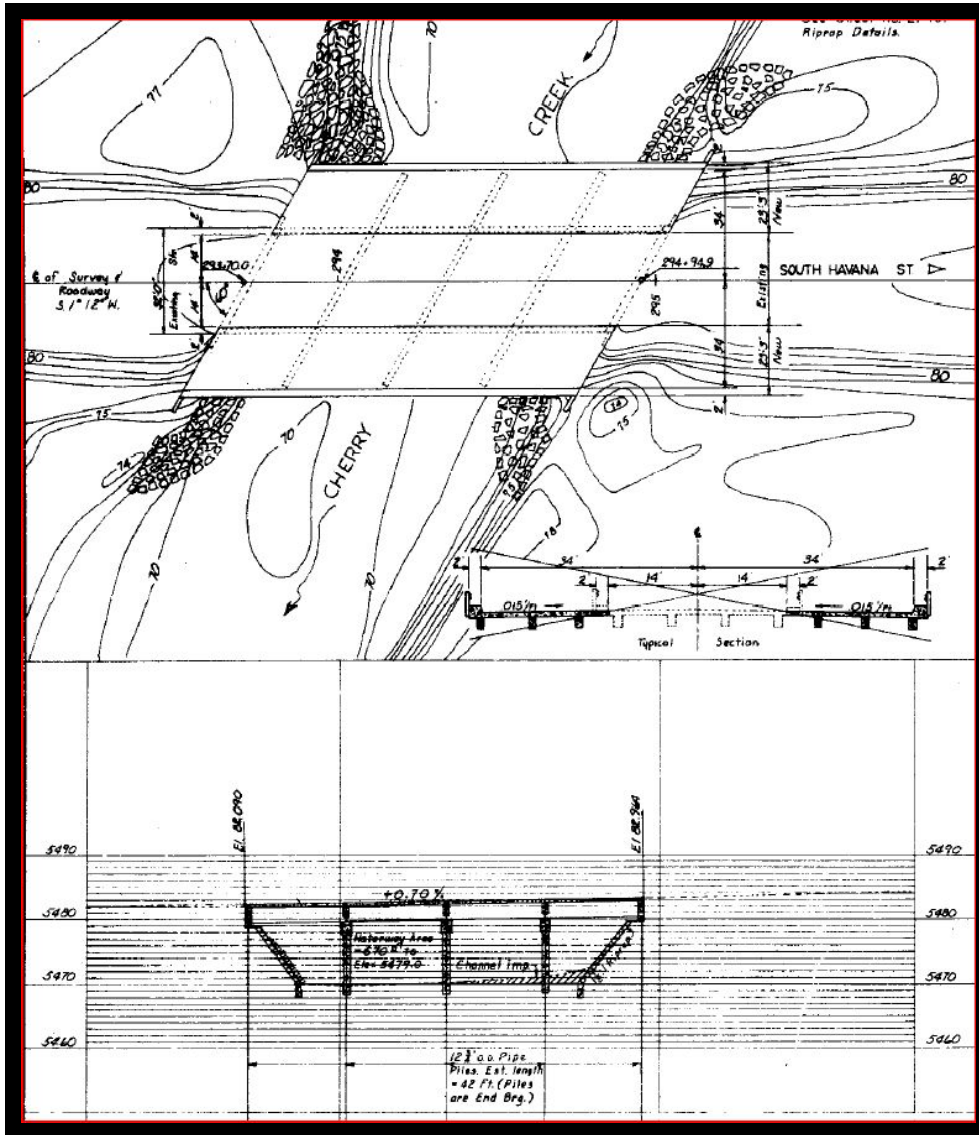
Figure 2 Existing Bridge Structure – CDOT As Built Drawings

The existing bridge structure is modeled with a total span of 125 feet, a length of 72 feet, and with abutment slopes of 1.5 to 1. The distance between the deck and bottom chord of the structure is estimated at 3.39 feet. The bridge was constructed in 1956 with abutments and piers set on 10 ¾ inch steel pipe piles filled with concrete. As-built drawings show the length of the pipe piles at 40 to 42 feet and extending down to approximate elevation 5440. The structure was widened in 1968 with abutments and piers set on 12 ¾ inch steel pipe piles filled with concrete. As-built drawings show the estimated length of the pipe piles at 42 feet.

The plans note that piles are end bearing and that the average terminal depths for piles are as follows:

Abut 1	5435.35
Pier 2	5435.30
Pier 3	5446.28
Pier 4	5447.58
Abut 5	5422.70

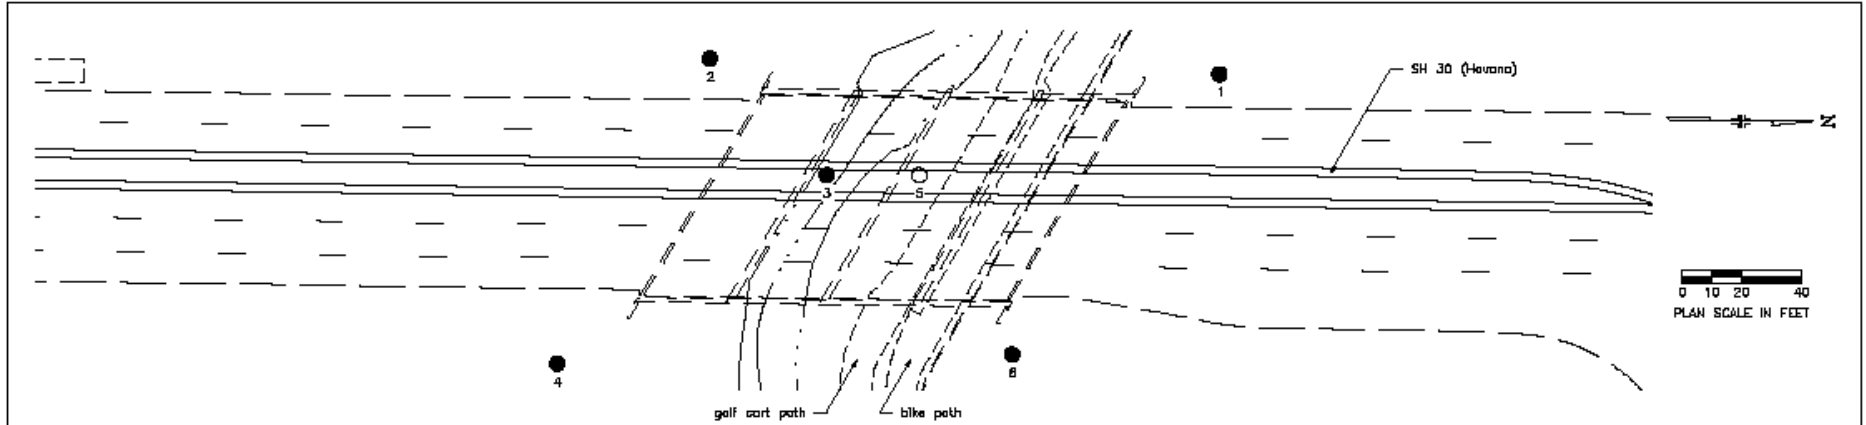
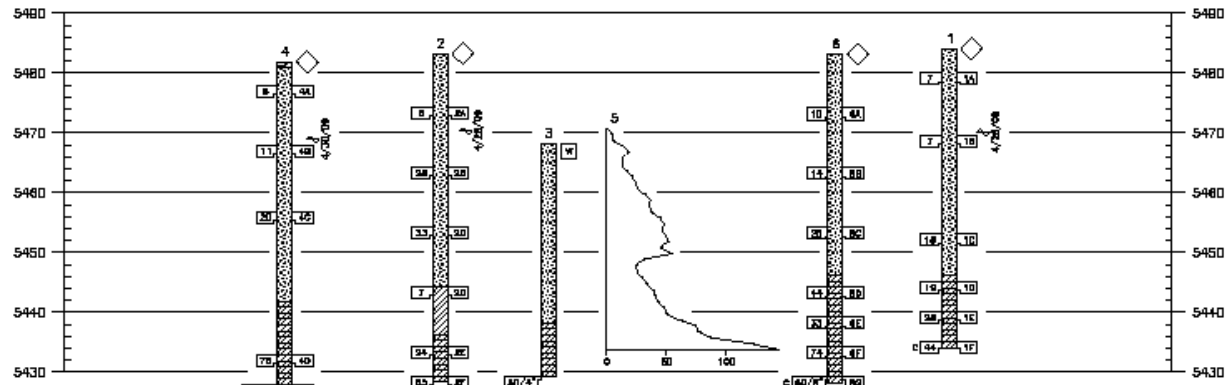
The boring logs of the above test holes and geotechnical report are on file in the Geotechnical Program Office, Staff Materials and Geotechnical Branch, (303)398-6601

Geotechnical field activities were completed on April 27th through 30th, 2009. The general geology consists of loose to dense, clayey to well graded sand overlying firm to very hard sandy claystone bedrock. Bedrock was encountered between 5,436 to 5,455 feet above mean sea level (amsl). Bedrock characteristics were consistent among borings.
