# AVALANCHE HAZARD IN OURAY COUNTY, COLORADO 1877-1976

Occasional Paper  
No. 24, 1977

UNITED STATES PROGRAM  
ON MAN AND THE  
BIOSPHERE

INSTITUTE OF ARCTIC AND ALPINE RESEARCH • UNIVERSITY OF COLORADO AT BOULDER

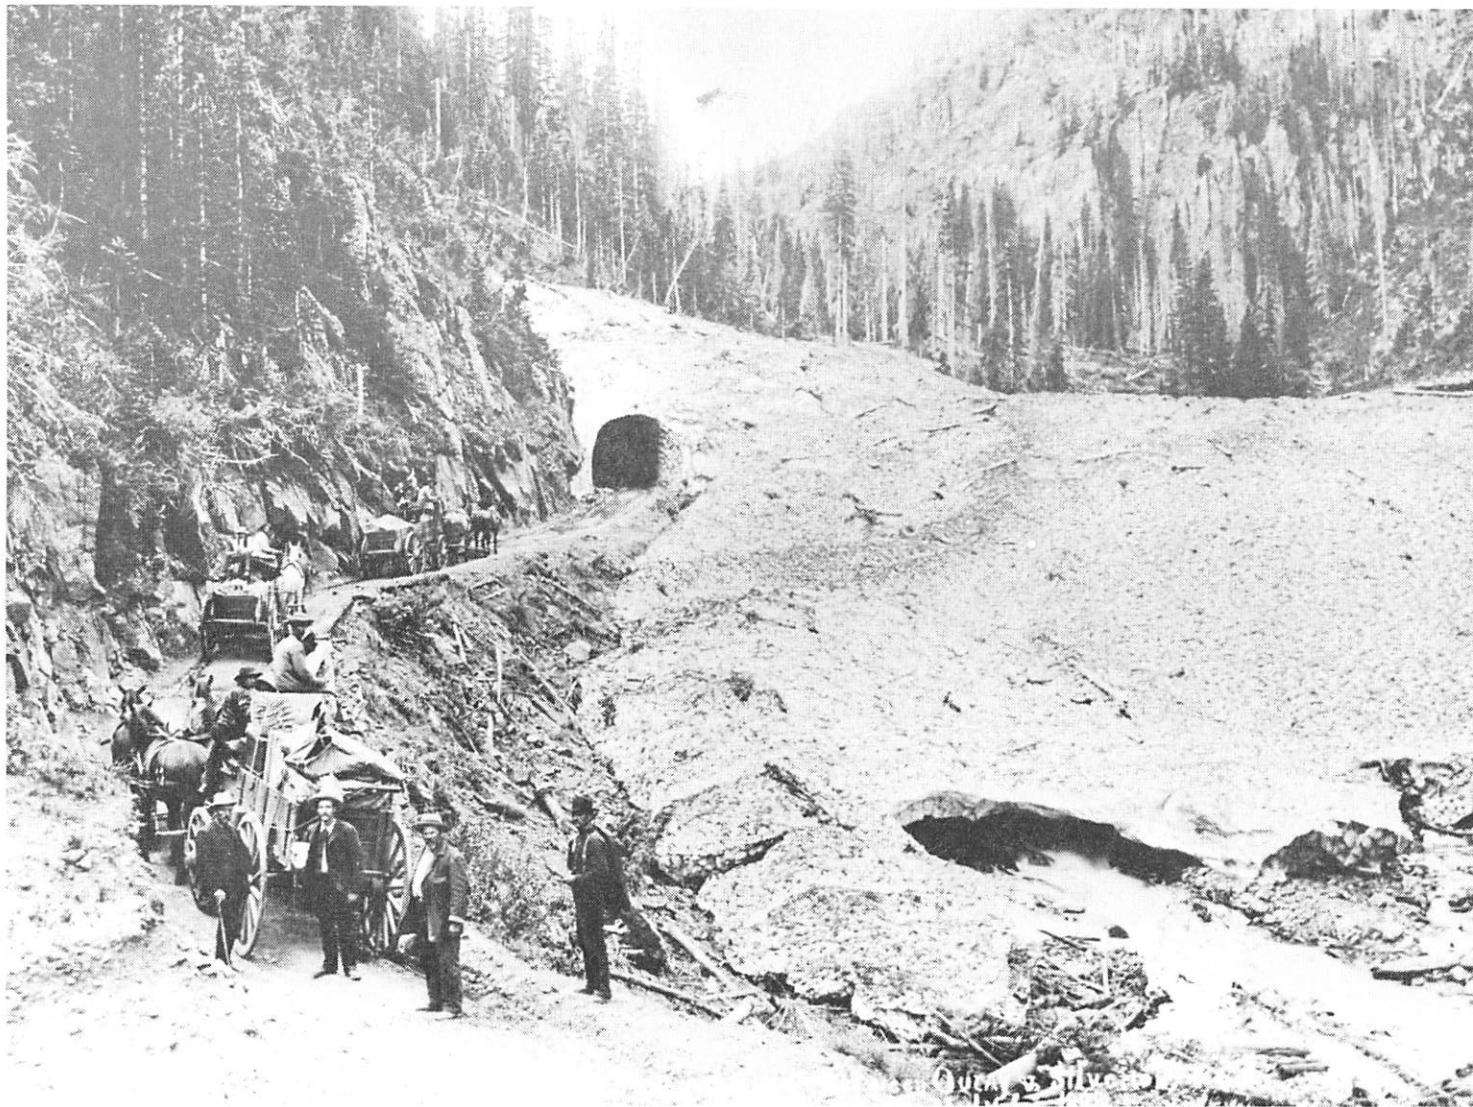
Frontispiece. July 1888 photograph of a hand-dug tunnel through the winter debris deposited by the East Riverside avalanche. Numerous mature coniferous trees brought down by the avalanche are scattered throughout the deposit and Red Mountain Creek flows through the debris. (San Juan County Historical Society)

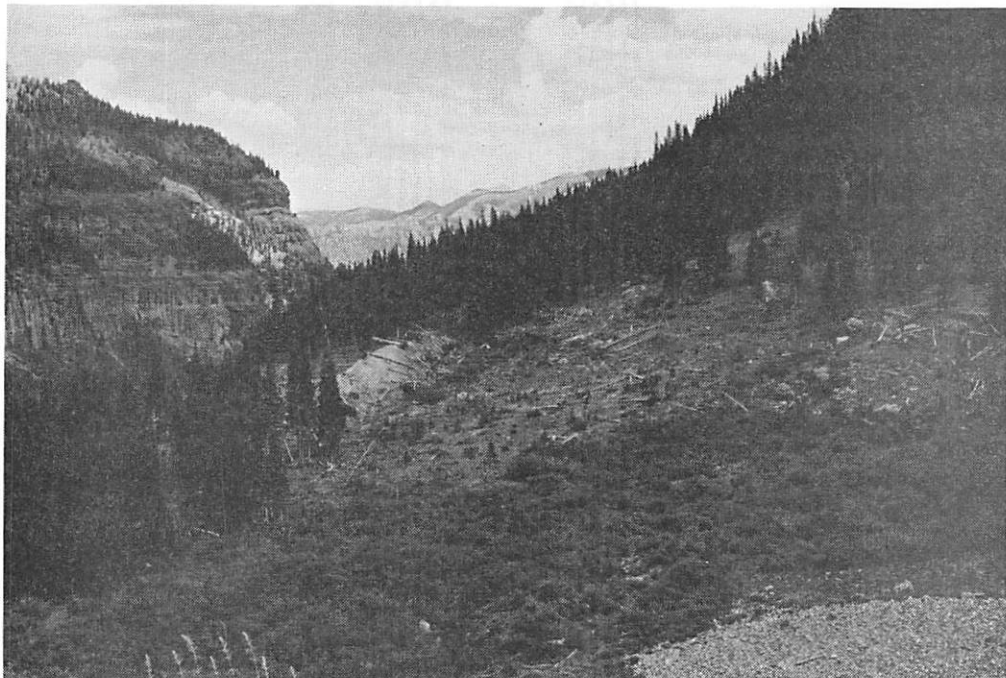
Figure 5. Earthen dam located just back from the cliff edge above the Camp Bird Mill. The dam was constructed shortly after the mill was destroyed by an avalanche on 17 March 1906. This photograph, taken in July 1976, shows large trees deposited against the uphill side of the dam by an avalanche from U.S. Basin on 9 January 1974. (B. Armstrong photo)

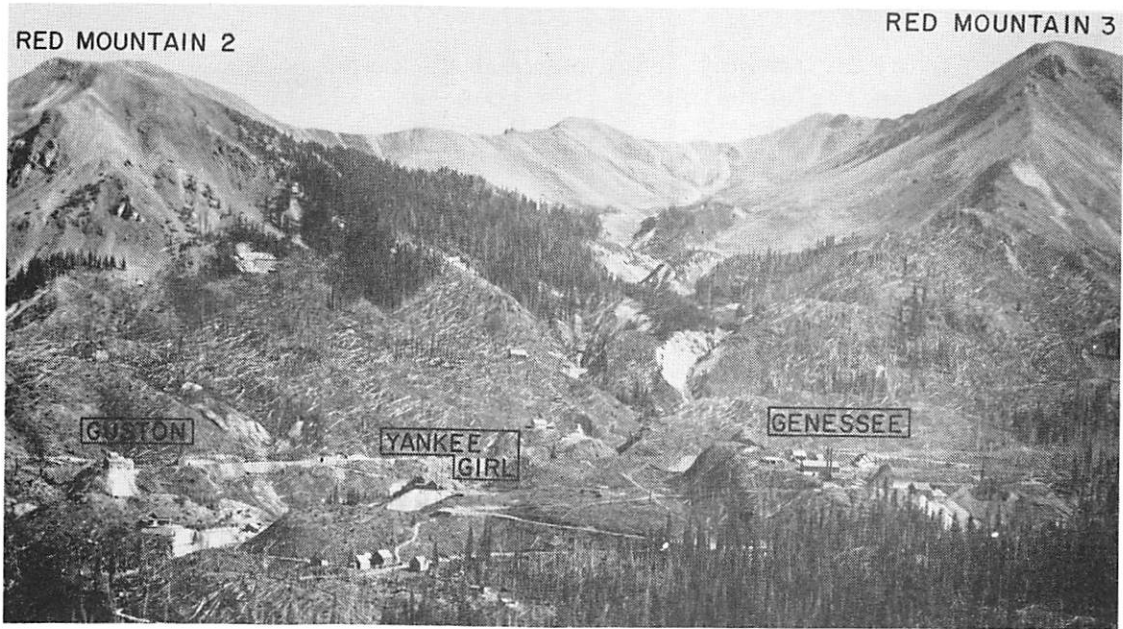
Figure 12. Red Mountain Mining District, 1888, showing Champion Gulch between the two Red Mountains and the three working mines below. (Denver Public Library, Western History Department)

Were the description not so detailed, it would be hard to believe the mound behind the town did not offer protection. However, photographs taken during that period (Figure 12), indicate the lower slopes of Red Mountain 2 and 3 had been timbered. Figure 13, a photograph taken in 1974, shows the path of this avalanche. In 1910, the town was again damaged by an avalanche, with one house destroyed and another losing its windows (Ouray Herald, 14 Jan 1910).

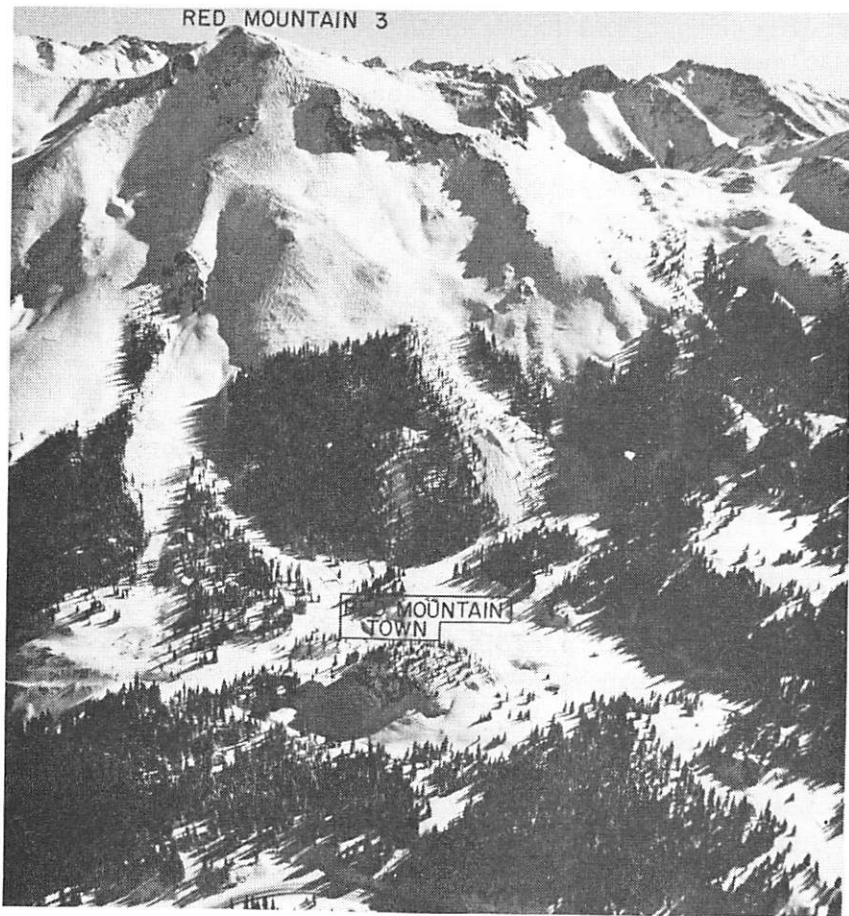
Figure 13. A 1974 photograph showing Red Mountain 3, 2,000 feet above the old site of Red Mountain Town whose buildings were damaged by avalanches from the mountain above. (INSTAAR photo)

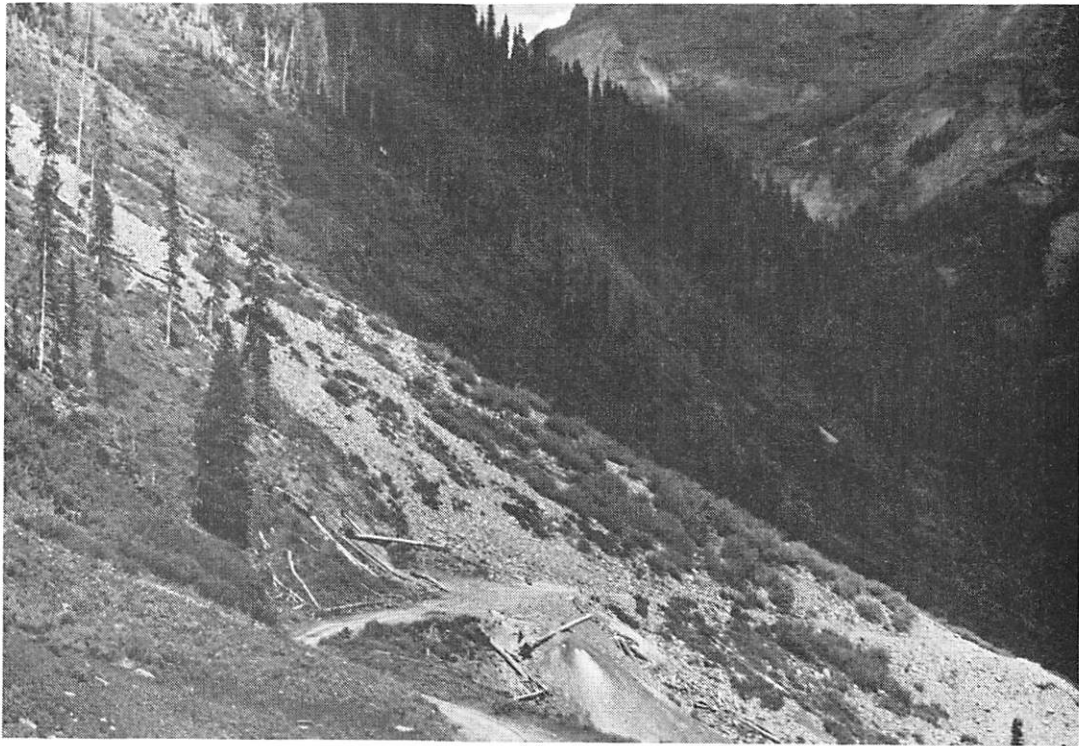
Figure 15. The site of the U.S. Mill in August 1976, taken from approximately the same location as Figure 14. (B. Armstrong photo)

the 1920s. Figure 14 shows the U.S. Mill in the 1920s; Figure 15 shows the site in 1976.

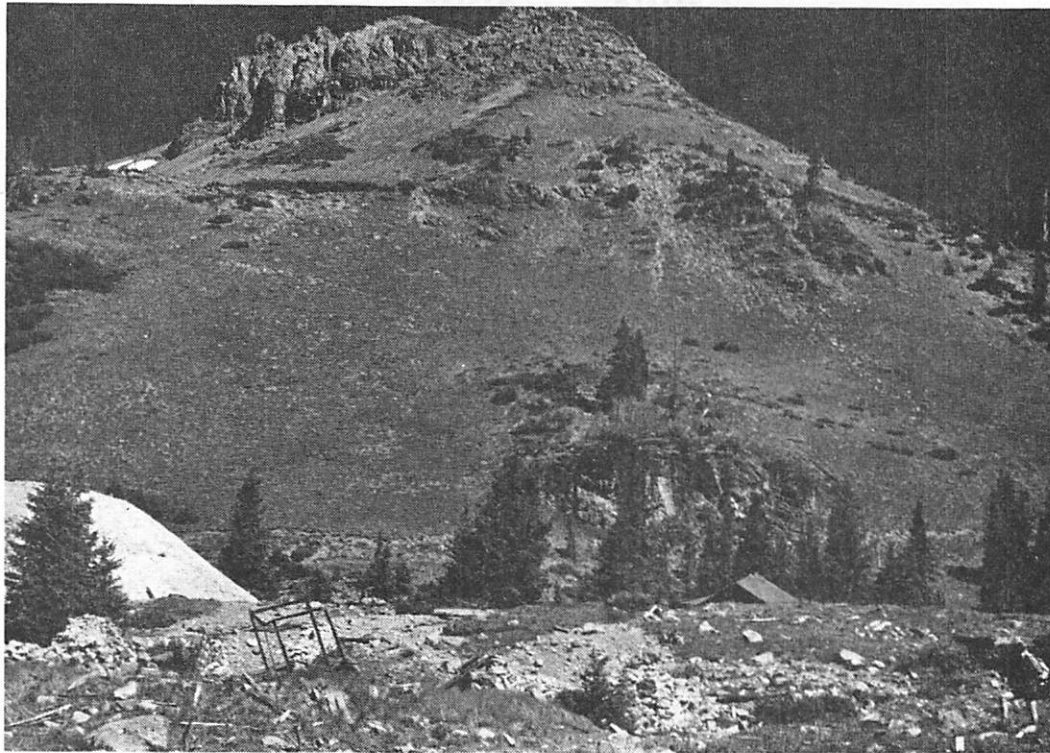
Figure 19. A summer 1976 view of the Barstow Mine, showing the mill site and the tailings and the same rock outcrop as in Fig. 18. The remains of an aerial tramway, swept downslope by an avalanche, are in the foreground. (B. Armstrong photo)

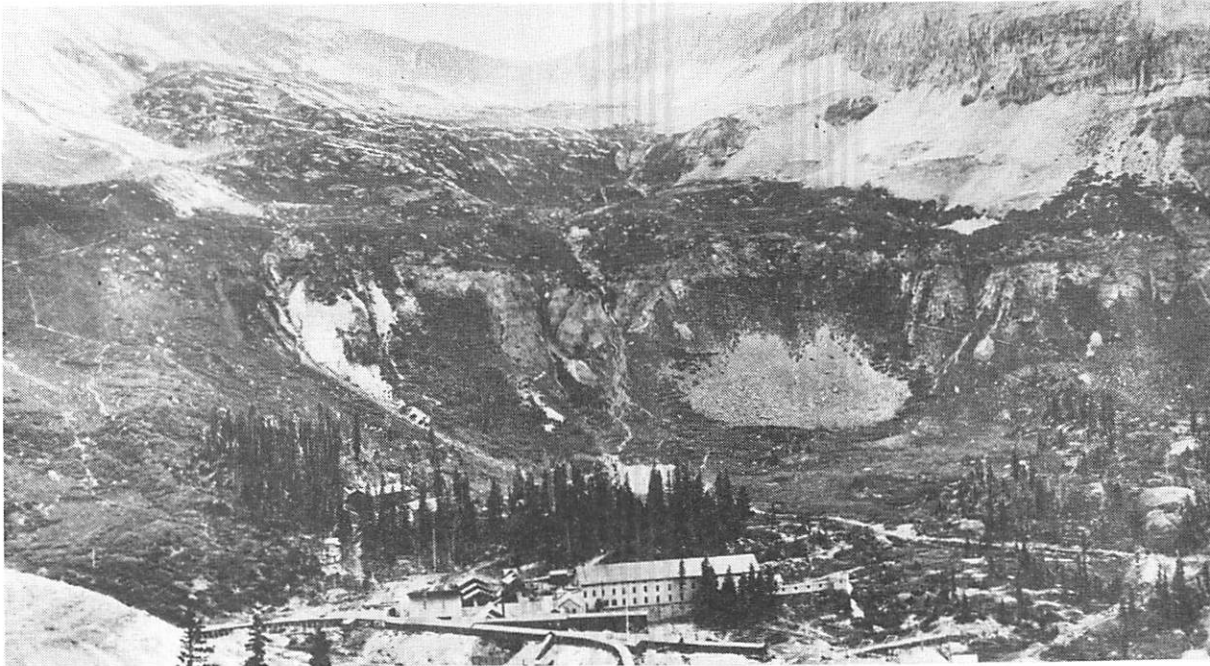
Figure 21. The Camp Bird No. 3 tunnel, mill, and boarding house, Imogene Basin, circa 1910. The Hidden Treasure Mine is located directly upslope from the boarding house, behind the trees. The large basin above the boarding house is the release zone for the Hidden Treasure avalanche. (Denver Pub. Lib., Wes. Hist. Dept.)

Figure 21, dating from about 1910, shows the Camp Bird Number 3 tunnel at the tongue of the rock glacier and the snowshed protecting the track from the entrance of the tunnel to the other buildings. The mill and boarding house are in the lower center portion of the photograph and the track continues to the tailings dump and loading station for the aerial tramway. The small tailings dump, upslope and behind the stand of timber from the boarding house, is the remains of the Hidden Treasure Mine and the basin above the mine buildings is the upper portion of the Hidden Treasure avalanche path.

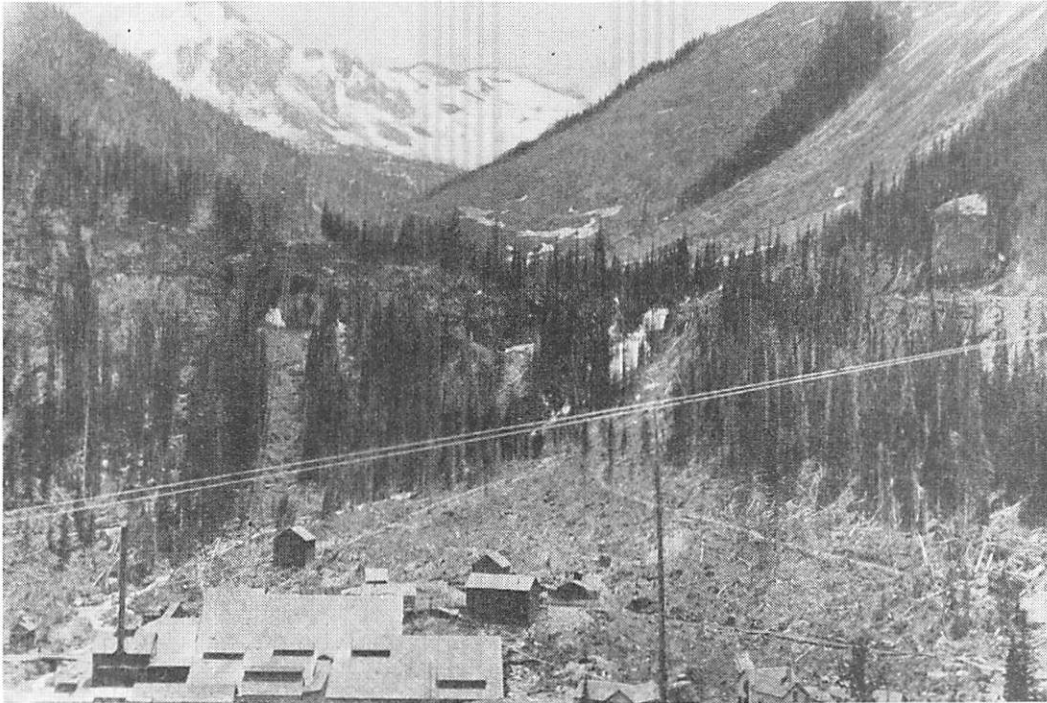
Figure 25. The Camp Bird Mill in 1903. Mature trees are evident at the top of the cliff band and on the slope below, except where the aerial tramway runs upslope from the mill. (Denver Pub. Lib., West. Hist. Dept.)

To illustrate the effects of these two avalanche events, March 1906 and January 1974, a time series of photographs is used. Figure 25 is a promotional photograph of the Camp Bird Mill taken in 1903 and published by the Ouray Board of Trade in a publication called, "Ouray, the Gem of the Rockies". While the trees in close proximity to the mill have been removed, a mature coniferous forest stands above the mill and above the cliff band, with the exception of the cut for the aerial tramway. The lower track of the U.S. avalanche is seen in the upper right portion of the photograph. The next photograph, Figure 26, is a wide-angle shot taken in 1912, six years after the 17 March 1906 avalanche. The path taken by the U.S. avalanche, over the cliff band to the mill, is clear. In this photograph, the aerial tramway towers have been rebuilt and little reforestation is apparent. Very little mature timber is left standing below the cliff band. Of interest are the five avalanche retaining structures in the closest of the two Mt. Hayden avalanche paths. One of these paths reportedly ran with the U.S. avalanche in March 1906, destroying the mill. These structures were probably built after 1906. At the same time, an earthen dam was constructed at the base of Mt. Hayden above the cliff band from the mill, to protect the mill from the U.S. avalanche (Figure 5, Chapter II).+

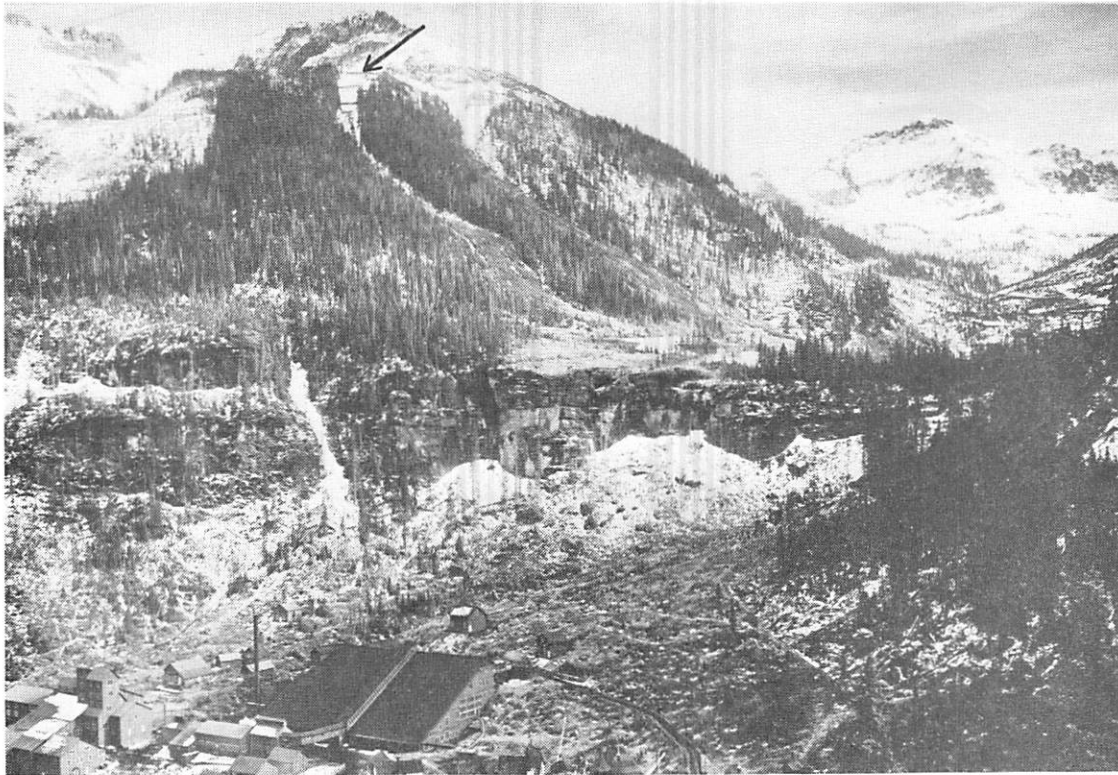
Figure 26. The rebuilt Camp Bird Mill, circa 1912, showing the lower path of the U.S. avalanche, entering on the right, and the two Mt. Hayden avalanche paths. On 17 March 1906, the U.S. avalanche and possibly one of the Mt. Hayden paths released to destroy the mill and the tramway, leaving only a few standing trees directly underneath the cliff band. Note the supporting structures in the starting zone of the left Mt. Hayden path. (Denver Pub. Lib., West. Hist. Dept.)

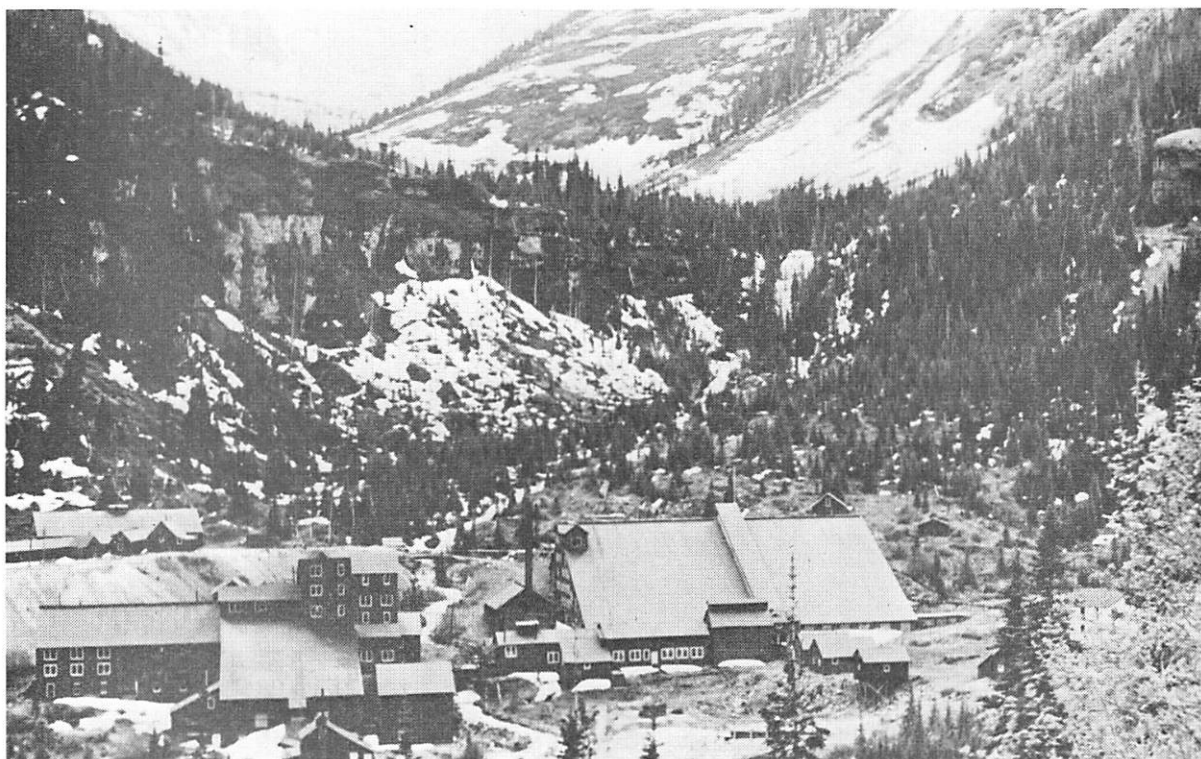
Figure 27. Camp Bird Mill, 1930s, a Sanborn Company post card. Reforestation above the mill and cliff band is progressing. (Denver Pub. Lib., West. Hist. Dept.)

Figure 27, is a post card view of the "World Famous Camp Bird Gold Mills" by the Sanborn Company, which was in business during the 1920s and 1930s (Denver Public Library, Western History Department, 1976). Reforestation of coniferous trees is evident both above the cliff band and below. An aerial tramway tower is visible above the cliff band. Figure 28 was taken in 1958 by Robert Brown and shows continued heavy reforestation. The final photograph in this series is Figure 29, taken by Rick Trujillo shortly after the 9 January 1974 release of the U.S. avalanche and shows the destruction of the mature coniferous forest. The fracture lines in the starting zone of the path are evident. Trujillo recalls the entire basin as well as the slopes in the timber releasing. In the summer of 1976, the downed trees were still providing firewood for the mine employees (Figure 30). Julius Sonza, who has worked the mines of Ouray County for much of his 80 years, said that the U.S. avalanche ran alone; had one of the Mt. Hayden avalanches run during the same period, as happened in 1906, the mill would surely have been destroyed again. ‡

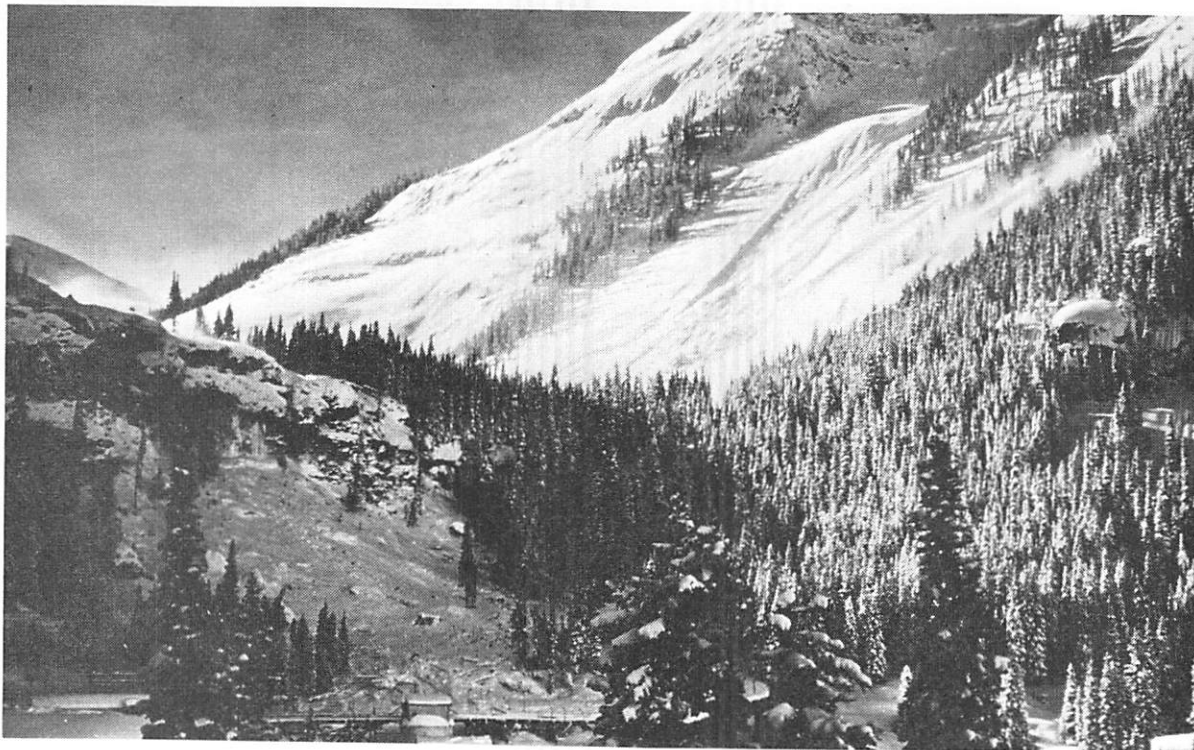
Figure 29. The path of the U.S. avalanche shortly after it released on 9 January 1974, coming within three feet of the Camp Bird Mill. Numerous fracture lines in the upper portion of the path are visible. (R. Trujillo photo)

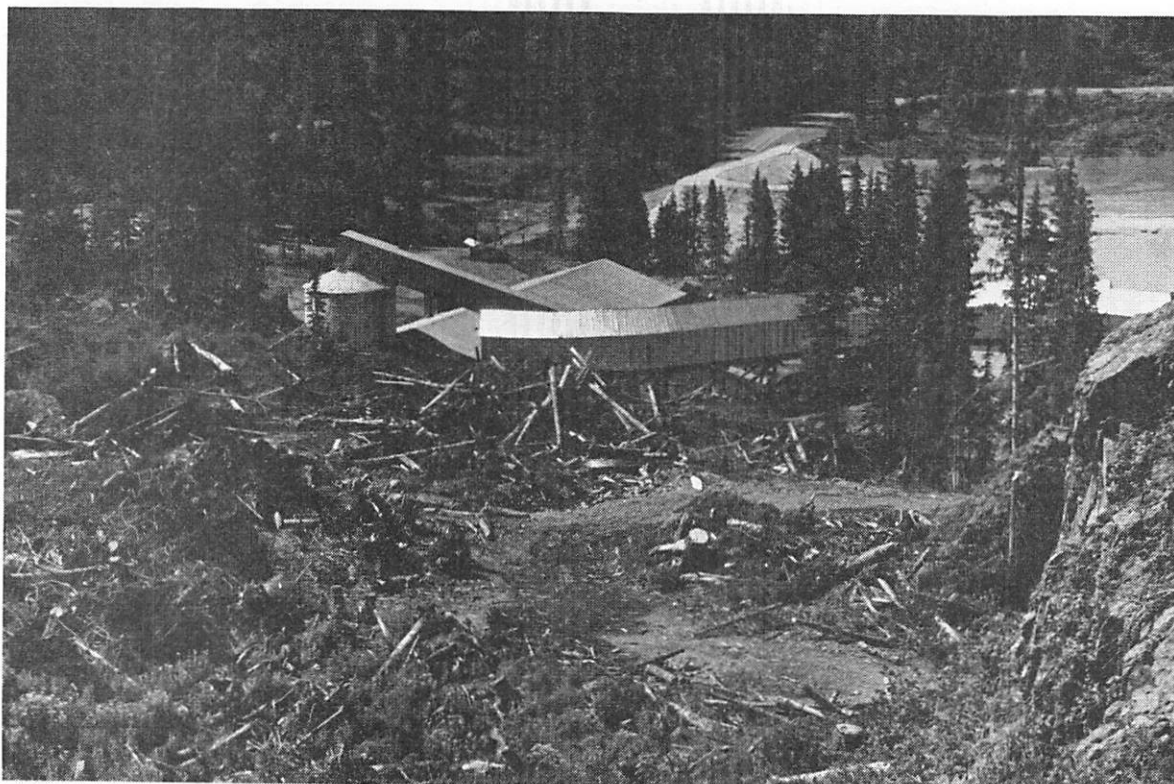
Figure 30. The Camp Bird Mill, July 1976, viewed from just downslope of the cliff band. Uprooted timber deposited by the 1974 avalanche still remains. (B. Armstrong photo)

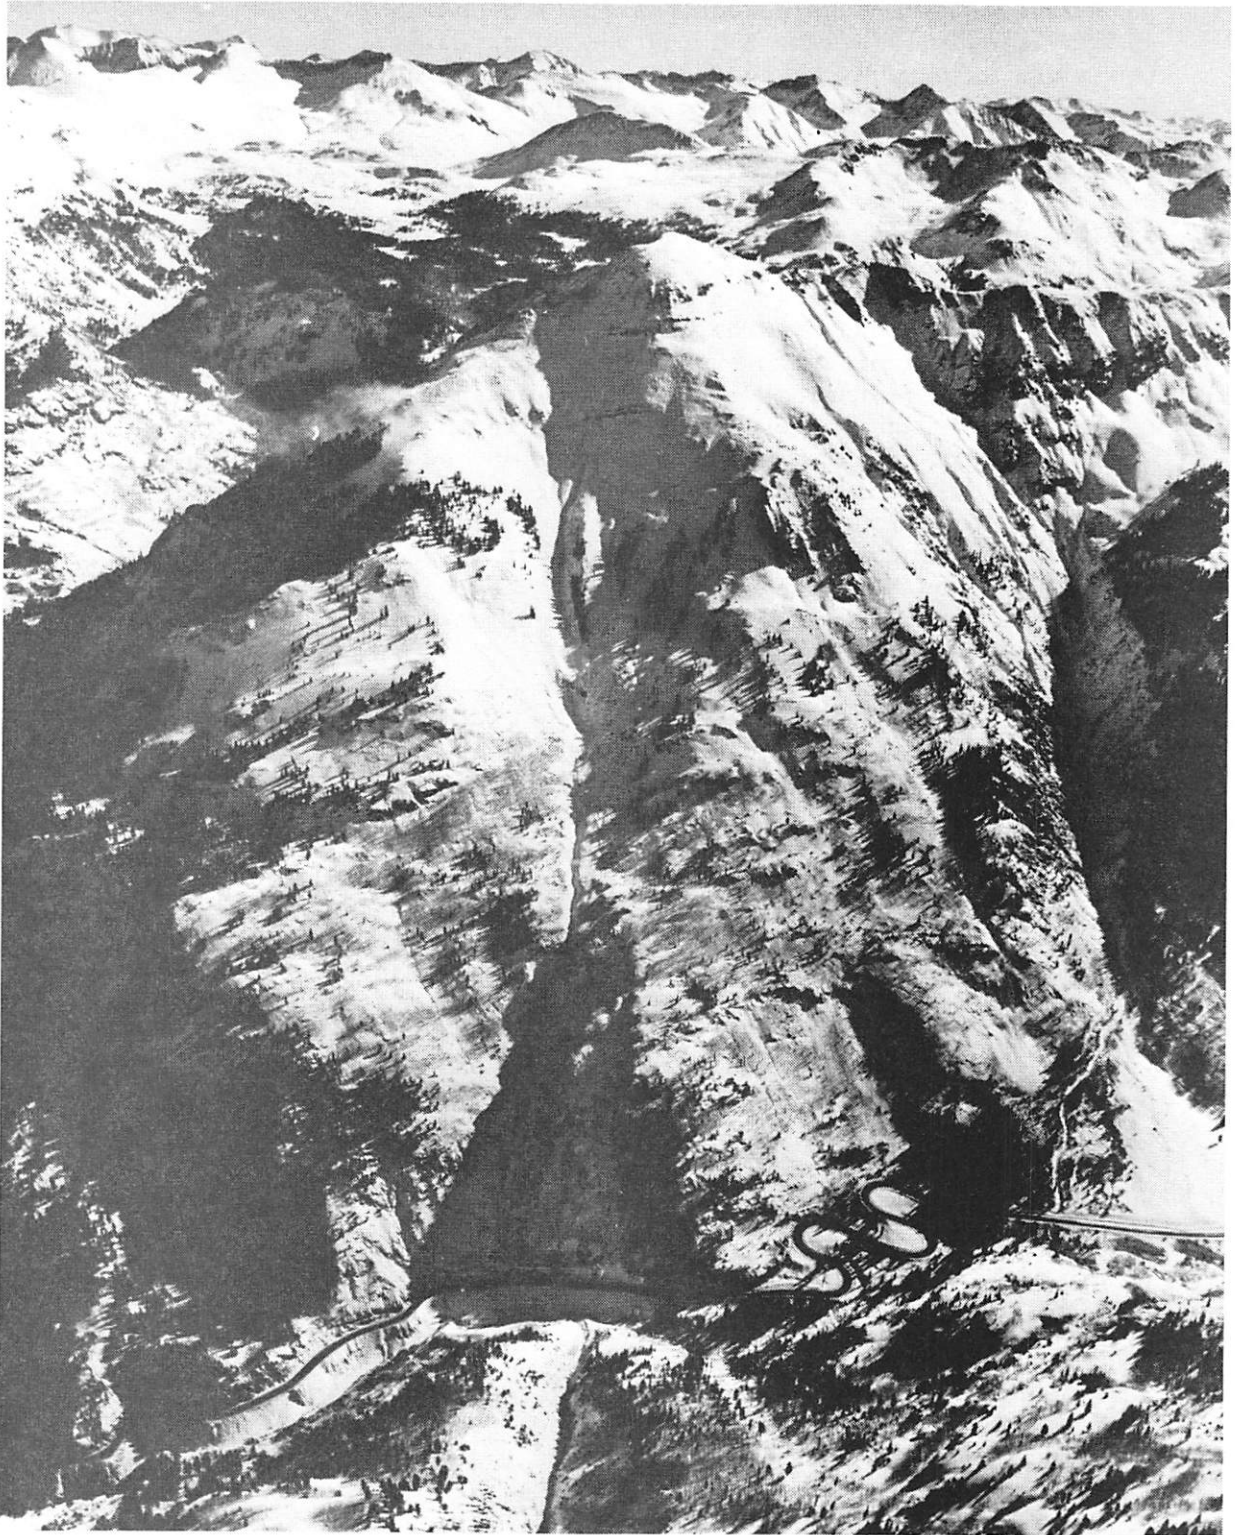
Figure 32. East Riverside avalanche path, U.S. Highway 550. (INSTAAR photo)

The East Riverside still poses a grave threat to travelers on U.S. Highway 550. Although control work with a 75 mm pack howitzer is often successful, this method cannot be used when visual sighting of the starting zone is obliterated by bad weather or darkness. Four lives would have been saved had the tunnel, proposed in March 1909 (Ouray Herald, 26 February 1909), been approved and built. In 1964, Hans Frutiger, in his survey of avalanches along Colorado mountain highways (Frutiger, 1964), recommended the construction of a tunnel or heavy avalanche shed to protect the highway from both the East and West Riverside avalanches. Had this been done then, Miller's life would not have been lost.

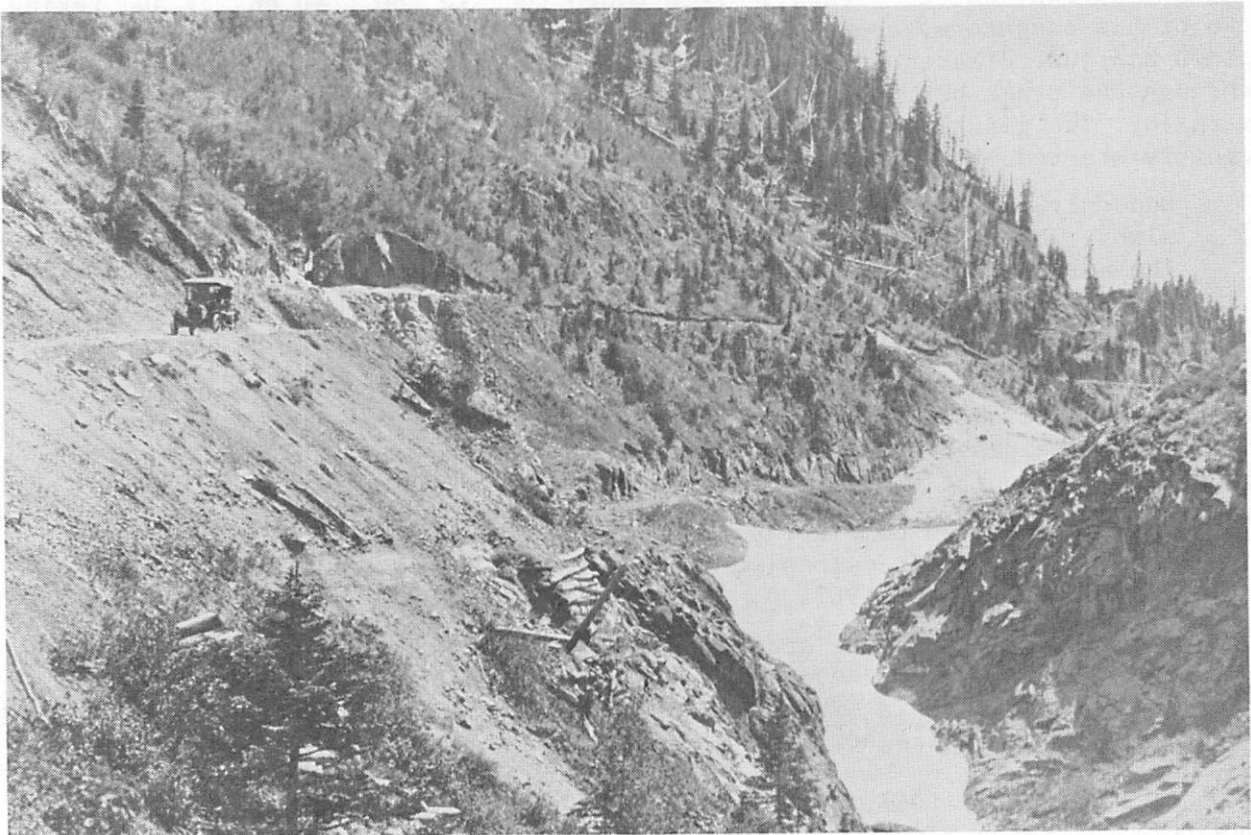
Figure 33. Debris from the East Riverside avalanche in the Uncompahgre Canyon, circa summer 1920s. (From the collection of Marvin and Ruth Gregory)
