THE BIG THOMPSON RIVER FLOOD

JULY 31-AUGUST 1, 1976, LARIMER COUNTY, COLORADO

FLOOD INFORMATION REPORT

OCTOBER, 1976

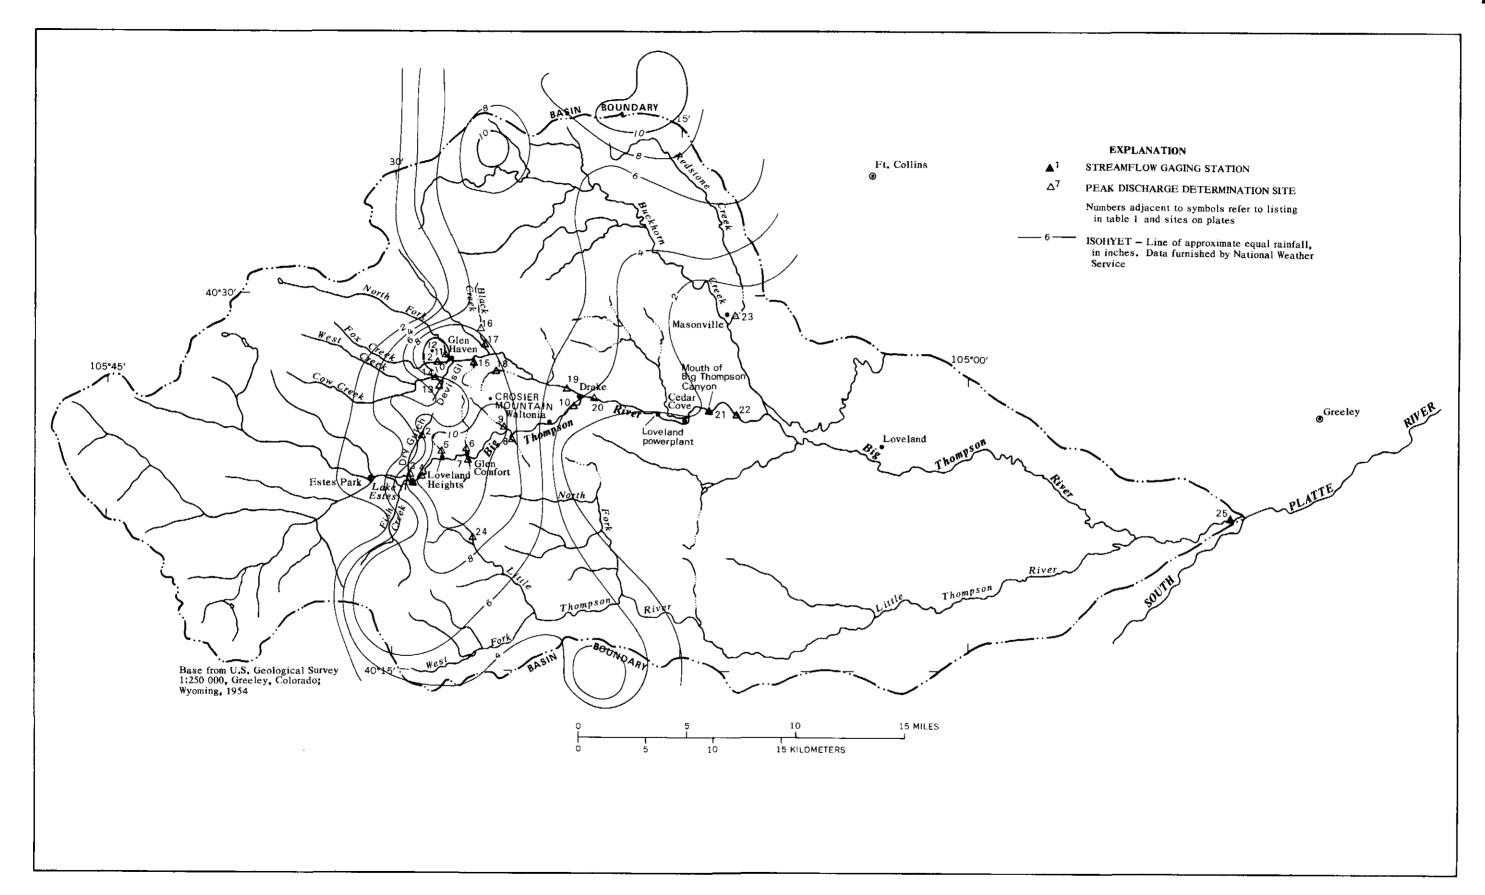
Figure 1.—Flood area, flood-data sites, and total precipitation.

The National Weather Service prepared an isohyetal map (fig. 1) of the total precipitation from July 31 to August 2, 1976. They also provided the following statement on the general meteorological conditions existing in the area that contributed to the extreme rainfall and runoff in the Big Thompson River basin.

Rainfall began about 6:30 p.m. on July 31, 1976, and ended about 11:30 p.m. that evening. Additional rainfall fell on August 1 and 2. Precipitation totals were as much as 10 inches (254 mm) between Estes Park and Drake and more than 12 inches (305 mm) in the Clen Haven area. Very little rainfall contributing to the flood occurred east of Drake and west of Estes Park.

Flood runoff in the Big Thompson basin derived from an area of approximately 60 square miles (155 km²) centered on the Big Thompson River from Lake Estes to Drake. The topography of the area is characterized by steep north-and south-facing slopes with rugged rock faces along the ridges and a thin soil mantle at lower elevations which supports a moderate stand of coniferous trees. Because of the steep slopes and small storage capacity of the soils, storm runoff quickly reached nearby surface channels. Based on records at stream-gaging stations in the area and on information from individuals who observed the flood. most streams in the area started to rise about 7 p.m. The first reported damage occurred about 7:30 p.m. along U. S. Highway 34, 7.5 miles (12.1 km) east of Estes Park where the highway was blocked by rocks and trees deposited by water cascading down the canyon walls and small gulches along the north side of the Big Thompson River. This area approximately corresponds to the areas of maximum rainfall as shown on figure 1.

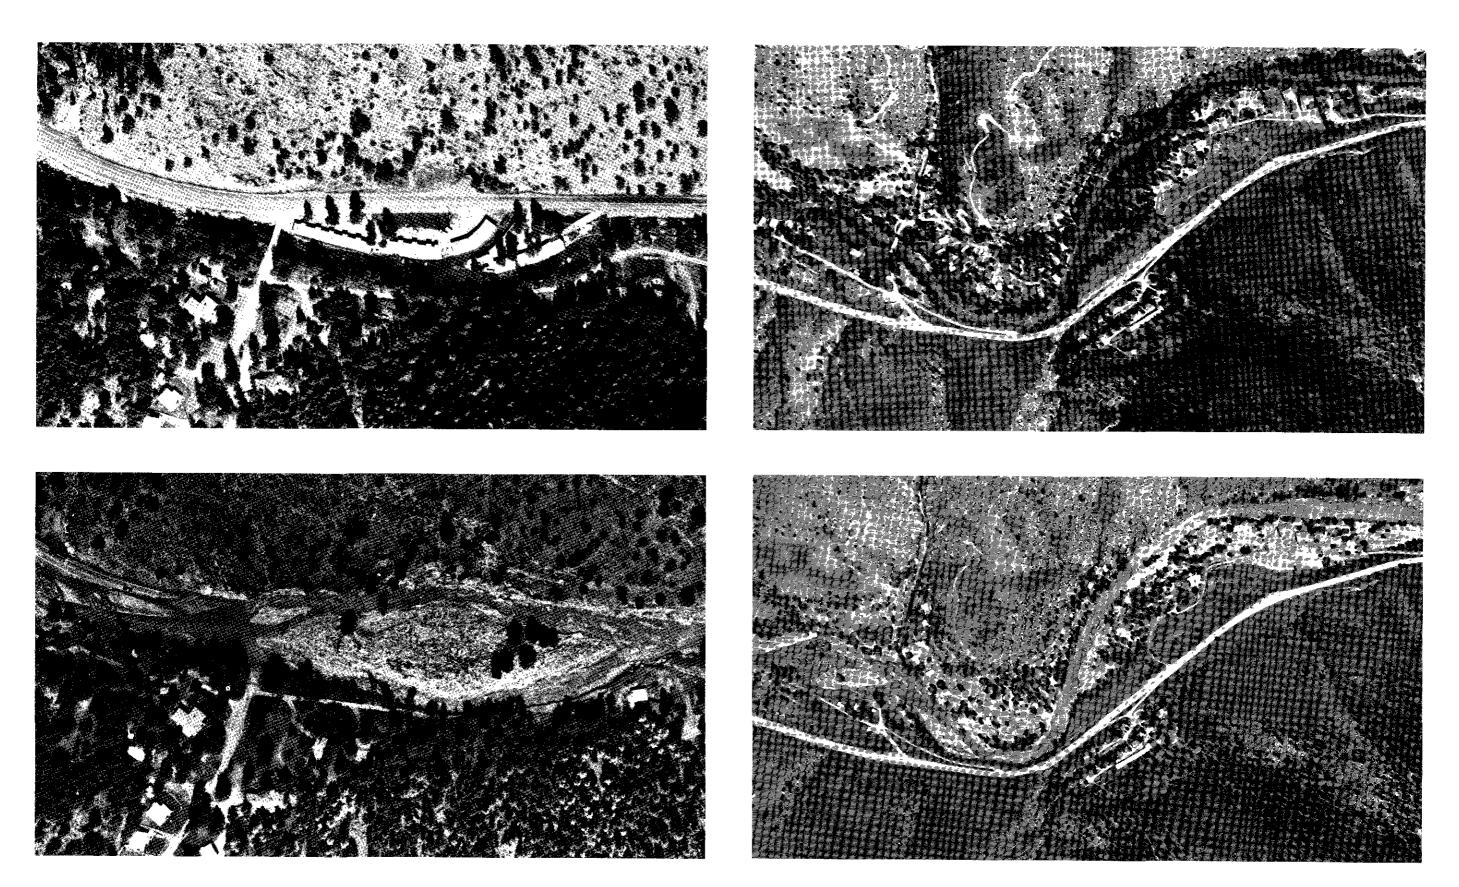
, Figure 2.—Aerial views of "before" and "after" the flood at Waltonia, Colo.

Figure 3.—Aerial views of "before" and "after" the flood at Cedar Cove, Colo.

Aerial photographs of "before" and "after" the flood at Waltonia and Glen Cove are shown in figures 2 and 3, respectively. Photographs of some of the destruction caused by the flood are shown in figures 4 through 10.

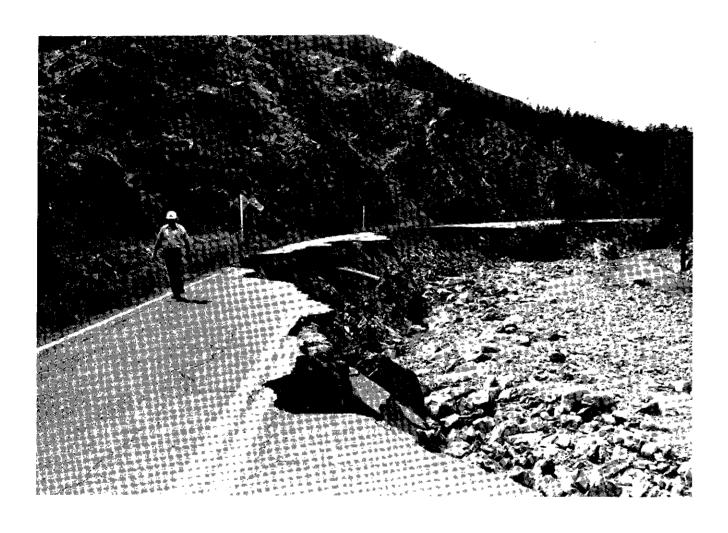
Figure 4.—Destruction of U. S. Highway 34 in Big Thompson Canyon. Photograph courtesy of the Loveland Daily Reporter-Herald.

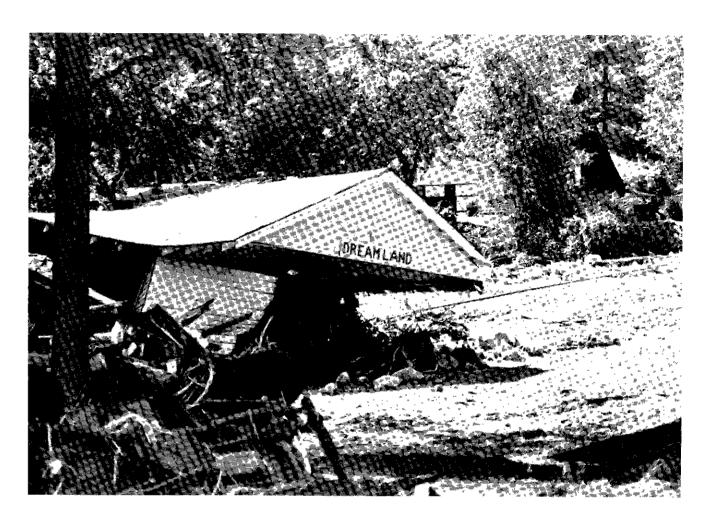
Figure 5.—Destruction of homes and vehicles at Drake, Colo. Photograph courtesy of the Loveland Daily Reporter-Herald.

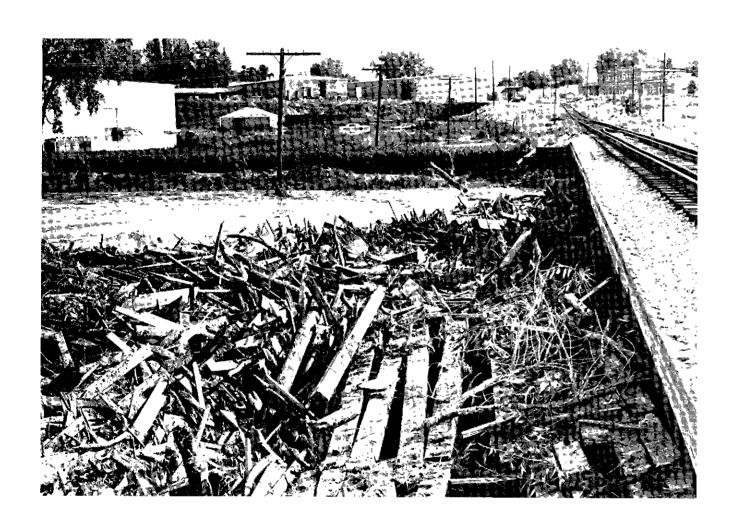
Figure 6.—Debris from the Big Thompson Canyon piled up against a railroad bridge at Loveland, Colo. Photograph courtesy of the Loveland Daily Reporter-Herald.

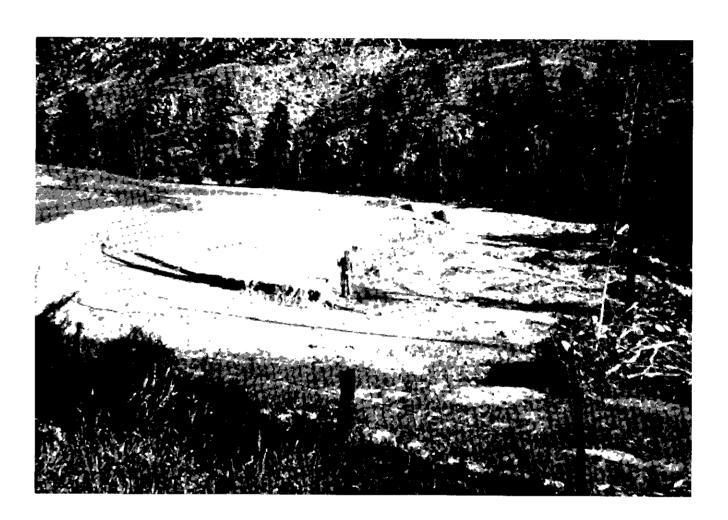
Figure 7.—Silt deposited on inside of bend, North Fork Big Thompson River near Drake, Colo.

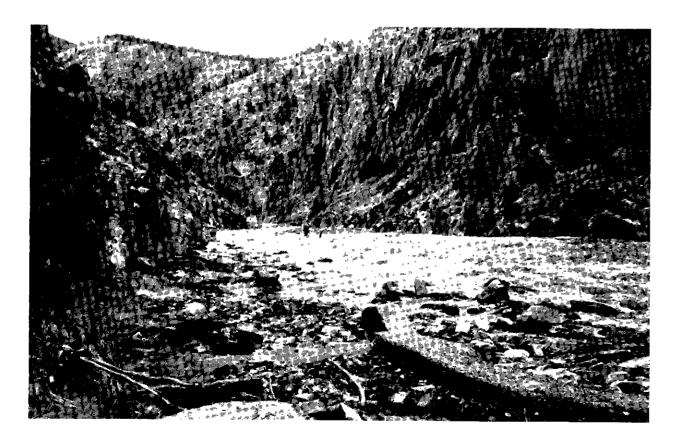
Figure 9.—Big Thompson River near mouth of canyon, near Loveland, Colo.

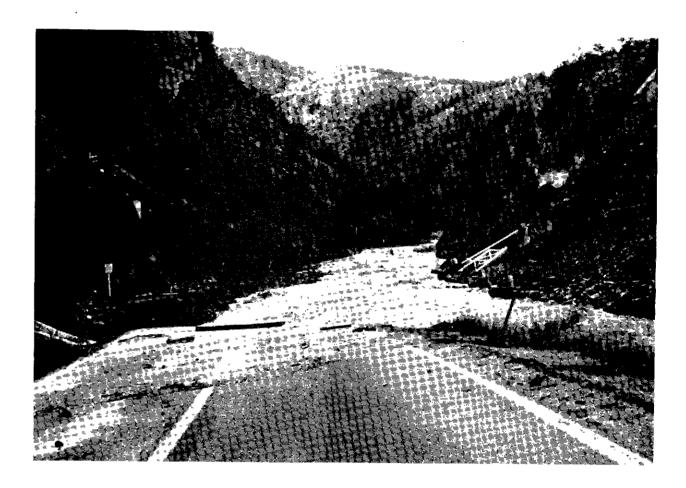
Figure 10.—Big Thompson River at mouth of canyon, near Loveland, Colo. Note irrigation siphon washed out and end of U. S. Highway 34.

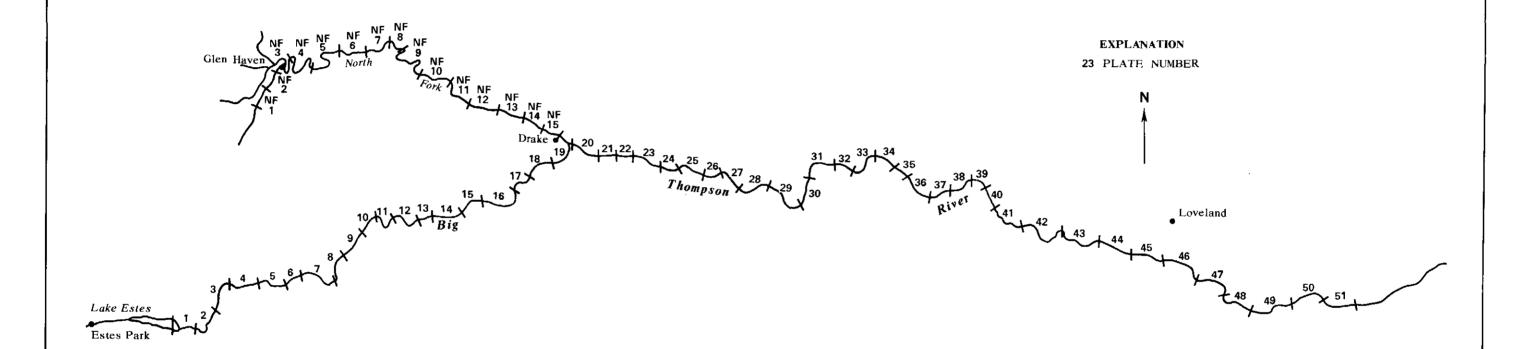
Figure 11.--Index to plates of aerial photographs showing flood outlines for flood of July 31-August 1,1976.

The area flooded on the Big Thompson River from Estes Park to east of Loveland and on the North Fork Big Thompson River from the Glen Haven area to Drake were outlined on aerial photographs, scale 1 inch - 200 feet (25.4 mm - 61 m) in the canyon area and 1 inch -400 feet (25.4 mm -122 m) in the Loveland area. These are reproduced as plates 1-51 for the Big Thompson River and plates NF1-NF15 for the North Fork Big Thompson River. The location of the individual plates are indicated on figure 11. The numbers in boxes, 15%, shown on some plates indicate the site of the peak discharge in table 1. The number on the plate corresponds to the site number on table 1.

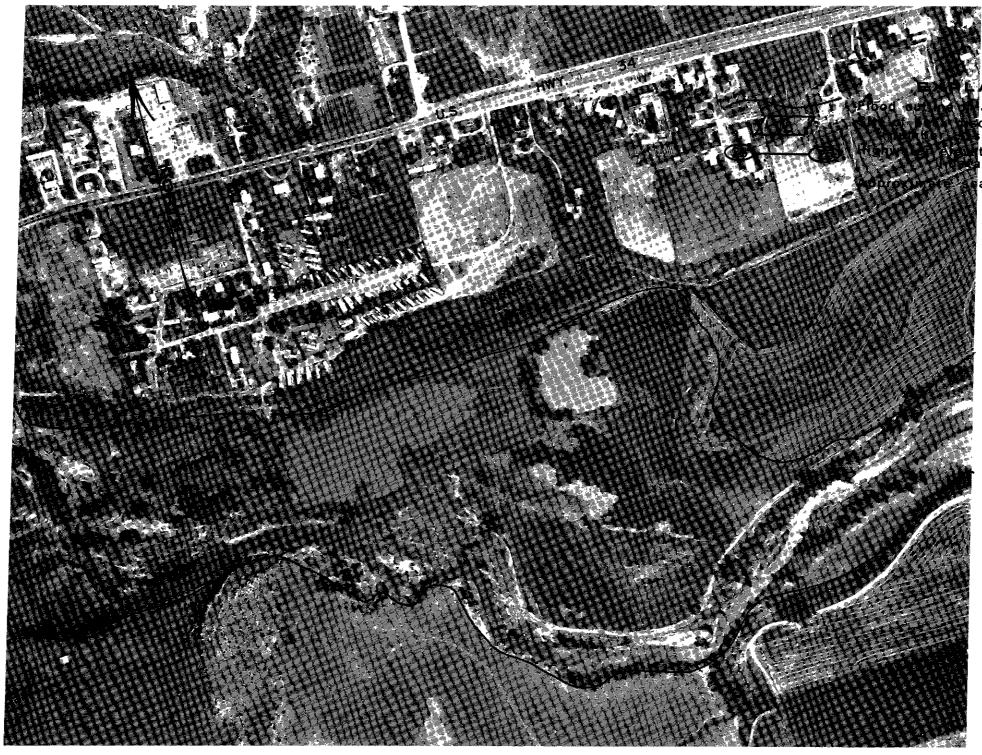
July 31,— August 1, 1976 charge determination ame as in table 1) tions and cross sections shown in table 2) ale: 1 inch = 400 feet

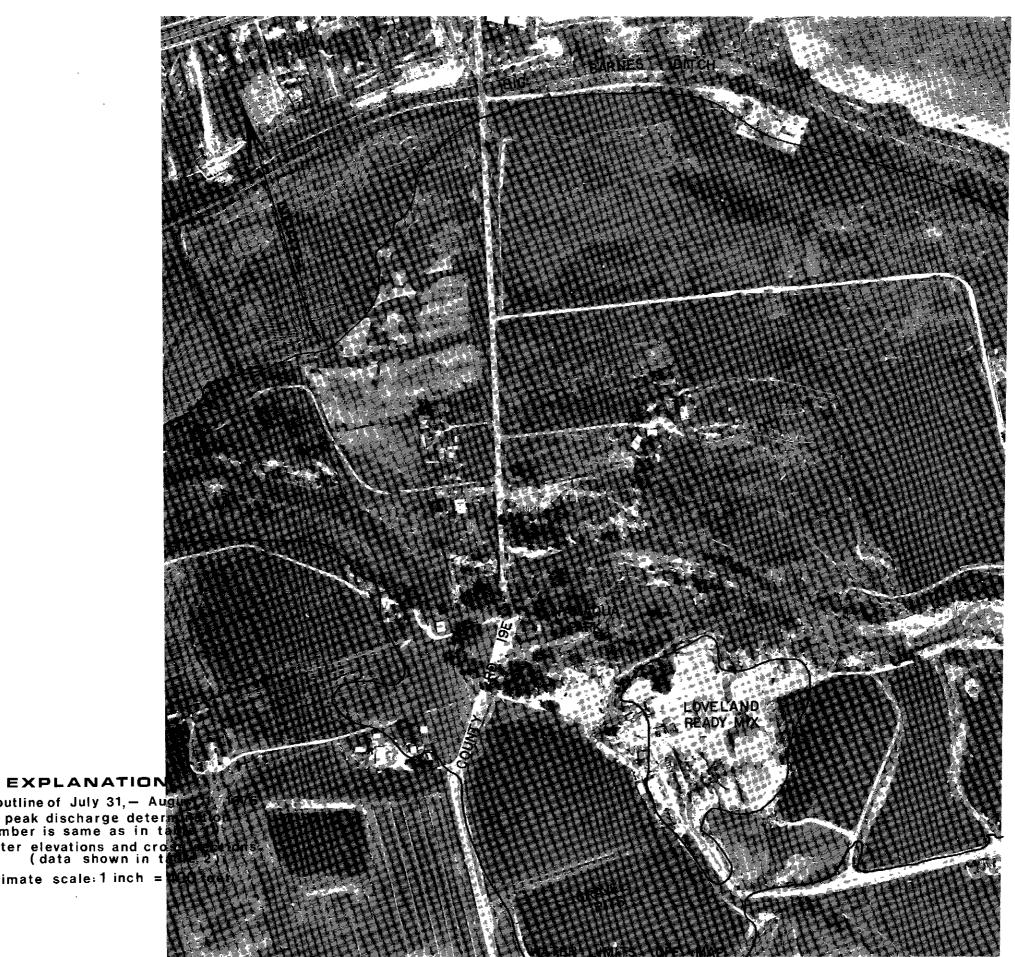
Flood outline of July 31,— August Site of peak discharge determine (number is same as in tall Highwater elevations and cro (data shown in t

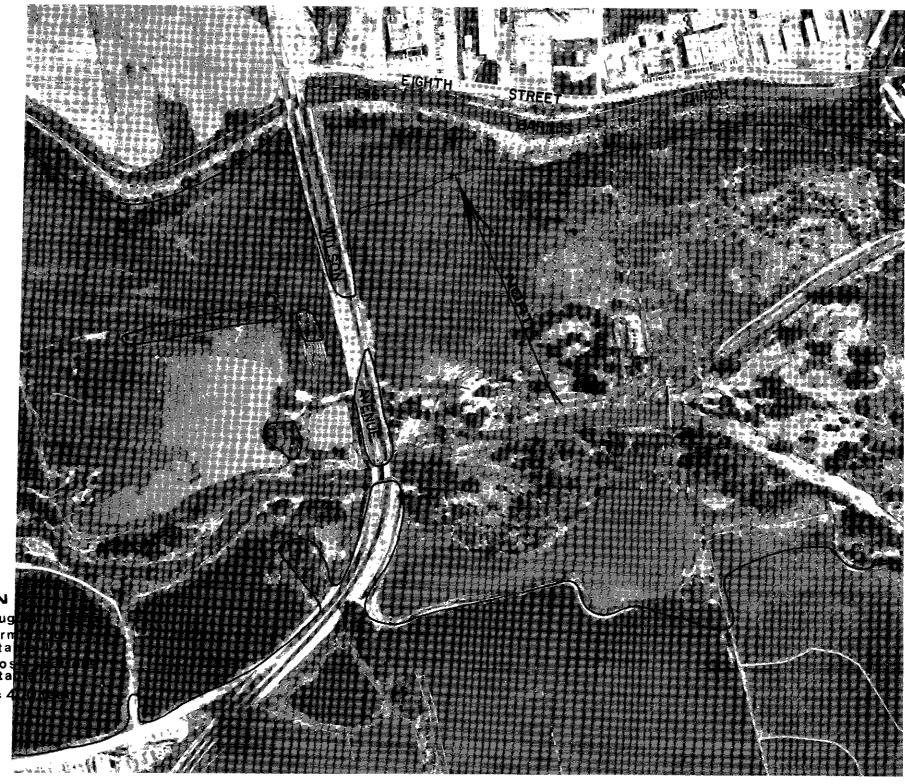
Flood outline of July 31,— Aug Site of peak discharge detern (number is same as in ta Highwater elevations and cros (data shown in ta

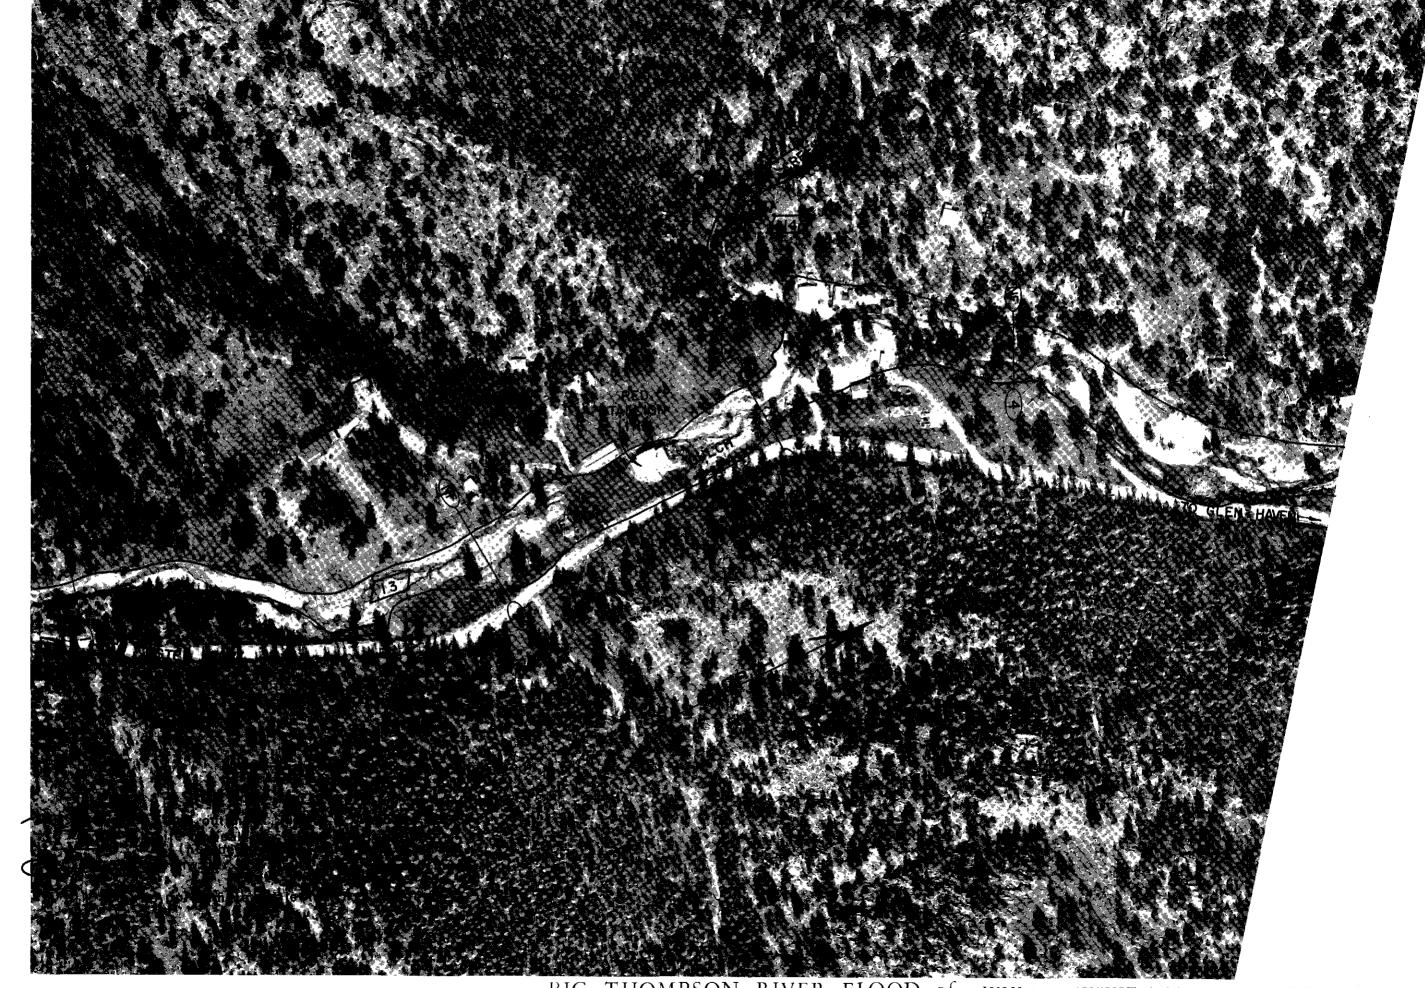
BIG THOMPSON RIVER FLOOD of JULY 31, -- AUGUST 1, 1976 PLATE NO. NF-1

Flood outline of July 31,— August 1, 1976
Site of peak discharge determination
(number is same as in table 1)
Highwater elevations and cross sections
(data shown in table 2)
