CIVIL ENGINEERING DEPARTMENT

NOVEMBER 1968

Completion Report

ARTIFICIAL GROUND WATER RECHARGE ON THE ARIKAREE RIVER NEAR COPE, COLORADO

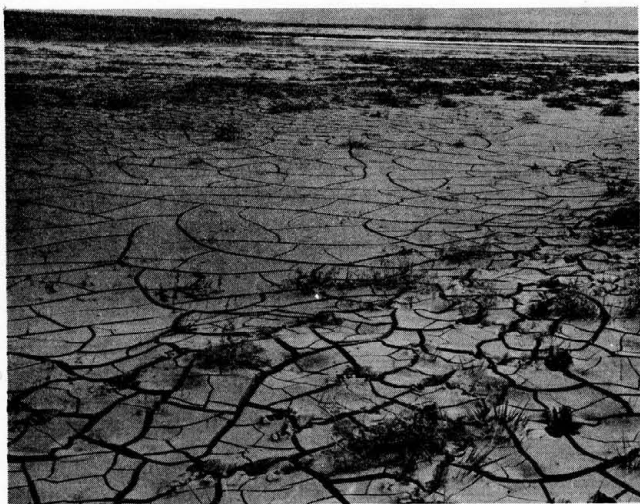
- Figure 6. View across site No. 1 showing deposit of fine clay sediment.
- Figure 7. Water table contour map prior to flow in the river.
- Figure 8. Water table contour map on June 28 after flows in the river on June 16 and 26, 1965
- Figure 9. Map showing the rise in water level between June 16 and June 28, 1965
- Figure 10. Aerial view of site No. 1 on June 18, 1965

Flood waters deposited large volumes of sediment in the recharge area. The coarser material was trapped behind the first structure and finer sediments settled over lower parts of the facility - thus sealing the bed and reducing rates of recharge. Removing these sediment deposits after every flow would be required to maintain high rates of recharge. The flood of July 1965 effectively removed 9-12 inches of sediment, but also removed most of the other structures too.

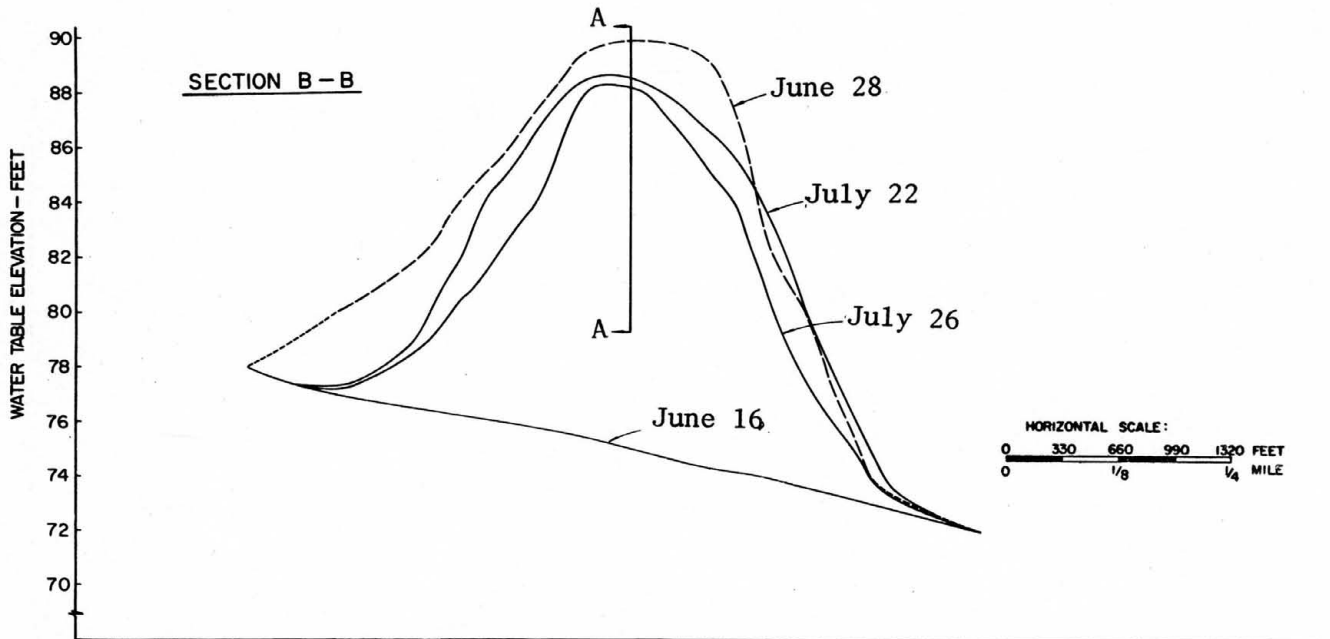
Figure 13. Cross sections for June 16, 28, July 22, 26, 1965

After each flow, a change in saturated thickness map was prepared to show the effect of recharge. A planimeter was used to determine the volume of aquifer that was saturated as the water level rose. Assuming a porosity of 20 percent, the estimated volume of recharge was computed. Table 2 gives dates and amounts of water recharged. Cross sections, Figs. 12-16, show the size and shape of the recharge mounds.

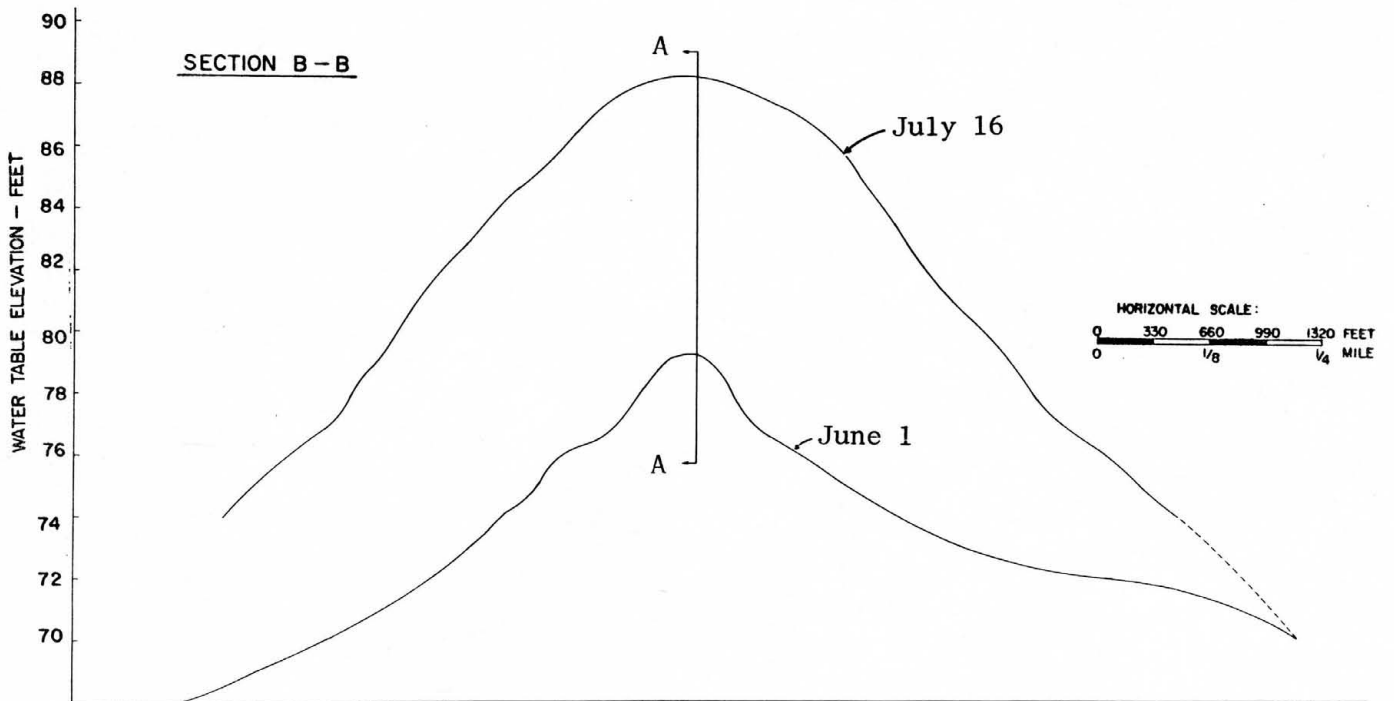
Figure 15. Cross sections for June 1 and July 16, 1967.

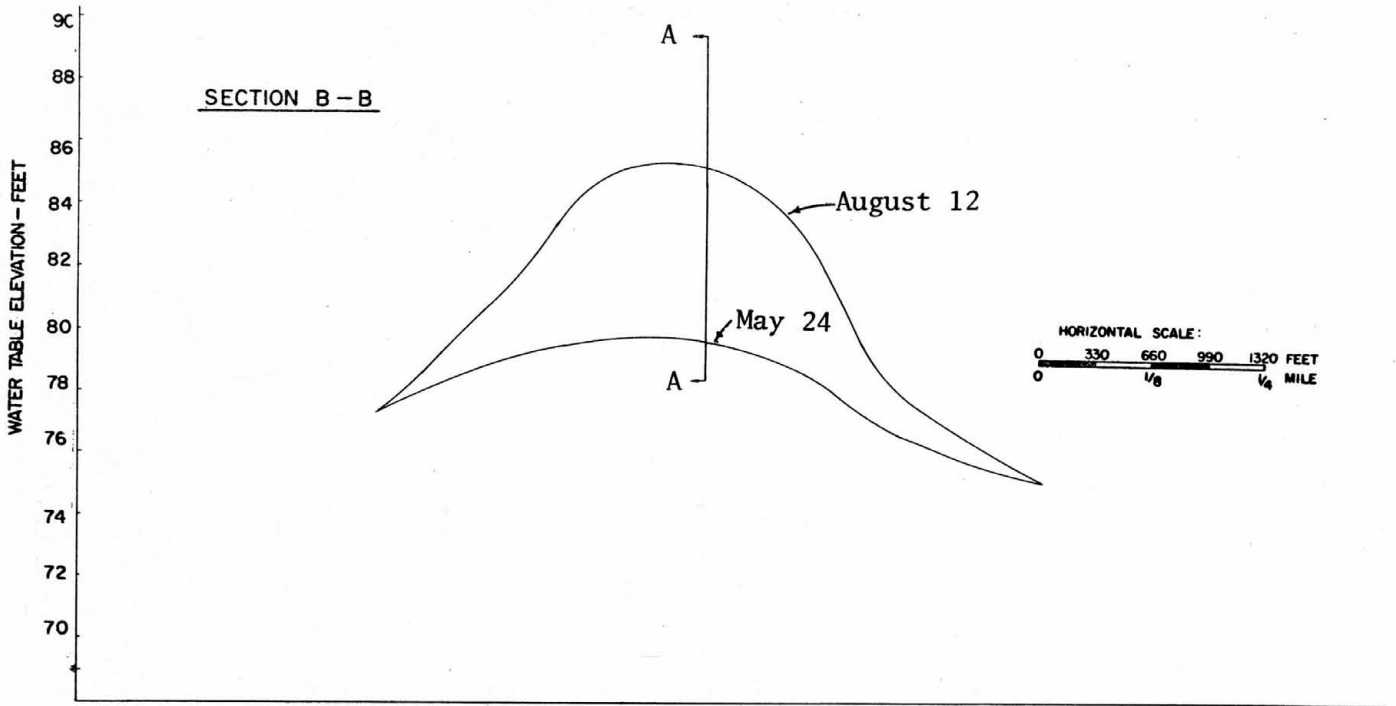
Figure 16. Cross sections for May 24 and August 12, 1968
