WB I-70 Peak Period Shoulder Lane

GEOLOGY AND SOILS TECHNICAL REPORT

October 26, 2018

Categorical Exclusion

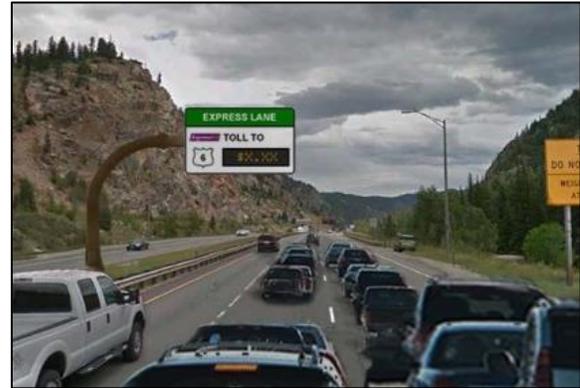
Active Traffic Management. Dynamic signage informs drivers so the WB PPSL is appropriately used to reduce congestion. This innovative design improves mobility.
