## WB I-70 Peak Period Shoulder Lane

# WETLANDS AND OTHER WATERS OF THE U.S. TECHNICAL REPORT

October 26, 2018

Categorical Exclusion

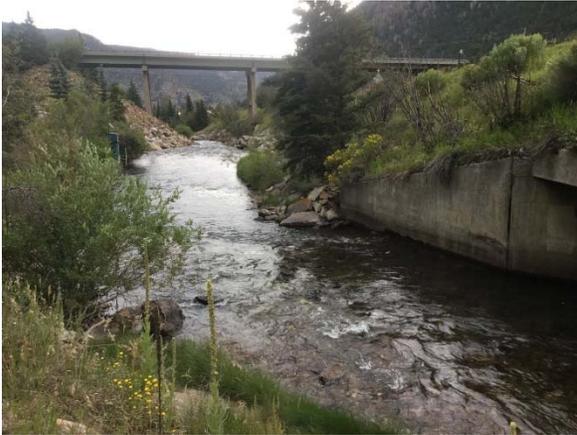
**Photo 1.** Looking northeast at stream S-1H (i.e., Clear Creek) as it flows east through the study area. Note the bridge over Clear Creek is County Road 308.

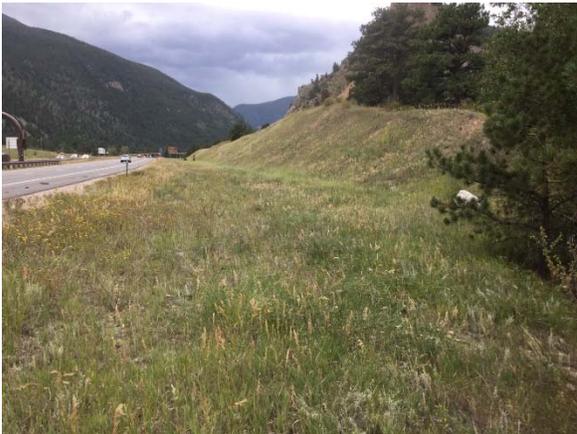
**Photo 2.** Looking southwest across the study area in the western portion of the study area. Note westbound I-70 on the left.

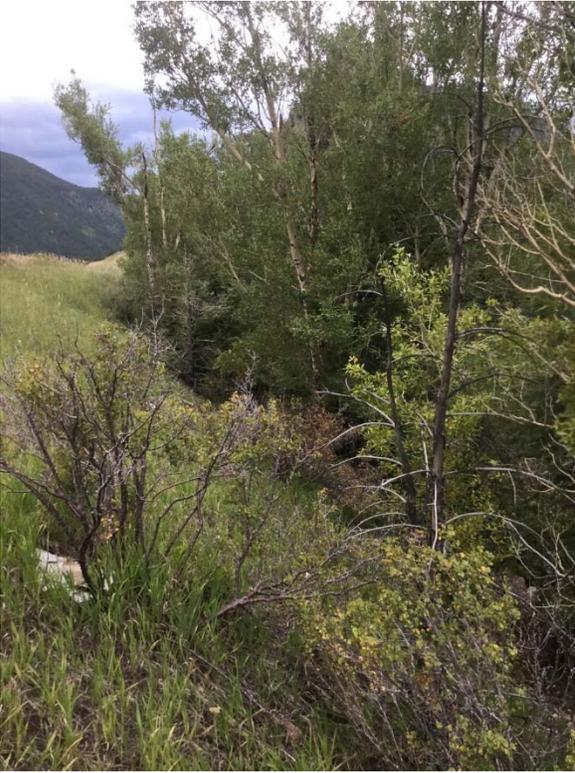
**Photo 3.** Looking west on the north side of I-70 in the western portion of the study area. Note the mature floodplain forest on the right, adjacent to Clear Creek and the steep slope separating I-70 from the floodplain.

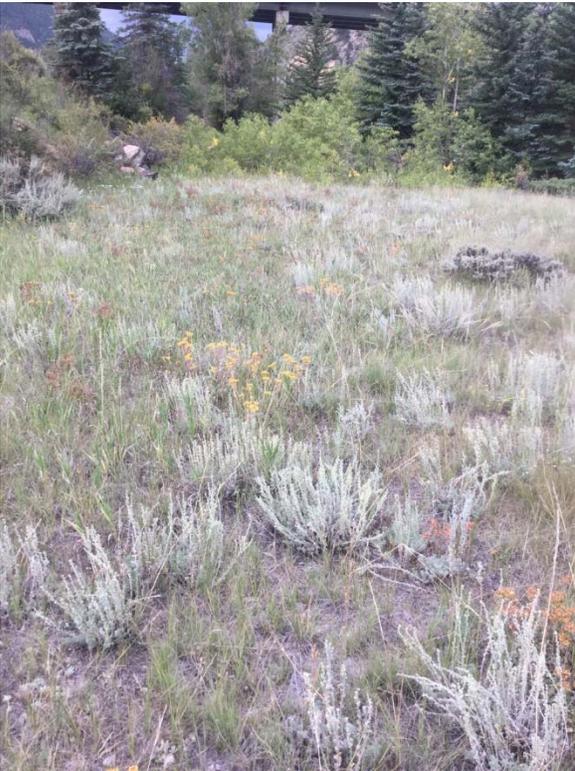
**Photo 4.** Looking southwest at the study area in the western portion of the study area. Note the bridge in the upper background is US 40.

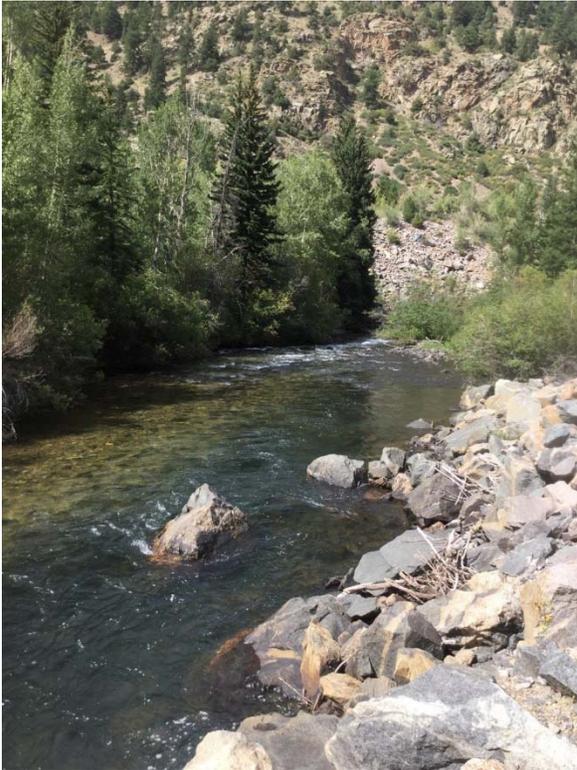
**Photo 5.** Looking north (downstream) at perennial stream S-1G (i.e., Clear Creek) in the western portion of the study area near MP 232.

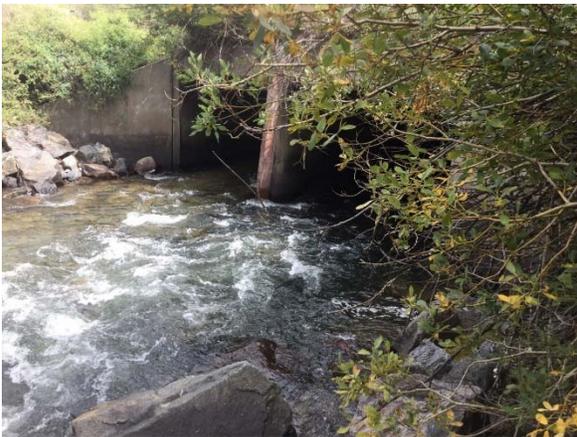
**Photo 6.** Looking southeast at perennial stream S-1F (i.e., Clear Creek). Note the large concrete box culvert that conveys water south and under I-70.

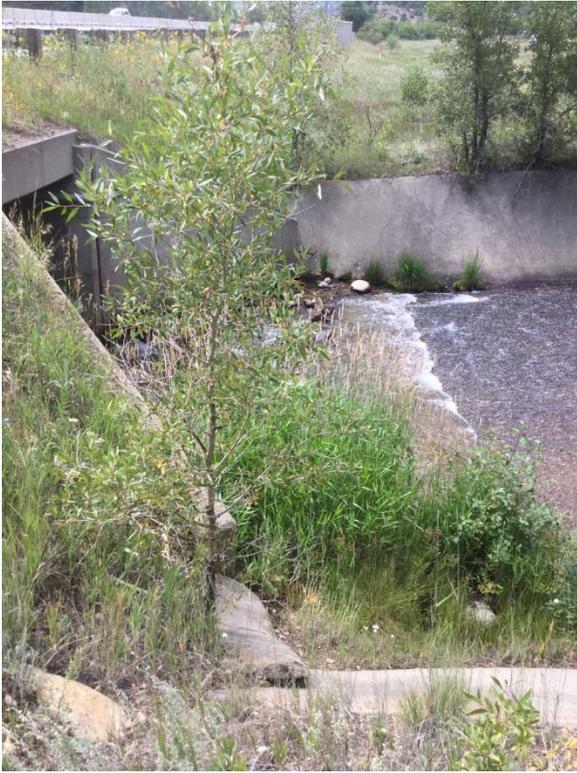
**Photo 7.** Looking southeast at perennial stream S-5 (i.e., Mill Creek). Note the riparian vegetation consisting of narrow leaf cottonwood (*Populus angustifolia*) and reed canarygrass (*Phalaris arundinacea*) growing along the fringe of the concrete-lined drainage.

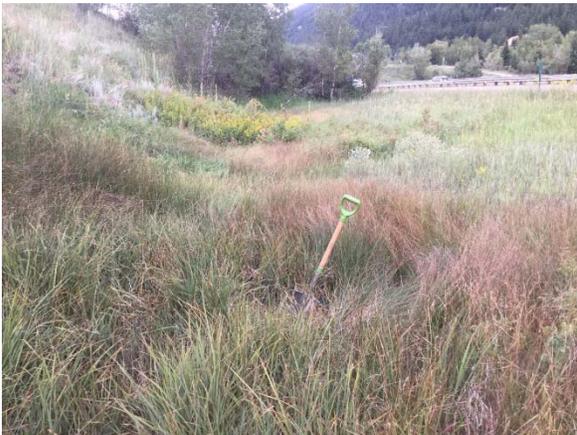
**Photo 8.** Looking east at emergent wetland W-1. The shovel marks the location of wetland data point DP-1. Note I-70 in the right background.

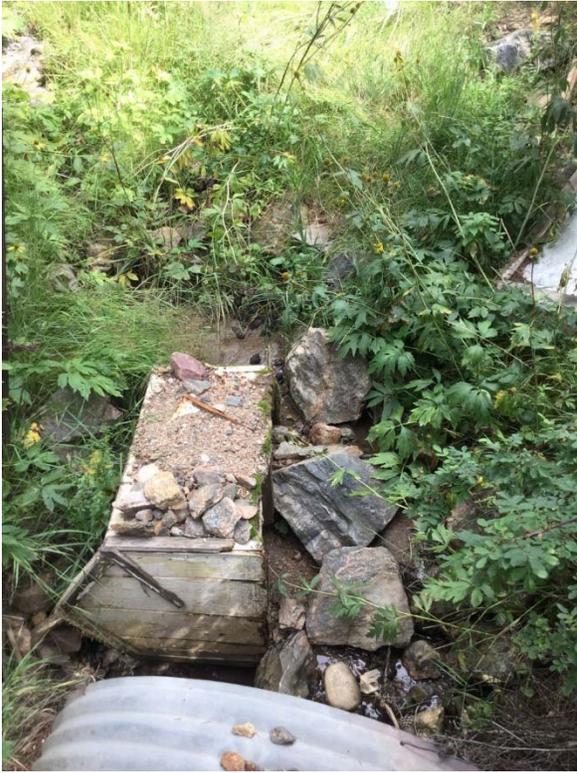
**Photo 9.** Looking north at intermittent stream S-4 (i.e., Spring Gulch) in the middle portion of the study area.

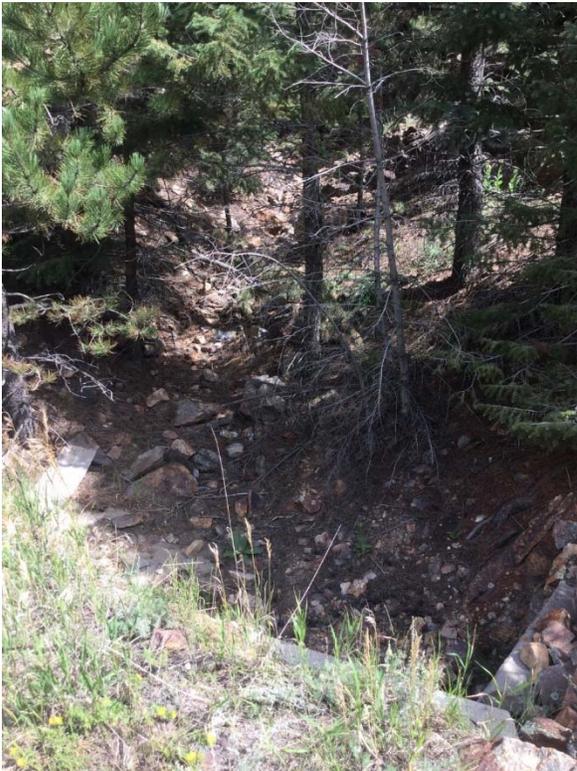
**Photo 10.** Looking north at intermittent stream S-3 (i.e., Georgia Gulch).

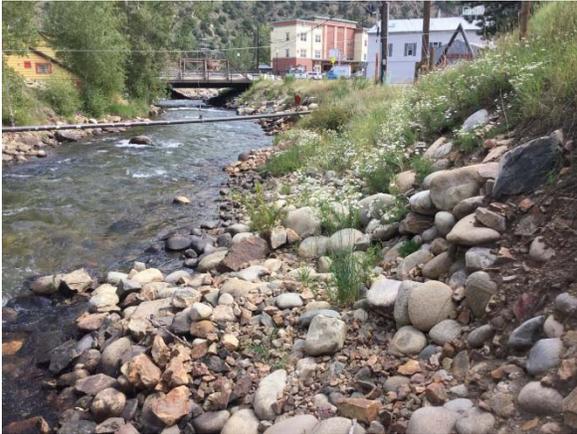
**Photo 11.** Looking north at perennial stream S-1D (i.e., Clear Creek) in the town of Idaho Springs.

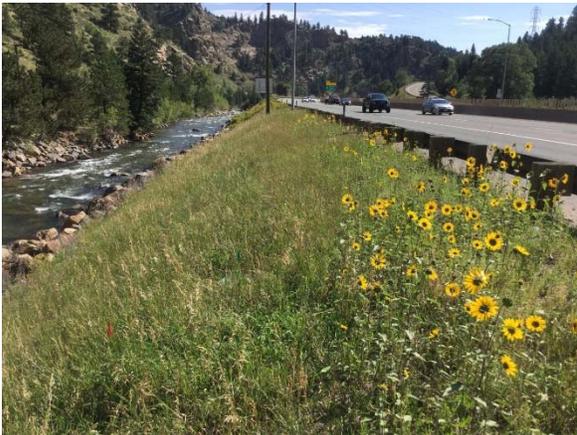
**Photo 12.** Looking northeast at perennial stream S-1C (i.e., Clear Creek) east of the town of Idaho Springs. Note westbound I-70 on the right.

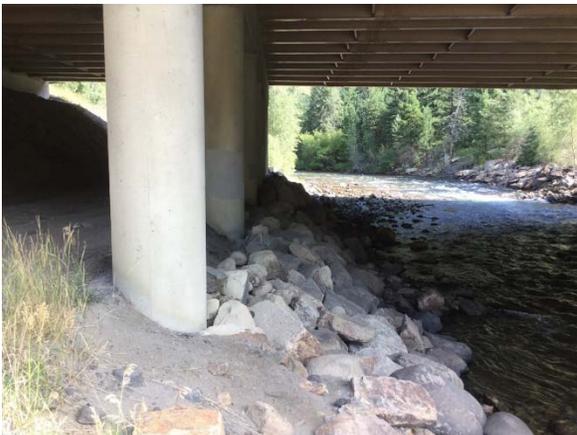
**Photo 13.** Looking northeast at perennial stream S-1B (i.e., Clear Creek) east of the town of Idaho Springs. Note the I-70 overpass and photo was taken on the western bank of the Creek.

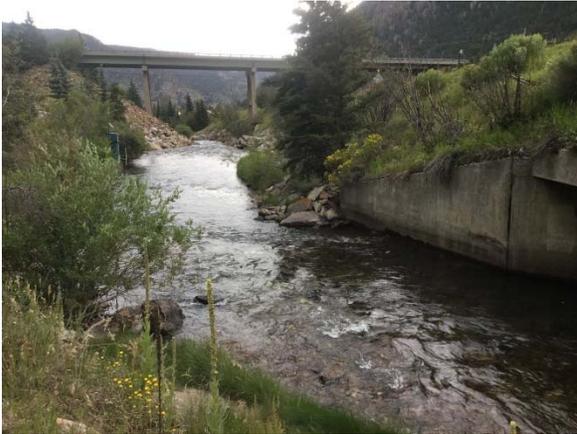
**Photo 16.** Looking northeast at stream S-1H (i.e., Clear Creek) as it flows east through the study area. Note the bridge over Clear Creek is County Road 308.

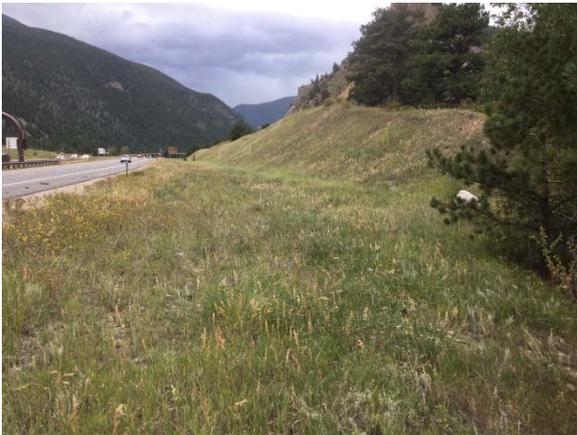
**Photo 17.** Looking southwest across the study area in the western portion of the study area. Note westbound I-70 on the left.

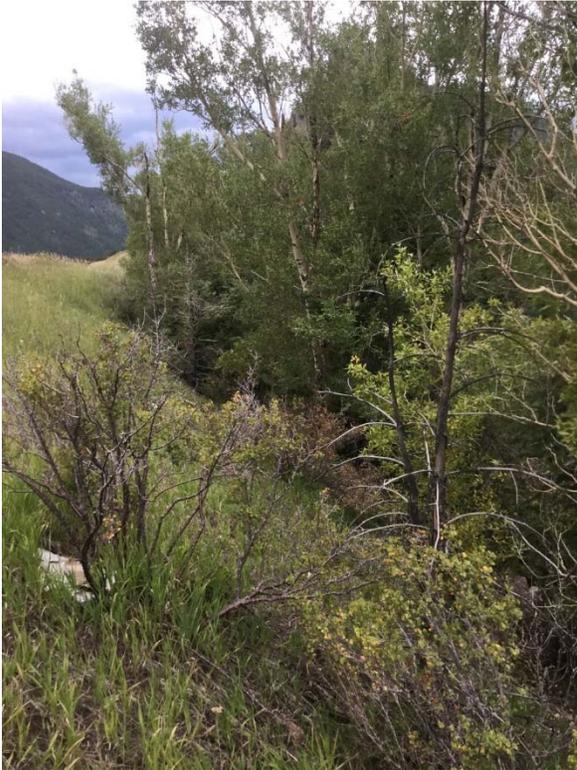
**Photo 18.** Looking west on the north side of I-70 in the western portion of the study area. Note the mature floodplain forest on the right, adjacent to Clear Creek and the steep slope separating I-70 from the floodplain.

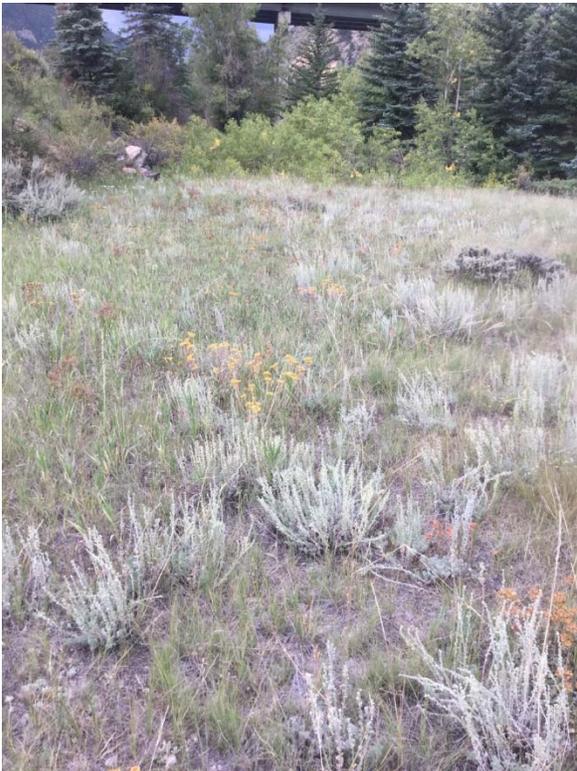
**Photo 19.** Looking southwest at the study area in the western portion of the study area. Note the bridge in the upper background is US 40.

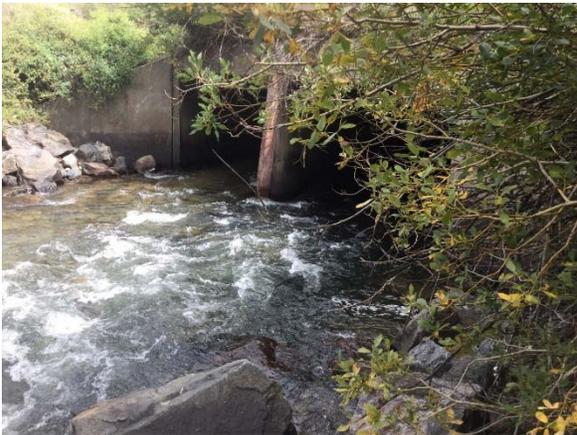
**Photo 21.** Looking southeast at perennial stream S-1F (i.e., Clear Creek). Note the large concrete box culvert that conveys water south and under I-70.

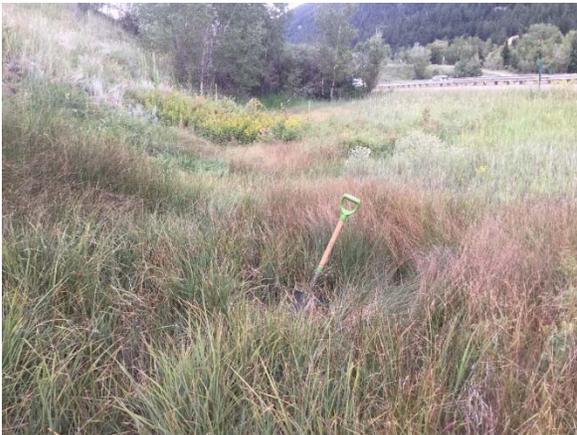
**Photo 23.** Looking east at emergent wetland W-1. The shovel marks the location of wetland data point DP-1. Note I-70 in the right background.

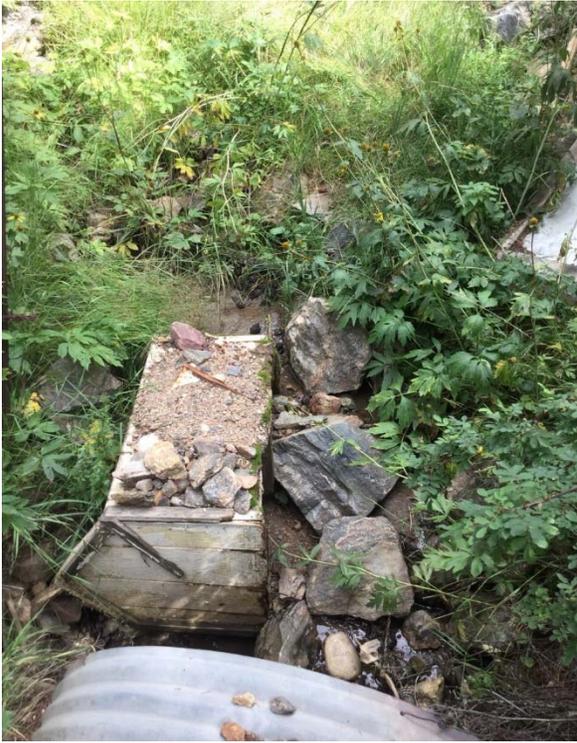
**Photo 24.** Looking north at intermittent stream S-4 (i.e., Spring Gulch) in the middle portion of the study area.

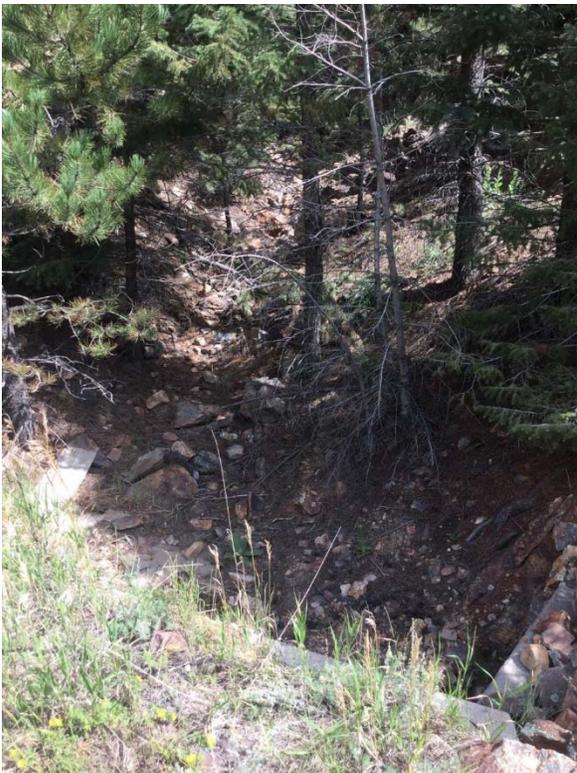
**Photo 25.** Looking north at intermittent stream S-3 (i.e., Georgia Gulch).

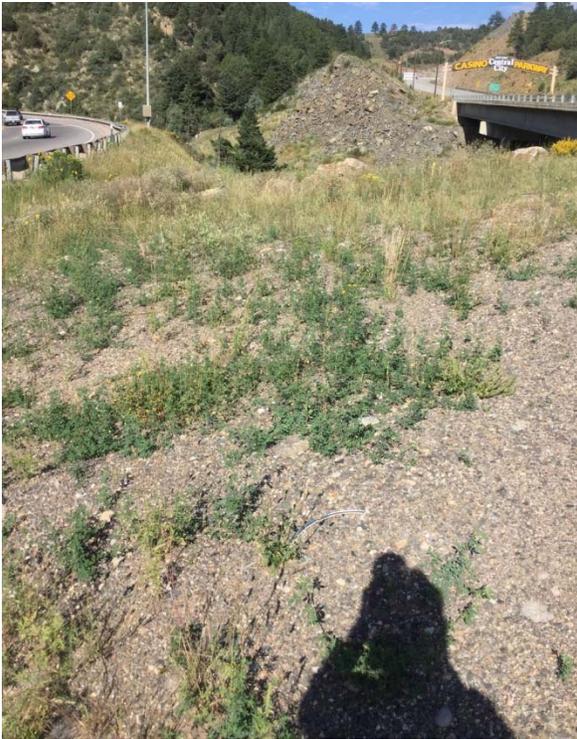
**Photo 30.** Looking west at the eastern portion of the study area. Note Central City Parkway on the right and I-70 westbound lanes on the left.
